Re: Pollution incident for Knockacummer Wind Farm Ltd., TFL00376919

I am a Forest Service inspector, with the Forest Service, with my headquarters at Hibernian house, South Mall, Cork city, county Cork. I inspected the site in Glennakeel South townland, Clonfert East, Kanturk, Co. Cork on the 31-03-2020 (see map 1 and 2).

There is a clearfell harvesting operation in progress. The felling licence number is TFL00376919. The plot being clearfelled and which are relevant to this pollution incident is plot 1.

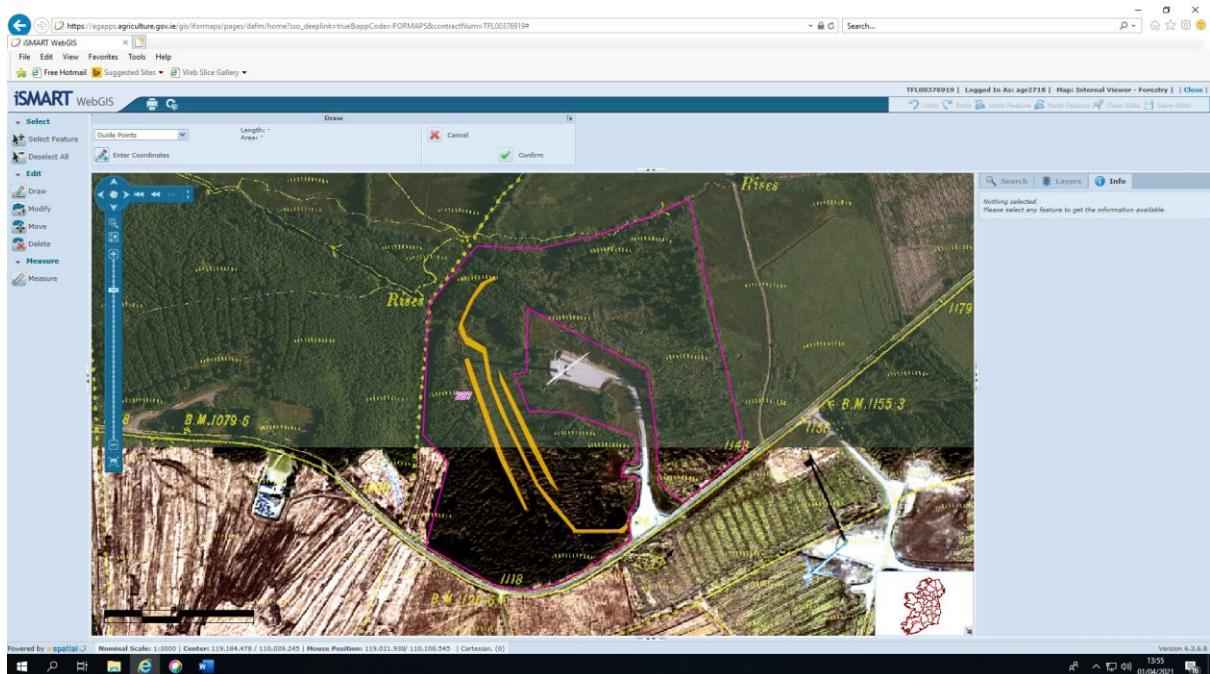
Map 3. The main extraction route is very heavily rutted and is highlighted as the broader orange line running north from the forest road turning area, where the logs are stacked. The approximate pathway of the sediment, flows east in the 1<sup>st</sup> order stream, which joins another stream further east, where they flow south to join with another stream as they exit the forest property. The pathway of the sediment laden water is highlighted in orange/yellow. Secondary extraction routes are located either side of the main extraction route. Locations are approximate.

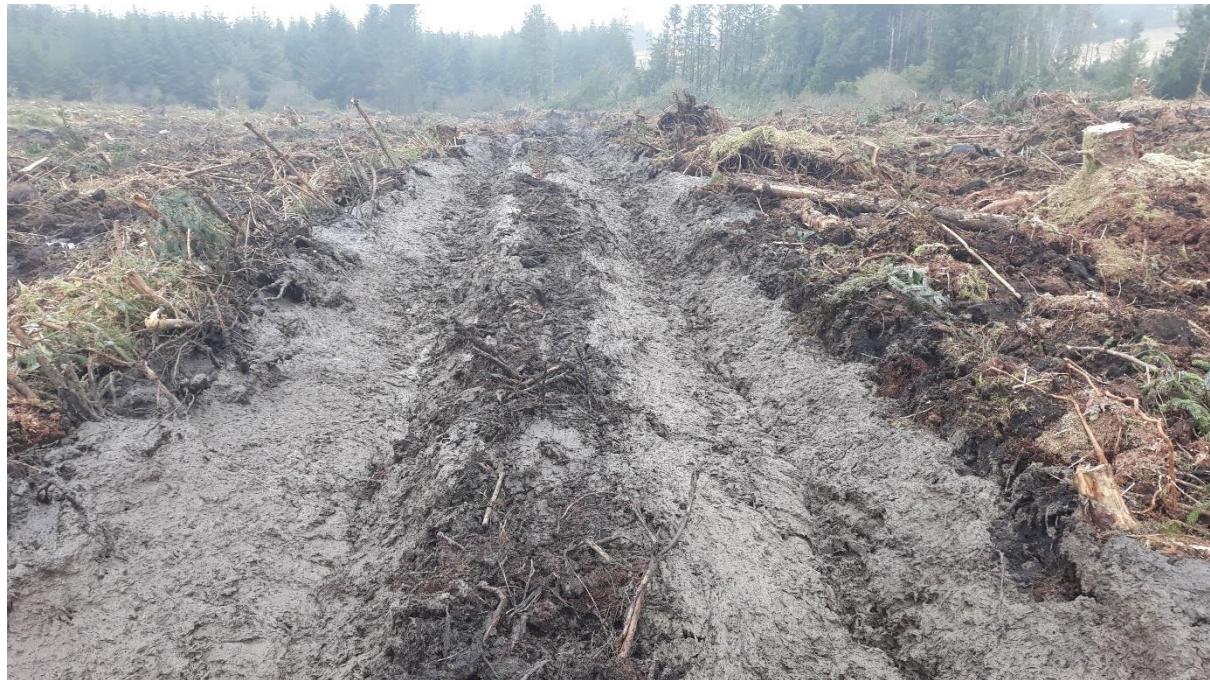
There is very severe rutting of the main extraction route running through the site, from the north-western area of plot 1, to the log stacking area on the southern-eastern boundary (see map 3 and photos 1 to 5). Some of the liquidised soil is entering drains and flowing overland and ultimately entering a first order stream, which originates in the north-eastern area of plot 1 and discolouring the water (Photo 6). The streams flow into the Feale river, approximately 6 kilometres downstream, which is part of the Lower Shannon river sac. The site is within the Mullaghmore SPA for hen harriers.

Photo 1. Very severe rutting of the main extraction route, about halfway from the log stacking area to the stream.

1. Extensive re-brashing of the main extraction route and secondary extraction routes, with brash ramps every 30-40m.

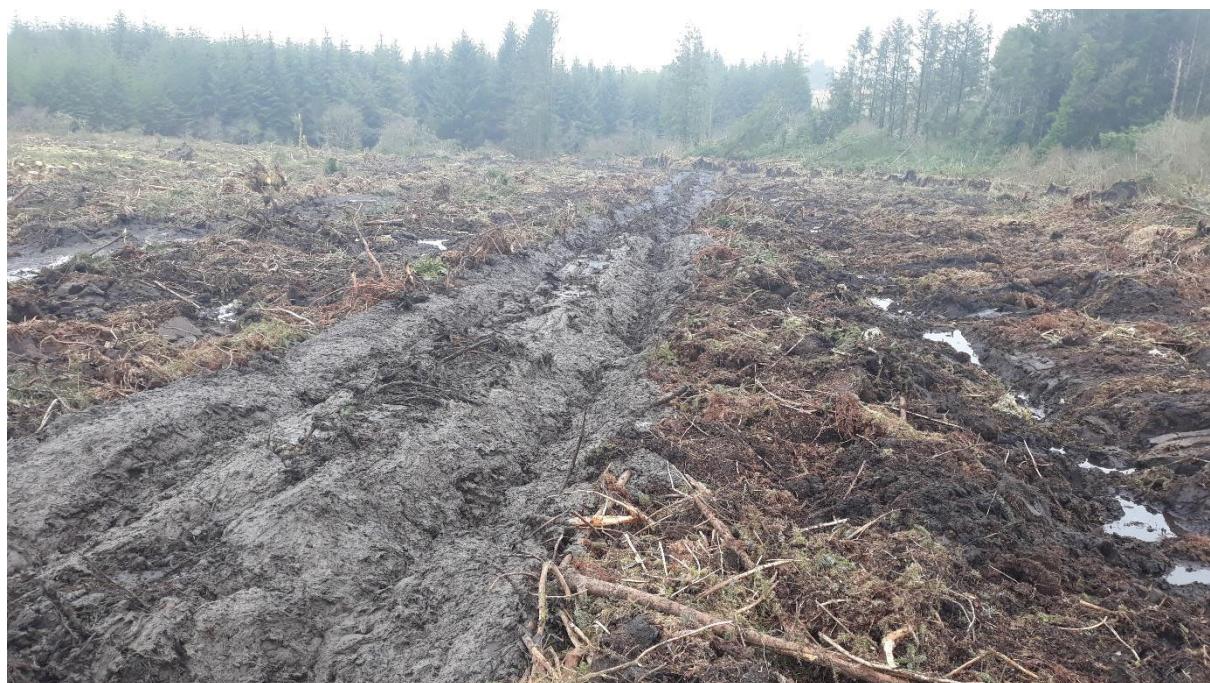
I have requested that my colleague, Mr. Ken Bucke, inspect the site, to determine any additional mitigation measures. Due to the moderate slope and large amount of unconsolidated peat/rutted extraction routes, there is a very high risk of peat flowing down the slope and into the stream. The applicant should be instructed to stop all further extraction activity, until the damage is corrected and adequate remedial mitigation measures are put in place, namely:

Photo 2. Very heavy rutting of the main extraction route, further north than photo 1. The peat soil either soil is disturbed and unconsolidated. There is a high risk of peat sliding after heavy rain.

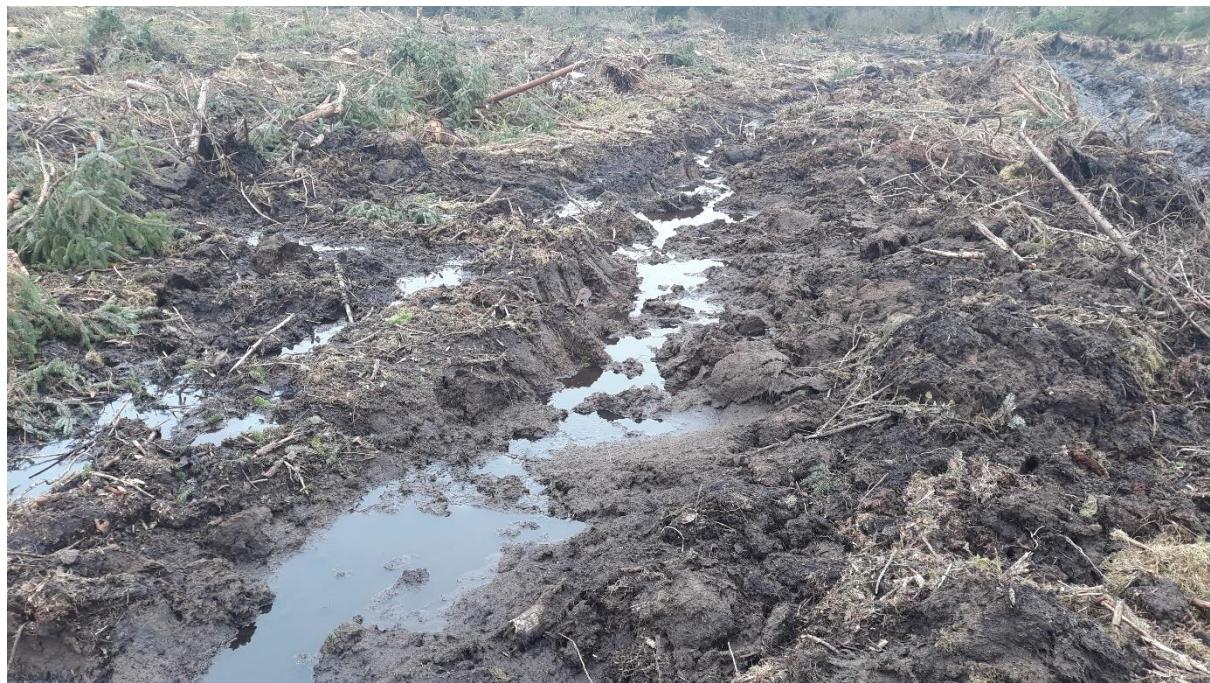
Photo 3. Liquidised peat soil beside one of the extraction routes. The 1<sup>st</sup> order stream is located in the background of this photo. There is overland flow of water from this area towards the stream.

2. Installation of a geotextile silt barrier erected along the area to the south and east of the stream. A barrier won't hold up to the weight of peat and water after heavy rain, so more long term measures also need to be put in place.
3. Physically removing large deposits of liquid soil, which will flow into the stream, when it rains and depositing them away from any possible pathways into the streams.
4. A reinspection takes place by inspectors to ensure remedial mitigation measures are put in place and effective.
5. Any other measures requested by the Inland Fisheries inspector (Mrs. Jane Gileran).

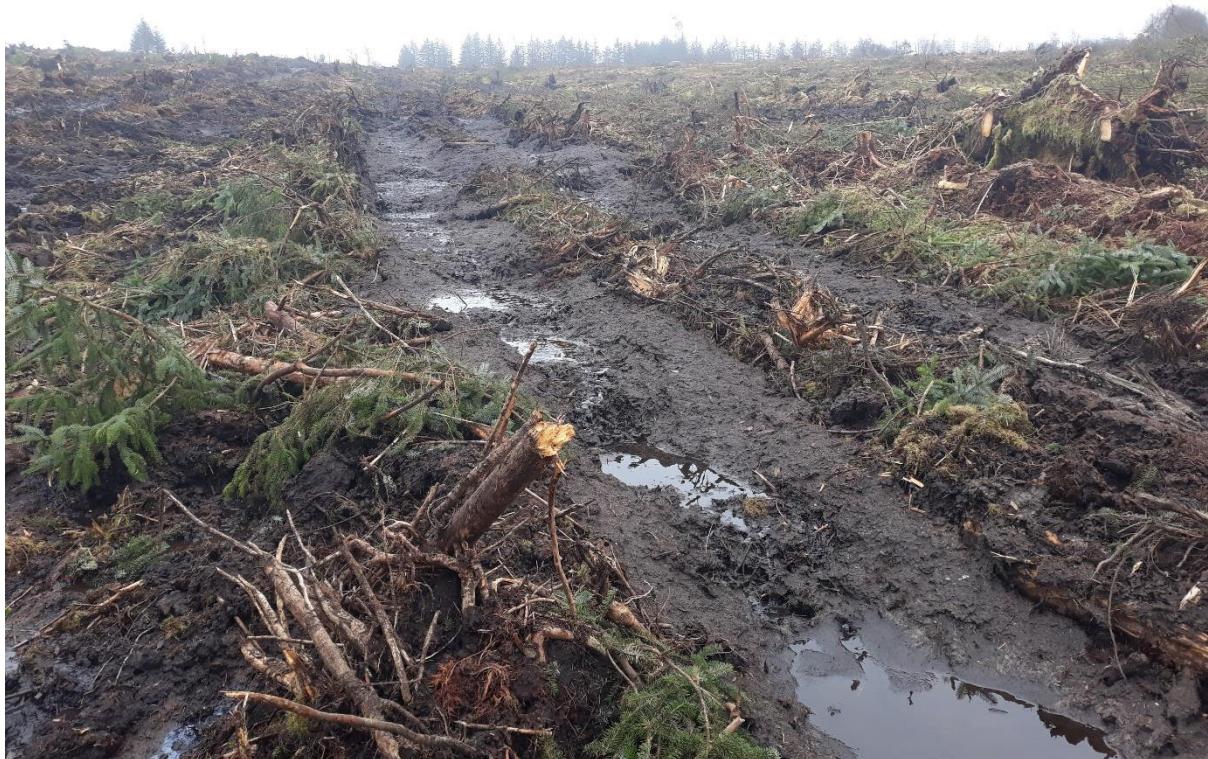
Photo 4. Previously used extraction route, to the west of the current, main extraction route. Very extreme rutting. It is impossible to walk safely across this area, as the soil is liquified. This area represents a large potential source of pollution, if it rains and starts flowing off the site.

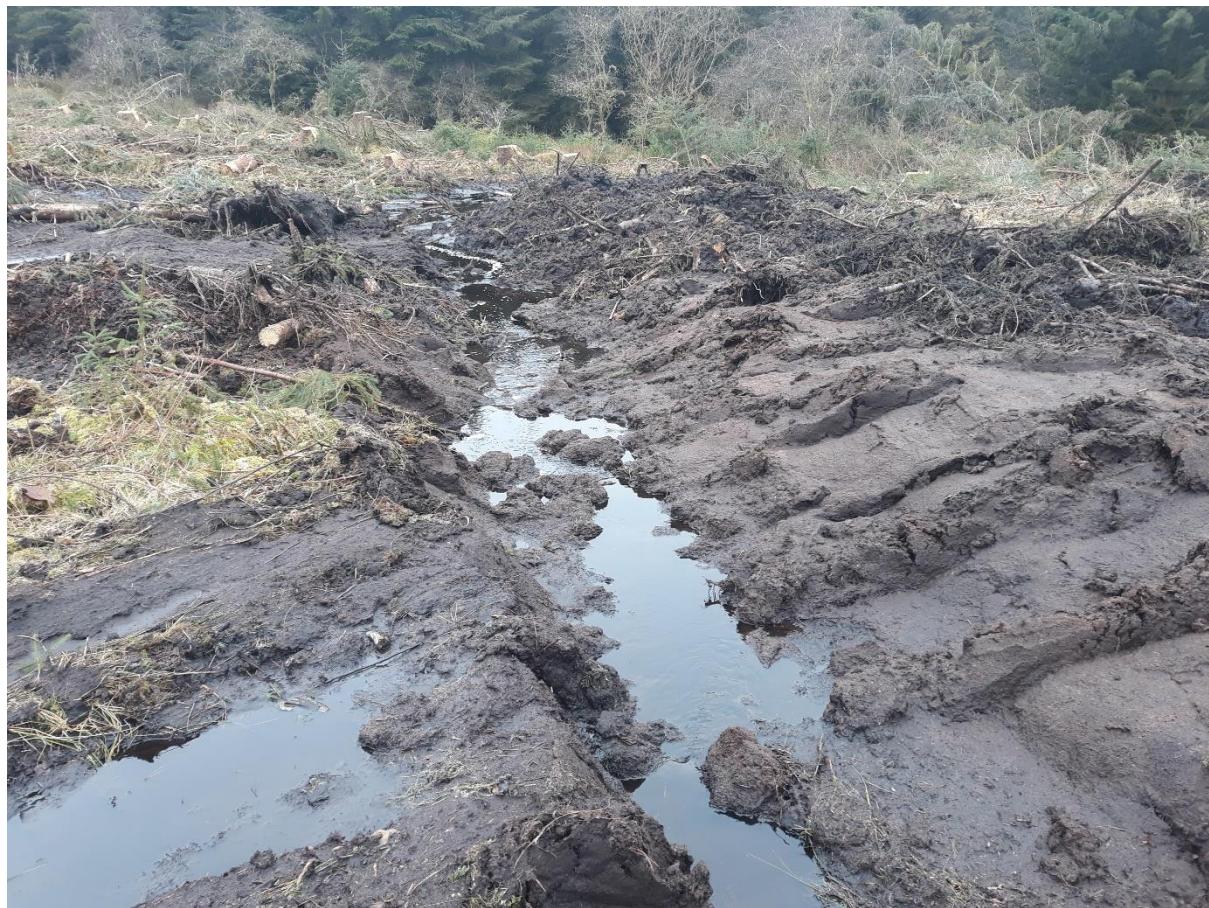
Photo 5. Large area of disturbed, unconsolidated peat immediately to the south-east of the stream. The water flowing in this photo flows directly into the stream which is located to the right of the background.

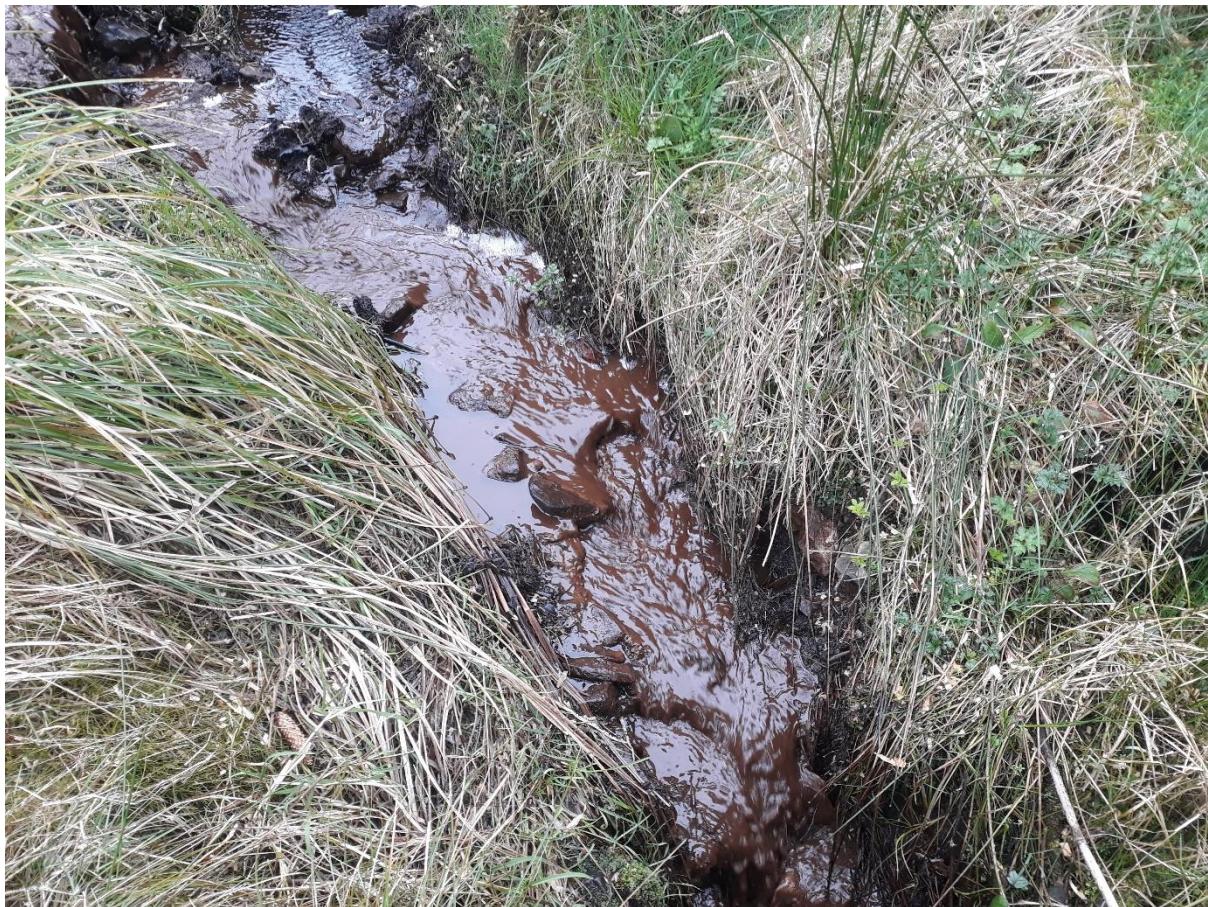
Photo 6. Badly discoloured, silt laden stream flowing west out off the site.
