Prepared by:

Engineer, OPW, South West Region Maintenance.

July 4th 2012. Amended July 10th 2012.

Summary.

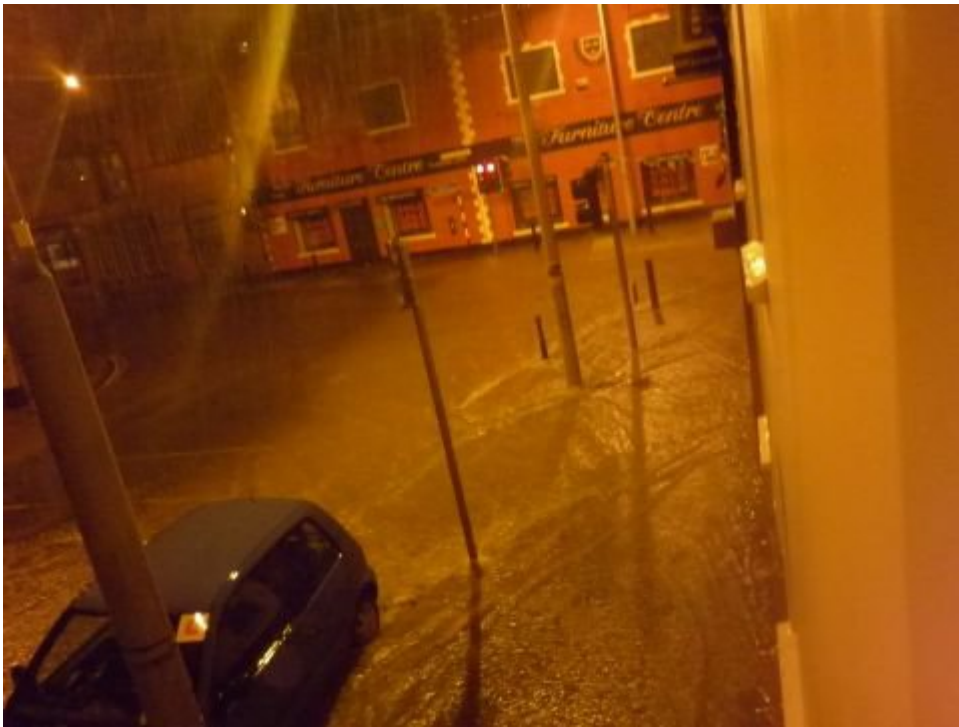
View looking east towards Watercourse Rd, on O Connell Street.

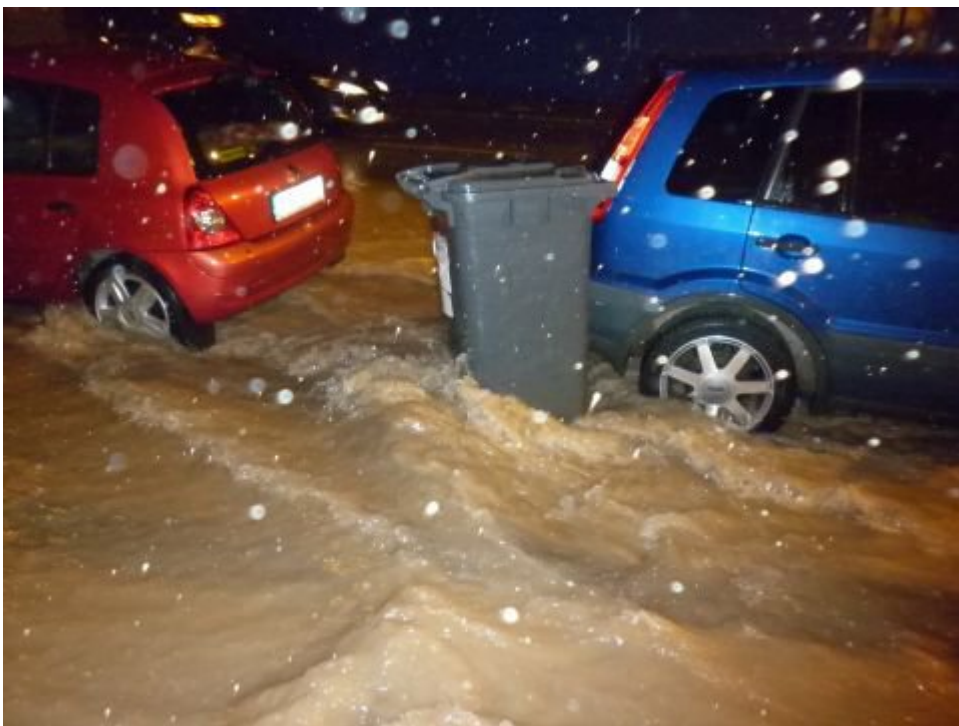
View from front door of property, looking across footpath to parked cars on O Connell Street

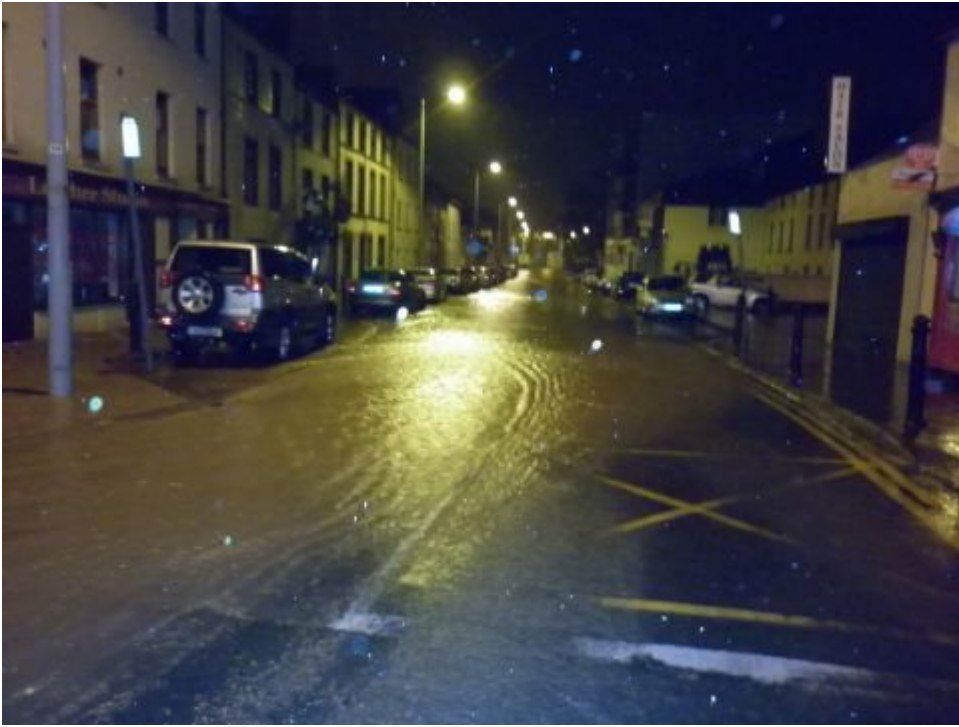
View looking south on Watercourse Rd from junction with O Connell Street.

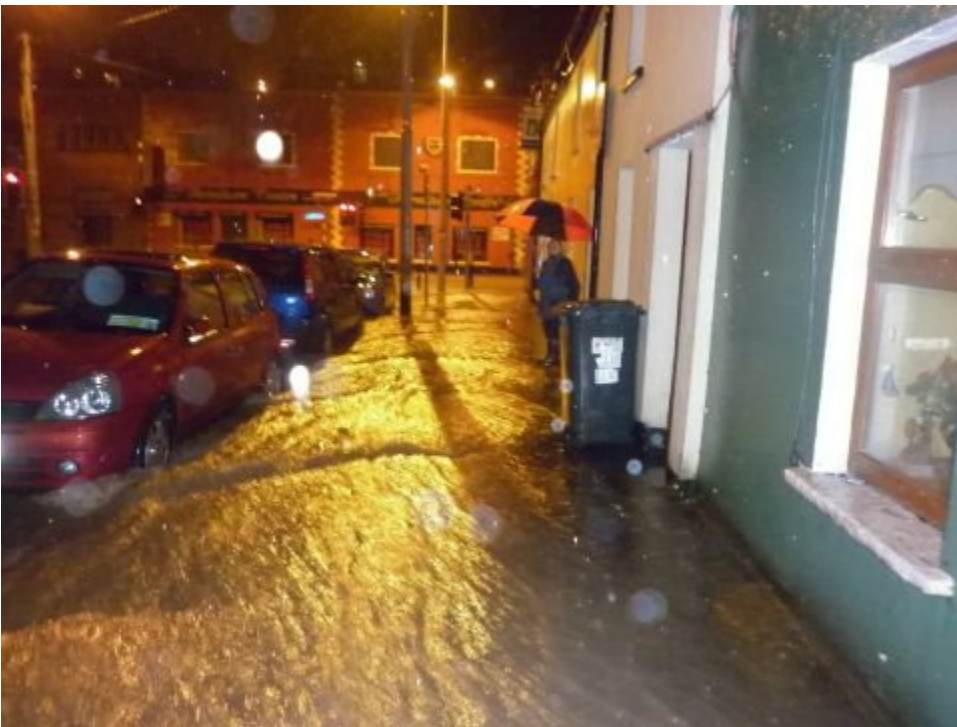
View looking down footpath on O Connell Street towards Watercourse Road.

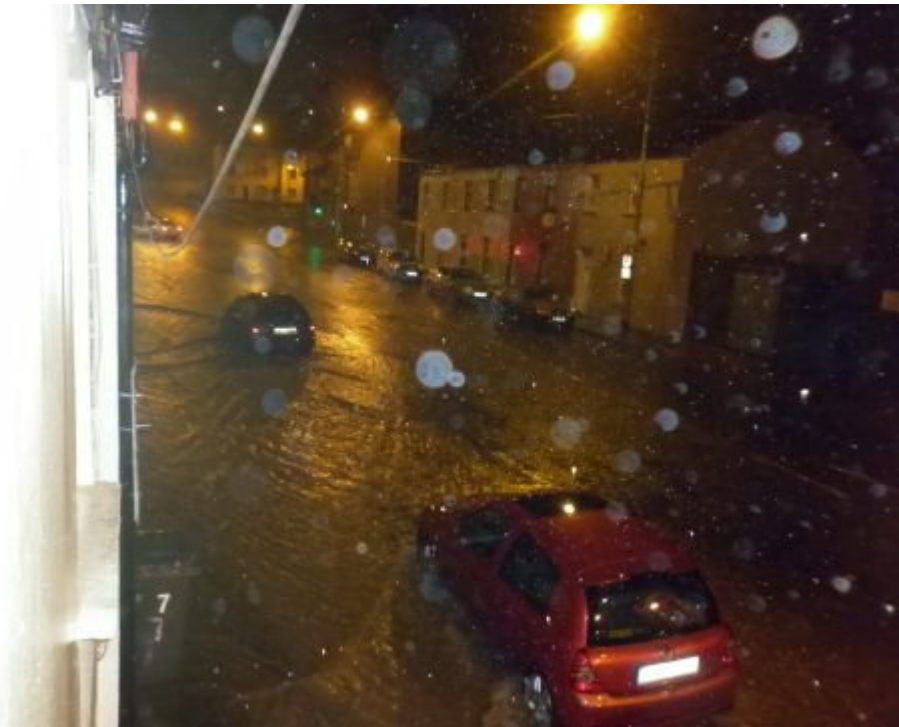
View looking up O Connell Street.

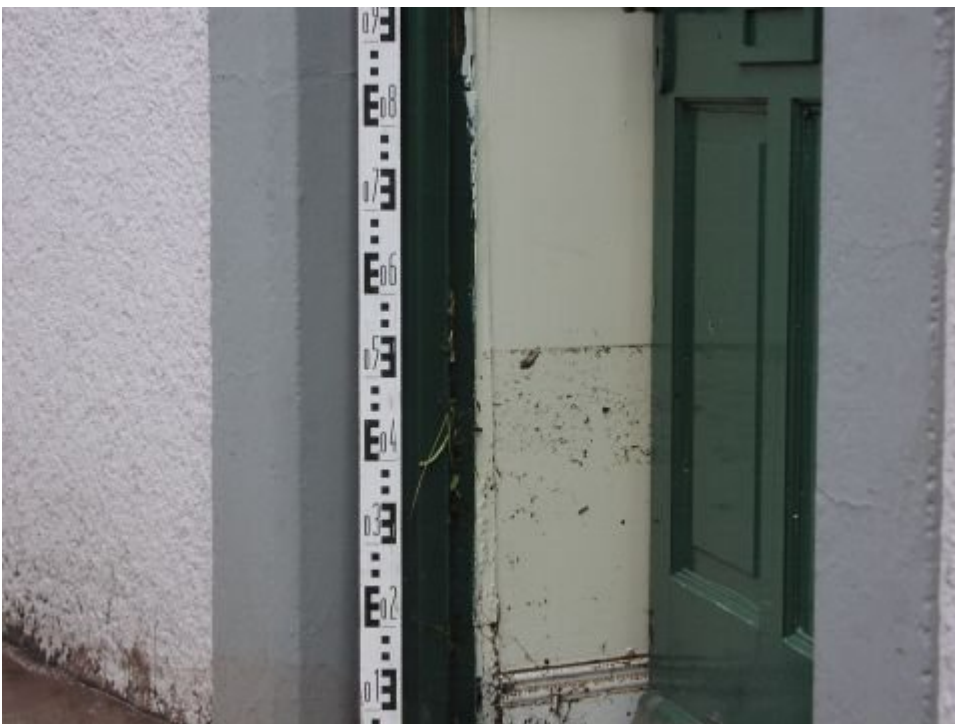
View showing depth of flooding in a house in Thomas Davis Street, (just over 0.5m).

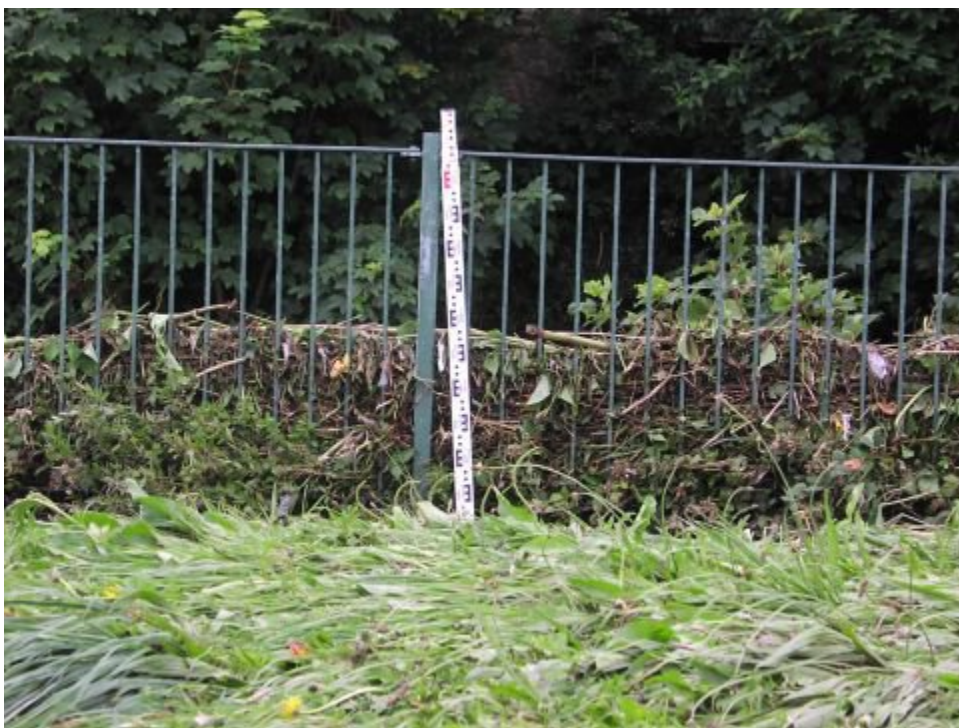
View showing depth of flood debris caught in railing along River Bride in Orchard Court (about 0.6m)

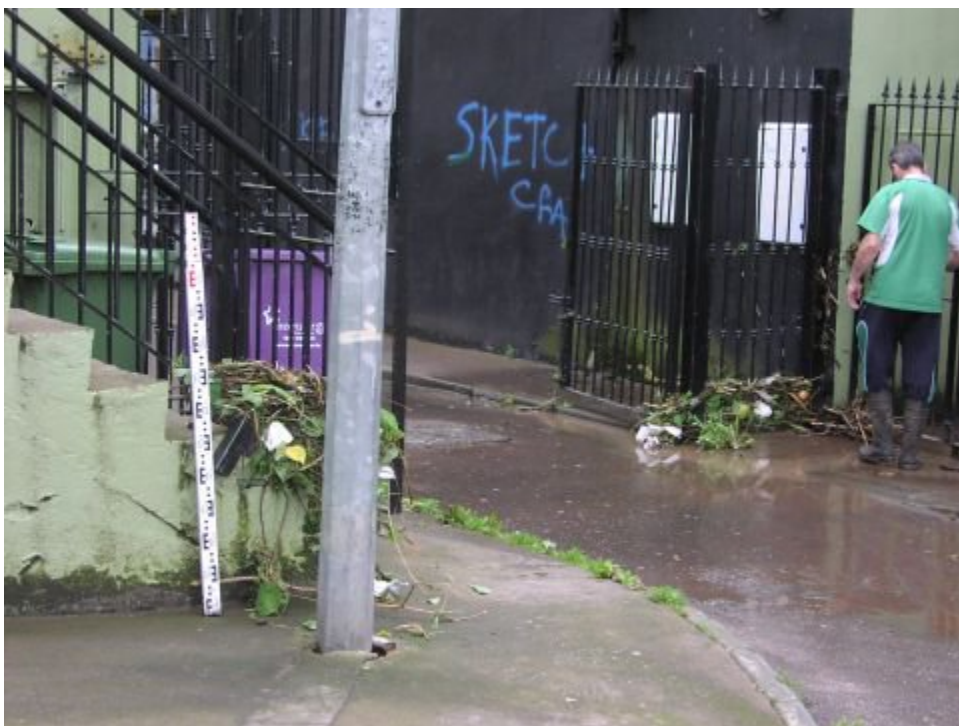
View showing debris indicating depth of flood at exit from Orchard Court car park to Thomas Davis Street.

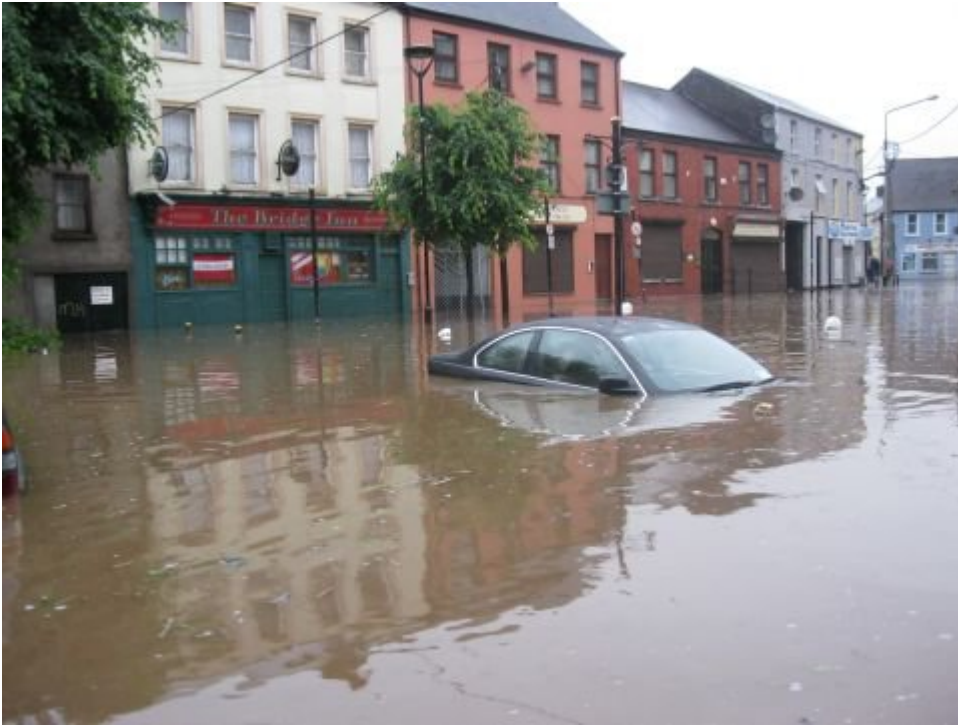
Flooding on Great William O Brien Street at about 5.00am

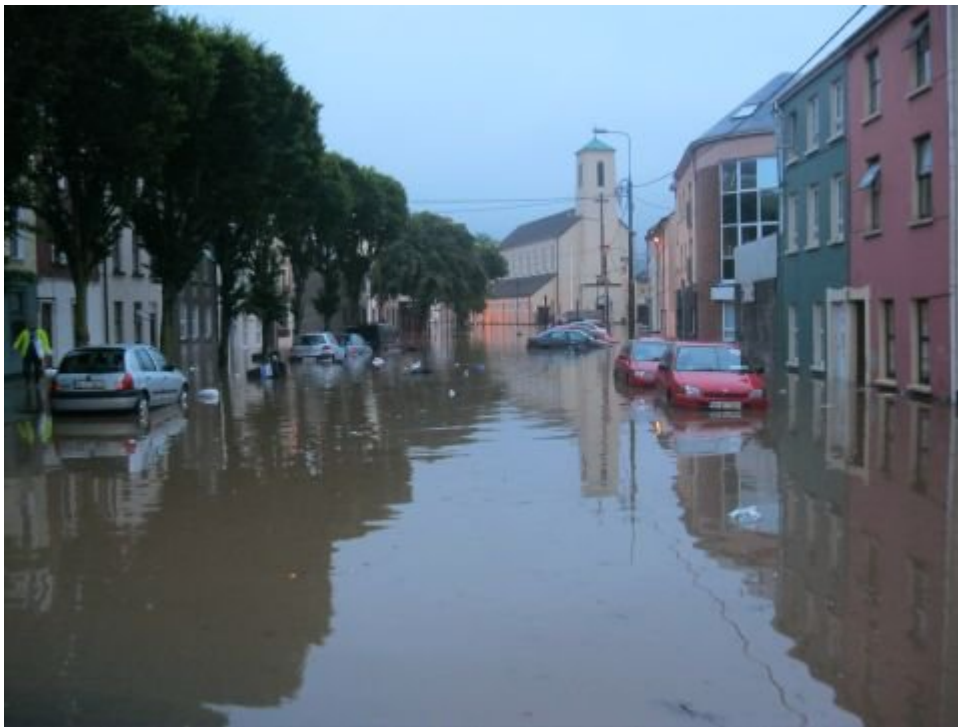
Flooding on Great William O Brien Street at about 4.15am

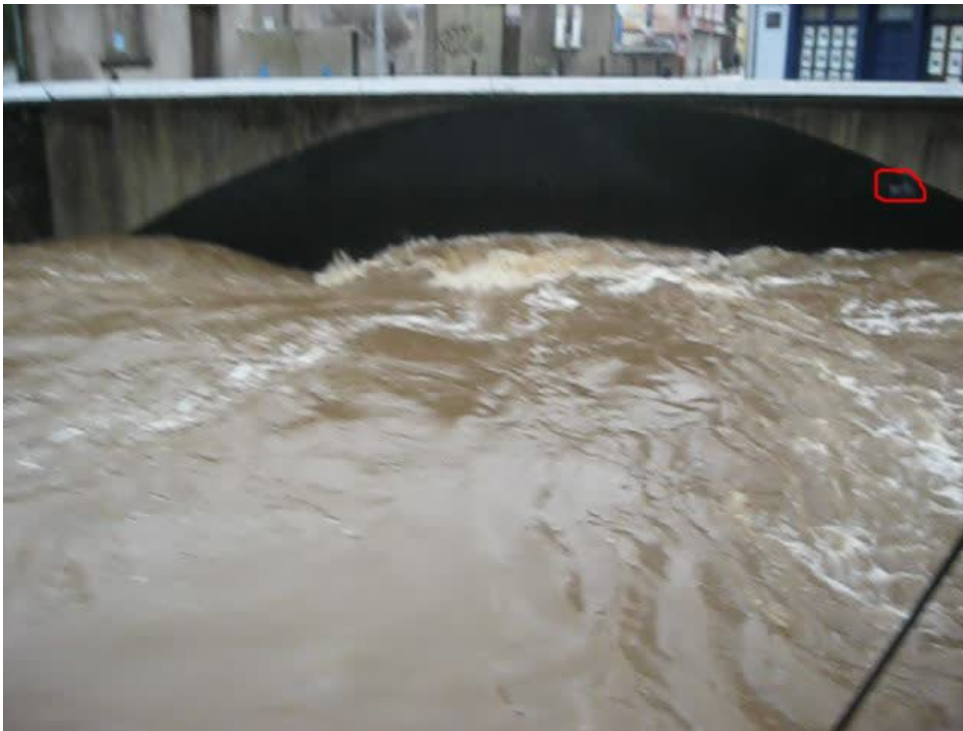
- **Blackpool Village.** Flooding was from the River Bride. The cause of flooding is considered to be culverts both at Orchard Court and south of Blackpool Church that were not capable of conveying the flood waters in the Bride River. It is not considered that there were any blockages in these culverts during the flood. This opinion is based on video footage of the flood at both culverts that was made available to me by a member of the public as well as a discussion with senior engineer who witnessed the floods at these locations at what is believed to be about the time of the peak flood level. The video footage was recorded about 5.00am to 5.20 am while the engineer witnessed the flooding at about 4.00am to 4.30am. (It is possible that flooding here could have been contributed to by the flow from Spring Lane along Thomas Davis Street.)

Entrance to Culvert adjacent to Blackpool Church. This view is a still from a video taken about 5.00 am. I was advised by a Senior Engineer from Cork City Council that the flood at this location was observed earlier at the level of the graffiti on the headwall of the culvert (ringed in red). This would be about 1.2m above the soffit level of the culvert, or at a level of about 8.7m O.D. Malin, based on Lee CFRAMS Channel & Cross Section Survey (7BRI_0). See following photo for clarification.

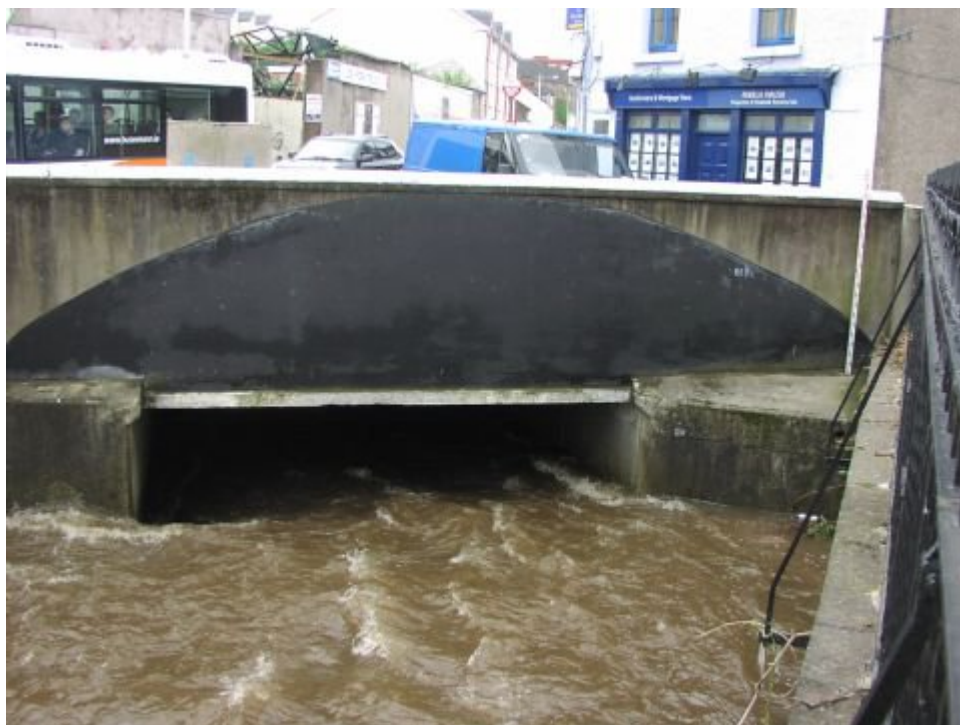
View of culvert at Blackpool Church with flood level reduced. Note staff in right of photos used to give estimation of height of Graffiti mark above soffit.

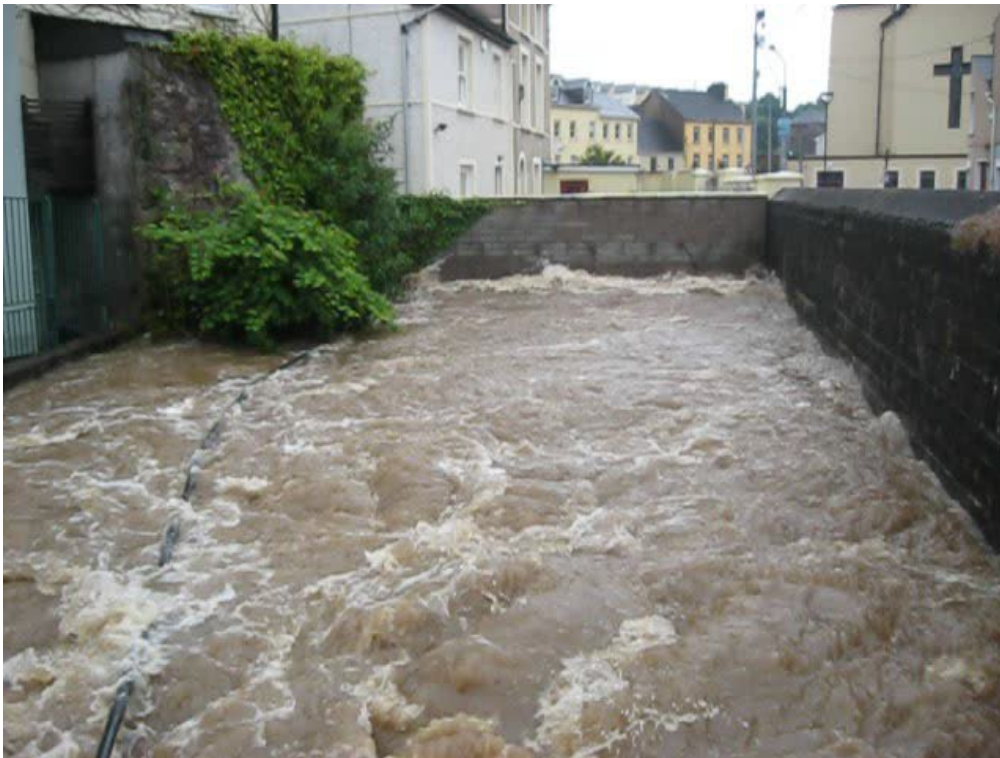
It was pointed out to me that on this occasion both the culverts at Orchard Court and adjacent to the church were clearly overwhelmed by the flood, but that on a previous occasion in about 2001, the culvert at the church clearly had spare capacity while the culvert at Orchard Court was overwhelmed. (It may have been the case there was a blockage in the Orchard Court culvert on the previous occasion.)

Entrance to culvert at Orchard Court. This view is a still from a video recorded at shortly after 5.00am. As with the culvert at the Church, I was advised that the flood had been observed earlier at a level of 10 blocks down from the top of the wall. See following photo.

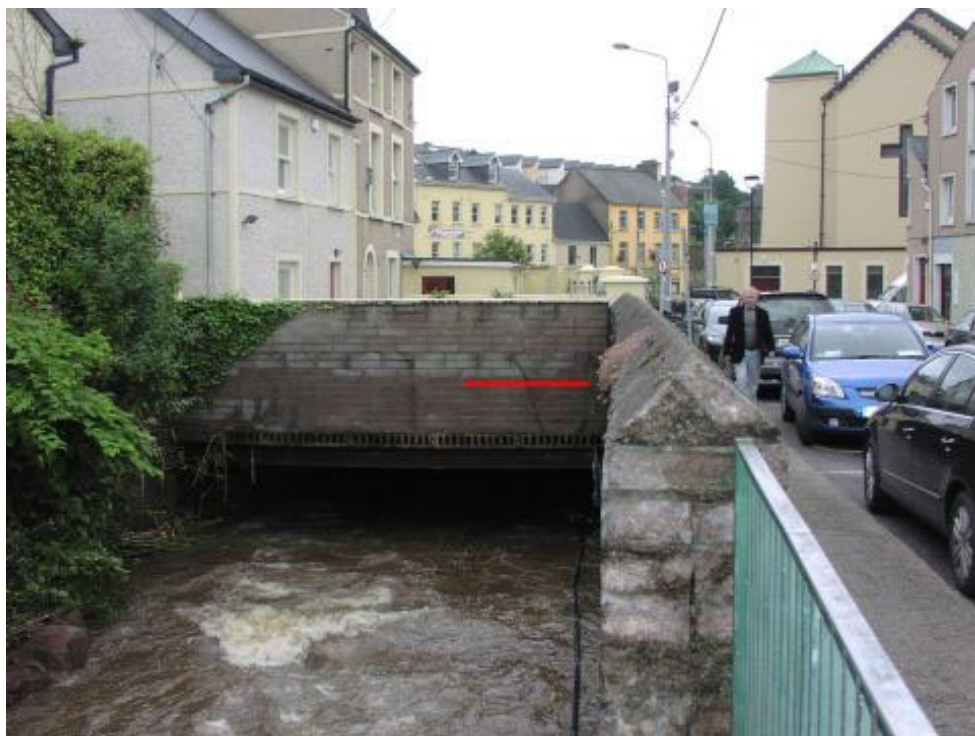
View of entrance to Orchard Court culvert after flood level reduced. Red line indicates level described as observed earlier. Based on Lee CFRAMS (7BRI_93) survey drawing this approximates to a level of about 9.4m OD Malin, and it is about 1.1m higher than the soffit level of the culvert entrance.

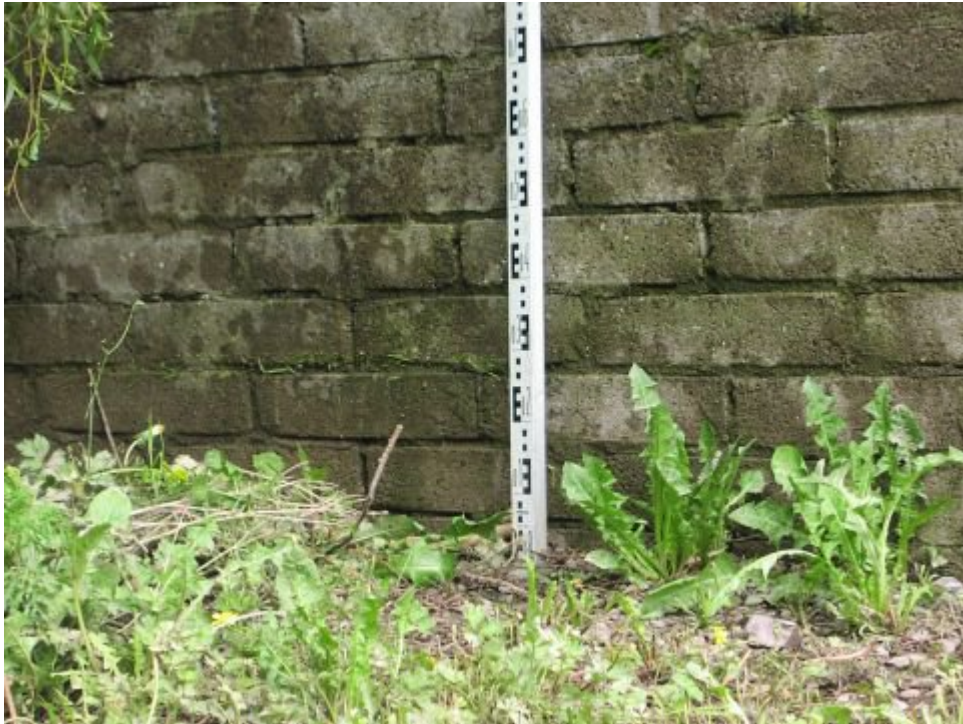
Photo showing tide line at about 0.27m on staff on inside of wall at exit from hotel grounds near north end of flood extent

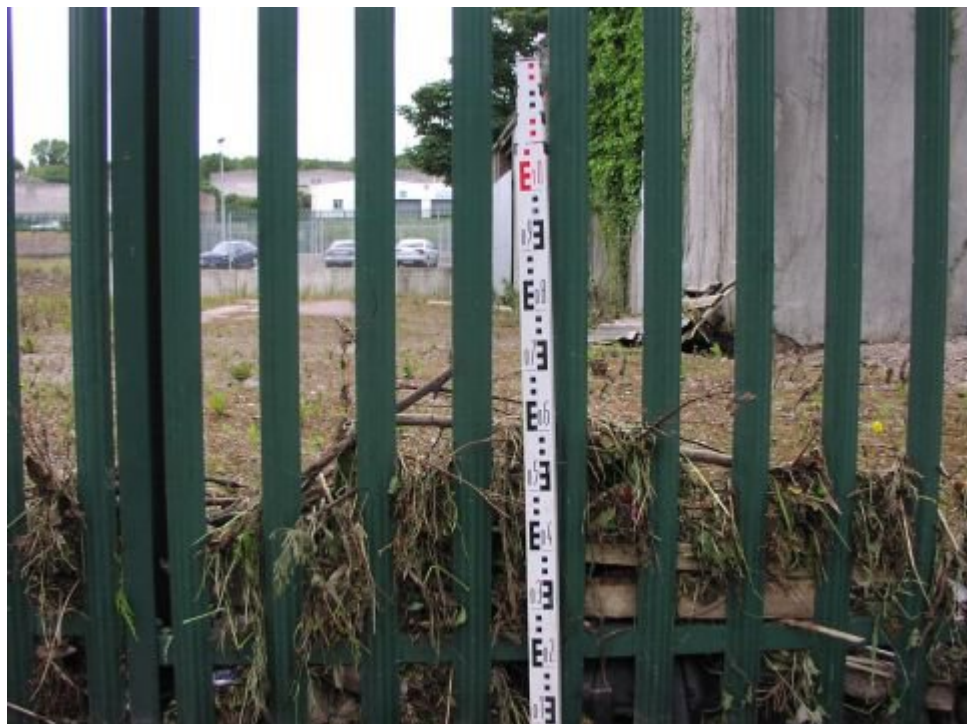
Photo showing flood debris on far side of security fence. This is located just north of Topaz filling station. The Bride River is just the other side of the yard inside the fence, but this side of the yard with the cars.

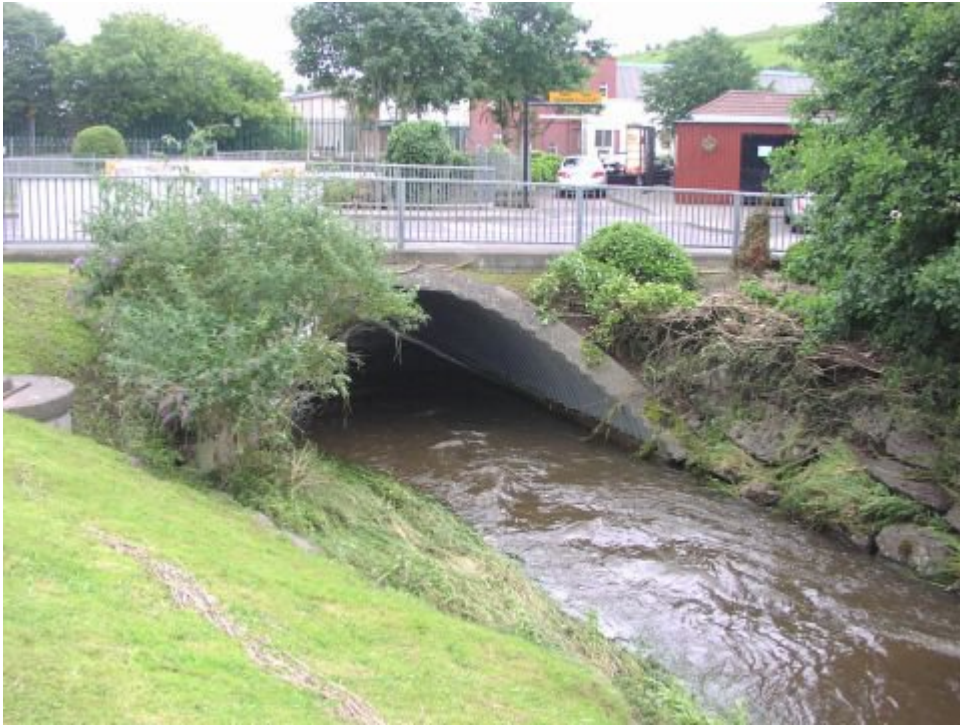
Large culvert on River Bride to east of Topaz filling station and Mc Donalds. Note tide line in left foreground and debris gathered on right bank.

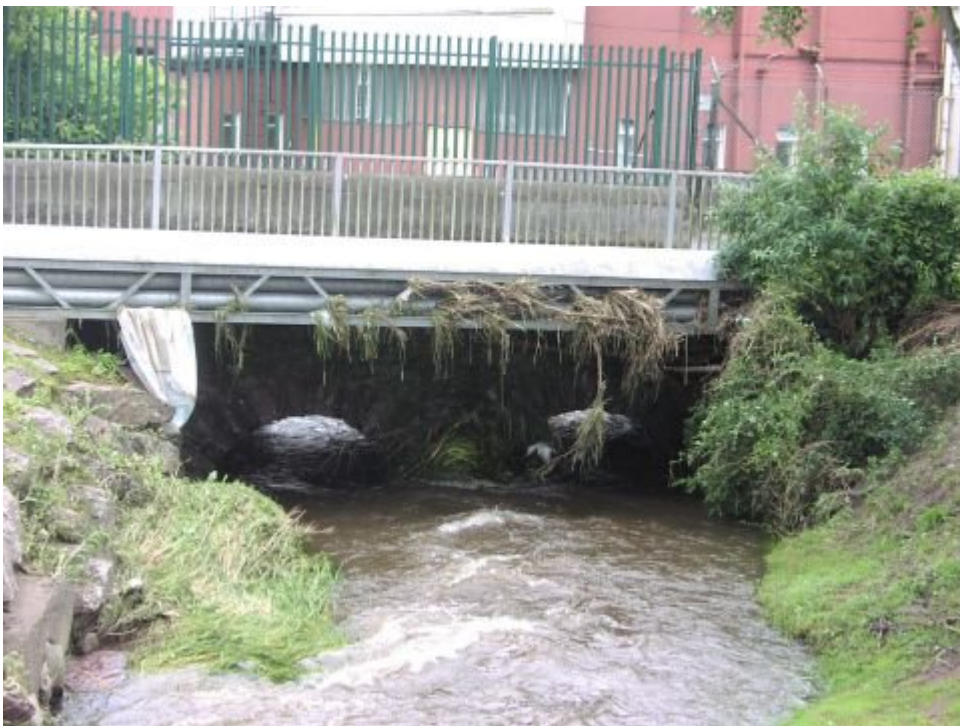
Photo showing small two arched bridge downstream of large culvert in previous photo. Note debris gathered on pipes. Based on the Lee CFRAMS Channel & Cross Section Survey (7BRI_1425), the flood level indicated by this debris would be about 18.1m to 18.2m OD Malin, but this would be a rough estimate and would need to be surveyed before being relied on.

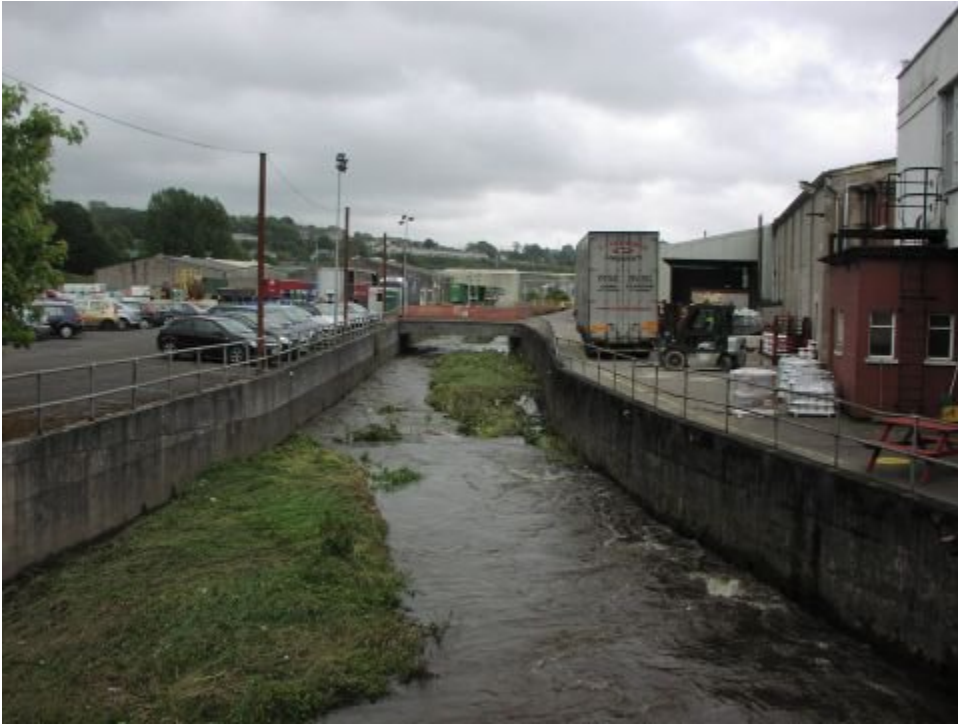
View along Bride River downstream from the two arched bridge on Fitz's Boreen. There were no signs of flooding visible from this bridge looking downstream.

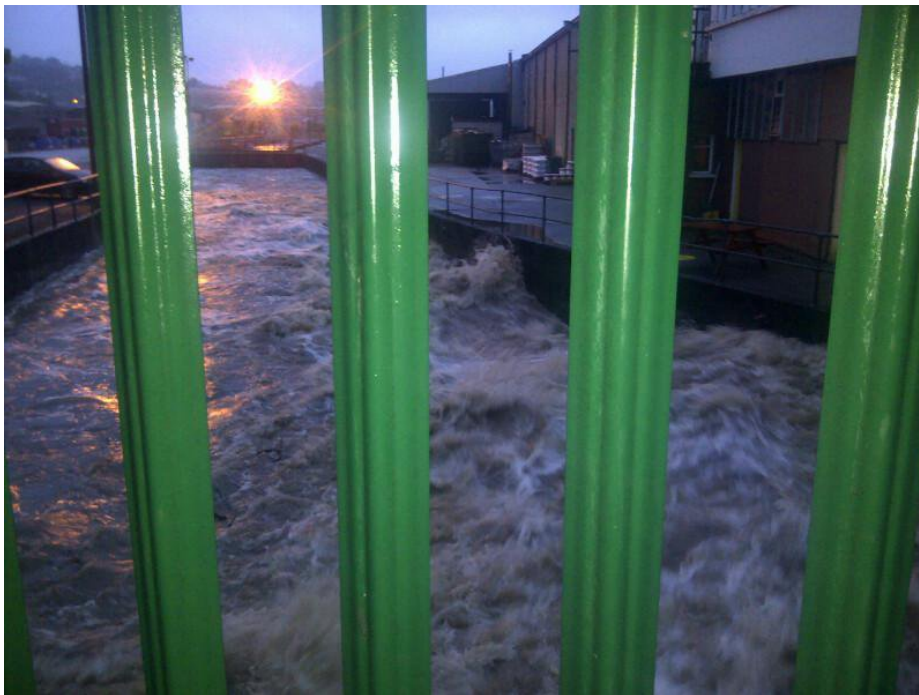
Photo given to me by a member of the public taken from the same location as the previous photo at about 4.30am or so.

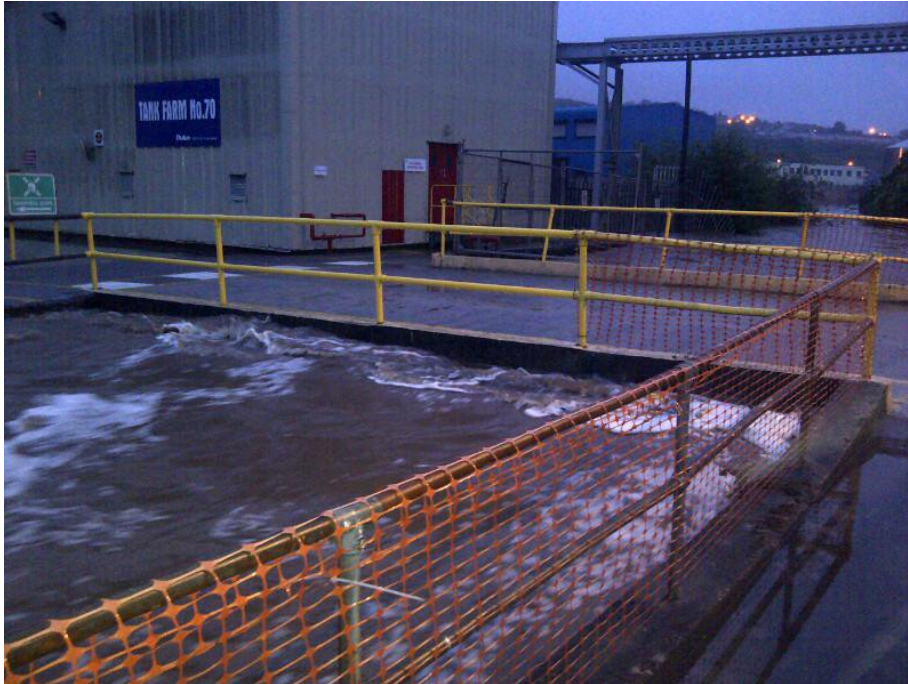
However, closer to the city in the flood extent here, persons advised that commercial properties were flooded both from the road and from the river. It is clear from debris marks on the ground that the River Bride overflowed its banks in this area, commencing at a point about 260m downstream from Fitz's Boreen

Photo given to me by a member of the public showing flood level shortly after 4.30 am. This bridge is located about 260m downstream from Fitz's Boreen. Based on the Lee CFRAMS Channel and Cross Section Survey (7BRI_1175), the flood level here at this time is about 15.85m OD Malin

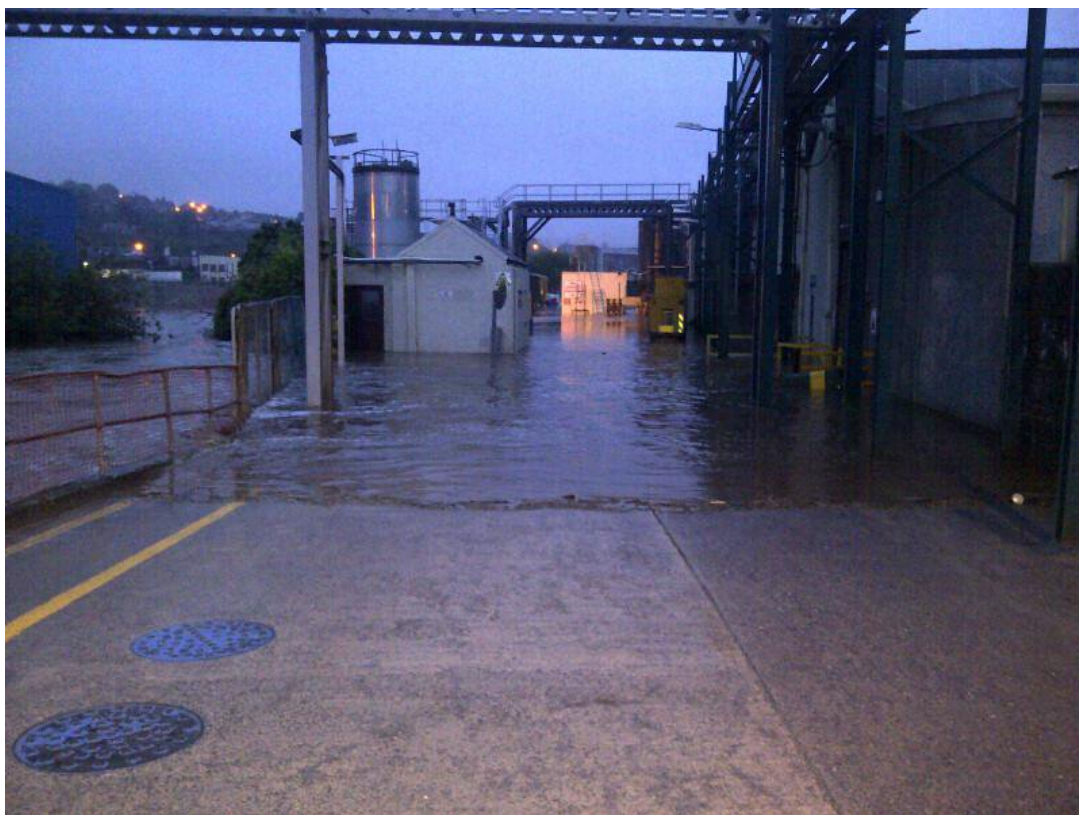
Photo given to me by a member of the public showing flood inundation on property about 10m or so downstream of bridge in previous photos.

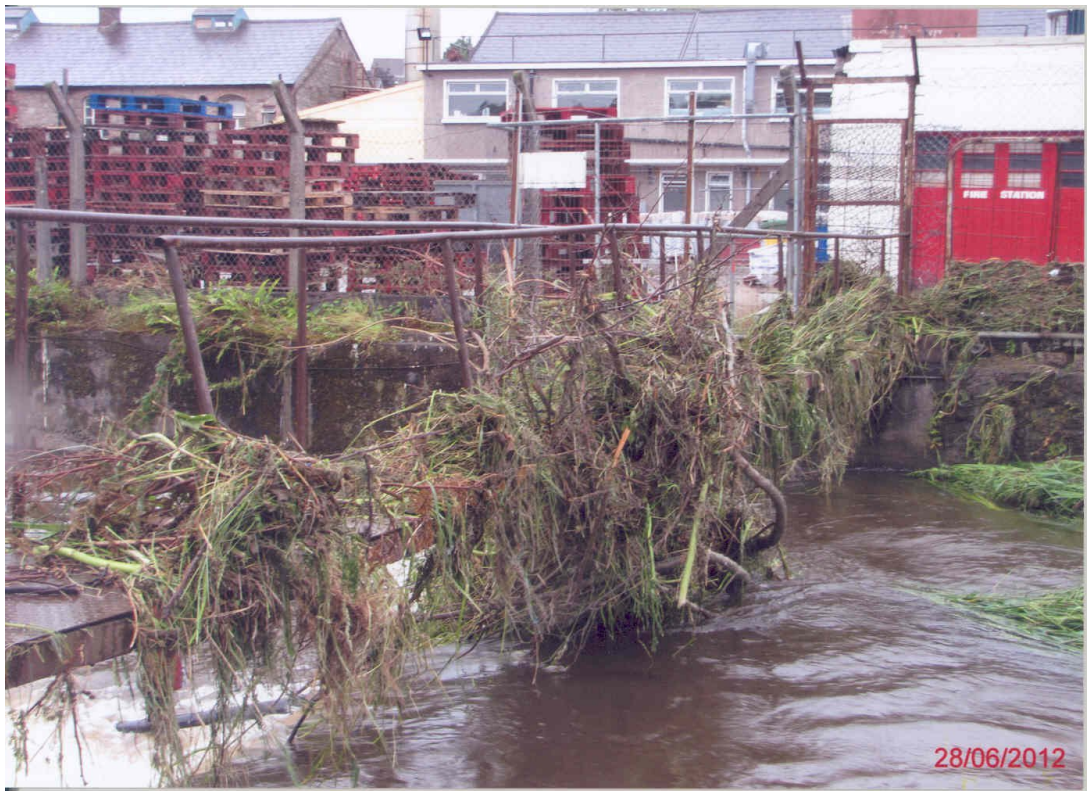
Photo Given to me by member of the Public. Based on the Debris level in this photo & the Lee CFRAMS Channel & Cross Section Survey (7BRI_1072), the flood level upstream of this footbridge would have been about 15.6m OD Malin. This should be regarded as a rough estimate, needing to be confirmed by survey, as the whole structure is not recorded in the Survey.

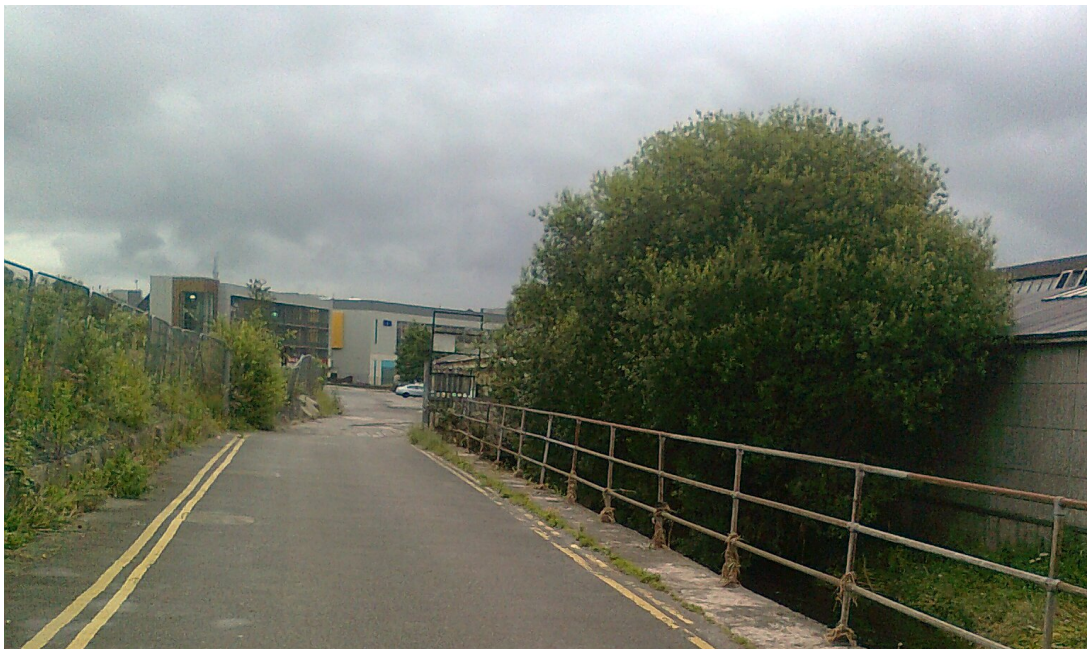
Photo looking downstream toward entrance to Culvert at Rear of Millfield Industrial Estate. Lee CFRAMS channel cross section 7BRI_991 is just upstream of the culvert entrance beyond the trees in the photo. Estimated level of flood here about 15.7m OD Malin. Again, this to be taken as a rough estimate only.

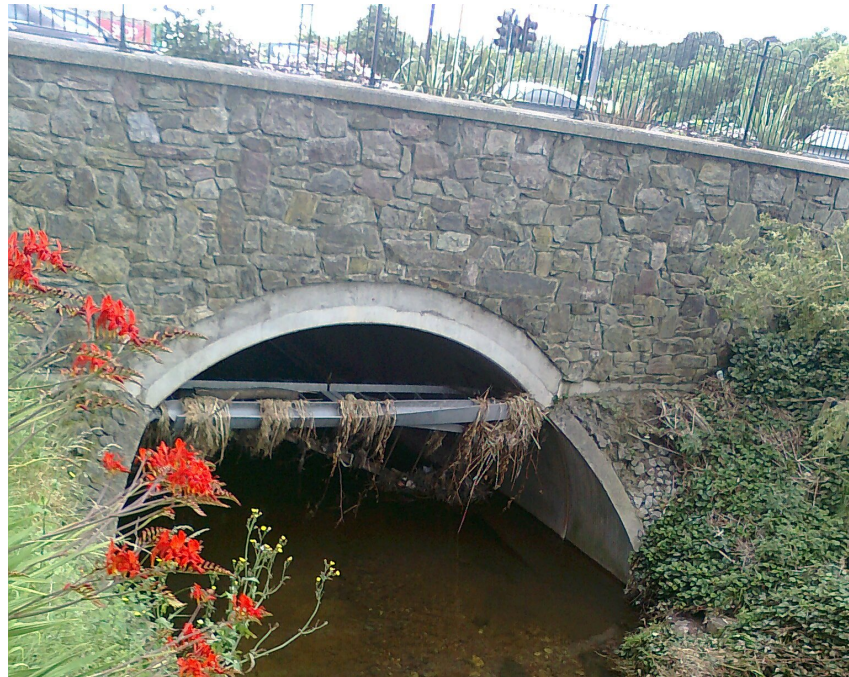
This photo is of the bridge at the entrance to the Blackpool Shopping Centre from the Commons Road. Based on the debris mark in the photo and the Lee CFRAMS Channel Cross section and Structure Survey (7BRI_548) the flood level here would appear to have been about 12.3m OD Malin or so.

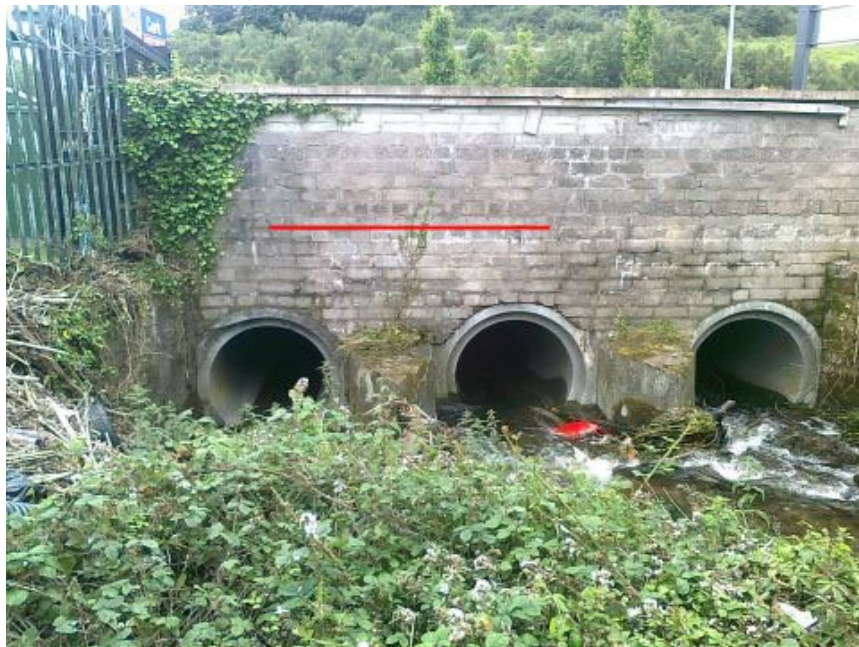
In the North Point Business park, flood waters entered the park as a result of over flowing upstream of the culvert under the entrance to the park (see photo later 7BR1_0). Some flow may have entered the park from the public road outside the entrance which might have been a combination of pluvial run off and run off from the Glenamought River which overflowed its banks upstream of the next culvert upstream from the entrance to the park (see further photo later 7BR1_91). It is clear from flood debris on the boundary fence between the park and the Bride River that flow was from the park to the river and not vice versa.

Photo showing upstream side of culvert at entrance to North Point Business Park on Glenamought River. Estimated flood level, based on debris marks, shown by Red line in photo. Based on lee CFRAMS survey of this structure (7BR1_0), flood level would have been about 24.3m OD Malin. It seems likely that flow into the North Point Business park would have been through the railing to the left of the photo.

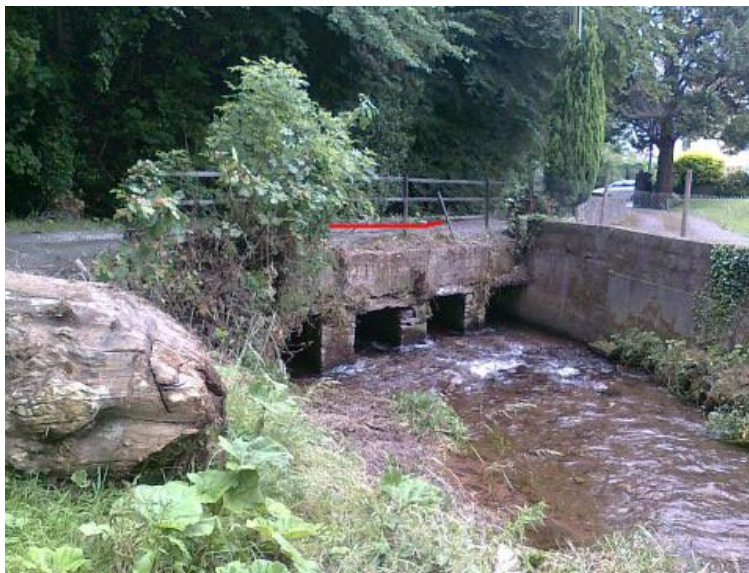
Photo showing upstream side of culvert on private access road on Glenamought River. Based on debris observed in the area and the Lee CFRAM Structure survey (7BR1_91), the estimated flood level, indicated by the red line is about 25.3m OD Malin. This may be conservative, (low) as there was considerable debris evident upstream along the road to the left of the picture

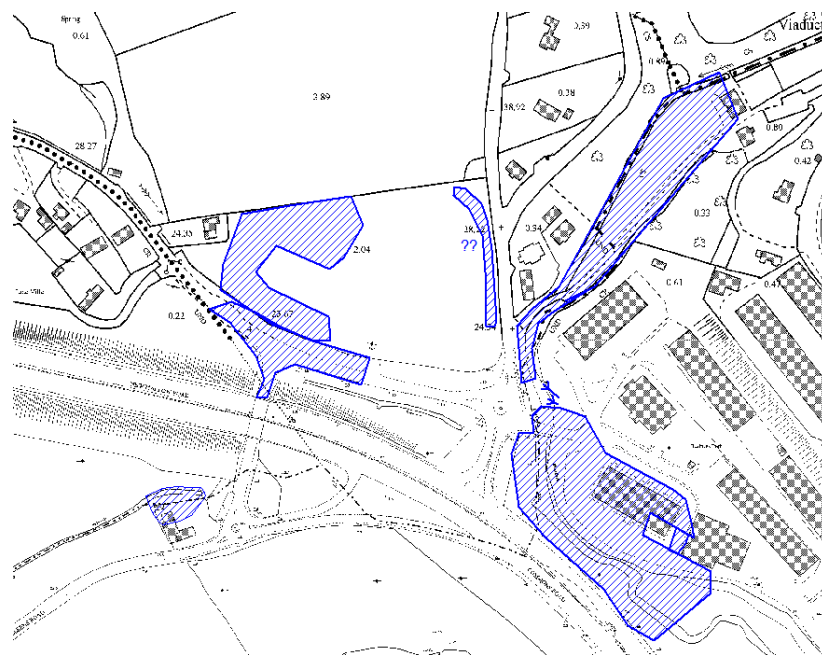
Lower Killeens Road (west of Mallow road) AND

Note. The 'C' shaped flood extent mark outline on the left, is to indicate that the flood here surrounded a building in this business park but the fluvial flood did not enter the building. The pair of question marks adjacent to the extent mark is because there was some flooding reported in this site, in the parking areas, that did not enter buildings, but no further information on the extent or location has been reported.

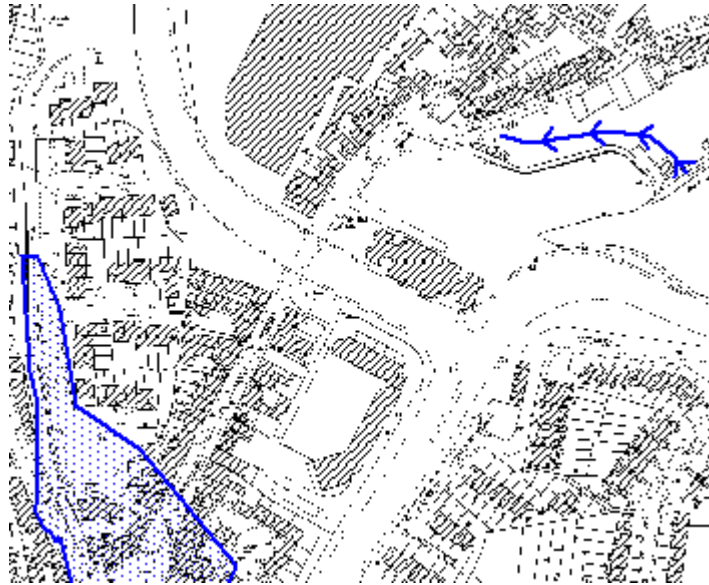
Spring Lane.

Note: Flood route described shown by line with arrows in upper right part of extract. Extent marked in bottom left of extract is part of that shown already for Blackpool Village.
