Cork County Council

Midleton Flood Relief Scheme

Storm Babet Flood Event Report

Draft 2 | 22 December 2023

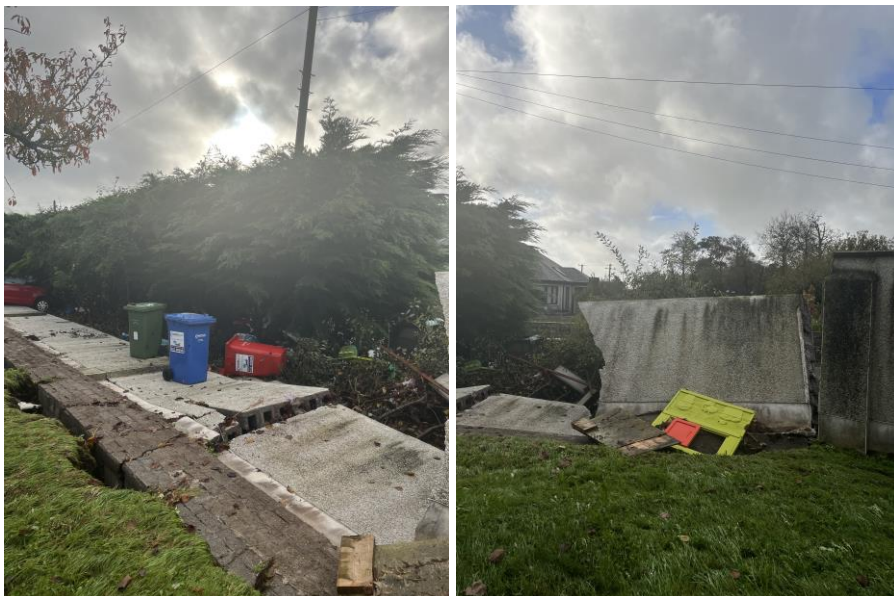
Figure 10: Wall failure at rear of First Steps Creche

The Western section of the wall however remained standing during the event such that the modelled Q1000 extent is greater than the estimated extent from Storm Babet in this area. A wrack was taken by Arup on the section of the wall which did not fail and the depth of flooding at this location was measured as 1m (Figure 11).

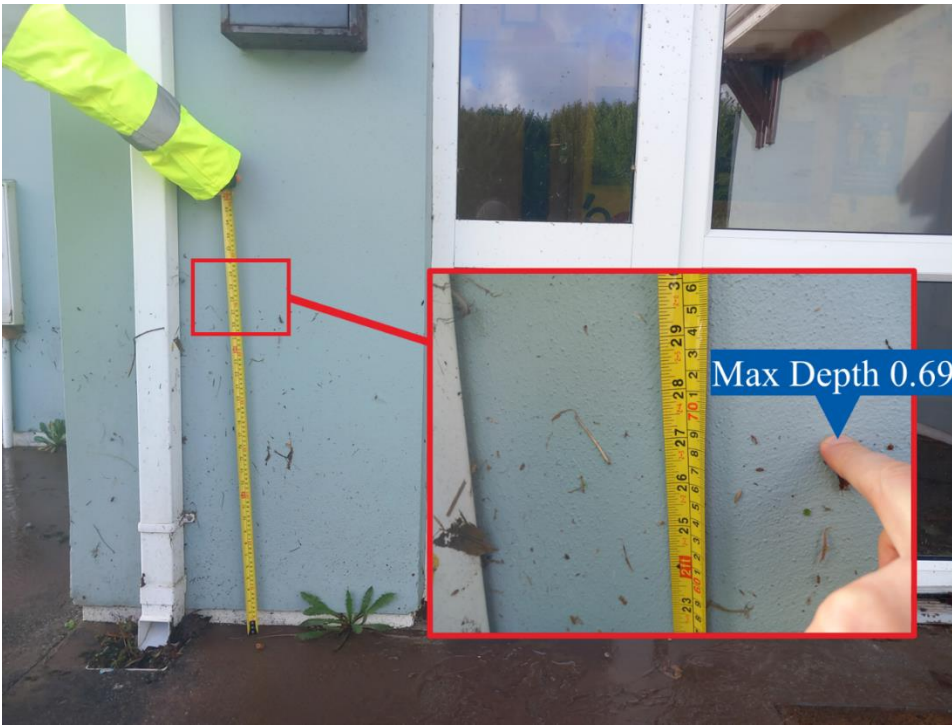
Figure 12: Wrack Mark at entrance to First Steps Creche

A wrack mark was also recorded by Arup at the front door of the First Steps Creche, the maximum depth of flooding at this location was circa 0.69m as shown in Figure 12.

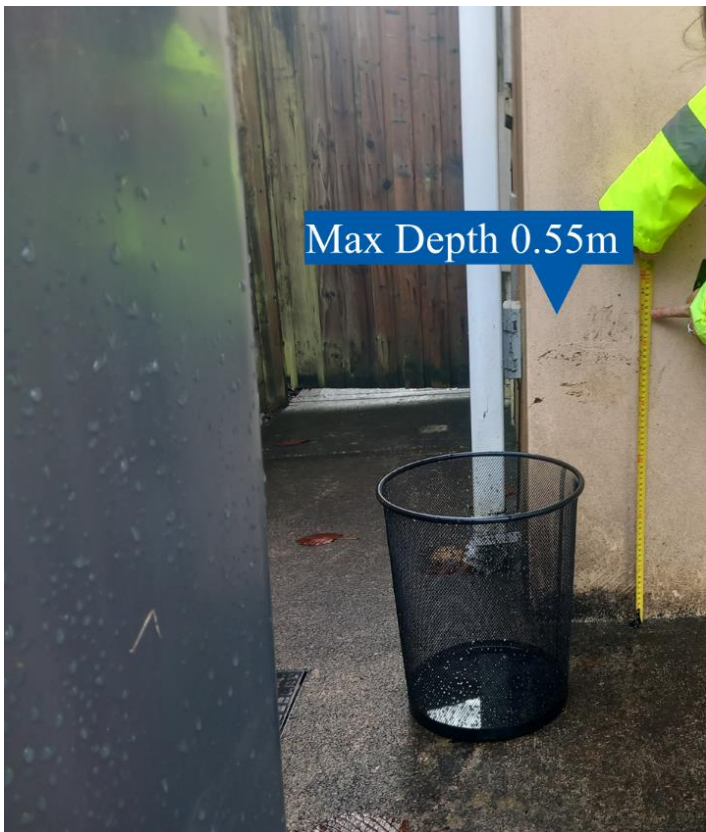
Figure 14: Wrack Mark at No. 62 The Meadows

A wrack mark was recorded by Arup at No. 62 The Meadows and No. 13 Riverwalk (locations outlined in Figure 13). The maximum depth of flooding at No. 62 The Meadows was circa 0.55m as shown in Figure 14 and 0.95m at No. 13 Riverwalk as shown in Figure 15.

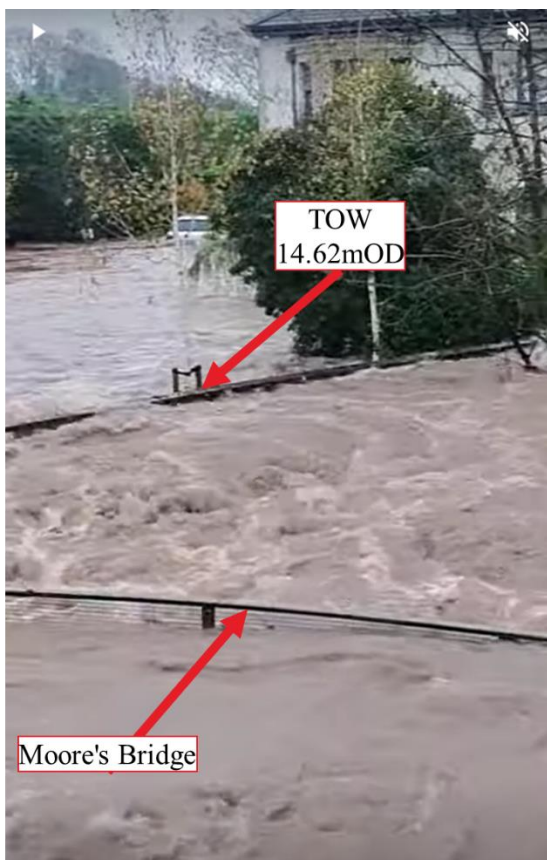
Figure 20: Still of Video Recorded showing Moore's Bridge During Flood Event

The recorded finished floor level of the property immediately downstream of Moore's Bridge on the left bank is 13.6mOD and wrack marks recorded close to the house suggest the max water level was circa 14.15mOD. The estimated depth of flooding of the property during the event is therefore circa 0.55m.

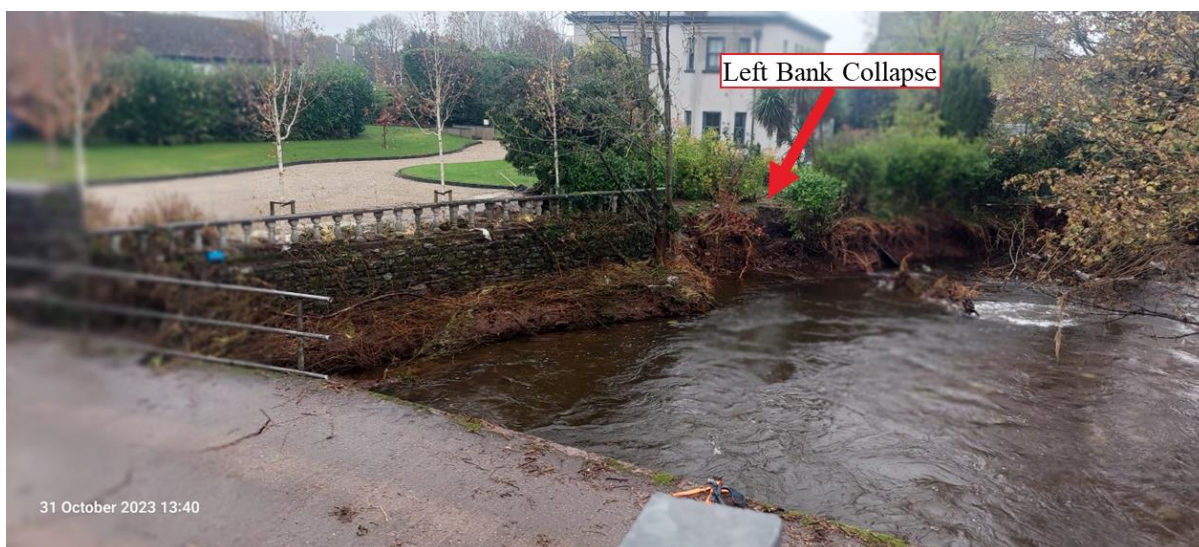
Figure 21: Collapsed Left Bank Downstream of Moore's Bridge

Images taken by CCC during a post event site walk over show that a section of the left bank downstream of Moore's Bridge collapsed (Figure 21). It was also evident from the site walkover that 3-4 trees fell into the river during the event which may cause a risk of blockage in the channel at the present time.

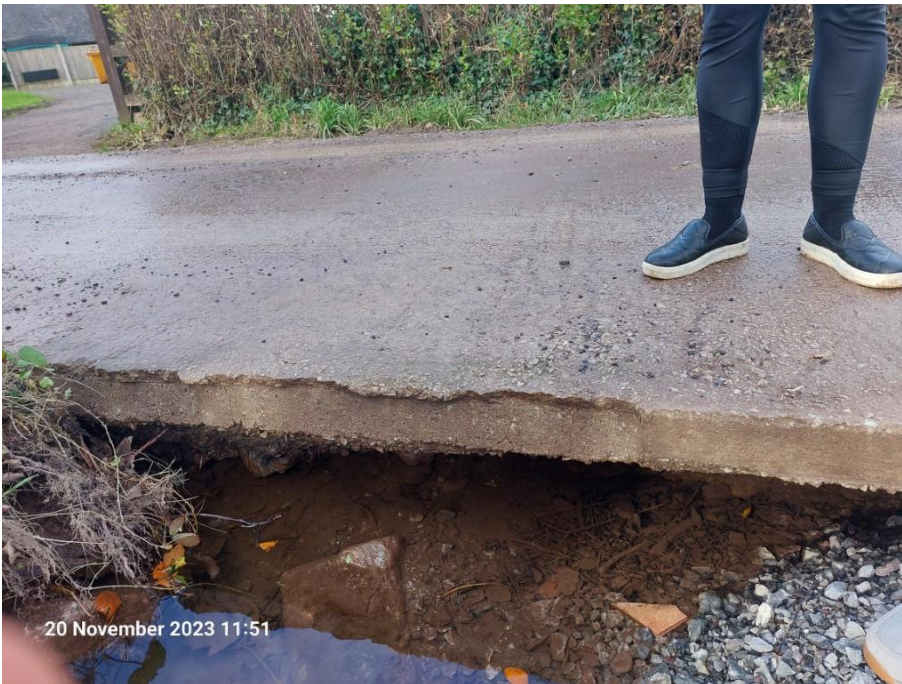
Figure 22: Broomfield Ridge undermined

As part of a further site visit by CCC on 20th November, it was noted that the road downstream of Moore’s Bridge (Broomfield Ridge) had been undermined at a number of locations during/ post the storm event and is presently unsafe to traverse (Figure 22).

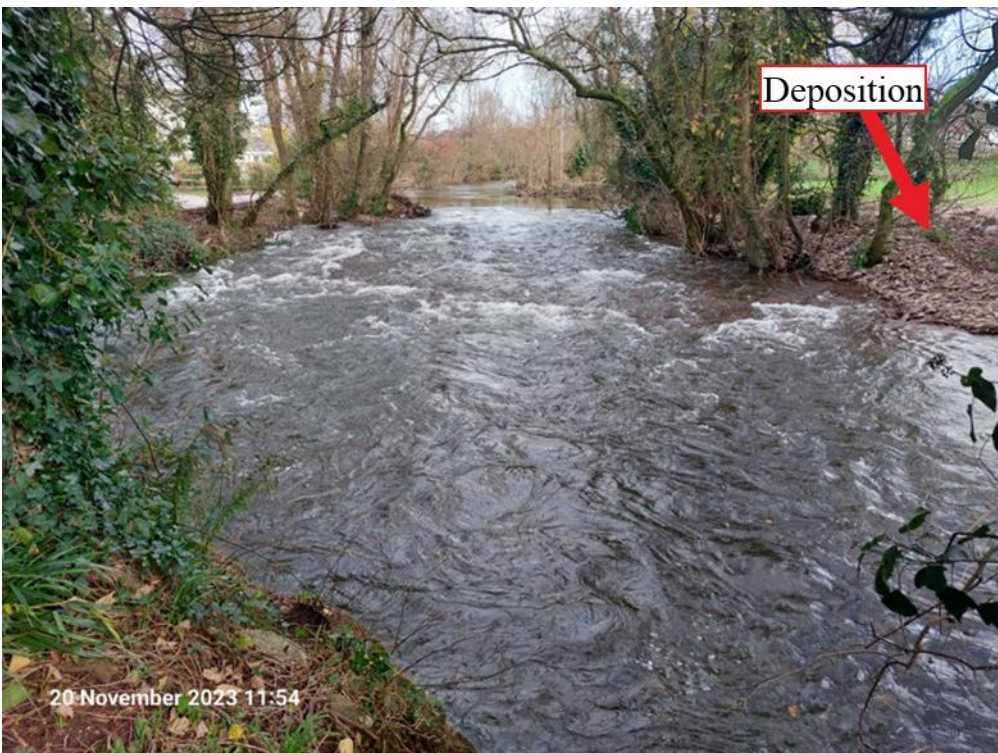
Figure 23: Deposition of material on the left bank and in channel (photo looking upstream)

CCC also noted deposition from the event at the bend in the river circa 240m downstream of Moore’s Bridge, Figure 23, was taken at the river bend looking upstream and shows the deposition of material.

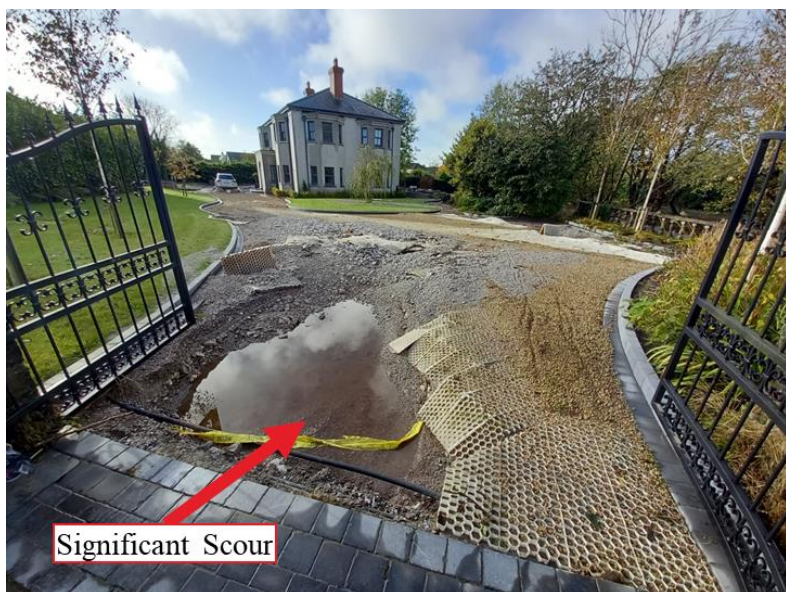
Figure 24: Significant Scour: Entrance to Property Immediately downstream of Moore's Bridge (left bank)

velocities at this location during the event would have been very significant. Further scouring was observed in the front yard of the neighbouring property immediately to the south as indicated in Figure 25.

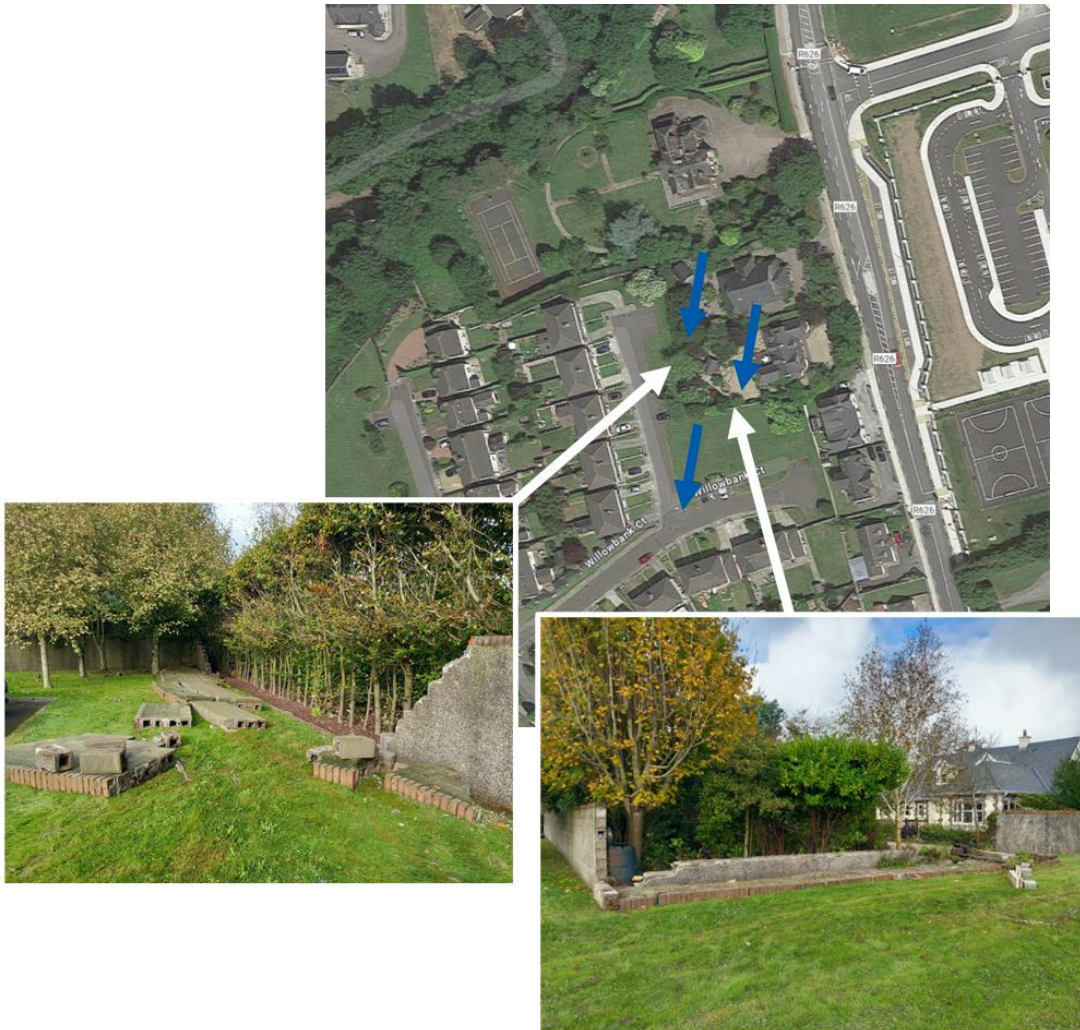
Figure 26: Boundary Walls Failed

As noted above two boundary walls to the North of the estate failed during the event which justifies our approach in removing the walls for extreme events. The walls in the estate however remained standing and did exert an influence on the flow paths during the event. This needs to be considered when comparing the estimated extent from the event with the modelled Q1000 extent.

The failure of the two boundary walls provided a route for the overland flow from the Owenacurra to enter into the estate. Once in the estate the floodwater travelled in a south westerly direction due to the fall in ground elevation in that direction. A video posted online at 2.20pm on the day of the event indicates the velocities and depths of flooding which we note were significant. A still of this video is presented in Figure 28 and shows the failed wall and the extent of flooding close to the peak of the event.

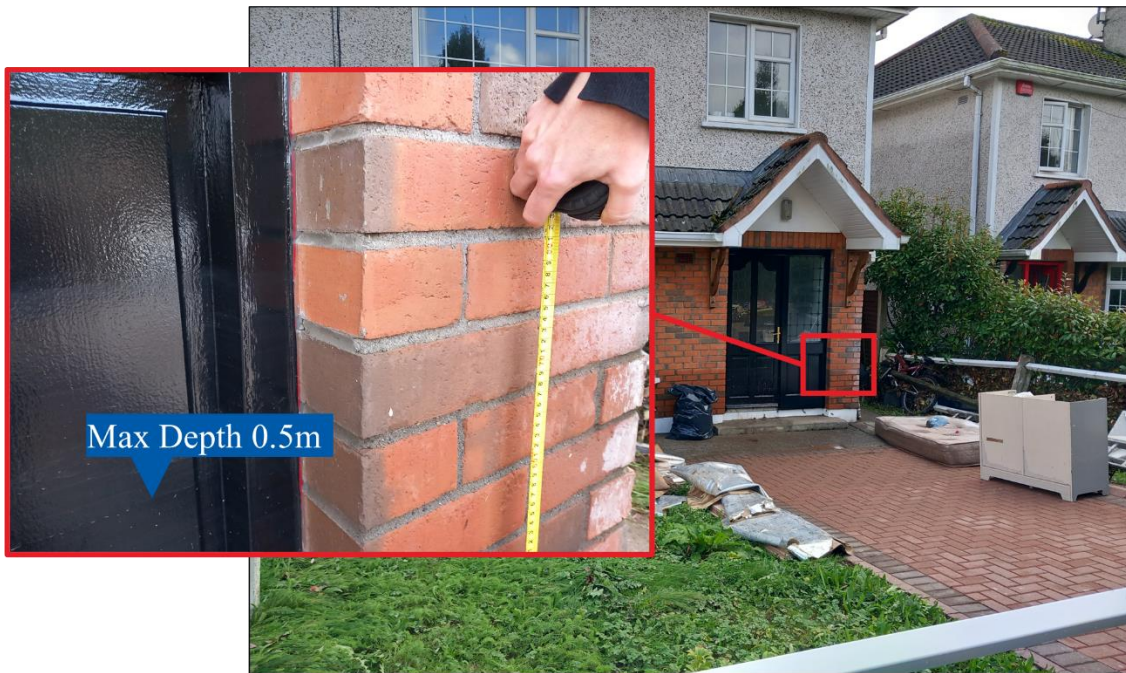
Figure 30: Wrack Mark at Willowbank Court

A wrack mark was recorded by Arup at a house on Willowbank Court, the maximum depth of flooding at this location was circa 0.50m as shown in Figure 30.

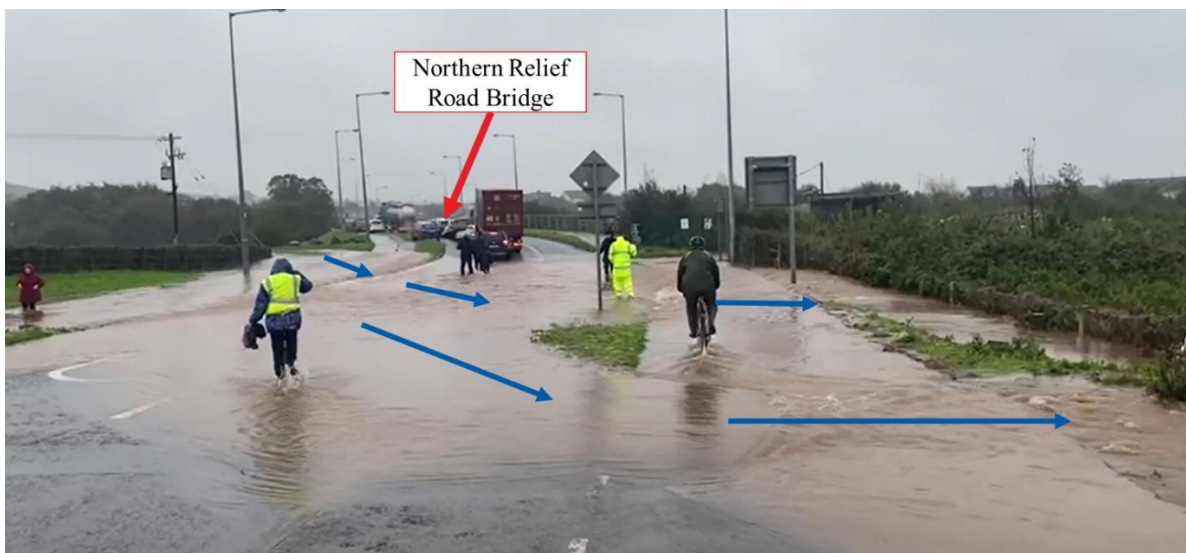
Figure 32: Water overtopping NRR West approach road

The road to the West of the NRR Bridge was also over topped during Storm Babet and flow was clearly observed to travel along the road and into the field to the south. Figure 32 presents a still of a video captured at 2.30pm which clearly shows this mechanism. It is noted that this corresponds to Mechanism B in the Figure 31.

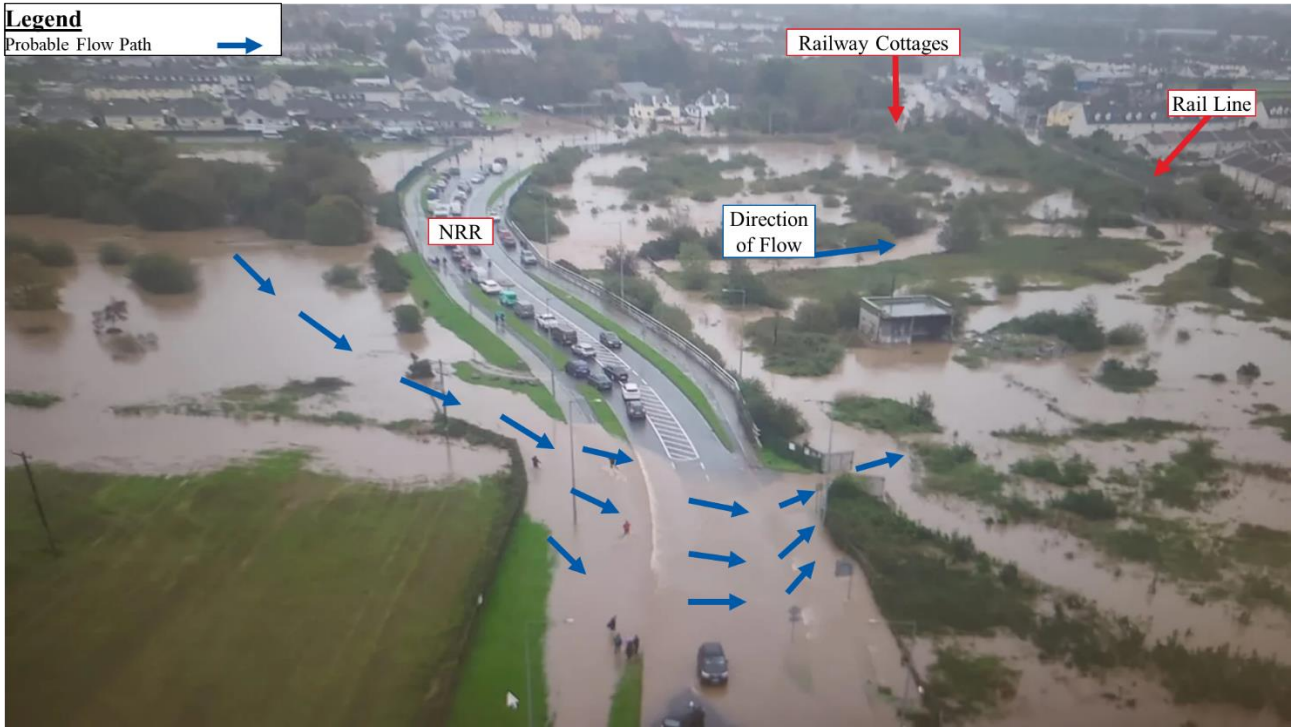
Figure 33: Water overtopping NRR West approach road (arial image)

An aerial image taken from a drone and shared on social media also shows Mechanism B during Storm Babet (Figure 33).

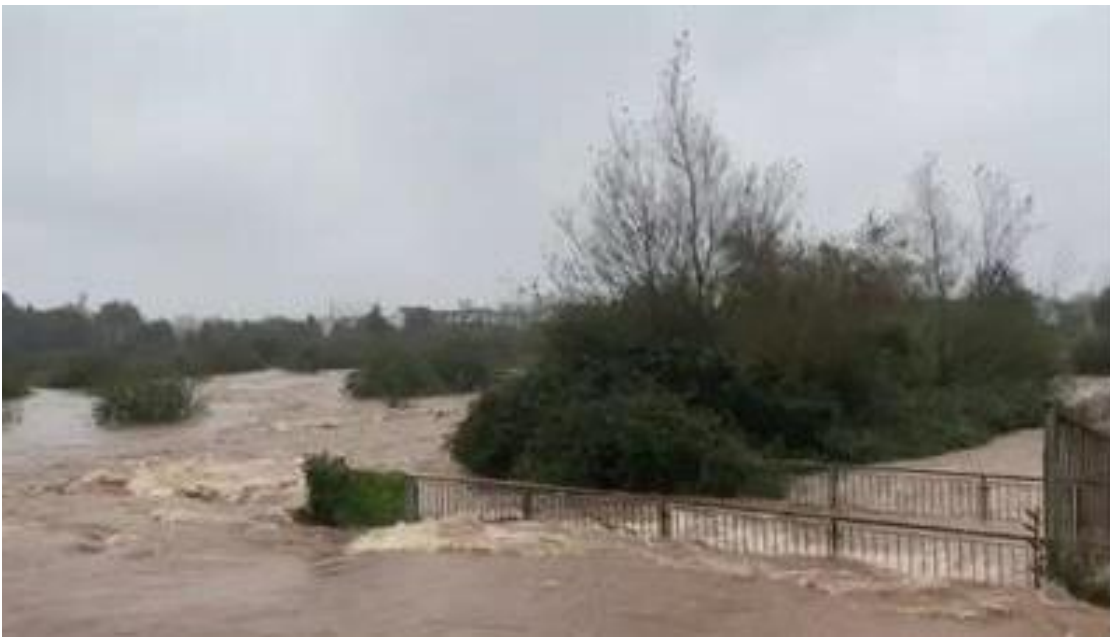
Figure 34: Bridge Downstream of NRR Bridge surcharged

The bridge downstream of the NRR was also surcharged during the event. Based on inspection of the video and cross referencing it against the surveyed cross sections for this reach, the water level is estimated to be circa 9.1mOD at the bridge which is higher than the Q1000 maximum water level of 8.6mOD at this location. Flow can clearly be seen getting out of channel via the left bank in the direction of the railway cottages.

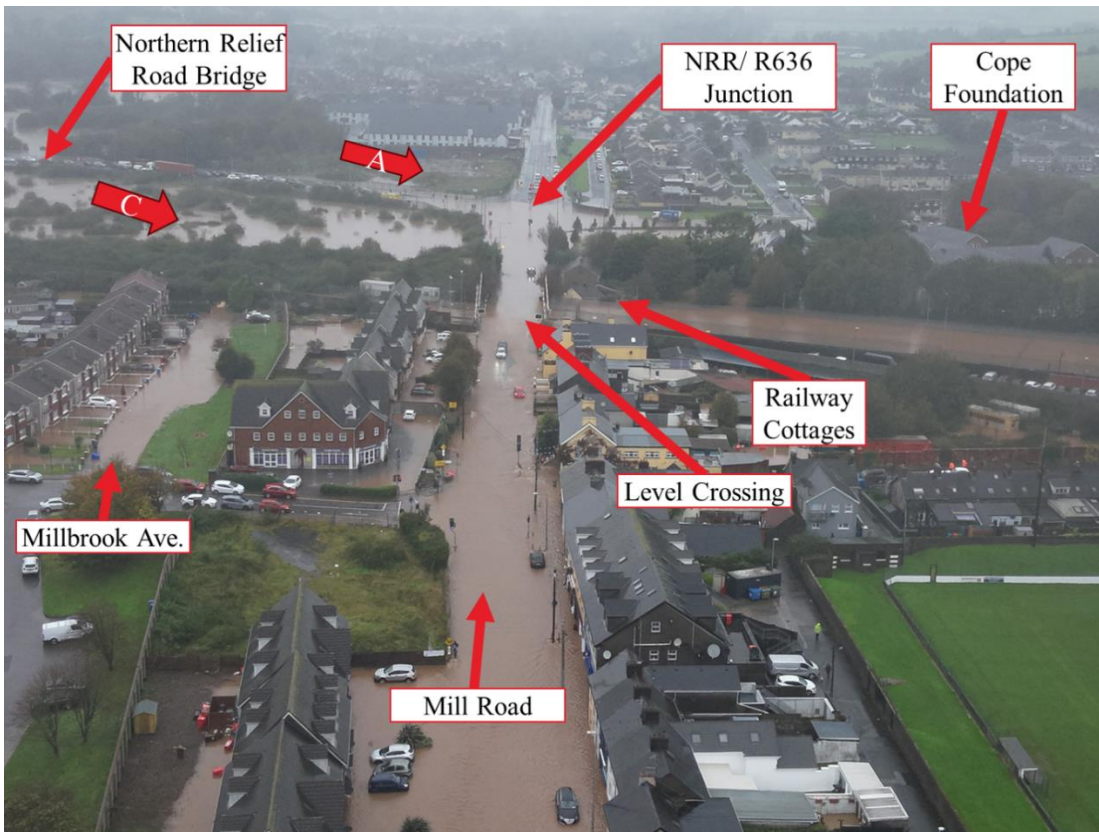
Figure 35: Aerial Image of Northern Relief Road/ Rail Line Level Crossing (Guileen Coast Guard)

An aerial image captured by Guileen Coast Guard shows the approximate extent of the flooding in this area. Flood mechanism A and C in this area are evidently occurring in the image.

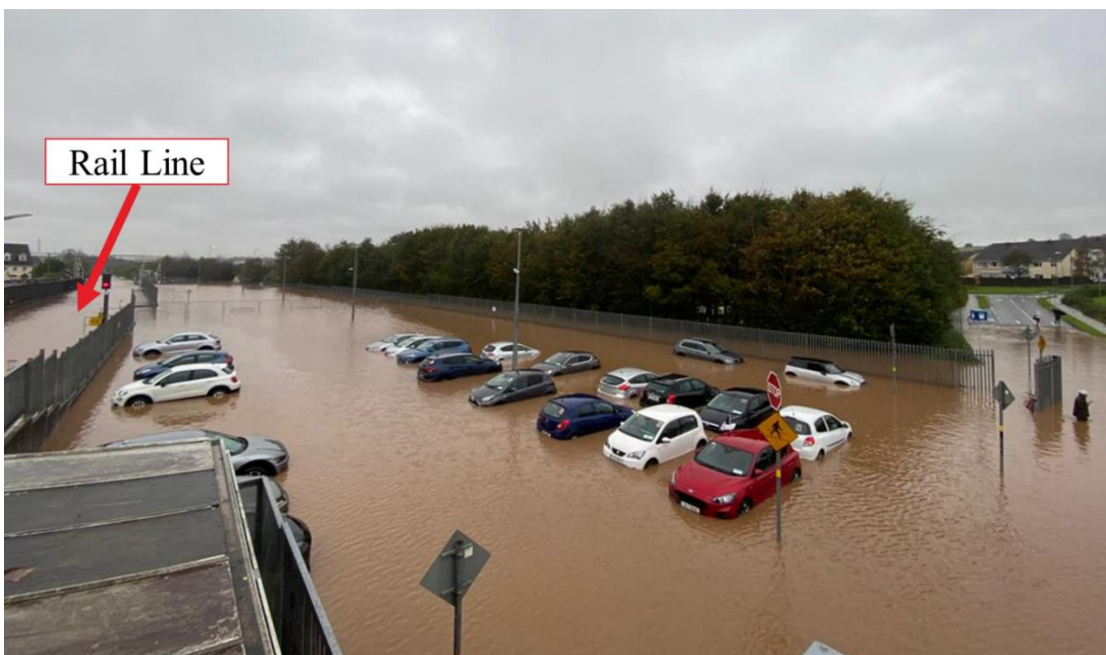
Figure 36: North Train Station Car Park flooded

The train station car park to the North of the railway track was also inundated as was the rail line itself (Figure 36).

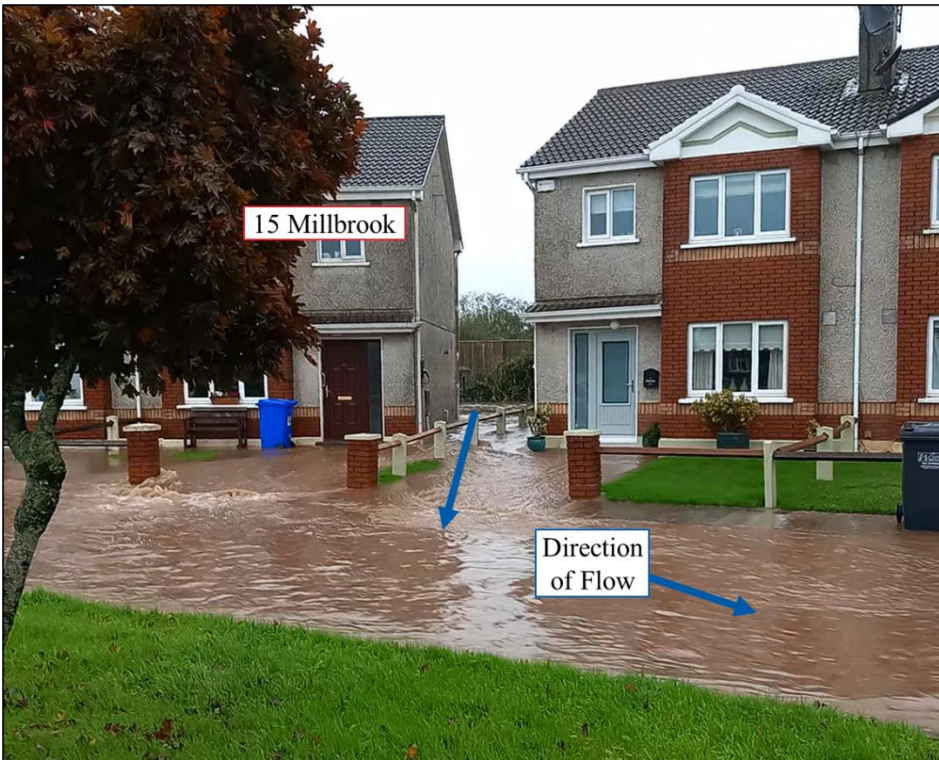
Figure 38: Flow Path of water Entering Millbrook and Travelling South at Shallow Depths. The image was captured at 1.16pm

The modelled mechanisms detailed above were all activated during the Storm Babet Event. It was reported by locals that the boundary walls at the back of the gardens of number 17 and 16 Millbrook Drive were severely damaged (location shown in Figure 37) which led water to flow unimpeded into their back gardens and around their properties into the estate (Figure 38). The two houses were also inundated at shallow depths. Once in the estate the water travelled in a southerly direction to the low point in the estate and collected given that it was unable to drain out onto Mill Road.

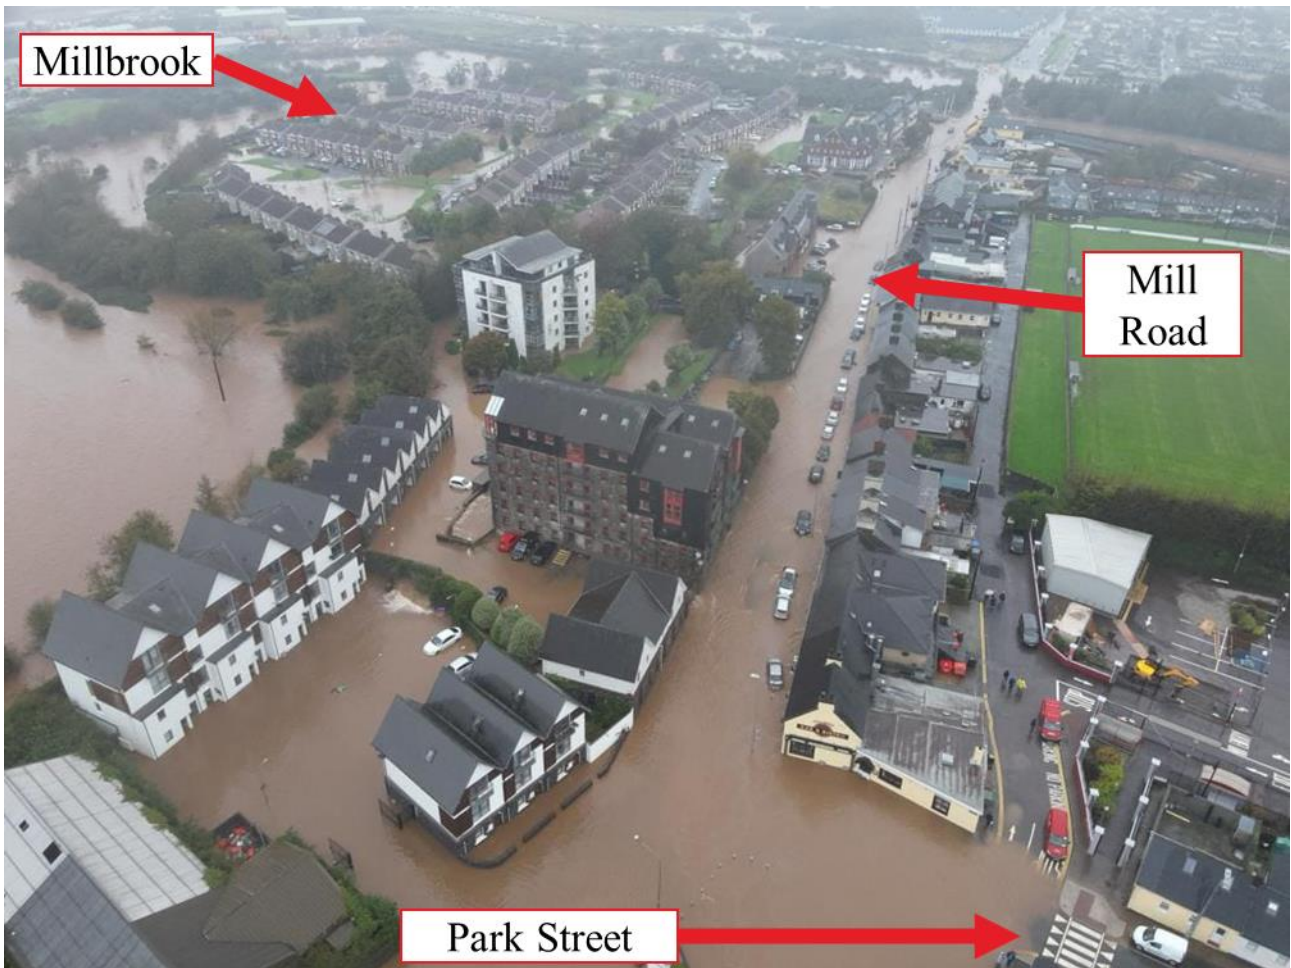
Figure 39: Aerial Image of Millbrook/ Mill Road Lower (Guileen Coast Guard)

The witnessed extent of flooding of Millbrook/ Mill Road Lower was slightly less than the modelled Q1000 extent which is likely due to the impact that the property walls had on the localised flow paths and extents. An aerial image from the Guileen Coast Guard shows the extent of flooding in the area. It is noted that the embankment to the Southwest of Millbrook did not over top during the flood event as shown in the Q1000 model.

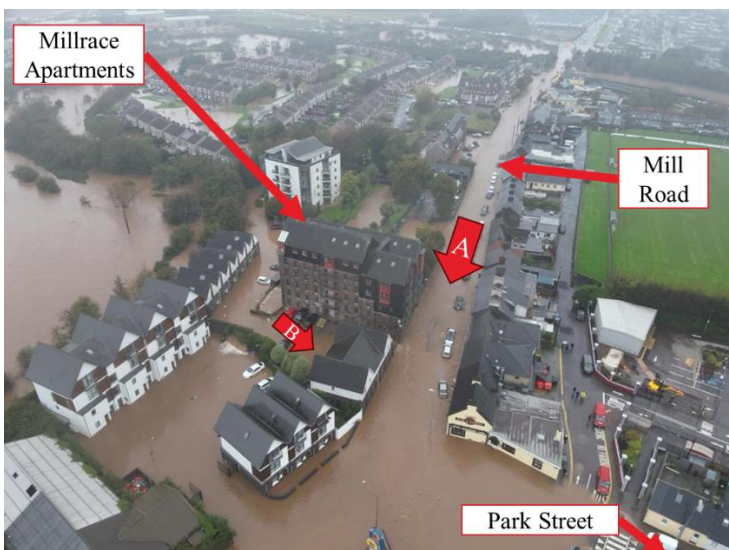
Figure 41: Flooding via Mill Road and the Millrace

All of the mechanisms of flooding detailed above occurred during Storm Babet with the exception of flood mechanism F i.e. flow from the East. The Suncourt estate however was flooded due to overland flow from the West i.e. a combination of flood mechanism A, B and D. Figure 41 clearly shows flooding from the Mill Road (Mechanism A) and overtopping of the Millrace (Mechanism B).

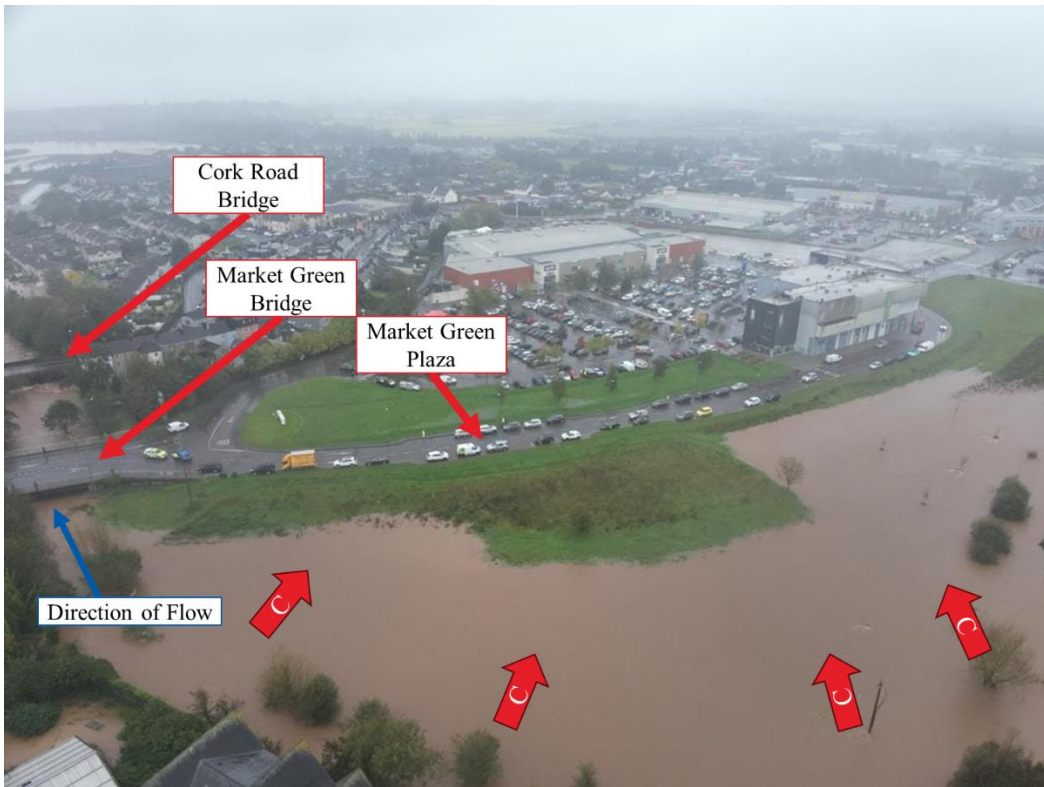
Figure 42: Flooding on Right Bank Upstream of Market Green Bridge

Figure 42 shows flooding of the right bank floodplain upstream of the Market Green Bridge (Mechanism C).

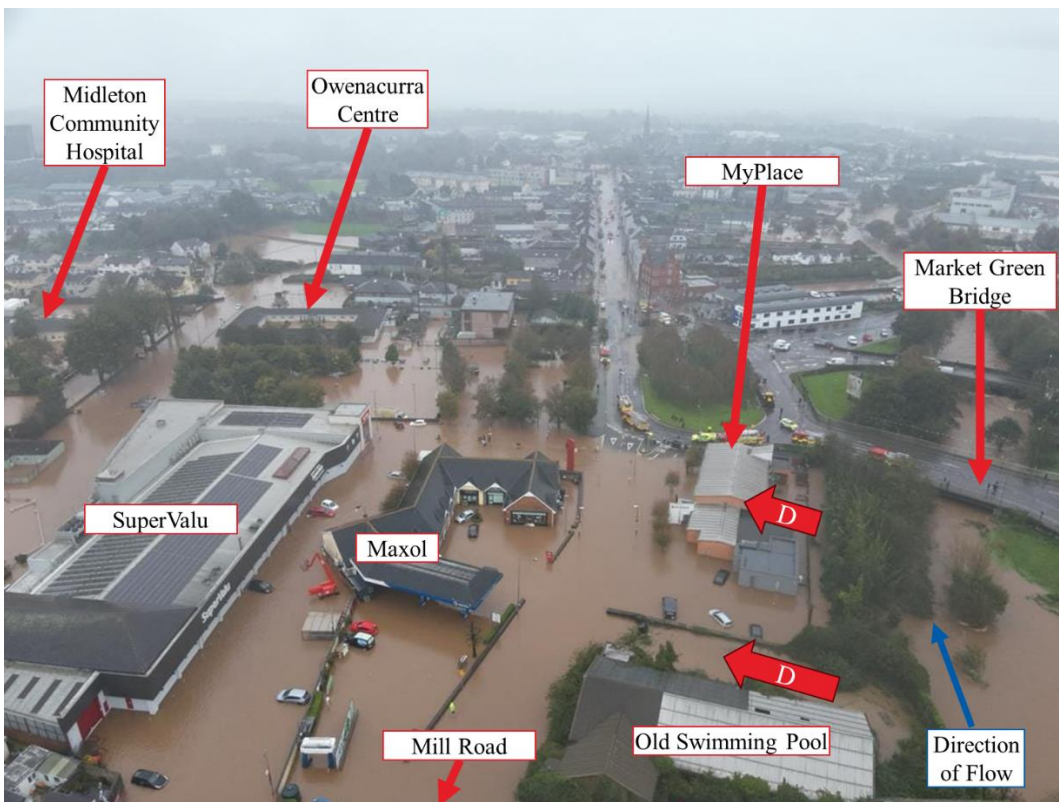
Figure 43: Flooding on Left Bank Upstream of Market Green Bridge

Figure 43 shows flooding of the left bank upstream of the Market Green Bridge (Mechanism D).

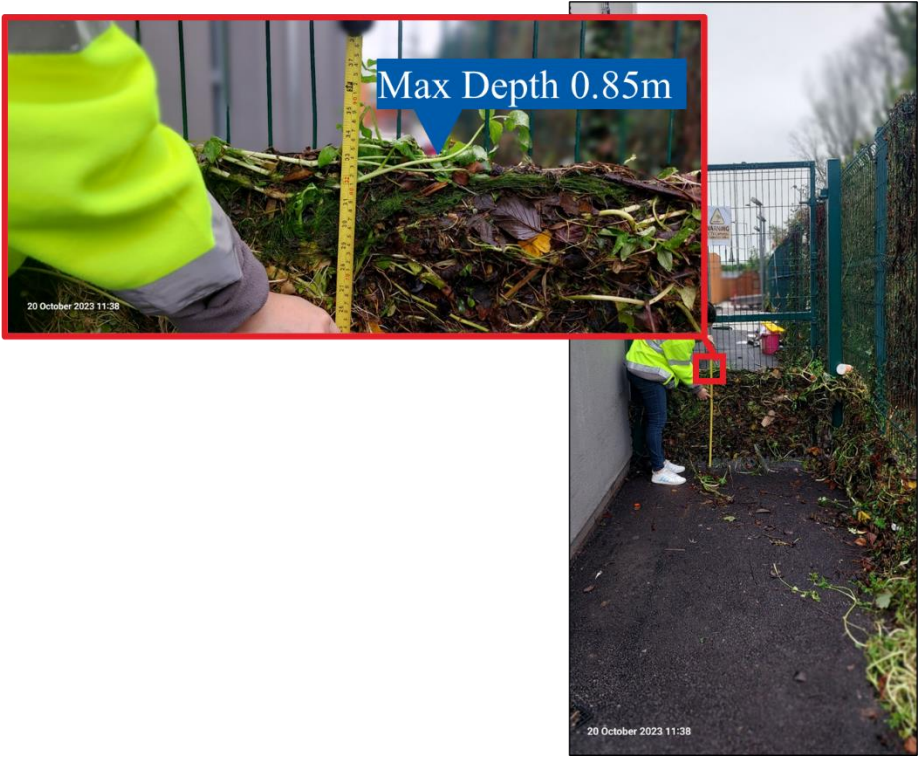
Figure 44: Wrack Mark at Rear of MyPlace

A wrack mark was recorded by CCC at the rear of MyPlace, the maximum depth of flooding at this location was circa 0.85m as shown in Figure 44.

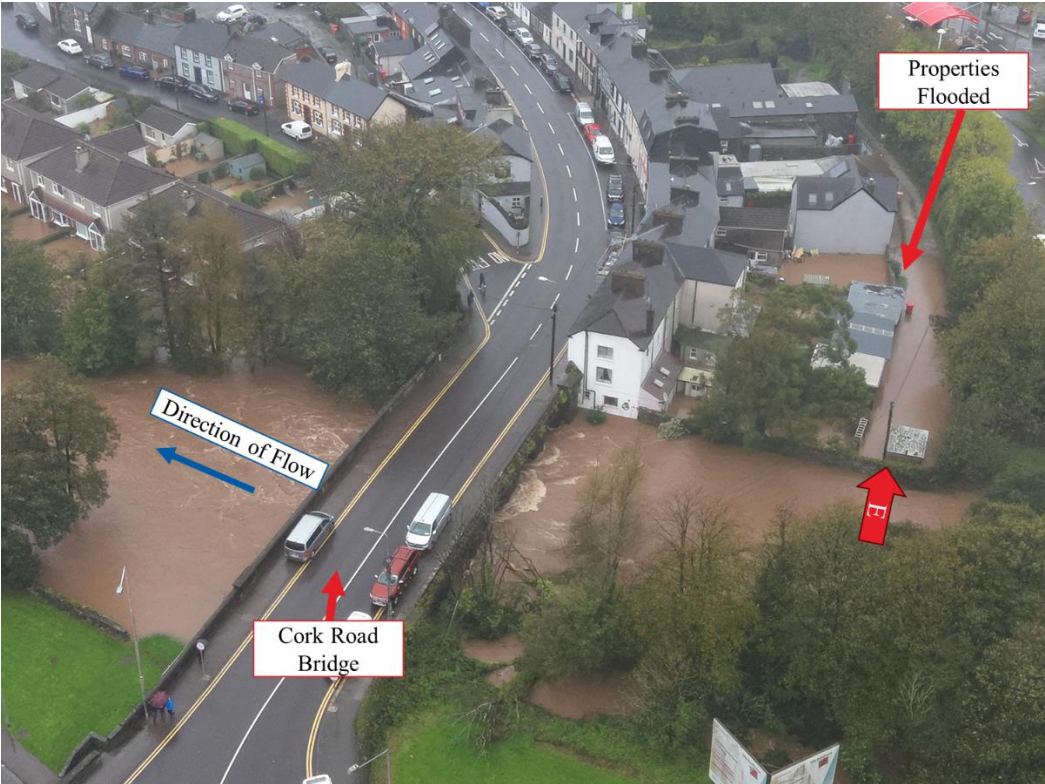
Figure 45: Flooding on Right Bank Upstream of Cork Road Bridge

Figure 45 shows flooding of the right bank upstream of the Cork Road Bridge (Mechanism E).
