Site Visit Report

Licensee	
Name of Installation	Perma Pigs Limited
Licensee	PERMA PIGS LIMITED
Licence Register No.	P0431-02
CRO Number	553066
Site Address	Littlegrange, Drogheda, Louth
Site Visit Reference No.	SV27757

Report Detail	
Issue Date	01/12/2023
Prepared By	Laura Foley

Site Visit Detail			
Date Of Inspection	14/11/2023		
Time In	14:25	Time Out	15:50
EPA Inspector(s)	Laura Foley Irene Doyle		
Additional Visitors			
Licensee Personnel and Role	Jack Carolan - Farm manager

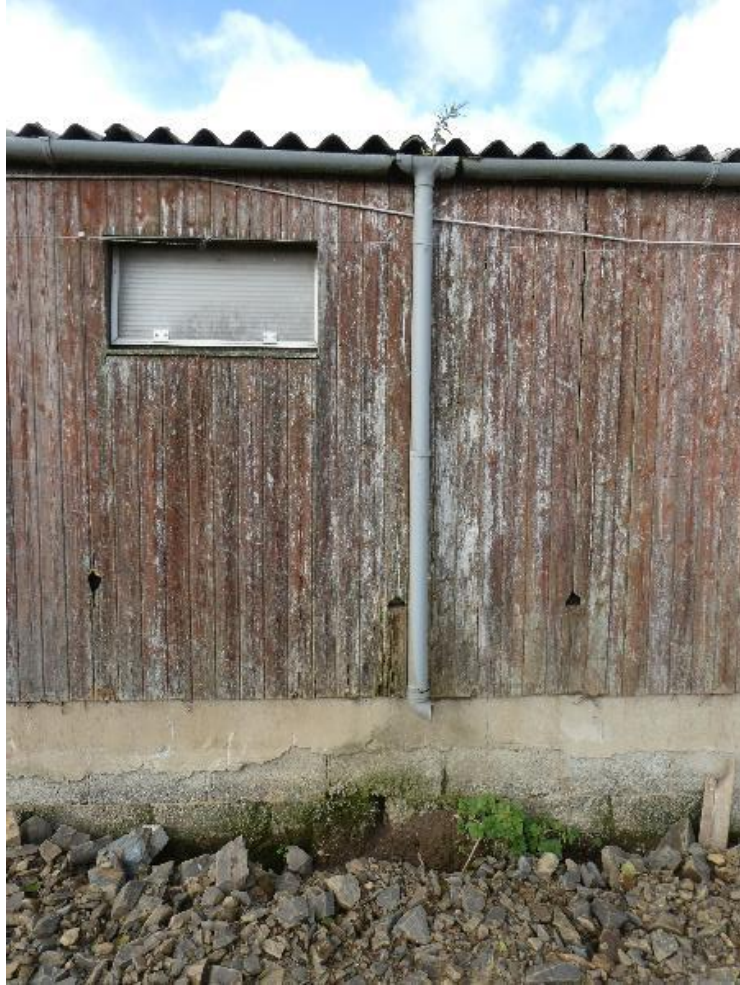
A number of rainwater downpipes on pig housing units discharge to ground (photograph 1 refer).

Photograph 1: Rainwater downpipe on animal housing unit

The licensee shall maintain a rainwater collection and drainage system for all pig housing on-site. The licensee shall divert all uncontaminated surface water runoff, from roofs and non-contaminated impervious areas of the site, to the surface water drainage system, in accordance with licence condition 7.1.

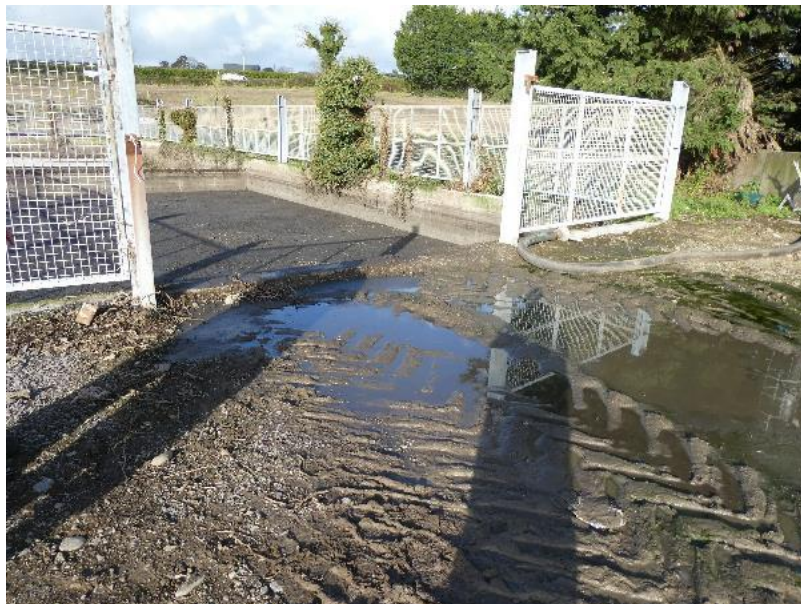
No groundwater and surface water protection measures were in place at the slurry store agitation access point (photograph 2 refer).

Photograph 2: Slurry store agitation access point

The licensee shall install a concrete pad at the slurry store agitation access point to ensure there are no unauthorised discharge of polluting matter to water, in accordance with licence condition 7.3.

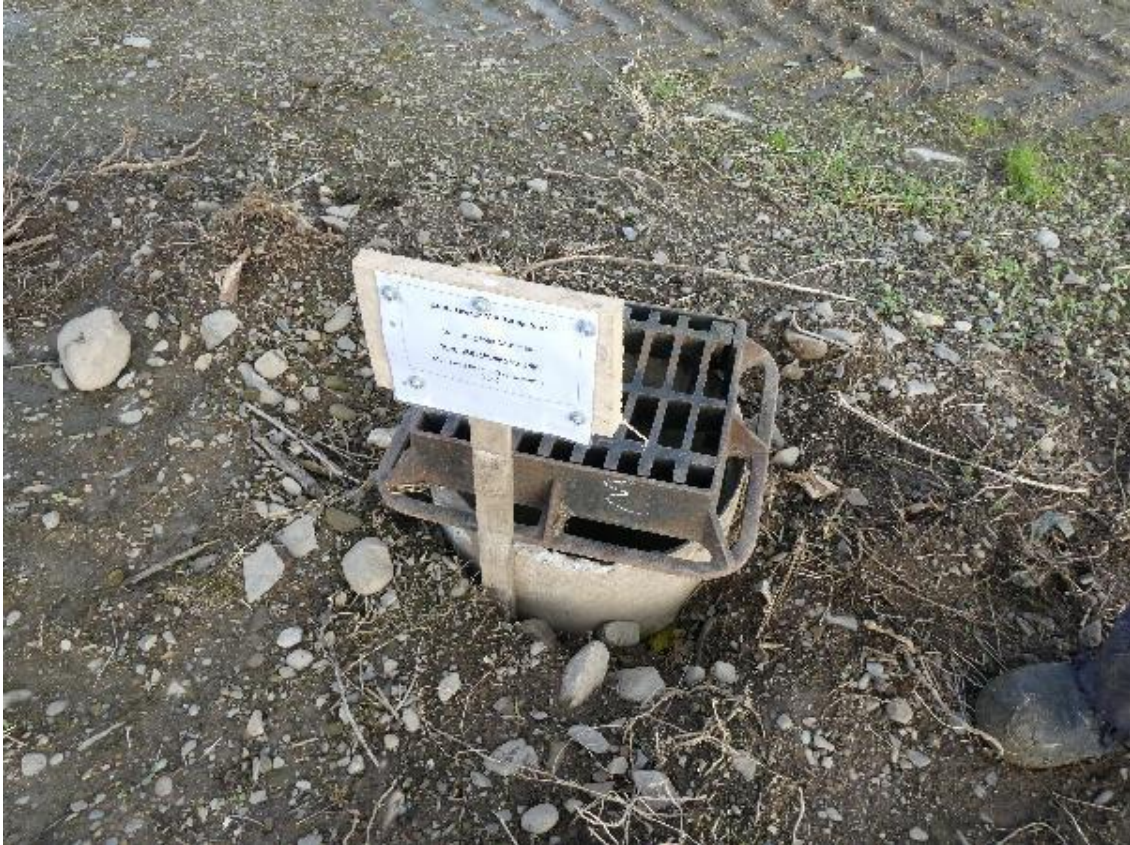
Answer	Condition Number	Non Compliance	Observation
Surface Water	Checked	7.3, 7.4	Yes	
Comment / Action Required				
<p>Surface water monitoring is not to the satisfaction of the Agency, with the monitoring locations and parameters not as listed in the licence Schedule 4(i). The weekly surface water inspection record was not available for inspection at the time of the site visit.</p> <p>This is non-compliant with licence Condition 7.4.</p> <p>The cover on surface water emission point ST-3 is not sufficient to prevent water inflow or contamination (photograph 3 refer).</p> <p>A build up of sediment was present in surface water emission point ST-4 at the time of the site visit (photograph 4 refer); this may impede flow and/or lead to storm water contamination.</p> <p>Loose plastic foam beads was observed beside the gilt yard (photograph 5 refer), which may blow to surrounding surface water bodies.</p> <p>Action Required:</p> <p>The licensee shall:</p> <ul style="list-style-type: none"> • carry out surface water monitoring and visual inspections as per licence Condition 7.4 and Schedule 3(i); • upload as a licensee return through EDEN the laboratory certificate of analysis for quarter 1 (Q1) 2024 surface water monitoring no later than 15 March 2024; • upload as a licensee return through EDEN the record of the surface water visual inspections carried out during quarter 1 (Q1) 2024 no later than 15 March 2024; • install on storm water emission point ST-3 an impervious cover that will prevent water inflow or surface water contamination; • remove the build up of sediment in storm water emission point ST-4; and • clean and appropriately dispose of the loose foam material from the area beside the gilt yard and upload as a licensee return through EDEN a photo of the cleaned area no later than 31 December 2023.

Photograph 3: ST-3 surface water emission point

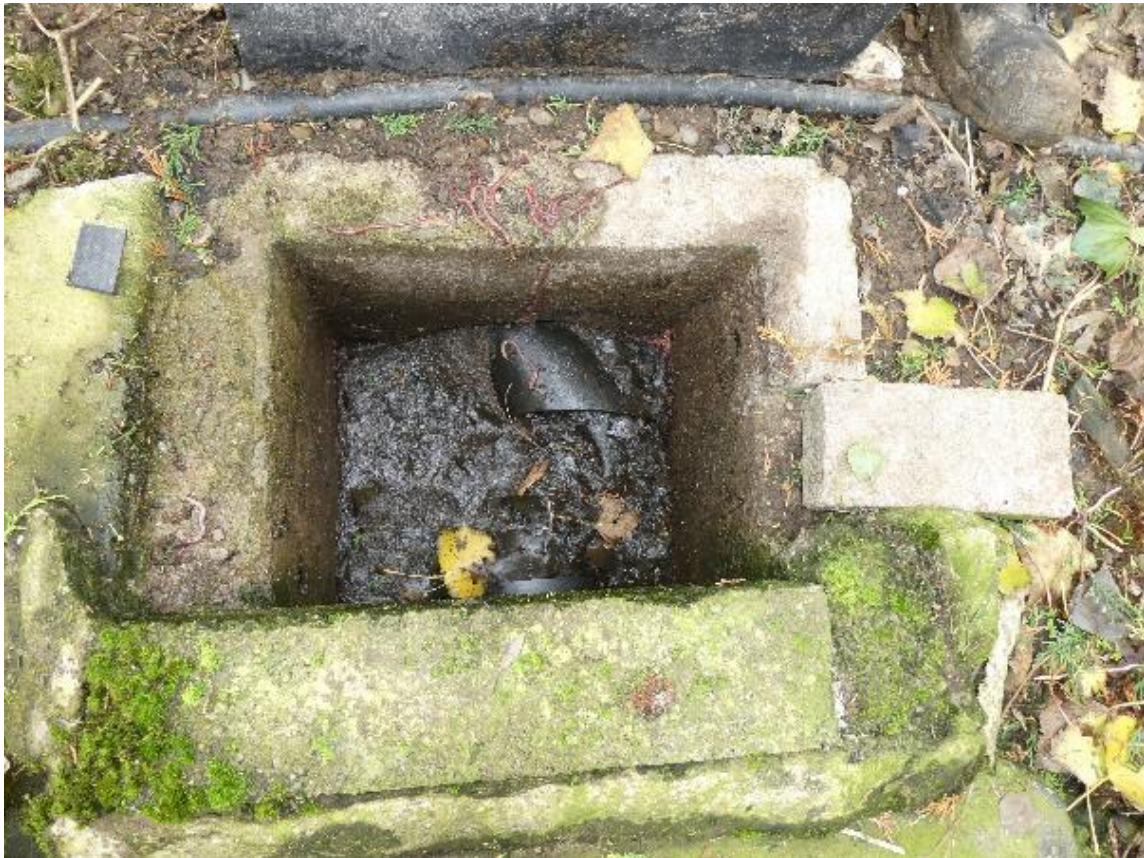
Photograph 4: ST-4 surface water emission point

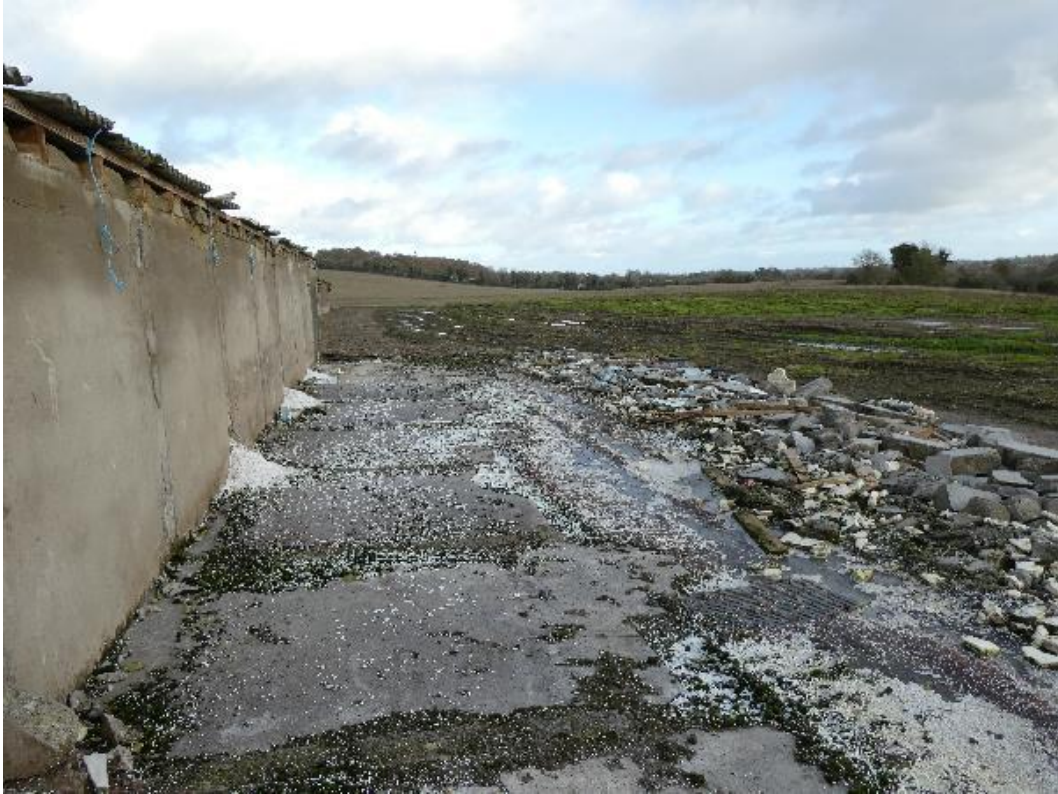
Photograph 5: Foam beside gilt yard

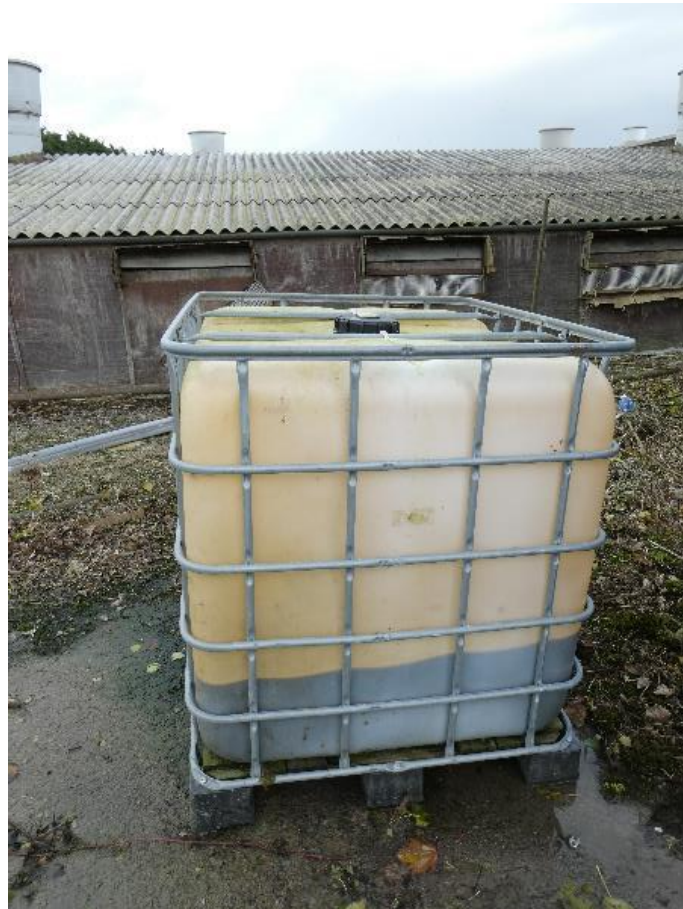
An intermediate bulk container (IBC) containing fly oil was not banded at the time of the site visit (photograph 6 refer).

Photograph 6: Fly oil IBC

The licensee shall ensure that all fuel tank storage facilities shall, prior to utilisation, as a minimum be banded, either locally or remotely, to a volume not less than the greater of the following;(i) 110% of the capacity of the largest tank or drum within the banded area(ii) 25% of the total volume of substance which could be stored within the banded area, in accordance with licence condition 7.11.
