Record of site inspection at unlicensed facility

Unlicensed Piggery

Date of assessment: 05/11/21 **Start time:** 15:02 **Finish time:** 16:30

This document's reference number: Site inspection – Unauthorised Piggery, Cooligboy, Timoleague, Bandon, County Cork – 05 Nov 2021

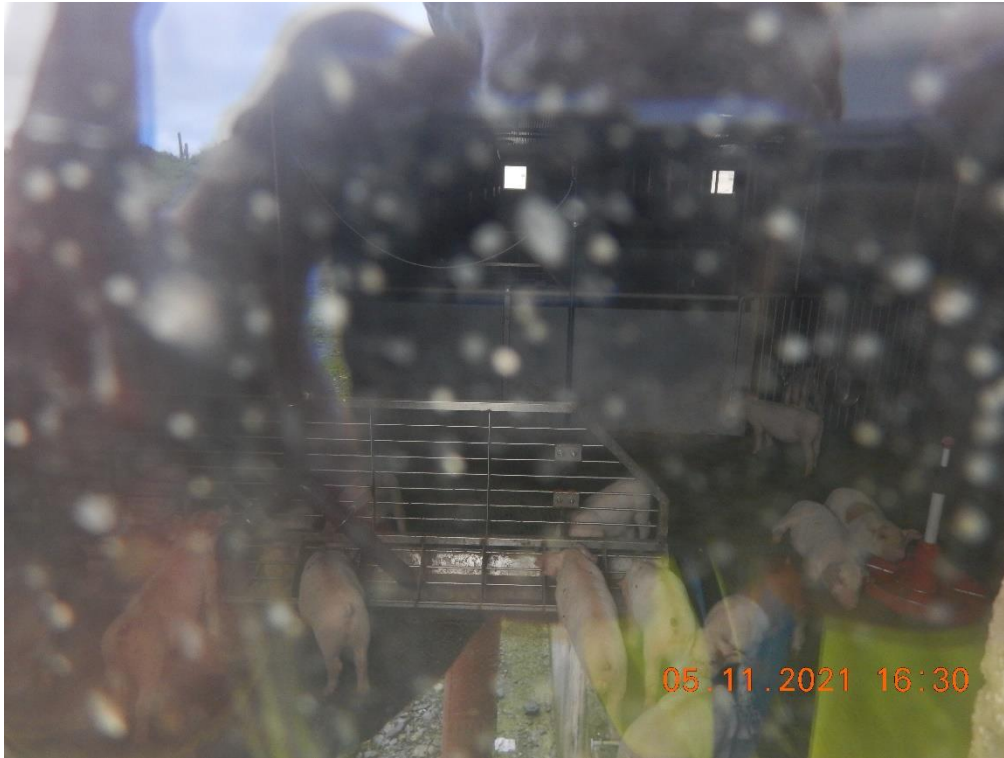
- All four pig houses were found to be stocked with pigs. A photograph was taken of weaner unit 8 which indicated the presence of pigs (photo 1 refers);

Photo 1; Pigs within weaner unit.

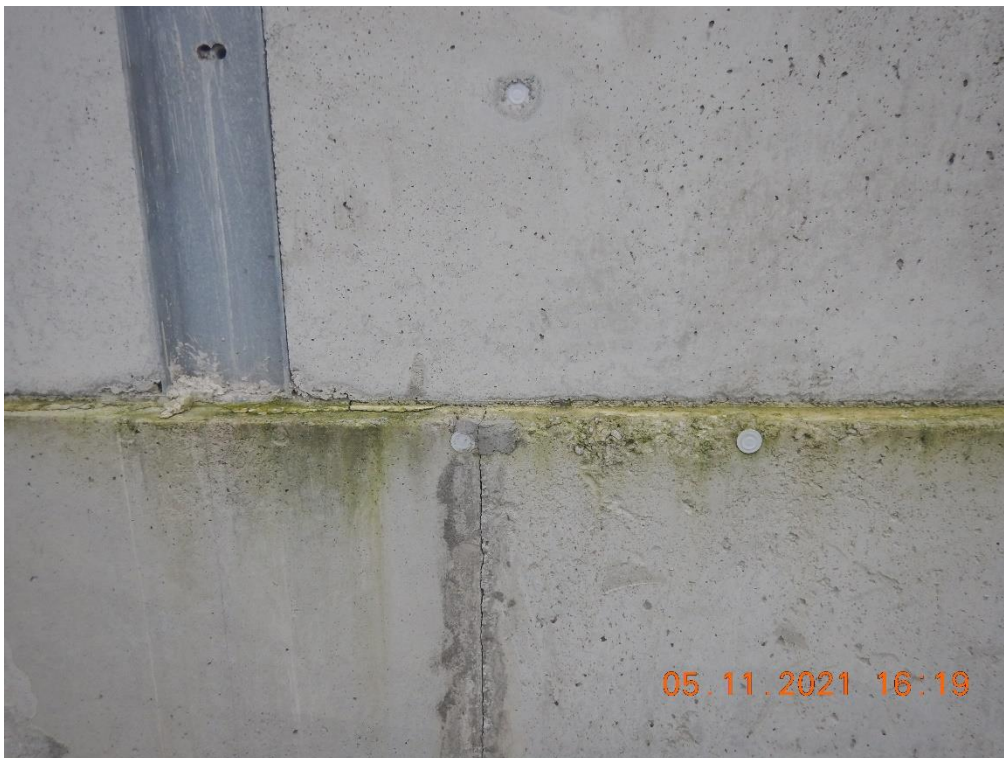
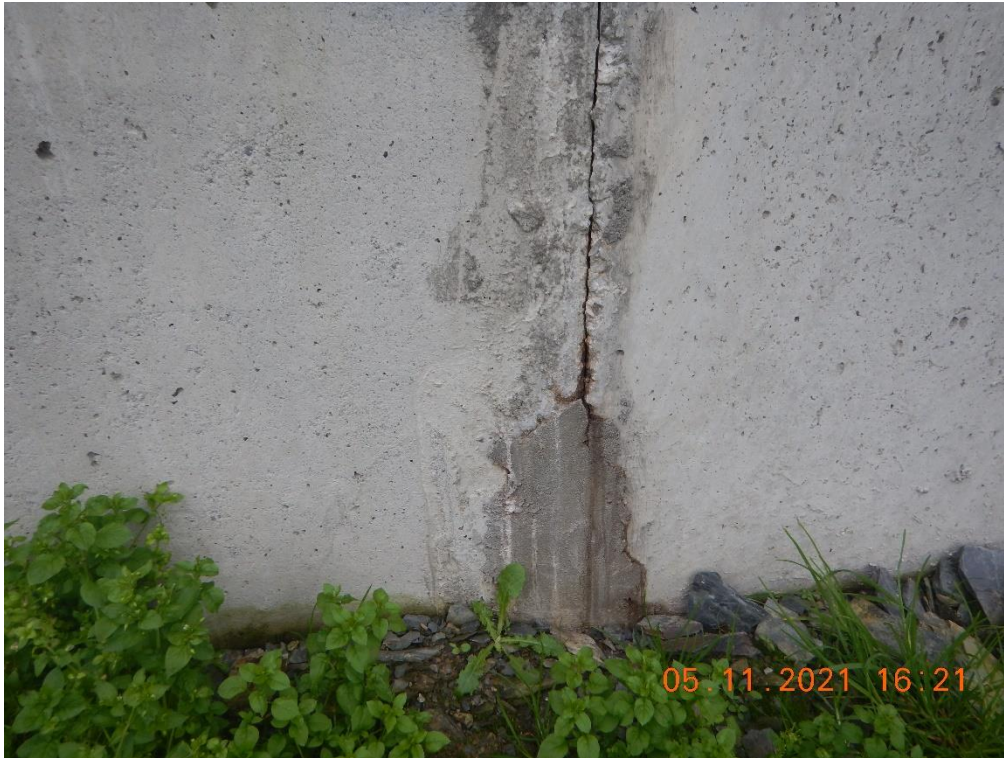
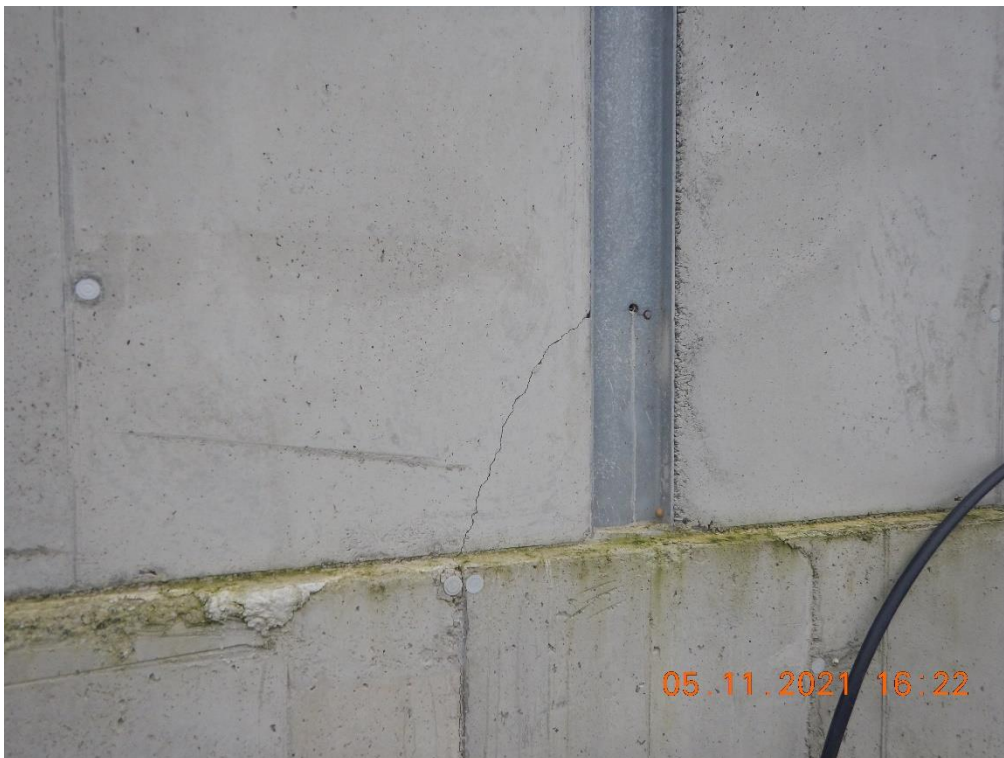
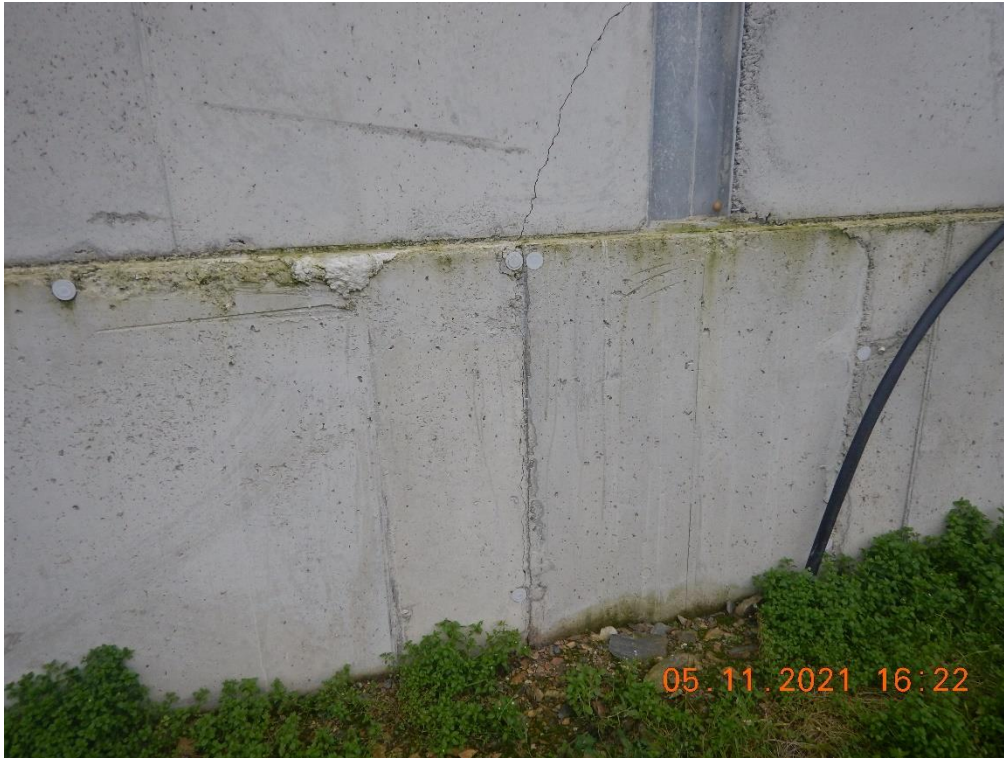
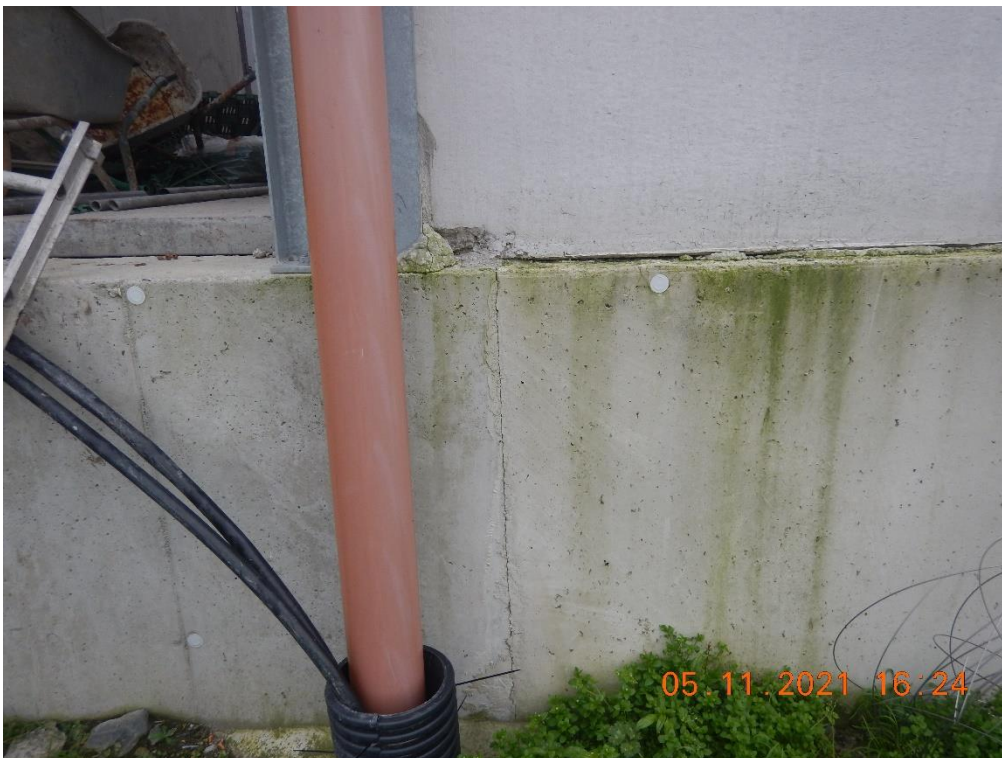
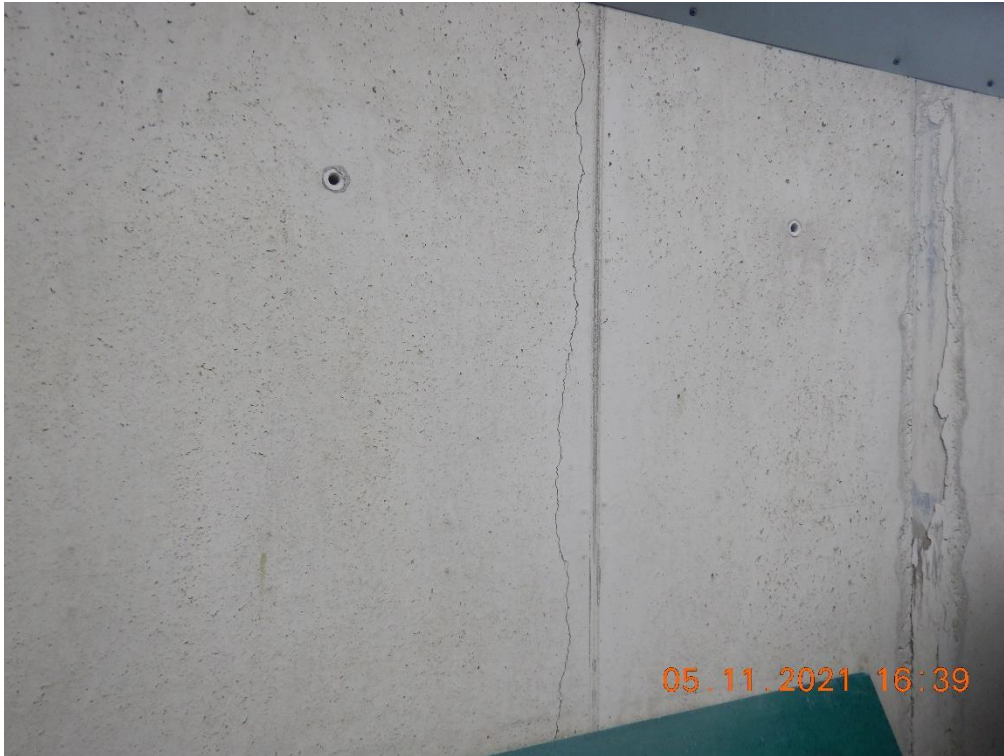
- The external walls of the pig houses were found to be cracked in a number of areas (Photos 2 to 7 refer);
- There was evidence that slurry was weeping from some of these external walls of the pig houses and onto unprotected ground (Photos 8 to 10 refer);

Photo 2; External wall of pig house.

Photo 3; External wall of pig house.

Photo 4; External wall of pig house.

Photo 5; External wall of pig house.

Photo 6; External wall of pig house.

Photo 7; External wall of pig house.

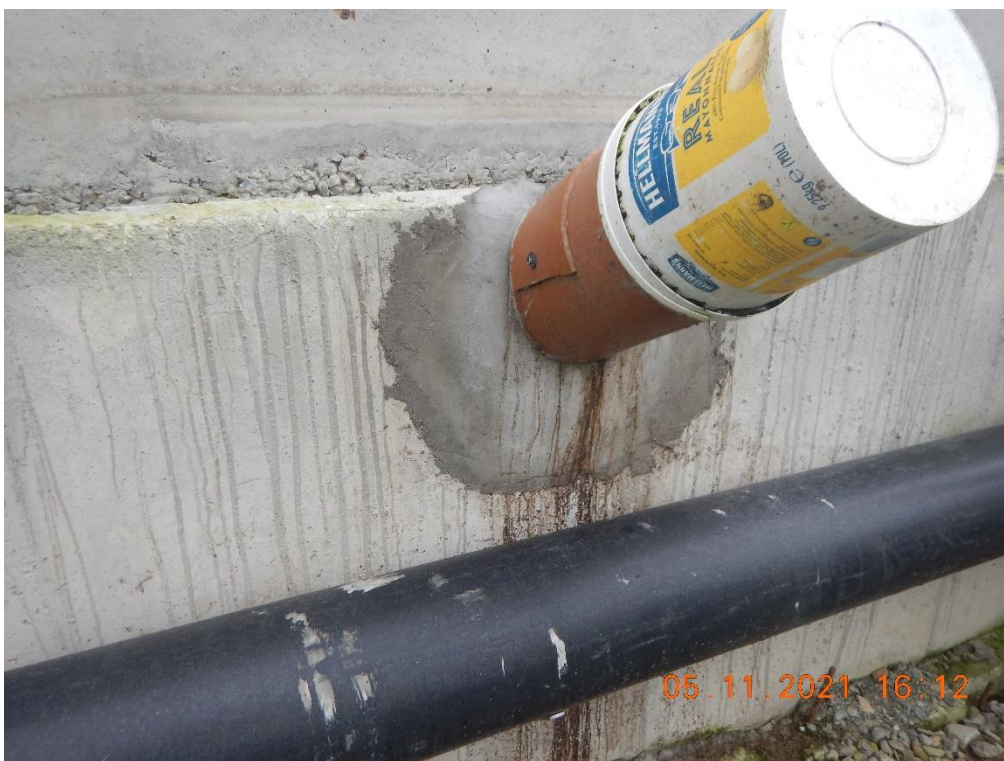
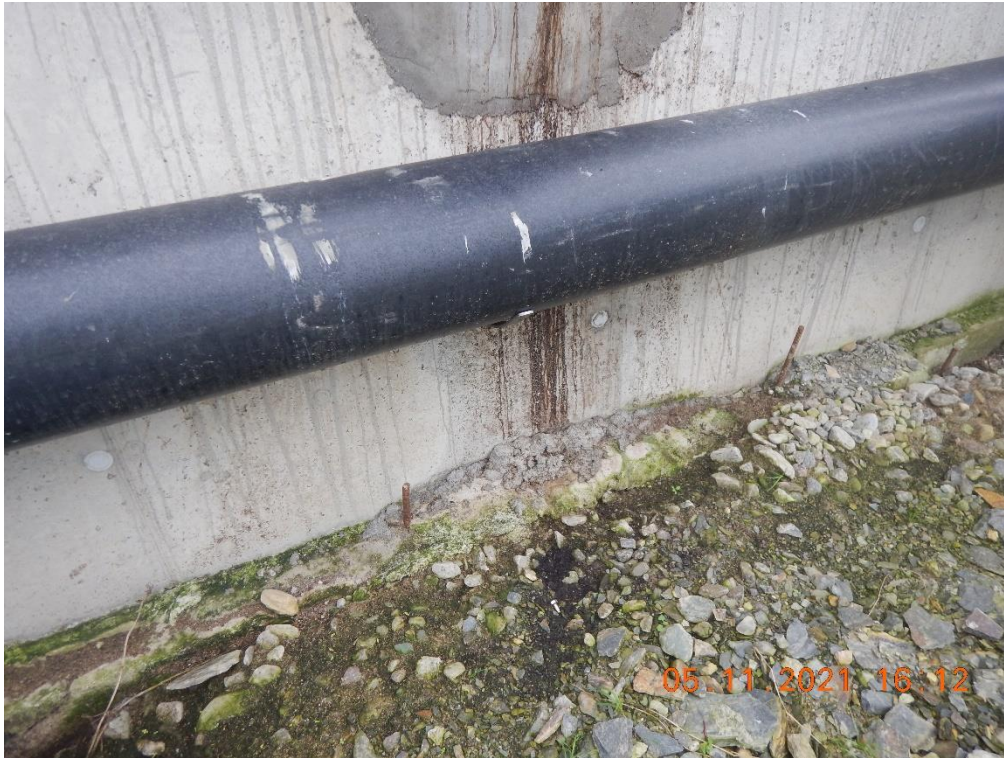
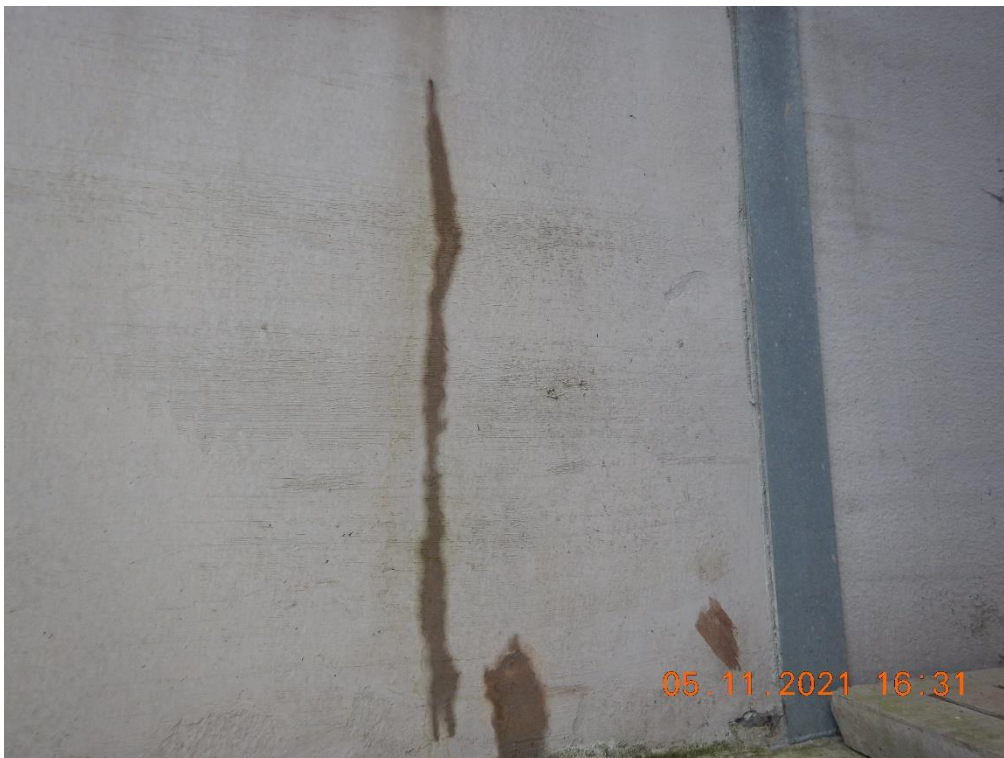
Photo 8; External wall of pig house.

Photo 9; External wall of pig house.

Photo 10; External wall of pig house.

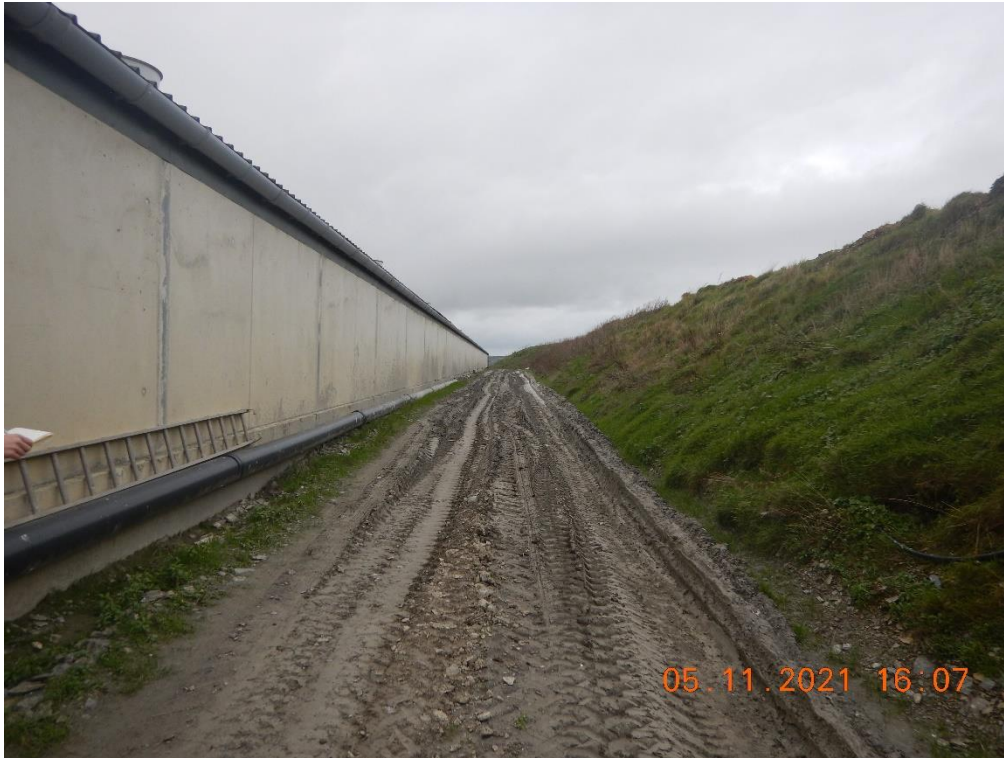
- Access tracks from agricultural machinery were found adjacent to external walls of pig houses (Photo 11 refers). The vibration from vehicle traffic passing close to the houses (less than 5 metres) creates a risk to the structural integrity of the walls of the pig houses which are already cracked;

Photo 11; Access track adjacent to pig house.

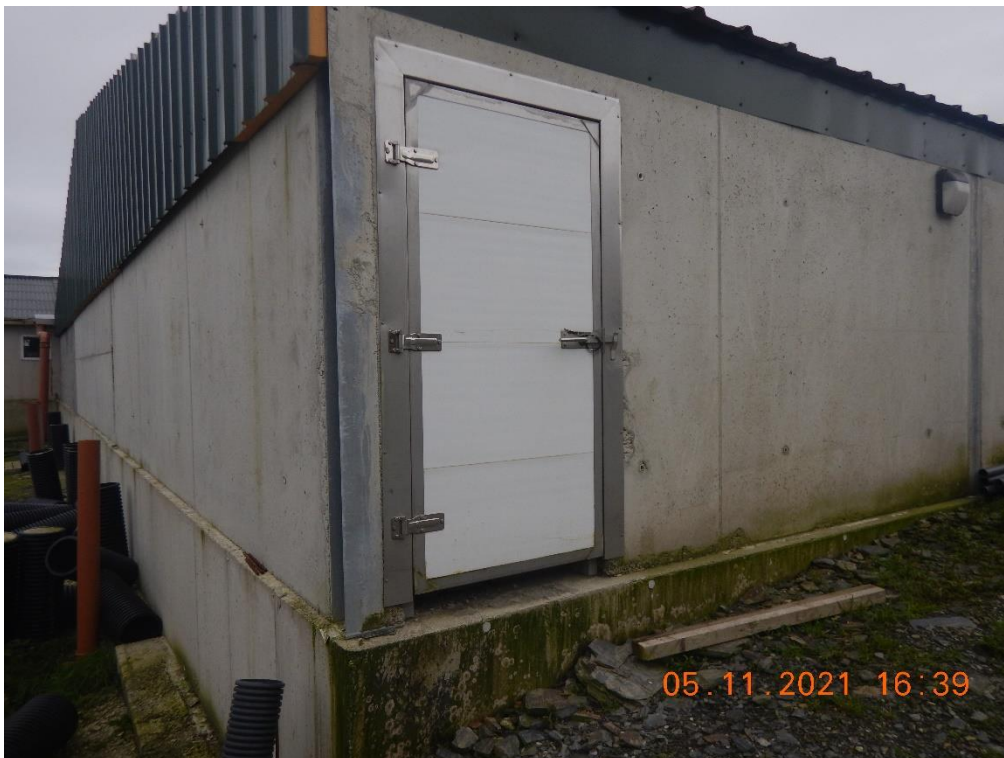
- An external door was found not be adequately fitted (photo 12 refers);
- Animal feed was found on unprotected ground adjacent to feed silos (Photo 13 refers);

Photo 12; External door of pig house.

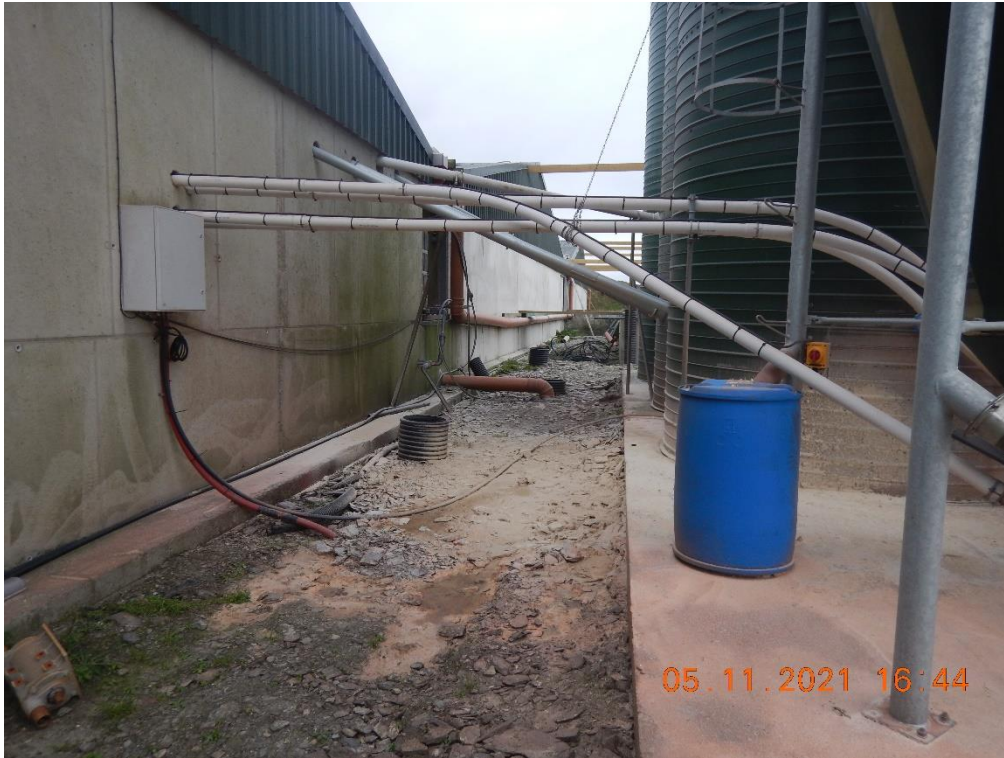
Photo 13; Unprotected ground adjacent to feed silos.

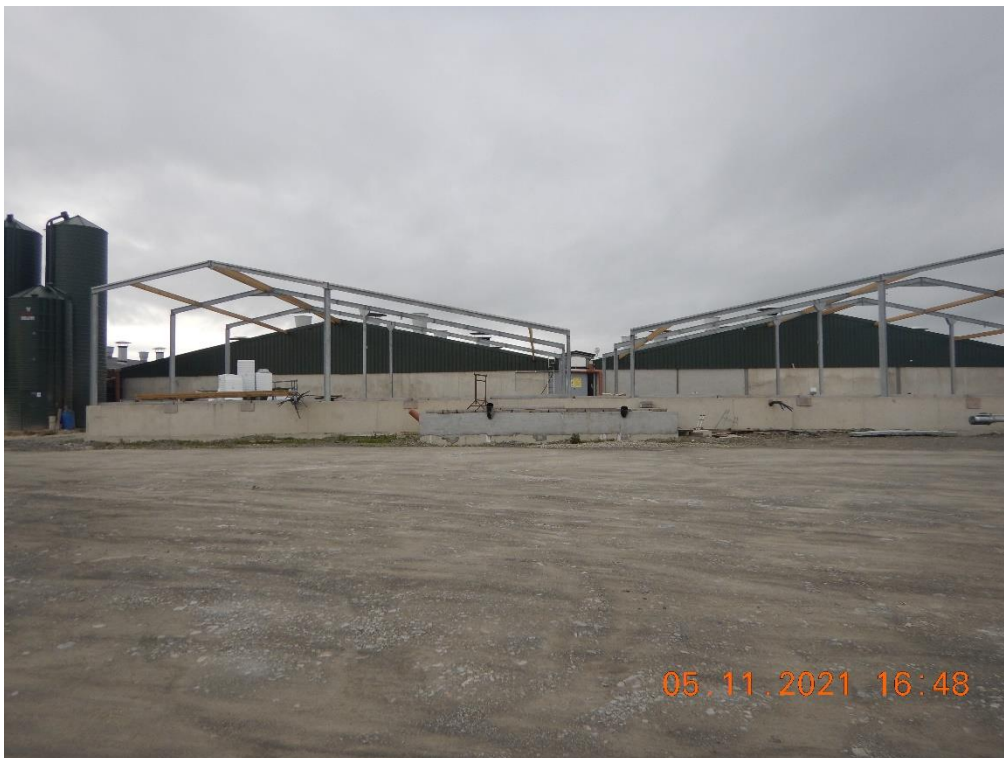
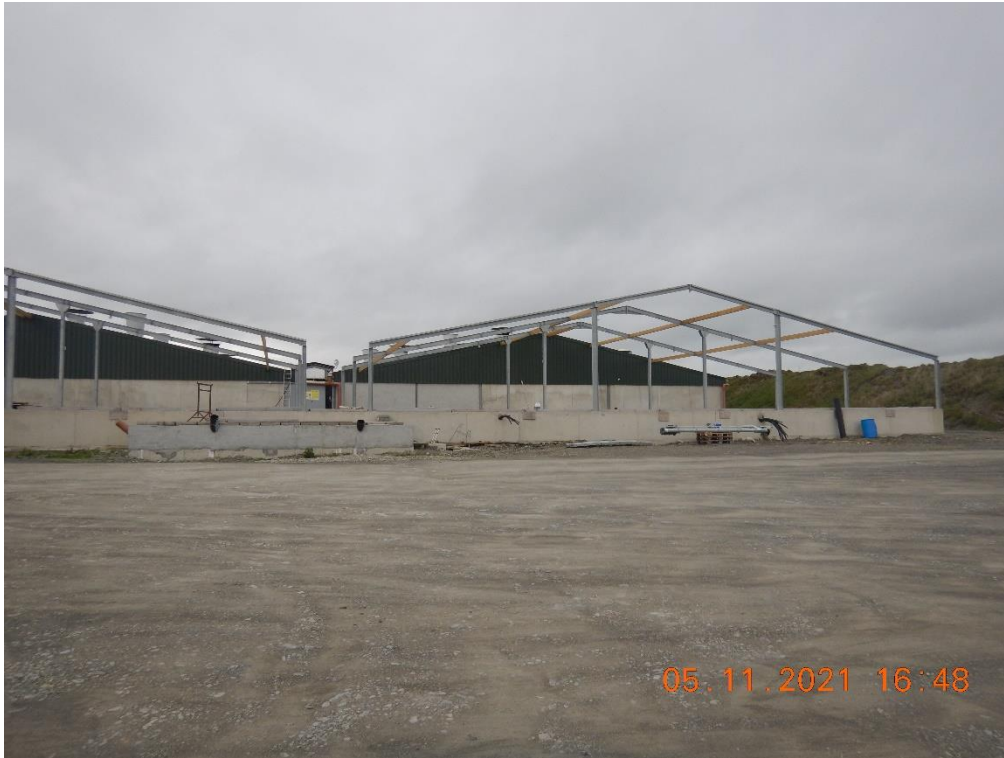
- Additional sheds were under construction at the southern section of the site (Photo 14 and 15 refers).

Photo 14; Additional sheds under construction.

Photo 15; Additional sheds under construction.
