| Licensee | | | | | |
|---|---|--|--|--|--|
| Name of Installation | Mr Martin O'Donovan | | | | |
| Licence Register No. | P0621-02 | | | | |
| Site Visit Reference No. | SV25536 | | | | |

| Site Visit Detail | | | | | | |
|---|---|---|--|---|--|--|
| Date Of Inspection | 05/04/2022 | | | | | |

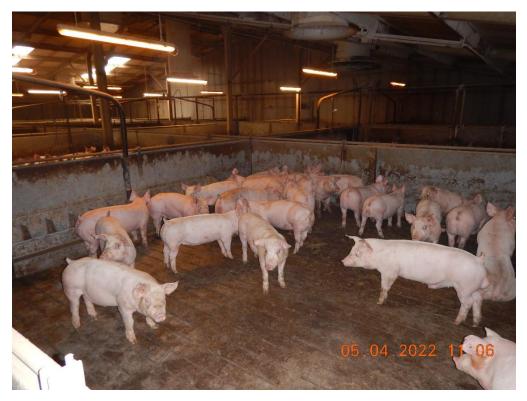
During the site visit the licensee was found to be operating pig houses outside the licensed site boundary (Photos 1 to 3 refer). The EPA first noticed these pig houses in operation during a site visit on 09/06/2021 (Site visit ref; SV22457 refers). A follow-up site visit was undertaken on 05/11/2021 which found that all 4 pig houses were stocked with pigs. Following this site visit the EPA issued a warning letter on 27/01/2022 serving notice under Section 82(2) of the EPA Act 1992, as amended to cease and desist the unauthorised operations, for activities falling under Class 6.2 of the First Schedule, unless and until the licensee has been granted a licence which authorises the operation of these unauthorised facilities.

This is non-compliant with condition 1.4 of the EPA licence.

**Photo 1**; Photograph of pigs in facilities outside of licensed site boundary.

The licensee is required to cease and desist from operating outside the licensed site boundary forthwith, and revert via CI ref; CI001994 indicating that operations have ceased.

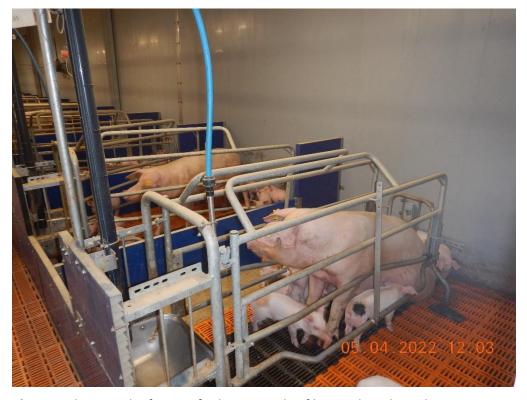
Photo 2; Photograph of pigs in facilities outside of licensed site boundary.

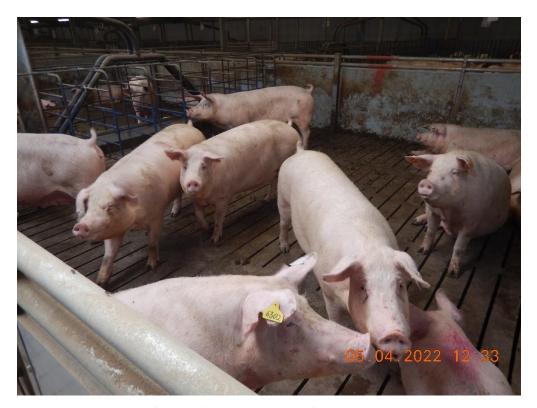
**Photo 3;** Photograph of pigs in facilities outside of licensed site boundary.
