# SITE VISIT REPORT

**Purpose of Site Visit:** Peat Extraction in Co. Kildare  
**Site Address:** Ballinderry, Carbury, Co. Kildare  
**Date of Visit:** 22/06/2023  
**Times of Visit:** 1030 to 1330  
**Visit Criteria:** Peat extraction investigation  
**EPA Attendees:** Mick Henry and Simon Buckley  
**Organisation:** Clairstone Ltd

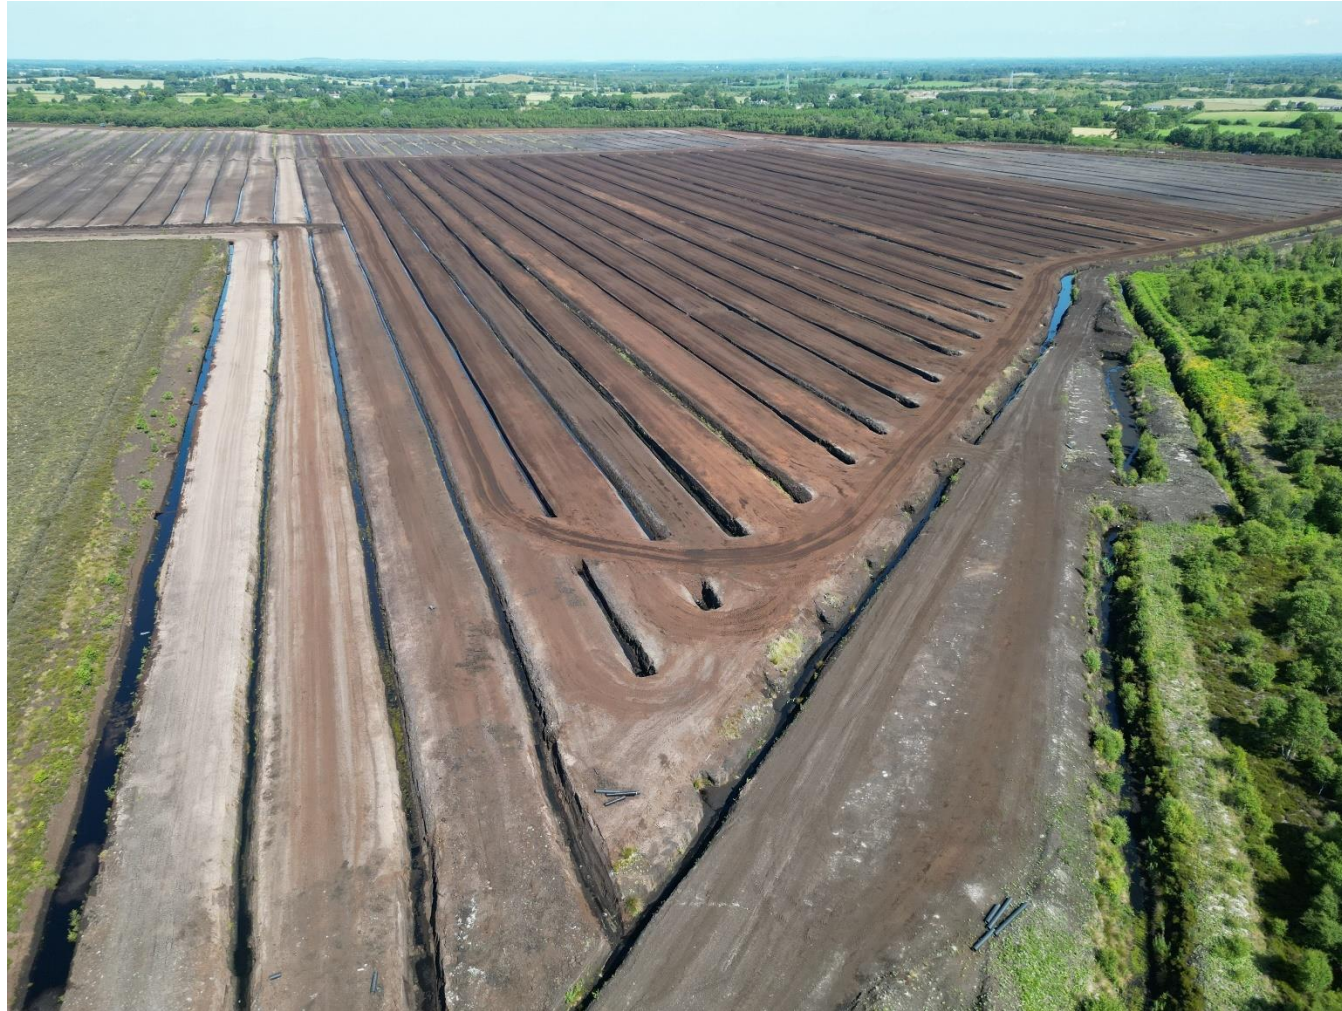
**Photo 1: Photograph of the ‘worked area’ of the peatland.**

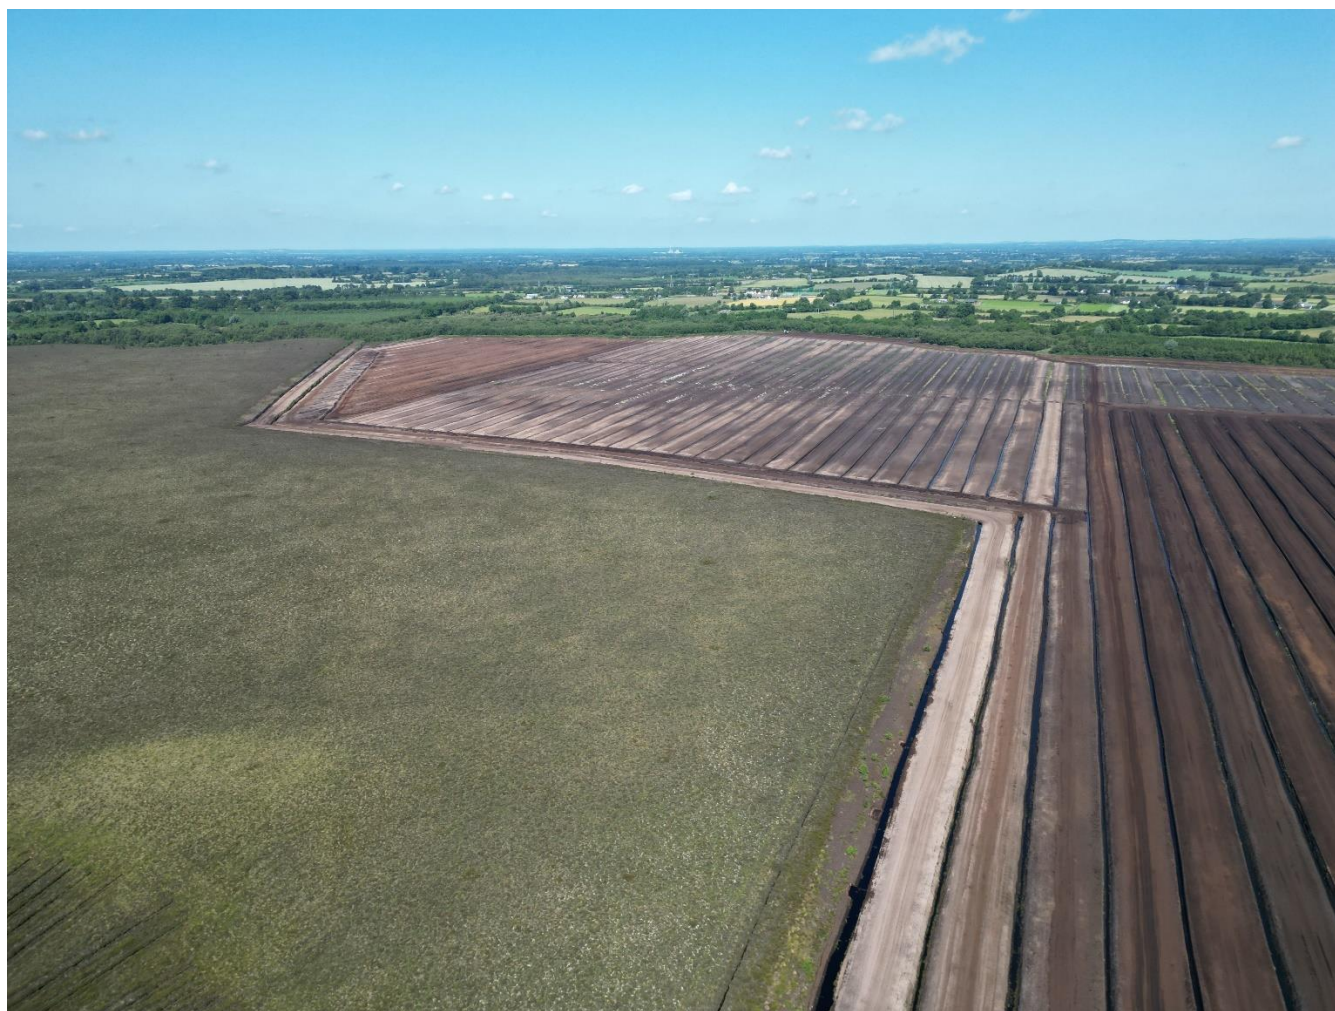
**Photo 2: Photograph of the ‘worked area’ of the peatland and the untouched adjacent peatland.**

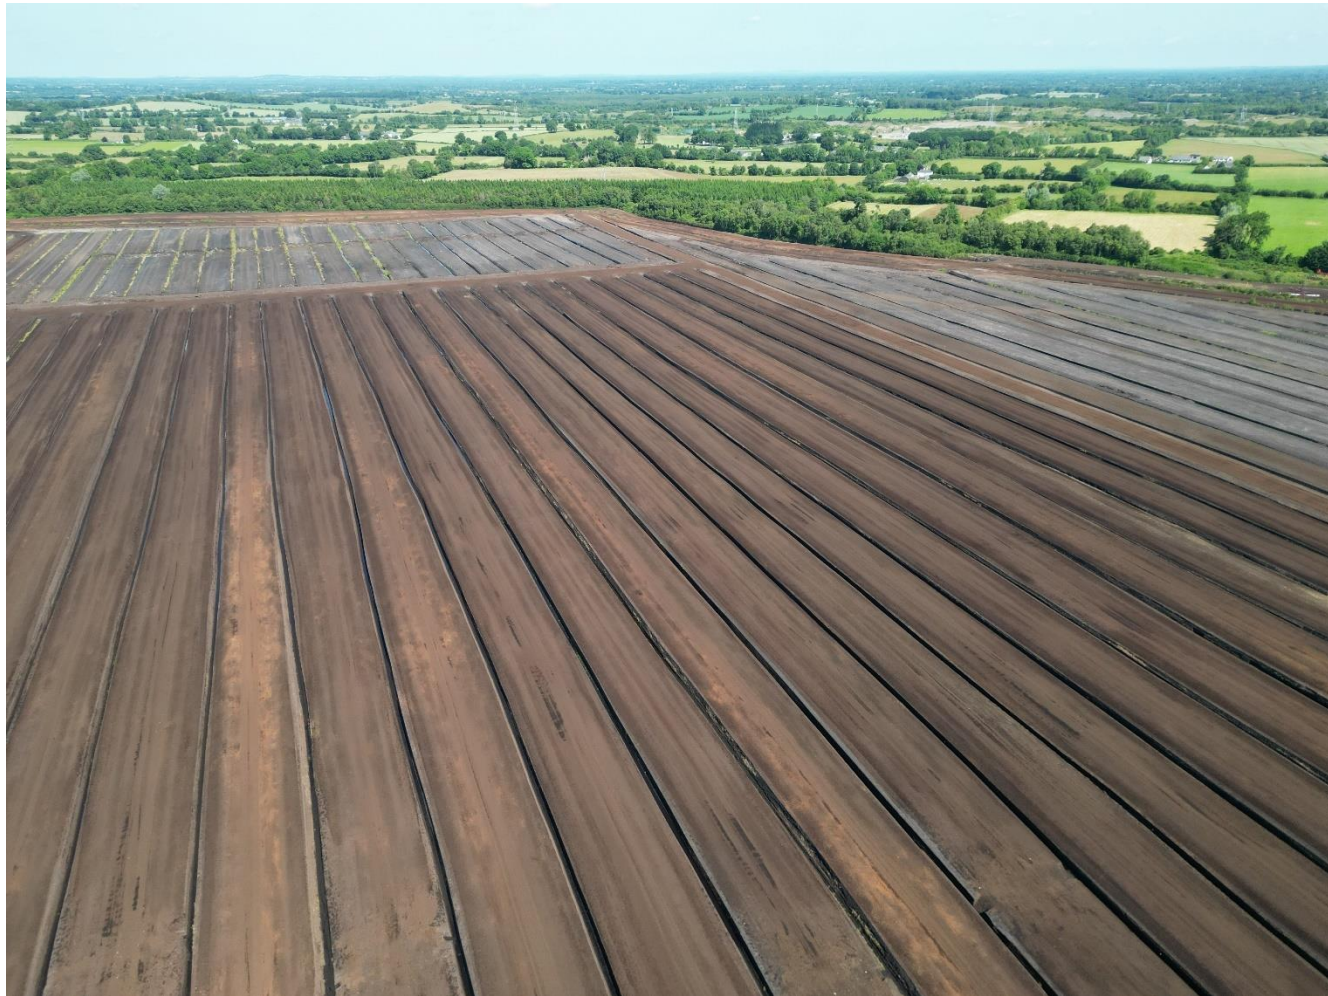
**Photo 3: Photograph of a section of the ‘worked area’ of the peatland showing peat extraction rows and drainage channels.**

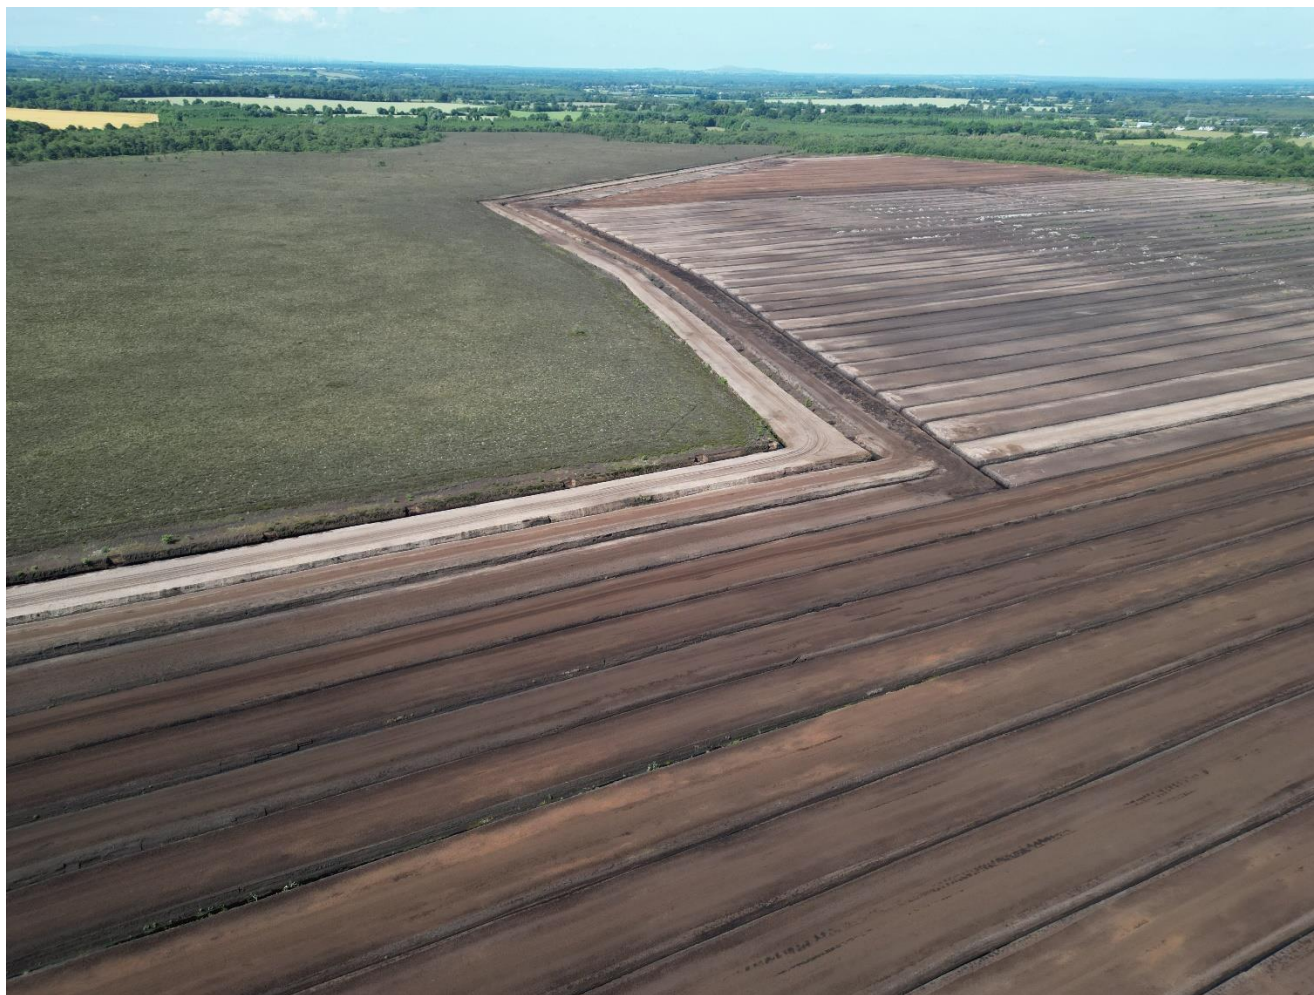
**Photo 4: Photograph of the ‘worked area’ of the peatland and the untouched adjacent peatland.**

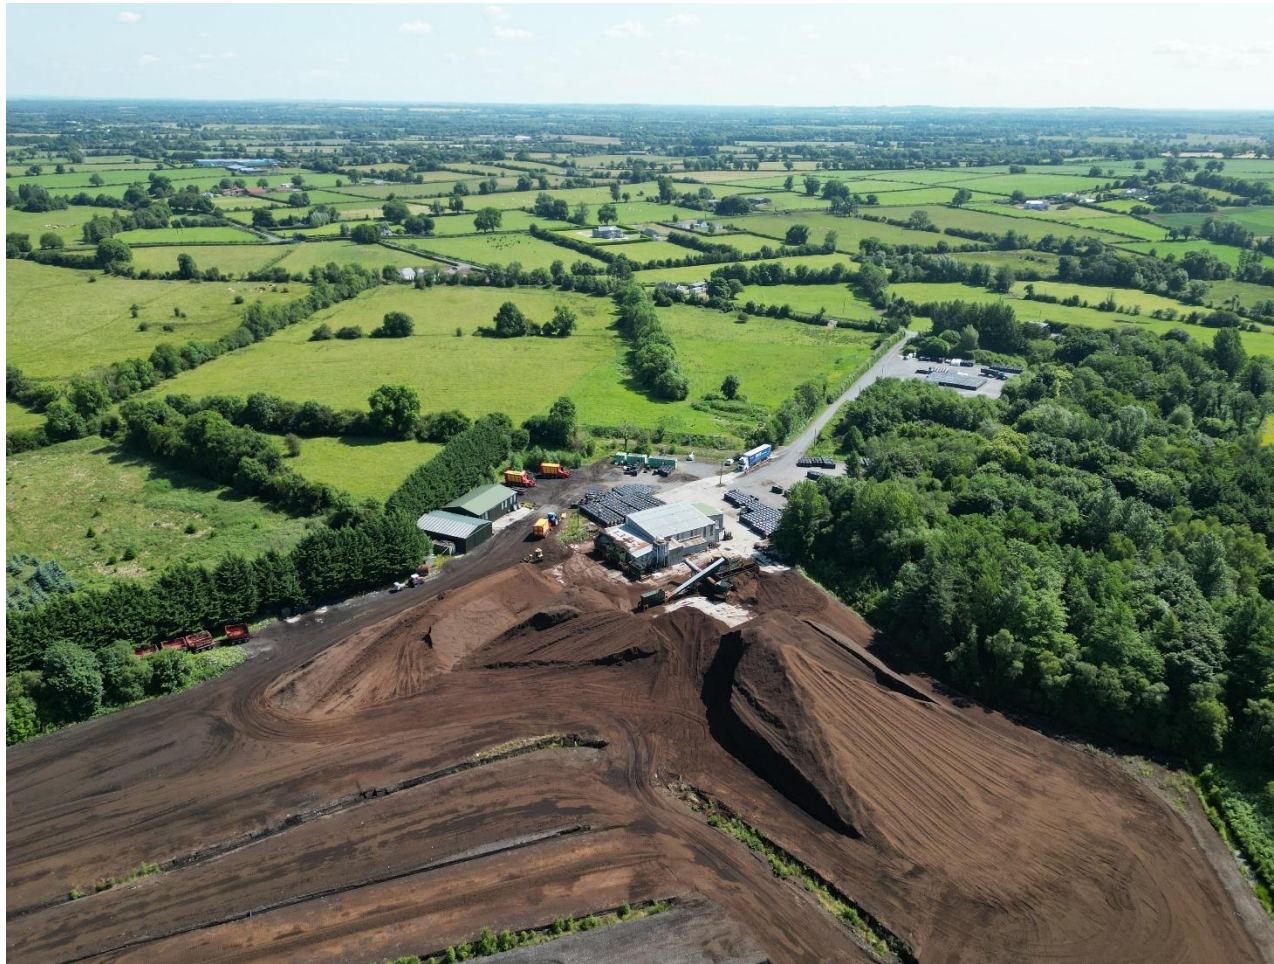
**Photo 5: Photograph of the processing and bagging plant, stockpiles of milled peat and storage areas.**

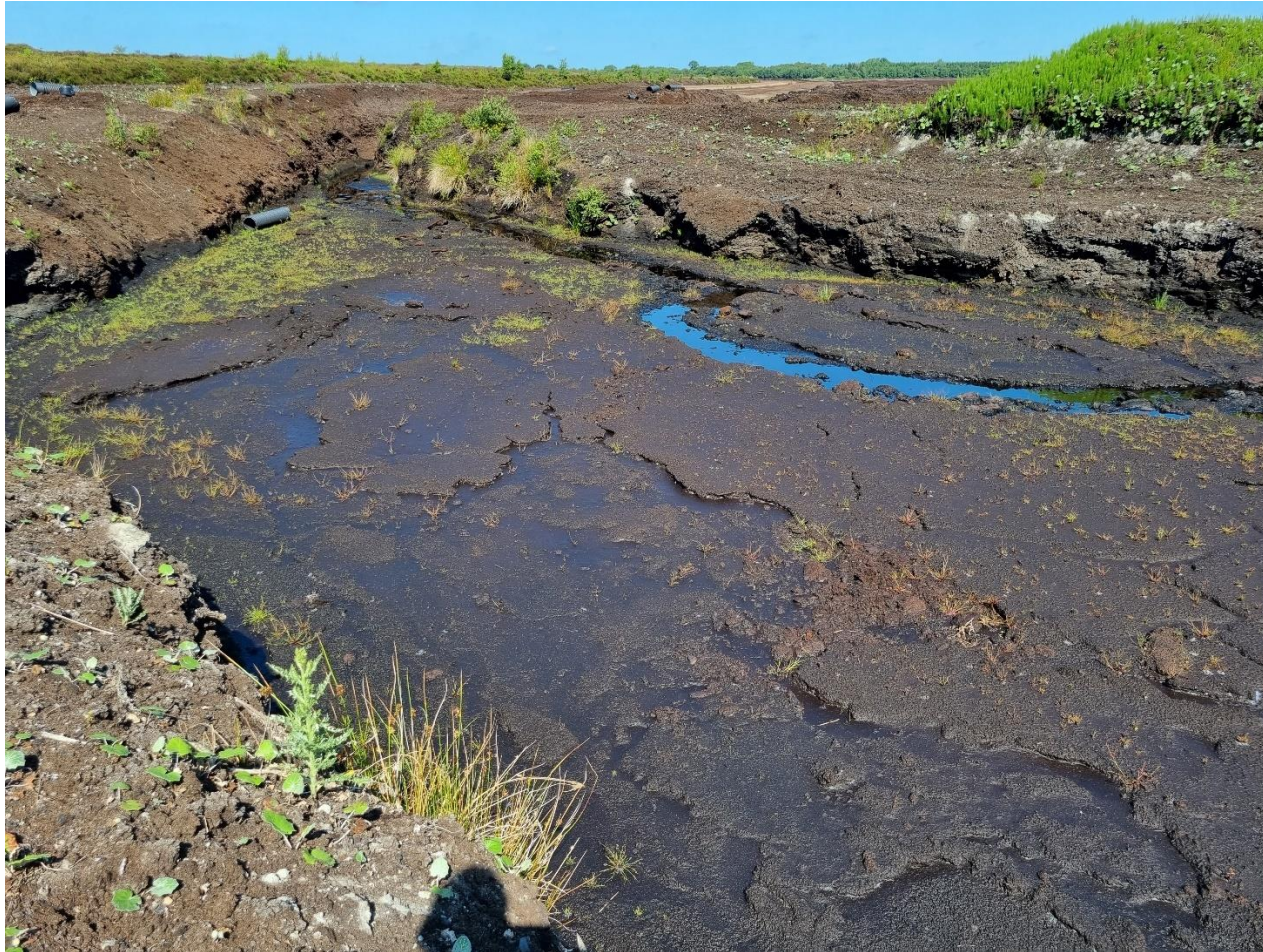
**Photo 6: Significant accumulation of solids noted in drainage network at the peatland.**

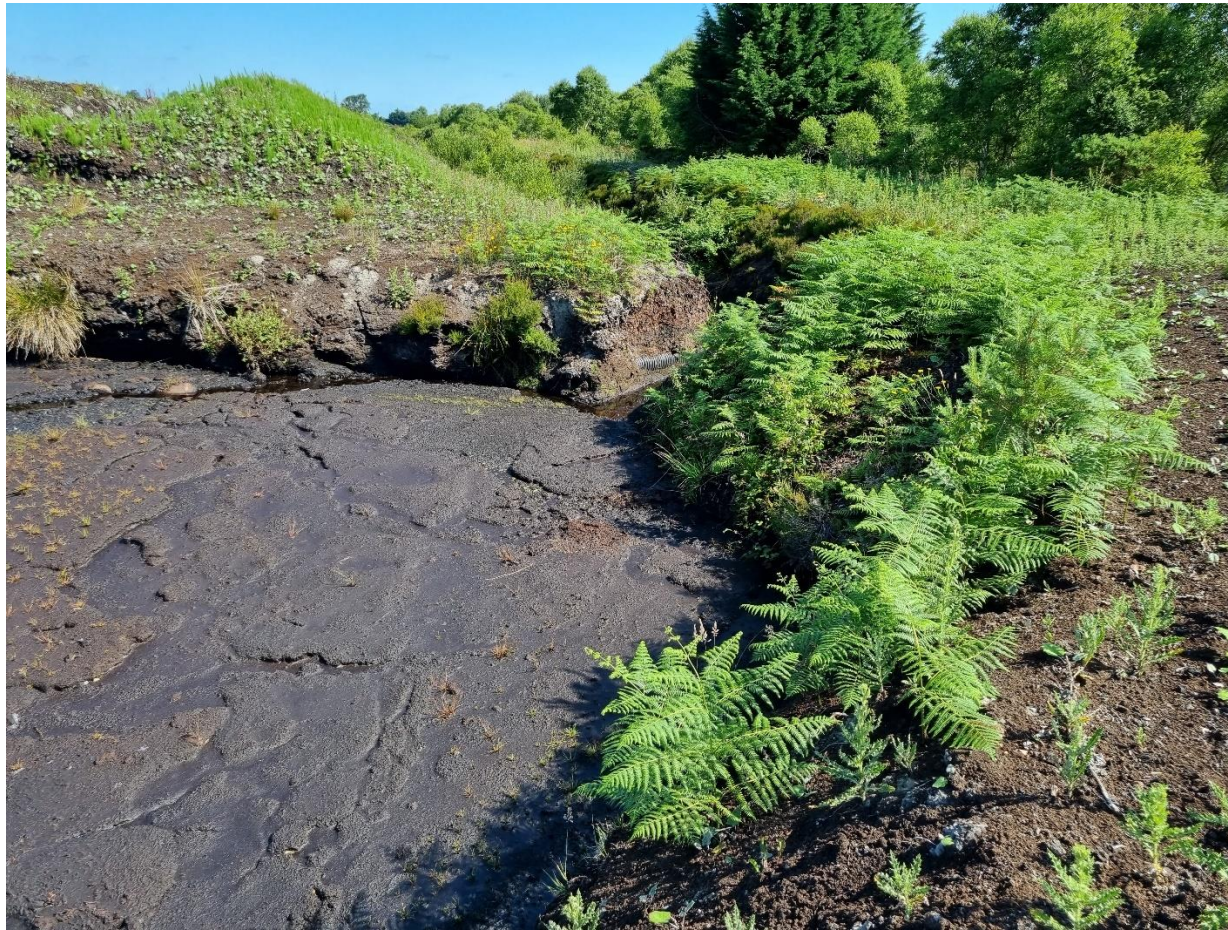
**Photo 7: Significant accumulation of solids noted in drainage network at the peatland.**

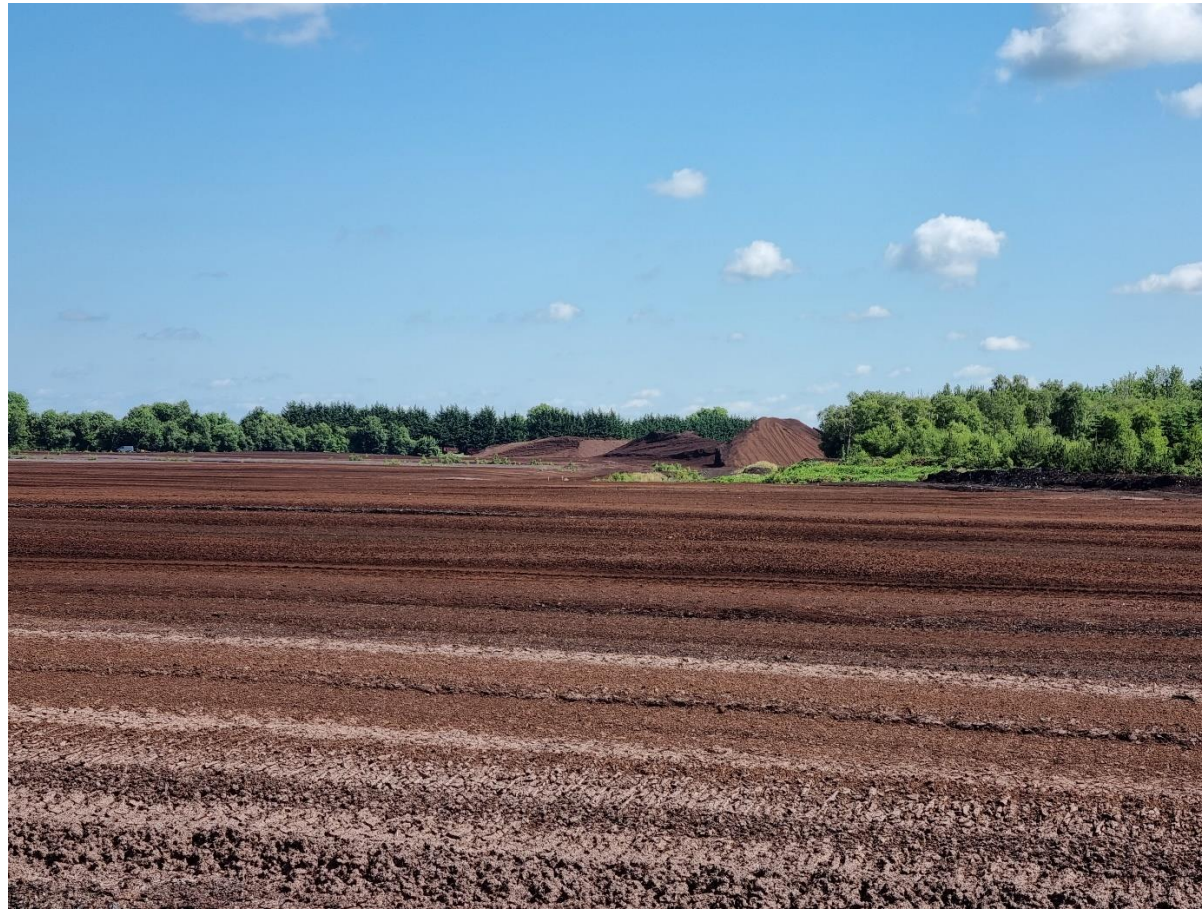
**Photo 8: Photograph showing recent extraction of peat on the peatland.**

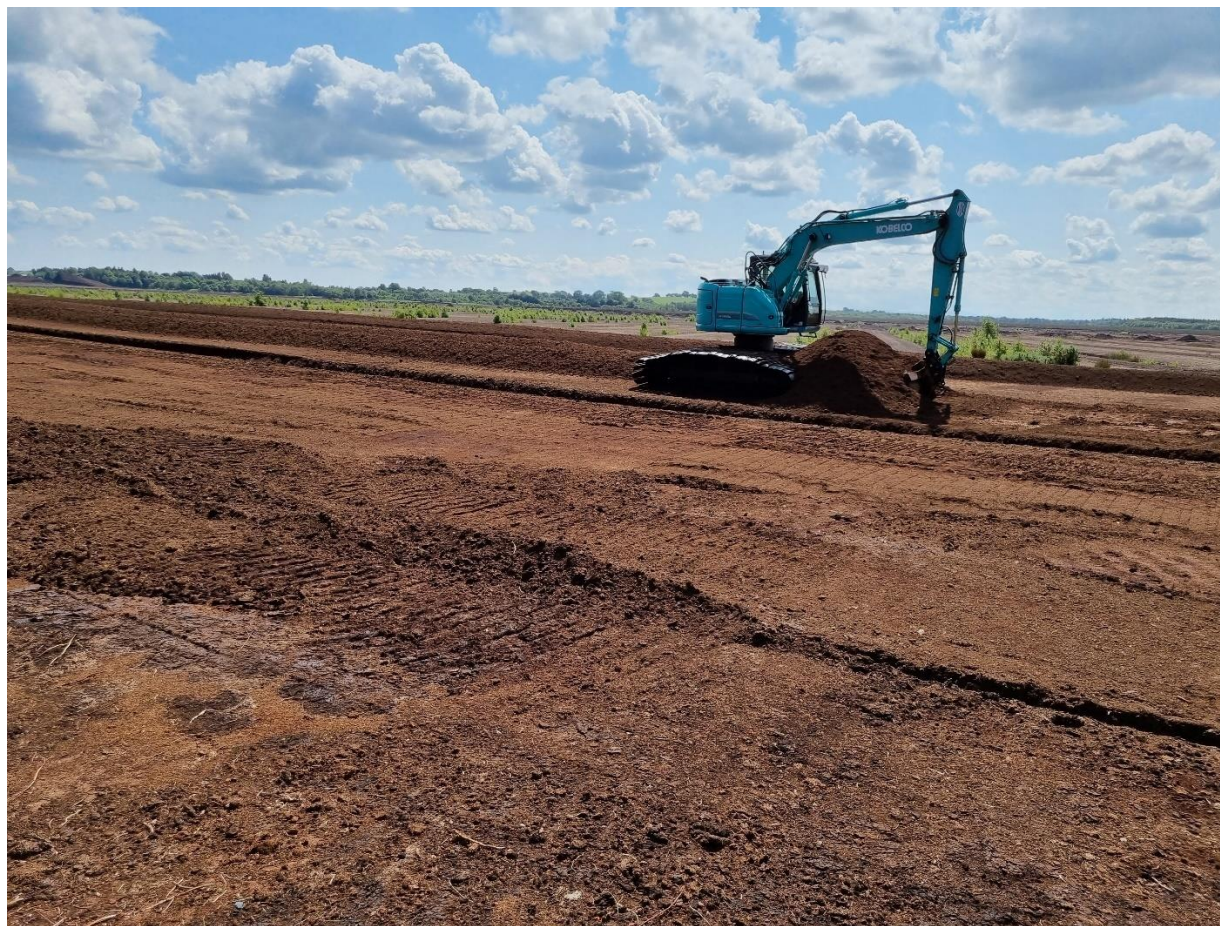
**Photo 9: Photograph showing excavator and rows of 'ridged' milled peat on the peatland.**

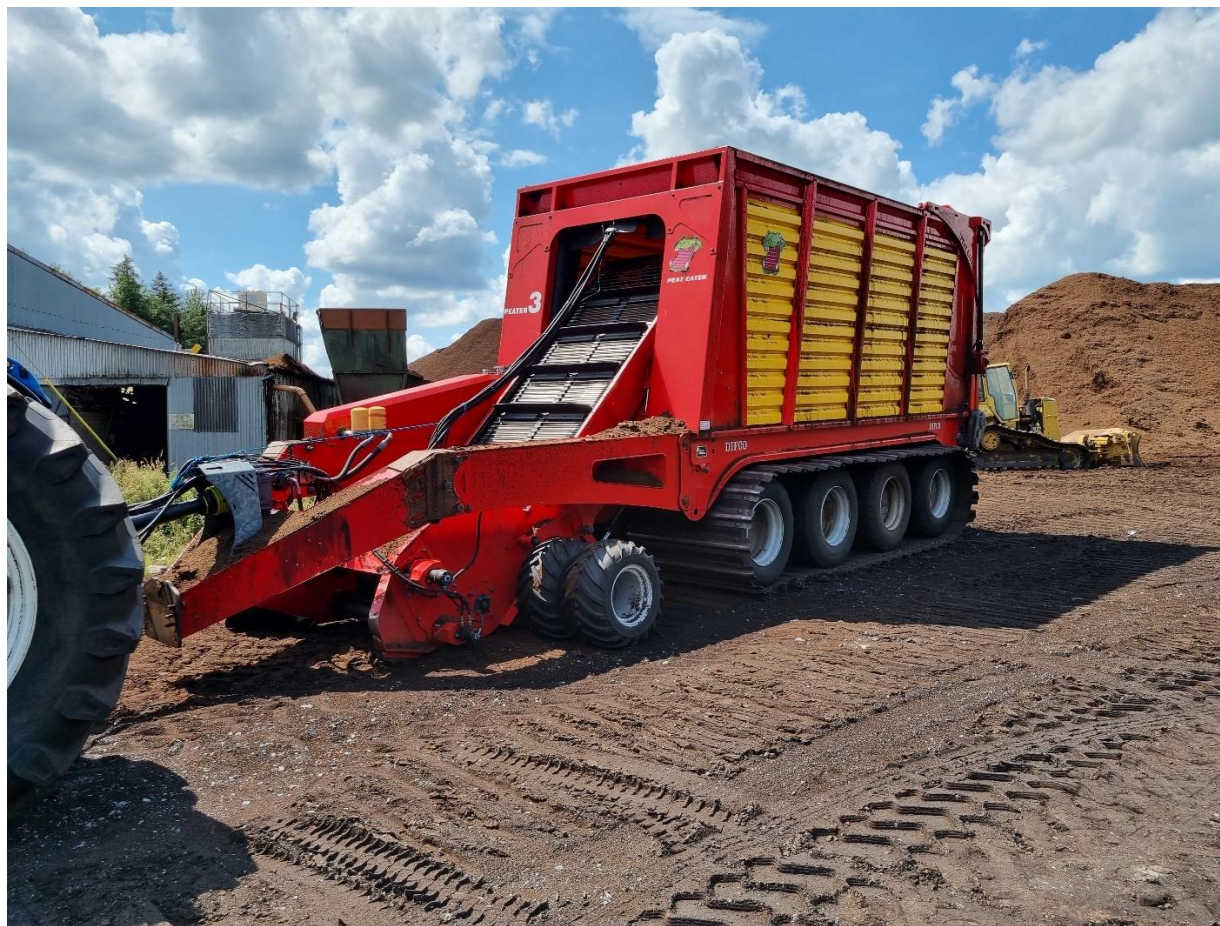
**Photo 10: Photograph showing peat harvesting equipment parked adjacent to the bagging/processing plant at the peatland.**
