SITE VISIT REPORT

Purpose of Site Visit:	Peat Extraction in Co. Kildare
Site Address:	Ballinderry, Carbury, Co. Kildare
Date of Visit:	10/07/24
Times of Visit:	1010 to 1540
Visit Criteria:	Peat extraction investigation
EPA Attendees:	Mick Henry
Organisation:	Clairstone Ltd

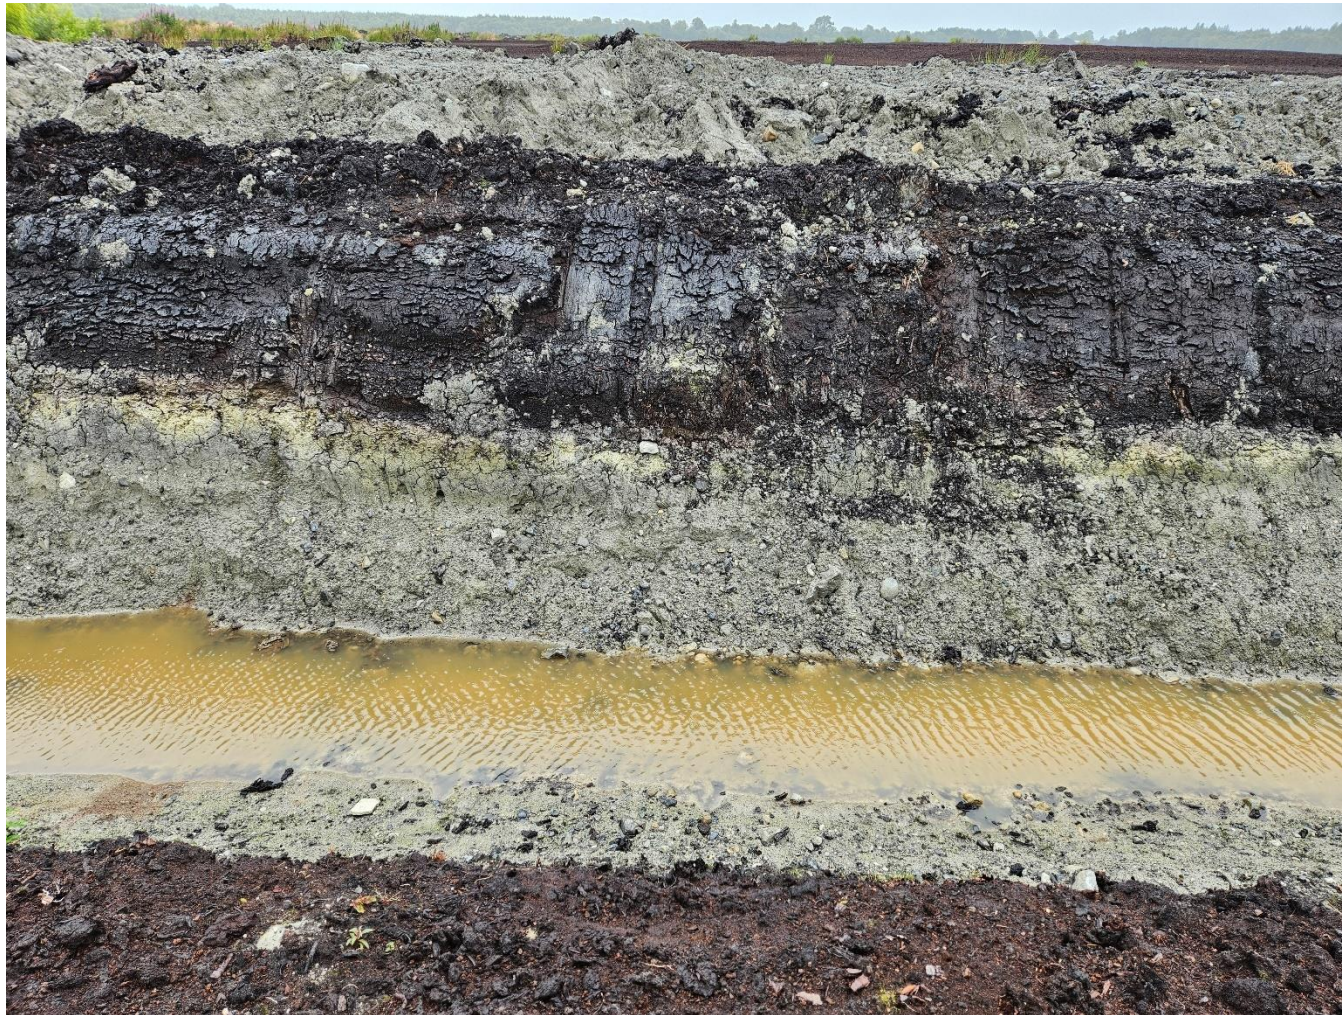
Photo 1: Photo showing the marl like materials underlying the remaining peaty deposits on the peatland.

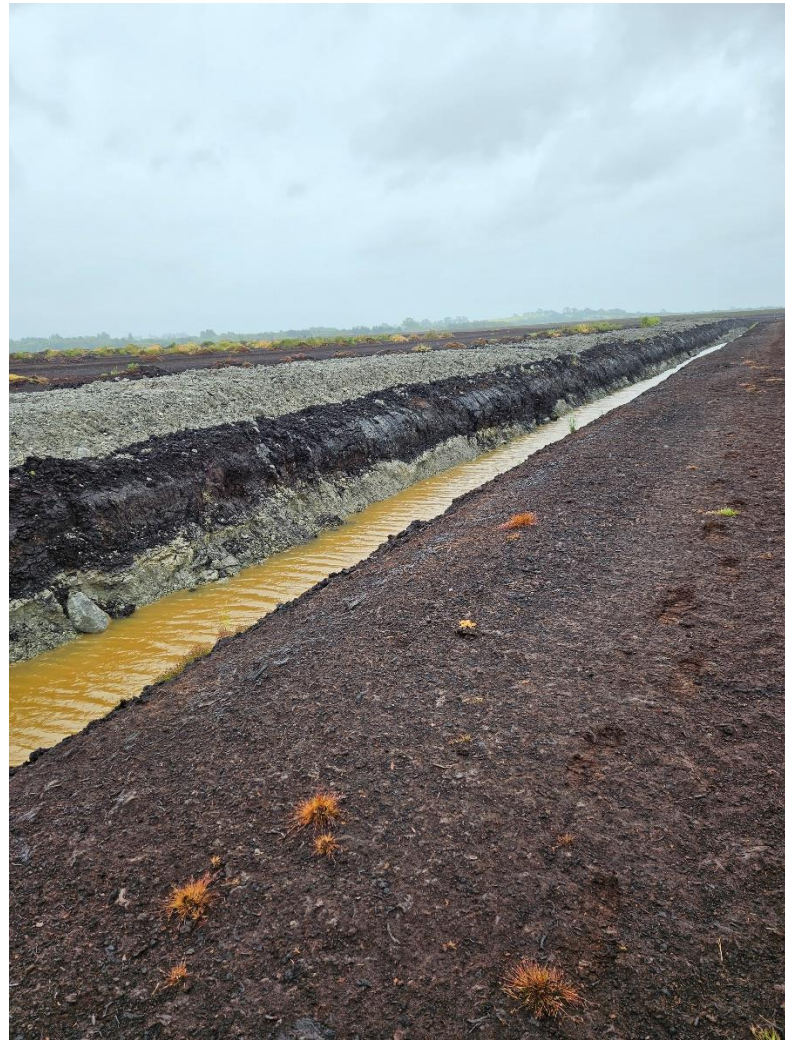
- An excavator was noted to be carrying out drainage works on the Eastern boundary of the peatland.
 - Significant drainage works had been carried out throughout the peatland. An examination of some of the drains on the peatland showed that the layer of peat was reduced to approximately one metre in places and the marl like material was evident in a number of the drains. Some of the drains were also noted to be a milky white/brown colour.

Photos 2 & 3: Milkywhite/brown colour noted in drains on the peatland, also note marl like material close to the surface of the peatland.

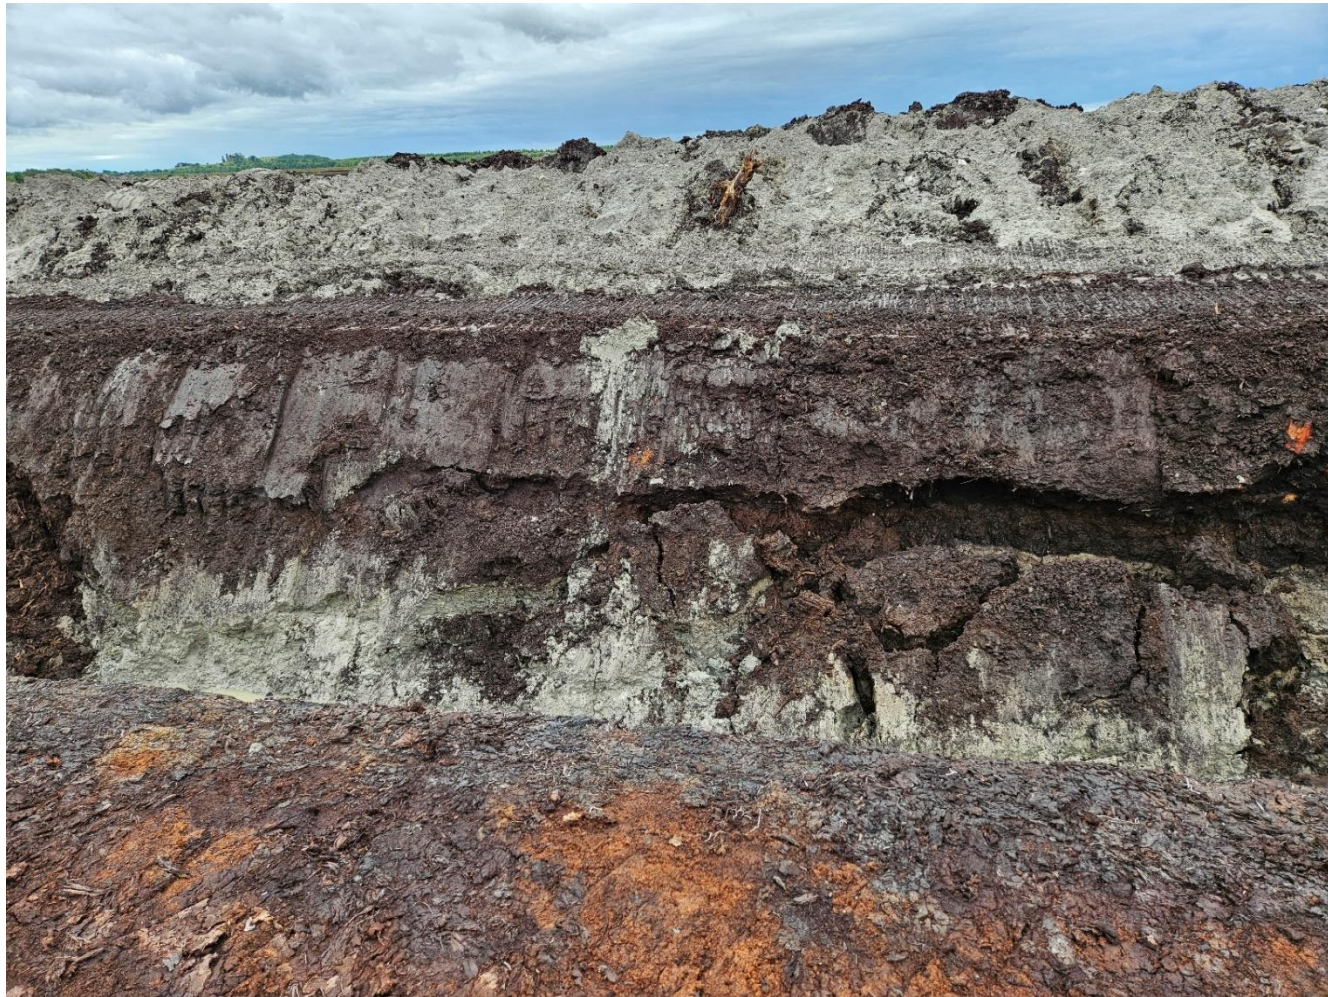
Photo 4: Photo showing slippage in some of the drains on the peatland.

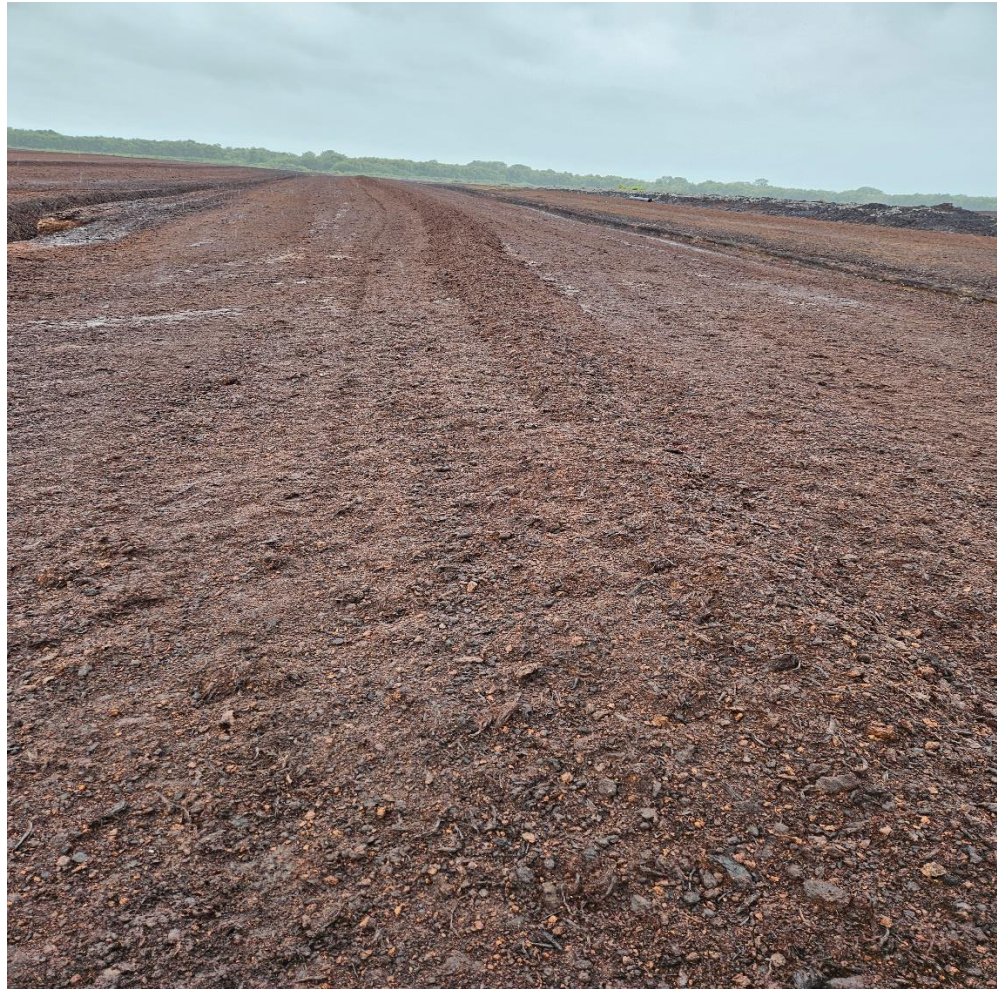
- I met with [REDACTED] and advised [REDACTED] of the purpose of the visit.
 - No peat extraction was taking place during the visit. However, it was noted that some peat had been milled/harrowed and ridged recently but had not been collected from the peatland.

Photo 5: Photo showing peat which had been recently milled and ridged awaiting collection from the peatland.
