SITE VISIT REPORT

Purpose of Site Visit:	Peat Extraction in Co. Kildare
Site Address:	Ballinderry, Carbury, Co. Kildare
Date of Visit:	12/06/24
Times of Visit:	1400 to 1550
Visit Criteria:	Peat extraction investigation
EPA Attendees:	Mick Henry & Kealan Reynolds
Organisation:	Clairstone Ltd

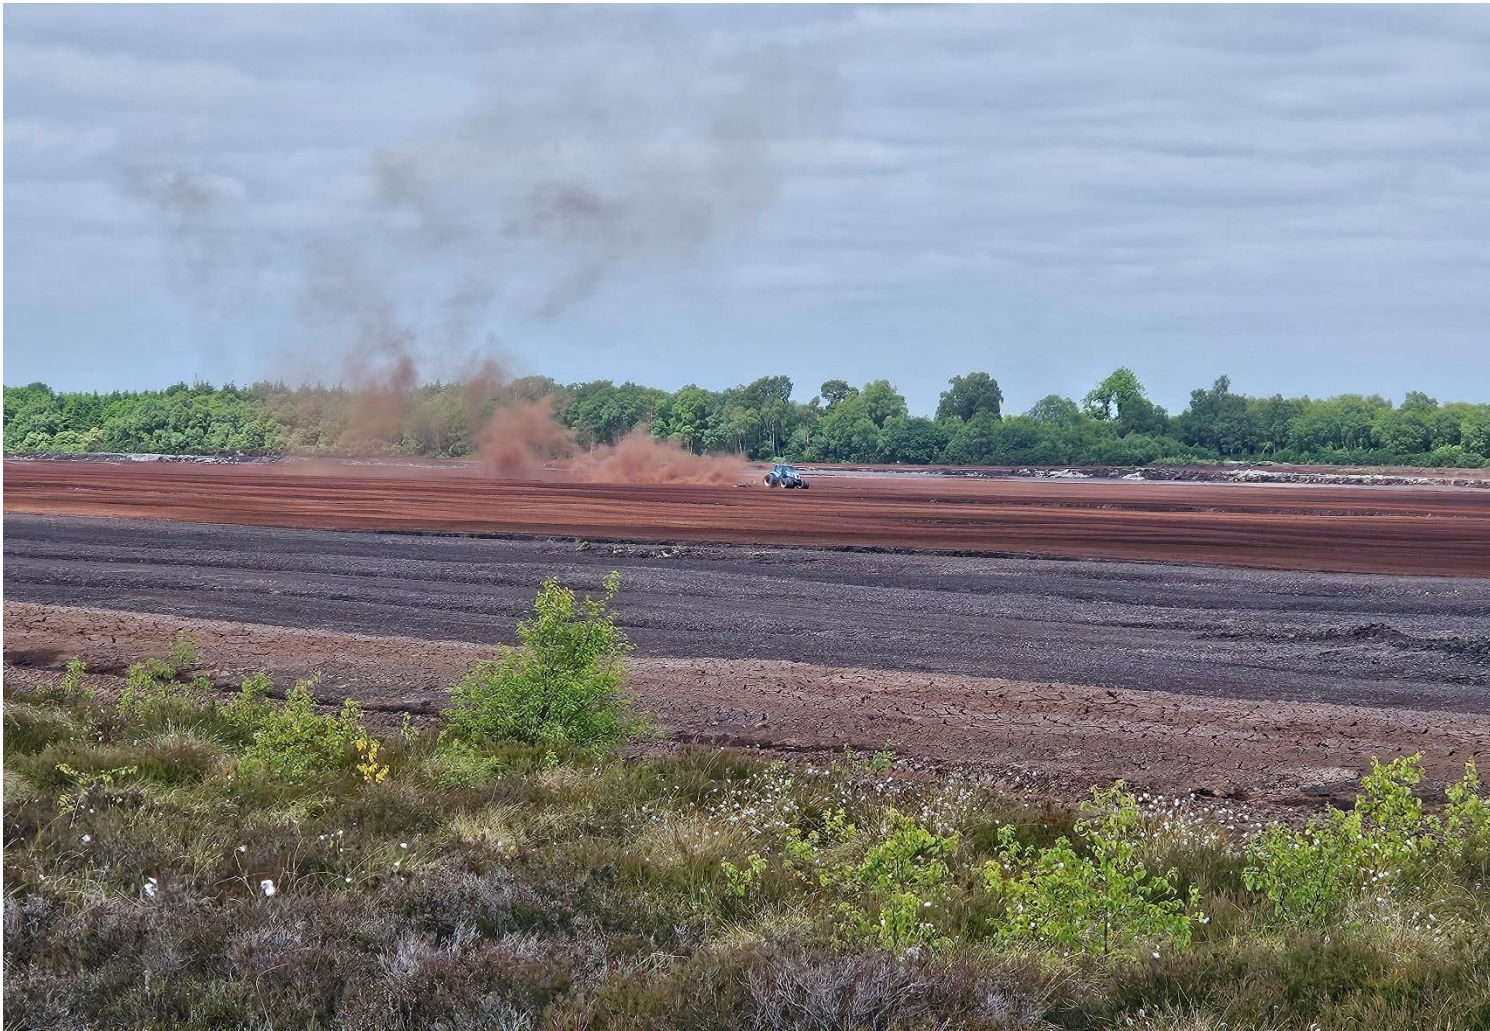
Photo 1: Peat extraction was noted to be taking place during the visit.

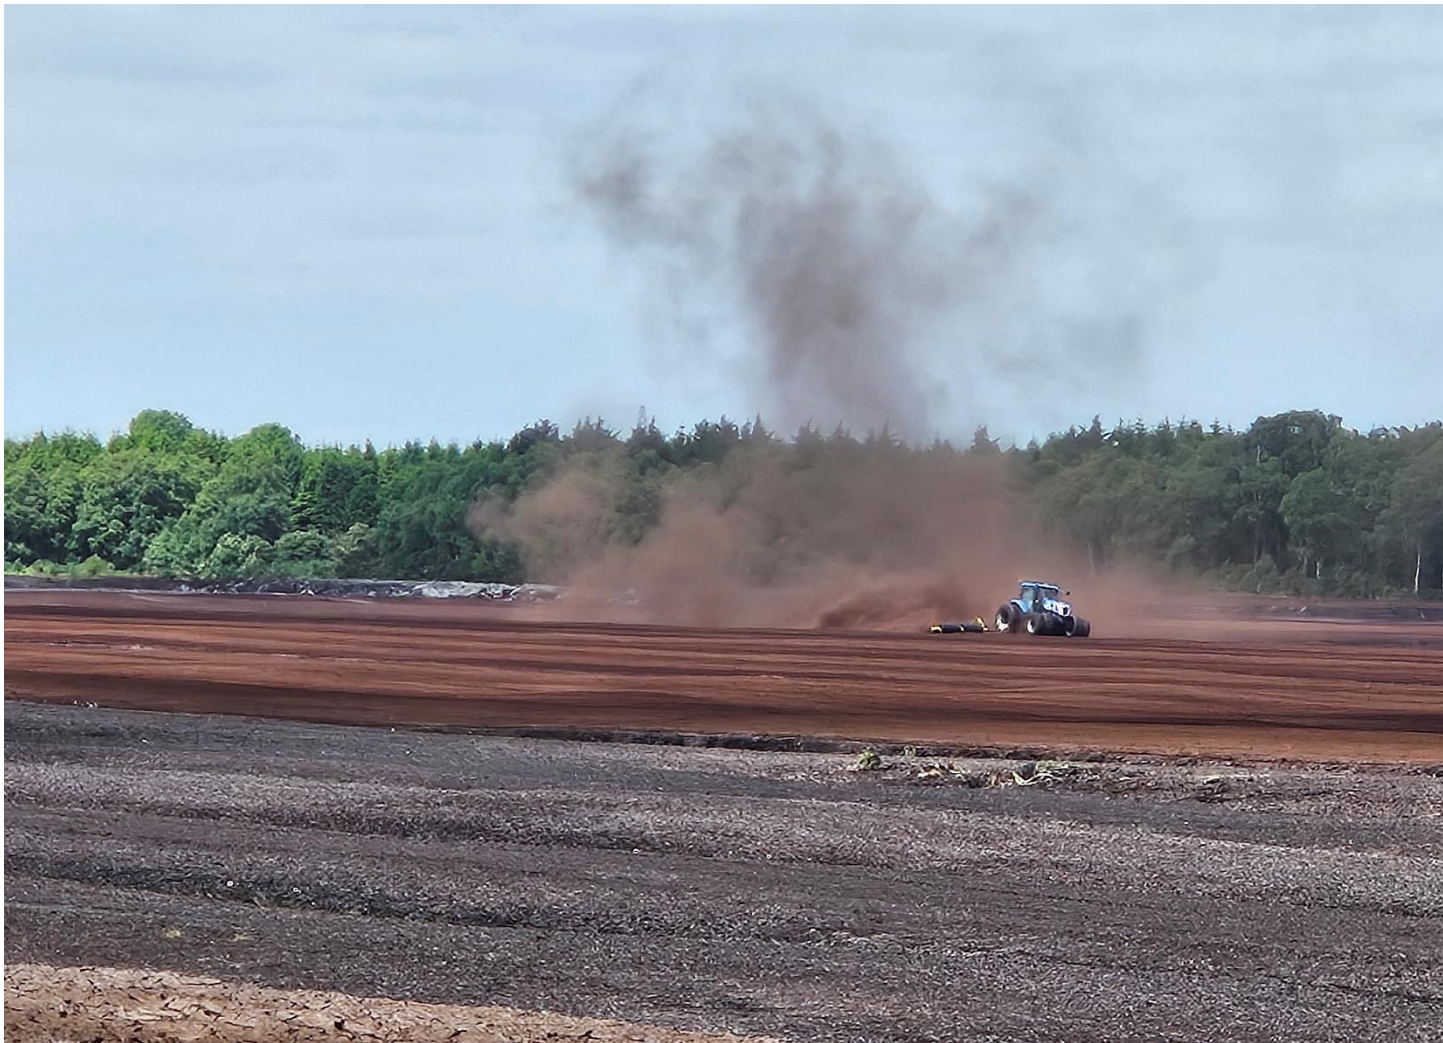
Photo 2: Peat extraction was noted to be taking place during the visit with significant dust arising.

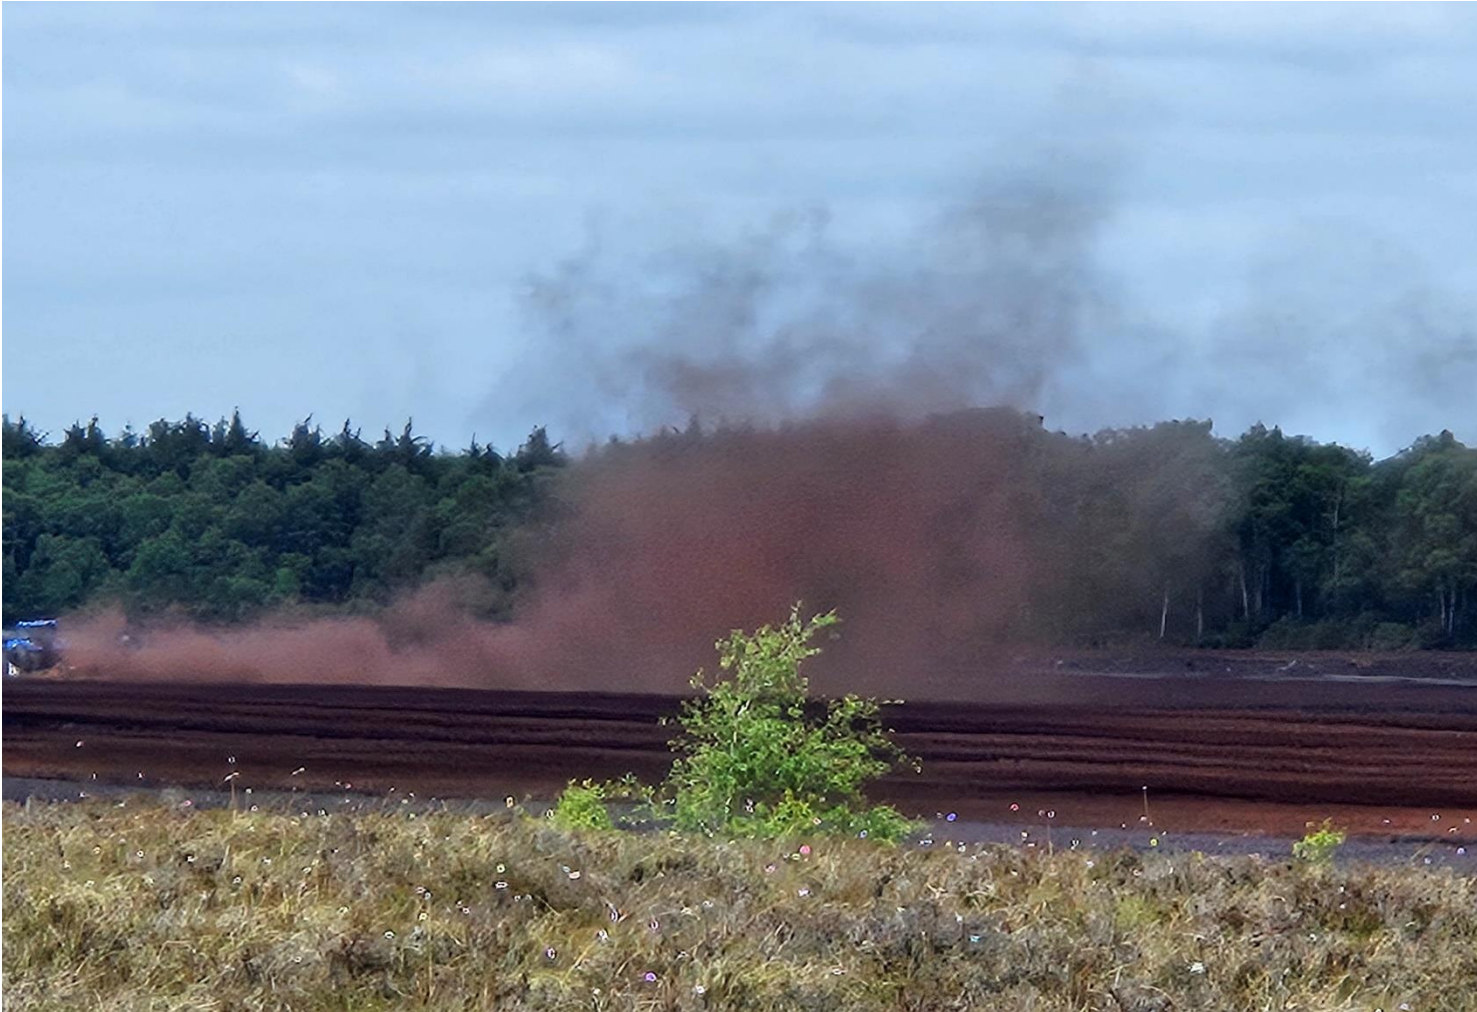
Photo 3: Significant dust emissions were noted to be coming from the peat extraction activities at the peatland.

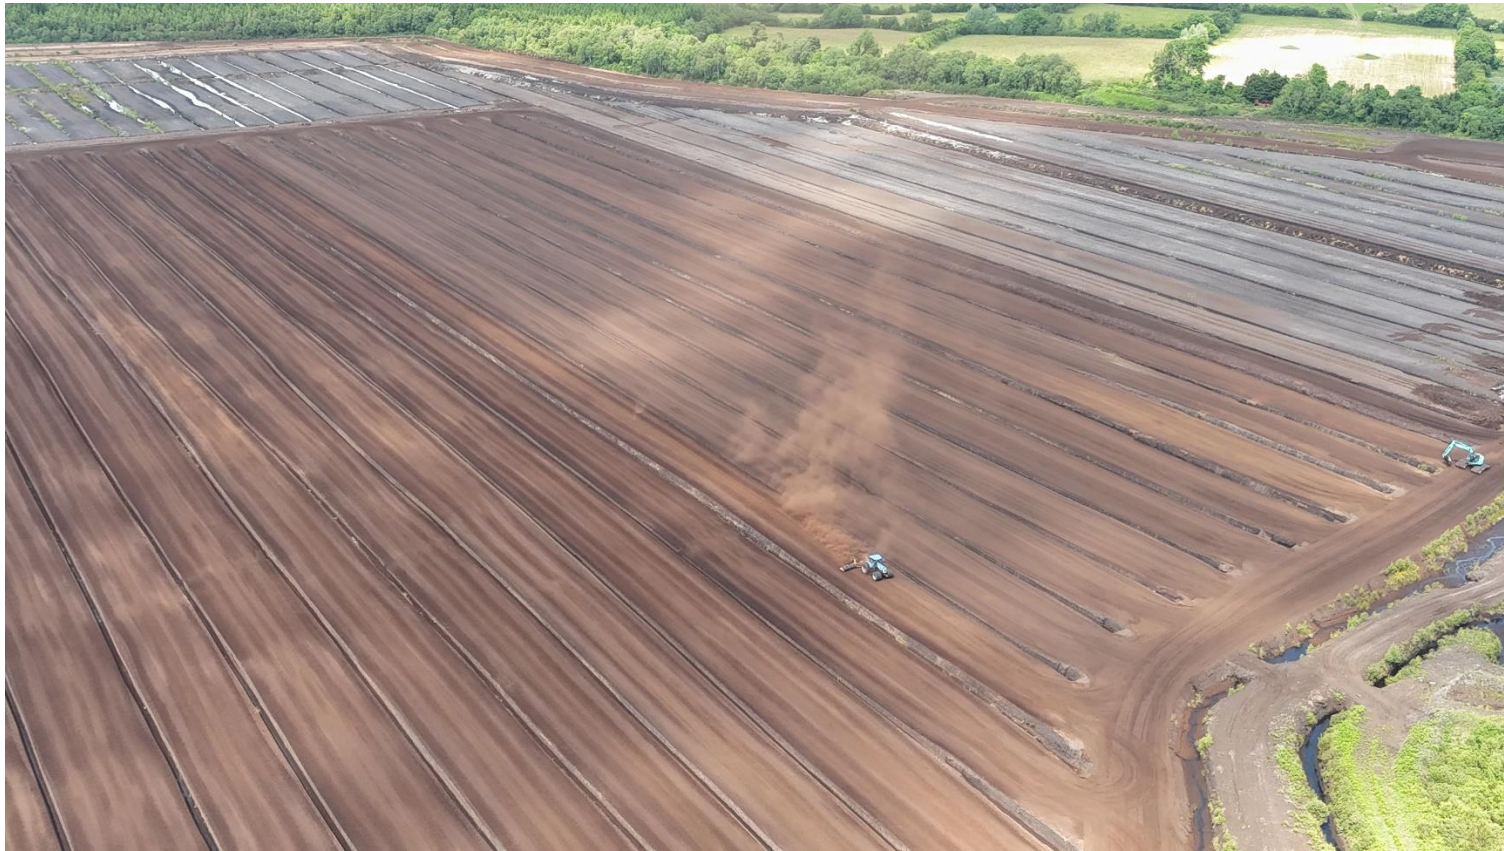
Photo 4: Aerial photo of milled peat extraction activities taking place during the visit.

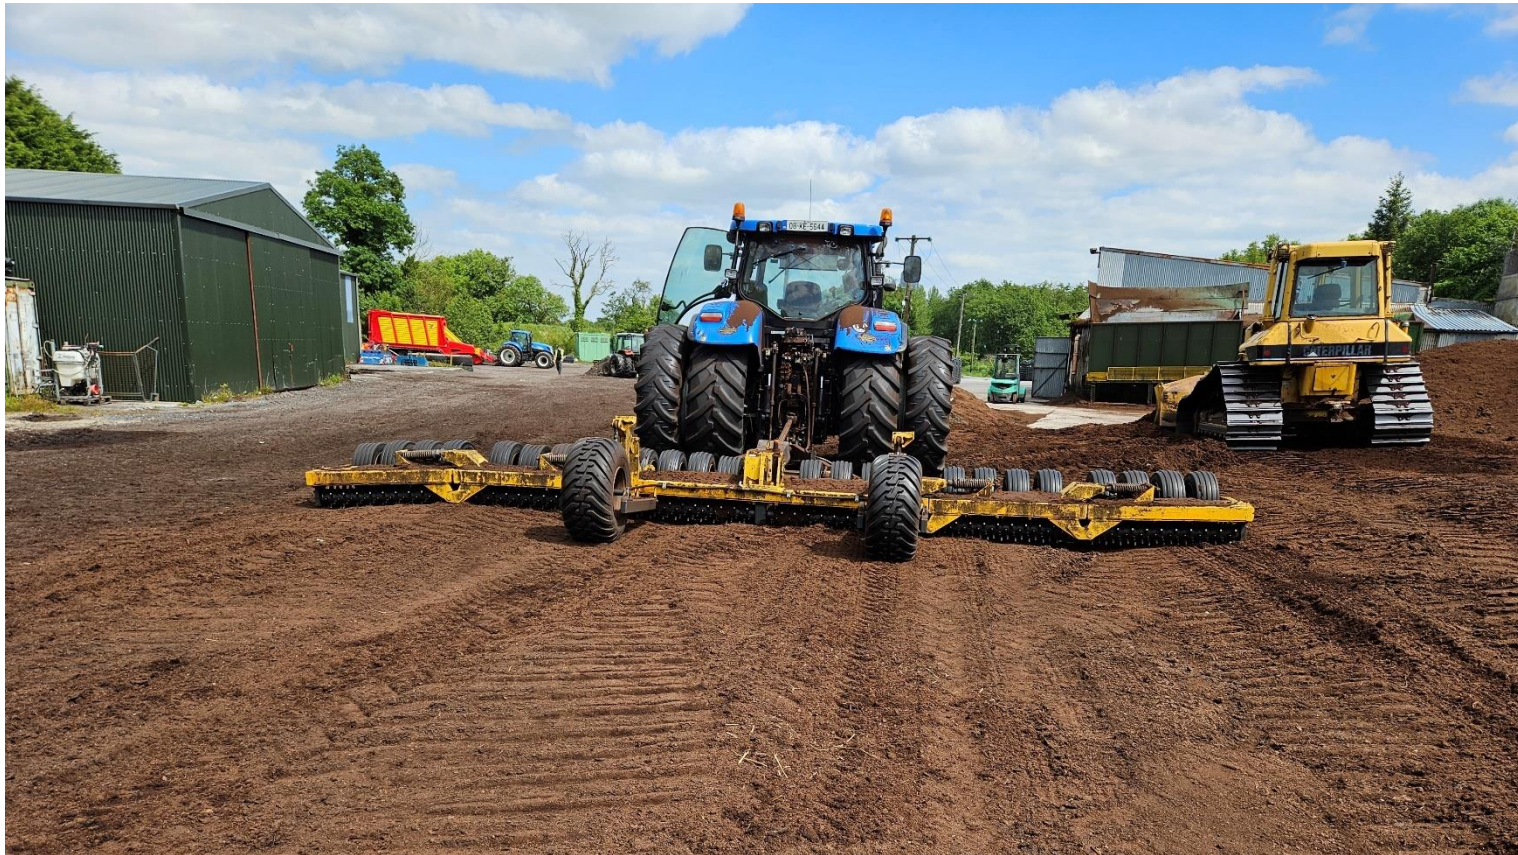
Photo 5: Machine for ‘milling’ peat was noted at the peatland.

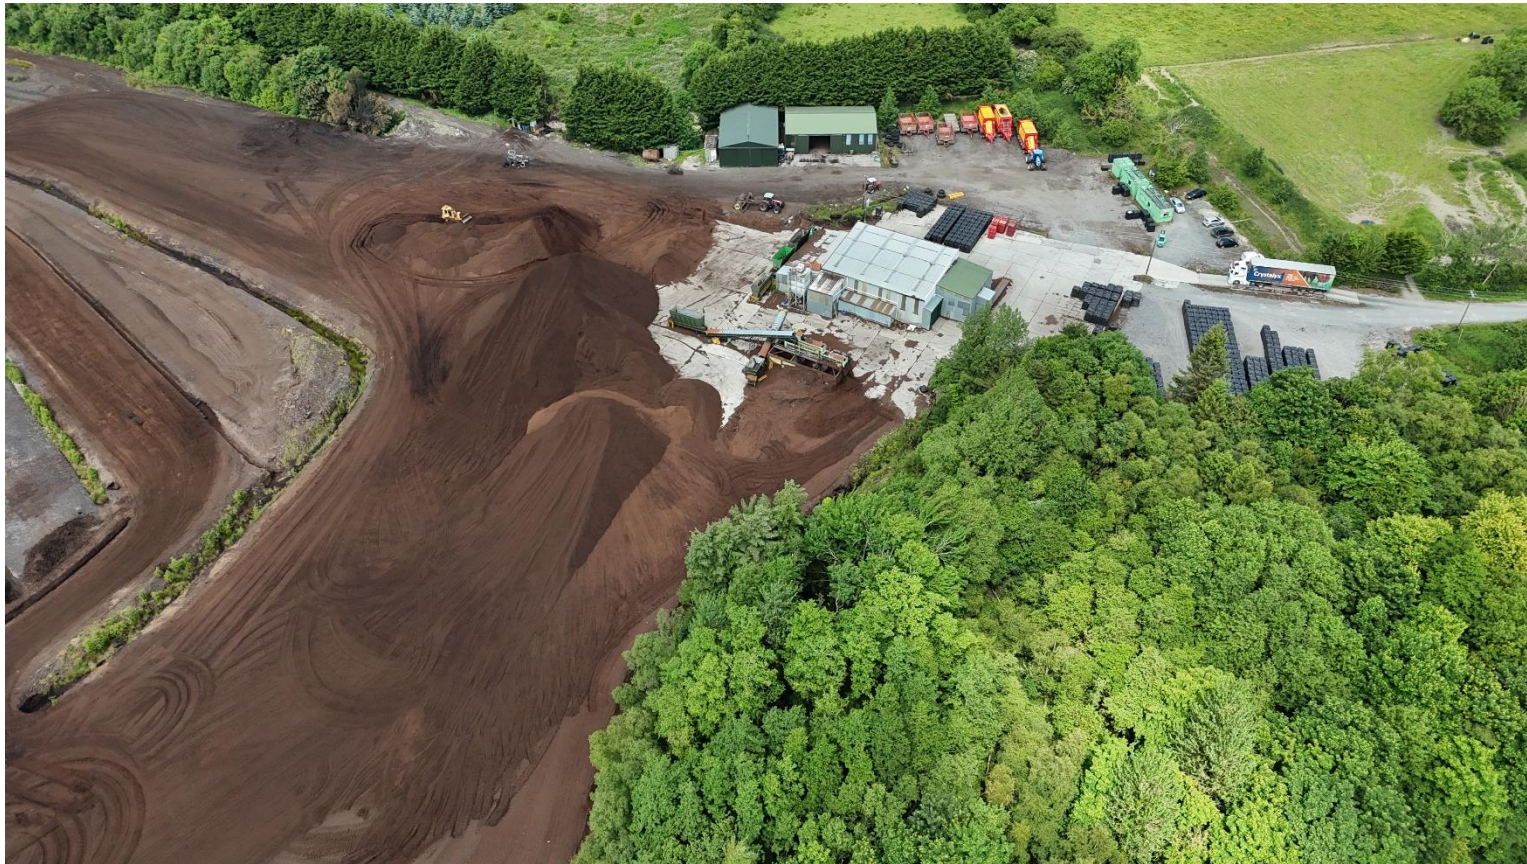
Photo 6: Significant stockpiles of milled peat were noted adjacent to the bagging plant.
