SITE VISIT REPORT

Purpose of Site Visit: Peat Extraction in Co. Kildare
Site Address: Ballinderry, Carbury, Co. Kildare
Date of Visit: 18/06/24
Times of Visit: 1550 to 1700
Visit Criteria: Peat extraction investigation
EPA Attendees: Mick Henry & Simon Buckley
Organisation: Clairstone Ltd

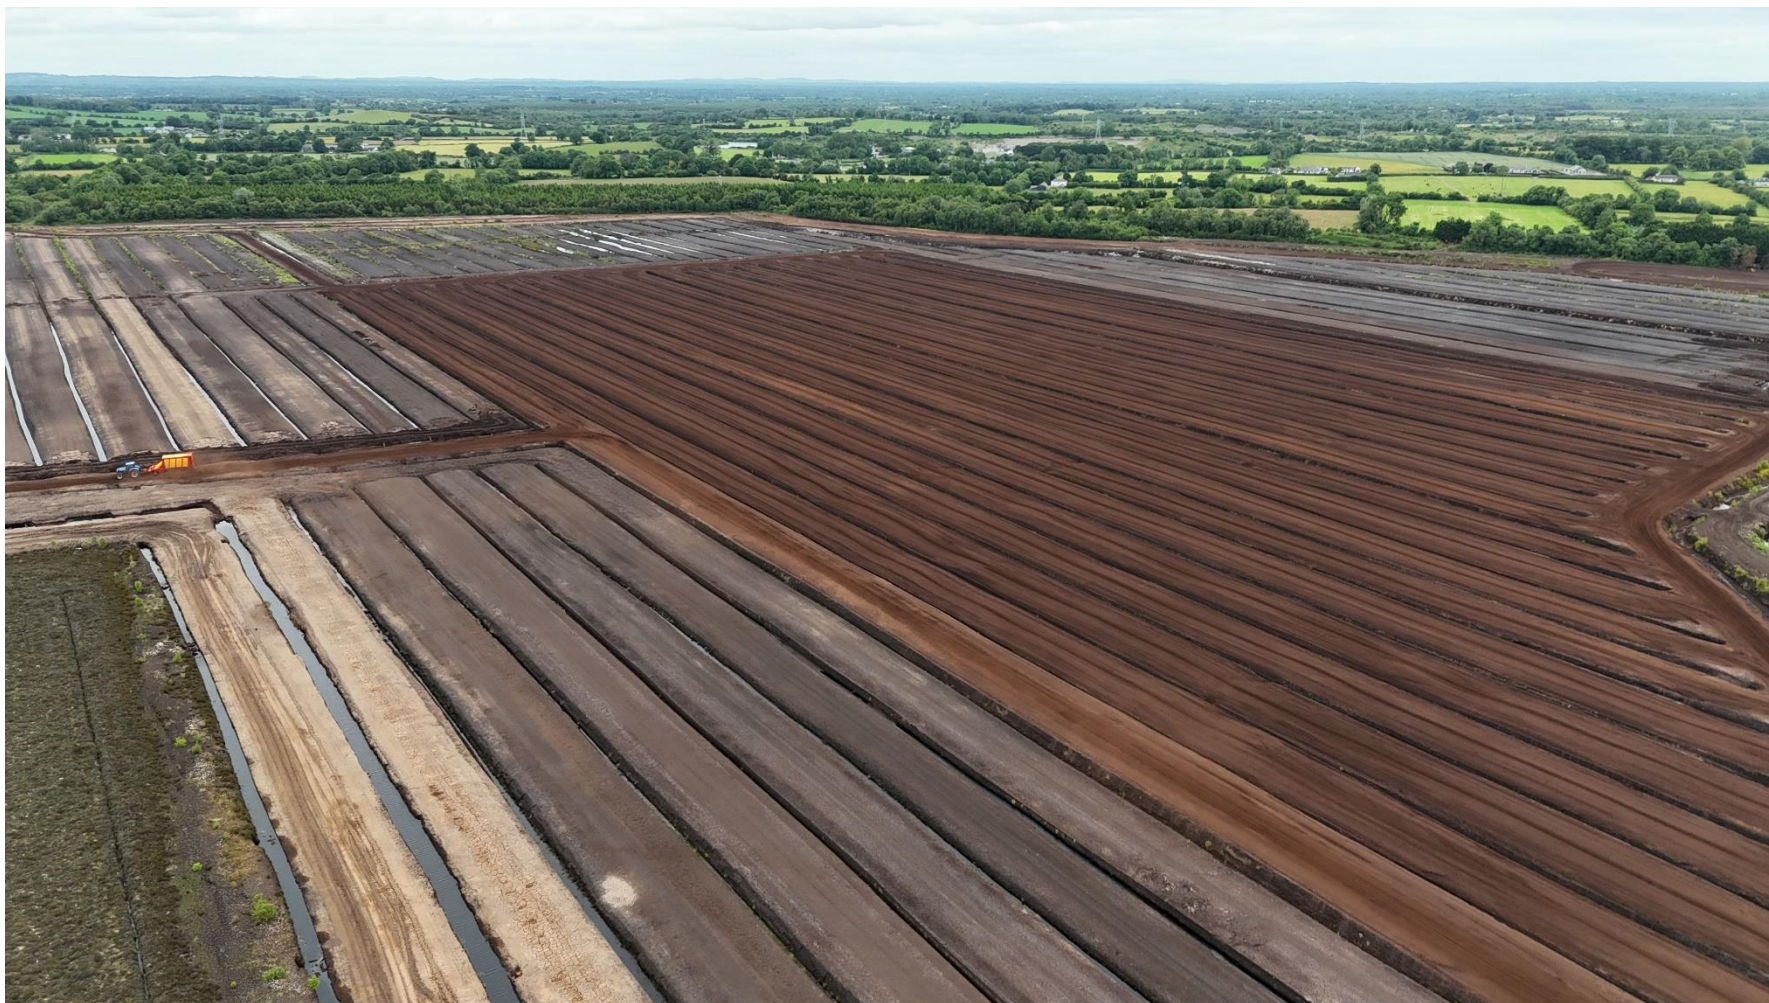
Photo 2: Photo of central part of the peatland where peat extraction had taken place recently (note dark brown colour). Also, note tractor and trailer ('Bog Hog') going to the South western part of the peatland to collect milled peat.

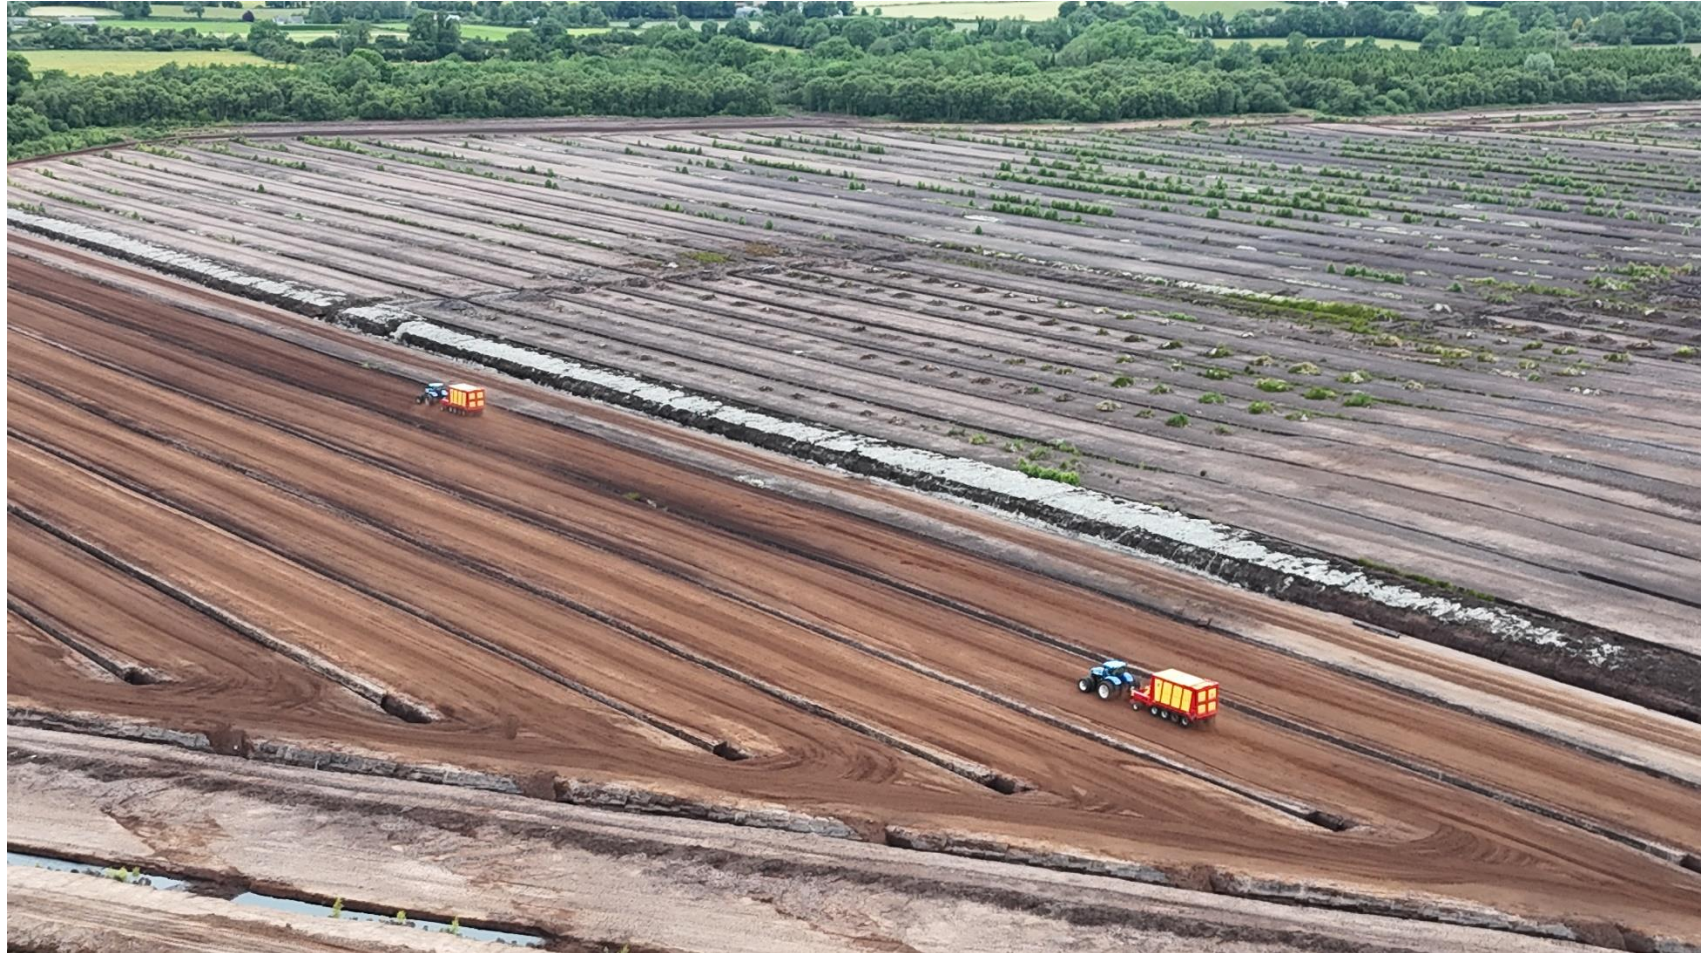
Photo 5: Two Tractors and trailers ('Bog Hog's') collecting milled peat at the South Western part of the peatland during the visit.

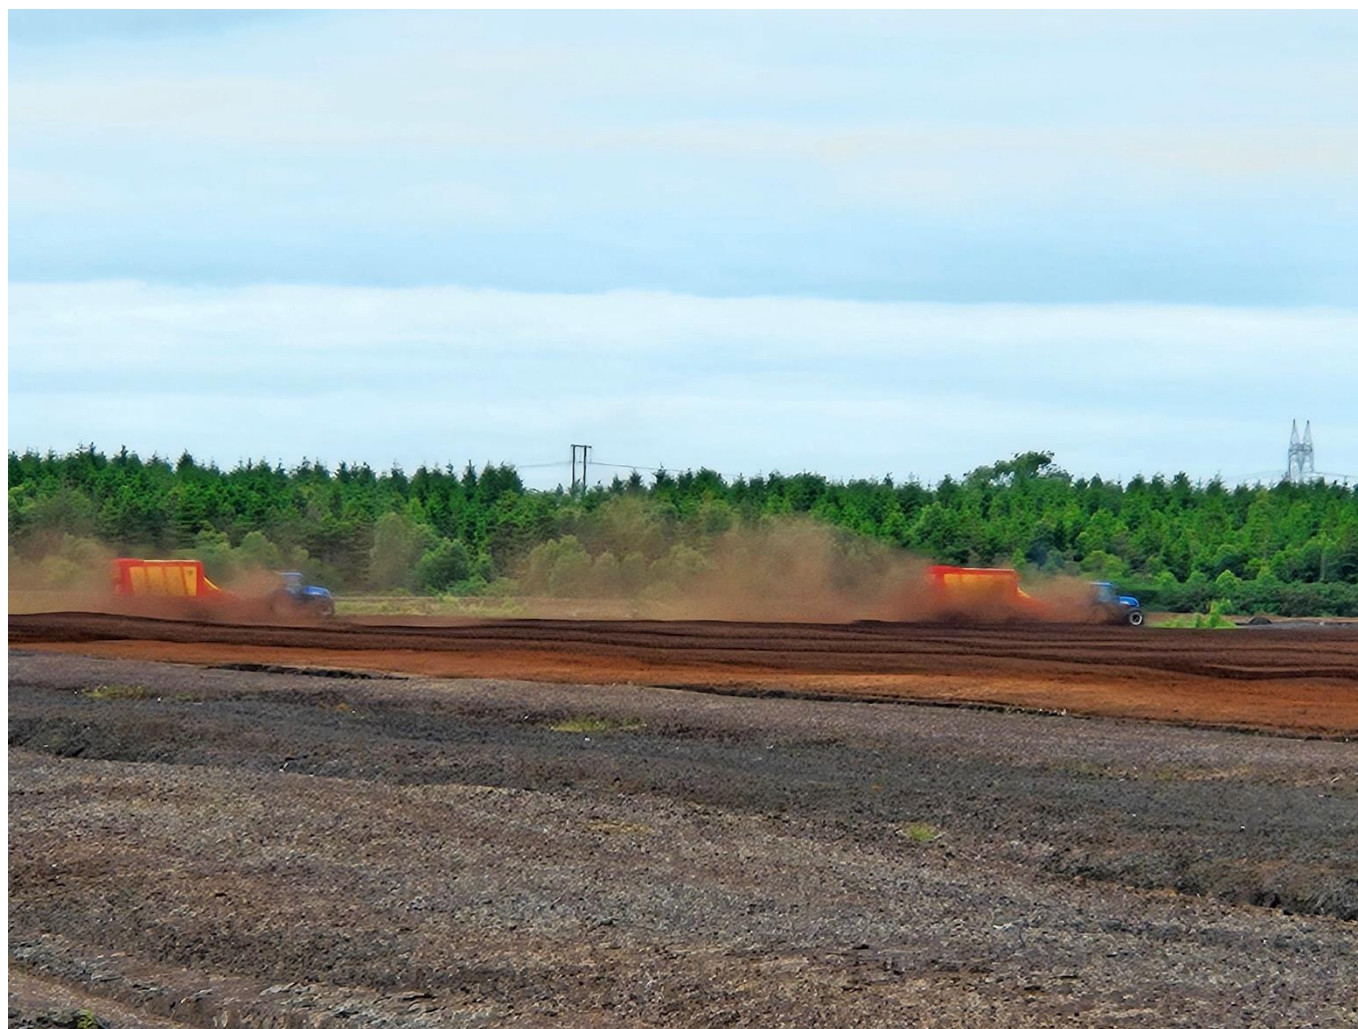
- Significant dust emissions were noted to be arising from the milled peat extraction activities, particularly as the milled peat was being transported from the South Western part of the peatland back up to the bagging/processing plant area.

Photo 6: Significant dust emissions noted from the transport of the milled peat back to the bagging/processing plant area.

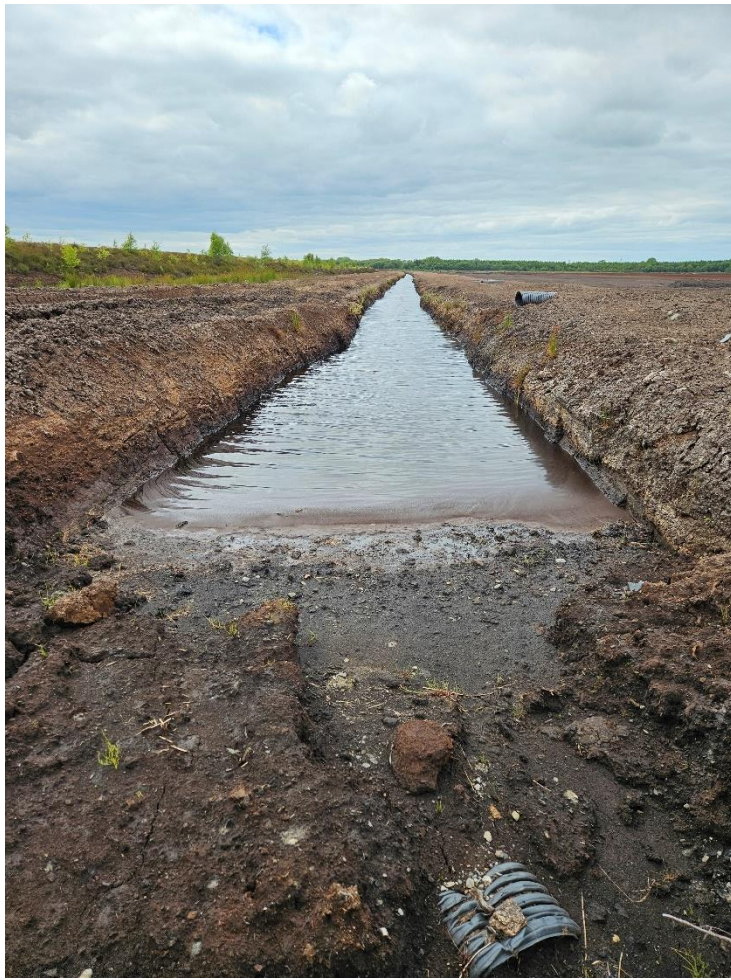
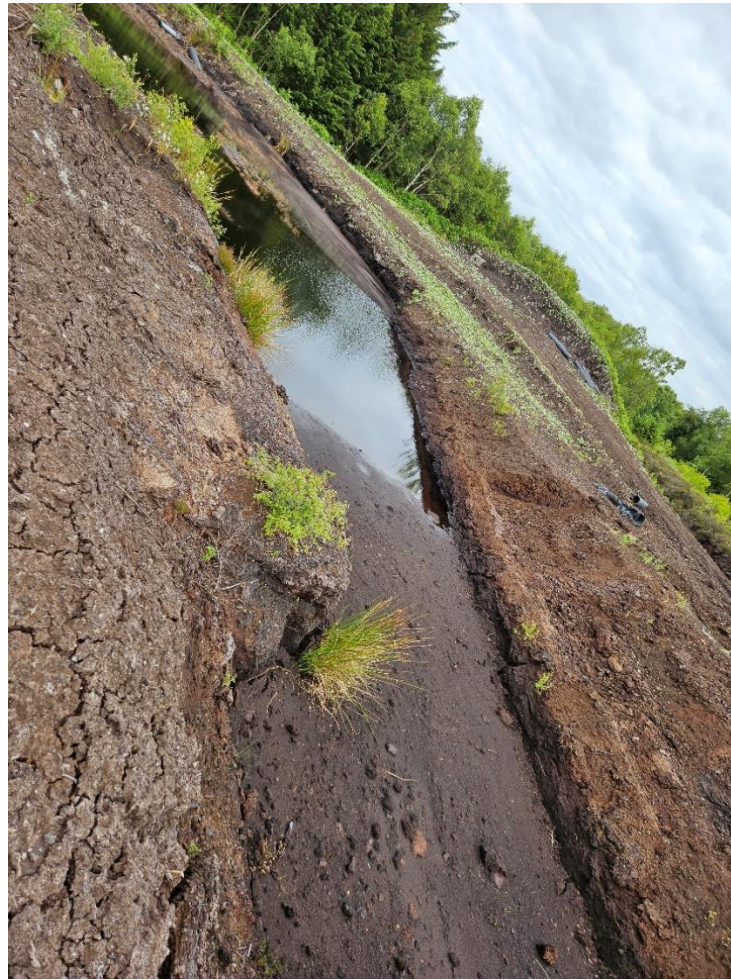
- Significant sediment build up was noted in the drainage network at the South eastern corner of the peatland.

Photos 7 & 8: Drainage network with significant sediment build up noted at the South Eastern corner of the peatland.
