SITE VISIT REPORT

Purpose of Site Visit:	Peat Extraction in Co. Kildare
Site Address:	Ballinderry, Carbury, Co. Kildare
Date of Visit:	05/06/24
Times of Visit:	10.35am to 2.10pm
Visit Criteria:	Peat extraction investigation
EPA Attendees:	Kealan Reynolds and Simon Buckley
Organisation:	Clairstone Ltd

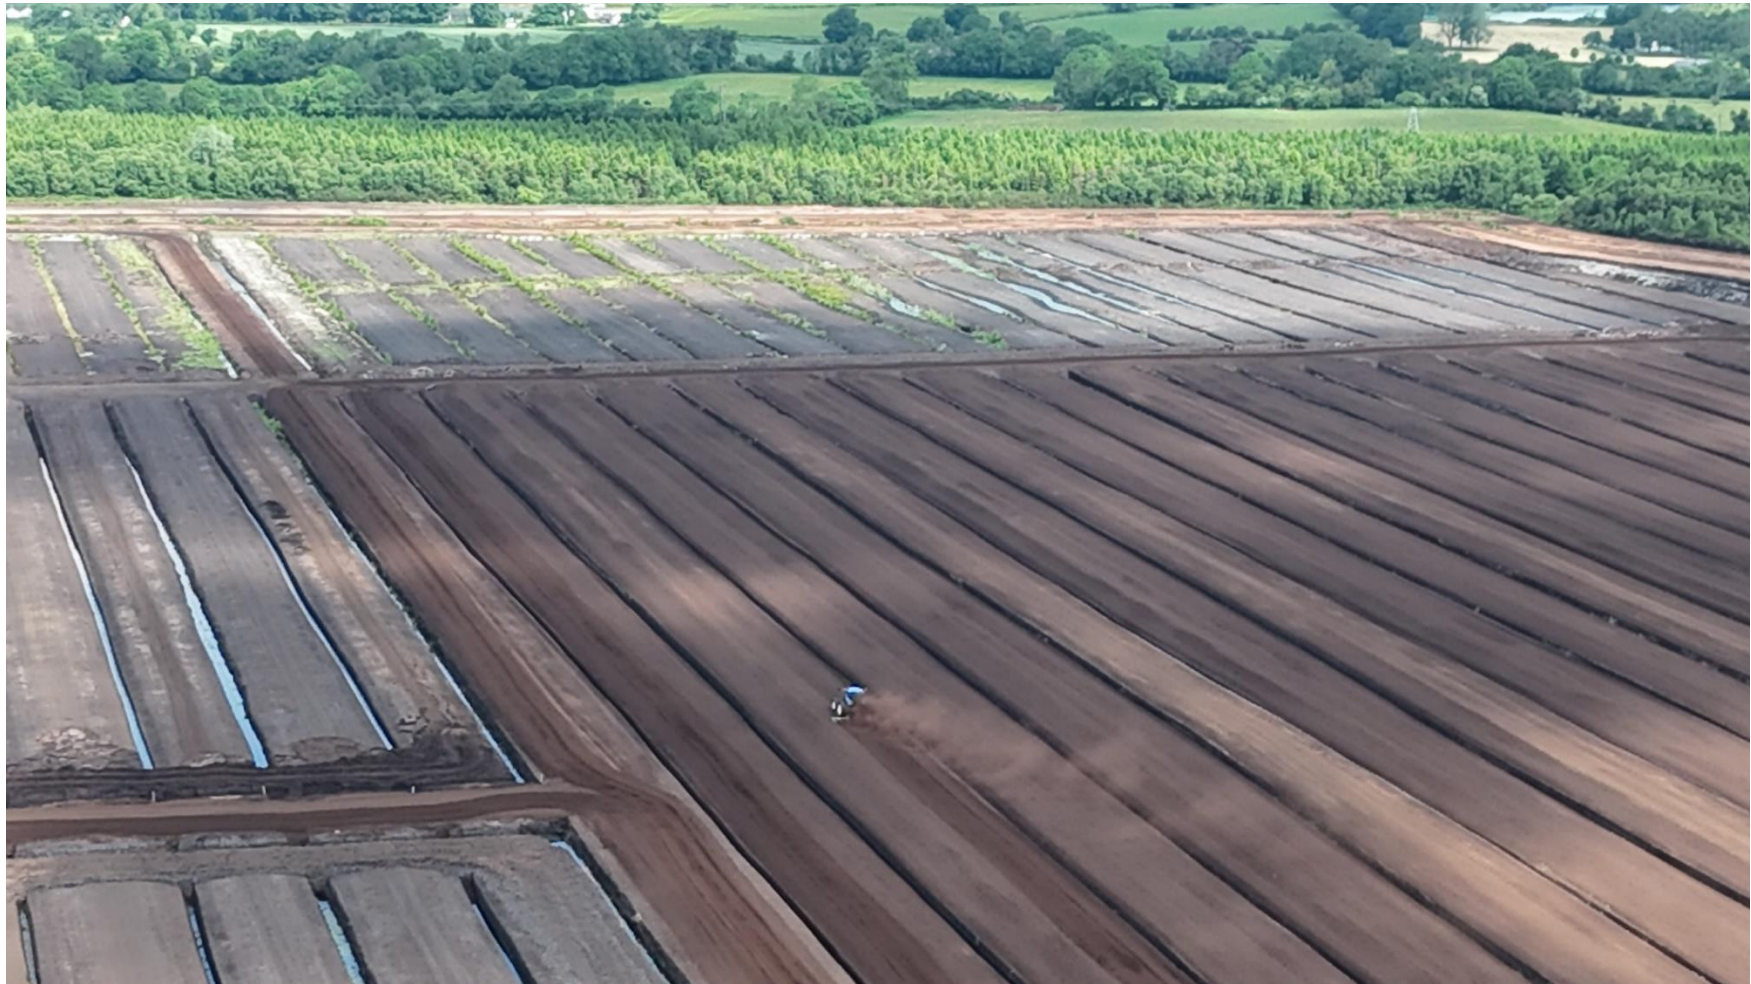
- Significant dust emissions were noted to be arising from the milled peat extraction activities.
 - EPA Inspectors met with [REDACTED] and advised [REDACTED] of the purpose of the visit. [REDACTED] informed the EPA Inspectors that they were working an area of less than 30 hectares and that included access roads, bagging and storage areas. [REDACTED] said that it was his intention to operate at <30ha for the foreseeable future.

Photo 1: Milled peat extraction was noted to be taking place during the visit, note significant dust emissions arising.

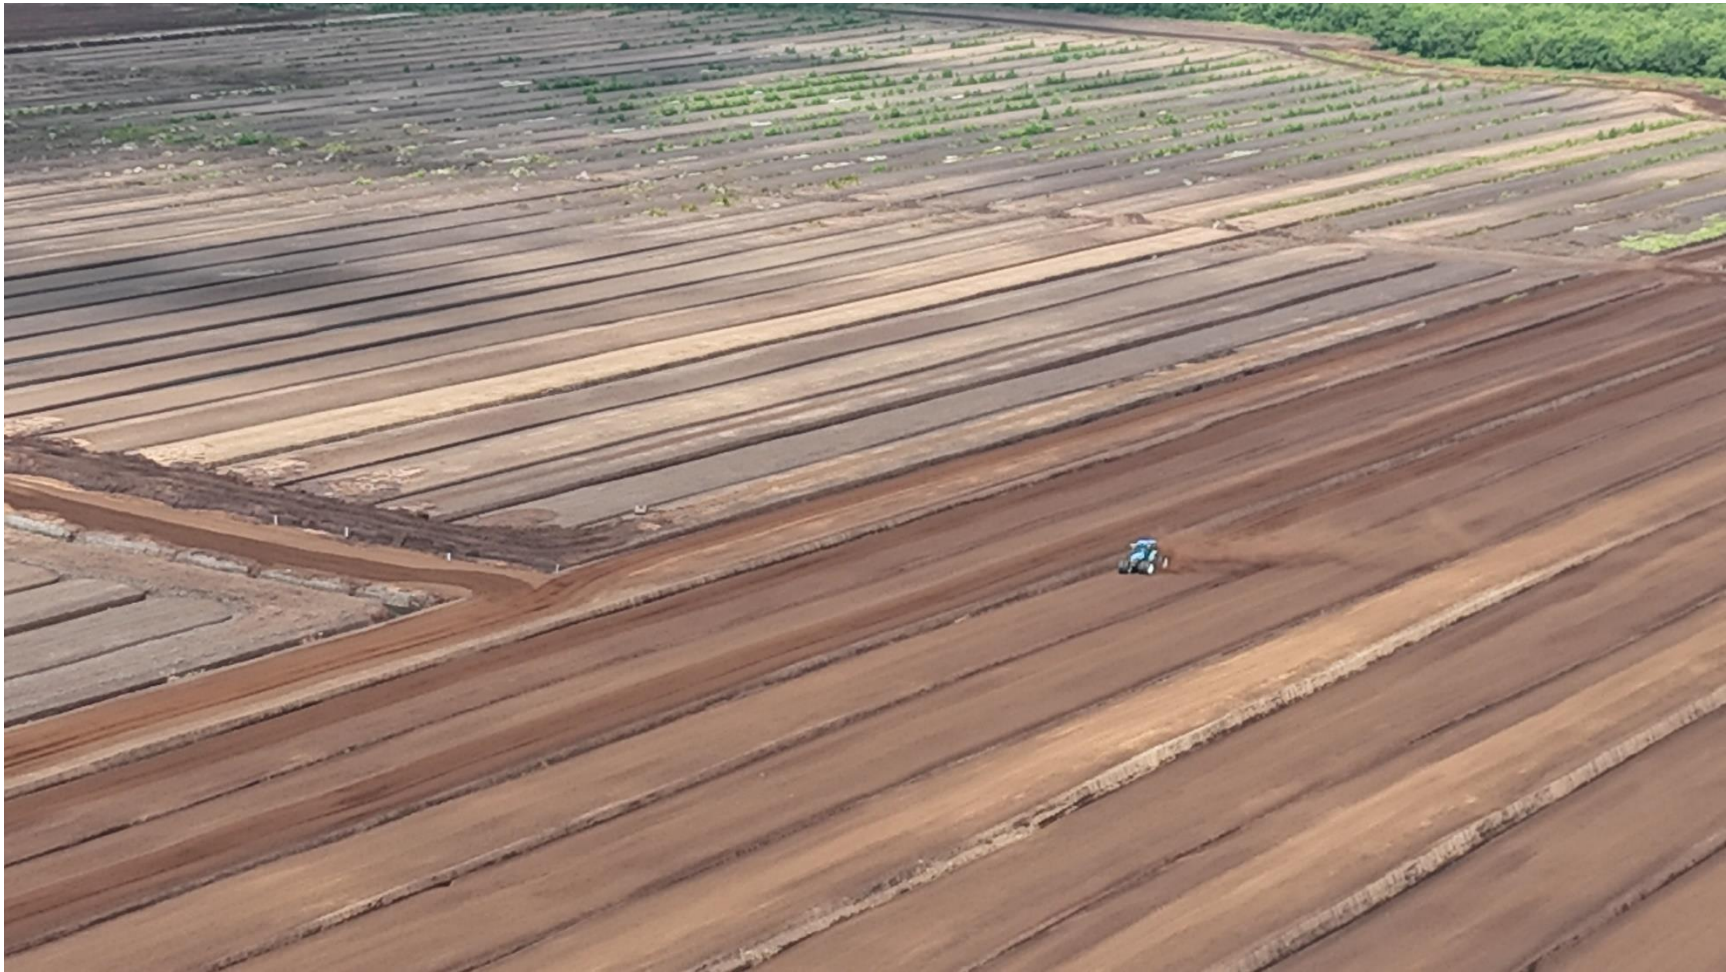
Photo 2: Milled peat extraction was noted to be taking place during the visit.

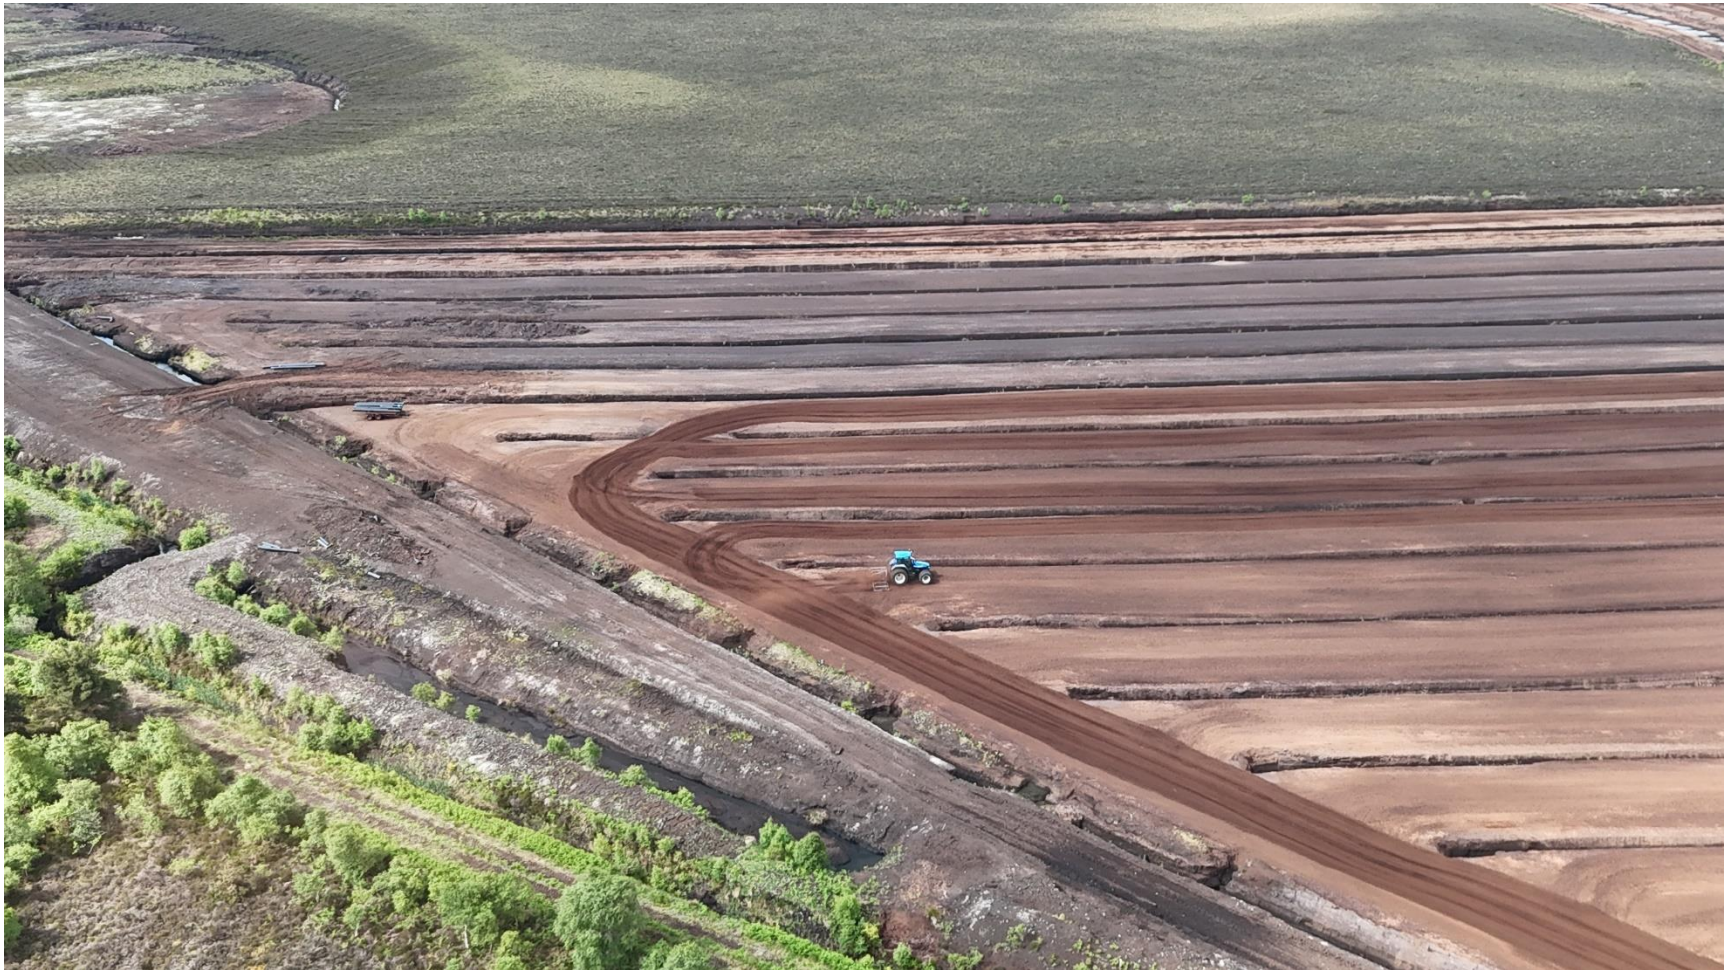
Photo 3: Milled peat extraction was noted to be taking place during the visit.

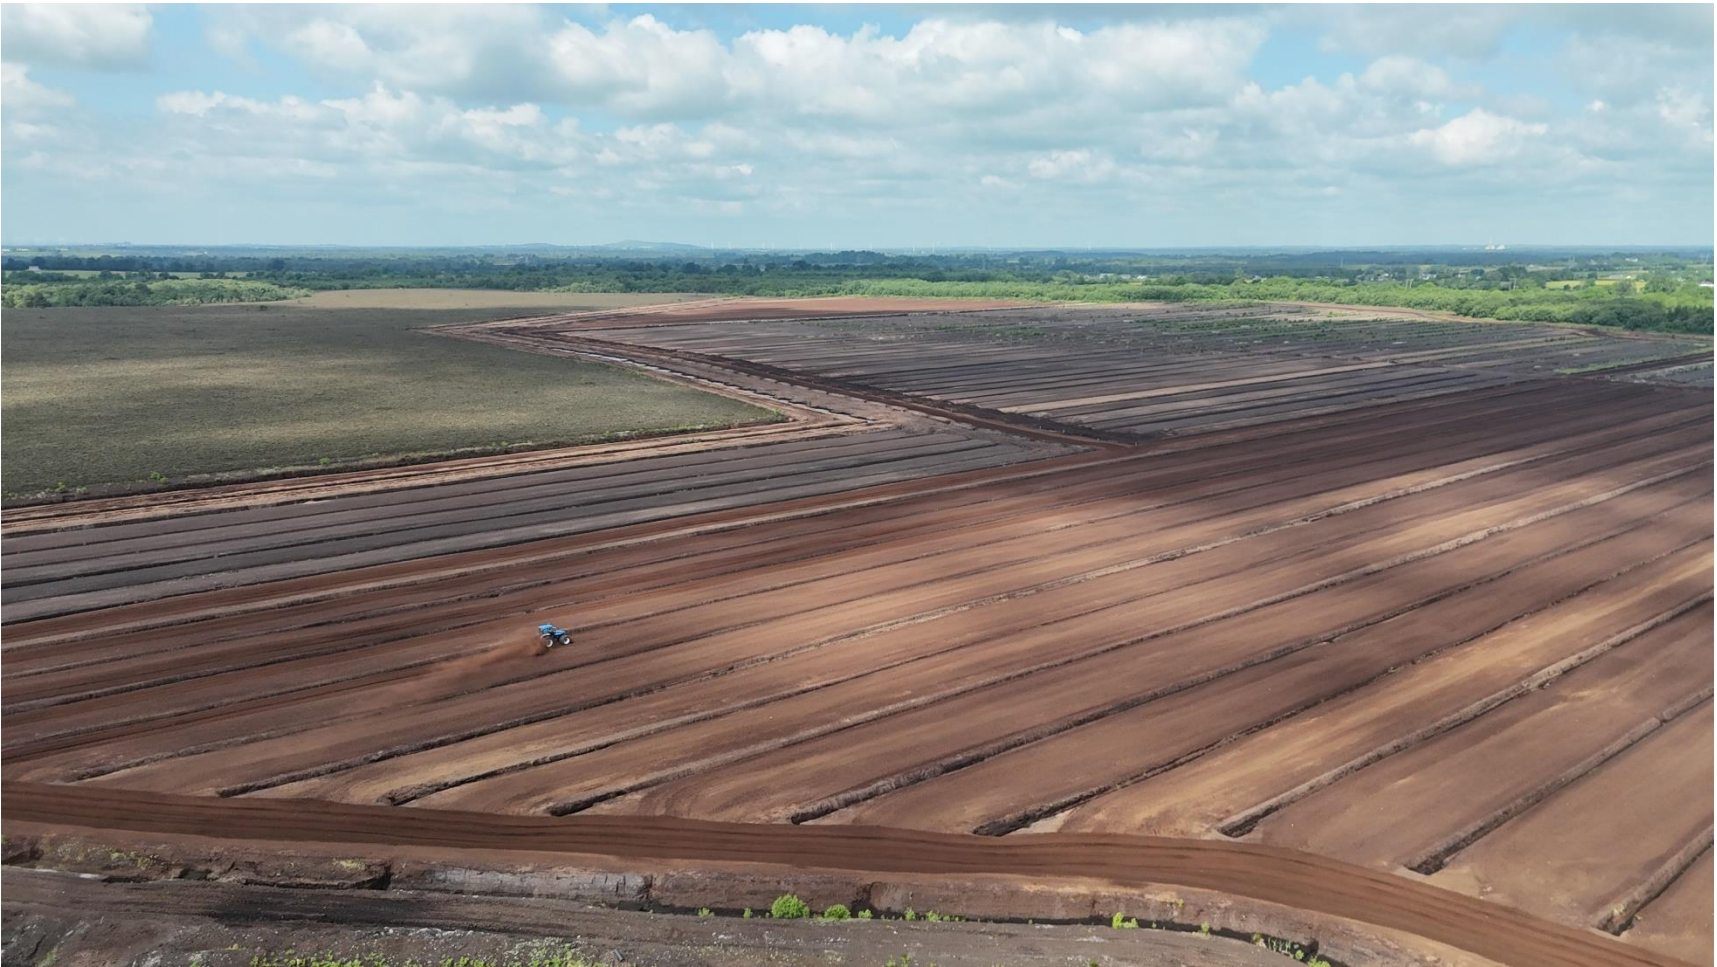
Photo 4: Milled peat extraction was noted to be taking place during the visit.

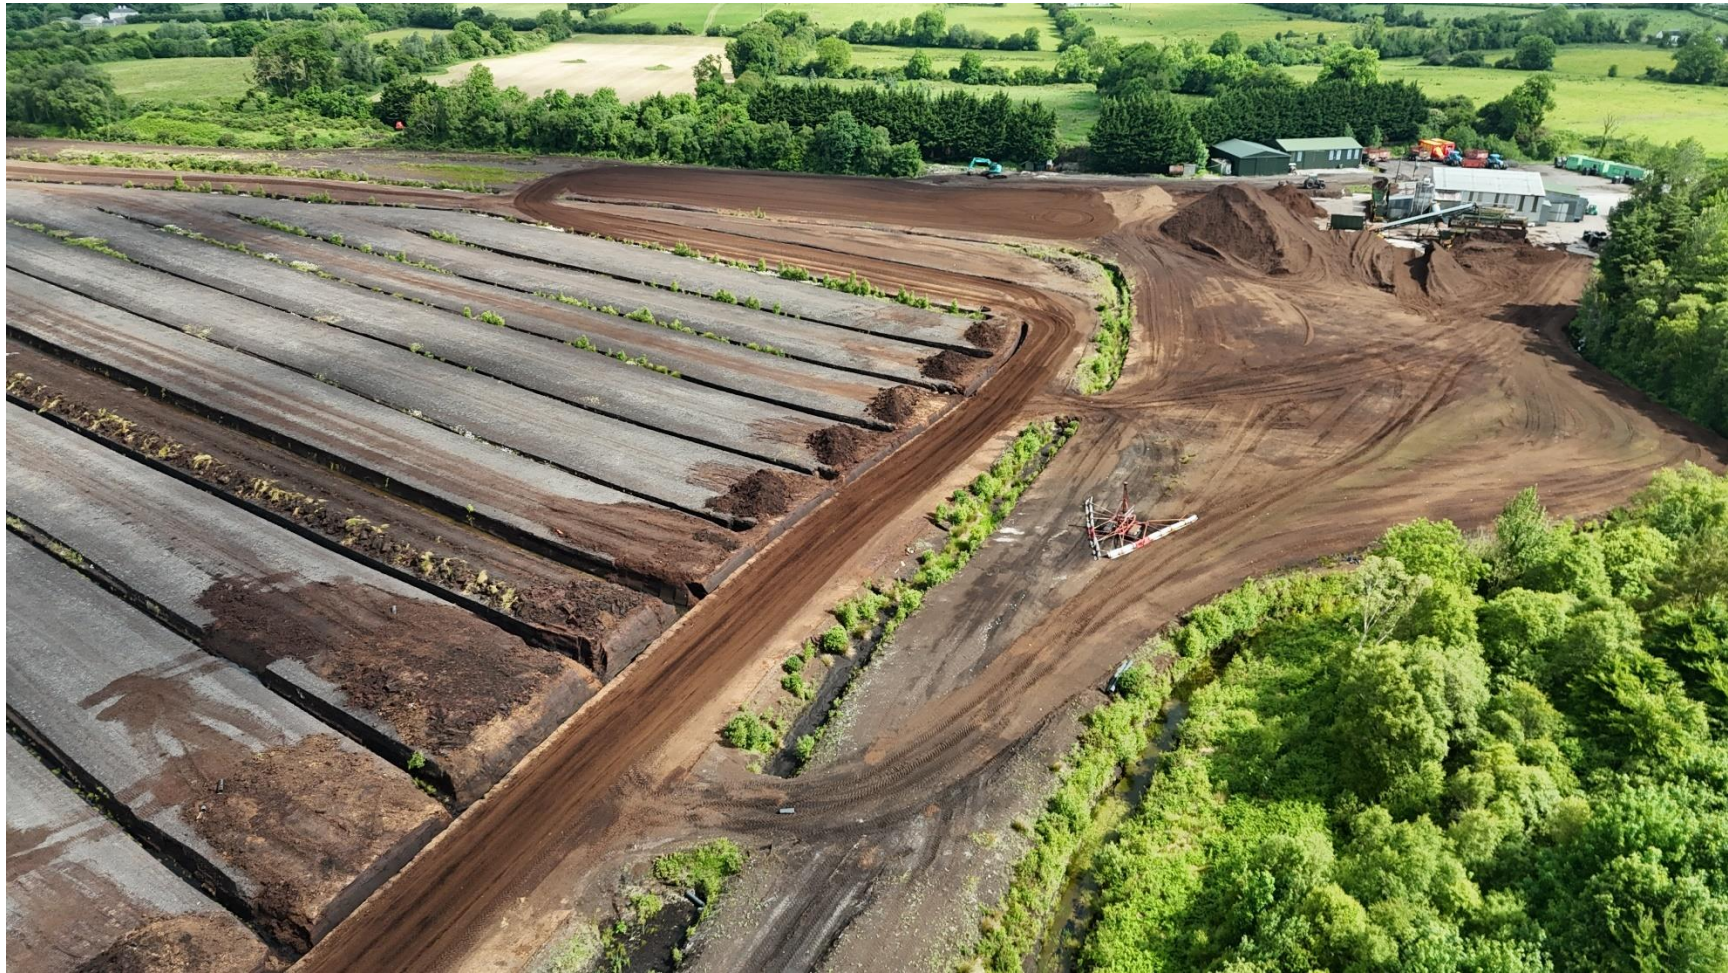
- EPA Inspectors walked the peatlands and noted the areas of the peatland where milled peat extraction had recently taken place.
 - Drainage works were noted to have been undertaken on the peatland and the water levels in the drains in some parts of the peatland were raised.

Photo 5: Drainage works noted on the peatland.

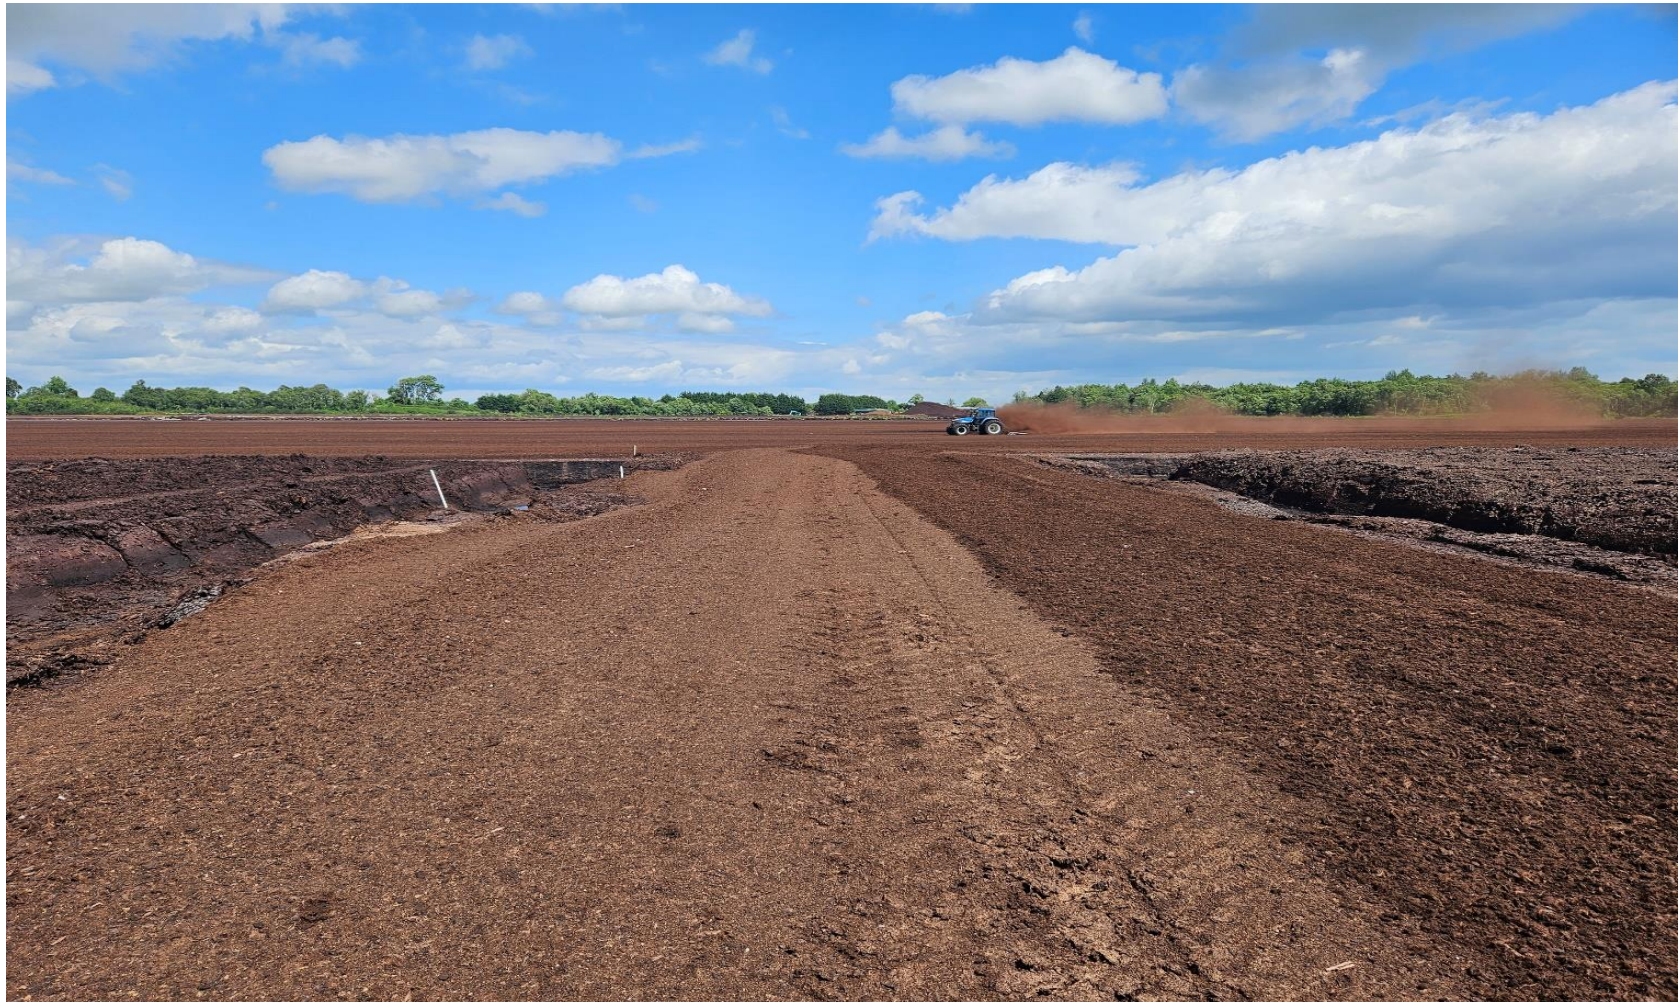
Photo 6– Milled peat extraction activities were ongoing during the visit.

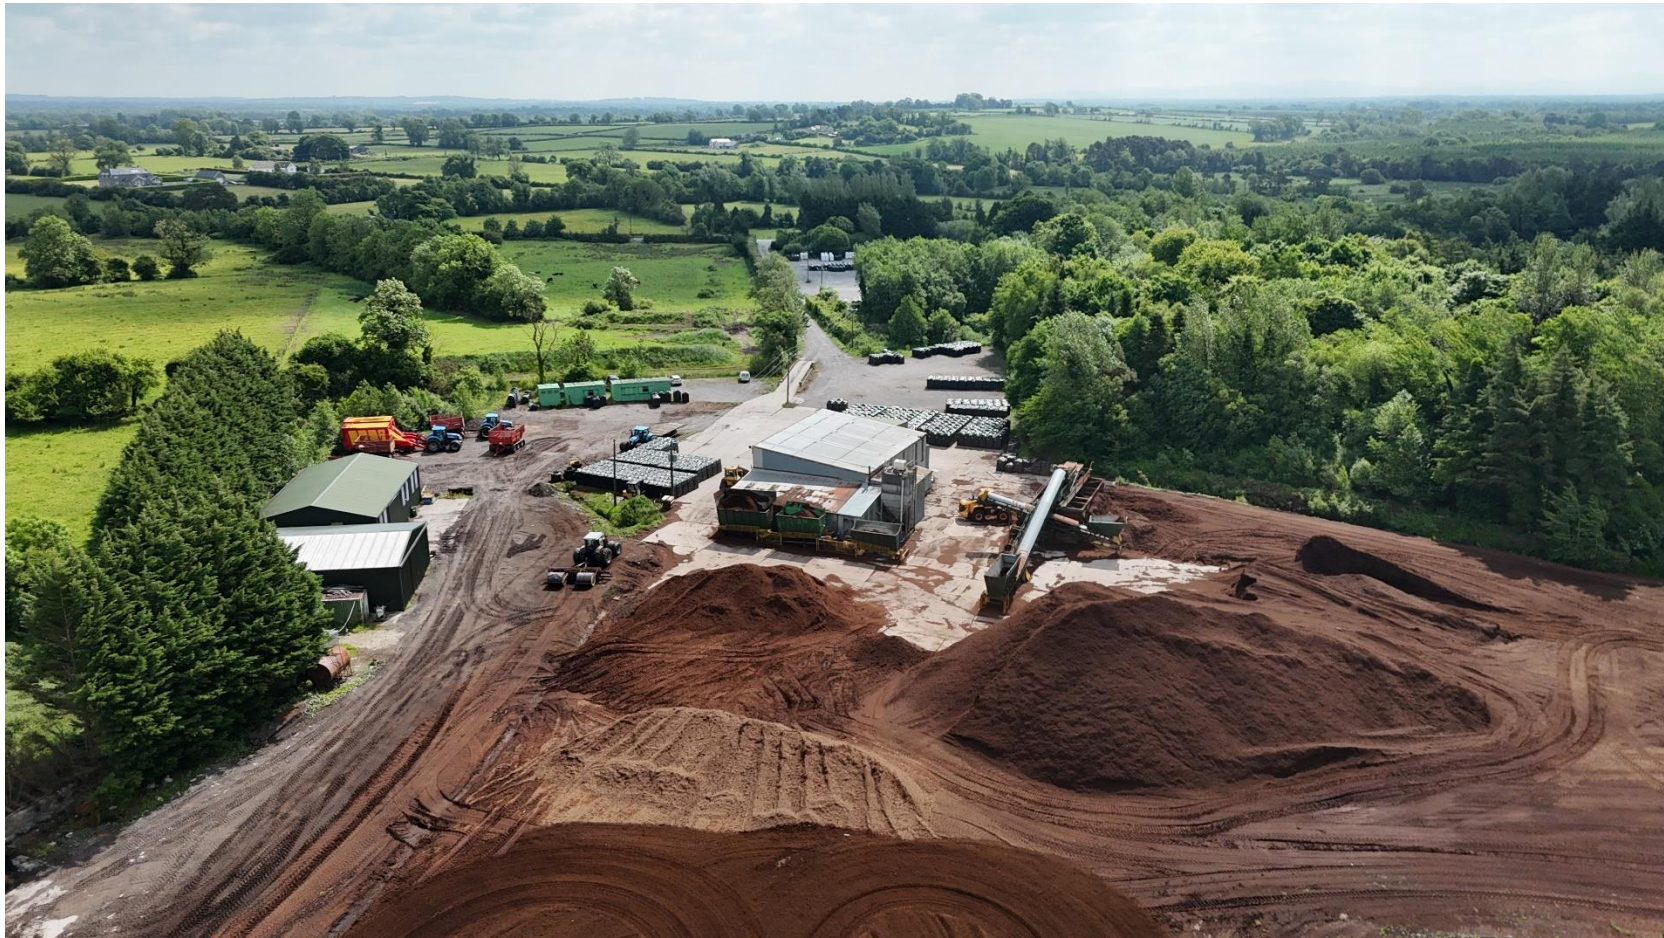
- Stockpiles of milled peat were noted adjacent to the bagging/processing plant and milled peat was being moved and processed from the stockpiles. The bagging plant was in operation during the inspection.

Photo 7– Photo of milled peat stockpiles adjacent to the bagging plant.
