SITE VISIT REPORT

Purpose of Site Visit: Peat Extraction in Co Longford

Site Address: Derrymore, Co Longford

Date of Visit: 12/06/2024

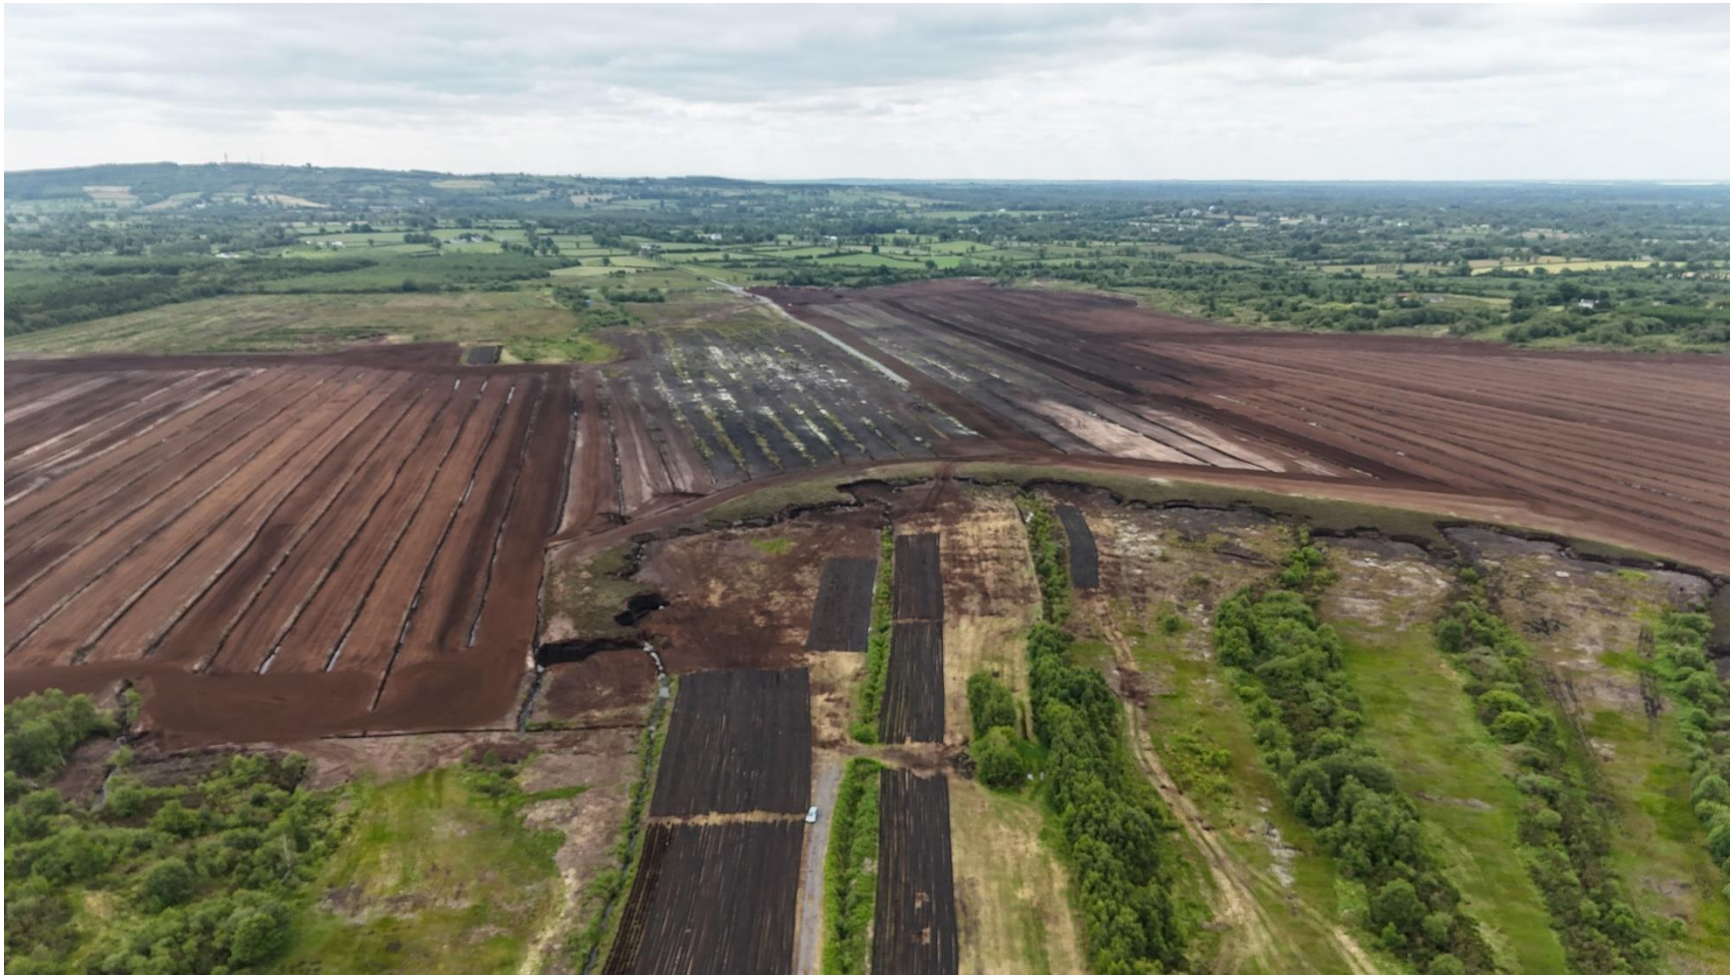
Photo 1: Overview of the peatland in a southerly direction.

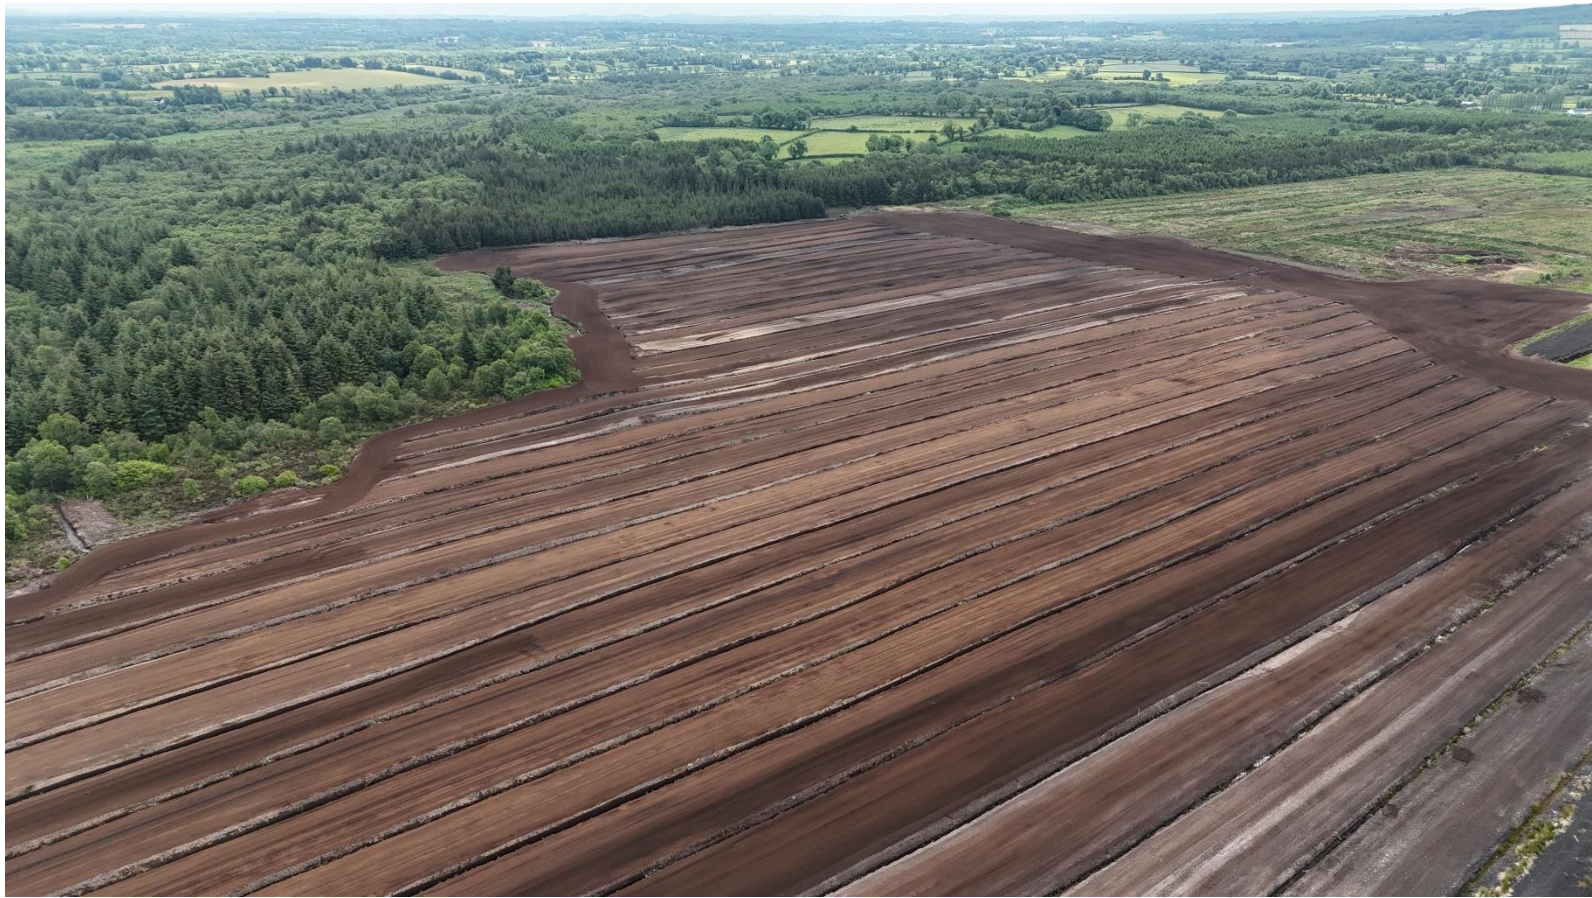
Photo 2: Aerial view of the eastern side of the peatland.

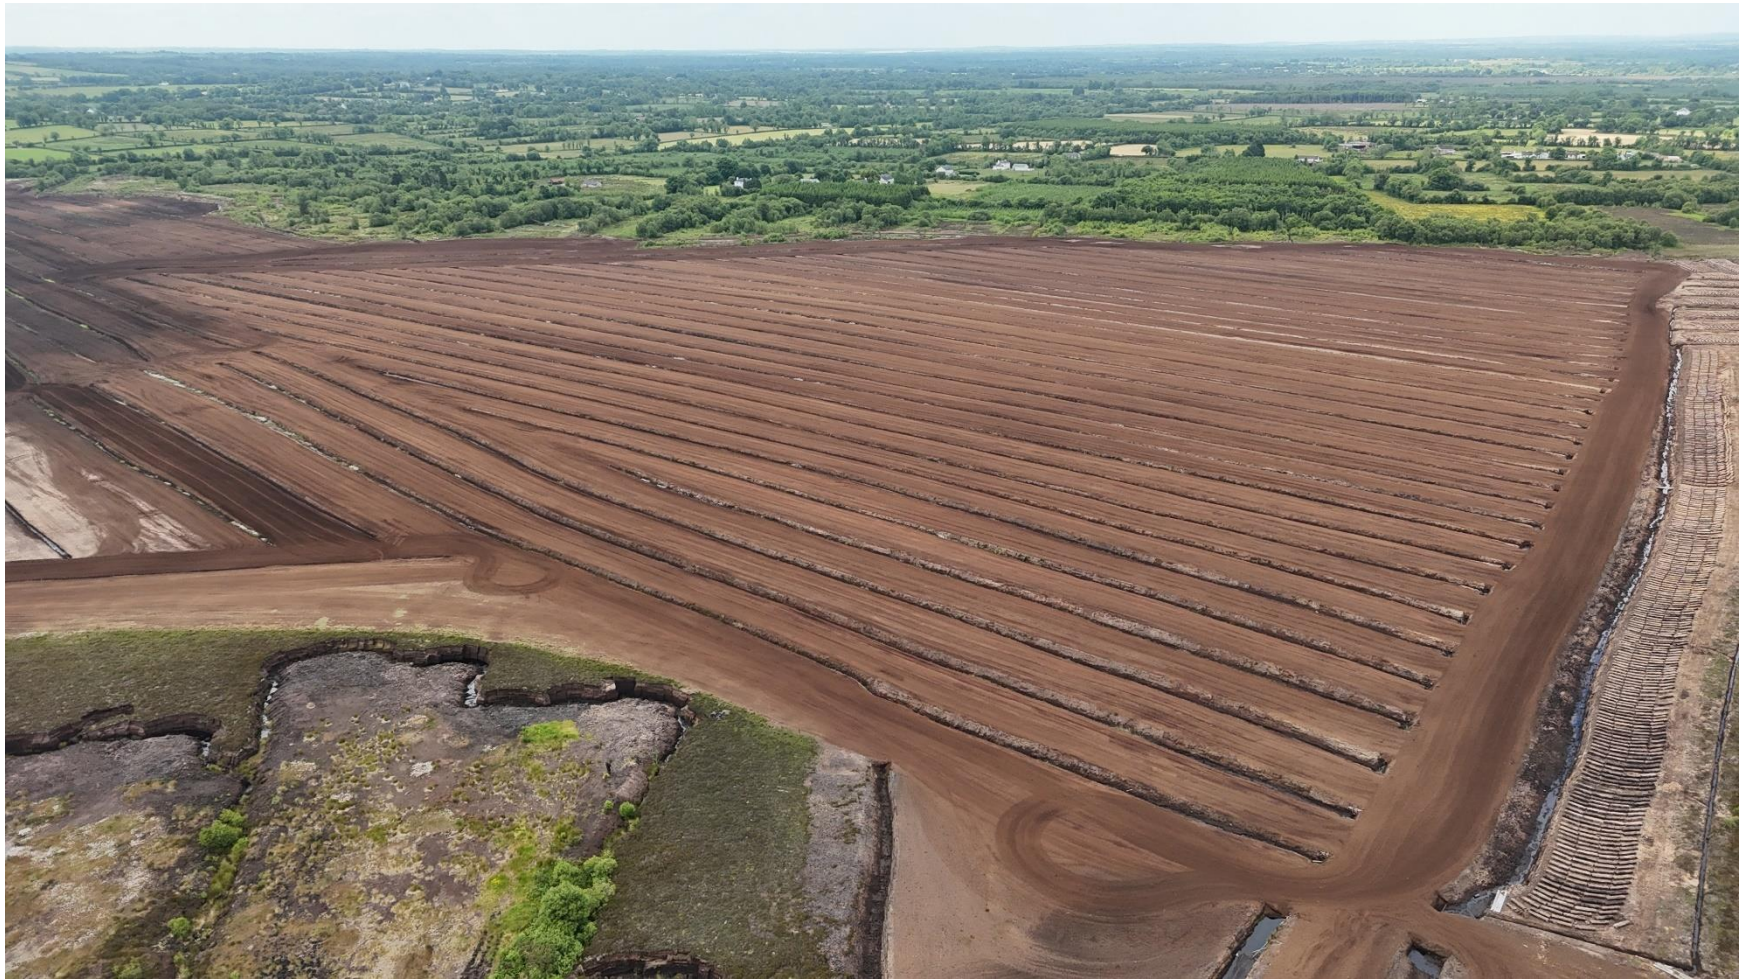
Photo 3: Photo of the western side of the peatland with large sod peat left to dry also noted (on right of photo).

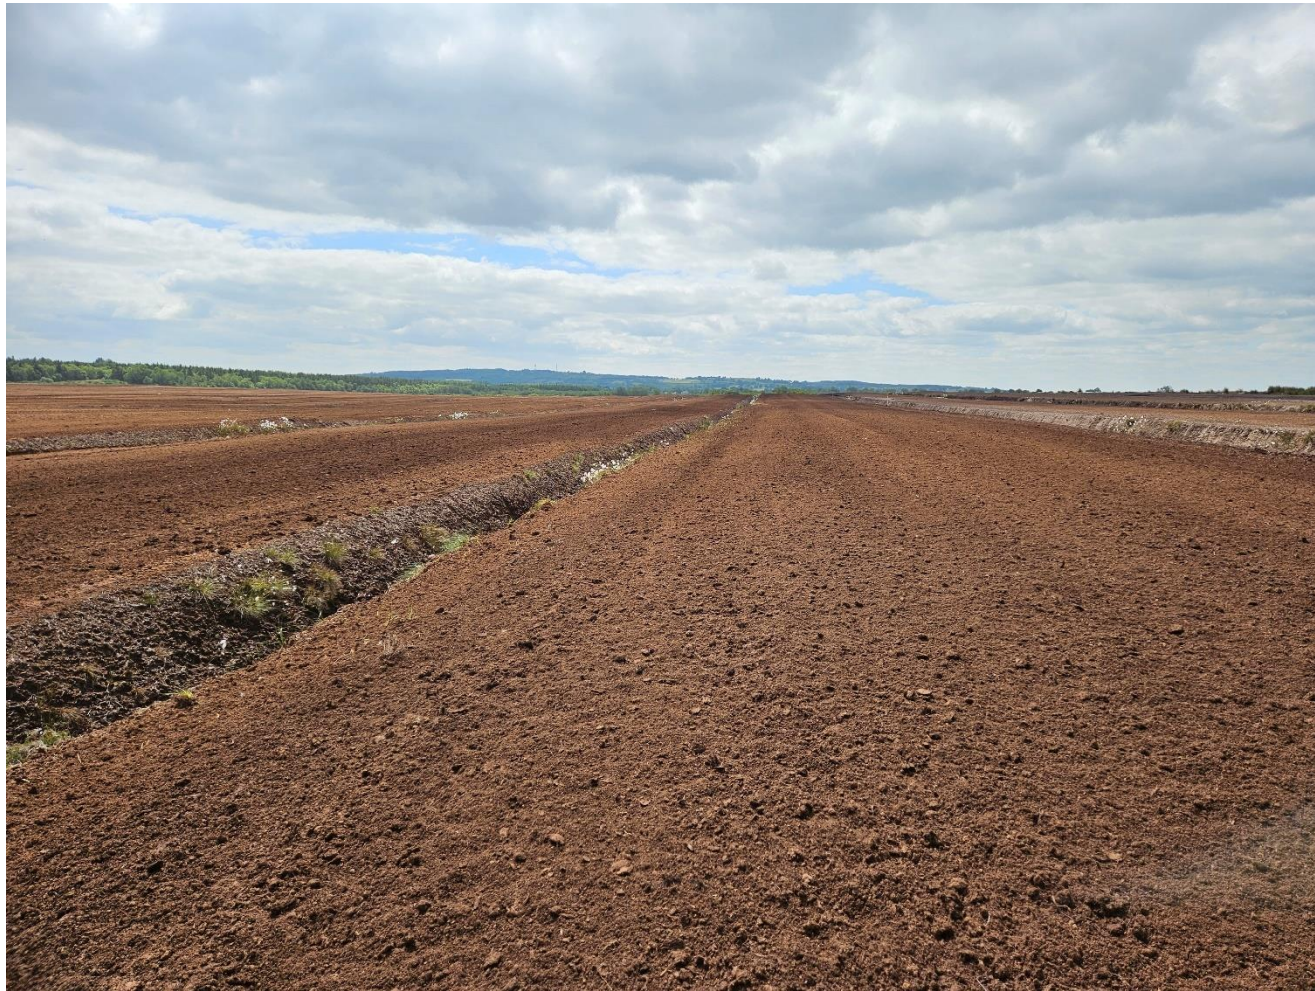
- Aerial footage and photos were taken during the visit.
- During the visit, we met with [REDACTED] and we outlined the purpose of our visit.
- No peat extraction/harvesting was taking place during the visit.
- Milled peat extraction was noted to have recently taken place on the peatland. The 'milled' peat was awaiting further processing (e.g. harrowing/ridging) prior to collection and removal off the peatland.
- Drainage works were noted to be underway at the Northern part of the peatland.

Photo 4: Recently ‘milled’ peat noted on the peatland awaiting further processing prior to collection and removal off the peatland.

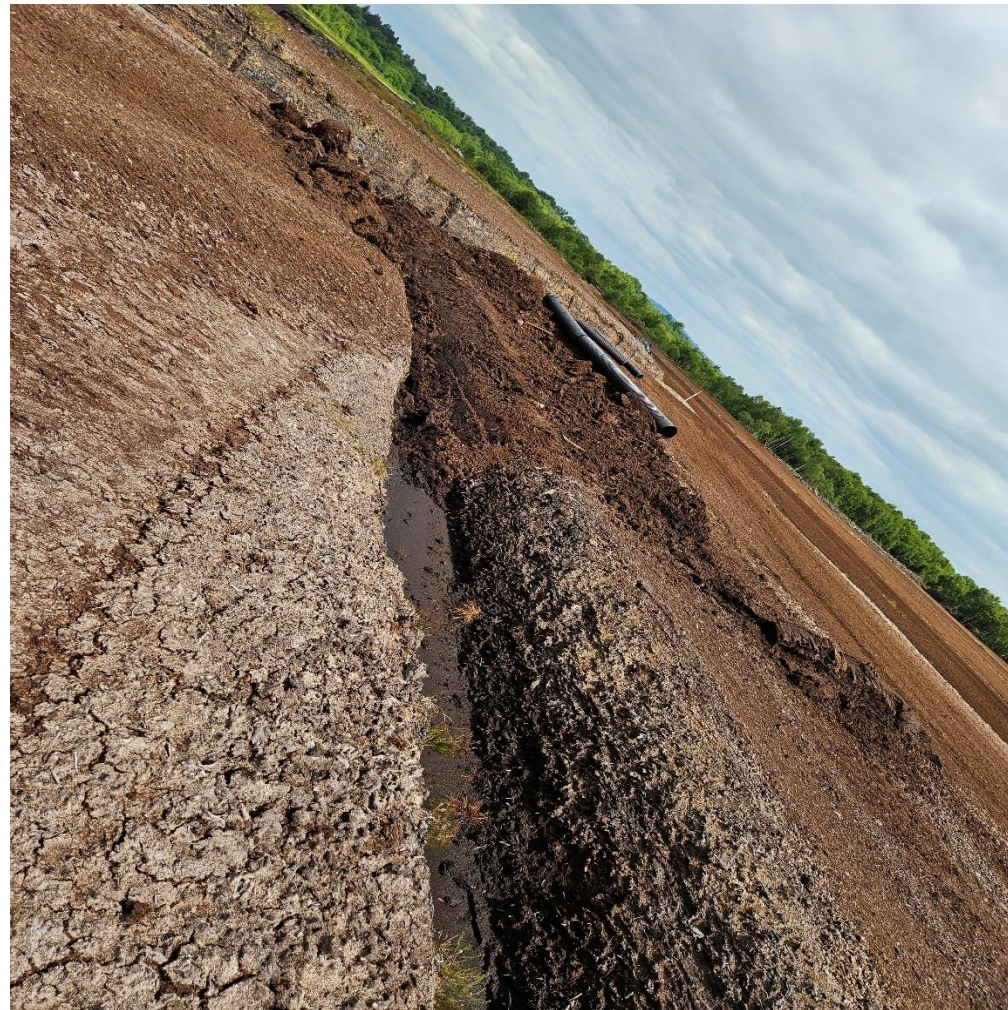
Photo 5: Drainage works noted at the Northern part of the peatland.

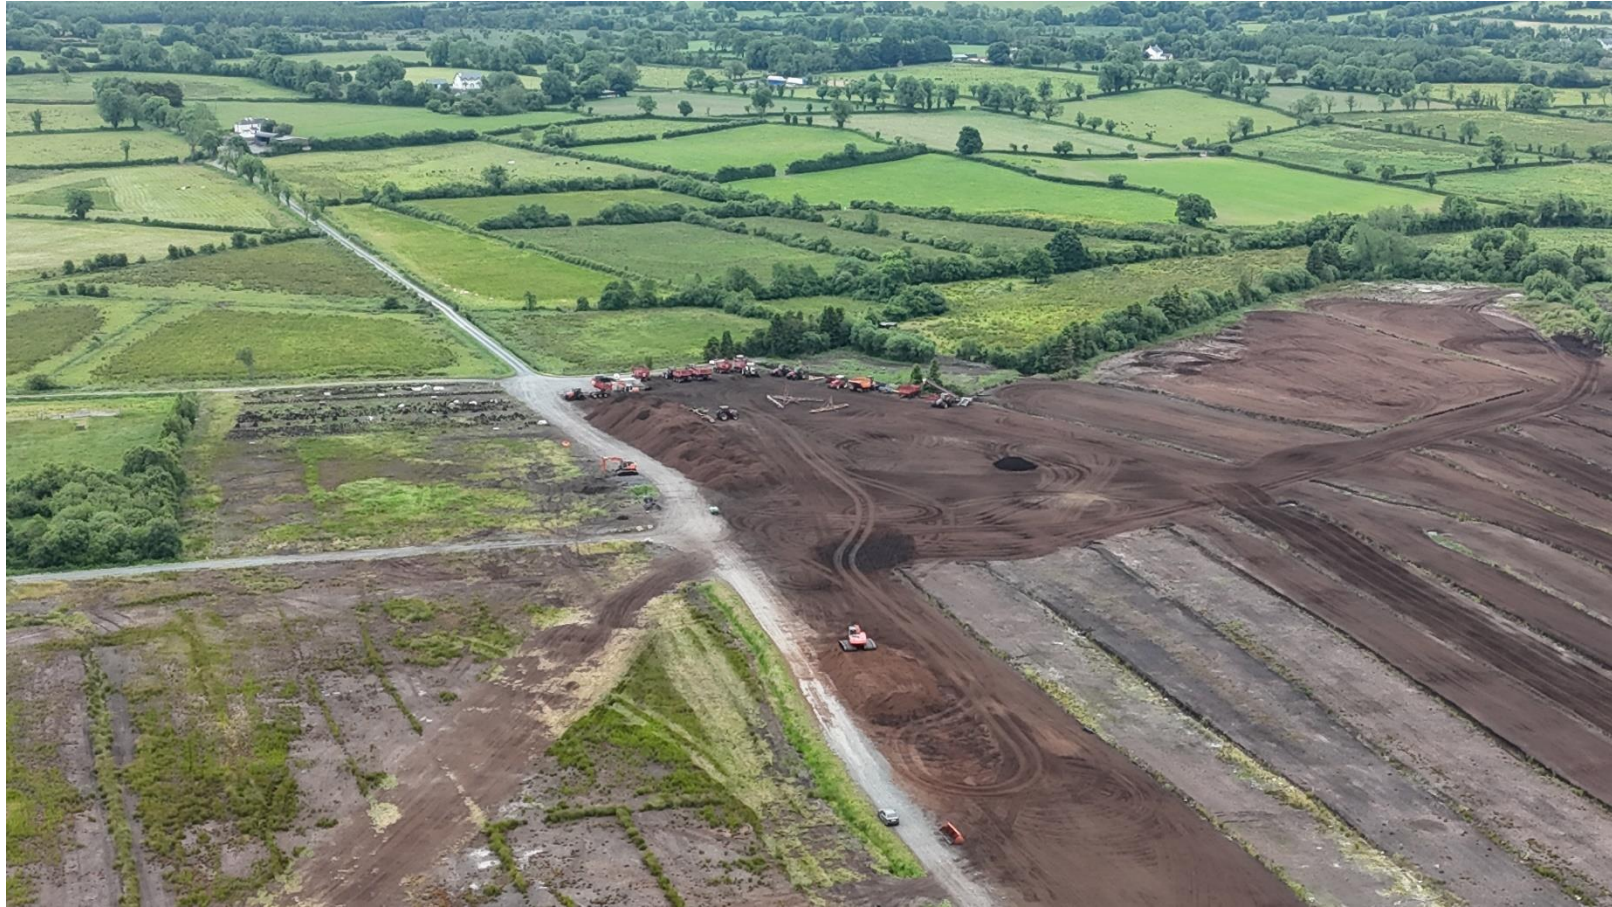
Photo 6: Stockpiles of milled peat and peat extraction and harvesting machinery noted at the loading area.
