SITE VISIT REPORT

Purpose of Site Visit:	Peat Extraction in Co Longford
Site Address:	Derrymore, Ardagh Co Longford
Date of Visit:	20/05/2024
Times of Visit:	09:00 to 14:40
Visit Criteria:	Peat extraction investigation
EPA Attendee:	Mick Henry and Simon Buckley
Organisation	Derrymore Peat Ltd [REDACTED], Midland Turf, [REDACTED] and [REDACTED] and/or its agents

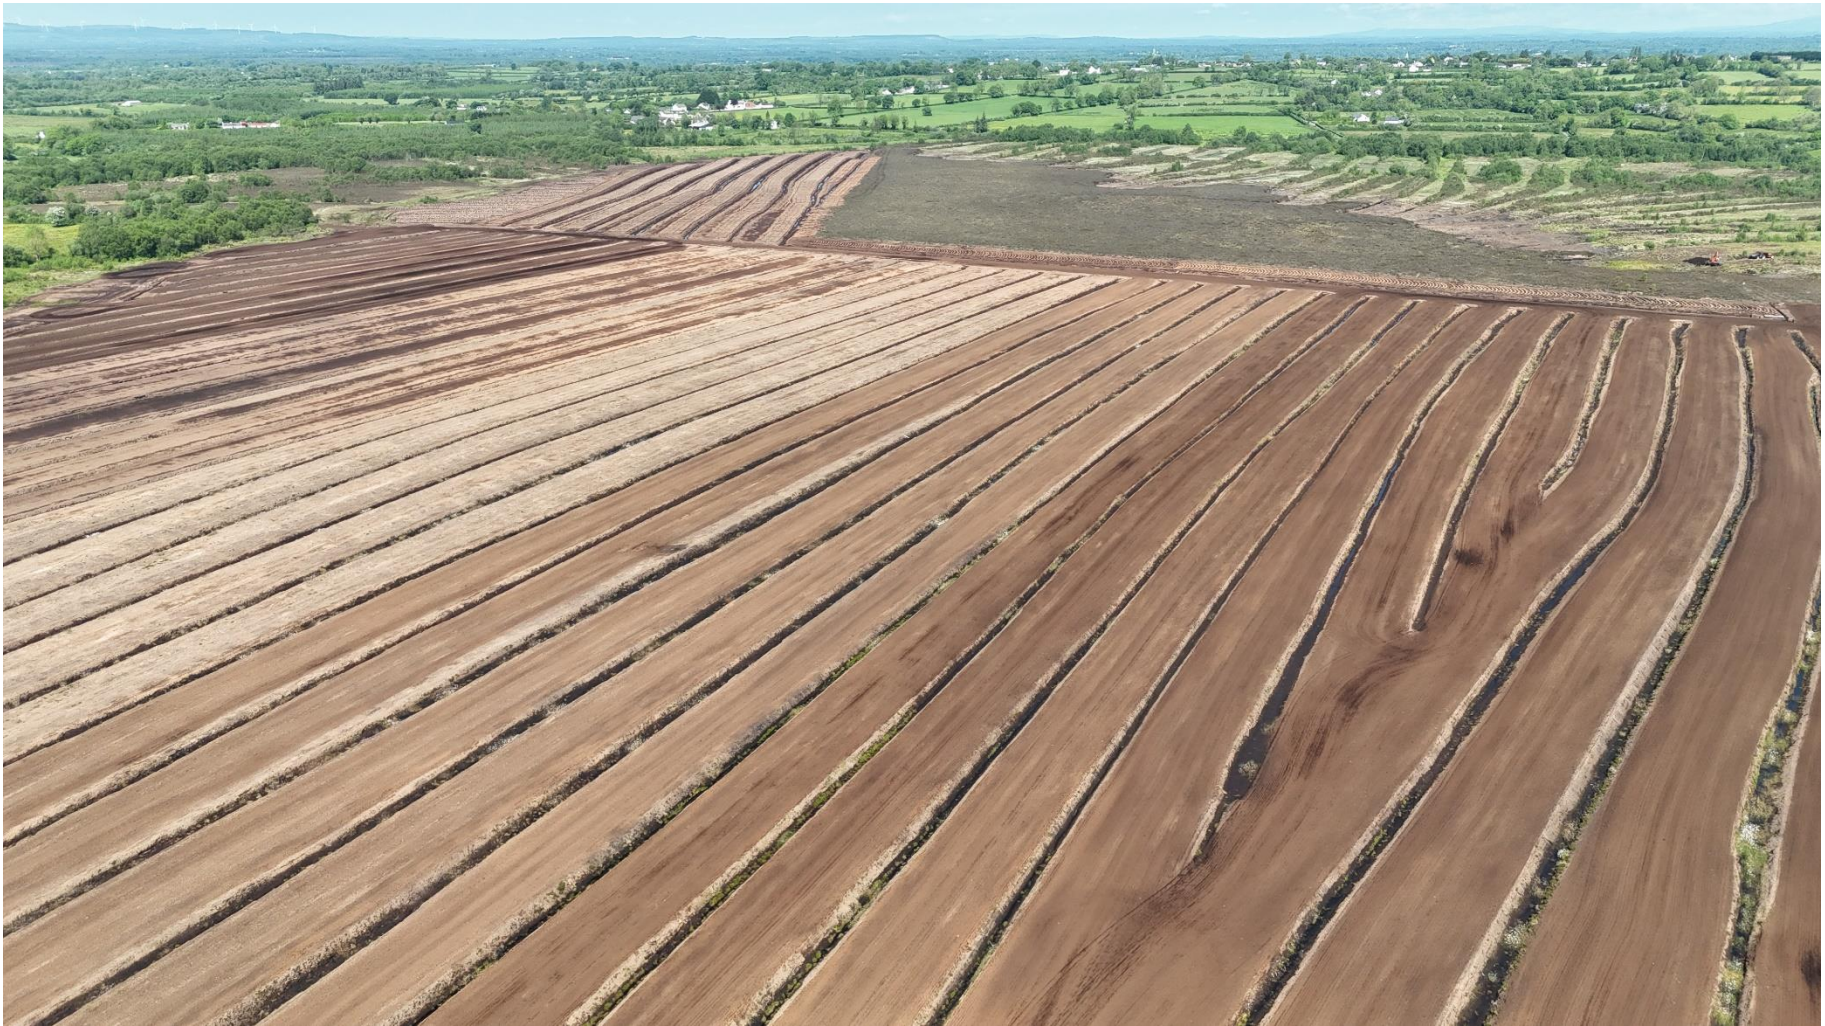
Photo 1: General overview of the North western section of the peatland.

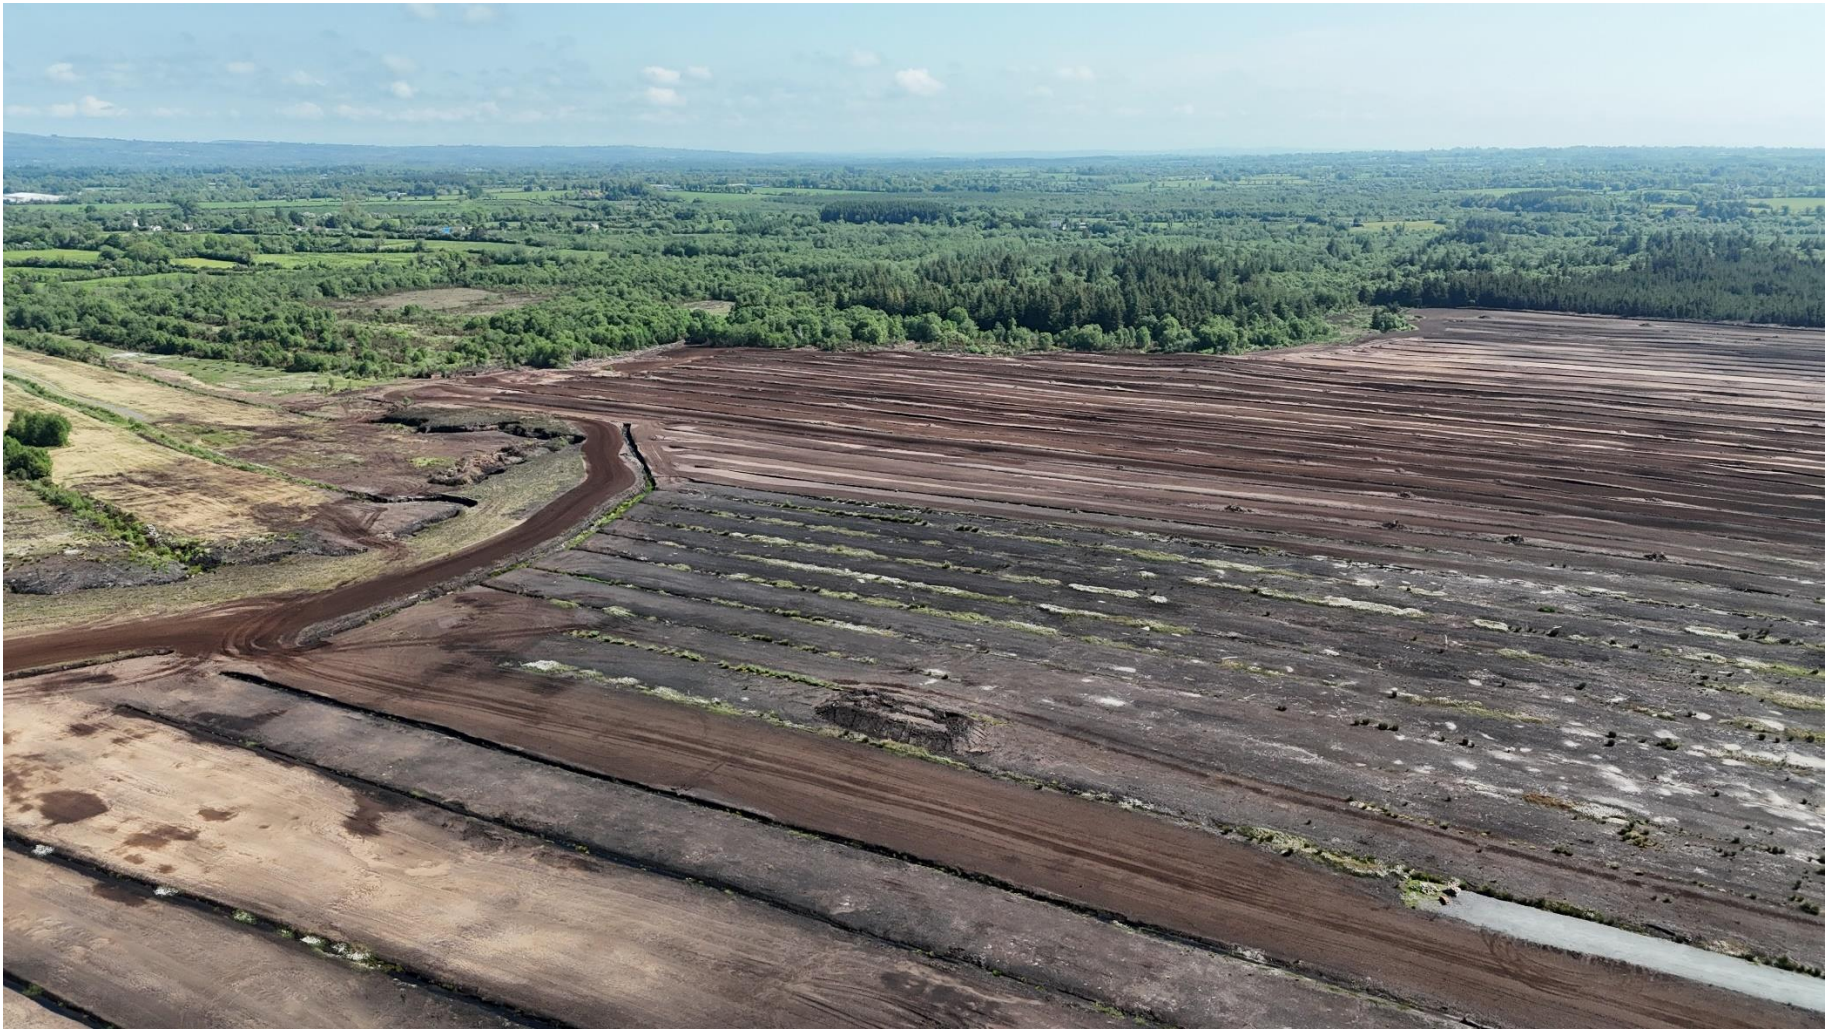
Photo 2: General overview of the North/North eastern section of the peatland.

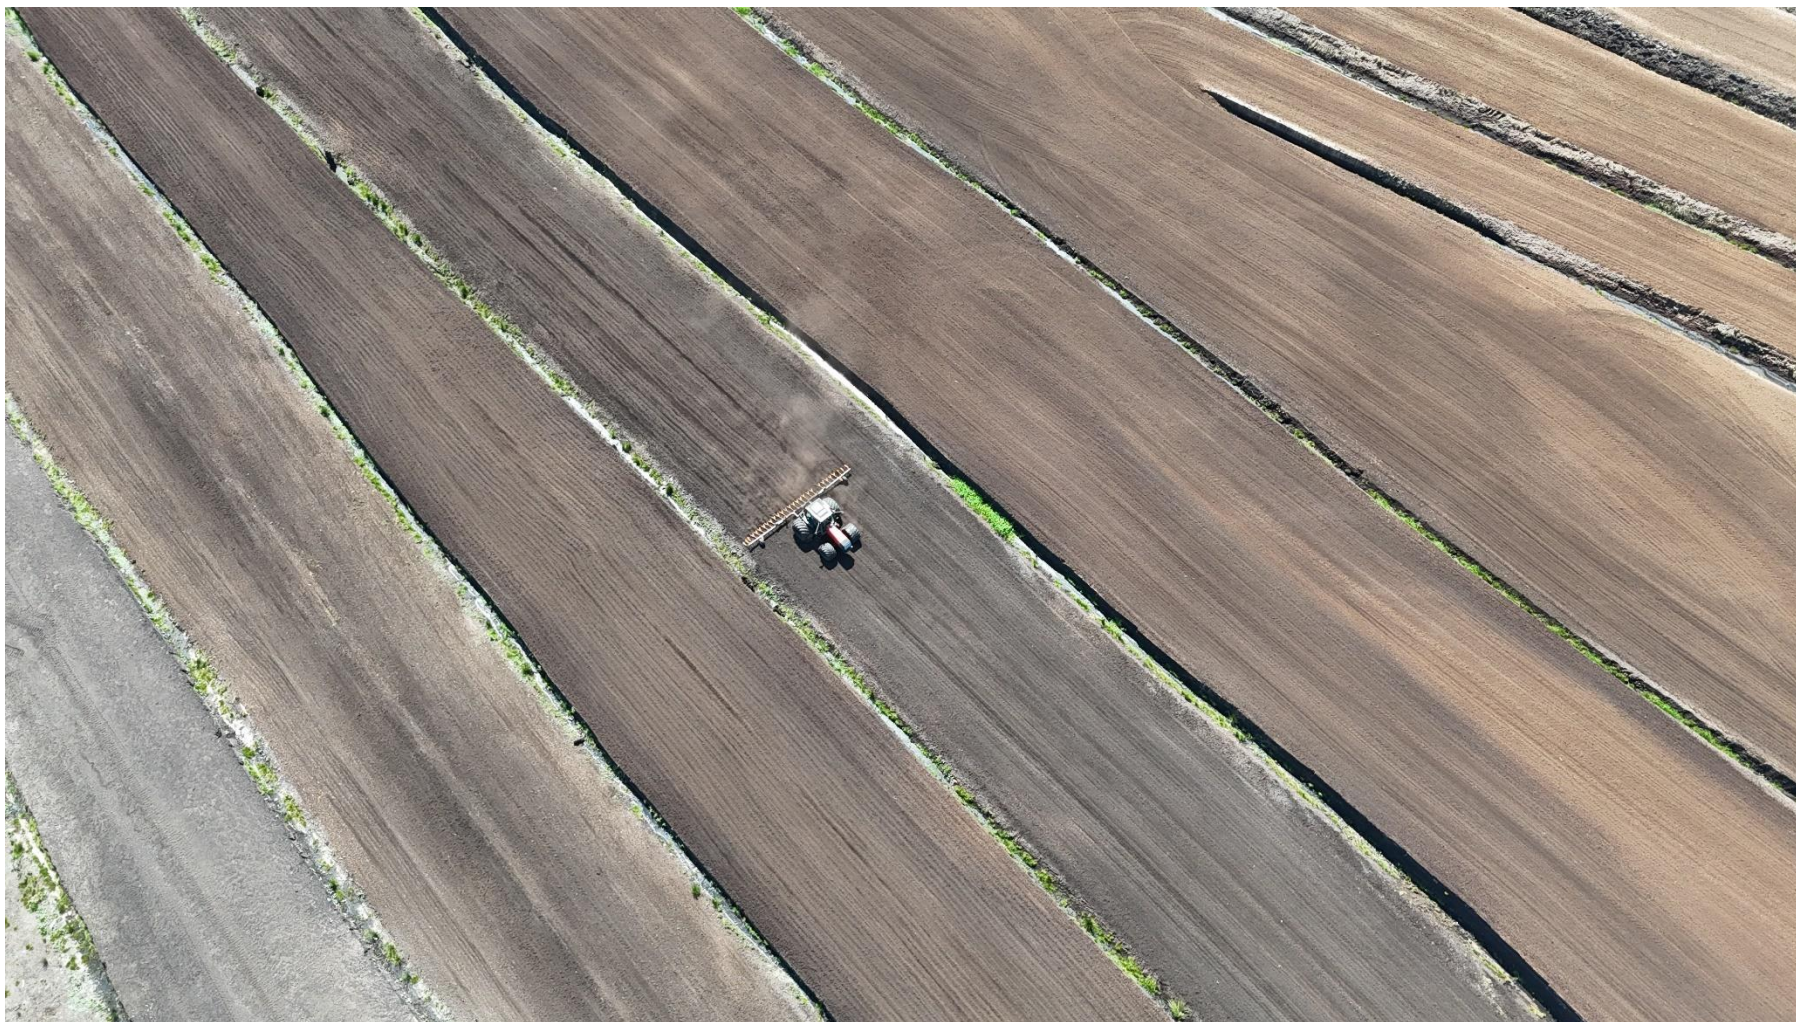
- Milled peat extraction was noted to be ongoing during the visit at various locations on the peatland. In particular, the harrowing of milled peat was taking place during the visit. Once we entered the peatland, the milled peat harrowing was noted to cease.

Photo 3: Milled peat harrowing was noted to be taking place during the visit.

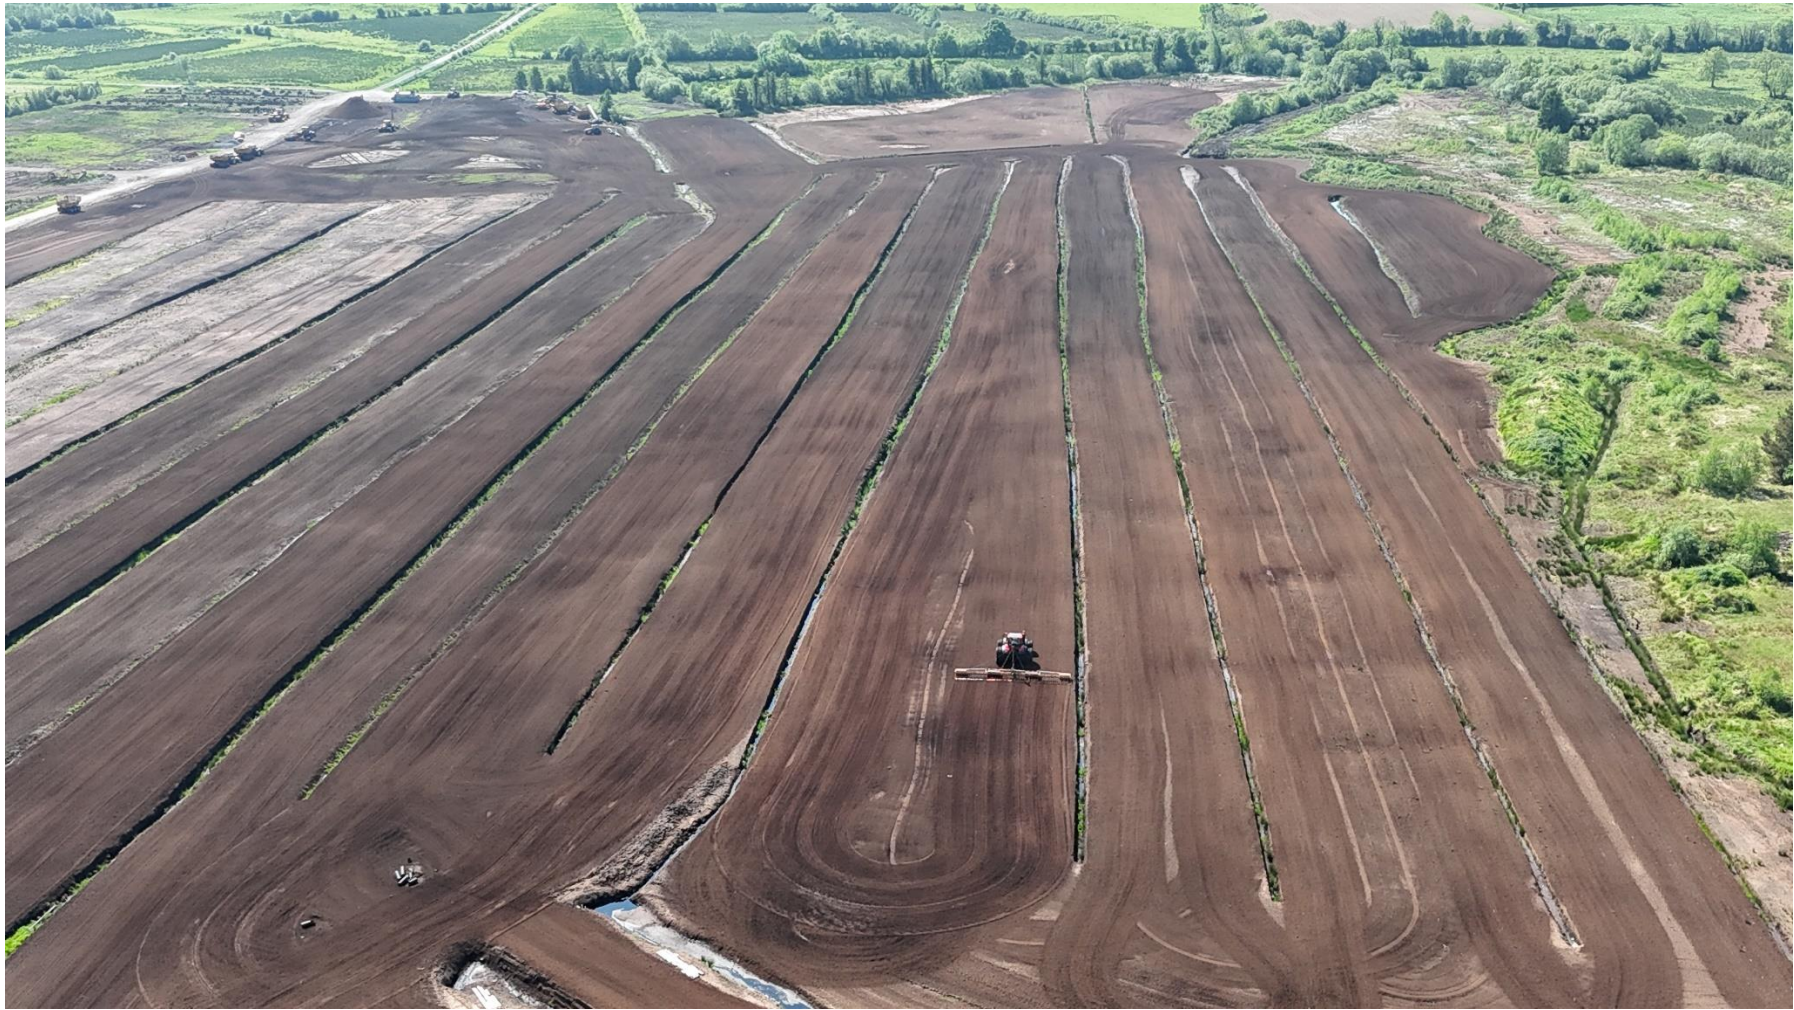
Photo 4: Milled peat harrowing was noted to be taking place during the visit.

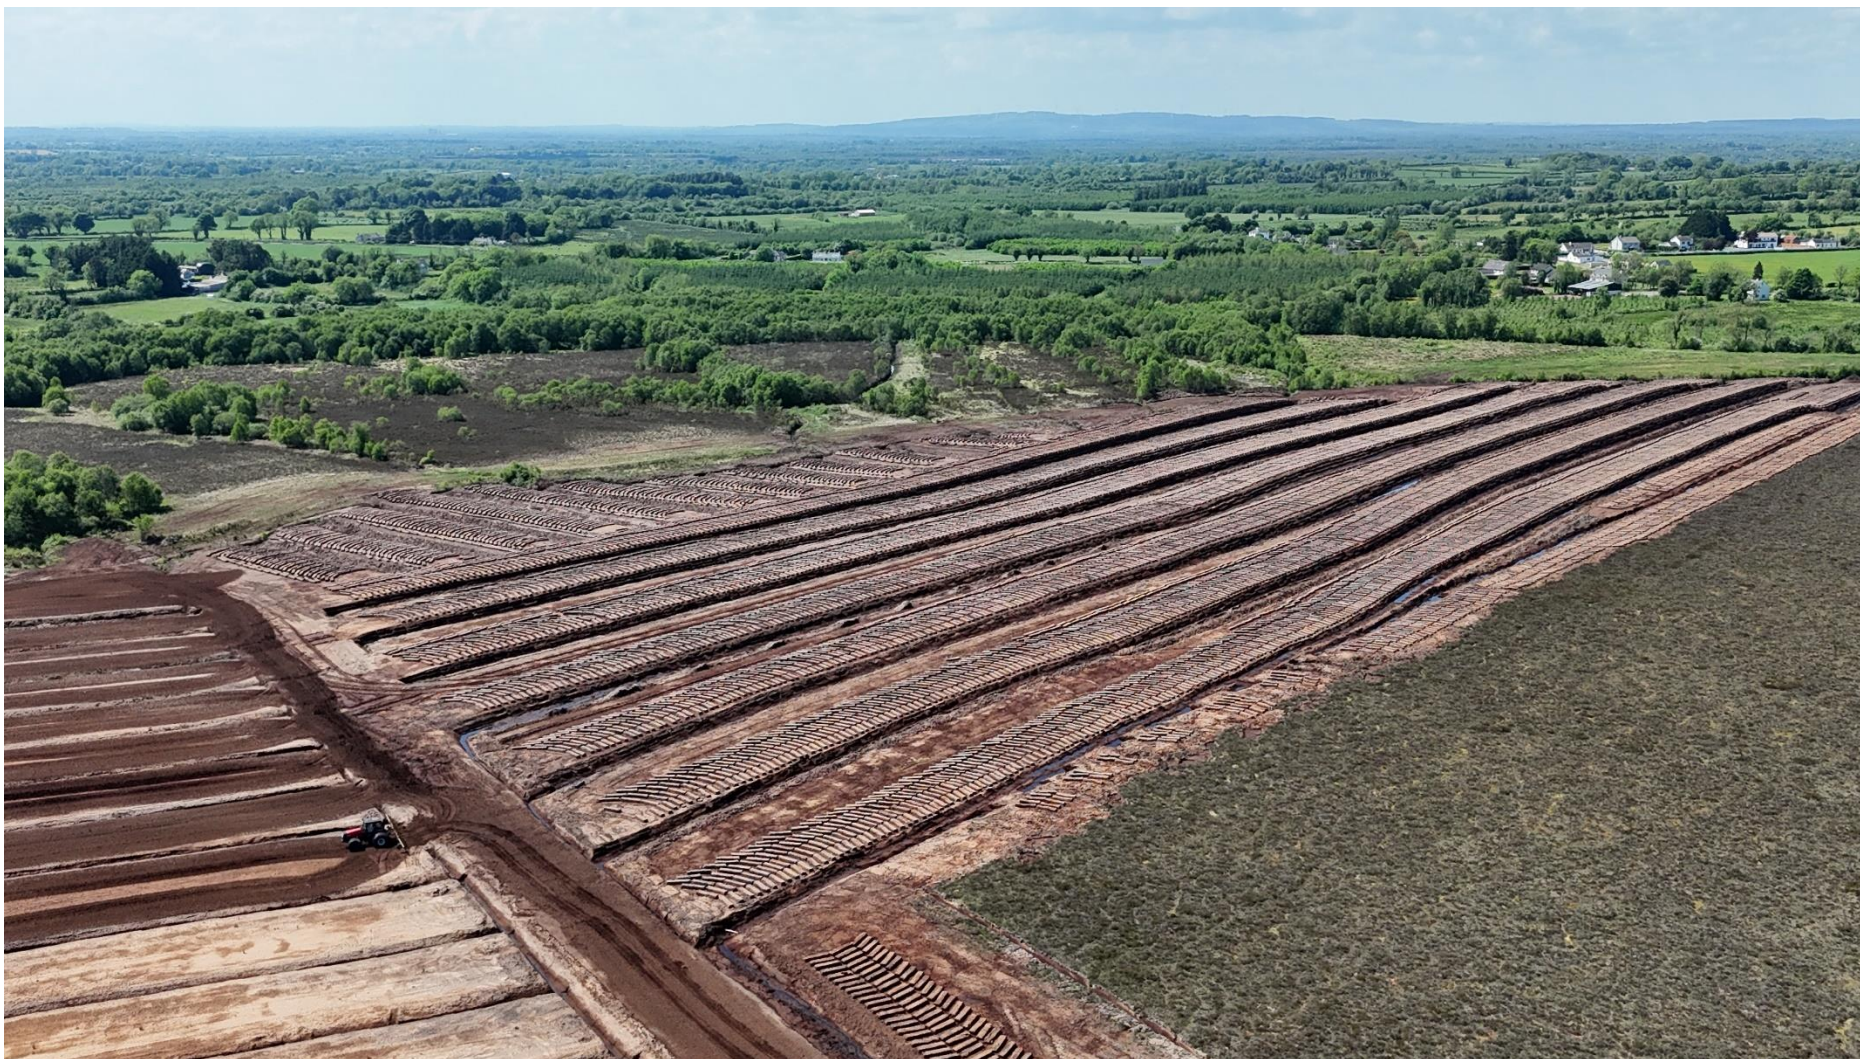
- Large sod peat had recently been extracted and left out on the North western section of the peatland. [REDACTED] said that he had extracted the large sod peat in the last month or so.

Photo 5: View of section of the peatland where large sod peat had recently been excavated, note milled peat extraction taking place also.

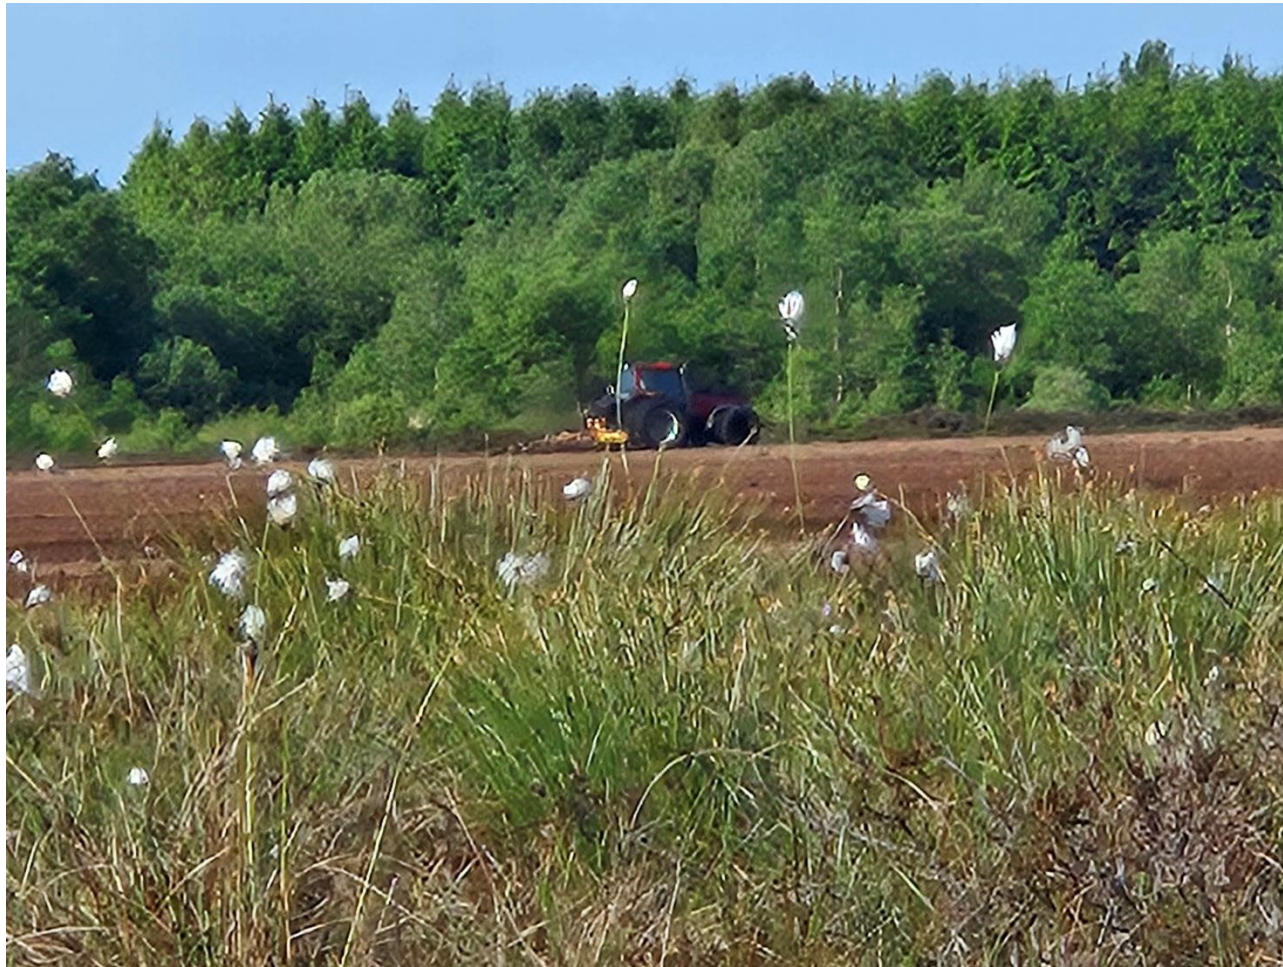
Photo 6: Milled peat harrowing was noted to be taking place during the visit.

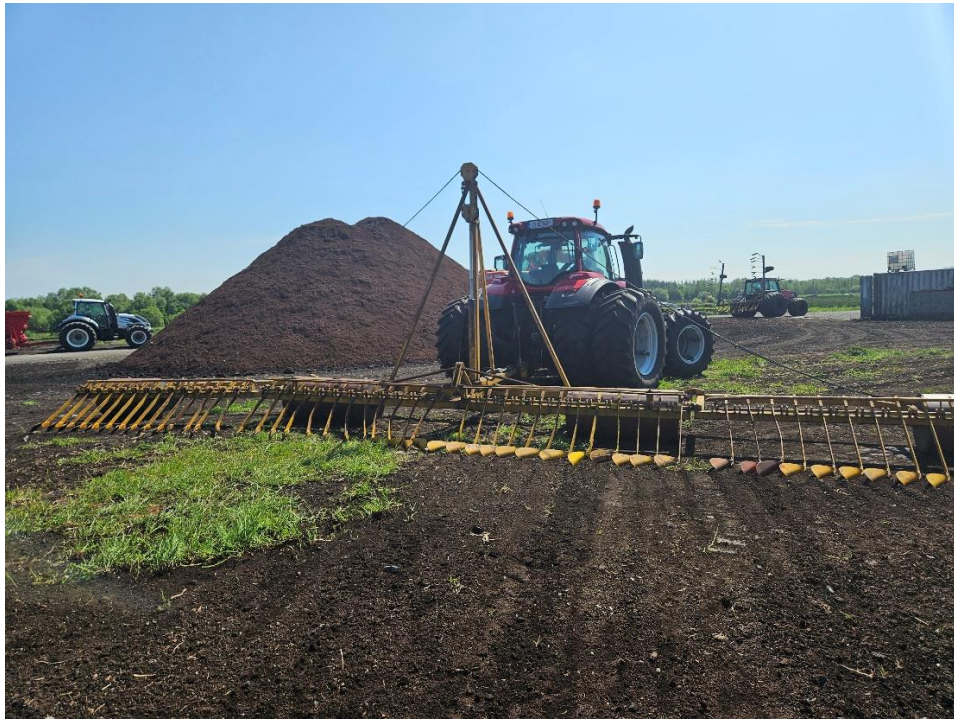
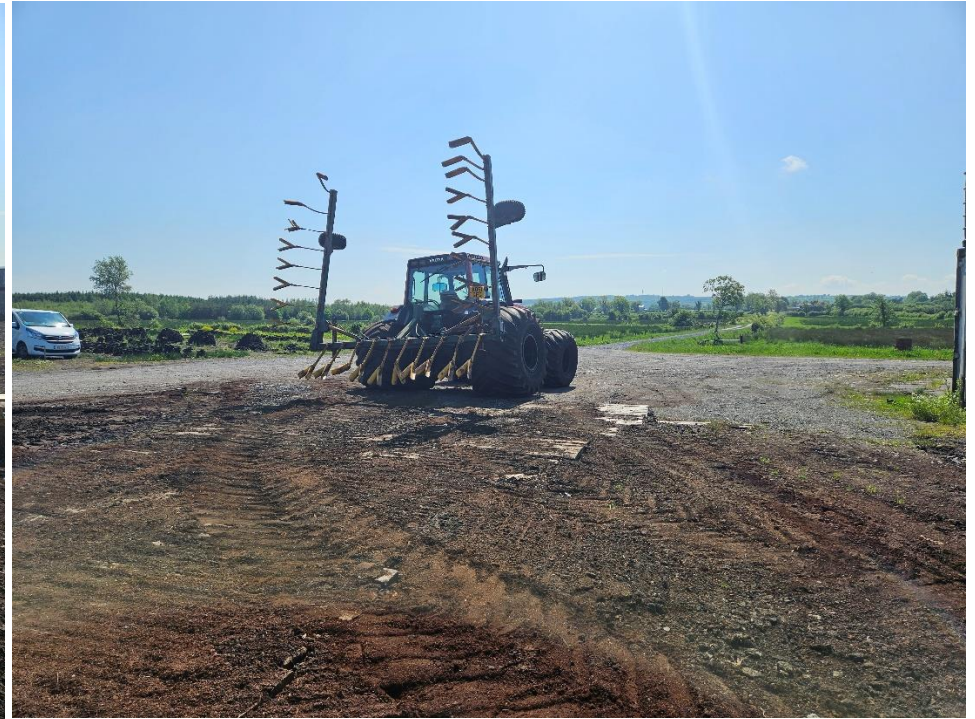
- One excavator was noted to be parked on a milled peat stockpile at the loading area.
 - A significant number of machines and equipment for peat extraction/harvesting was noted to be parked adjacent to the loading area/entrance at the Southern part of the peatland.

Photos 7 & 8: Milled peat extraction machinery and equipment noted at the loading area.

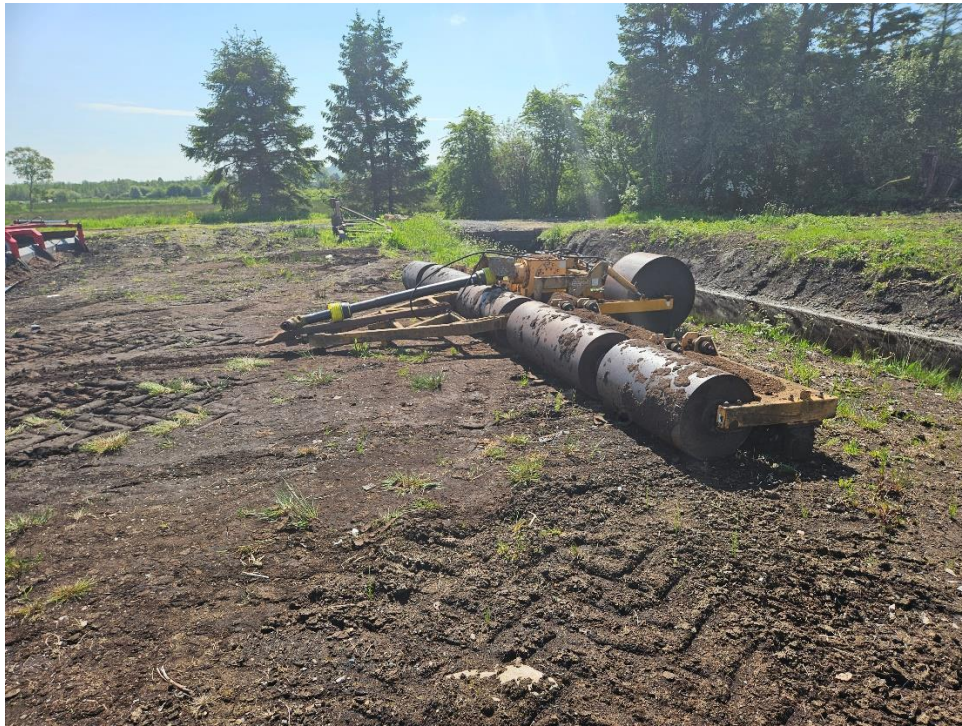
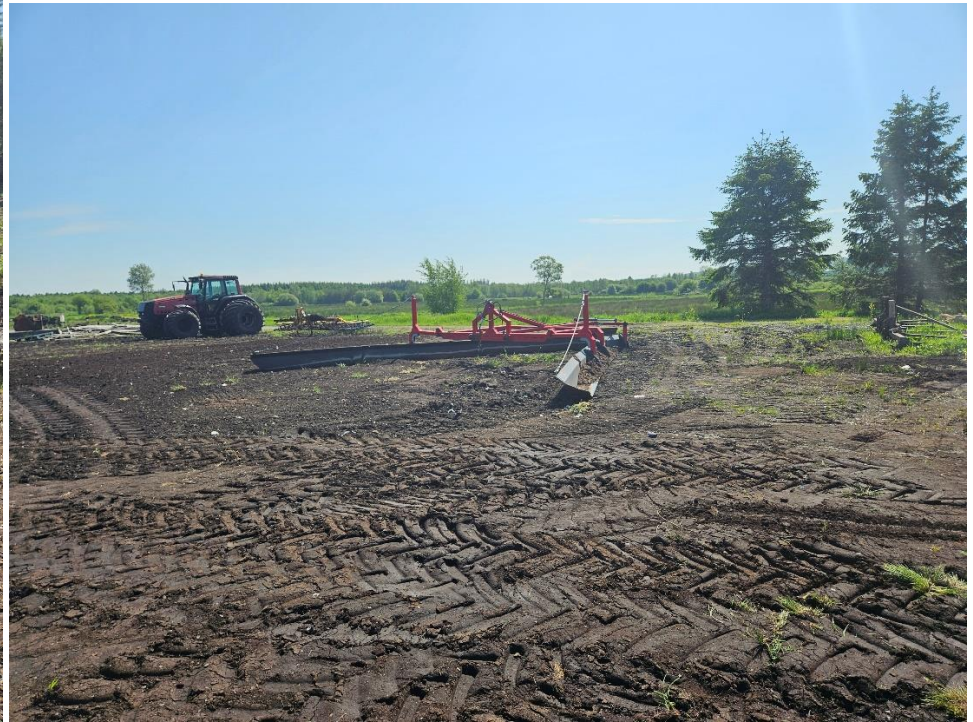
Photos 9 & 10: Milled peat extraction machinery and equipment noted at the loading area.

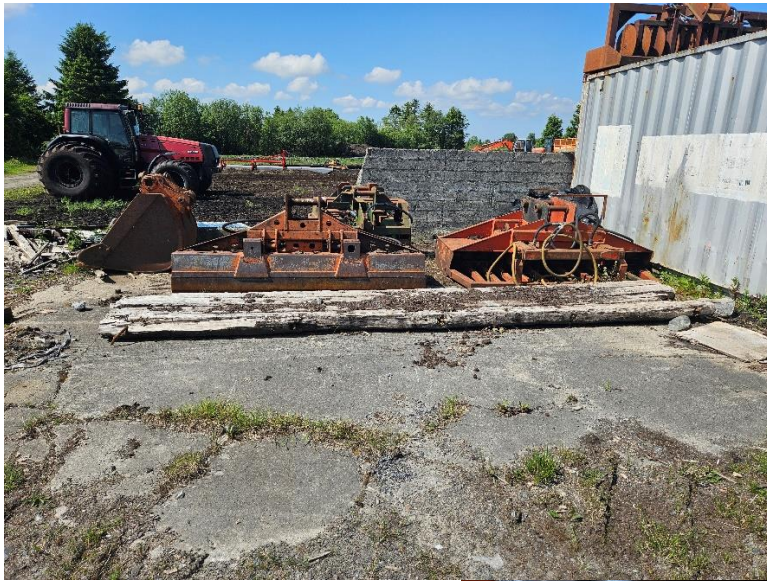
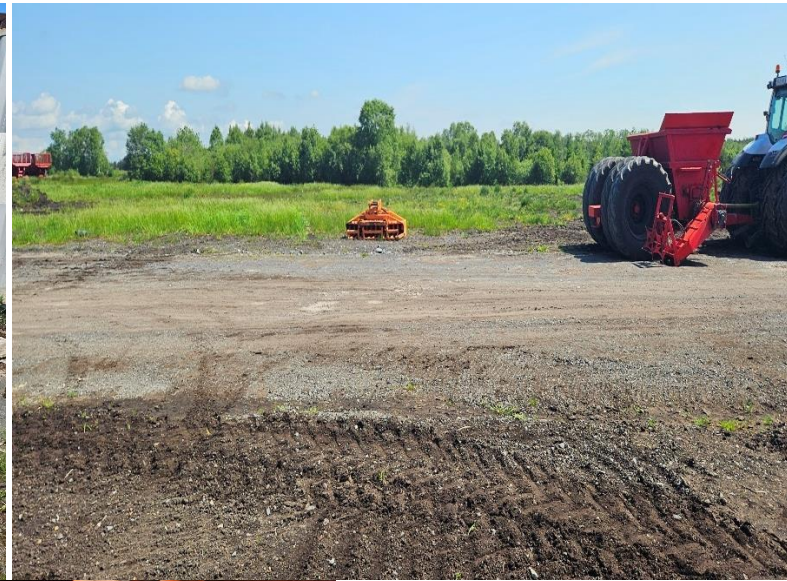
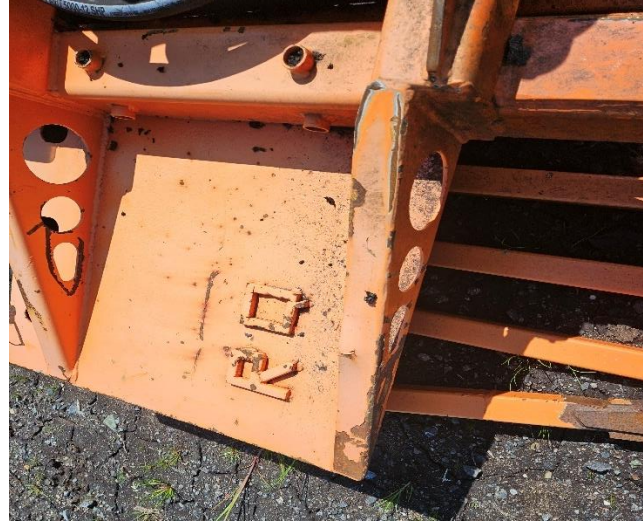
Photos 11, 12 & 13: Large sod peat extraction attachments were noted at the loading area.

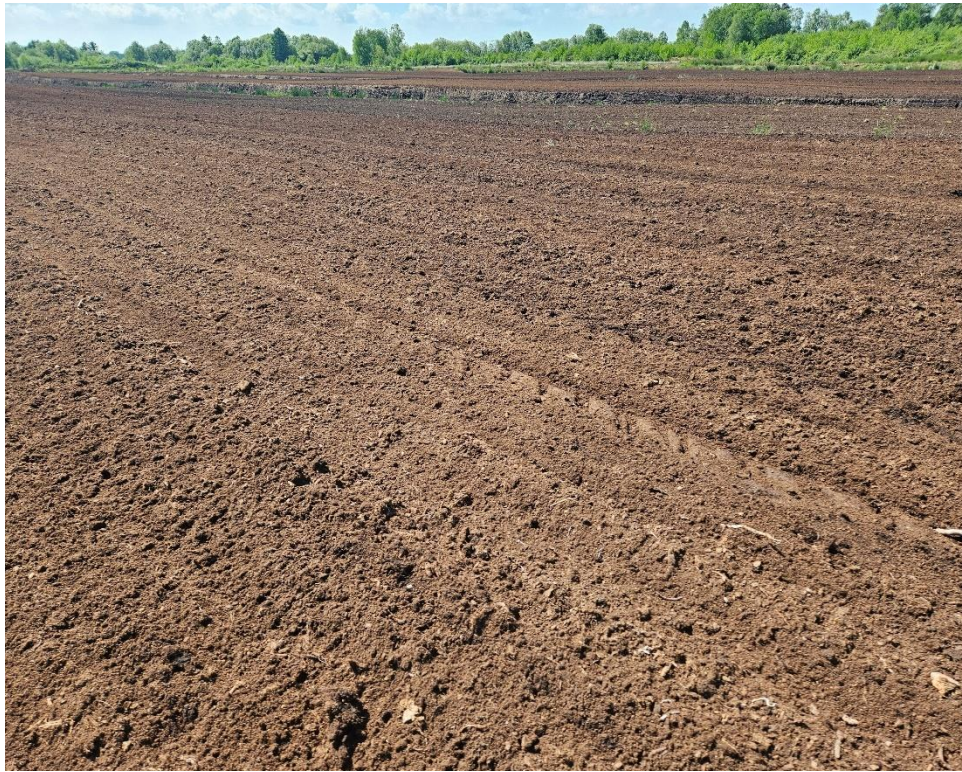
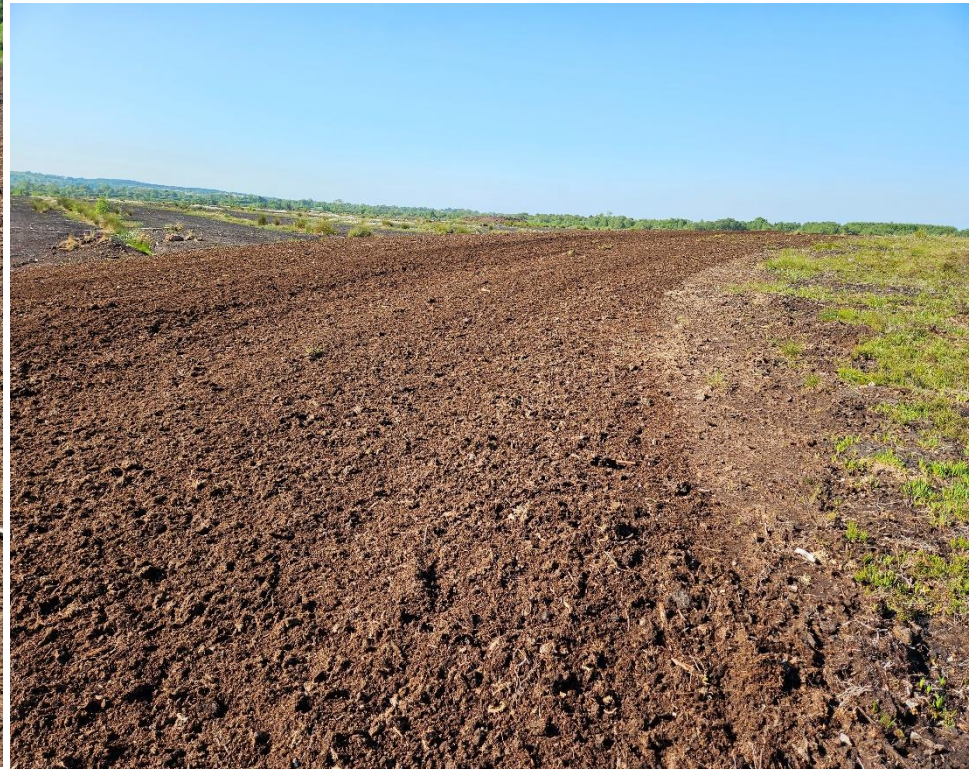
Photos 14 & 15: Recently milled peat noted on the peatland.
