# SITE VISIT REPORT

**Purpose of Site Visit:** Peat Extraction in Co Longford

**Site Address:** Derrymore, Co Longford

**Date of Visit:** 07/06/2024

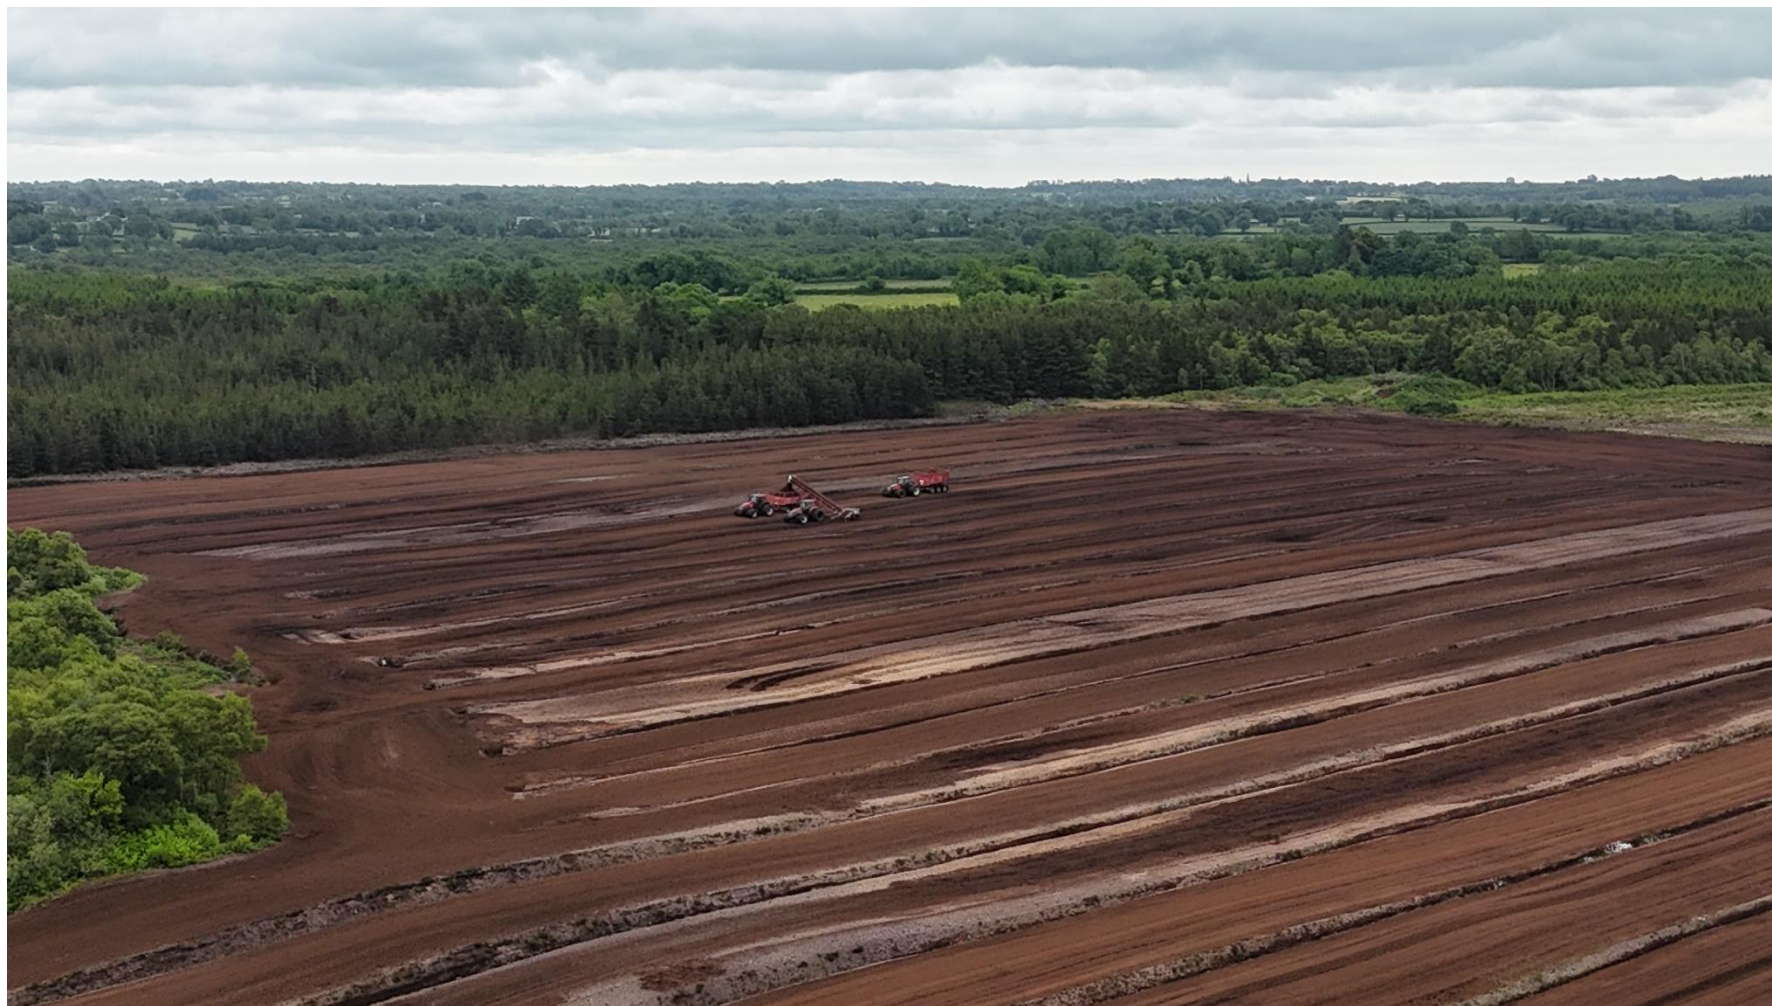
**Photo 1: Collection of milled peat was noted to be taking place at the Eastern side of the peatland.**

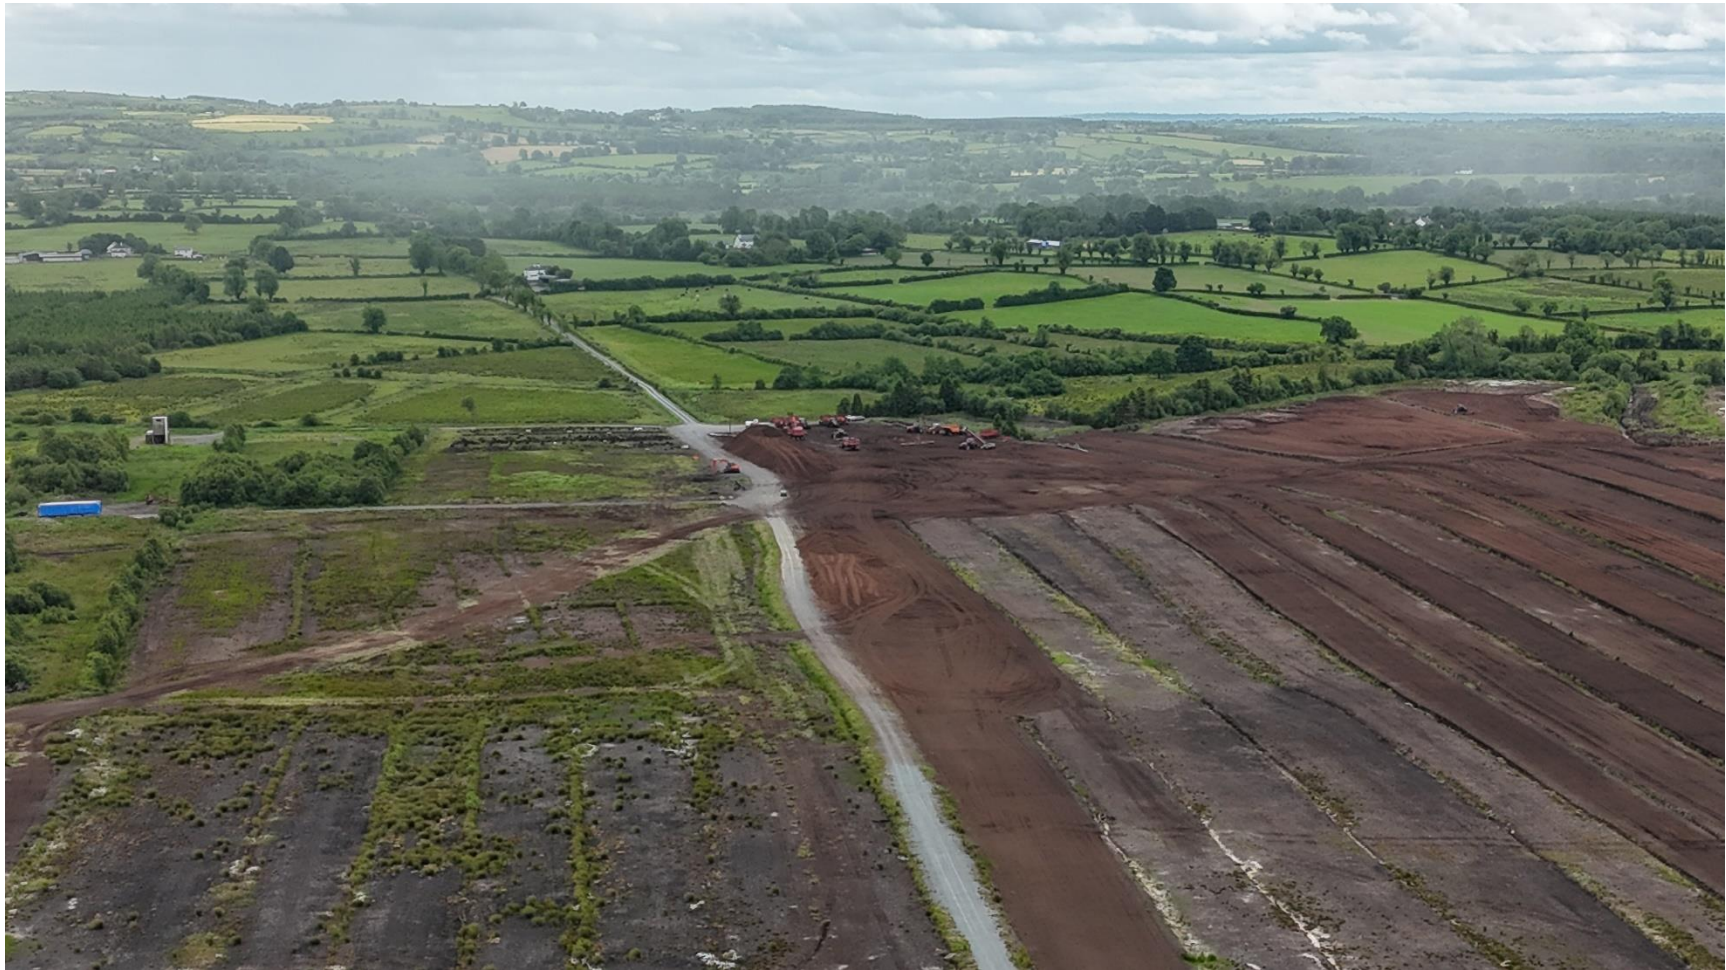
**Photo 2: Milled peat extraction noted to be taking place at the South Western tip of the peatland.**

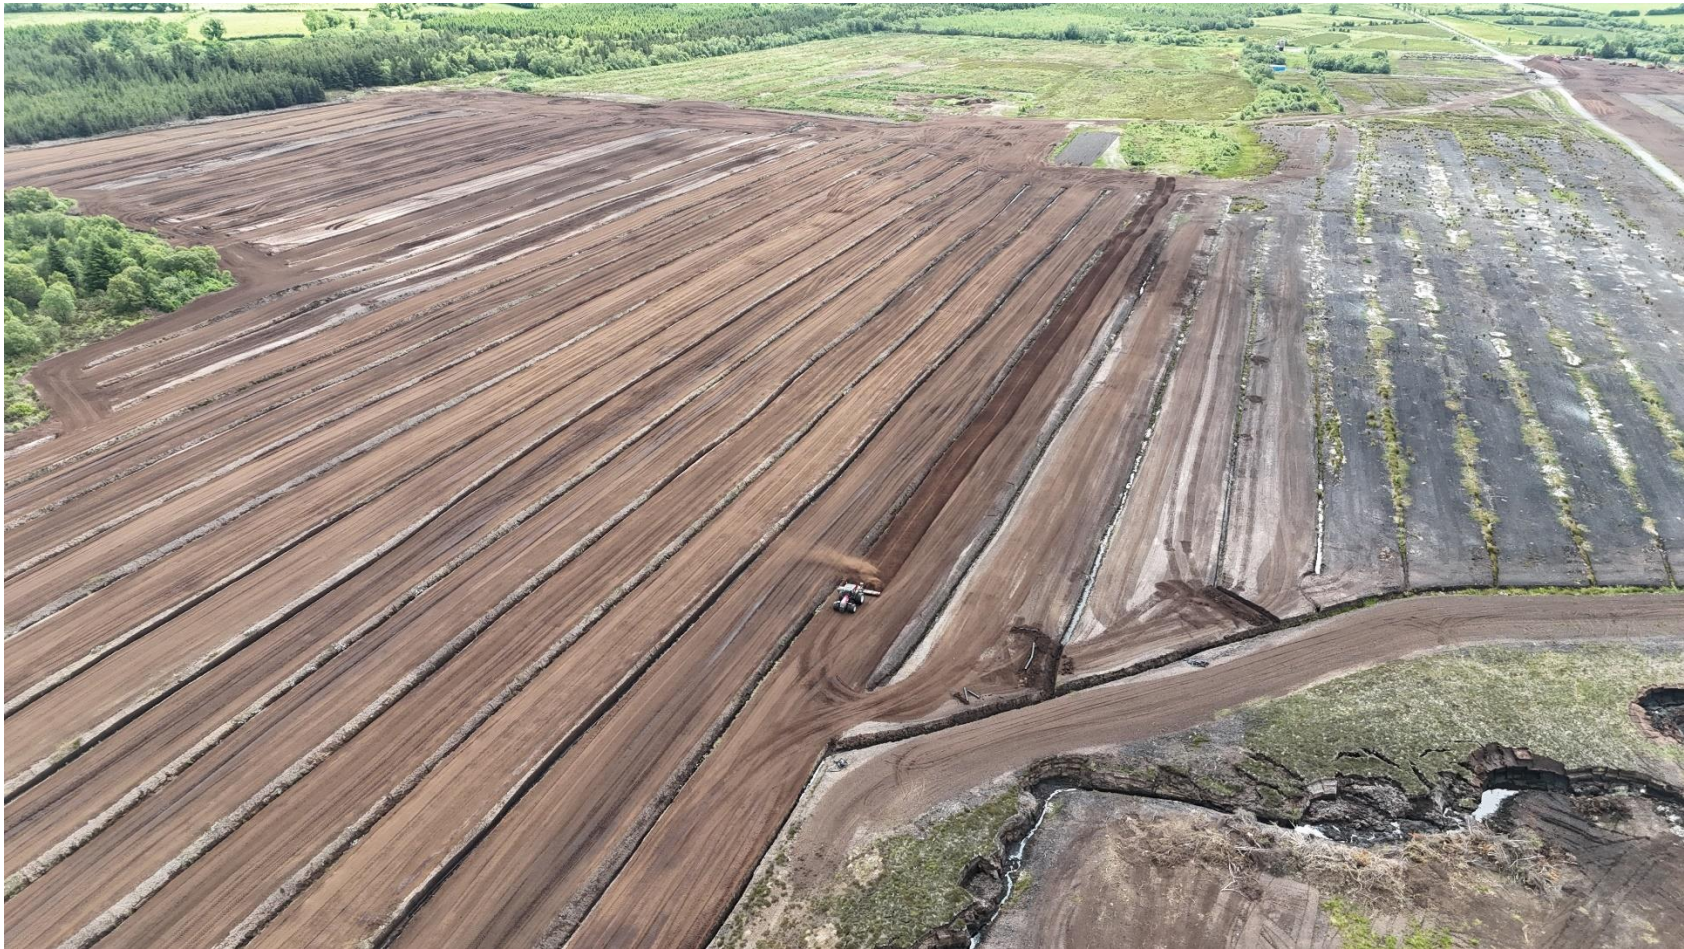
**Photo 3: Milled peat extraction noted at the Northern part of the peatland.**

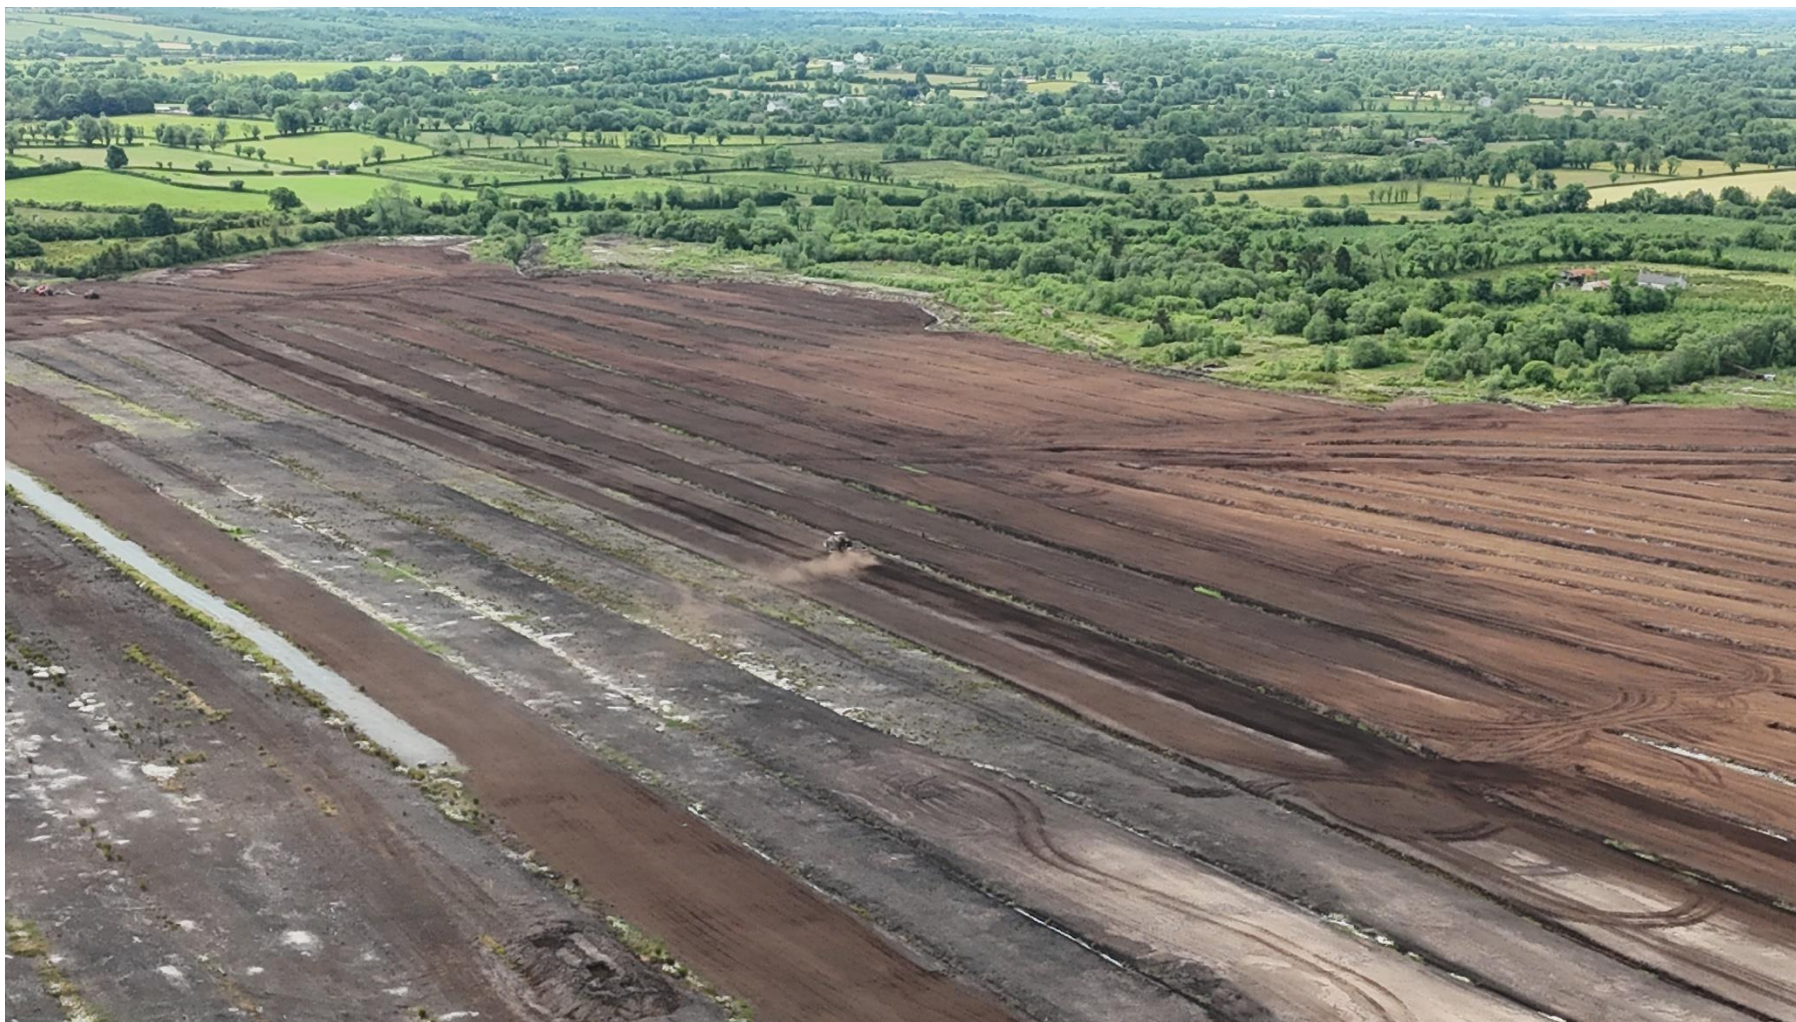
**Photo 4: Milled peat extraction was noted during the visit.**

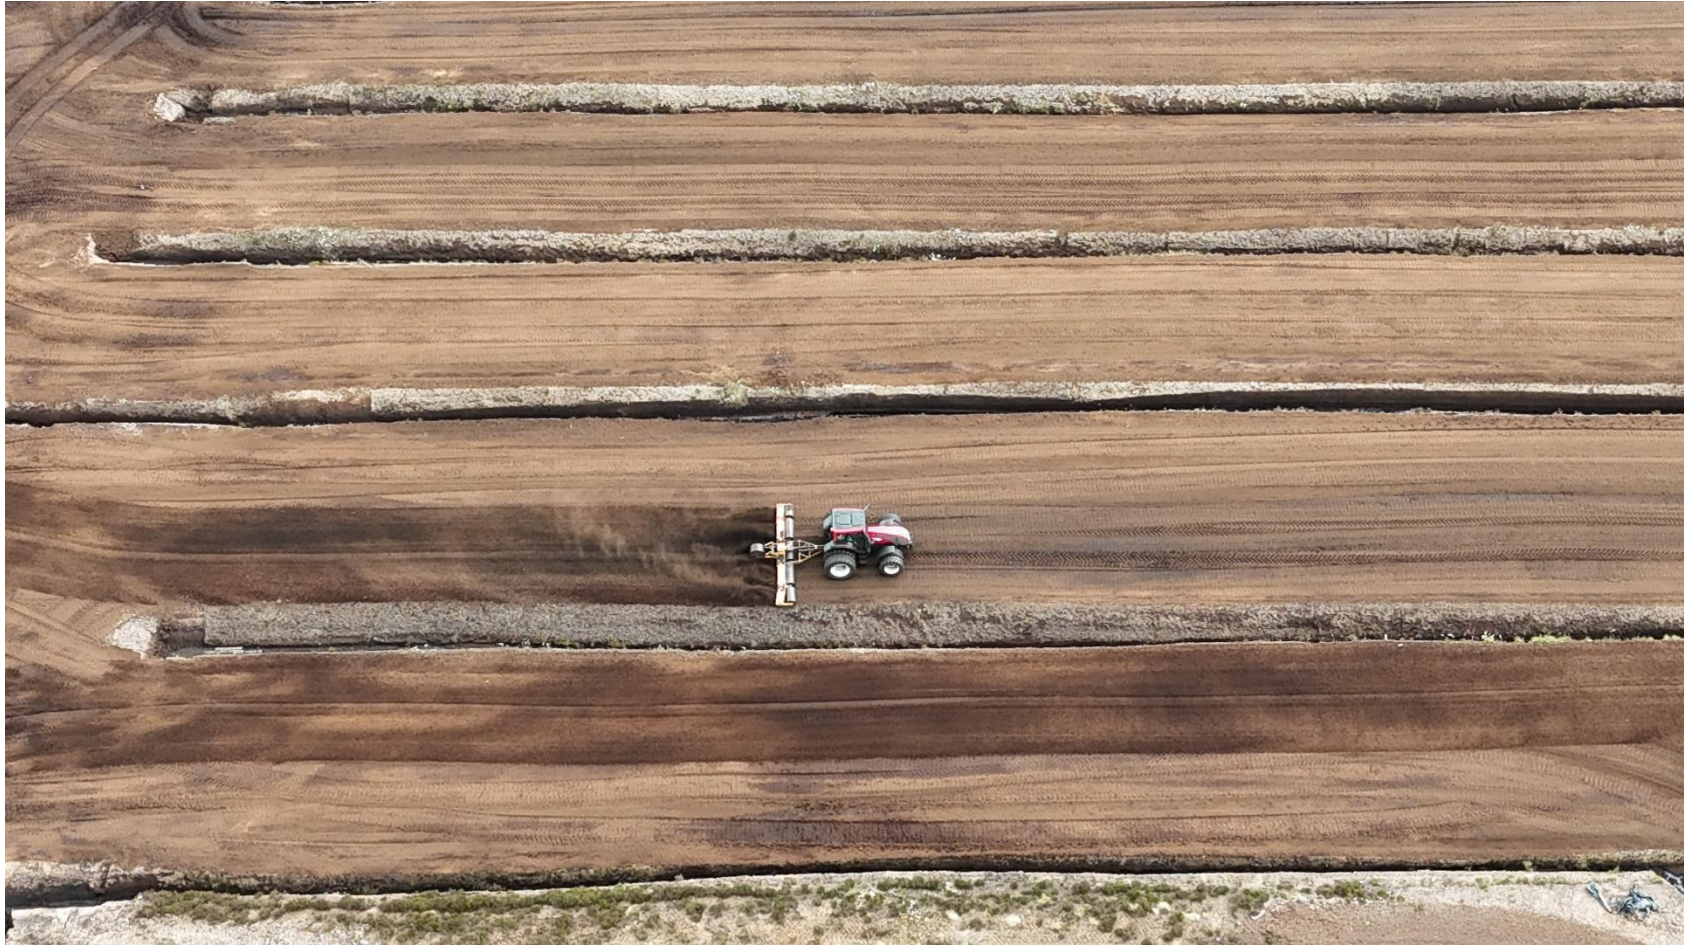
**Photo 5: Milled peat extraction was noted during the visit.**

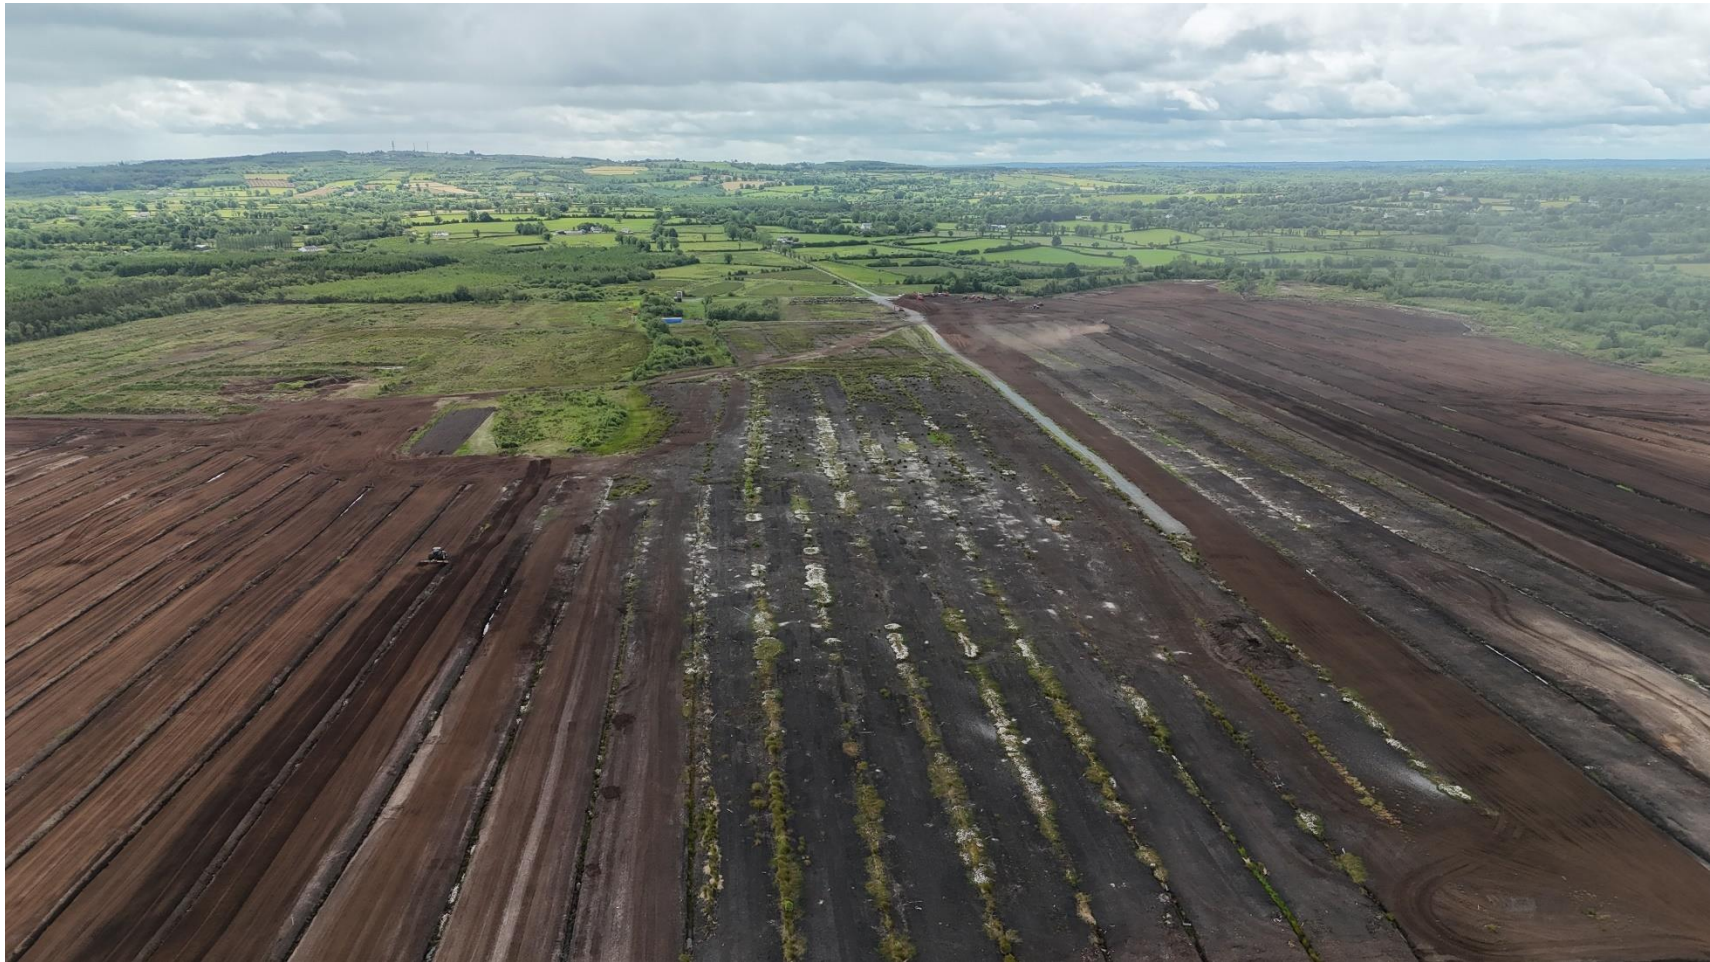
**Photo 6: Milled peat extraction was noted during the visit.**

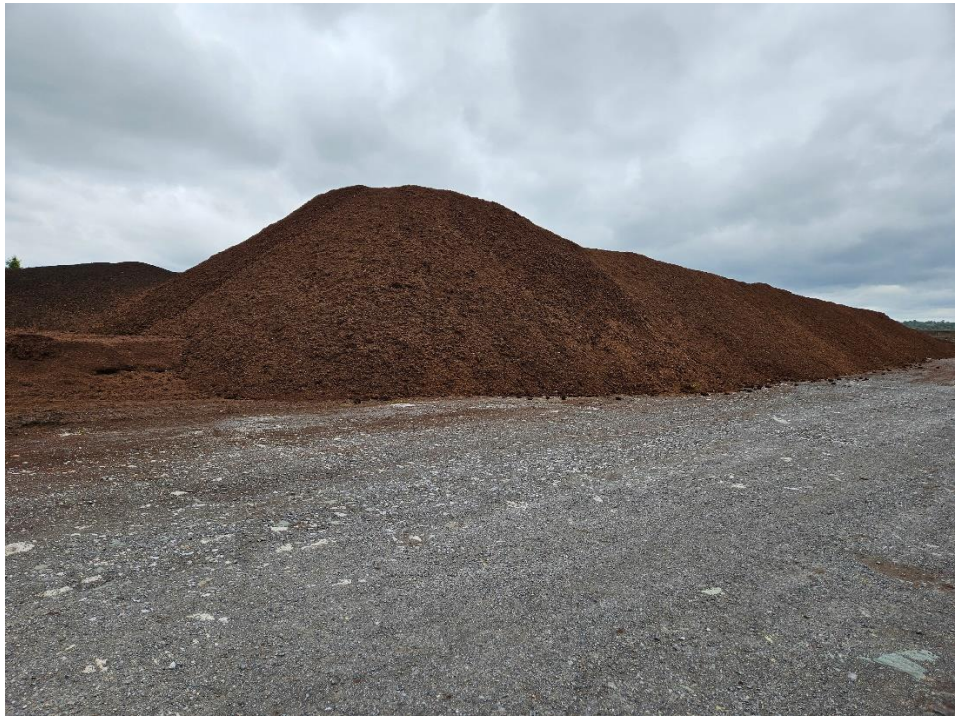
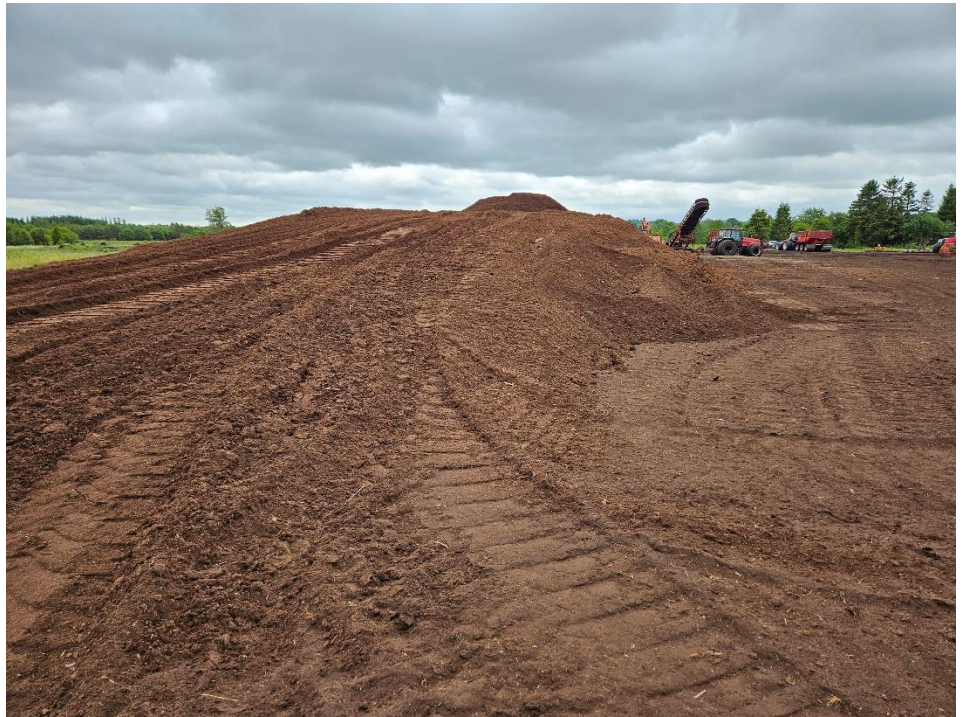
**Photos 7 & 8: Significant stockpiles of milled peat at the loading area at the Southern part of the peatland.**

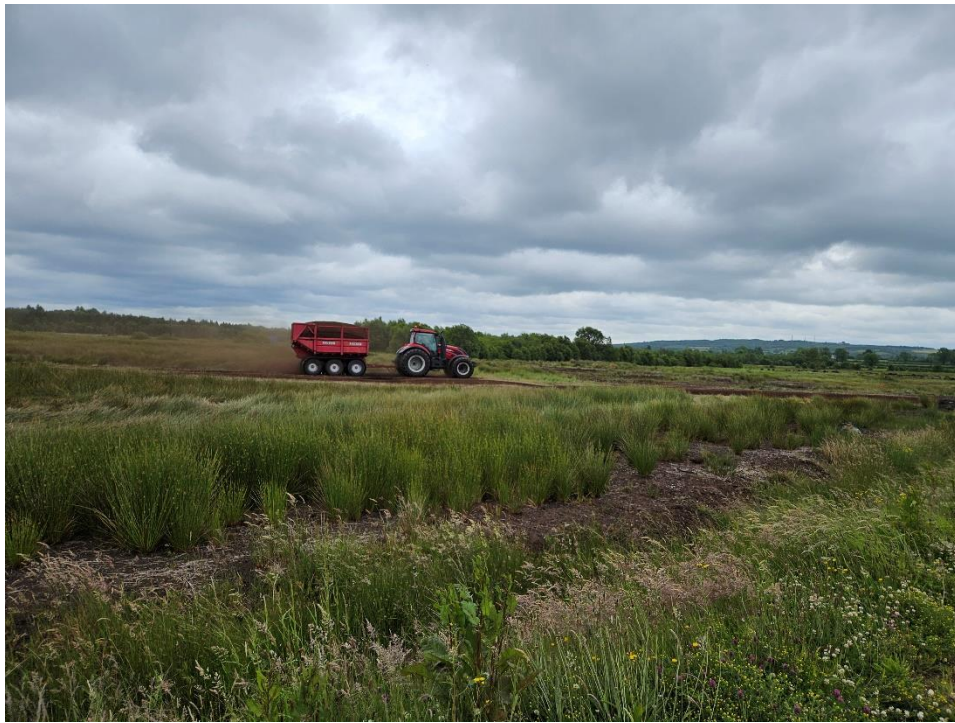
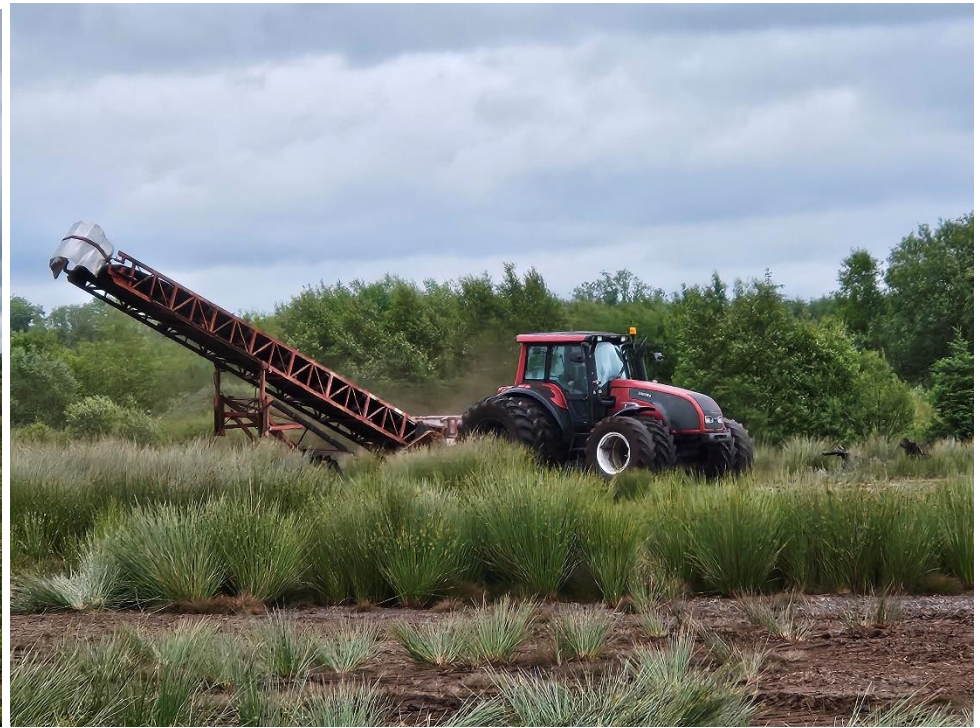
**Photos 9 & 10: Machinery for the collection and transport of milled peat noted during the visit.**

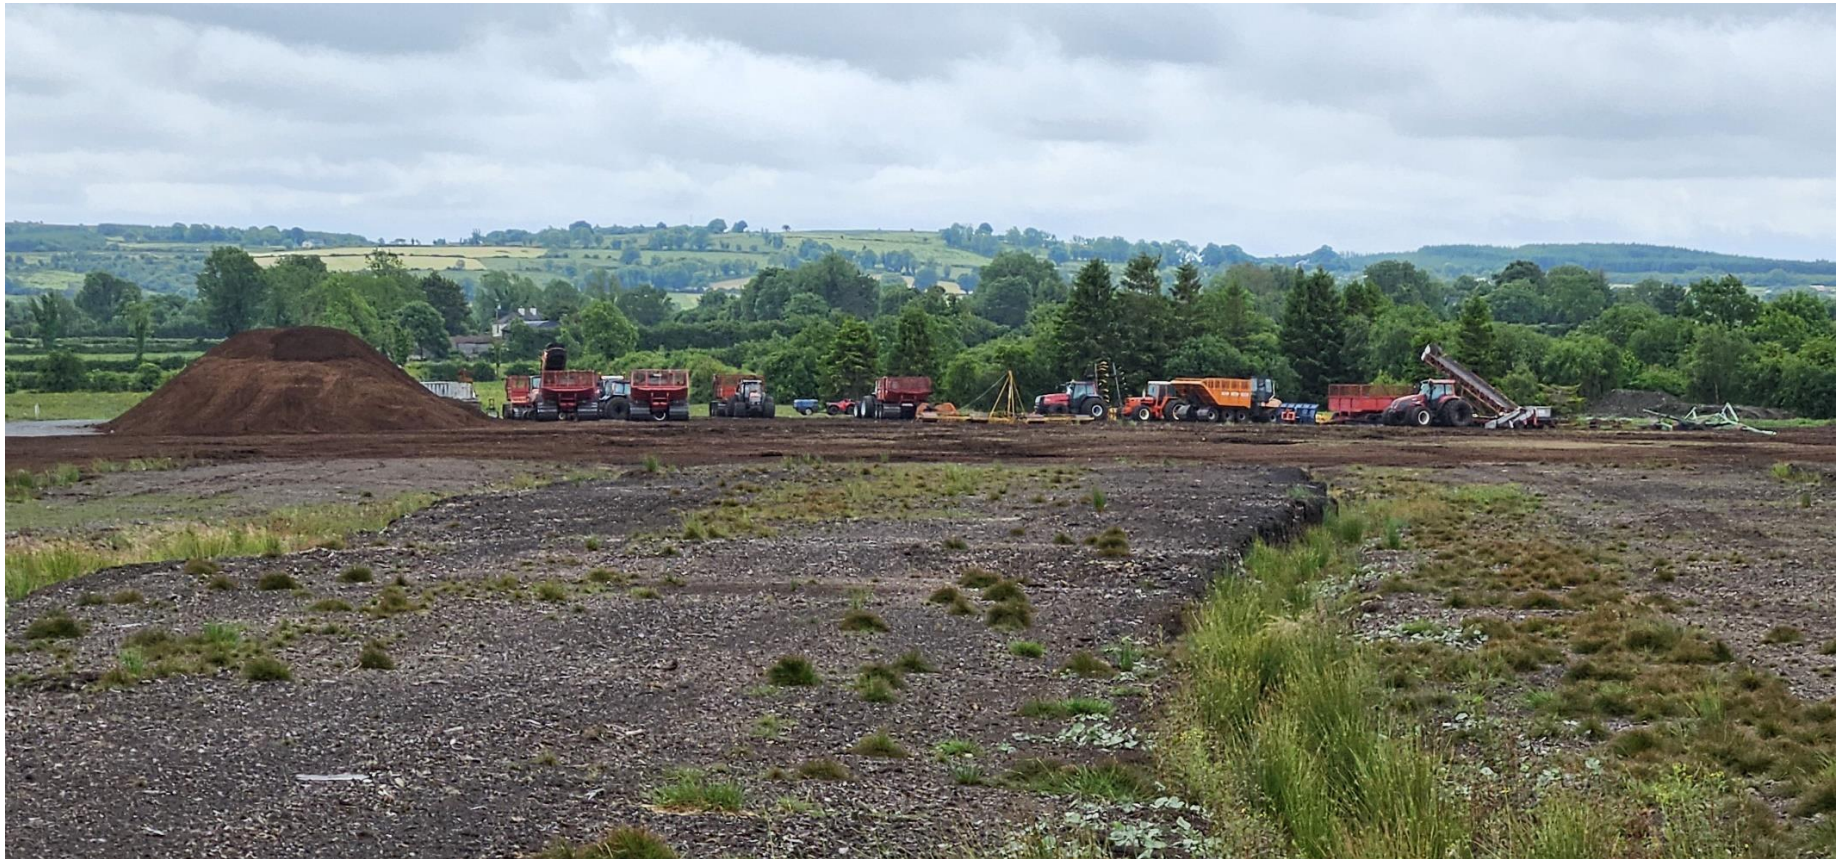
**Photo 11: Machinery and equipment for milled peat extraction noted at/adjacent to the loading area, note stockpiles of milled peat also.**
