St Cleran's Priority Area for Action

Kilcolgan_030

Section 4 Discharge Referral

| Document No. | Kilcolgan_030_GCC_RFL_F01 |

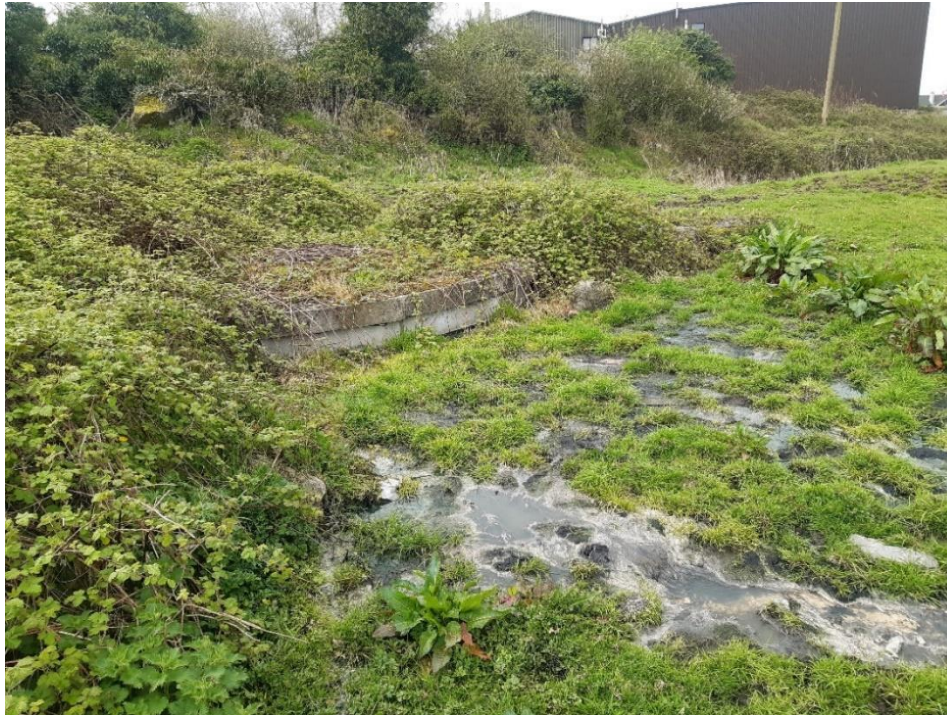
A catchment walk from the monitoring station in Craughwell to approximately 300m upstream, identified a serious waste water issue on the south side of the Kilcolgan_030, at the back of the Dún Ard housing estate. Waste water effluent was observed flowing from a concrete tank that is buried in the ground and that has mostly been grown over by scrub and briars (see Figure 3Error! Reference source not found.). This waste water treatment system was granted a Section 4 discharge licence (W410/06) at the time of development, but it is not operating sufficiently and does not appear to have the capacity to receive and treat the volume of waste water currently being collected from the Dún Ard housing estate. The greyish and odorous effluent flows downslope from the concrete tank

Figure 3: Section 4 discharge licence W410/06 at the back of Dún Ard housing estate from which waste water effluent flows

If the overall ecological status of the Kilcolgan_030 is to improve sufficiently to meet its WFD objective, the ongoing waste water issue related to the Section 4 discharge licence W410/06 must be resolved given its close proximity to the operational monitoring station in Craughwell. This, in addition to improvements in the hydromorphological condition of the river following the flood relief works and improvements at Loughrea WWTP, should result in improvements in water quality.

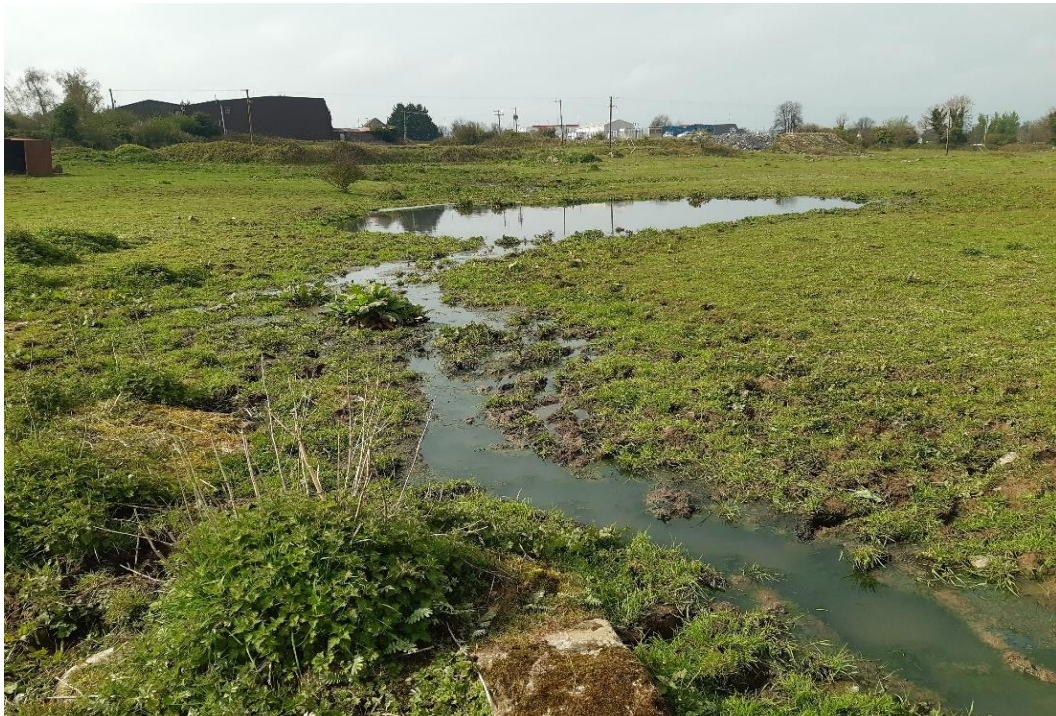
towards the Kilcolgan_030, with sewage fungus observed on the ground where it flowed. The effluent forms a pond in the field at the back of the Dún Ard housing estate, approximately 70m from the river (see Figure 4 and **Figure 5** for location). The effluent continues to flow from the pond towards the river and appears to soak into the ground beside an area of scrub and forestry adjacent to the river (**Figure 6**). The lowest point in the field which is directly adjacent to the river also appears to be an area where effluent could be washed to during wet weather and where it would either soak into the ground or be washed directly into the river during flood events (**Figure 7**). This site would be re-visited during a heavy rainfall event to determine if there are pathways for effluent to directly enter the river.

Figure 4: Effluent pond formed in the field at the back of Dún Ard housing estate by the waste water flowing from the Section 4 discharge licence W410/06; note that the effluent continues to flow towards the Kilcolgan_030 from this point

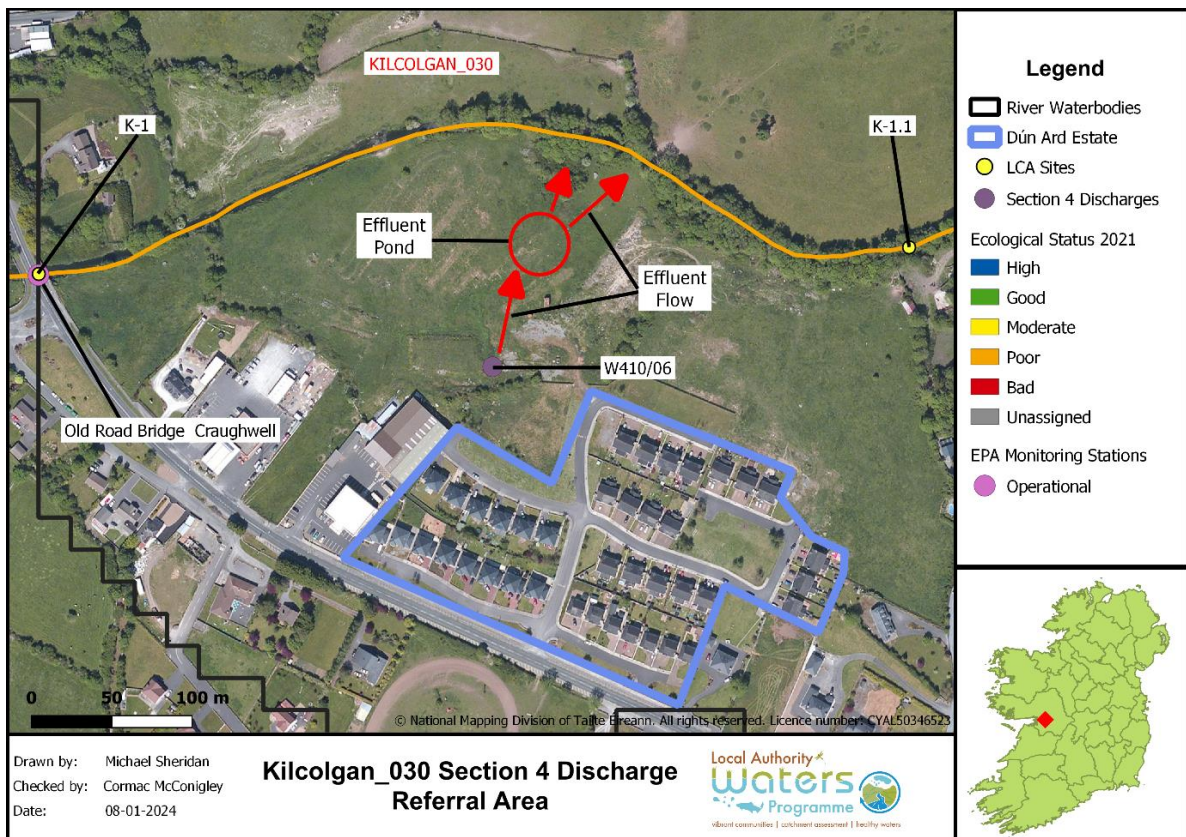
Figure 5: Location of the Section 4 Discharge Licence W410/06 and the flow of waste water effluent towards the Kilcolgan_030

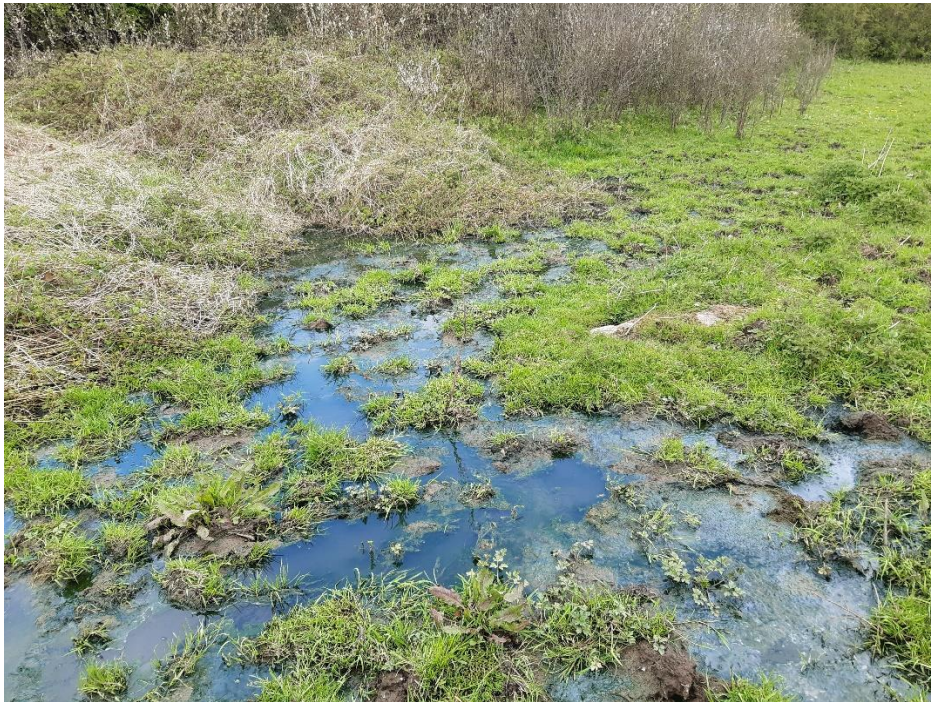
Figure 6: Most effluent that flows from the pond appears to soak into the ground beside an area of scrub and forestry adjacent to the Kilcolgan_030

Although no direct pathways for waste water effluent to enter the Kilcolgan_030 were observed during LCA, diffuse pathways may be resulting in the input of the organic discharge to the river where ponding occurs in saturated areas adjacent to the river. Nutrients, particularly phosphorous, may therefore be leaching through the soils without much attenuation and transiting the 5 – 40m into the river via groundwater depending on where the effluent leaches into the ground. The impacts of this would be heightened during dry periods when a greater proportion of flow in the river is provided by groundwater and when nutrient loads aren't being diluted to the same degree, resulting in eutrophication. It was observed during LCA that the lowest point of this field, which is directly adjacent to the river, is susceptible to flooding (**Figure 8**). The EPA pollution impact potential (PIP) maps indicate this area is at high risk of phosphorous loss to the river via overland flow as it is PIP rank 2. The soils

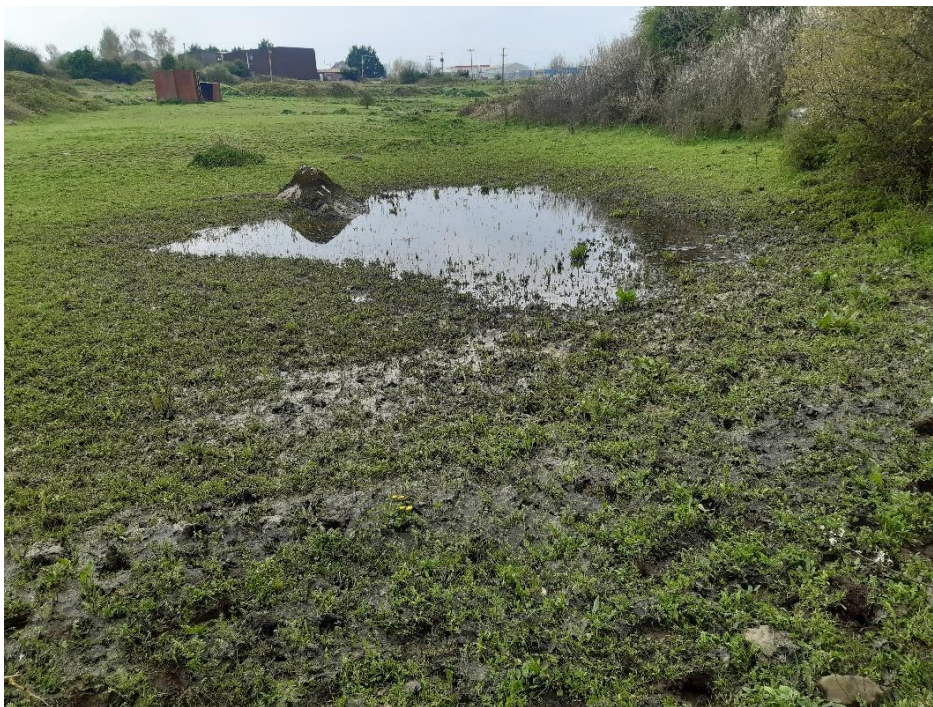
Figure 7: The lowest point of the field which is directly adjacent to the Kilcolgan_030 and where it appears effluent is washed down to during wet weather; photo taken in April 2023

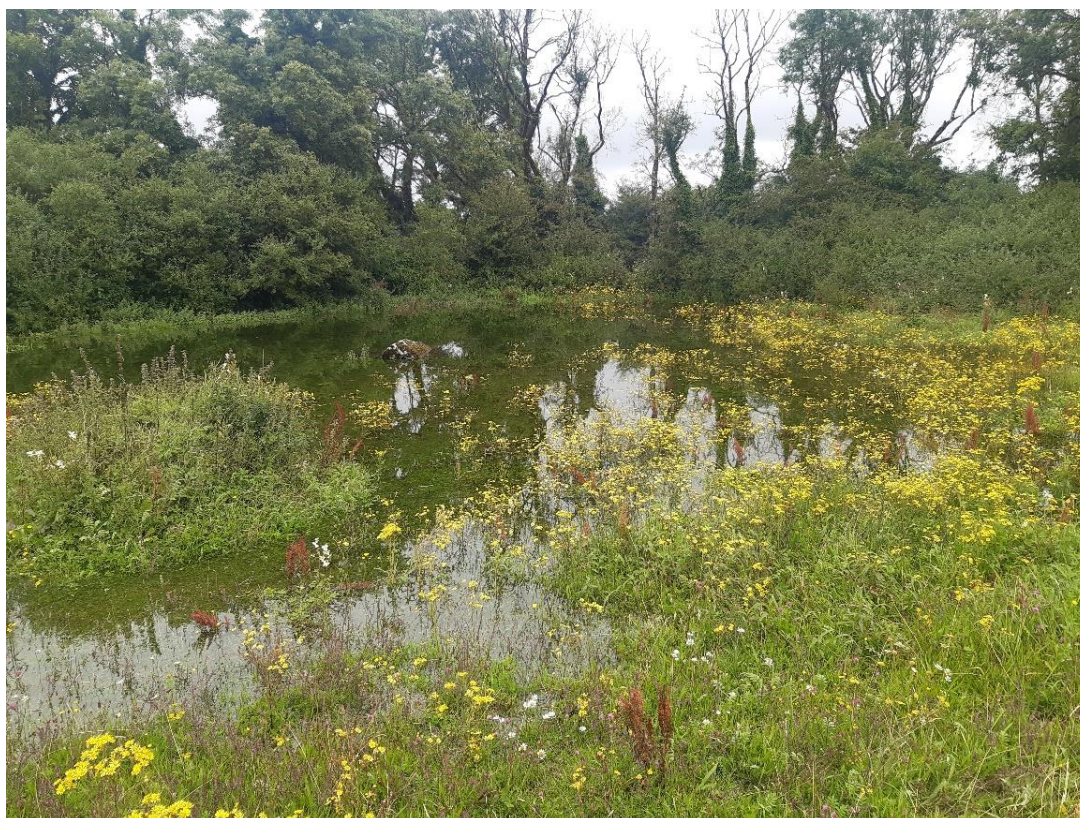
Follow-up LCA after heavy rainfall was carried out in July 2023 with a repeat of the catchment walk that was carried out in April 2023 between LCA sites K-1 and K-1.1, with physico-chemical sampling at these sites in addition to sites K-2 and R-1. The Kilcolgan_030 was in flood, and it was not possible to enter the river or observe macroalgal coverage at any site on the day, but presumably most macroalgae would have been washed away. The waste water effluent from the concrete tank in the field at the back of the Dún Ard housing estate continued to flow at a similar rate to what was observed previously. From the pond that had formed in the field, effluent continued to flow into the area of scrub and forestry adjacent to the river. The lowest point in this field, which is directly adjacent to the river was now flooded, and effluent was observed trickling down to this point from the effluent pond (**Figure 8**). No surface pathways for the transport of effluent directly into the river were observed in this area; an embankment along the river was high enough to prevent run-off on the day, however, a more prolonged period of heavy rainfall would likely result in the embankment being breached.

Figure 8: The lowest point of the field which is directly adjacent to the Kilcolgan River and where effluent was observed trickling down to from the effluent pond in July 2023
