Acute Water Incident Report – DAFM, Forestry Division, Environment Section

Affected EPA waterbody	OW_020

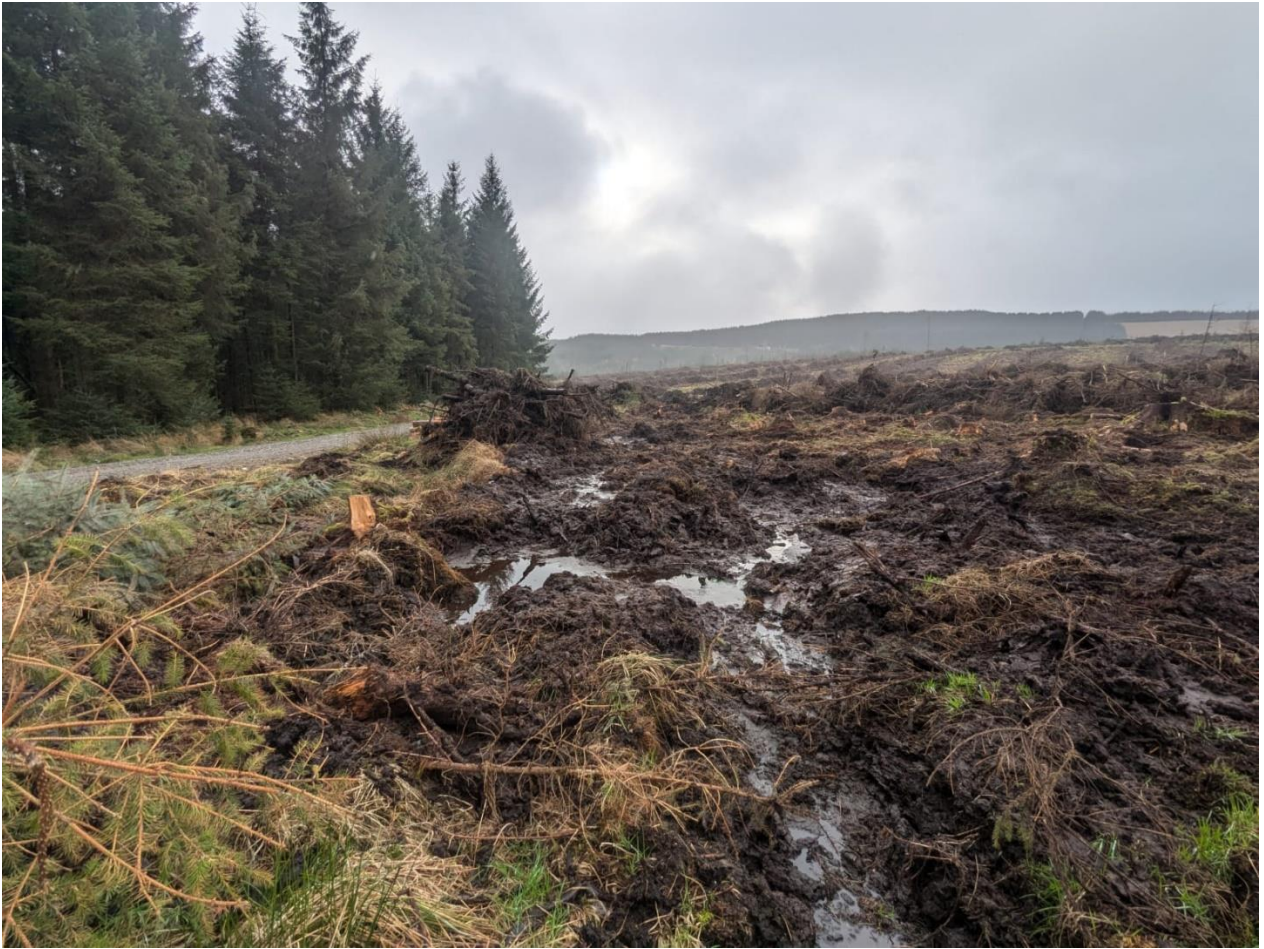
Image 14: Very poor ground conditions around stacking area. Overland flow occurring.

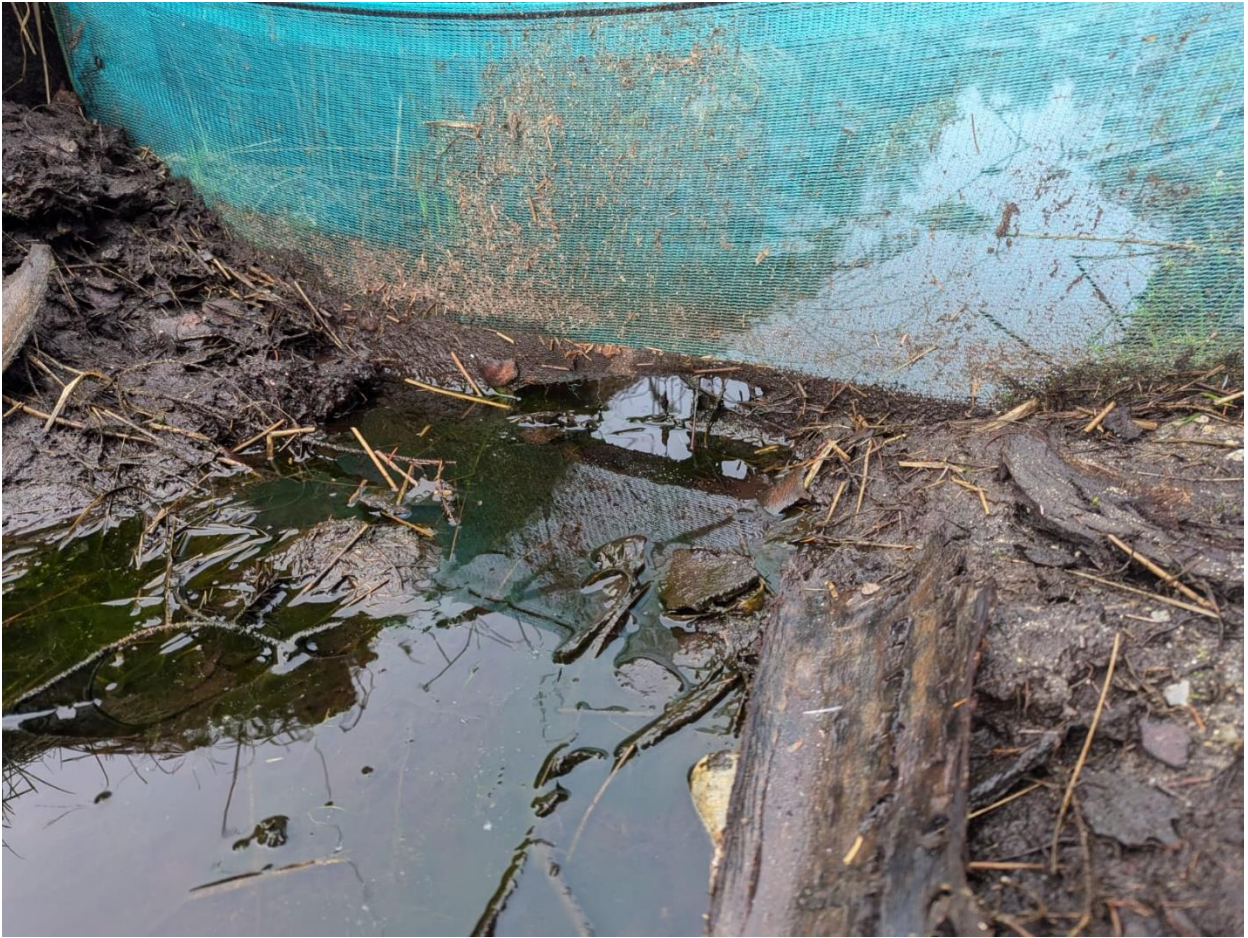
Image 15: Hole punched through sediment trap. Sediment visible beside trap.
