Environmental Emergencies/Incidents Summary 2021

Emergency Response Procedure

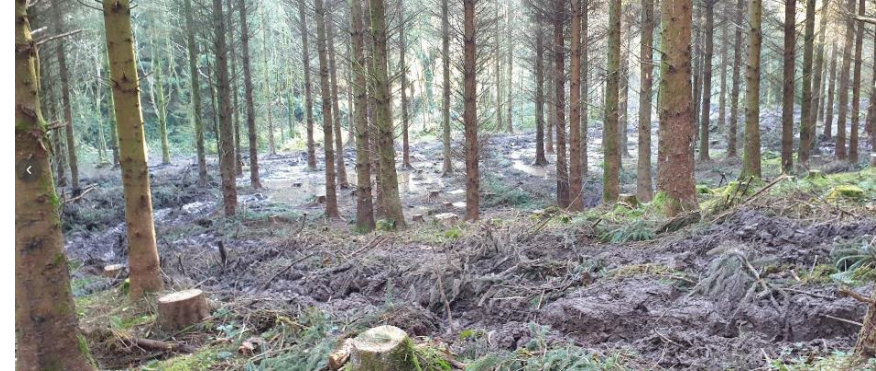
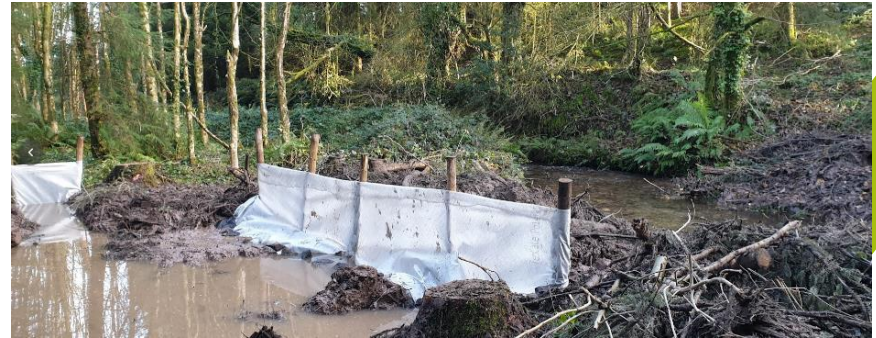
- **Issue:** Subsequent thinning that resulted in the alleged siltation of the adjacent river
- **Significance:** 8/10
- **Background:** IFI inspector visited the site on foot of a anglers compliant of discolouration of the river

- **Root Cause:**
 - Experienced forwarder operator did not follow best operational practice and direction from the Harvesting Forester in relation to the protection of soils and water.

- **Environmental Issues Identified:**
 - Siltation of the Glenaboy River river
- **Recommendations:**
 - **Site Pack** - turn Soils and Water section to BLUE due to hydrological connectivity to the Blackwater River (Cork/Waterford) SAC 1.9km d'tream.

- **Maps** - Aquatic zones to be shown better on the map, better map scale for the thinning operations and the definition of the raster detail background.

- **Timing of Operations** - consideration should have been given to completing this operation during the Summer months
 - **Discussion with contractor on sub-optimal forest mgt practices** - inadequate utilisation of brush on the main extraction racks and at the location of bridge crossing, protection of watercourses, communication with FWM to flag site issues with site and identification of additional mitigation options, cessation of works , if deemed necessary, and follow instructions issued in the Harvest Site Monitoring forms.

- **Monitoring** - Ongoing monitoring of silt traps to ensure that they are effective and identify weak spots that may need to be addressed with further installations as required.

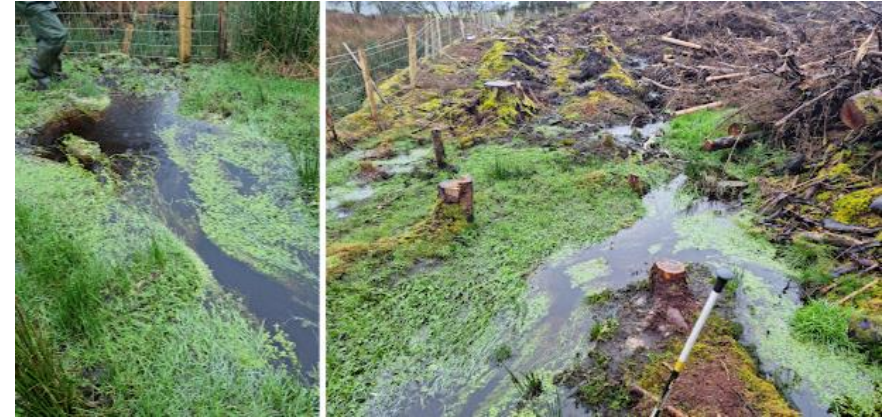
- **Issue:** Forest operations causing an alleged water pollution incident
- **Significance:** 8/10
- **Background:** Section 12 Notice under the **Local Government (Water Pollution) Act, 1977** issued **by** Leitrim Co. Council to BAU 1

- **Root Cause:**
 - Implemented mitigation measures were sub-optimal in portions of this very wet site.
- **Environmental Issues Identified:**
 - Harvesting debris and uncontrolled overland waterflow by the Derrynahimmirk river in high flow conditions over portions of the site.

- **Recommendations:**
 - A new silt curtain was put in place at the end of the drain created to carry the water from neighbouring property through the South East end of the site. A log damn was also placed in this drain to help trap any heavy silt or branches.

- New silt curtains have been installed at the end of ploughed furrows prior to the water overflowing into the adjacent Derrynahimmirk river.
 - All loose brash and debris have now been removed from the stream.

- Water samples were taken where the water entered our lands and where they left (awaiting full results)

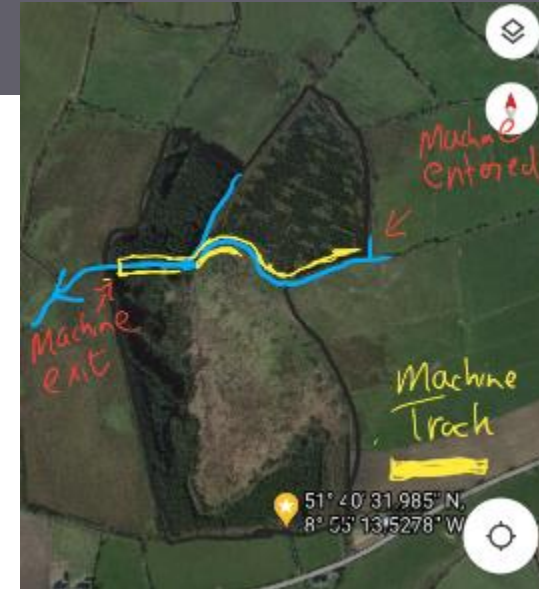
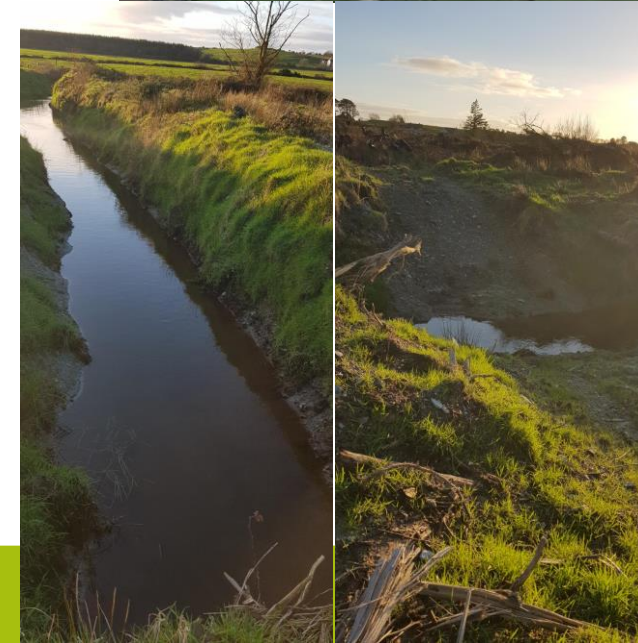
- **Issue:** Un-authorized aquatic zone stream clearance works though Coillte's land
Significance: 7
- **Background:** Establishment contractor alerted the Establishment Mgr of un-authorized stream clearance of spoil and vegetation from the stream on a 2021 establishment site
- **Location:** CK25, Knockskagh
 - Size of impacted area: N/a
- **External Reporting:**
 - Reported to BAU 6 by establishment contractor
- **Root Cause:**
 - Un-authorized activity
- **Environmental Issues Identified:**
 - Machinery movement in the AZ sets backs dug out spoil and vegetation from the stream
 - The machine dug the banks in two different places to cross through the stream which has resulted in some of the Coillte site access paths being blocked
- **Recommendations:**
 - Under investigation by BAU 6 and Environment Officer

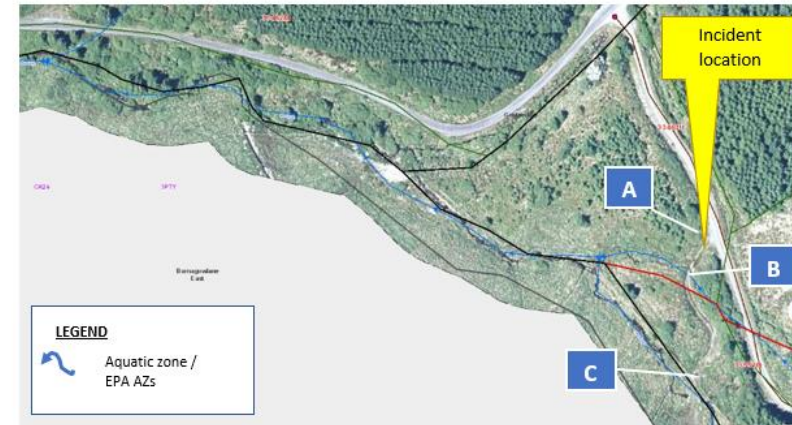
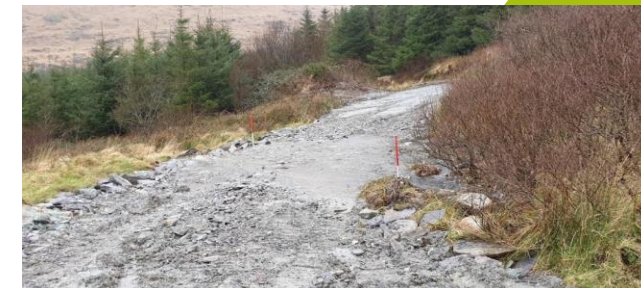
- Unsanctioned extension of a ROW, installation of a water crossing point and development of turning area

- The work includes depositing construction material to build up a direct crossing of an aquatic zone (EPA Order 1) that is a tributary of the Mealagh river.

Map 2 - Satellite image of Barnagowlane. Source: BlueSky Orthon 2016-2020 Coillte. A is where the ROW starts, B is the actual water crossing and C is the turning area.

- Establish with Coillte Legal section, who has the legal rights over the ROW.
- Contact the adjoining landowner who had approached Coillte about carrying out proposed works to see if they have knowledge of same and note the response.
- Based on the response from adjoining landowner, revert to Coillte Legal section to seek advice as to whether to proceed with a legal response or not.
- Notify the relevant regulatory authorities, i.e. Inland Fisheries Ireland of the incident.

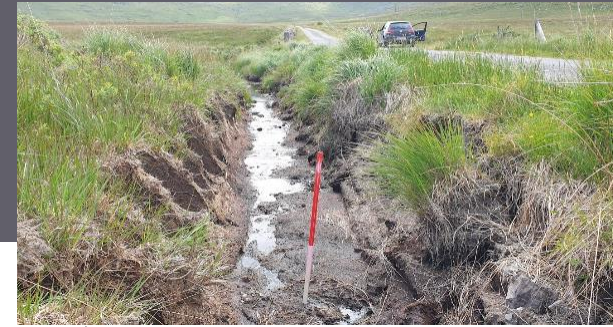
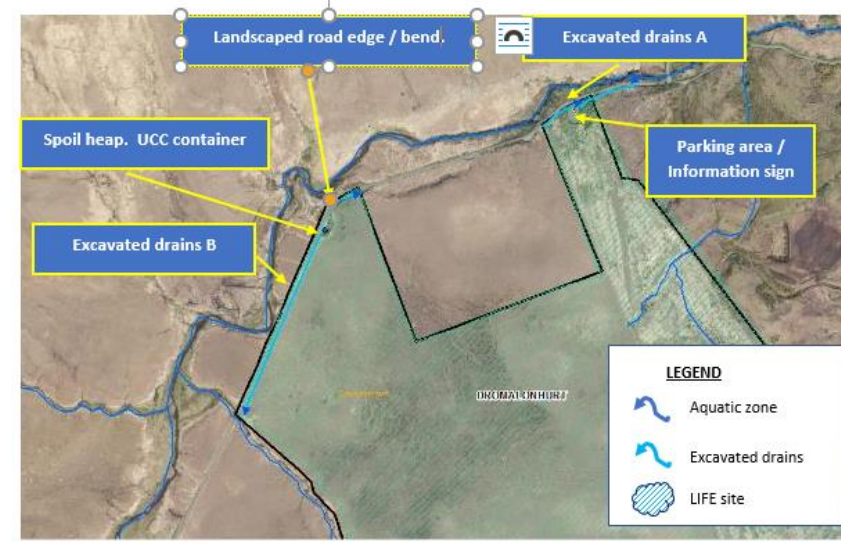
- **Issue:** Unauthorised roadside drainage works adjacent to EU Life Dromalohurt Bog in Co. Kerry.

- **Background:** Roadside drains have been excavated adjacent to the EU-LIFE Nature site of Dromalohurt Bog in Co. Kerry.
- **Location:** B6, KY09, Dromalohurt, Co. Kerry (~470m)
- **External Reporting:**
 - Reported to AO'S by an interested stakeholder on the 12th June 2022
- **Root Cause:**
 - Excavation of drains adjacent to the county road on Coillte lands by a 3rd party without notice
- **Environmental Issues Identified:**
 - IpNHA and is classed as High Conservation Value Forestry (HCVF).
 - BioClass rating 2 with a potential rating of 1
 - Top 8 FWPM catchment, there is a population of mussels 2.7km downstream
 - [LIFE02NAT/IRL/8490 project](#) - Active Blanket Bog Restoration in Ireland that ran from 2003-2007 Dromalohurt Bog (101.9 ha)

- **Recommendations:**
- **Communications**
 - Establish who the 3rd party was that is responsible for the work.
 - Follow up communications with the 3rd party to convey the importance and location of the LIFE project – site meeting required.
 - Inform NPWS of unsanctioned work.
- **Assessment:**
 - Ecologist with expertise in Blanket bog to assess the impact of the work and if mitigation measures are required.
- **Operations:**
 - Short term - Install silt traps in the drains.
 - Medium term – follow up on mitigations recommended by contract ecologist.

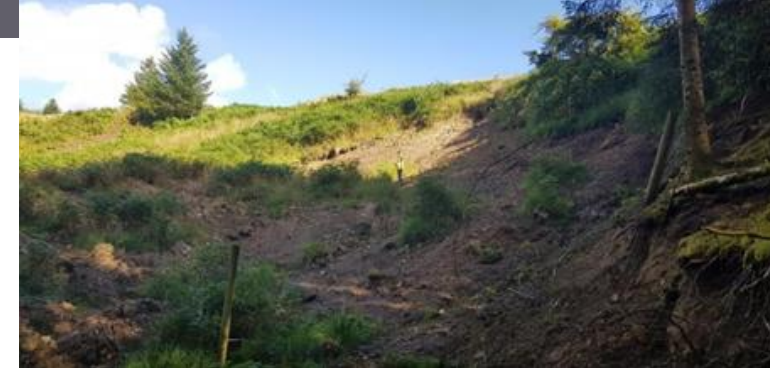
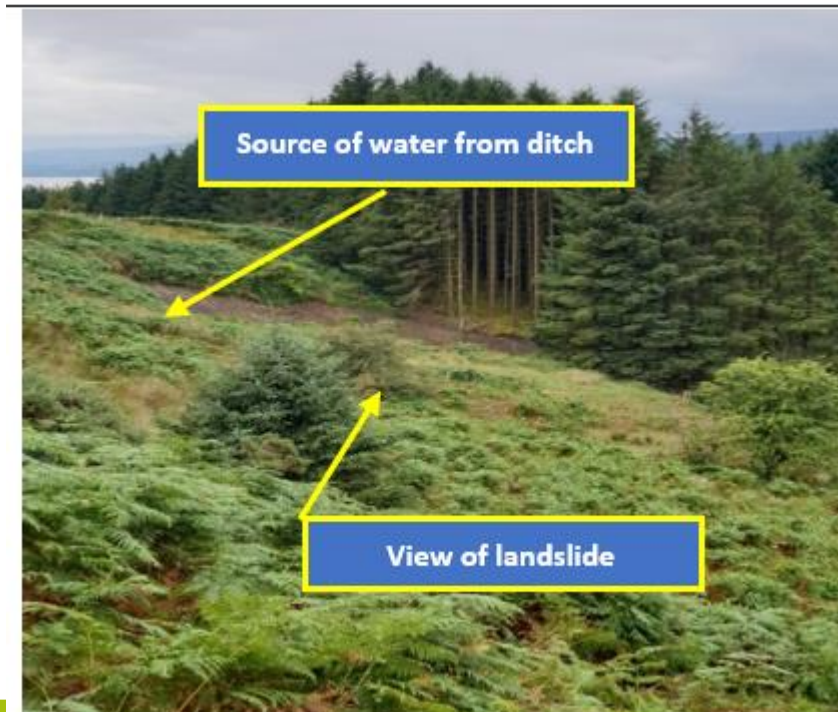
- **Issue: Landslide leading to silt run-off**
Significance: 3/10
- **Background:** Local stakeholder notified Coillte in October'21, followed by another stakeholder in the August 2022

- **Root Cause:**
 - Landslide originating outside of Coillte land after a heavy rainfall event - spoil from the landslide entered the headwaters of the Yellow River

- **Recommendations:**
 - Short-term:
 - Notify Inland Fisheries Ireland (IFI), Leitrim County Council (LCC) and Forest Service (FS) notified in November'21

- Co-ordinated site visits by FS-DAFM and IFI
 - Implement mitigation works as agreed with IFI in November'21 as complimentary assistance to protect the water courses.

- Medium term:
 - BAU Harvesting team to assess the possibility of the following;
 - (1) harvesting the site through cable extraction,
 - (2) partial clearance with no extraction or

- (3) long-term retention will all be considered.
 - BAUs will also see about getting external specialist advise, if available.
 - Once a management plan has been drafted local consultation with the statutory and local stakeholders will be undertaken.

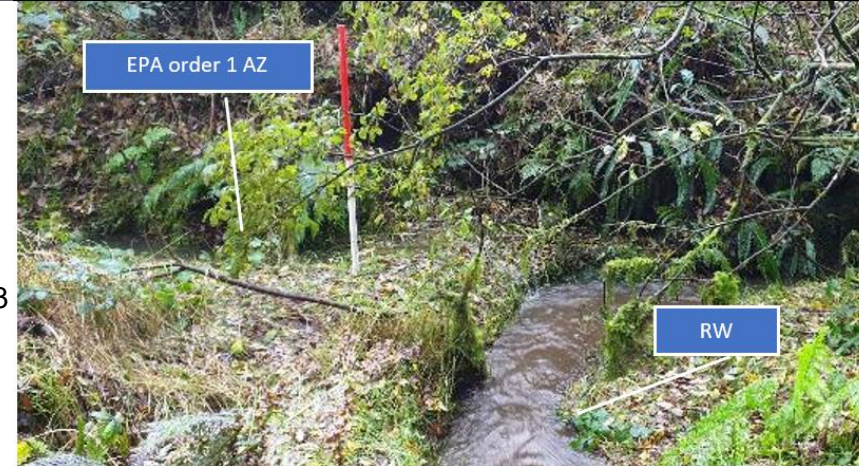
- **Issue: Siltation of aquatic zone during harvesting (2nd Thinning)**
- **Significance: 10/10**
- **Background:** Routine inspection by IFI inspector when above issue noted

- **Root Cause:**
 - The combination of heavy rain, a poorly maintained main extraction rack and the removal of a temporary log crossing point caused debris and silt to ultimately discharge into adjacent aquatic zone

- **Key Environmental Issues Identified:**
 - Poorly maintained main extraction rack
 - Poor removal of a temporary log crossing over a deep drain causing debris and soil to enter the drains that were connected to the RW and the AZ.

- **Key Recommendations:**
 - Ongoing monitoring of the silt traps until the site has dried and the risk is averted.
 - Forward driver to attend ERA Refresher training & re-circulate the Brash Management Guidelines to Harvesting operators.

- Better communication between harvesting operators, main contractor and forest works manager when a site starts to go awry to seek further instruction.

- Raise the awareness of harvesting operational staff of the risks posed by the more frequently occurring downpours that are occurring.
 - More appropriate methods of deployment of temporary crossings to be agreed between harvesting contractor and harvesting team when crossing deep drains, i.e.

- deploy a heavy-duty plastic culvert lengthways into the drainage channel and cover with brash material rather than use a temporary crossing point using logs.

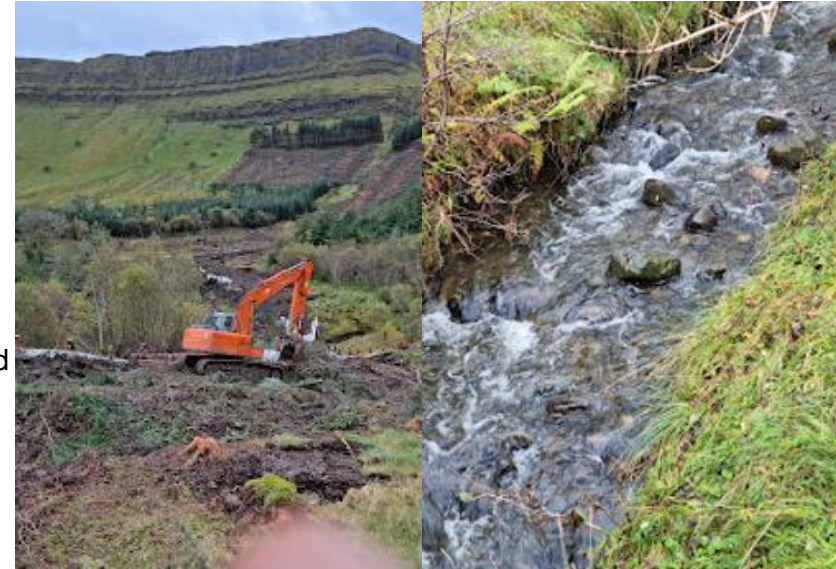
- **Issue: Siltation of aquatic zone during harvesting (Clearfell)**
- **Significance: 10/10**
- **Background:** Inspection by Co.Co. on foot of stakeholder compliant

- **Root Cause:**
 - Dry drain started to carry water from a previously unknown underground water source following a severe rainfall event leading to silt/sediment release into the Black River

- **Key Environmental Issues Identified:**
 - 13.5ha clearfell, gley soil type.
 - Slope is moderate on the lower section of the site but becomes steep towards the south to southwest portion.

- **Key Recommendations:**
 - Ongoing monitoring of water flow, check efficacy of silt traps and maintain same when required.
 - Recommence forwarding operations as soon as possible to make use of existing brush mats and supplementary brush available on site. Logs available on site will also be used to reinforce the main extraction rack.

- Timing of the operation has had a considerable influence on the siltation event. Harvesting operations are restricted to the period outside 1st March to 31st August due to possible impacts on nesting birds associated with the Sligo/Leitrim Uplands SPA (Peregrine and Chough). Perhaps more consideration should be given to prioritisation of water sensitive sites while balancing the requirements for the protection of the listed birds.

- Agree further site meetings with representatives from Leitrim Co. Council and the Forest Service to monitor effectiveness of remediation works and take on board any further recommendations.

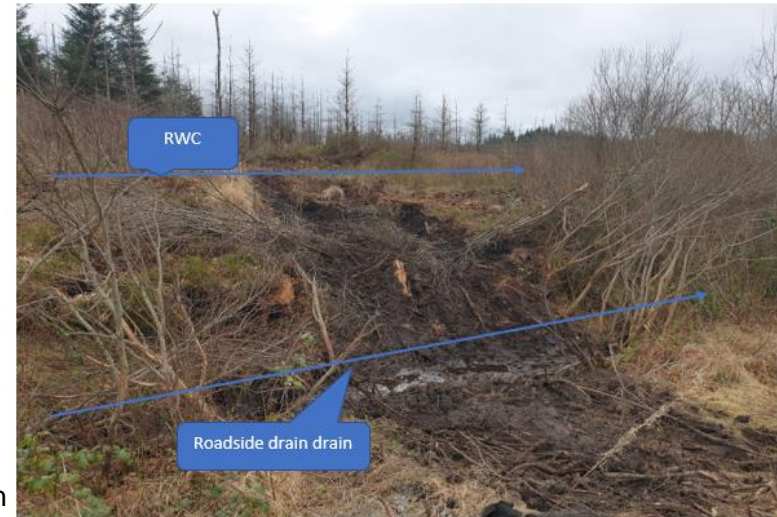
- **Issue: Traversing watercourses (RW, AW and drains) without proper temporary bridging and mitigations in place**
- **Significance: 7/10**
- **Background:** Twitter reports from SL alerted B3 establishment team
- **Location:** B3, LM09 - Pottore Property, Co. Leitrim
- **External Reporting:** N/a
- **Root Cause:**
 - Contractor did not adhere to standard mitigations and site monitoring was not adequate to pick up on these non-compliances and address them before site was completed.

- Good planning work was done (deciding not to cultivate and species ch
- Field data collection was carried out and features were recorded for the site pack.
- A lack of understanding by the contractor/operator was evident, despite communication of details in the plan at pre commencement meeting. A tracked excavator traversed over 4 watercourses, including an aquatic zone, without the implementation of standard mitigations.
- The site works were carried out during an unusually dry spell in February 2023, a major factor in preventing a siltation issue.
- Site monitoring needs to be carried out, ensuring standards are met as part of good site management.

- The Establishment team in conjunction with the Environment Manager will undertake to provide further training, guidance and mentoring to the operator/contractor at the earliest opportunity, focussing on crossing point/silt traps.
- Crossing points on sensitive sites need to be agreed and marked on Safety and Environment map in site pack
- Site monitoring of sensitive sites needs to happen, especially where a tracked excavator is working.
- Install silt traps in roadside drain at crossing 1 and at the crossing of RW x 2.
- If access is required at crossing point 5, install the pipe at a suitable point above or below old crossing point.

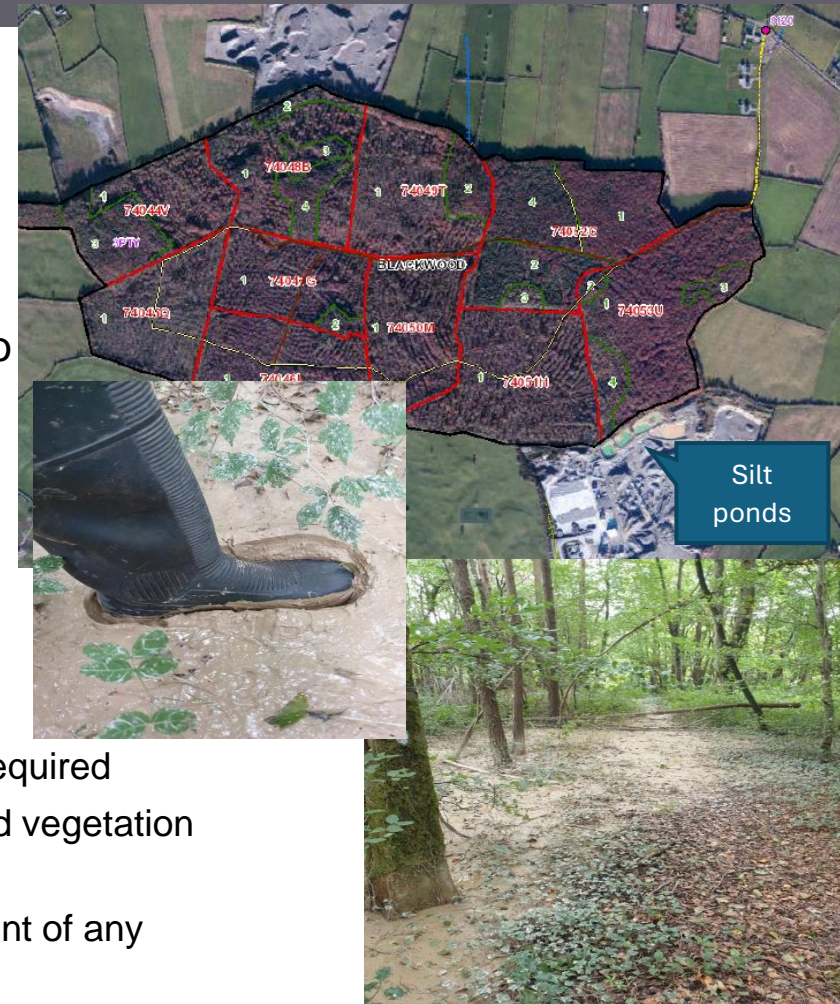
- **Issue:** Silt pond overflow onto Coillte lands
- **Significance:** 5/10
- **Background:** During a period of prolonged heavy rainfall, Kilsaran Quarry silt pond overflowed and a large amount of water carrying silt flowed into Blackwood property.
- **Location:** B3, OY01, Blackwood, Co. Offaly
- **External Reporting:**
 - Member of the public on the 26/9/2023
- **Recommendations (summarised):**
 - Additional mitigation and enhancement of silt pond required
 - A clean up of the deep silt required to allow woodland vegetation recover.
 - A brief operation plan required prior to commencement of any remedial operations.

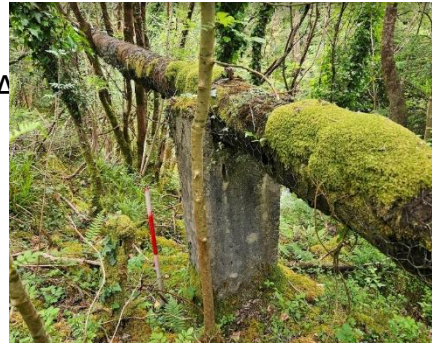
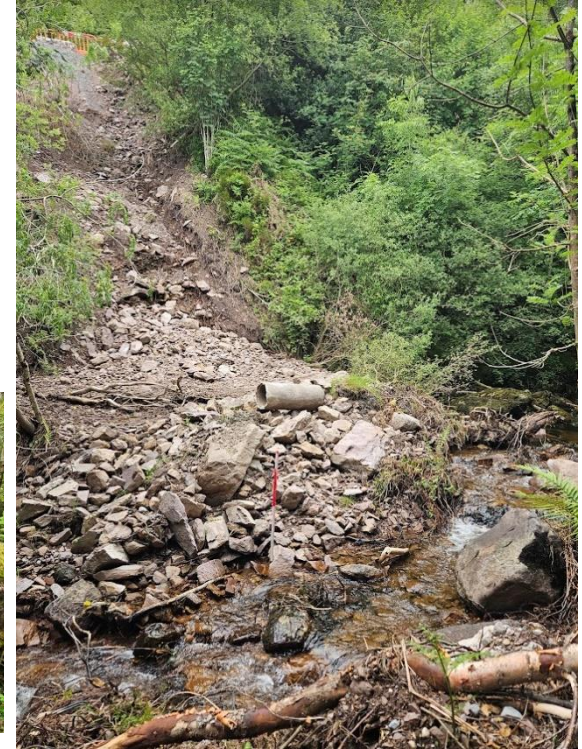
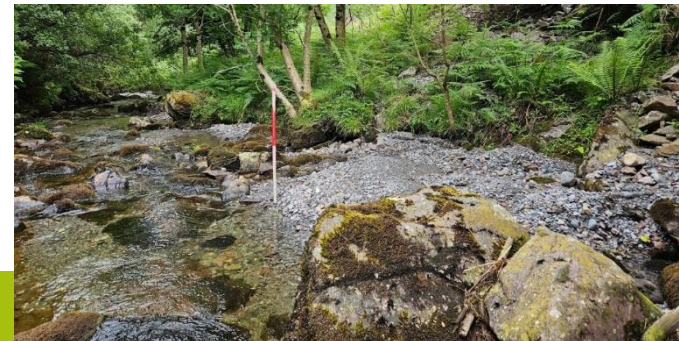
- **Issue:** Burst high pressure water pipe adjacent to an EPA AZ order 2 (May 2024)
- **Location:** B5, TY19, Knockballiniry, Co. Tipperary
- **Background:** Forest road collapse due to a burst water mains (x3) over a period of c. 6 months
- **Significance:** 7/10
- **Issues noted:**
 - Significant volumes of material entering the A substrates
- **External Reporting:**
 - Inland Fisheries Ireland (to be reported)
- **Recommendations:**
 - Draft & agree communications protocol with IFI for reporting of environmental incidents
 - Determine availability of Úisce Éireann GIS network spatial files
 - Request Úisce Éireann to get an aquatic assessment of
 - the potentially impacted headwaters of the Glengalla River

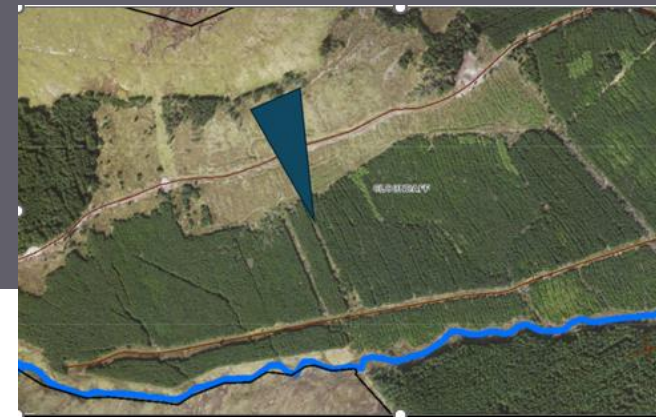
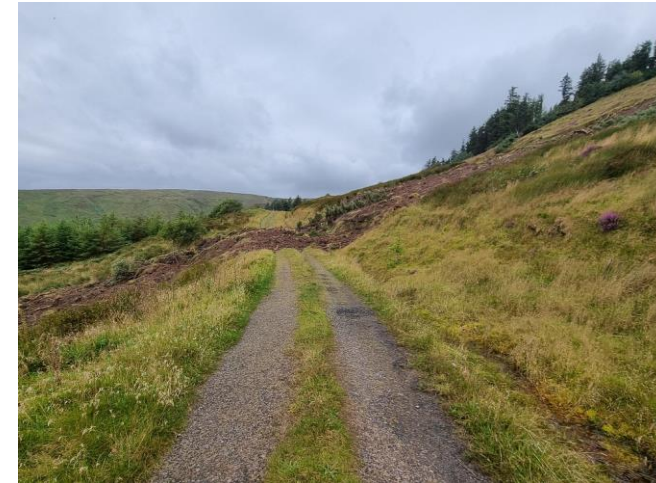
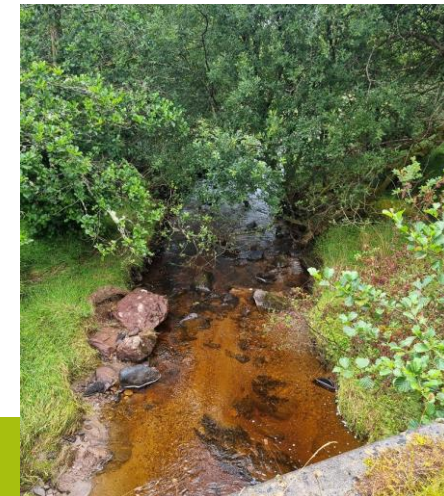
- **Issue:** Landslide (August 2024)
- **Location:** B1, MO19, Cloondaff, Co. Mayo
- **Significance:** 5/10
- **Background:** Landslide 50m wide and 100m long on a peaty podzol (above road) to poorly drained mineral soil (below road) in early August and stopped short of young forest plantation. Silt was not apparent in the downstream AZ. The GSI landslide susceptibility rating for this area is somewhat inconclusive.
- **Issues noted:**
 - Blockage of forest road for 30m
 - Damage to BioClass 4m for grassland & heath
- **Root Cause:**
 - Cause of landslide is not overly apparent from the walk-over survey.
- **External Reporting:**
 - N/a
- **Recommendations:**
 - Clear the forest road – completed
 - Conduct water sampling downstream of the landslide == completed

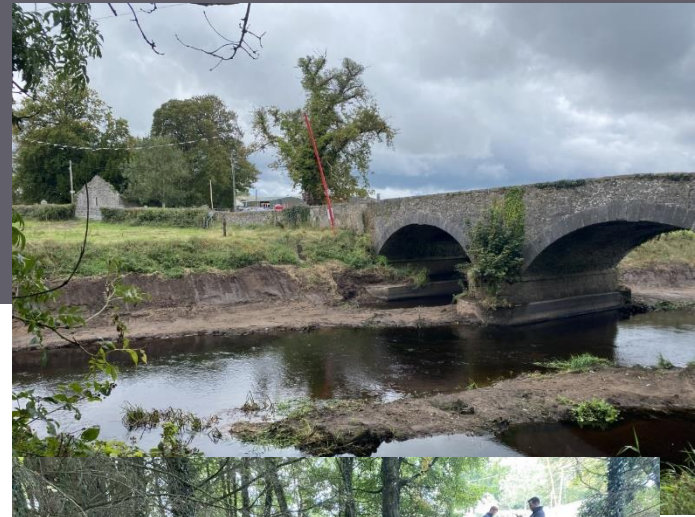
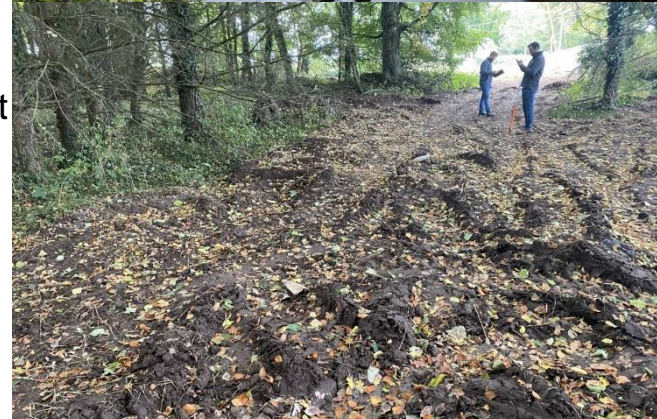
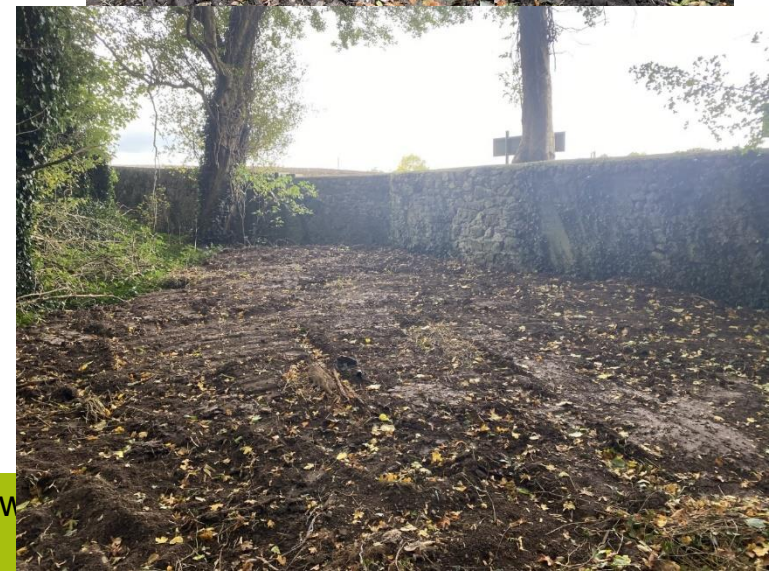
- **Issue: Un-authorized flood relief works (September 2024)**
(May 2024)
- **Location:** B3, OY03, Garryhinch, Co. Laois
- **Background:** Inter agency agreement (IFI, Laois Co Co & Coillte) on flood relief works in August. AA completed. Works progressed without sanction from Coillte & IFI and adhering to AA mitigations.
- **Significance: 6/10**
- **Issues noted:**
 - Deposited silt (c.40cm) deposited on Coillte setback & OWS
 - Site not left in a safe condition for public access
 - Failure of inter-agency agreement
- **External Reporting:**
 - Inland Fisheries Ireland, Laois Co. Co. & NPWS
- **Recommendations:**
 - Remediation plan needs to be agreed between Coillte, IFI and Laois Co. Council
 - Construct berm as agreed and make safe public access to fish.
 - Remedial works to be completed & LCC be billed for these works by Coillte.

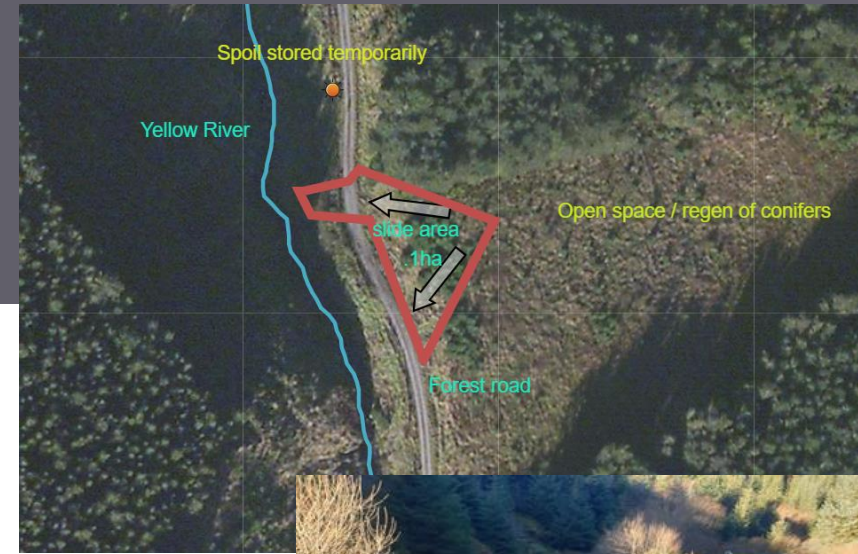
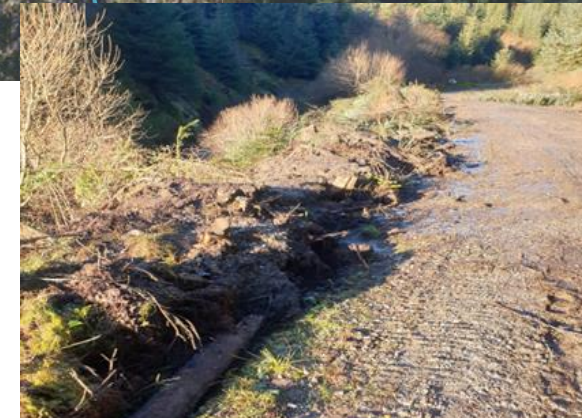
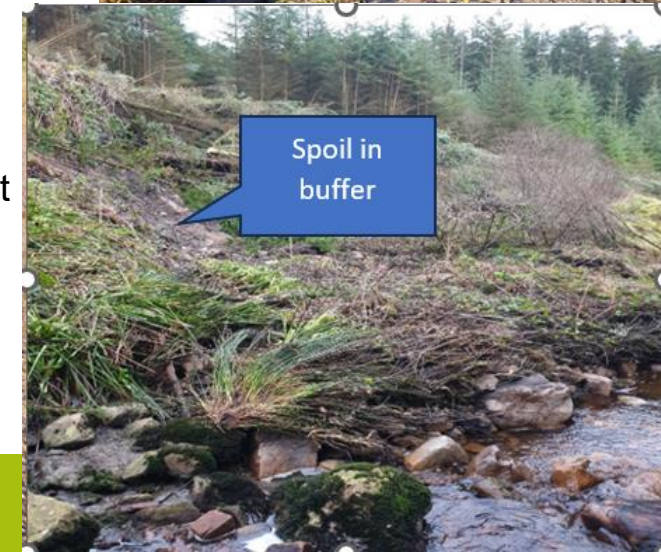
- **Issue:** Landslide (November/December 2024)
- **Location:** B3_LM09_Altakeeran
- **Significance:** Medium
- **Background:** Slide was triangular in shape, c.0.1ha, originating from open unplanted land with nat. regen. The slide moved down a steep bank for 22m onto the forest road that runs in parallel with the Yellow River. Some spoil settled on the riverbank in the setback area.

- **Issues noted:**
 - Local farmers had driven through the slide to access their lands.
 - Spoil temporarily stored at a wider section of road.
 - Spoil slipped into the setback but didn't enter the aquatic zone.

- **Root Cause:**
 - Possible impact from a rainfall event in on 28th Nov'24, equivalent to monthly rainfall amount for this time of year.
- **Recommendations (summarised):**

- All remedial works to be done during dry weather.
 - Install silt mitigation measures in roadside drains.
 - Remove soil from lower side of road and deposit away from site and river.

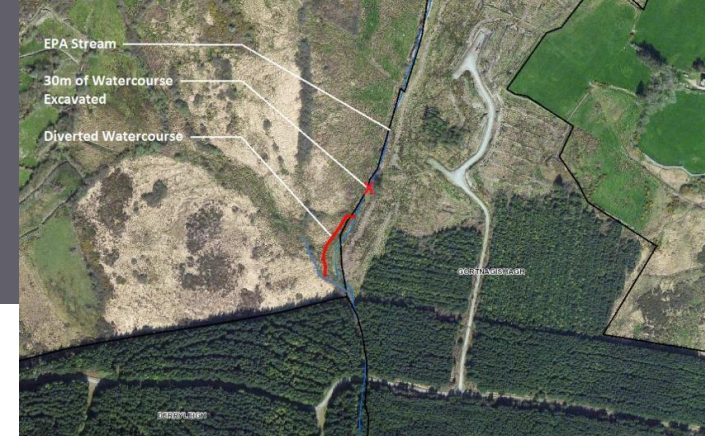
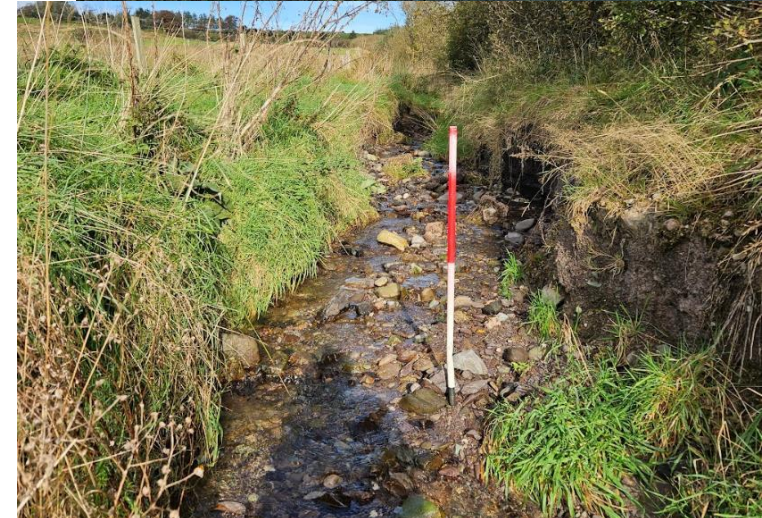
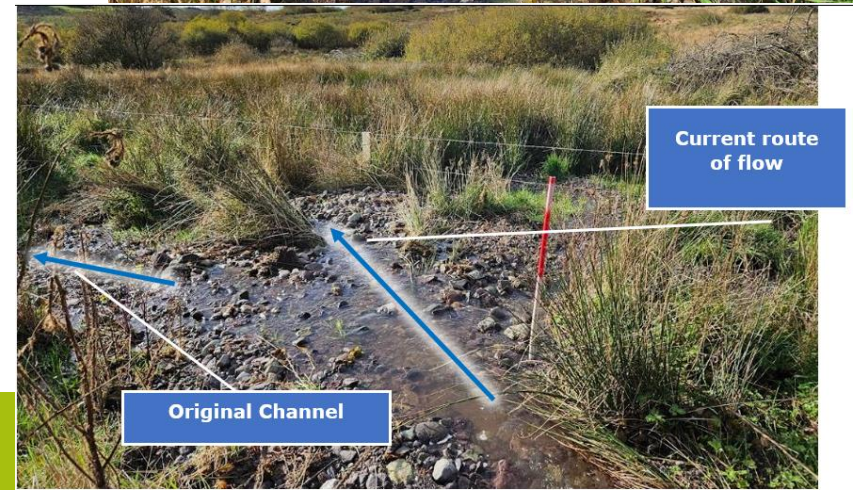
- **Issue: 3rd party non-sanctioned drainage works**
- **Location:** B6_CK11_Gortnagishagh
- **Background:** Request received in Feb '24 that water flowing from Coillte property into adjoining farmer's land be diverted. It transpires the landowner had got a contractor in Nov'22 to excavate a section of the AZ that bounded the two properties, which lead to the diversion of surface water onto his land.
- **Significance: Medium to low**
- **Site Visit Issues Noted:**
 - c. 30m of the stream bank had been excavated & weakened in high flow.
 - Diverted surface water filtered into wetland.
 - Aquatic zone was running clear.
- **Root Cause**
 - 3rd party excavation of EPA Order 1 AZ causing a blow out of gravel and debris that blocked the natural route of the AZ.
- **Recommendations (summarised):**
 - Leave the site undisturbed and monitor intermittently

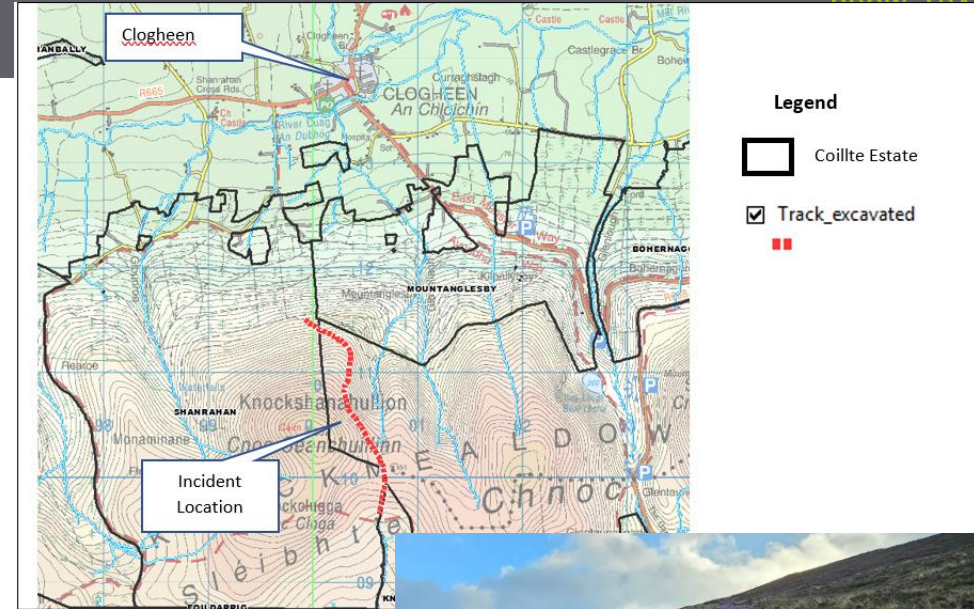
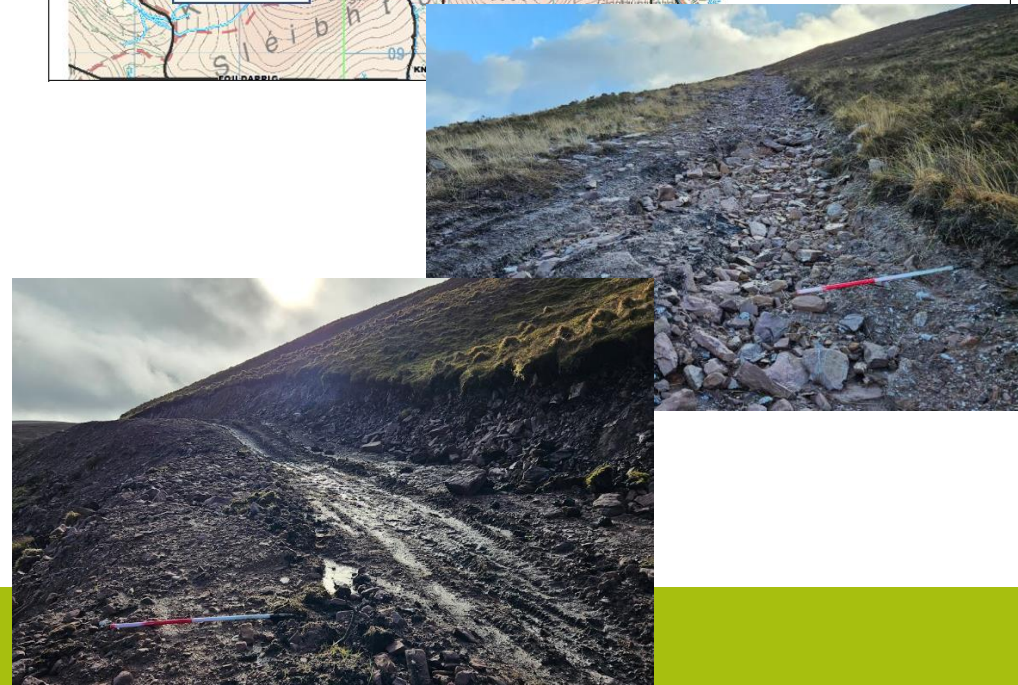
- **Issue:** Unconsented trail excavation
- **Location:** B5, TY19, Shanrahan & Knockadav
- **Significance:** 7/10
- **Background:** Short portion of unsanctioned track was constructed in 2023. A larger section of unsanctioned track (3.5 km) constructed in Oct / Nov 2024 that crossed into non-Coillte land.
- **Issues noted:**
 - Rhododendron foliage pickers an issue
- **Root Cause:**
 - Ongoing issues with trespass in locality
 - Barrier locks continuously cut
- **External Reporting:**
 - AIE request in Oct'24
- **Recommendations:**
 - Report to the Gardai.
 - Leave the track to vegetate over
 - Continue to monitor the area.
