# Bray to Greystones Cliff Walk Assessment

North Beach Greystone – Recent storm damage and risk to path

February 2026

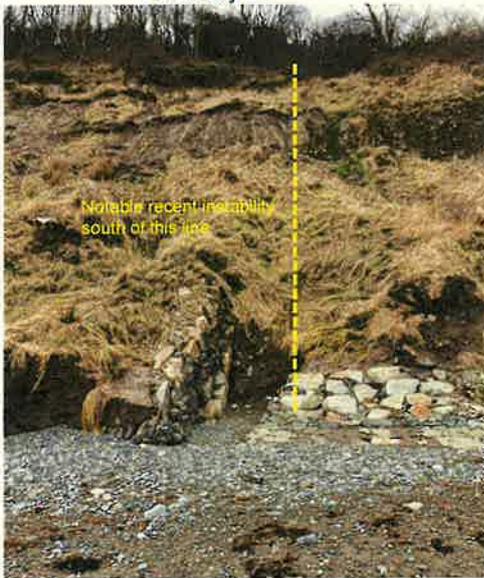
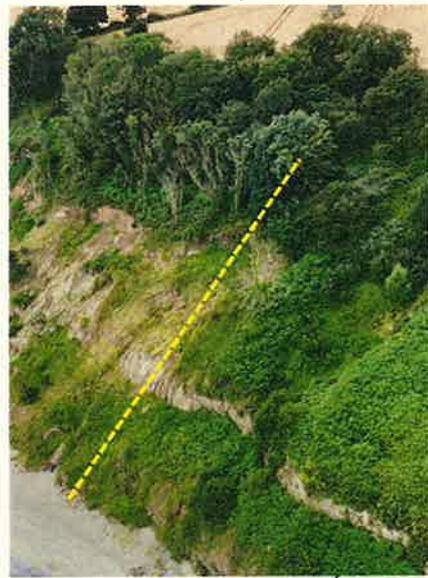
## Ch 3800

- Marks northern boundary of notable recent instability
- Minor slippage / erosion of existing scarp
- Toe erosion and exposure of masonry at toe

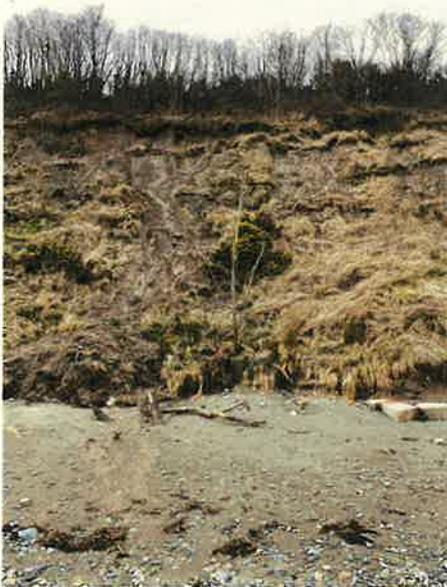
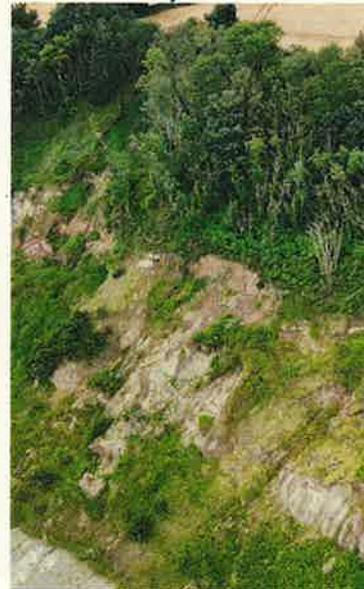
## Ch 3800 to 3850

- Slippage along existing scarp in upper slope
- Multiple slumping at toe
- Debris flow onto beach
- Estimated failed volume  $50L \times 4D \times 30H = 6,000m^3$

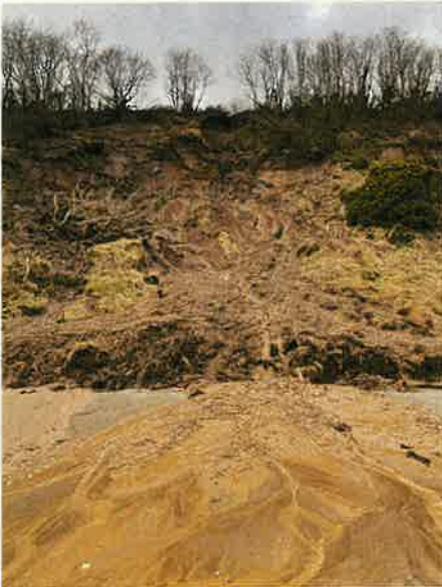
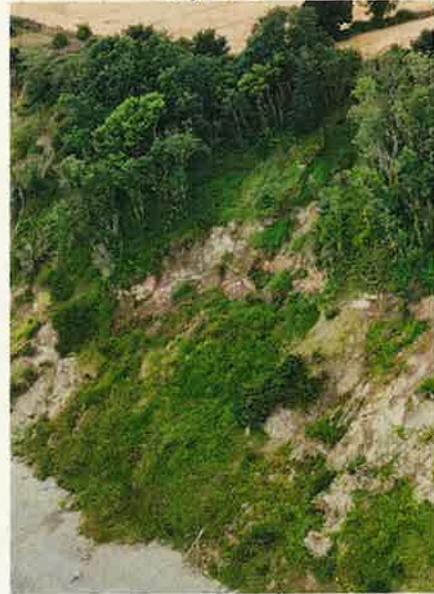
## Ch 3850 to 3900

- Site of existing landslide scar almost reaching path
- Slumping along existing scarp in upper slope
- Debris flow onto beach
- Estimated failed volume  $50L \times 4D \times 40H = 8,000m^3$

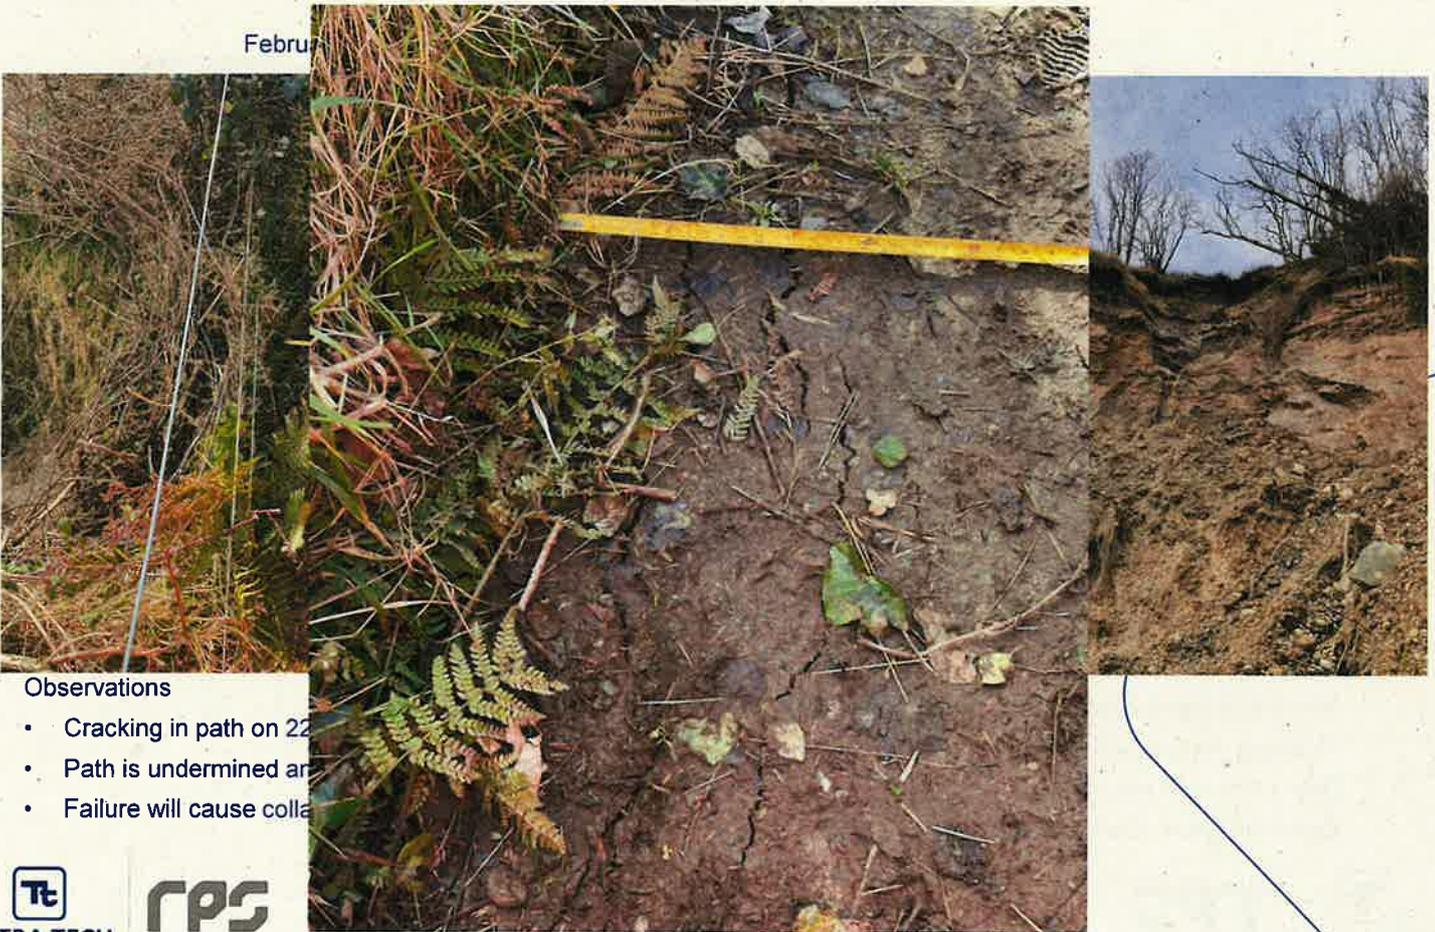
## Ch 3850 to 3900 continued

- Cracking in path on 22
- Path is undermined and
- Failure will cause colla

Path is actively being undermined in the northern section, particularly at ch 3880 where:

- THE PATH IS UNDERMINED WITH A 4 TO 5m VERTICAL FACE BELOW
- THERE IS PROGRESSIVE CRACKS OPENING UP IN PATH
- THIS REPRESENTS AN IMMINENT RISK TO PERSONS ON THE PATH

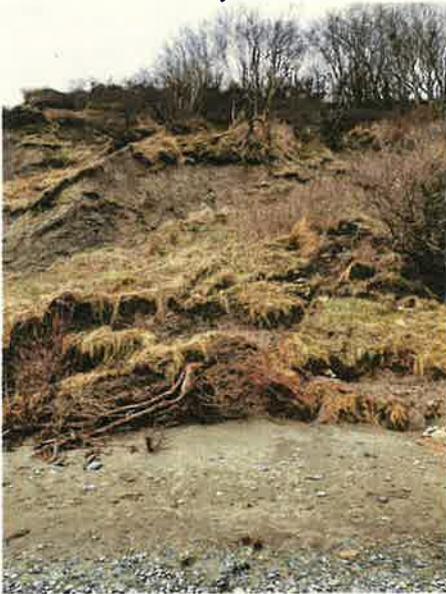
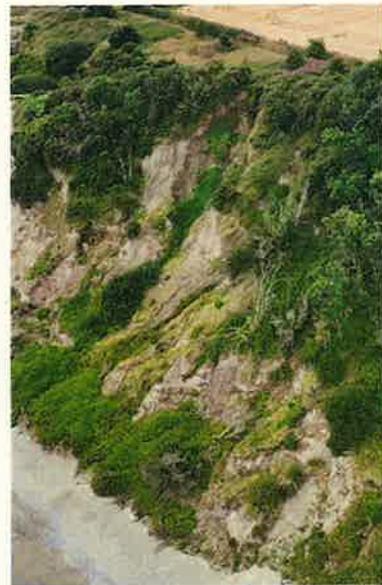
## Ch 3900 to 3970

- Slumping along existing scarp in upper/middle slope
- Debris flow and slumping onto beach
- Estimated failed volume  $70L \times 4D \times 40H = 11,200m^3$

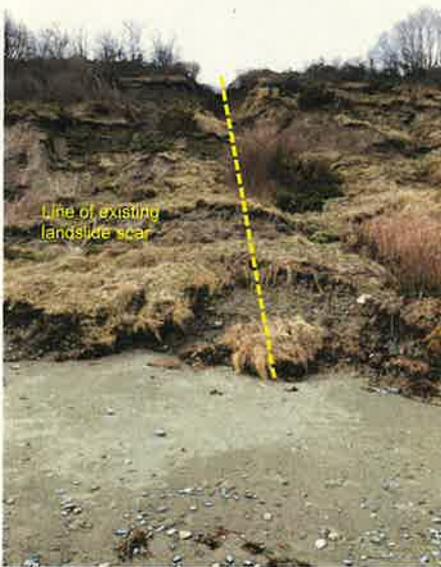
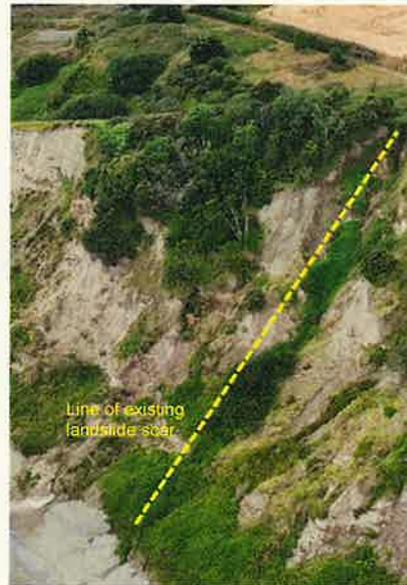
## Ch 3970 to 4000

- Site of existing landslide scar extending inland
- Slumping within landslide scar
- Debris flow /slumping onto beach
- Estimated failed volume  $30L \times 4D \times 50H = 6000m^3$

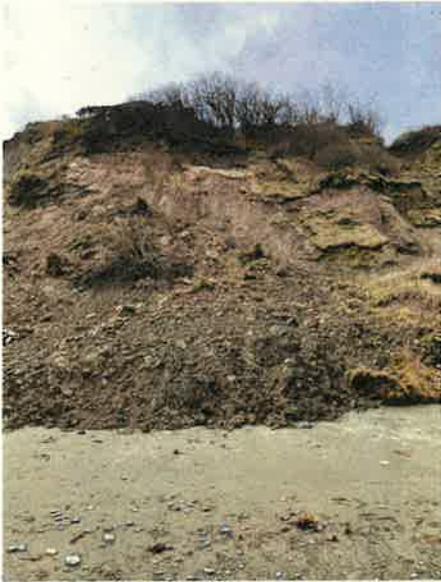
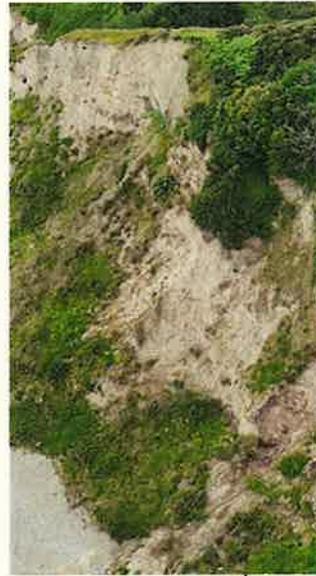
## Ch 4000 to 4040

- Slumping along existing scarp in upper/middle slope
- Debris flow and slumping onto beach
- Estimated failed volume  $40L \times 5D \times 30H = 6,000m^3$

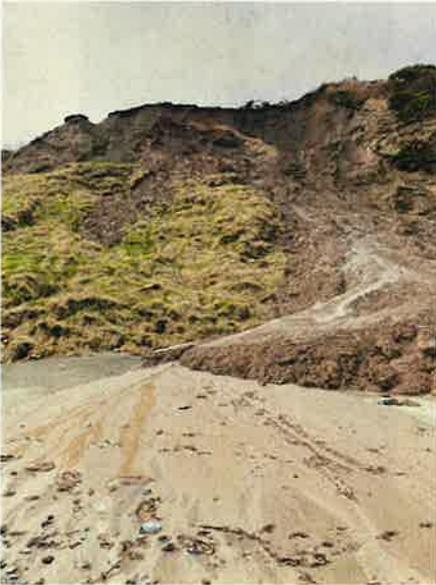
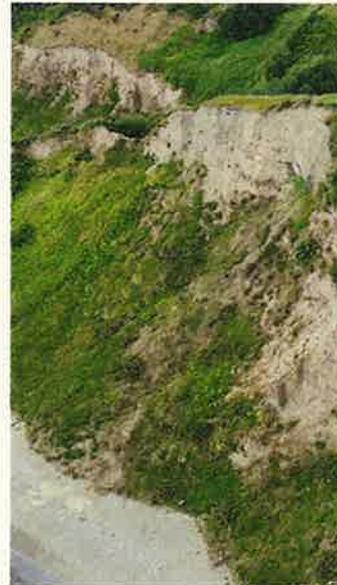
## Ch 4040 to 4070

- Slumping along existing scarp in upper slope
- Debris flow onto beach
- Estimated failed volume  $30L \times 4D \times 30H = 3,600m^3$

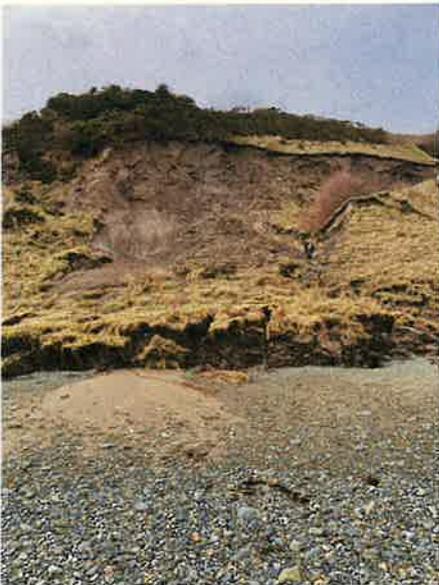
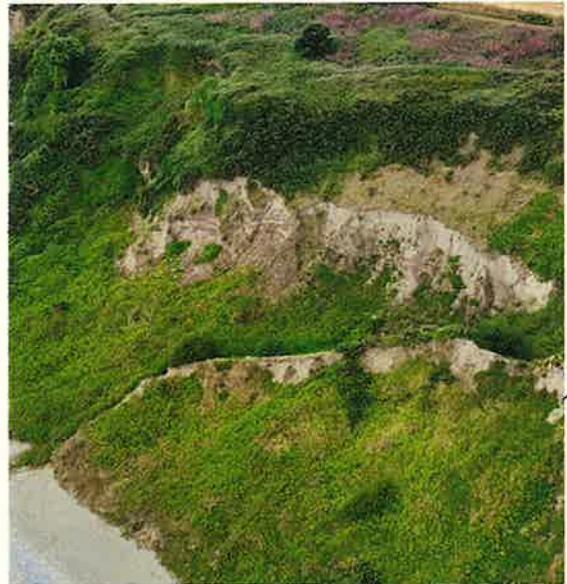
## Ch 4100 to 4140

- Slumping along existing scarp in upper slope
- Debris flow / slumping onto beach
- Estimated failed volume  $40L \times 4D \times 30H = 4,800m^3$

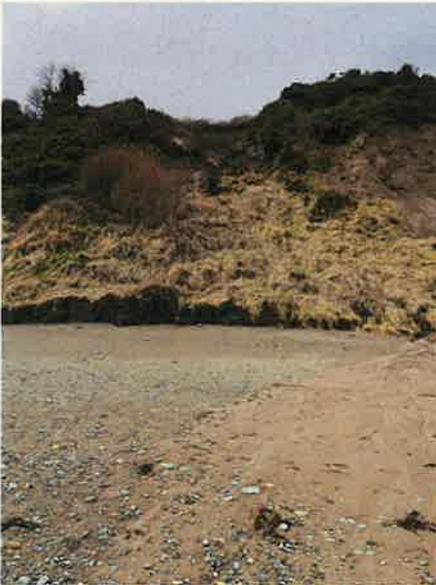
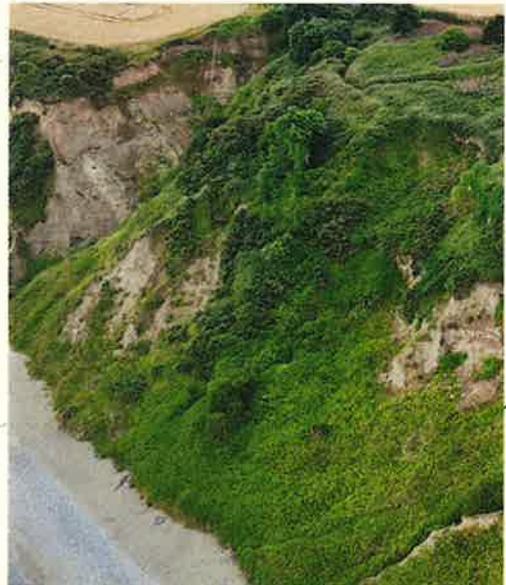
## Ch 4140 to 4235

- Slumping along existing landslide scarp and along existing scarp
- Debris flow / slumping onto beach
- Estimated failed volume  $95L \times 3D \times 30H = 8,550m^3$

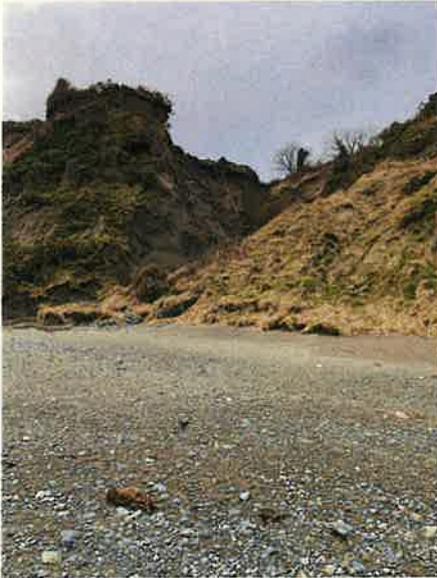
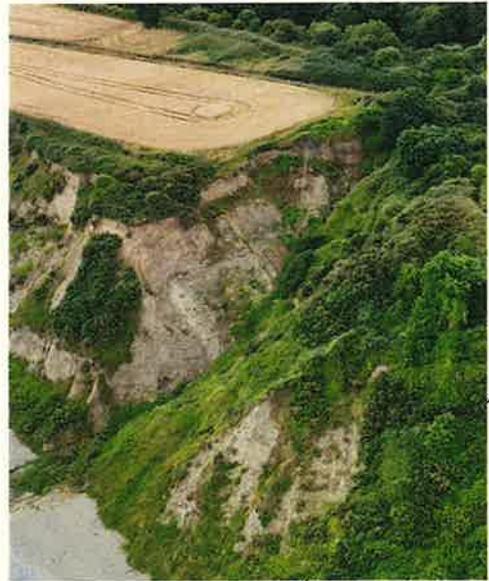
## Ch 4235

- Slumping within existing valley
- Debris flow onto beach
- Estimated failed volume  $20L \times 2D \times 30H = 1,200m^3$

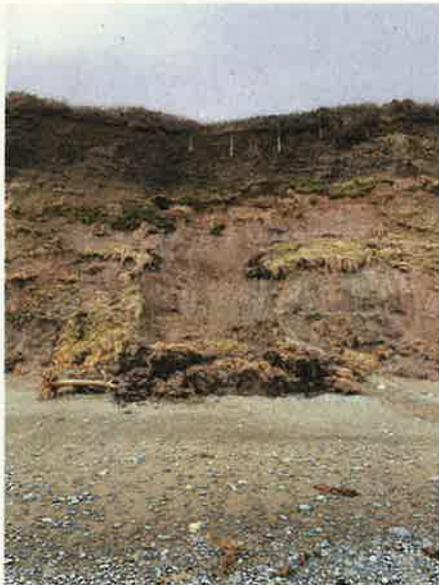
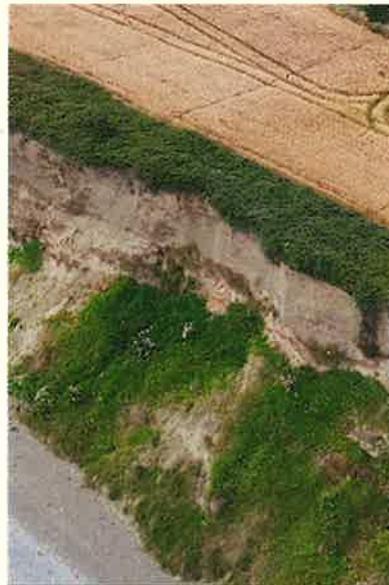
## Ch 4235 to 4550

- Minor shallow slumping along parts of lower slope in places
- Occasional slumping onto beach
- Estimated failed volume  $315L \times 1D \times 6H = 1,890m^3$

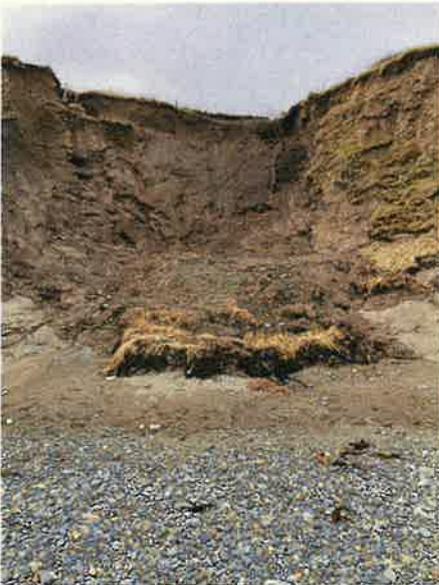
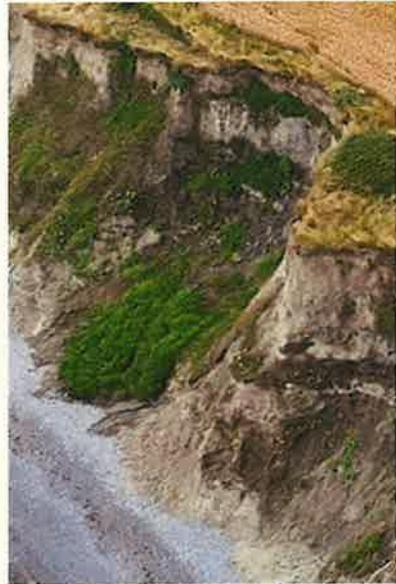
## Ch 4550 to 4820

- Minor shallow slumping along parts of lower slope in places
- Occasional slumping / flow onto beach
- Estimated failed volume  $270L \times 1D \times 6H = 1,620m^3$

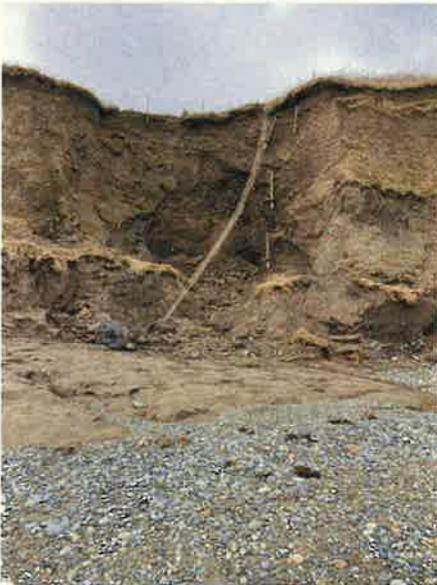
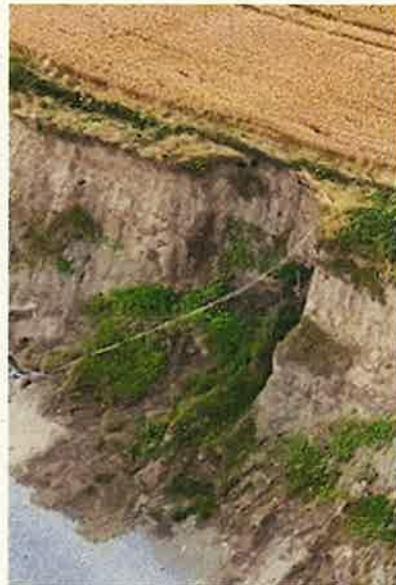
## Ch 4820 to 5032

- Minor localised shallow slumping along parts of lower slope in places
- Occasional slumping onto beach
- Estimated failed volume  $212L \times 0.75D \times 5H = 795m^3$

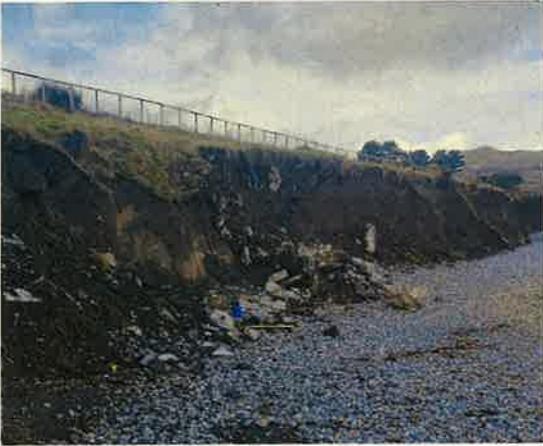
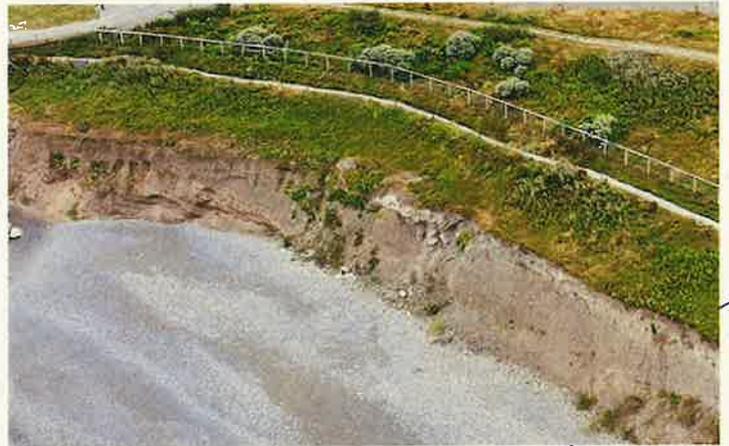
## Ch 5032 to 5342 - below Marina Park

- Collapse of some of made ground within cliff
- Minor localised shallow slumping along parts of lower slope in places
- Notably greater failure volume near ramp to beach
- Occasional slumping onto beach
- Estimated failed volume  $310L \times 0.75D \times 5H = 1,170m^3$

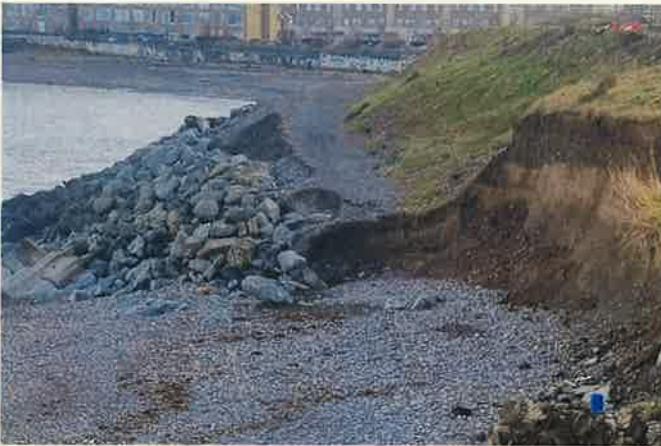
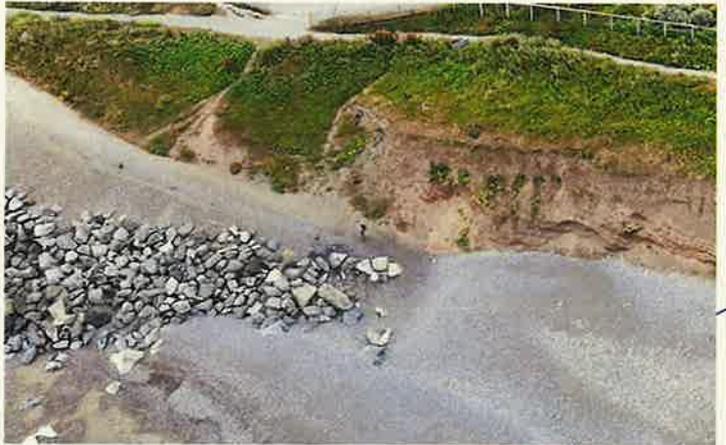
## Southern end – ramp to beach

- Lower end of ramp eroded (say 3 to 5m)
- Estimated locally 2m of cliff eroded
- Wave action has eroded ramp fill behind armour
- Beach lowered at toe of rock armour
- Cliff in area comprises gravelly sand – readily erodible
