TULLAGHOBEGLEY BANK PROTECTION AND HABITAT ENHANCEMENT PROJECT REPORT

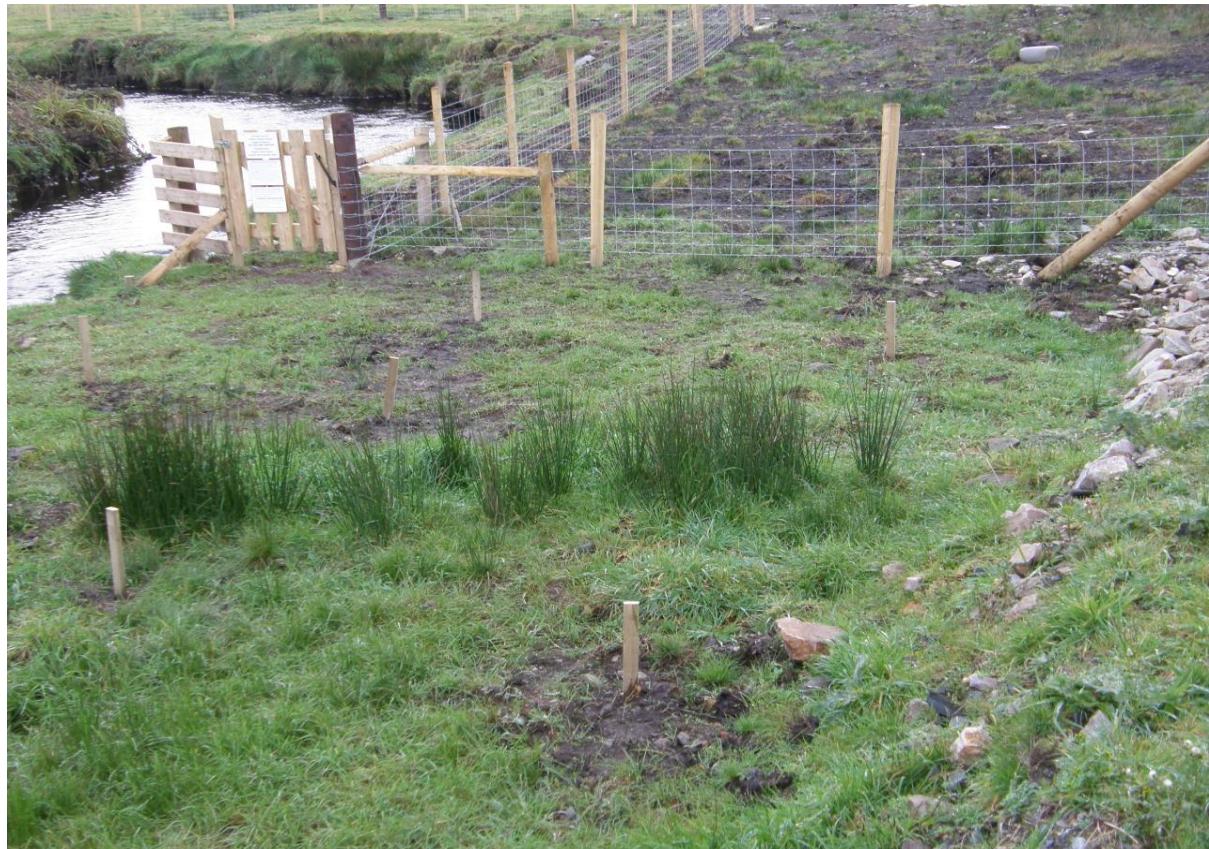
595 metres of fencing has been installed along the right bank of the river (Figure 2). The fencing meets standard specifications in relation to stakes, posts and wire used, and height and construction details. The fence has been installed by CAA's river team in conjunction with the landowner, all of whom are competent operators experienced in working in riparian zones. The fencing has been set back from the river bank to provide a buffer zone and access route for anglers. Buffer zone width was determined by local topography, river bank condition, strategic location, adjacent land use and permanent vegetation, and landowner agreement. An average minimum width of 3m has been achieved (Figure 3). The river is now protected from invasion by livestock. To meet the needs of livestock for water, two aquamat pumps with side bowls and c/w strainers have been provided.

Figure 2 Newly installed fencing along the right bank and gated access point

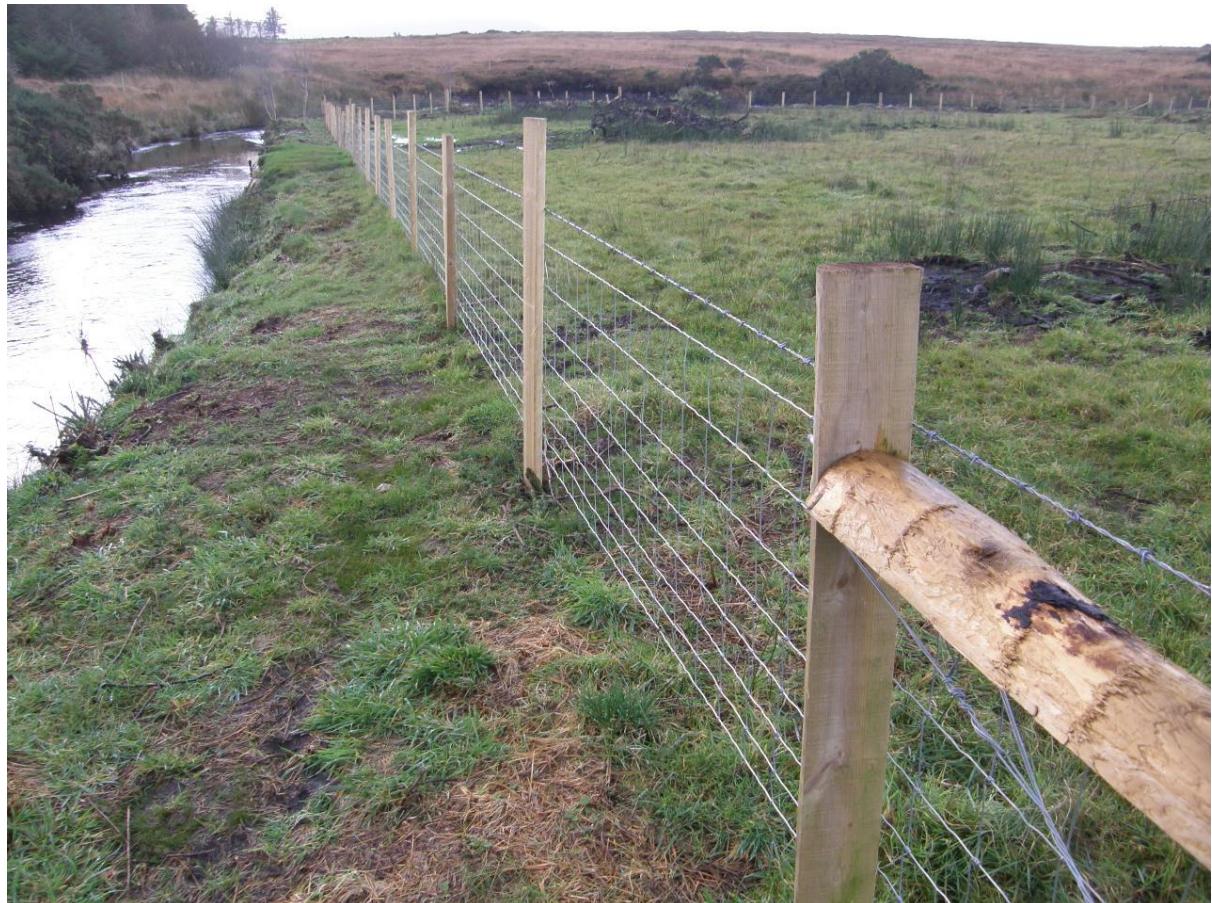
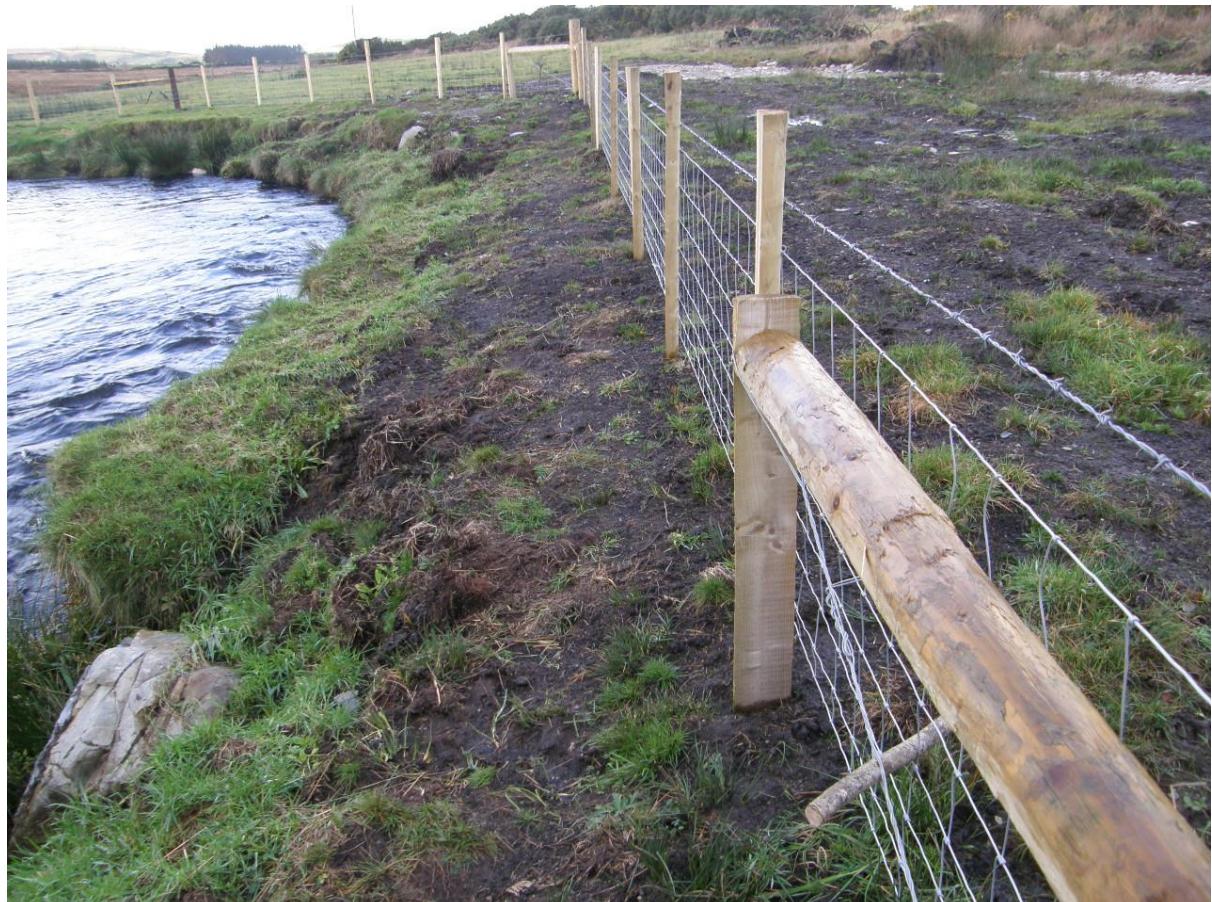
Figure 3 Riparian buffer strip 3m wide on average

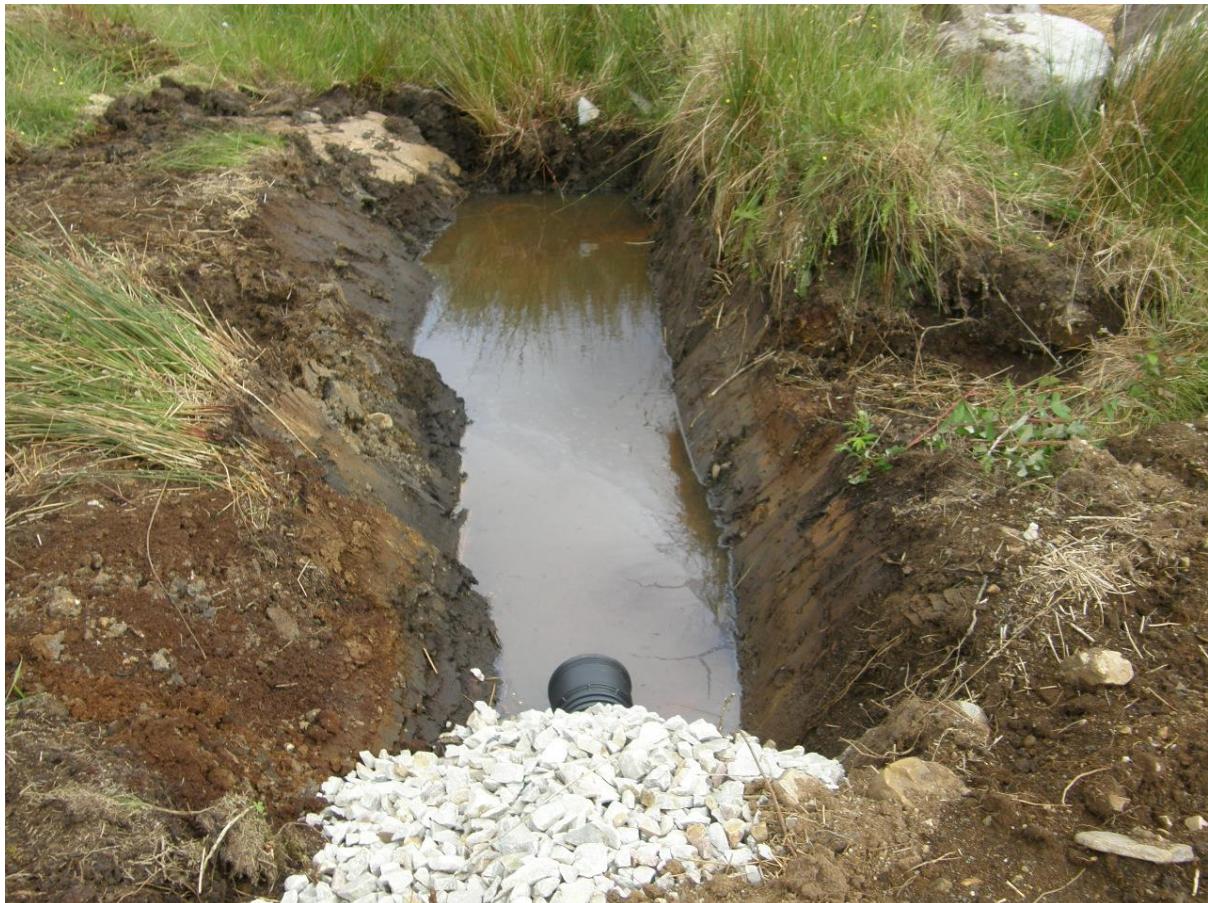
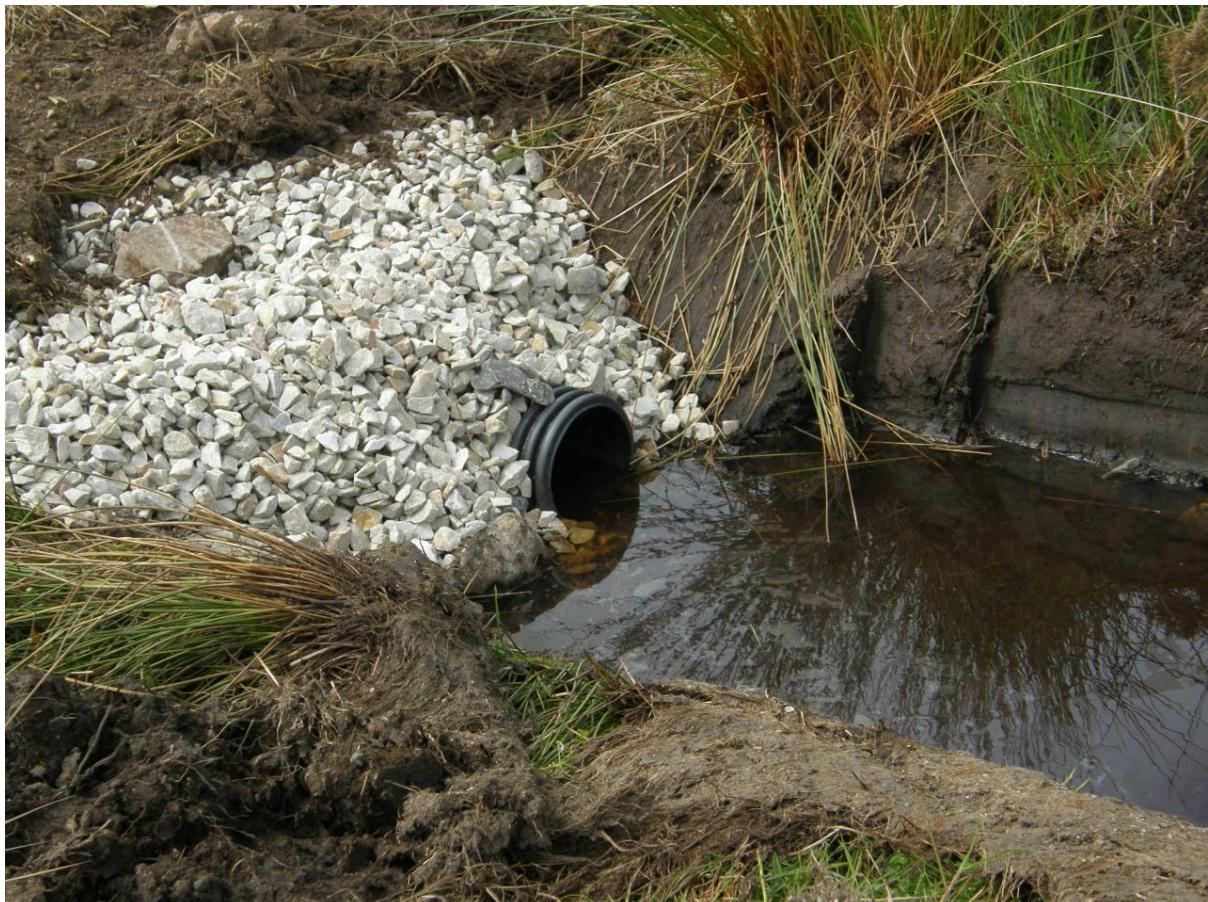
Approximately 7 existing drains (sheughs) were identified that required mitigation measures to reduce silt export to the river. These deep drains also created obstacles to access along the bank. The drains were bridged using a stone ramp near their discharge end to allow pedestrian passage. The stone used in the ramp was clean local quartzite (Figure 4). To prevent any elevation of pH in this naturally acidic soft water river, no limestone was used.

Figure 4 Culvert construction using clean quartzite stone

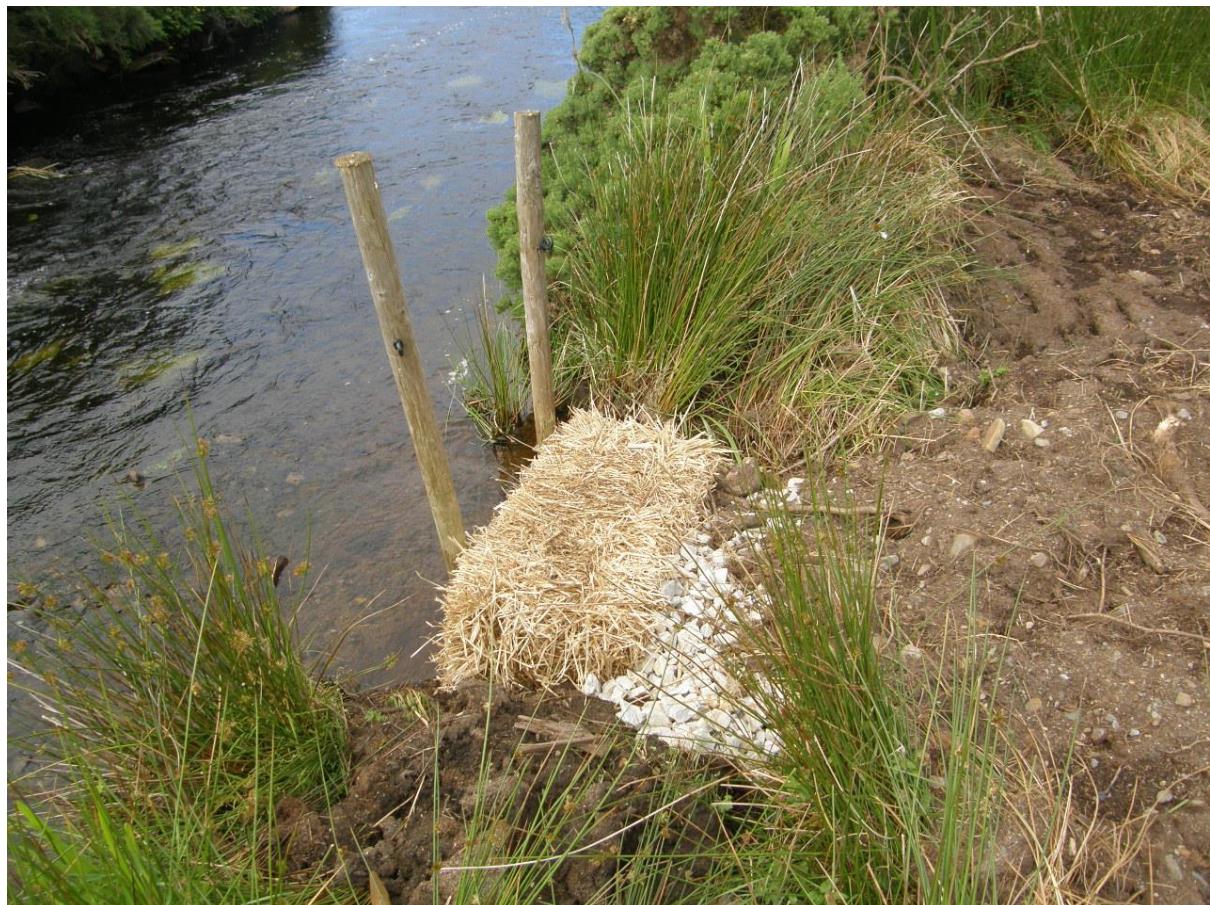
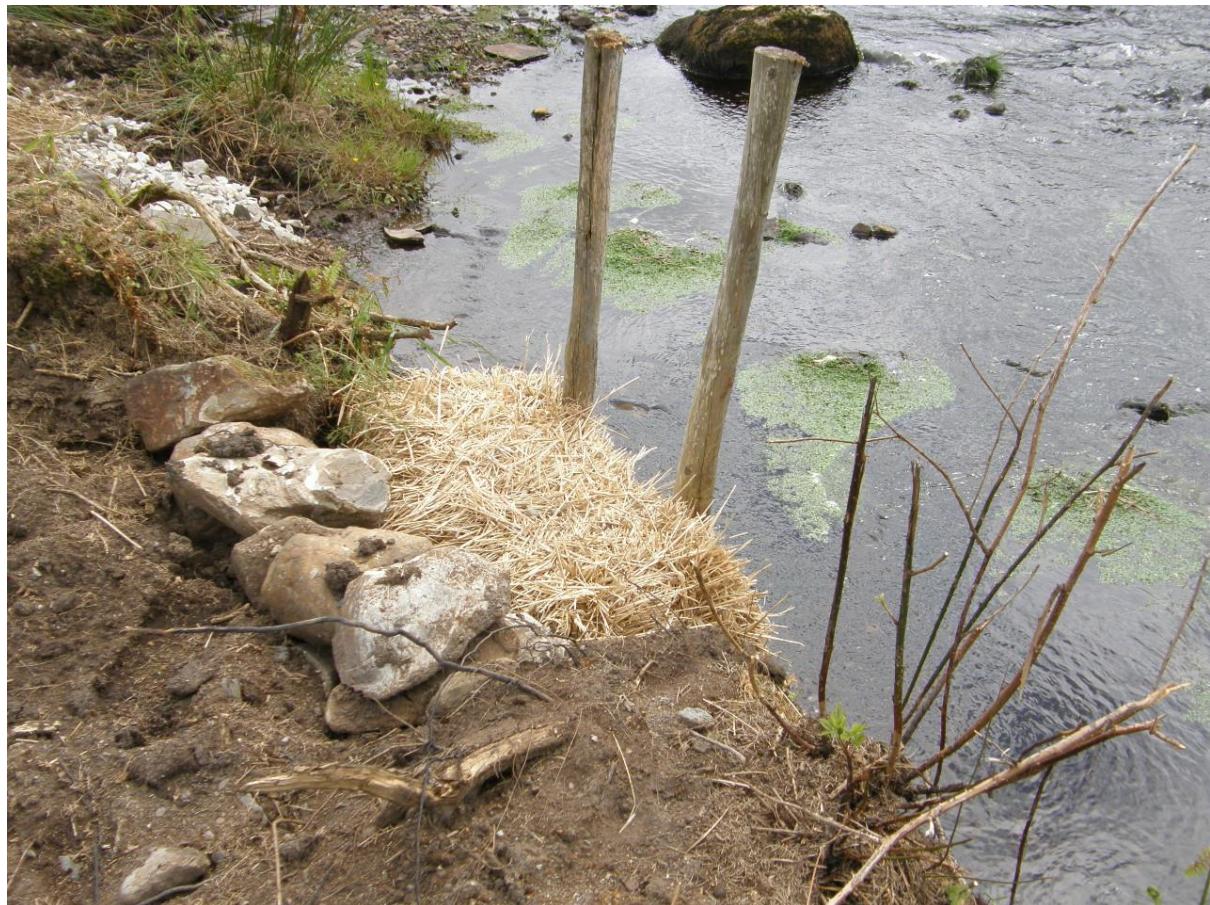
Straw bales were used to effectively block the ditch outfall before works commenced and during works to provide separation and filtration and prevent any sediment reaching the river (Figure 5). Drain mitigation works were carried out in dry/low flow conditions. Culverts have been installed to allow drainage water to pass through the ramps. Although the drains are artificial managed systems and not currently a habitat suitable for fish, the culvert inverts have been carefully positioned at a level that does not create obstacles or barriers to passage of fish. Such areas could provide a function as nursery streams in the future.

Figure 5 Use of straw bales to dam ditch outfalls during works

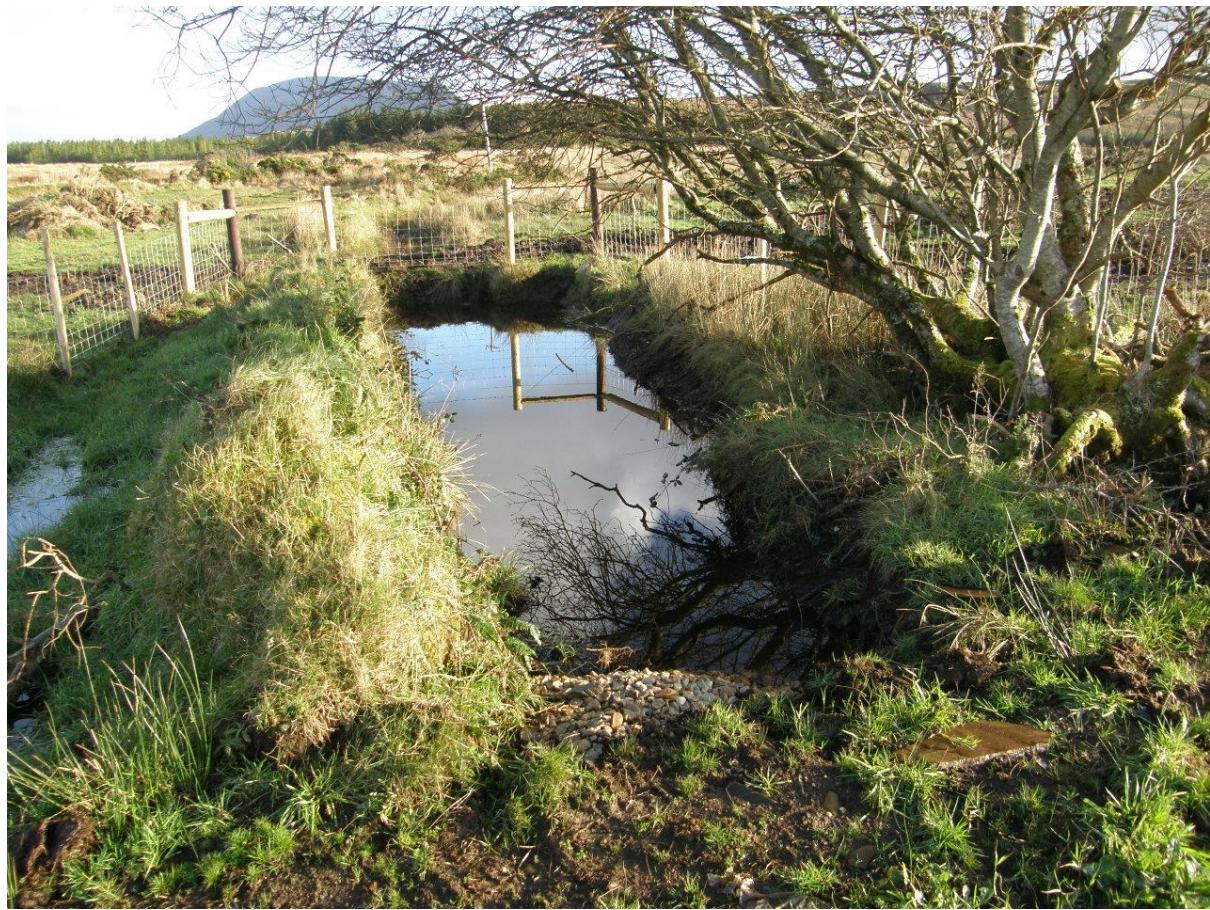
Upstream of the stone ramps the ditch bed has been deepened to provide settlement sumps for silt carried in the drains and to prevent export to the river (Figure 6). These sumps will be managed as part of the normal drain cleaning cycle and CAA will work with the landowner to ensure implementation of best practice during drain management to mitigate any environmental impacts and maintain biodiversity. In one major ditch, a pond has been created at both the input end and the downstream end. This provides more opportunities for treatment of drain discharges and greatly enhances biodiversity. Current vegetation in drains will colonise ponds but if necessary, and to accelerate pond maturation, local macrophytes may be planted.

Figure 6 Deepening and widening of drains to create settlement sums at the outfall

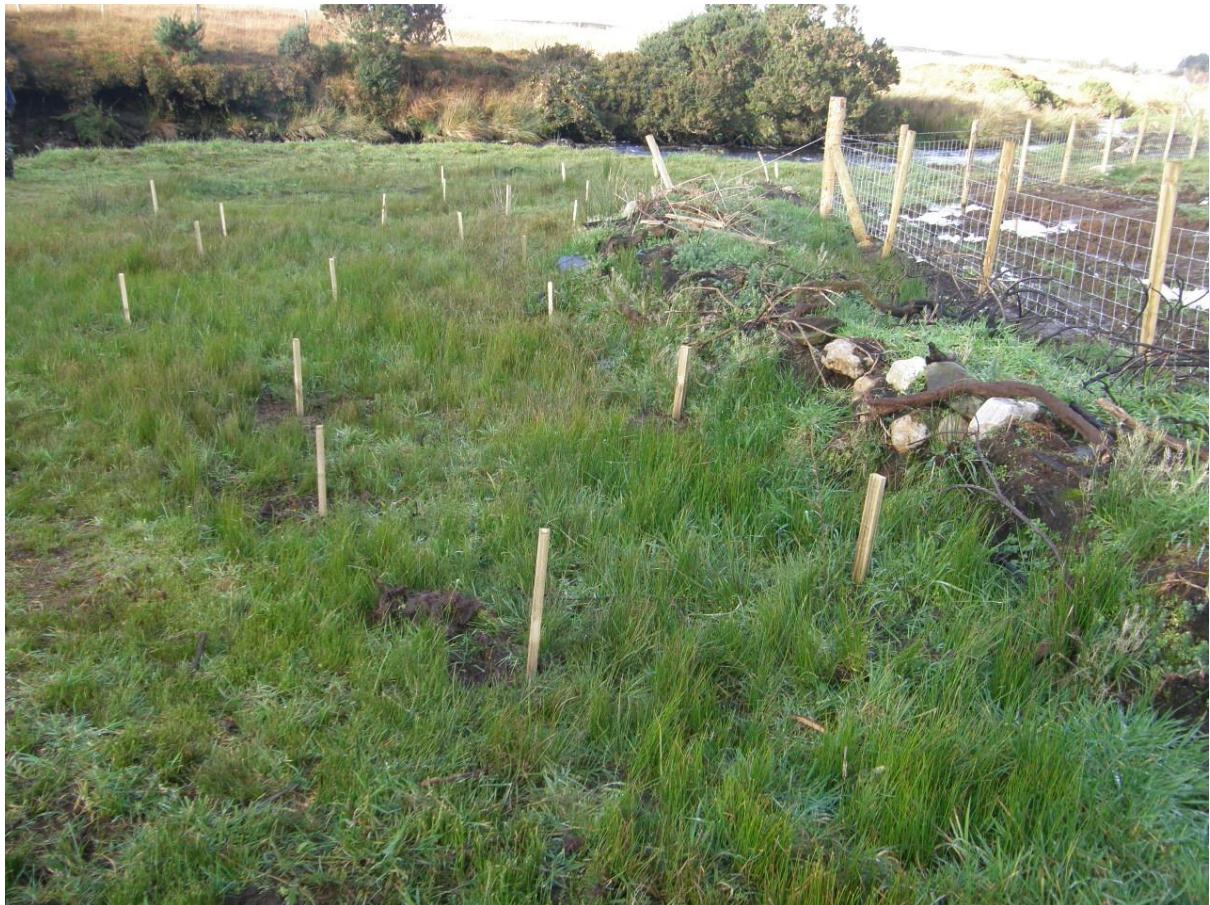
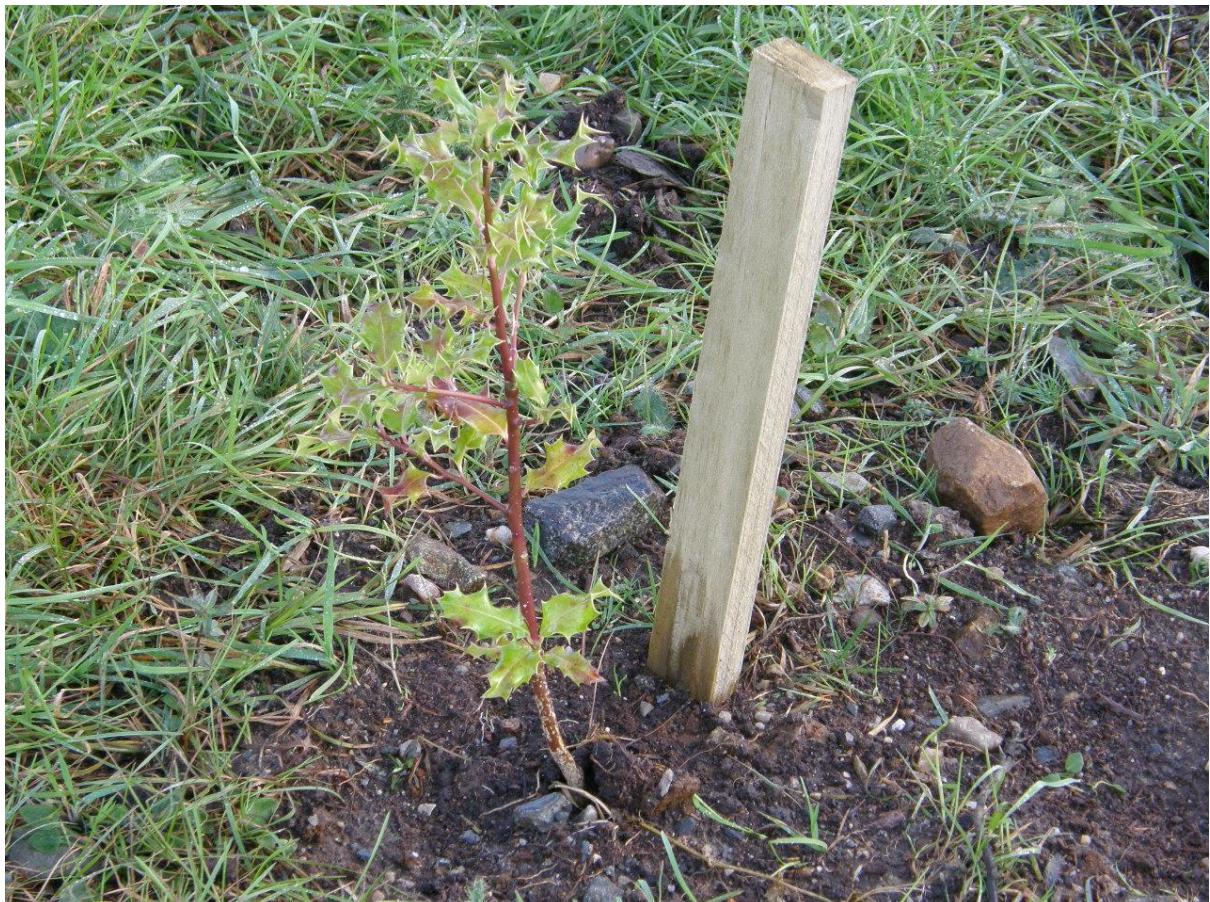
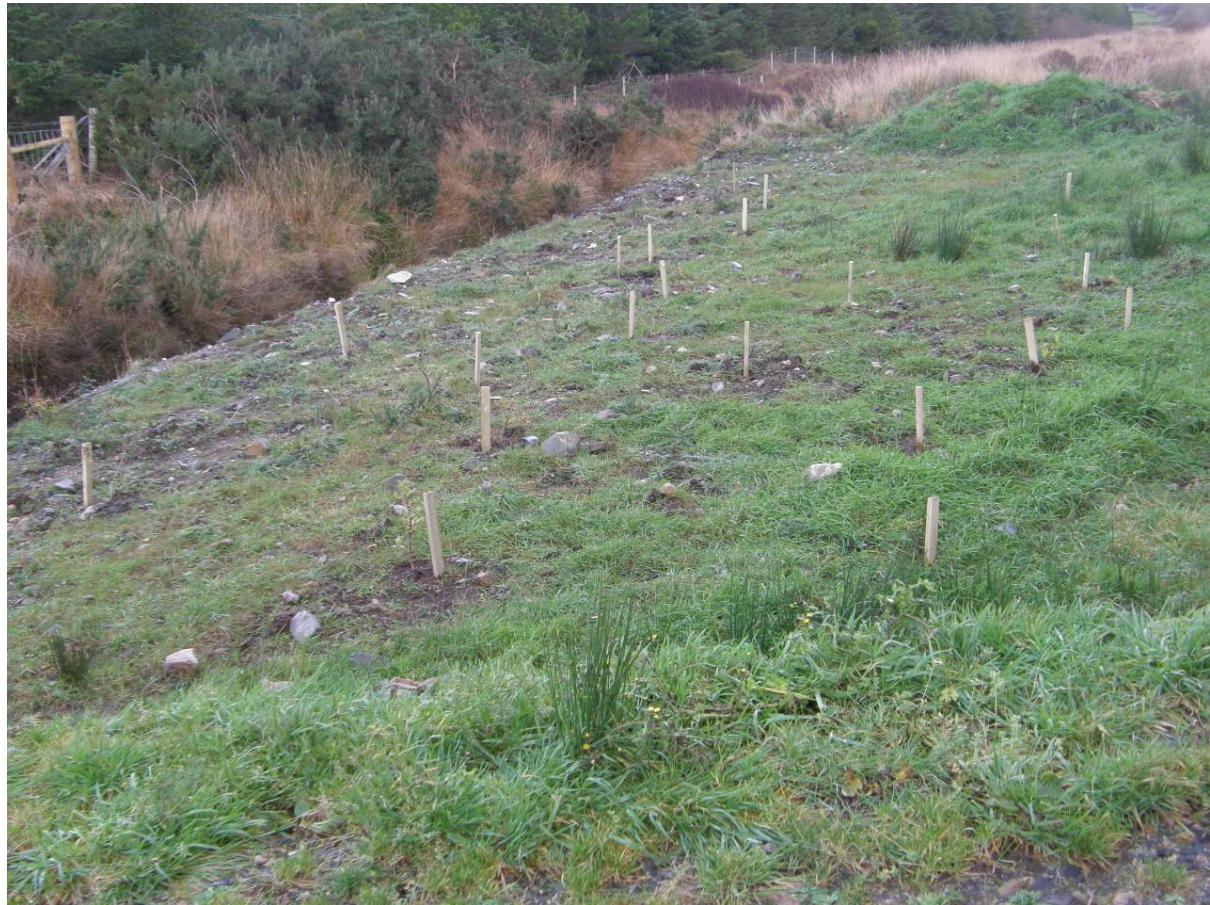
Tree planting at appropriate locations to establish riparian woodland and copses has been carried out in conjunction with NPWS and Coillte. Species planted include birch, alder, oak and holly. Approximately one hundred and fifty trees have been planted. The location of each tree planted has been marked with a stake to facilitate ongoing maintenance to aid growth in the early stages e.g. clearing competitive vegetation in the immediate area (Figure 7). Where banks have been reprofiled, a species diverse mixture of native grasses and herbs suitable for acid soils has been used to re-seed bare soils.

Figure 7 Planting of riparian trees of mixed species composition

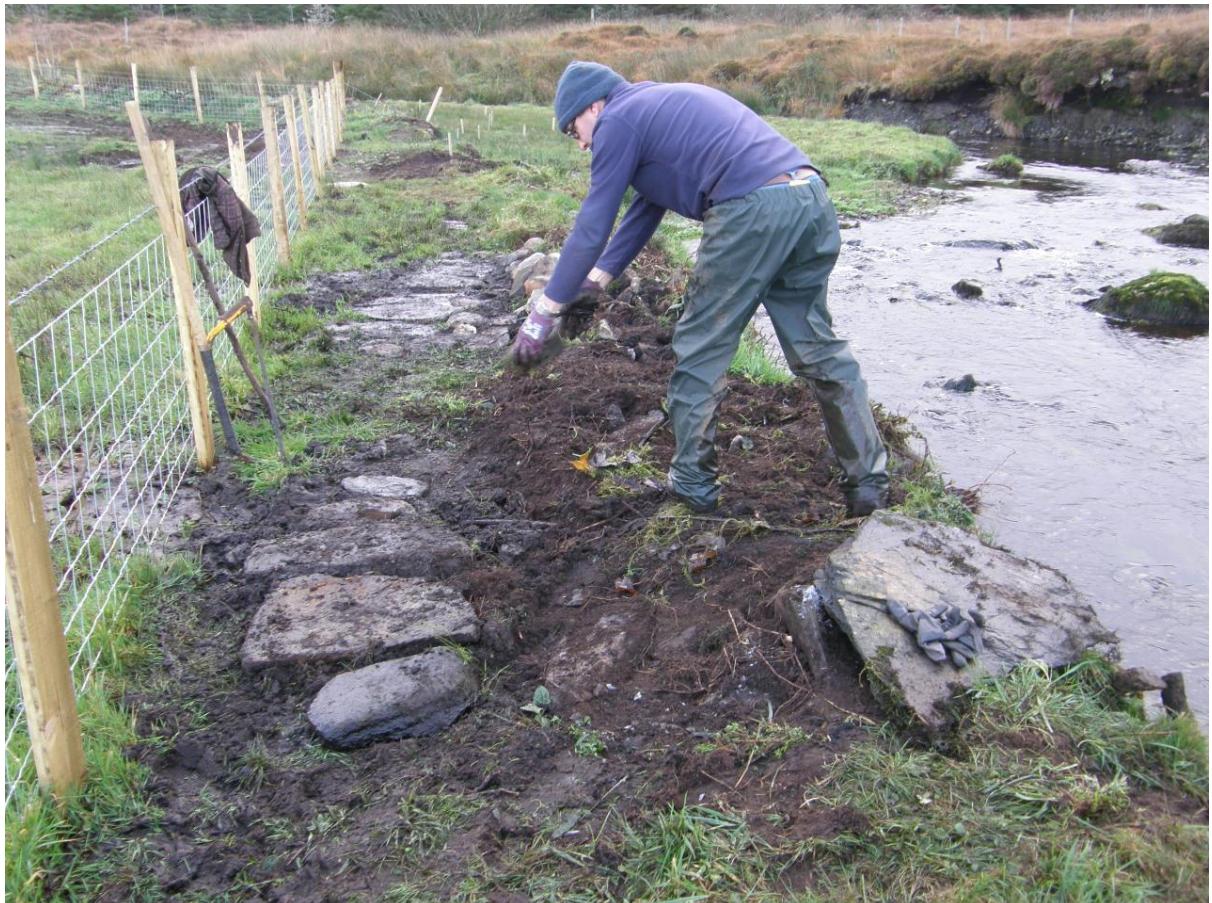
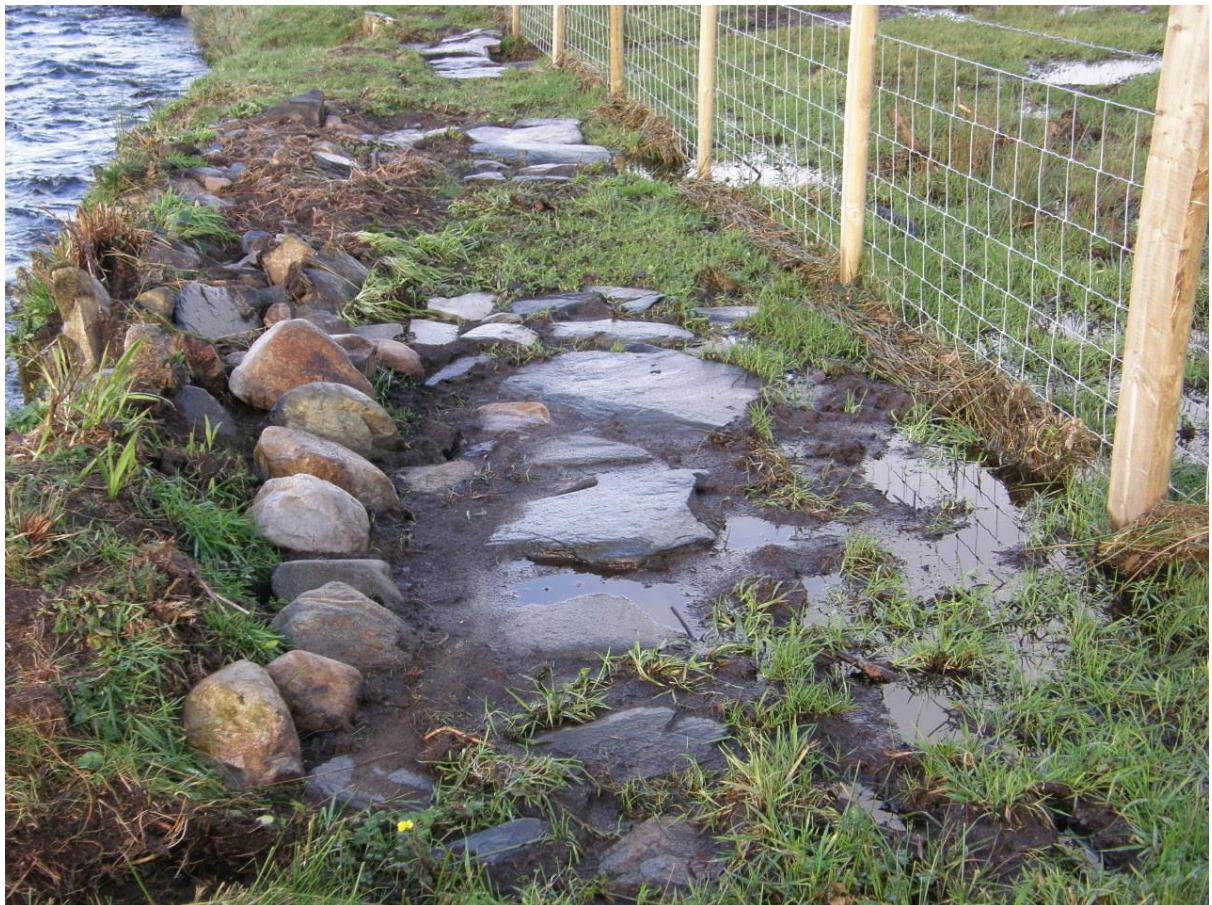
At locations where the river bank substrate had become perilously weakened, the area was strengthened by the introduction of reinforcement using stone harvested from the adjoining land (Figure 8). This will be covered in topsoil and reseeded as noted above.

Figure 8 Stone protection on damaged bank surfaces in the riparian buffer strip

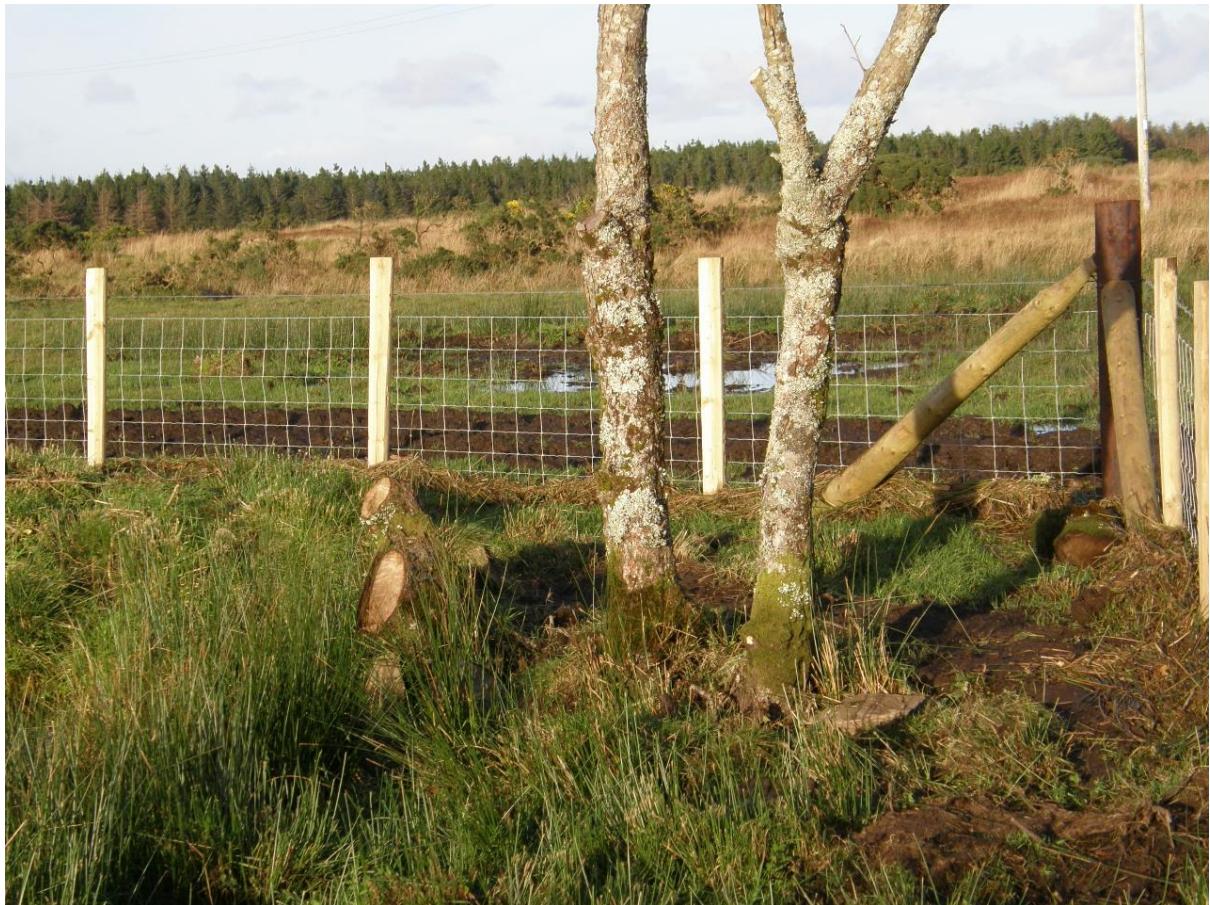
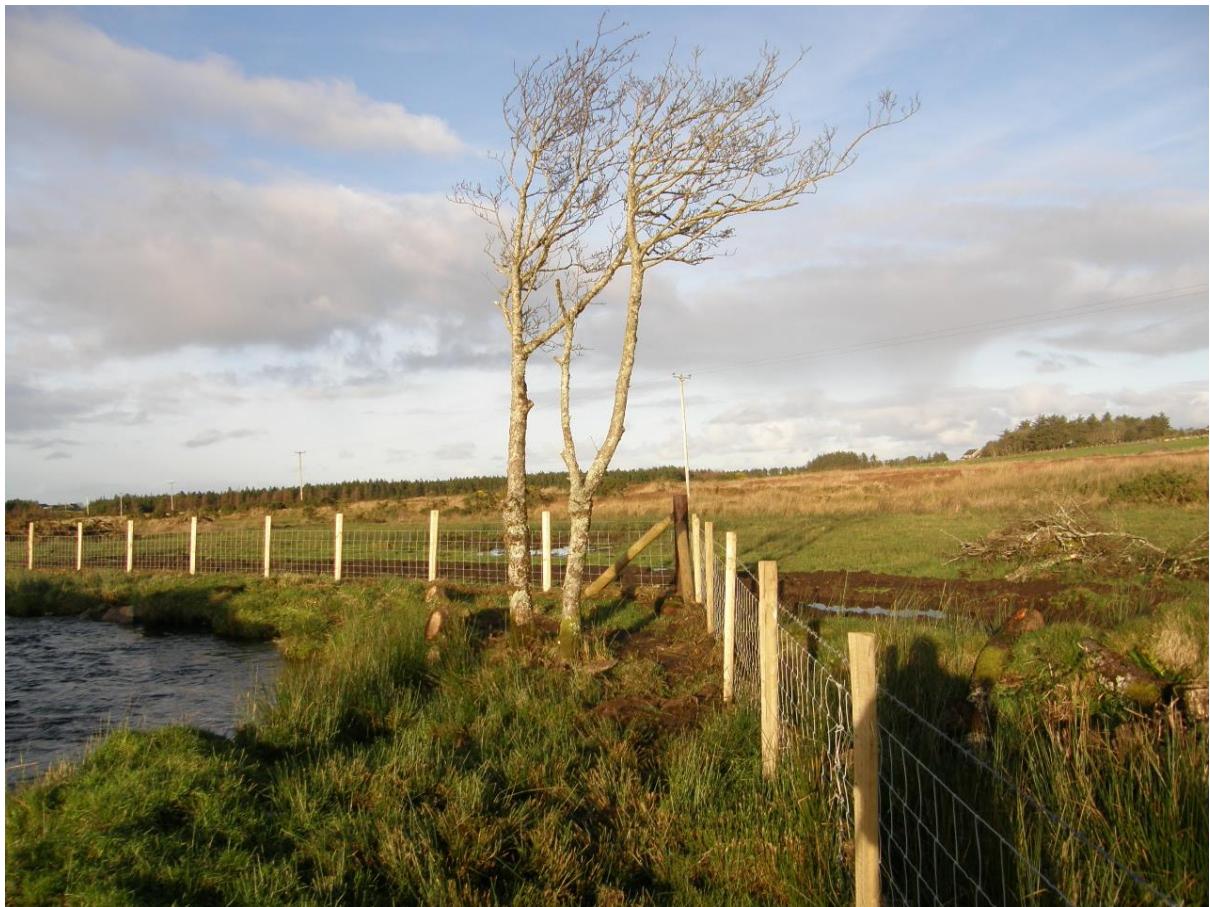
In some places established trees had grown through river bank faces and posed a grave threat to the integrity and long term survival of the immediate riparian area. In these cases the tree was trimmed to ensure the protection of the river bank (Figure 9).

Figure 9 Trimming of tree stems projecting through the river bank at vulnerable locations

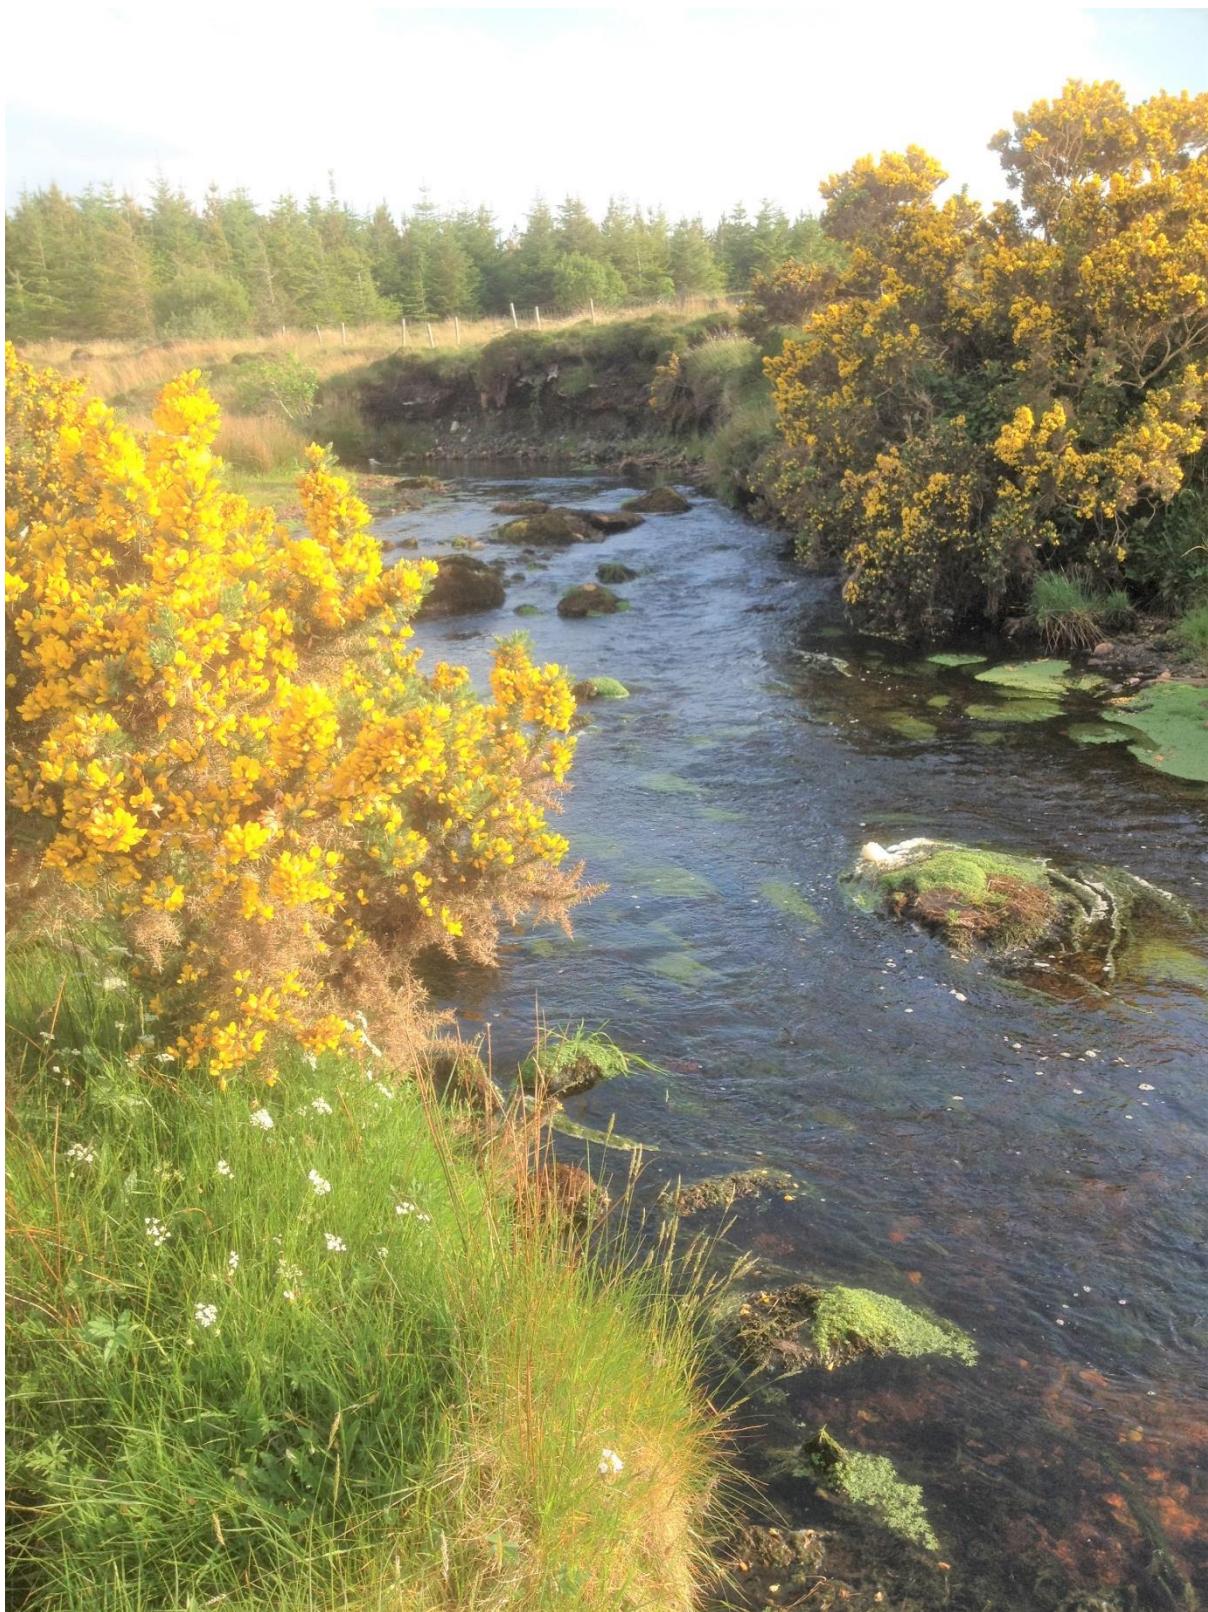
Point D View upstream on right bank with undercutting resulting in bank slippage and collapsing fence line at rear

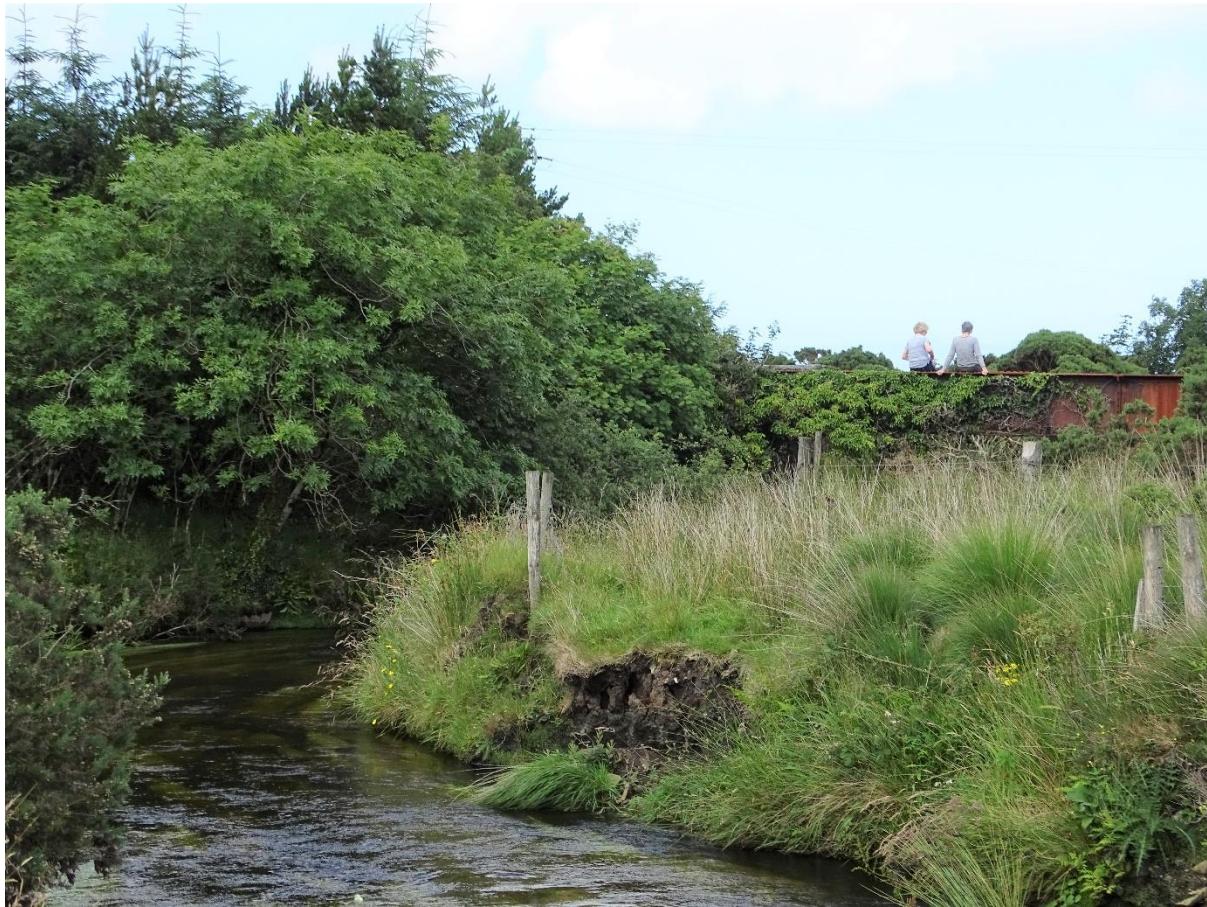
Point E View downstream on left bank to railway bridge, with bank and fence collapse on right bank

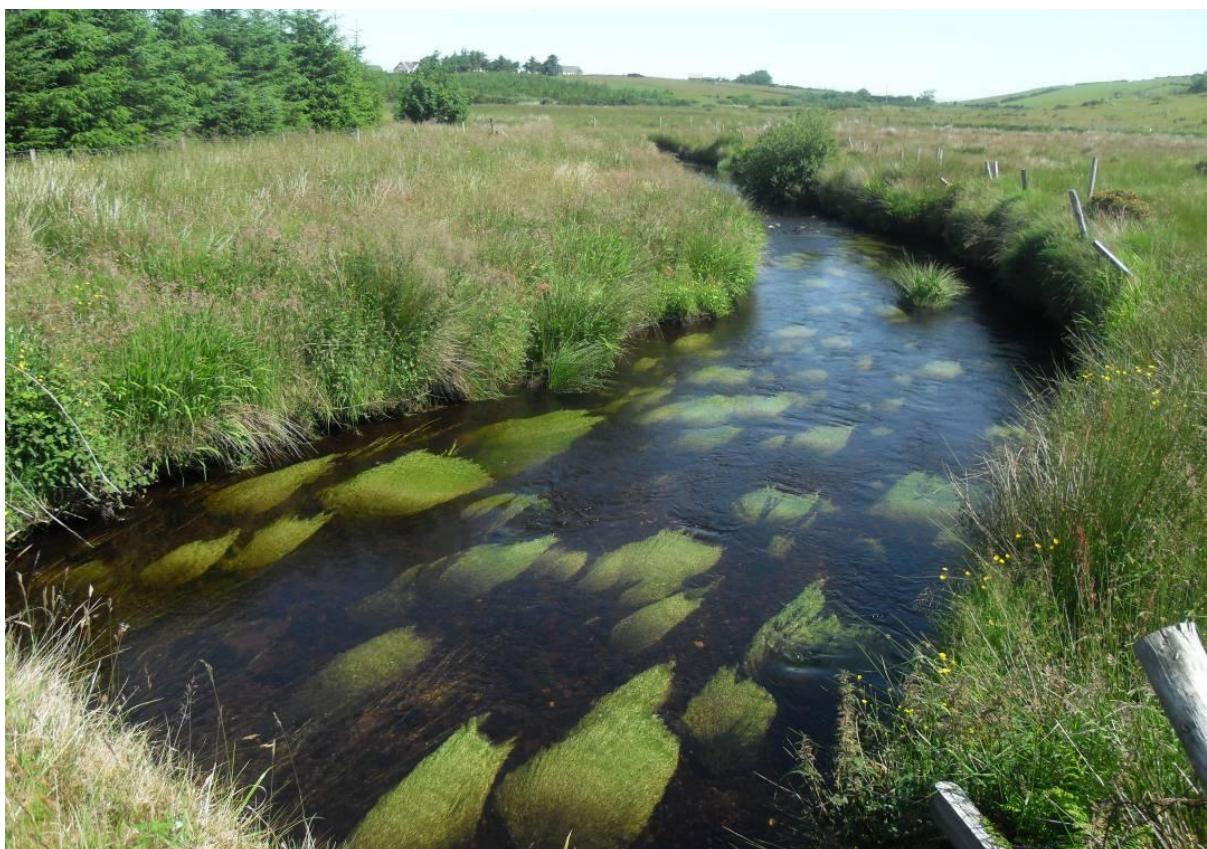
Point G View downstream at old tractor bridge showing extensive macrophyte growth
