## **Attachment E.1. Appropriate Assessment**

**SCREENING STATEMENT**

**FORMER FINISKLIN LANDFILL AND  
PROPOSED REMEDIATION WORKS**

**JANUARY 2012**

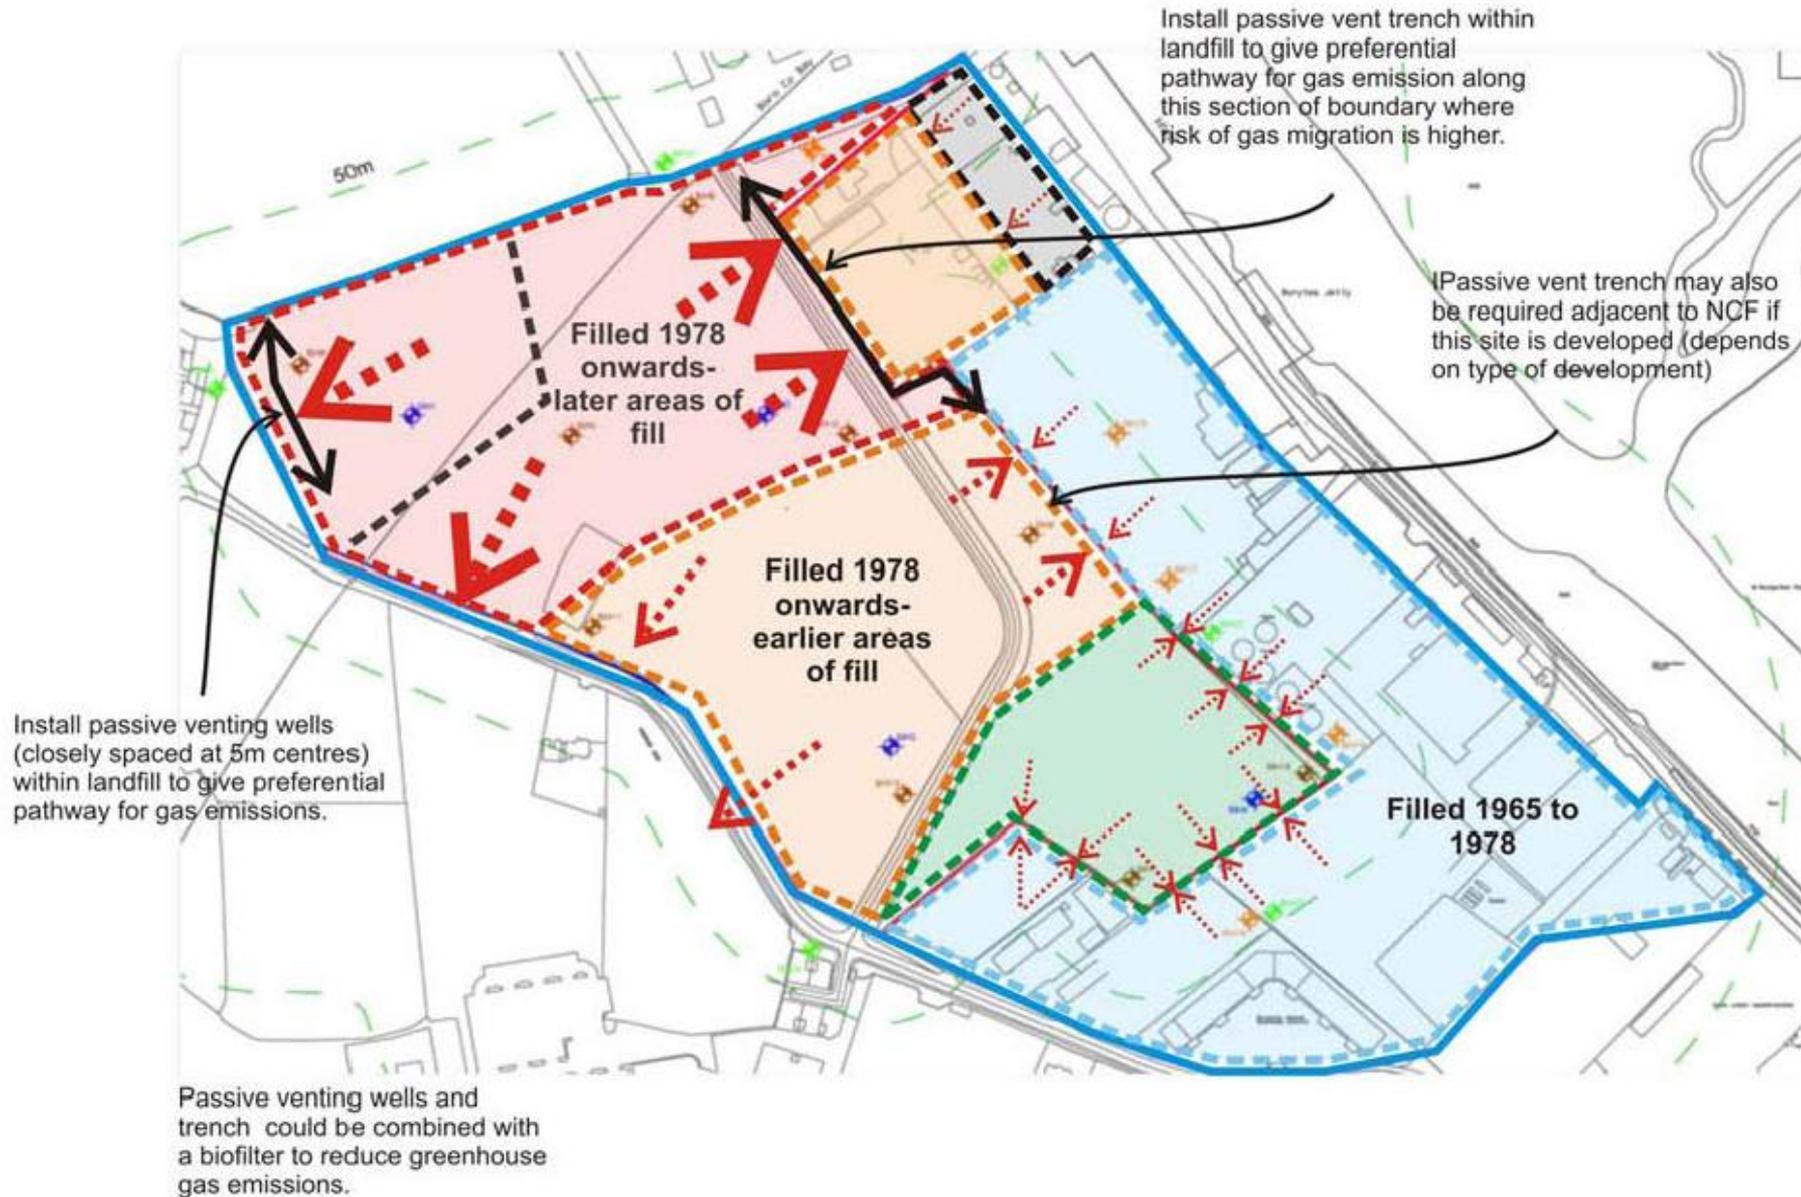
Figure 3

**Remedial options - site in current condition**

Based on the findings of these detailed assessments, recommendations have been made in regards to remedial works that would need to be undertaken at the site. These relate to landfill gas and consist of a vent trench along the northern end of the eastern boundary and a vent well system at the northern part of the western boundary. Some minimal works to the capping layer are also required. The proposed remediation measures are detailed on Figure 3, Appendix I.

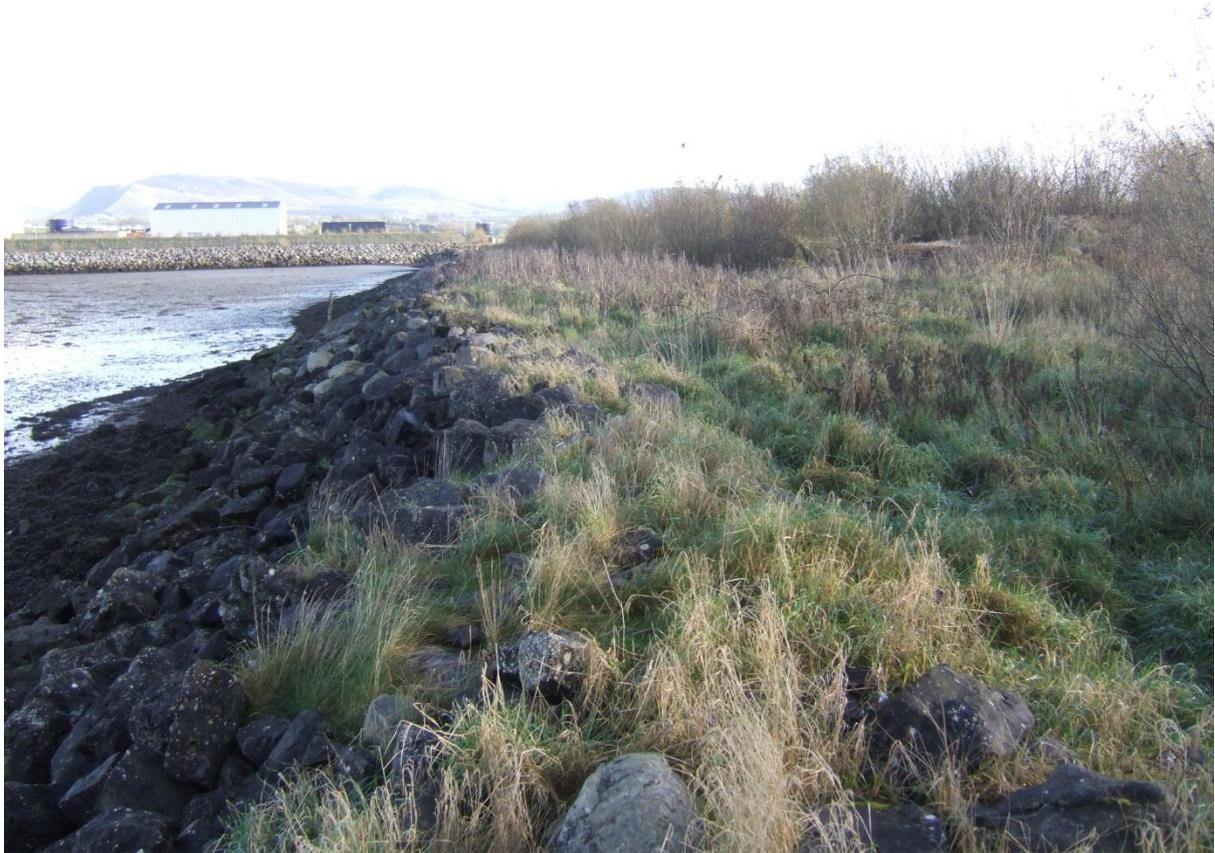
Plate 1. The margin of the landfill above the rock armour is now well vegetated with rank grassland and scrub (looking eastwards).

The sector of the former landfill above the estuary is now well vegetated with a mix of rank, weedy vegetation, wet grassland and scrub (mostly willow) (see Plate 1). The edge of the former landfill is stepped towards the rock armour. The rock armour is continuous along the margin of the former landfill.

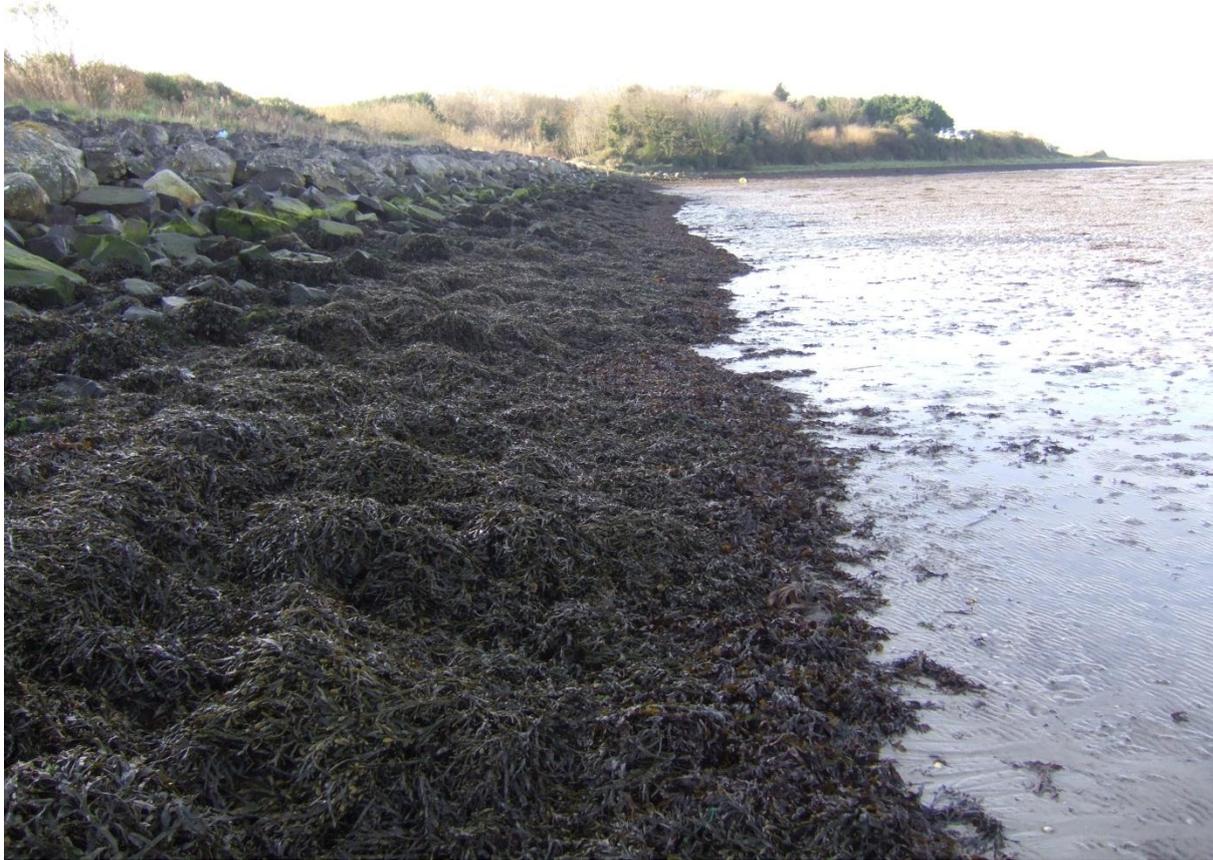
Plate 2. The lower part of the rock armour has a heavy covering of furoid algae which extends onto the upper shore. The normal high tide mark is shown by the green algal line (looking westwards).

The lower strip of rock armour is inundated by the tide and is almost totally covered with brown fucoid algae (see Plate 2). Green algae (fine *Enteromorpha* species) occur on the boulders at the top of the tide line. Boulders occur scattered onto the shore where there is a narrow stony-gravel strip in places. The brown algae which cover the boulders and the extreme upper shoreline are mostly *Fucus spiralis* and *Fucus vesiculosus*, with *Pelvetia canaliculata* occasional on the upper boulders.

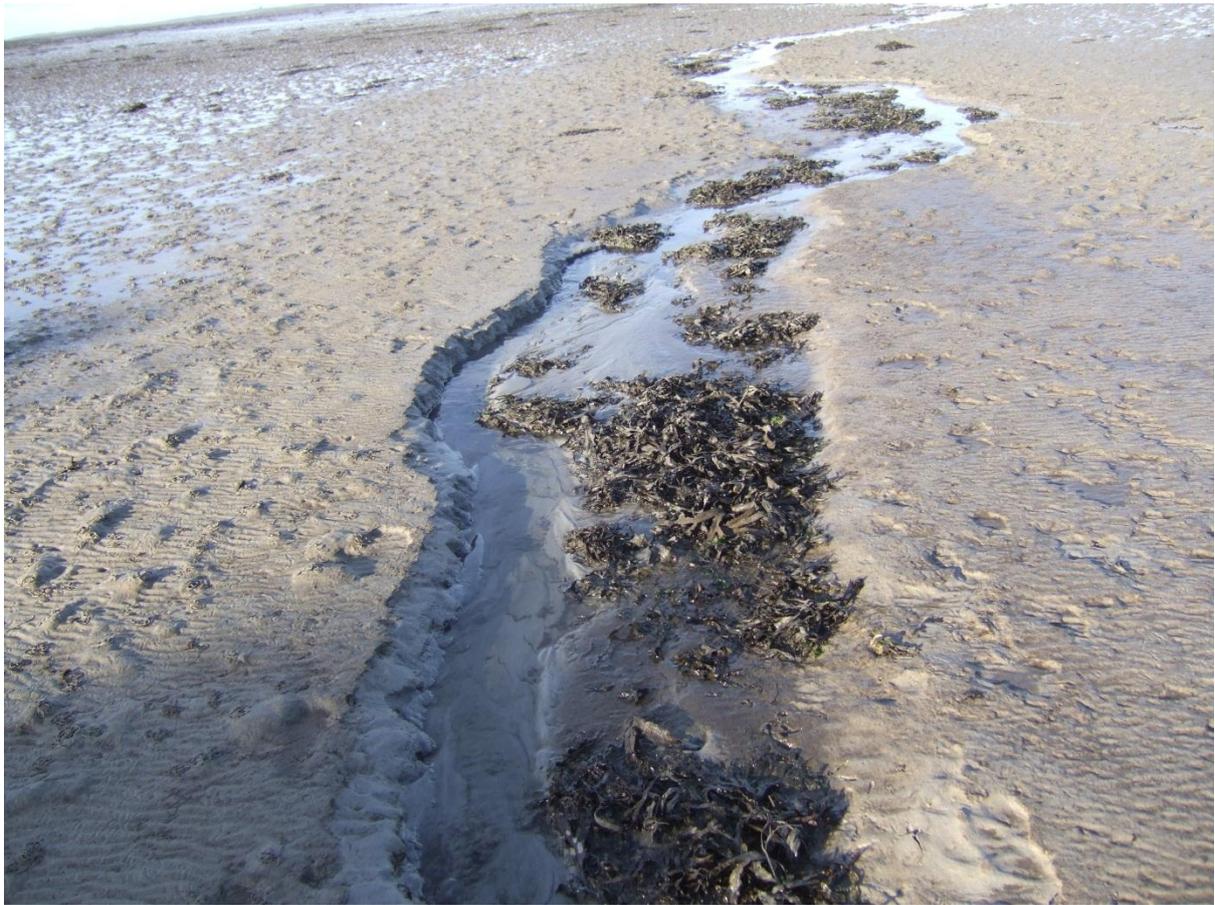
Plate 3. View of a seepage channel which emerges from the base of the rock armour.

A substantial drain enters at the westernmost end of the rock armour (water brown/red tinted at time of survey), and there were several channels/seepages entering from the base of the rock armour (water clear) (see Plate 3).

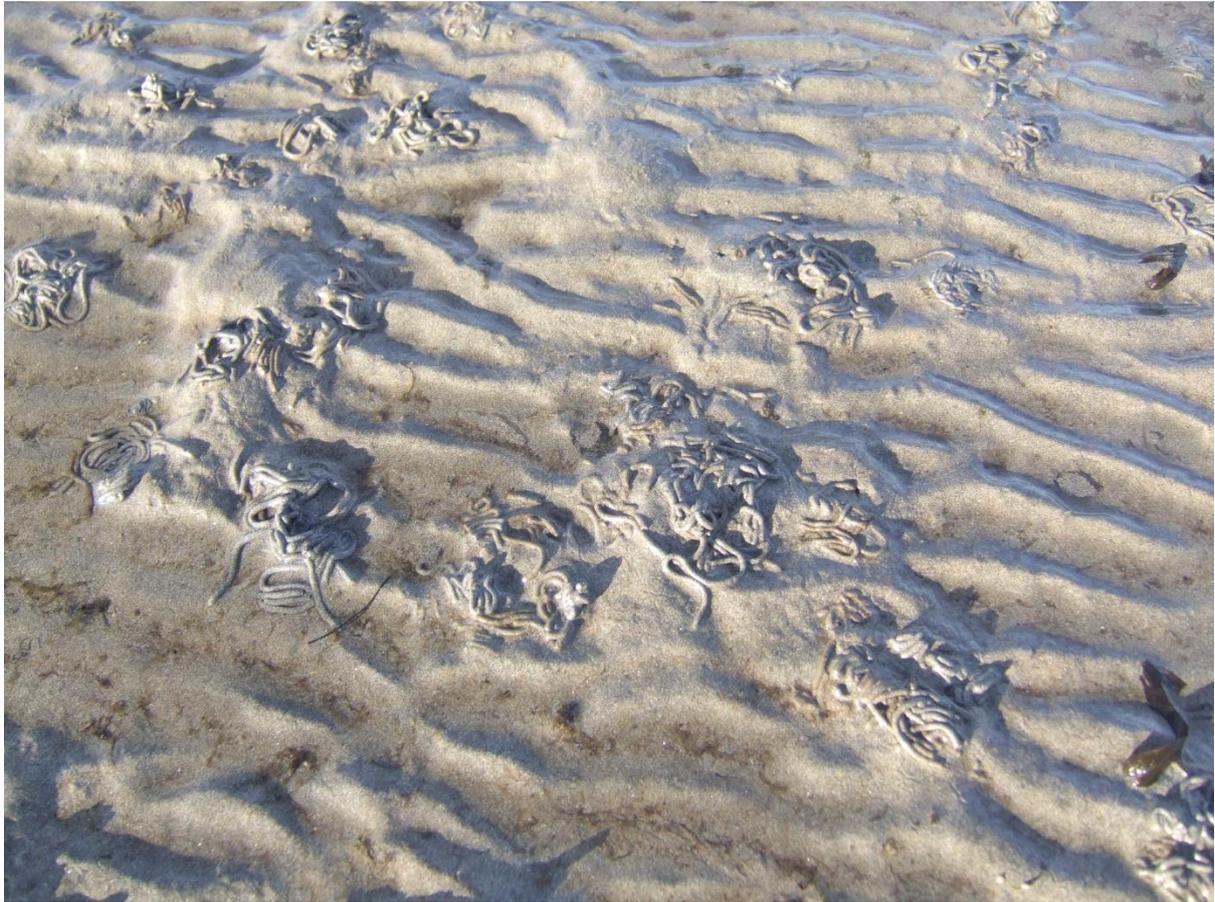
Plate 4. The sediments below the rock armour are medium to fine sands. These support a typical infauna, with good numbers of lugworms.

The lugworm *Arenicola marina* is a common component of the infauna, with casts frequent throughout (see Plates 4 &5). The cockle *Cerastoderma edule* was also fairly widespread in the sands. The small gastropod *Hydrobia ulvae* occurs in localised patches, with scattered thin tellin *Angulus tenuis* and Baltic tellin *Macoma balthica*. Thin worm casts were probably those of *Pygospio elegans*. Mussels *Mytilus edulis* occur washed up attached to strands of furoid algae of scattered rocks (a large mussel bed occurs c.500 m offshore north of Gibraltar Point).

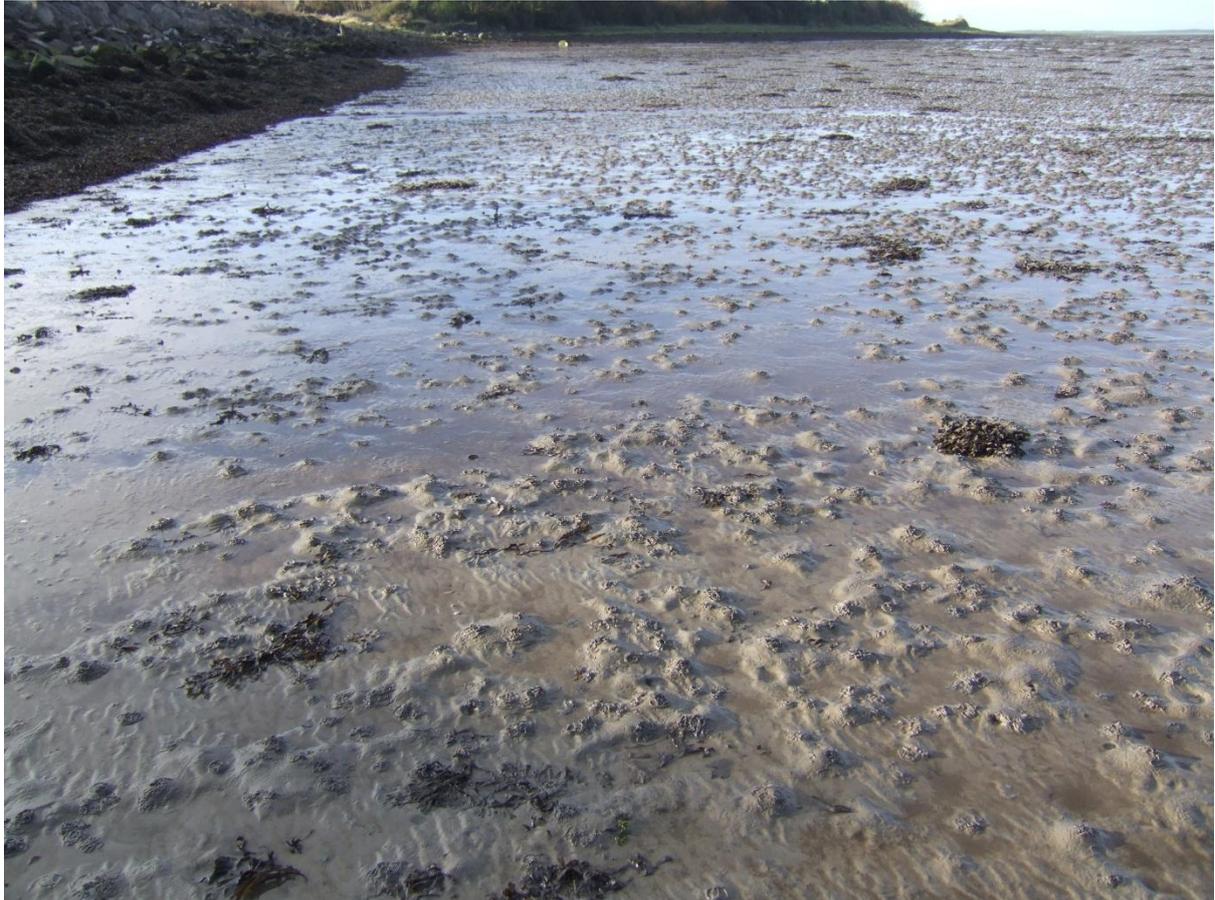
Plate 5. View of intertidal sediments with high density of lugworm casts (looking westwards).

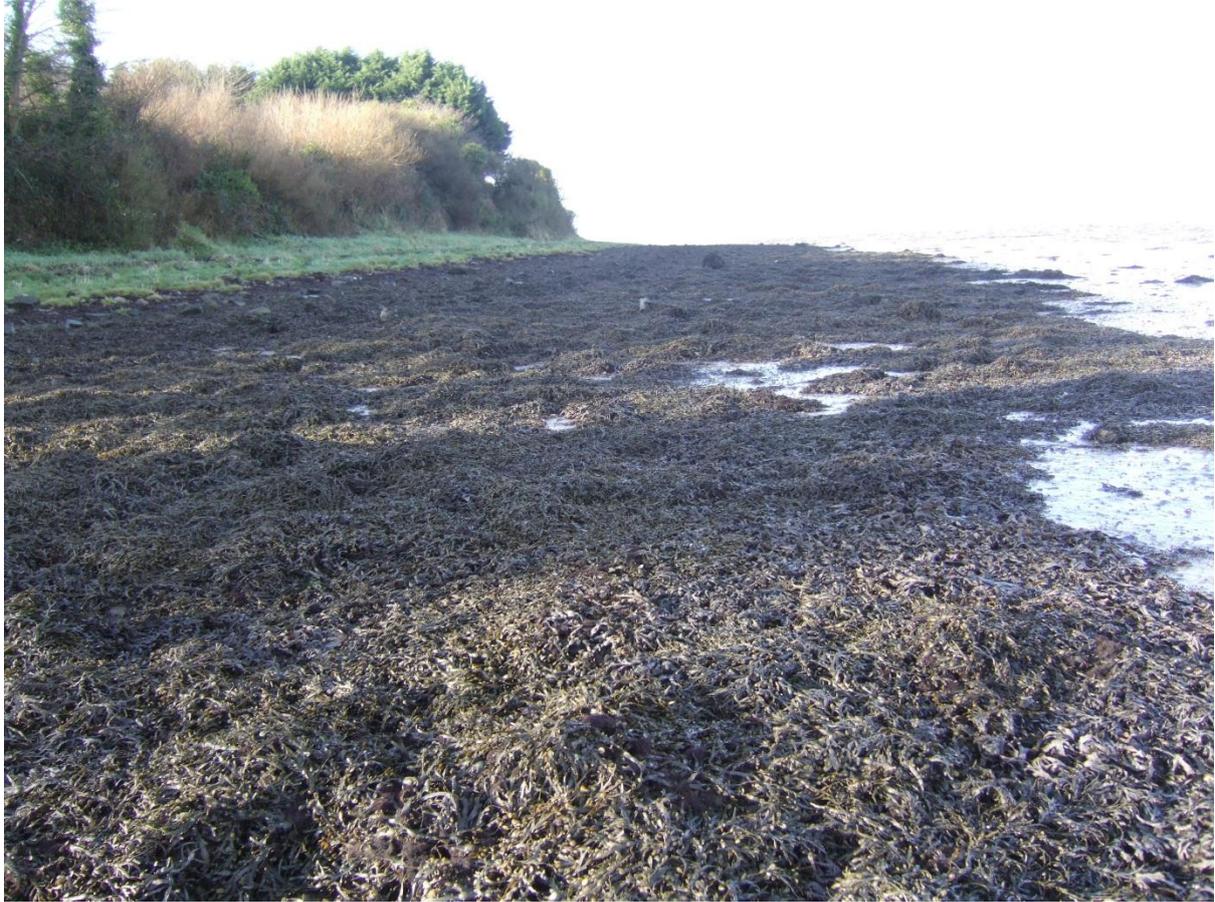
Plate 6. The natural shore to the west of the landfill has a wide furoid zone and a narrow salt marsh strip.

While the intertidal zone below the rock armour appears normal and similar to other areas in the harbour at this shoreline level, the upper shore has been removed by infill. This would have been a fairly sheltered area with a higher mud fraction expected in the sediments. The shoreline would have been marked by a wide fucoid zone on stones and gravel and probably a salt marsh fringe (similar to what still occurs immediately to the west of the rock armour and leading towards Gibraltar Point – see Plate 6).
