Desk Top Assessment

Lough Key

Priority Area for Action

Version F02

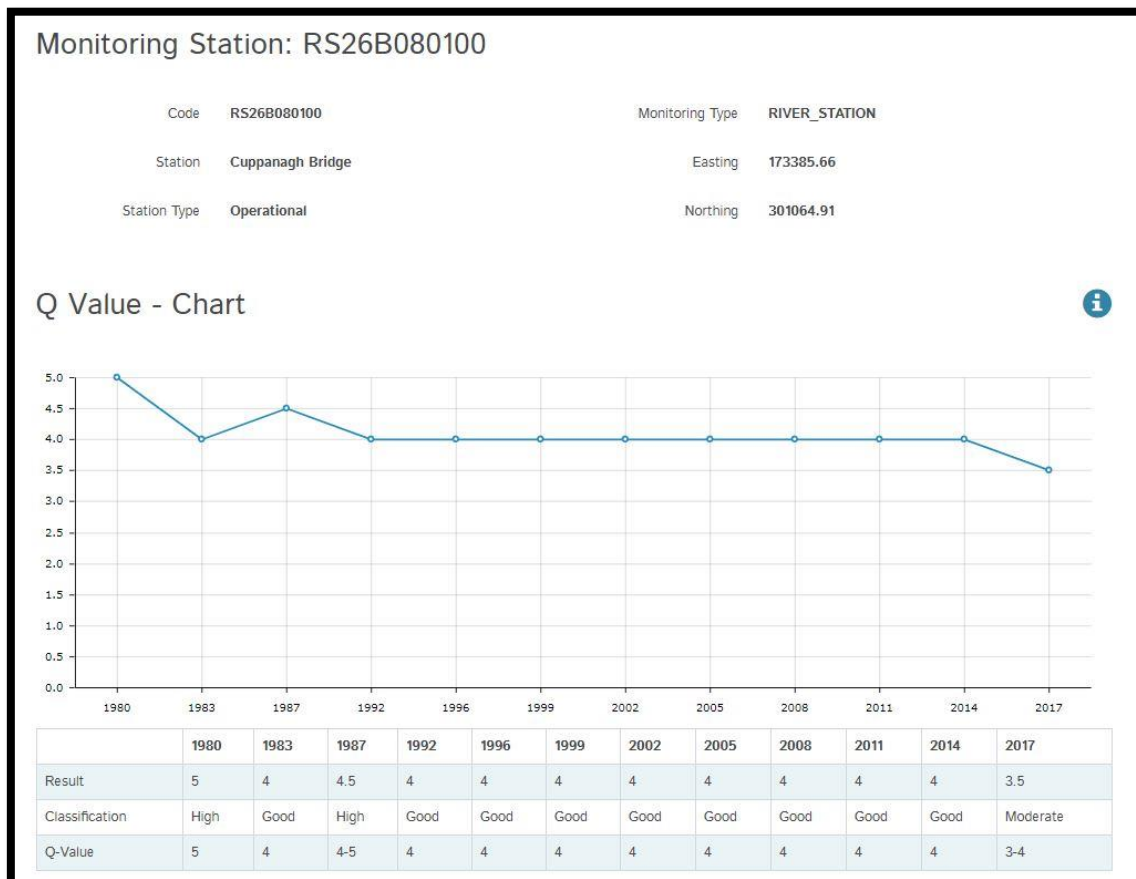
Figure 6 Q Values available for **Cuppanagh Bridge** – Invertebrates driving Status

The **Boyle_010** river waterbody is in the Boyle_SC_10 which is located upstream of the Lough Key PAA. This waterbody is *At Risk* and is at Moderate Status (2013-2018). There are two EPA Monitoring Stations on the Boyle_010; **Cuppanagh Bridge** (Operational) which has Q Values (**Figure 6**) and **Culwoe Bridge** (Investigative) which has no Q Value Data. There is Hydrochemistry data available for Cuppanagh Bridge only which is pre-2007. The annual average EQS was breached for total phosphorus, ammonia and nitrate historically for this site. (**Table 3**). The annual average EQS for BOD was breached in 1997 (1.64mg/l), 2006 (1.925mg/l) and 2007 (2.72mg/l).

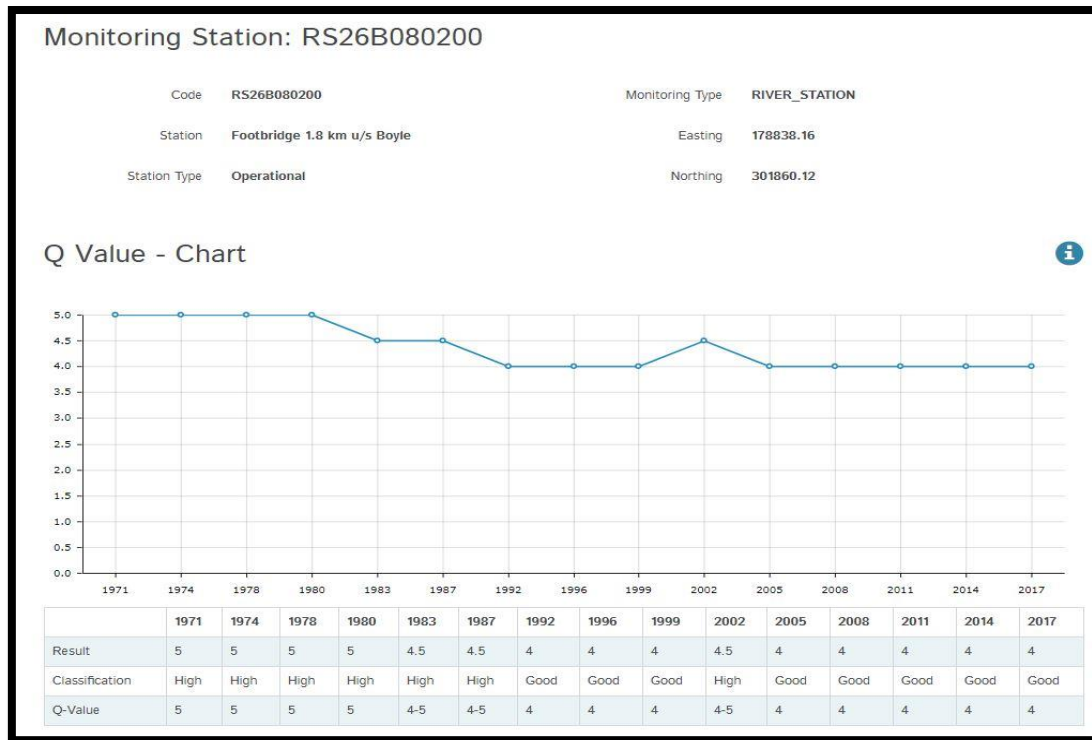
Figure 7 Q Values for *Footbridge 1.8km u/s Boyle*

The **Boyle_020** waterbody is *Not at Risk* and is at Good Status. It has one EPA operational monitoring station (**Footbridge 1.8km u/s Boyle**). The Q Values for this station can be seen in **Figure 7** below. The hydrochemistry data is detailed in **Table 5**. The hydrochemistry data for 2007 onwards does not indicate an issue with ortho-phosphate, nitrate, ammonia. In the late 90's/early 00's however, a spike in ortho-phosphate was noted (2002), and ammonium and nitrate exceedances. In addition, the annual average EQS for BOD was breached in 1998 (1.630mg/l), 2003 (1.597mg/l) and in 2005 (1.674mg/l).

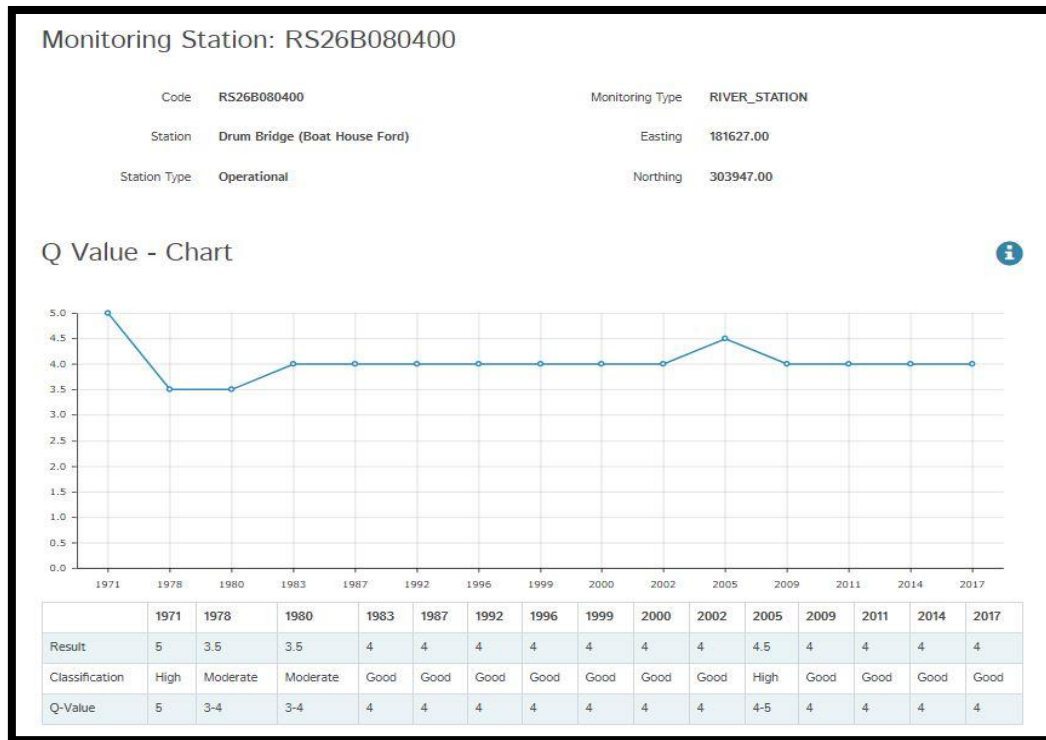
Figure 8 Q Values for Drum Bridge (Boat House Ford)

The **Boyle_030** is also *Not at Risk* and is at Good Status. It has one EPA operational monitoring station (**Drum Bridge (Boat House Ford)**). The Q Values for this station can be seen in **Figure 8** below. The hydrochemistry data is detailed in **Table 5**. The hydrochemistry data for 2007 onwards does not indicate an issue with the nutrient's ortho-phosphate, nitrate or ammonia, however it is noted that in the late 90's, ortho-phosphate, ammonium and nitrate levels were much higher than they are today indicating nutrient pollution issues at that time. In addition, there were breaches in the annual mean EQS for BOD in 1996 (1.563mg/l), 1998 (1.558mg/l), 2004 (1.933mg/l), 2006 (1.555mg/l), 2007 (1.6mg/l), 2008 (1.65mg/l) and 2014 (1.56mg/l).

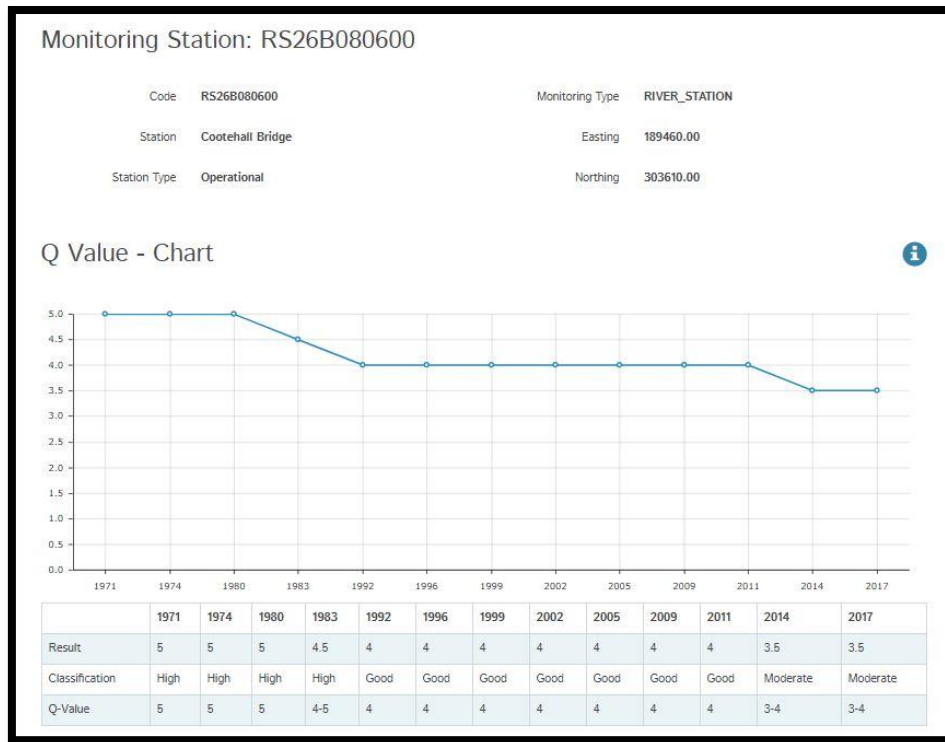
Figure 9 Q Values for Cootehall Bridge

The **Boyle_040** is *At Risk* and is at Moderate Status. It has one EPA operational monitoring station (**Cootehall Bridge**). The Q Values for this station can be seen in **Figure 9** below. The hydrochemistry data available from 2007 onwards does not indicate an issue with the nutrient's ortho-phosphate, nitrate or ammonia (**Table 5**). There has been no breach in either EQS for ammonia or ortho-phosphate since 2007. In the late 90's, a spike in ortho-phosphate was noted in 1997, while ammonium and nitrate levels were also significantly higher than they are today. In addition, there were exceedances in the annual Mean EQS for BOD in 2006 (2.034mg/l) and 2014 (1.59mg/l). It should be noted that the monitoring point however is downstream of Lough Key, and downstream of Oakport Lake, given its location at Cootehall Bridge, and therefore is not reflecting inputs to Lough Key.

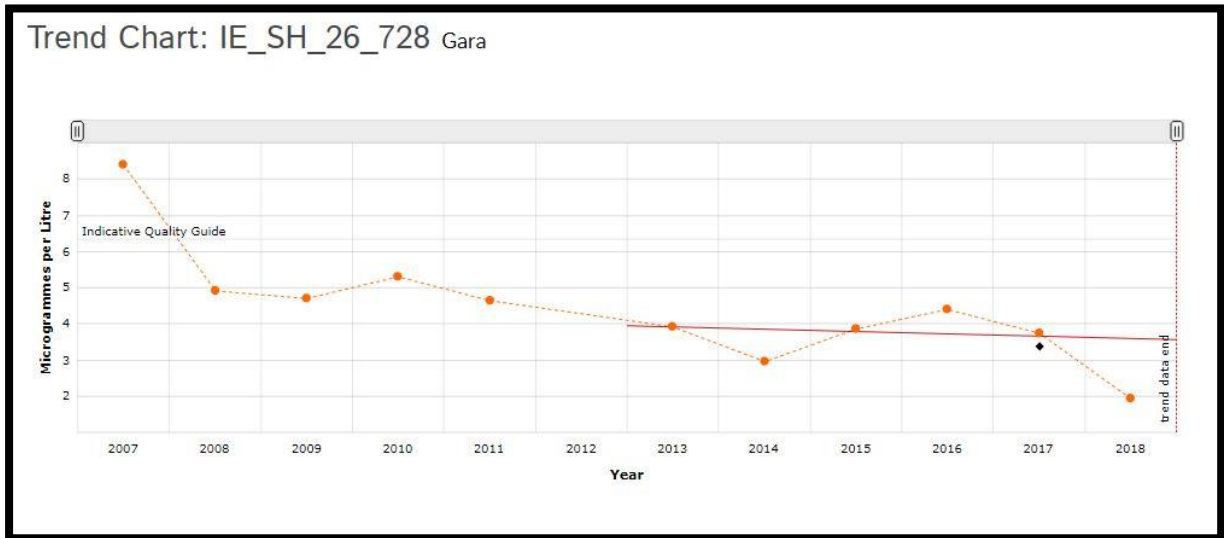
9.1 Chlorophyll Trend Chart for Lough Gara

Lough Gara is a low altitude, high alkalinity, shallow and large lake (Type 10). The mean EQS for total phosphorus was exceeded at Site 1, Site 2, Site 3 and Site 4 in 2020. There has been no exceedance since 2007 at Site 5. Chlorophyll levels have been below the good/moderate boundary for all sites except Site 4 in 2007. Zebra mussels are present in the lake. It should be noted that Phytoplankton biomass (chlorophyll) should be used with caution for assessing lake ecological and trophic status when zebra mussels are present (S.I No. 77 of 2019 Surface Water Regulations Amendment). The Lough Gara North Roscommon Regional Supply Scheme was non-compliant for pesticides in 2015. The key issues in this source were MCPA and Glyphosate. However, there has been no evidence of ongoing issues with pesticides based on recent updates from the National Pesticides in Drinking Water Action Group.

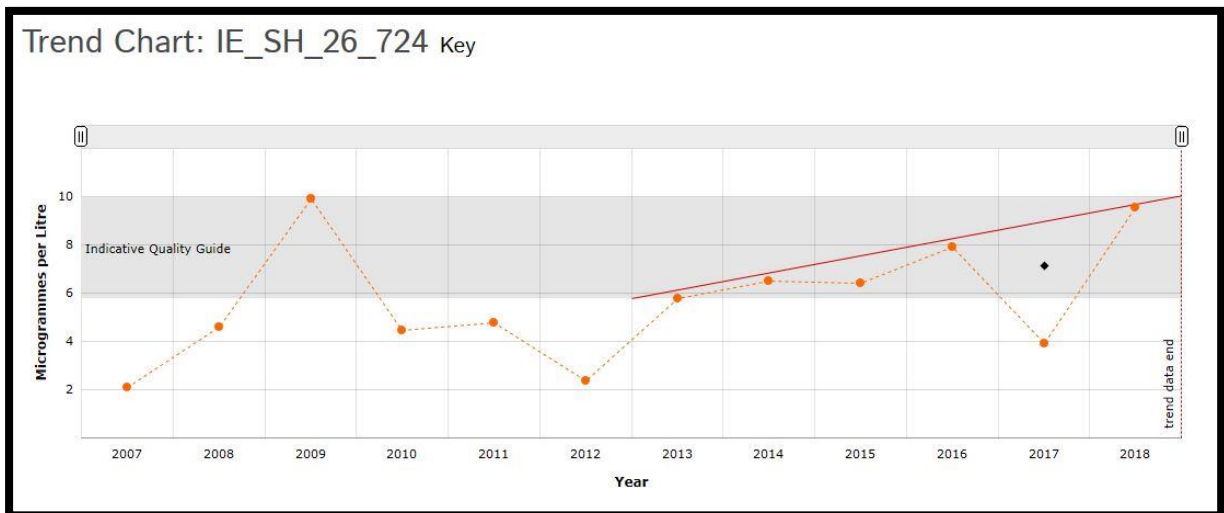
9.2 Chlorophyll Trend Chart for Lough Key

Chlorophyll levels have also been below the good to moderate boundary for the majority of years between 2008 and 2020 except for Station 30 in 2009 and 2018 and Station 40 in 2020. It should be noted that phytoplankton biomass (chlorophyll) should be used with caution for assessing lake ecological and trophic status when zebra mussels are present (S.I No. 77 of 2019 Surface Water Regulations Amendment).
