**Environmental  
Monitoring Services at the  
Former Mining Areas of  
Silvermines (Co. Tipperary)  
and Avoca (Co. Wicklow)**

**Avoca Monitoring Report -  
Round 8**

August 2021

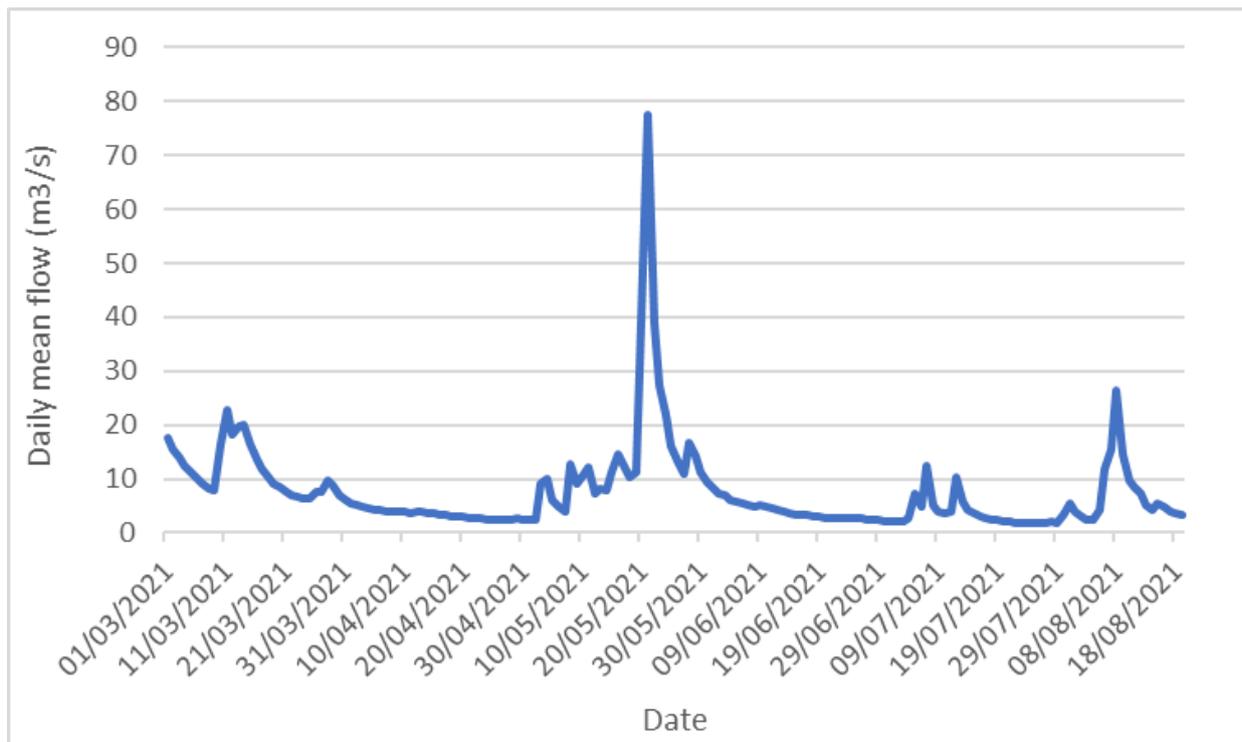
**Figure 1 Mean Daily Flow (m<sup>3</sup>/s) at Whites Bridge (Station 10044) from 01 March 2021 to 19 August 2021**

Figure 1 shows the flow data (hydrograph) from 01 March 2021 to 19 August 2021 for Whites Bridge GS. The hydrograph shows the flow ranged from a low of approximately 1.67 m<sup>3</sup>/s in late-July to a high of 77.5 m<sup>3</sup>/s in late May. The river is flashy in nature, showing a rapid response to rainfall. The median flow for this period, 4.84 m<sup>3</sup>/s, was nearly half the long-term (2009-2021) median of approximately 8.18 m<sup>3</sup>/s. The lowest flow 1.67 m<sup>3</sup>/s (July) was below the 95%-ile flow (Q95, low flow) for the river (2 m<sup>3</sup>/s).

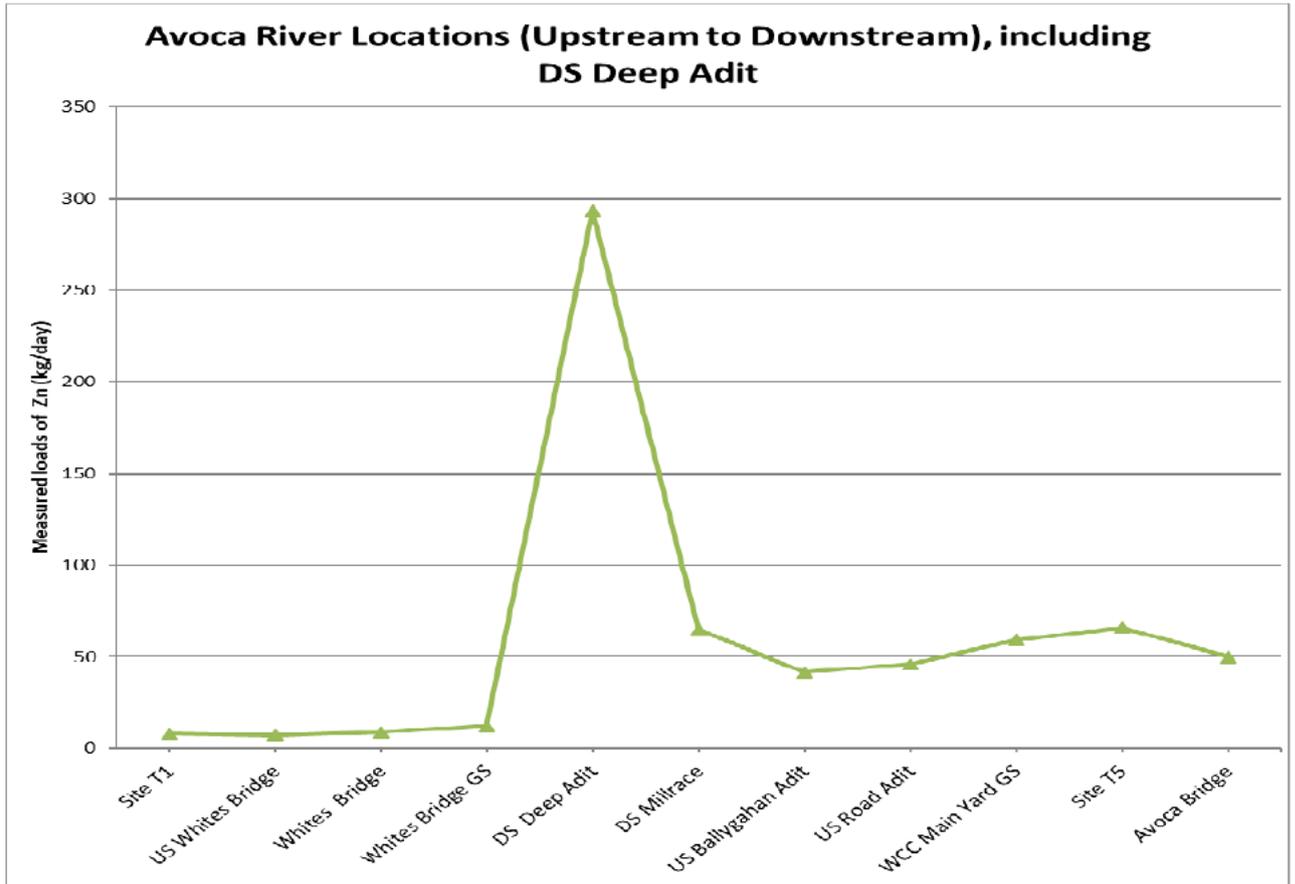
Figure 2 Calculated Loads of Dissolved Zinc (Kg/day) in the Avoca River (including DS Deep Adit) in August 2021

Background metals loads upstream of the Avoca Mining Area were calculated using Site T1 data. Figure 2 and Figure 3 show the loads of dissolved zinc, and copper, respectively, at each location along the Avoca River from Site T1 upstream of the mining area to Avoca Bridge (see also Map 1 and 3 in [Appendix A](#)). Composite samples could not be collected due to the flow conditions and therefore loading estimates contain a relatively high level of uncertainty. It is expected that the concentrations (and thus loads) at DS Deep Adit are elevated due to bank sampling and incomplete mixing of the Deep Adit discharge with the stream at this sampling location, leading to inflated results. Due to the very high concentrations and thus loads of metals in this sample, inclusion of these data in the graphs obscures the information for the other sites. To permit full interpretation of the data, Figure 2 and Figure 3 include the load data for DS Deep Adit, while Figure 4 and Figure 5 exclude the load data for DS Deep Adit.

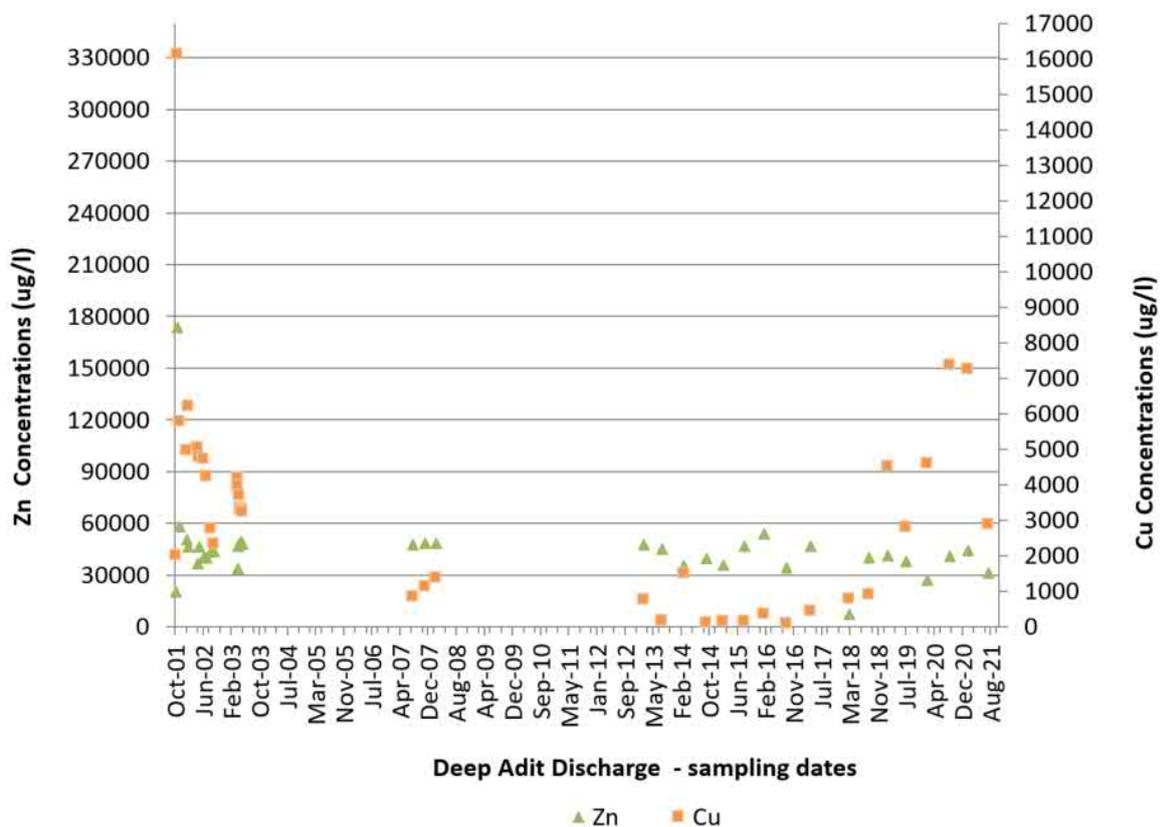
Figure 6 Concentration trends for dissolved copper and zinc within the Deep Adit Discharge (and Deep Adit plus 850 Adit from 2014)

Note, as previously discussed, after the box culvert was constructed in October 2014, the 850 Adit flow and the Deep Adit flow were combined so that measurements at the exit to the box culvert (Deep Adit) reflect the flow from the Deep Adit plus the 850 Adit and US Tigroney West.

- There is no trend in dissolved copper at Avoca bridge, while it is increasing at the Deep Adit and increasing at the Road Adit. As noted above, the concentration of dissolved copper at Avoca bridge has been above the ecological assessment criteria of 5 µg/L since mid-2002.
- Dissolved iron is both decreasing in the Deep Adit and in the Road Adit.
- Dissolved zinc is decreasing at all three locations. Dissolved zinc has been above the ecological assessment criteria of 50 µg/L at Avoca Bridge since mid-2002, as shown in Figure 9.

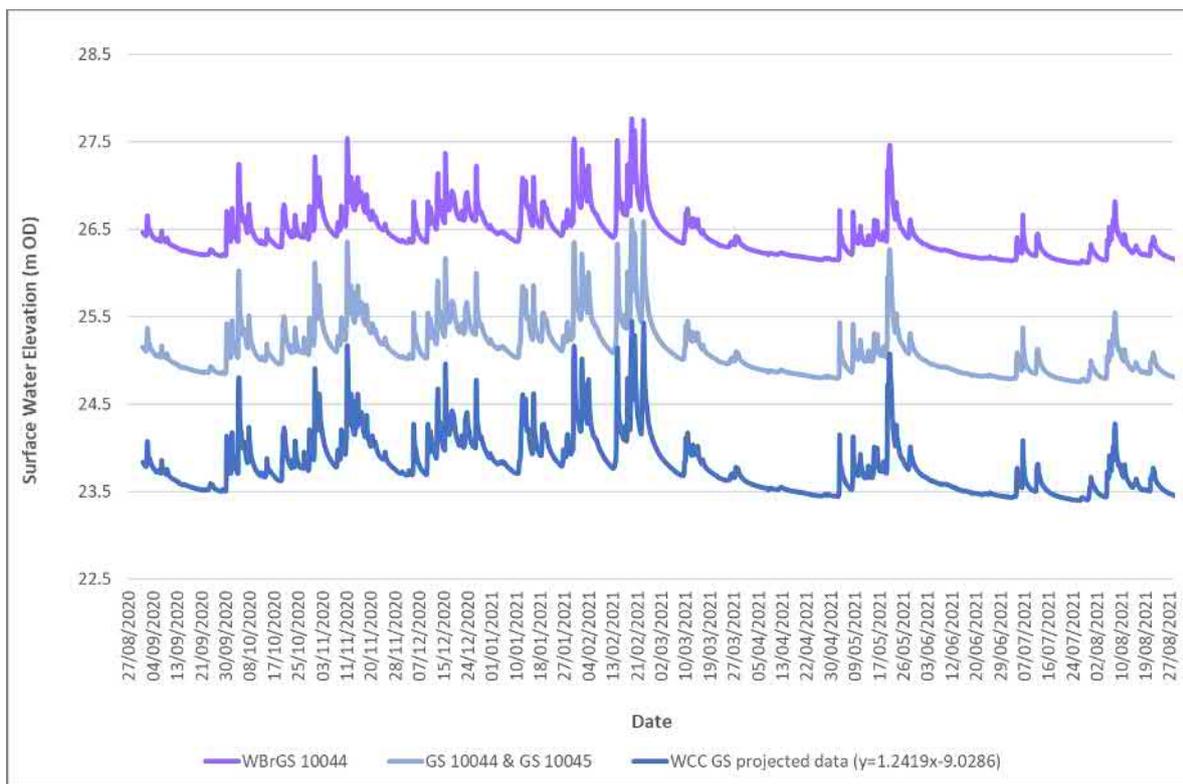
**Figure 9 Elevation of the Avoca River at GS 10044 Whites Bridge and GS Wicklow County Council Maintenance Yard 10045 (projected) and their interpolated mid-point level to represent the river at the Deep Adit Area from 01 September 2020 to 31 August 2021**

As described in Section 5.1 Surface Water Flows, there were two EPA stream flow gauges on the Avoca River near the mine site: Whites Bridge GS (EPA station 10044) and the Wicklow County Council Maintenance Yard (EPA Station 10045). Wicklow County Council Maintenance Yard (EPA Station 10045) was decommissioned in February 2020. Hourly water level data for Whites Bridge GS (EPA station 10044) for the entire monitoring period were obtained from the EPA. Previous data has shown that the river responds similarly at both gauging stations. An analysis of previous water level data for the two locations found there was a predictable relationship between the water level at Whites Bridge GS (EPA station 10044) and the Wicklow County Council Maintenance Yard (EPA Station 10045);  $y=1.2419x-9.0286$ , where  $y$  is the level at Wicklow County Council Maintenance Yard and  $x$  is the level at Whites Bridge GS, with excellent correlation between values ( $r^2=1$ ). This equation was used to predict the Wicklow County Council Maintenance Yard using the Whites Bridge GS levels. The distance between the two gauging stations is approximately 470 metres. The measured and extrapolated water elevations from 01 September 2020 to 31 August 2021 are reproduced in Figure 9. The calculated elevations (average) of the Avoca River at the mid-point between the two automatic flow gauges are also shown in Figure 11.

Previous data has shown that the average gradient between the two gauges is 0.006. Streambed characteristics and the elevations both influence the flow rates and help define any apparent losses or gains in river flow.

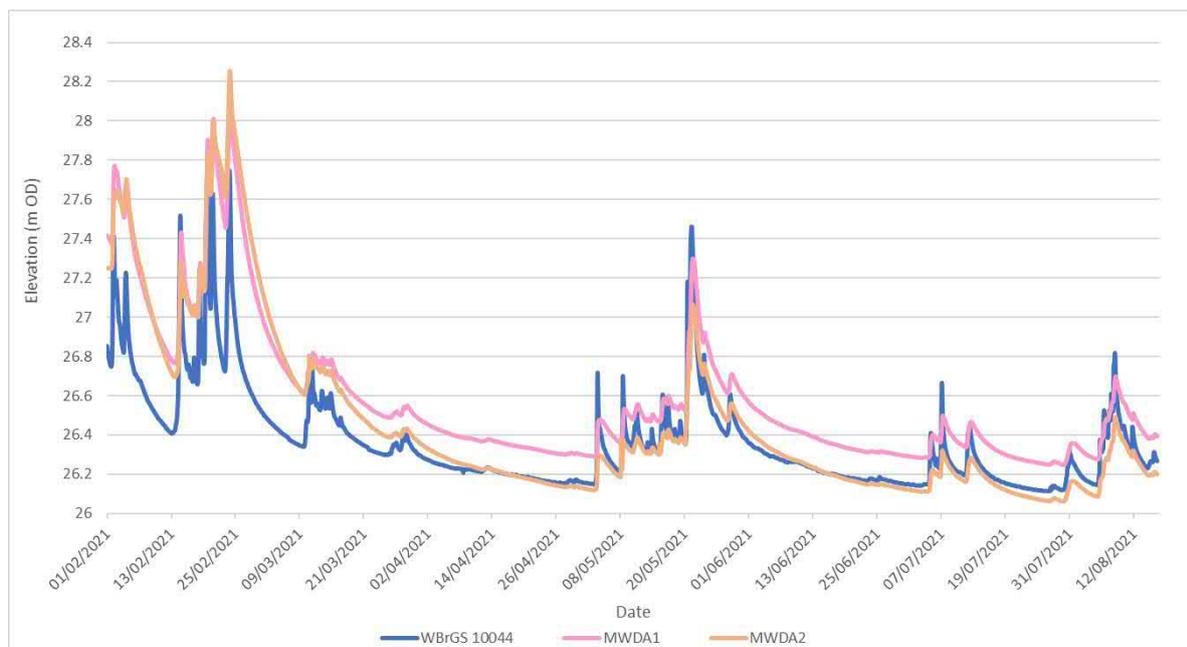
**Figure 10 Comparison of Groundwater Elevation and Elevation of the Avoca River (GS 10044) at the Deep Adit Area from 01 February to 16 August 2021**

Both figures show that there were several significant hydrological (rainfall) events which resulted in groundwater levels rising. For example, groundwater levels rose by approximately over 75 cm (MWDA1 (78 m) and MWDA2 (60 m)) on 20/21 May 2021. This peak was in response to river levels which rose by 96 cm during the same event. In general, the head observed in the monitoring wells is above the water levels in the river. However, the opposite can occur for major increases of the water level in the river, which follow periods of low to moderate rainfall (illustrated by individual rises in water level).

The implication is that the spoil and the alluvial areas on both sides of the river contribute contaminant load to the river. However, Figure 10 (Deep Adit area) shows that a negative gradient occurs on occasion between both MWDA1 and MWDA2 and the river during periods of high flow, particularly when a major rise in river water level follows a period of low or moderate rainfall, as mentioned previously. This phenomenon highlights the slower response of the alluvium compared to the faster response of the river. For example, the rise in river level on 20/21 May 2021 resulted in higher water elevation in the river than in the wells the MWDA2 and MWDA1 wells (i.e., negative gradient), indicating that water moved from river into the surrounding alluvium spoils at this time.

The projected elevation of the river was higher than that of MWDA2 (i.e., negative gradient) occasionally during the monitoring period (Figure 10). In turn, negative gradients occurred infrequently for the shallower well MWDA1. The average gradient at MWDA1 during the period measured was 0.005m. The average positive gradient indicates that shallow groundwater in the Deep Adit area was discharging to the Avoca River for the majority of the monitoring period. The gradient is comparable to that normally measured between the river and MWDA1, allowing climatic variability (rainfall and evaporation) etc.

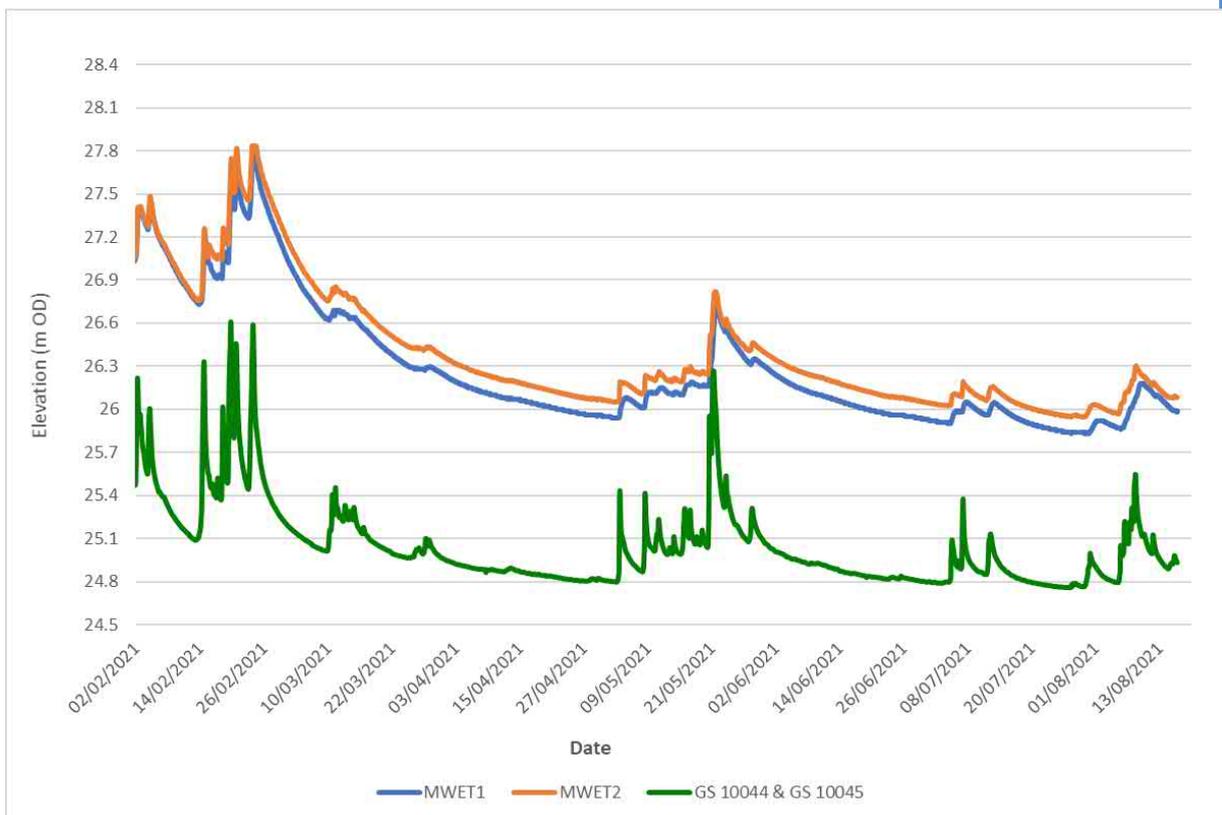
**Figure 11 Comparison of Groundwater Elevation and Elevation of the Avoca River (GS 10044 & 10045) at the Emergency Tailings Area from 01 February to 16 August 2021**

Except for one occasion for MWET1 on 28 July 2021, only positive gradients were observed for MWET1 and MWET2 with a minimum positive gradient of 0.003m (MWET1) and a maximum of 0.029m (MWET2). The average gradients of MWET1 and MWET2 were 0.016 and 0.019 respectively for the period 01 February to 16 August 2021. Note, the elevations are based on the GPS survey of the boreholes and the river water elevations were estimated using both the Whites Bridge GS elevation and the projected Wicklow County Council Maintenance Yard because they are located equidistance between the gauges.

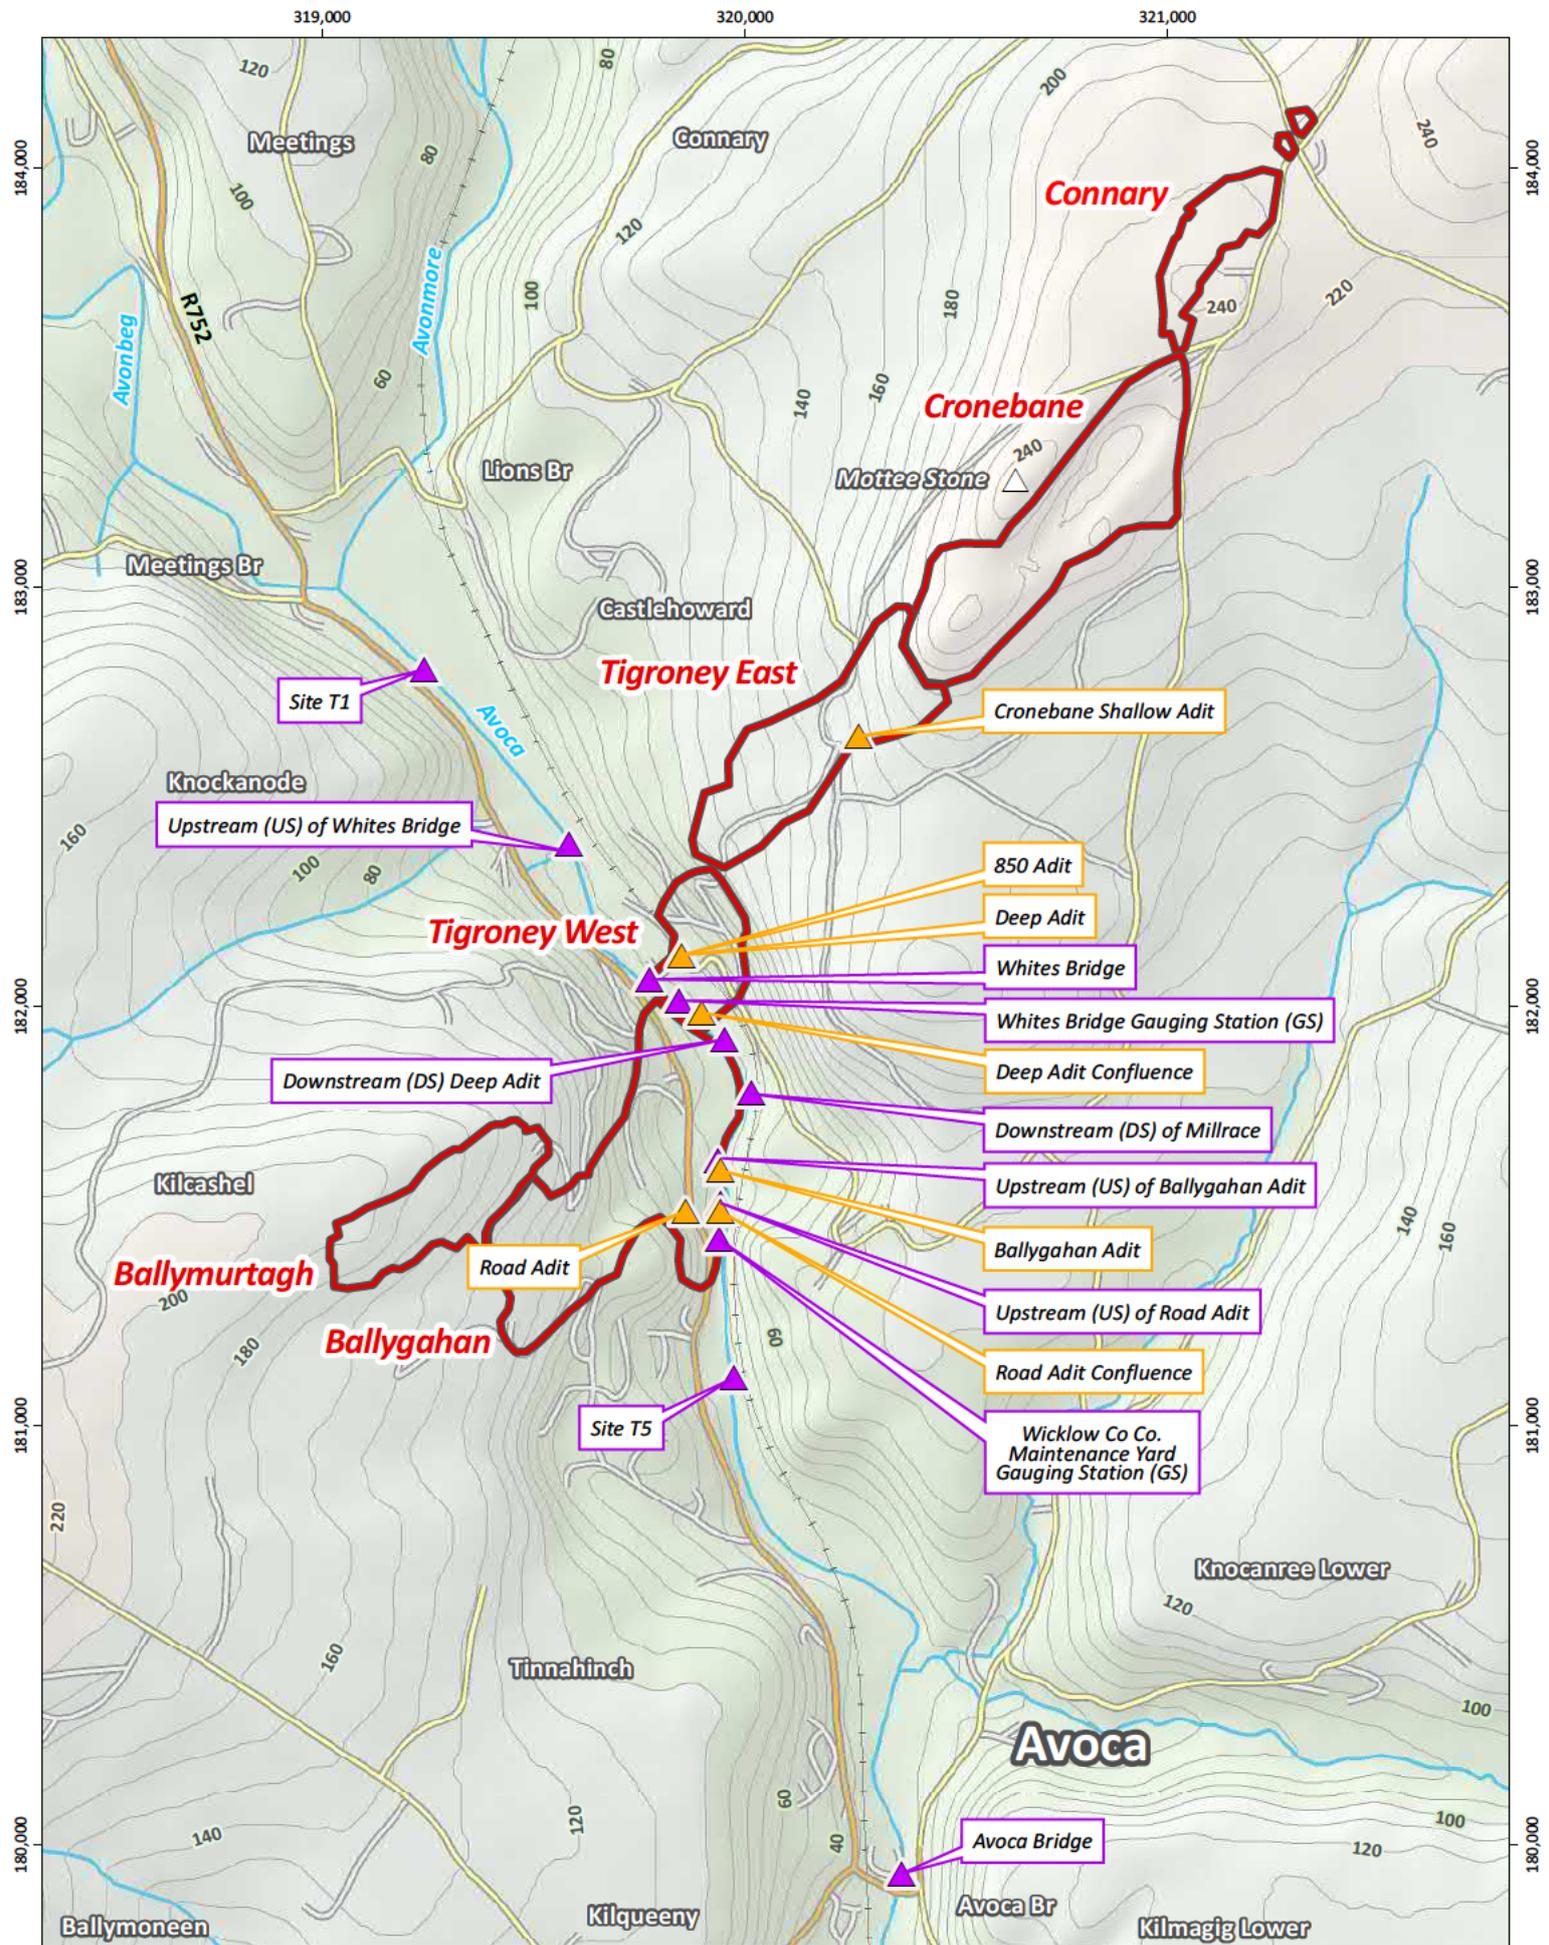
### Map 1 - Avoca - Main Area

Map 1 in [Appendix A](#) shows the adits with active discharges that were sampled and are described in this section.

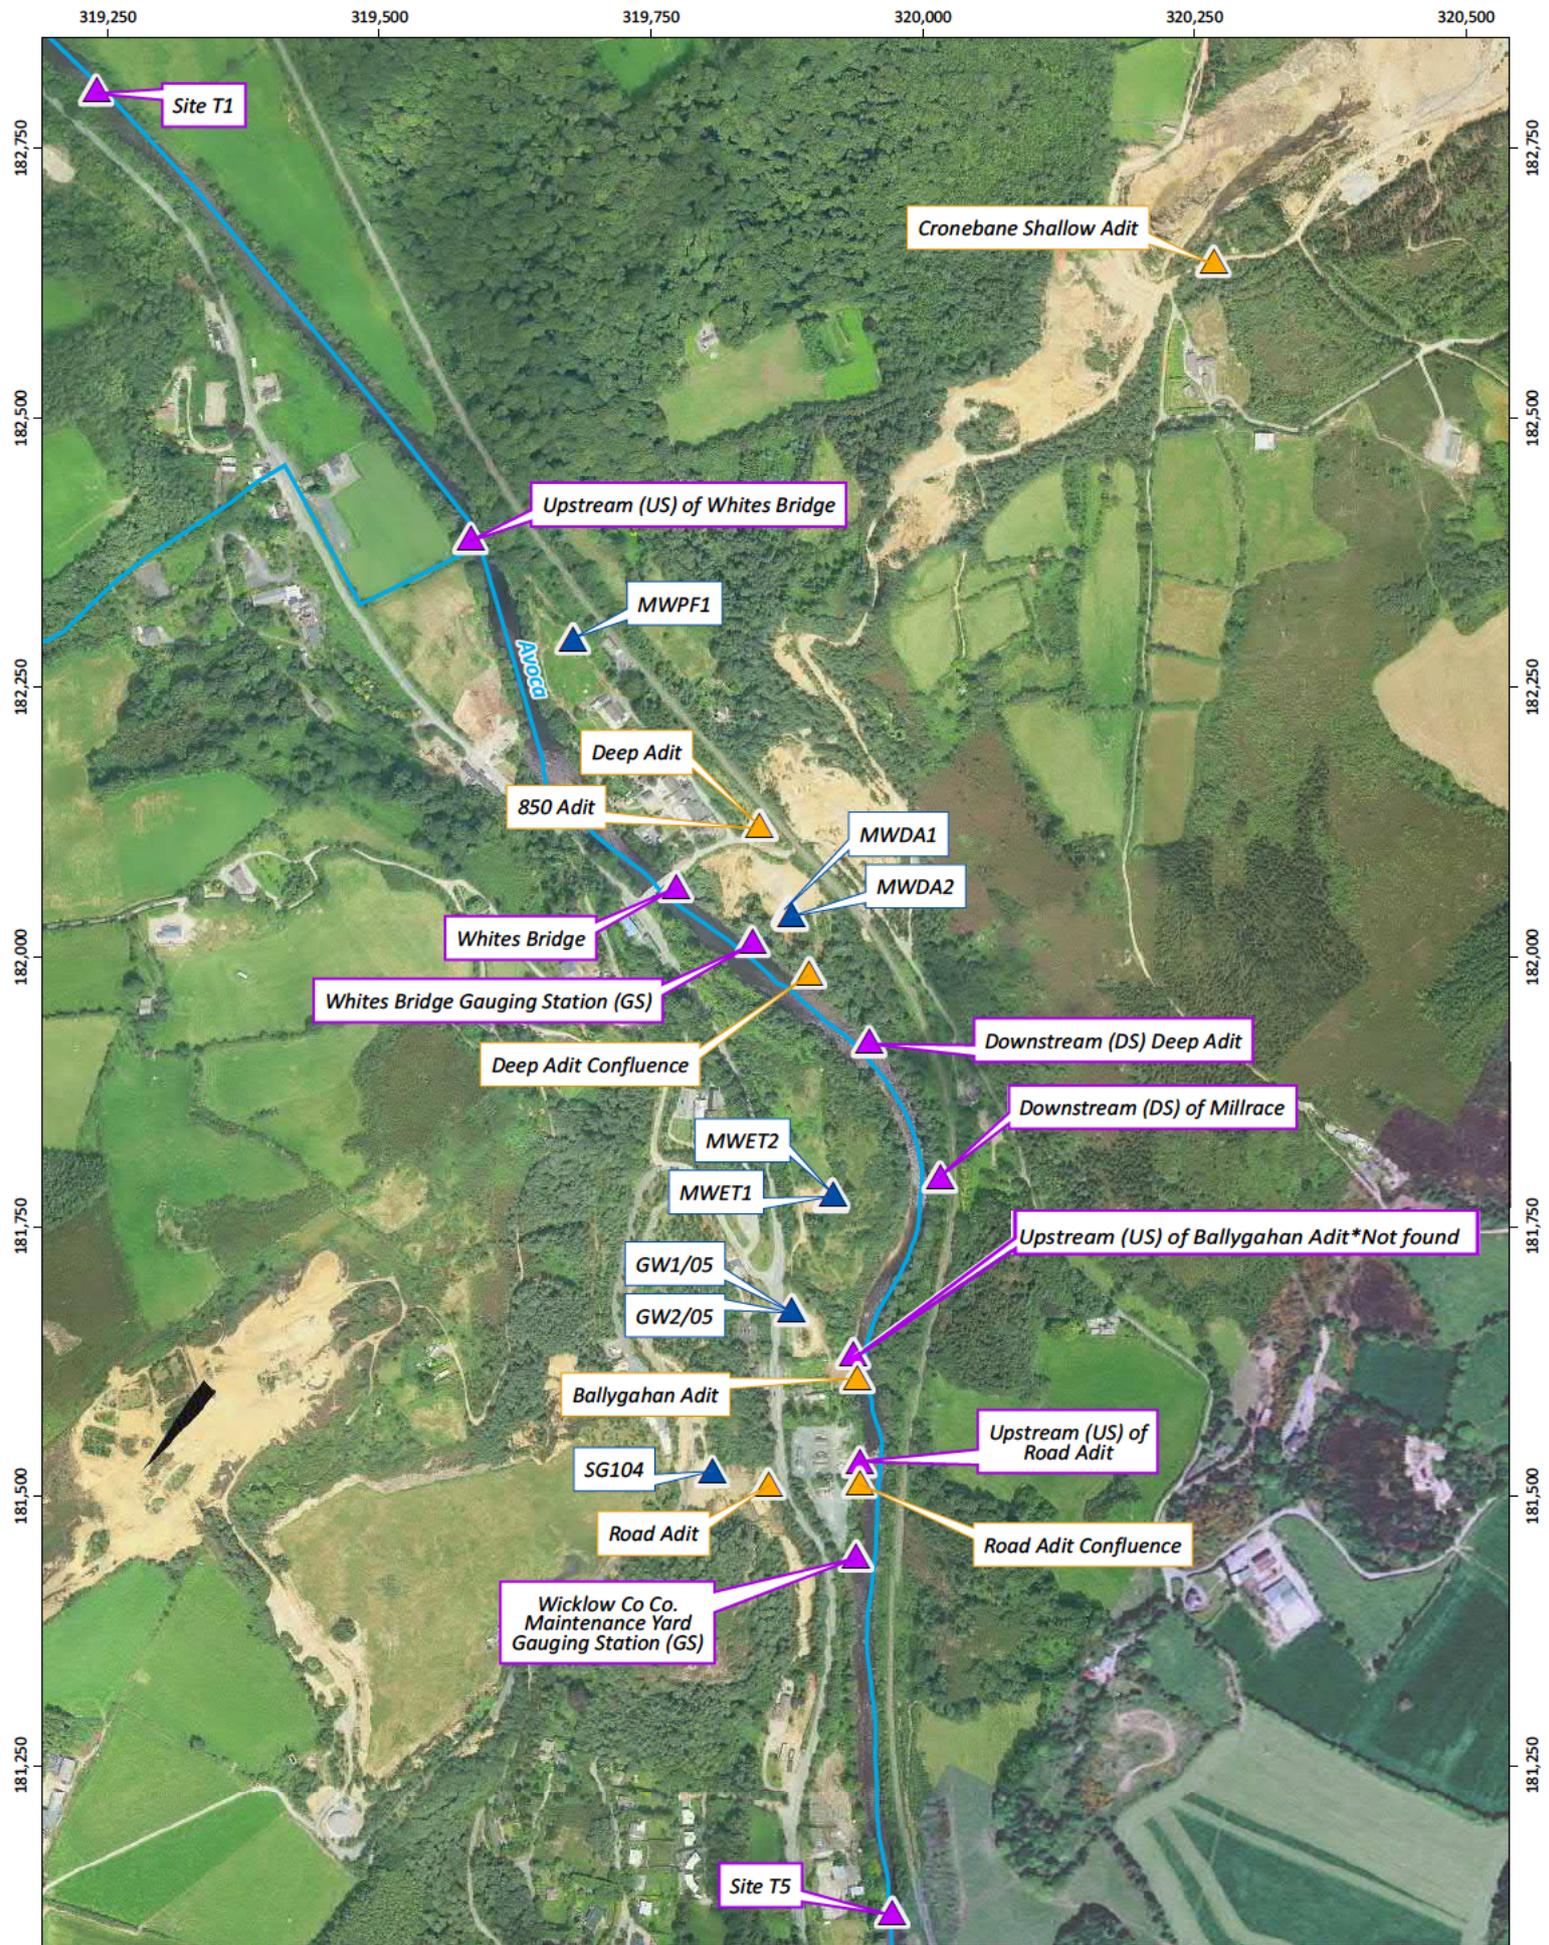
### Map 3 - Avoca - Main Area - Surface Water and Groundwater

There is one EPA stream flow gauge on the Avoca River near the mine site, Whites Bridge gauging station (GS) (EPA station 10044). There was a second Gauging Station, Wicklow County Council Maintenance Yard GS (EPA Station 10045), however, this was decommissioned in February 2020, and it not included in this report for the purposes of surface water flows. Previous reports have found that the river responds similarly at both gauging stations. Whites Bridge GS is located 90 m downstream of Whites bridge and just upstream of the confluence of the Deep Adit discharge as shown on Map 3 in [Appendix A](#).
