Agricultural related water quality issue examples forwarded by Regional Operational Committee implementing bodies

**Observations on Agriculture GAP Regs compliance and good practice 2021
Presentation to ASSAP Farm Consultative Group Meeting 24 Jan 2022 &
discussion through WFD governance structure: SE and SW ROCs &
SERWEMC*

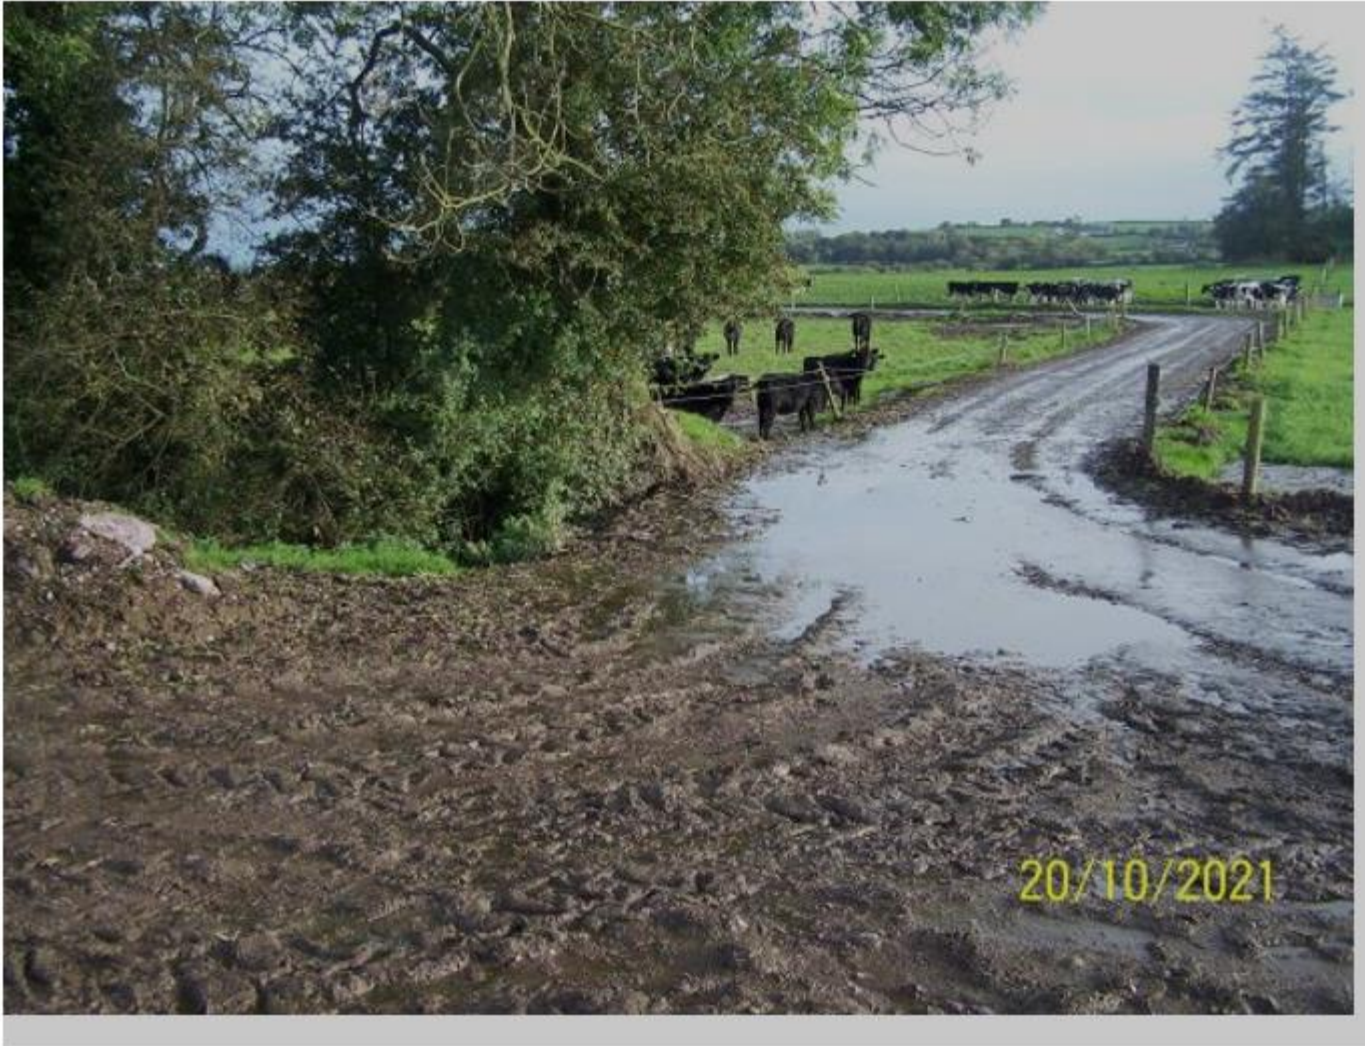
Farm Roadway impact

Roadway discharging to drain

Derogation dairy farm.

1. Small stream discharging to **Inniscarra Reservoir**.
2. Inniscarra is a reservoir which supplies a -
3. major **drinking water abstraction** for Cork city south suburbs, Ringaskiddy, Carrigaline & surrounds.

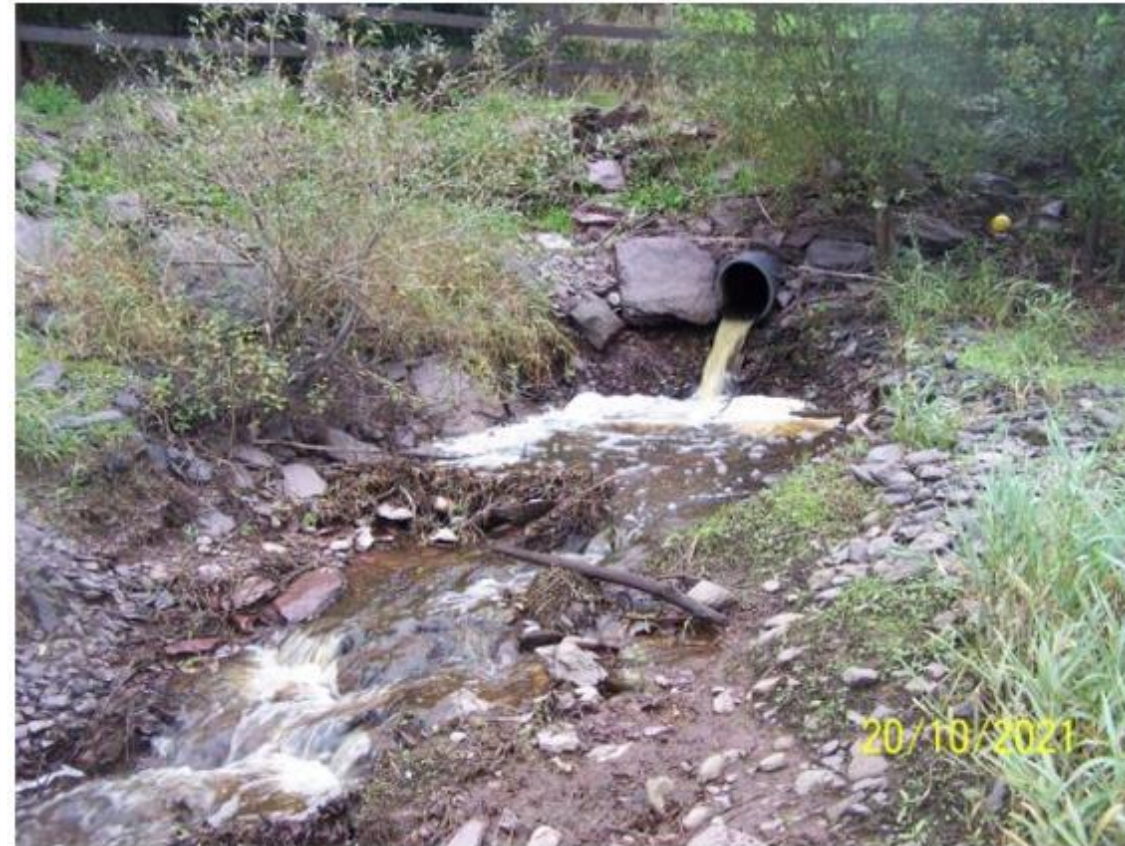
Dairy Derogation

1. reseeded grassland and drain cleaning
2. length = 300m approx.
3. Awbeg R – **important for Salmon, brown trout**
4. in a priority Area for Action
5. the entire drain within the SAC boundary

This was what the drain looked like before it was cleaned, this is immediately downstream of bridge

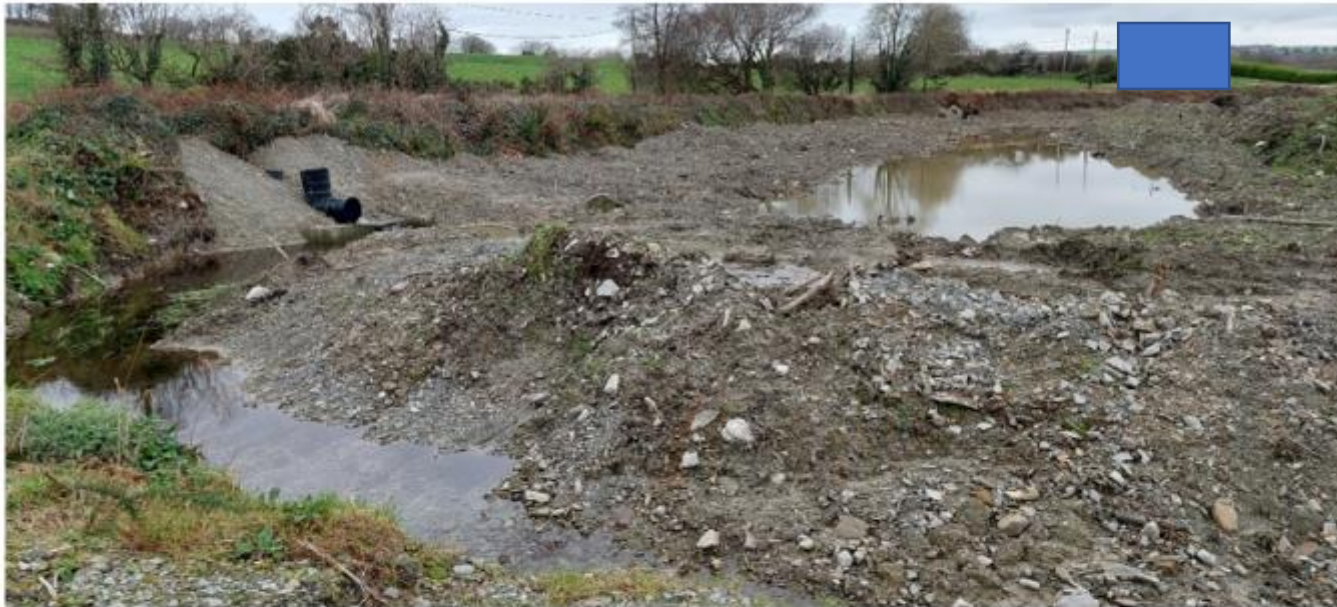
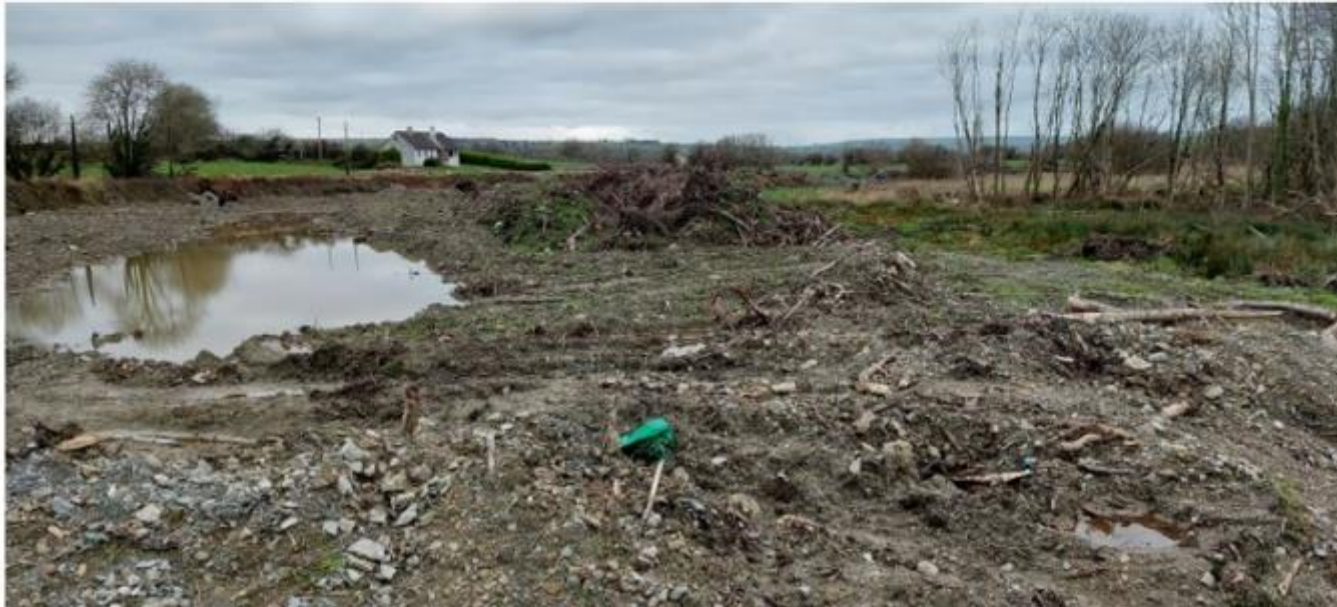
Unknown farm type

1. Streams rerouted and area excavated
2. upstream of an SAC, SPA and pNHA

Aerial photo showing land parcel in forestry circled in red, area which was cleared is circled in green, this happened in last few months. Reported to IFI & Forest Service.

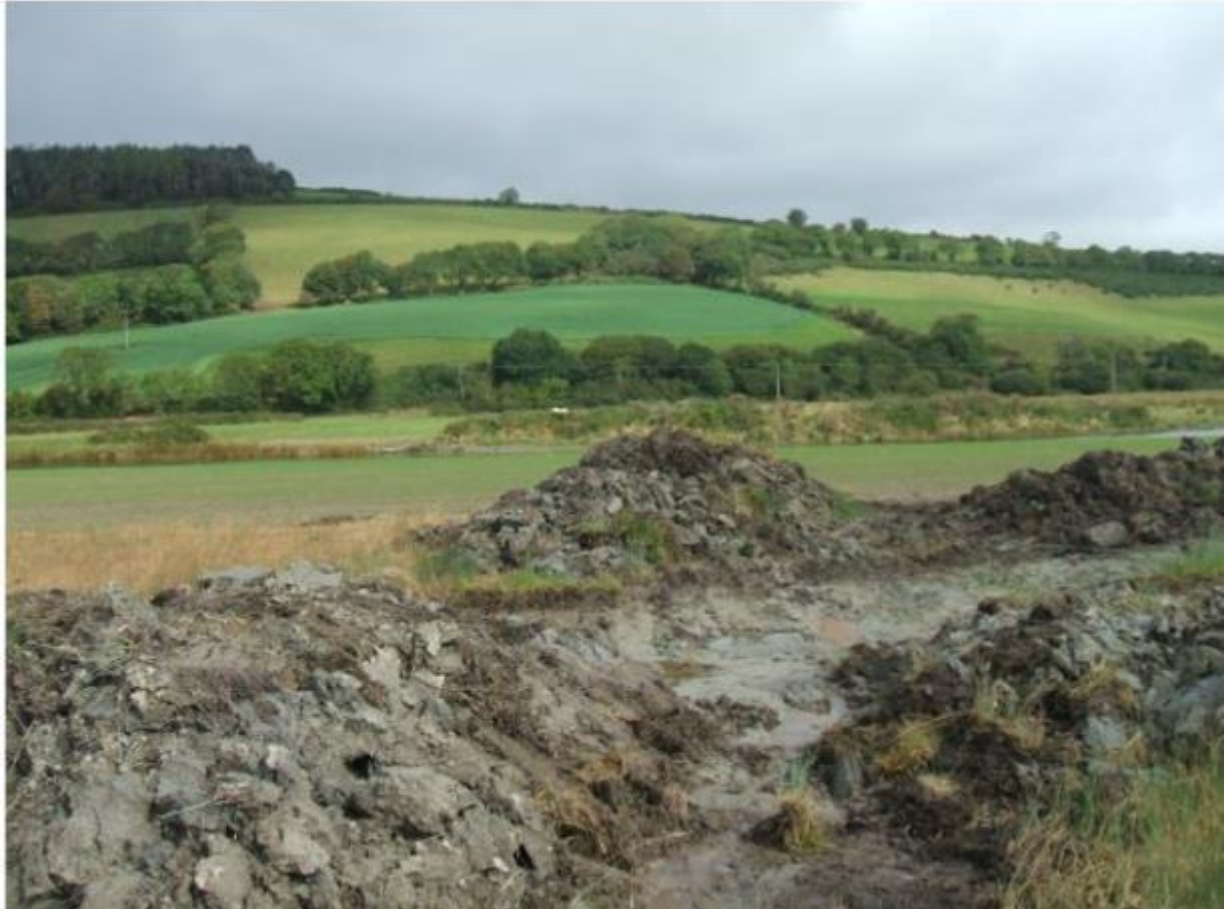
Example of Drainage work, claimed to be clearing old drains.

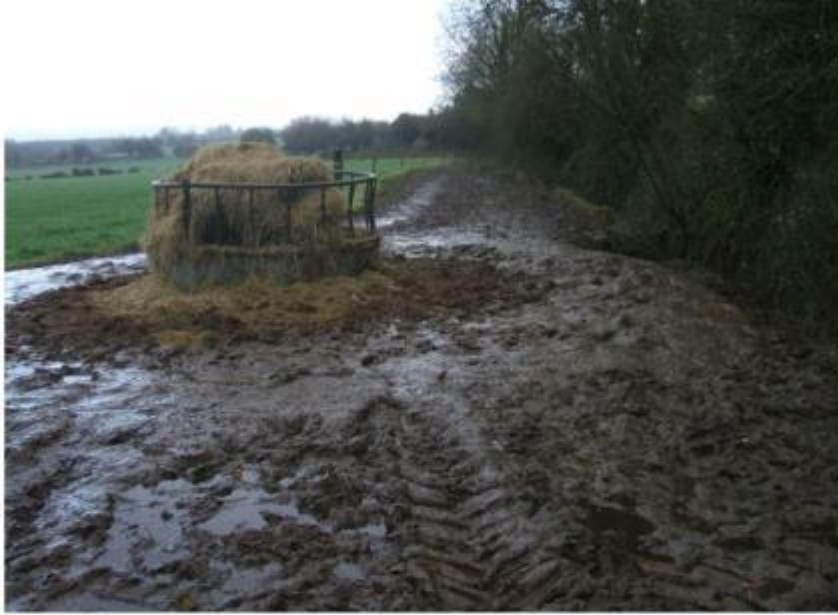
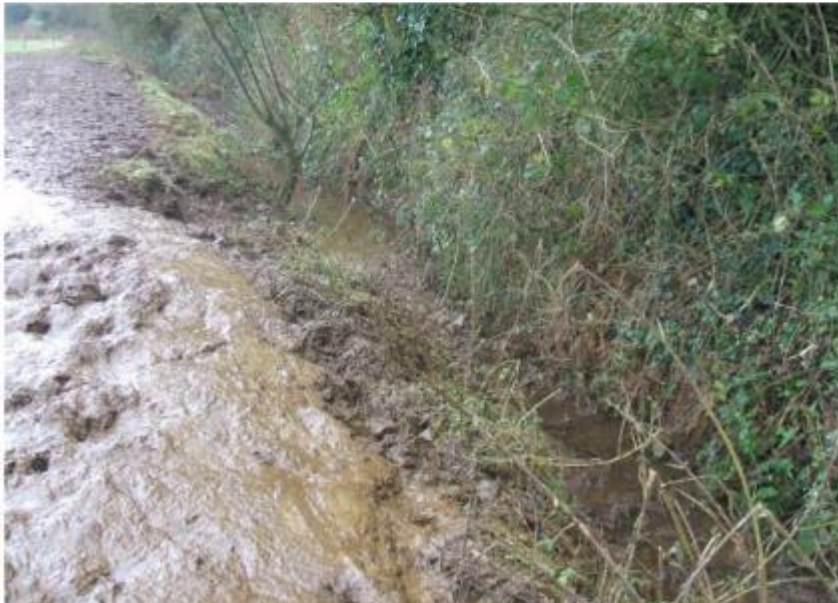
Outwintering Replacements, feeding on farm roadway beside drain

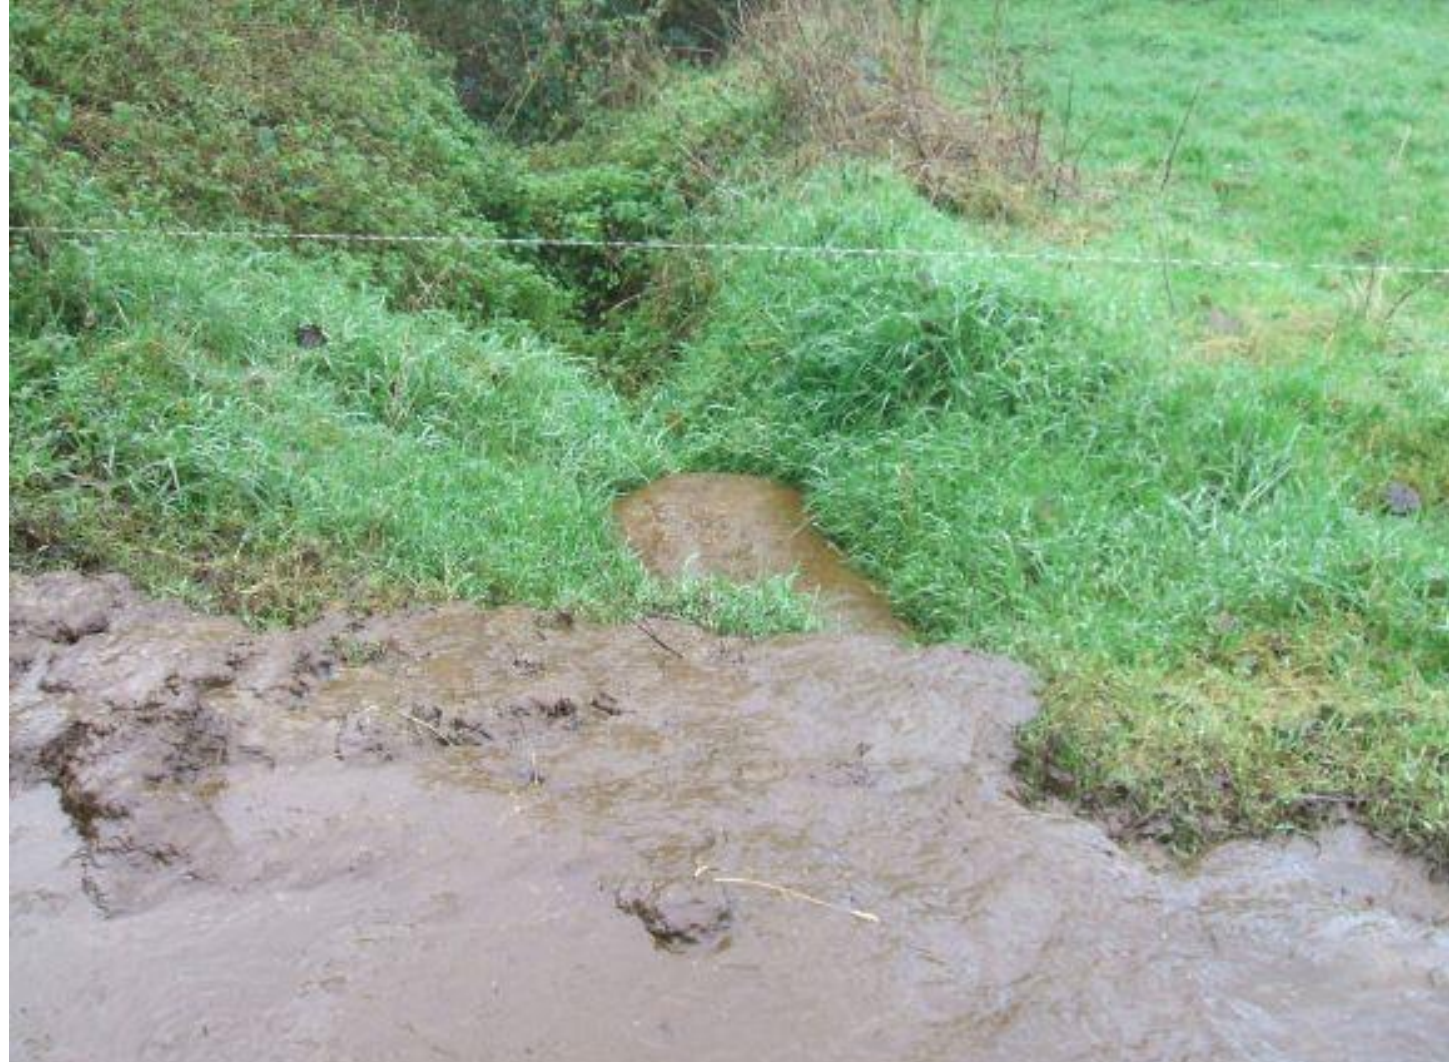
Derogation Dairy Farm

Upper reaches of the Douglas (Bride) River, Douglas (Bride)_10.

1. This is a Salmonid river & a tributary of the Bride (Waterford).
2. The Bride is part of the Blackwater River (Cork/Waterford) SAC.

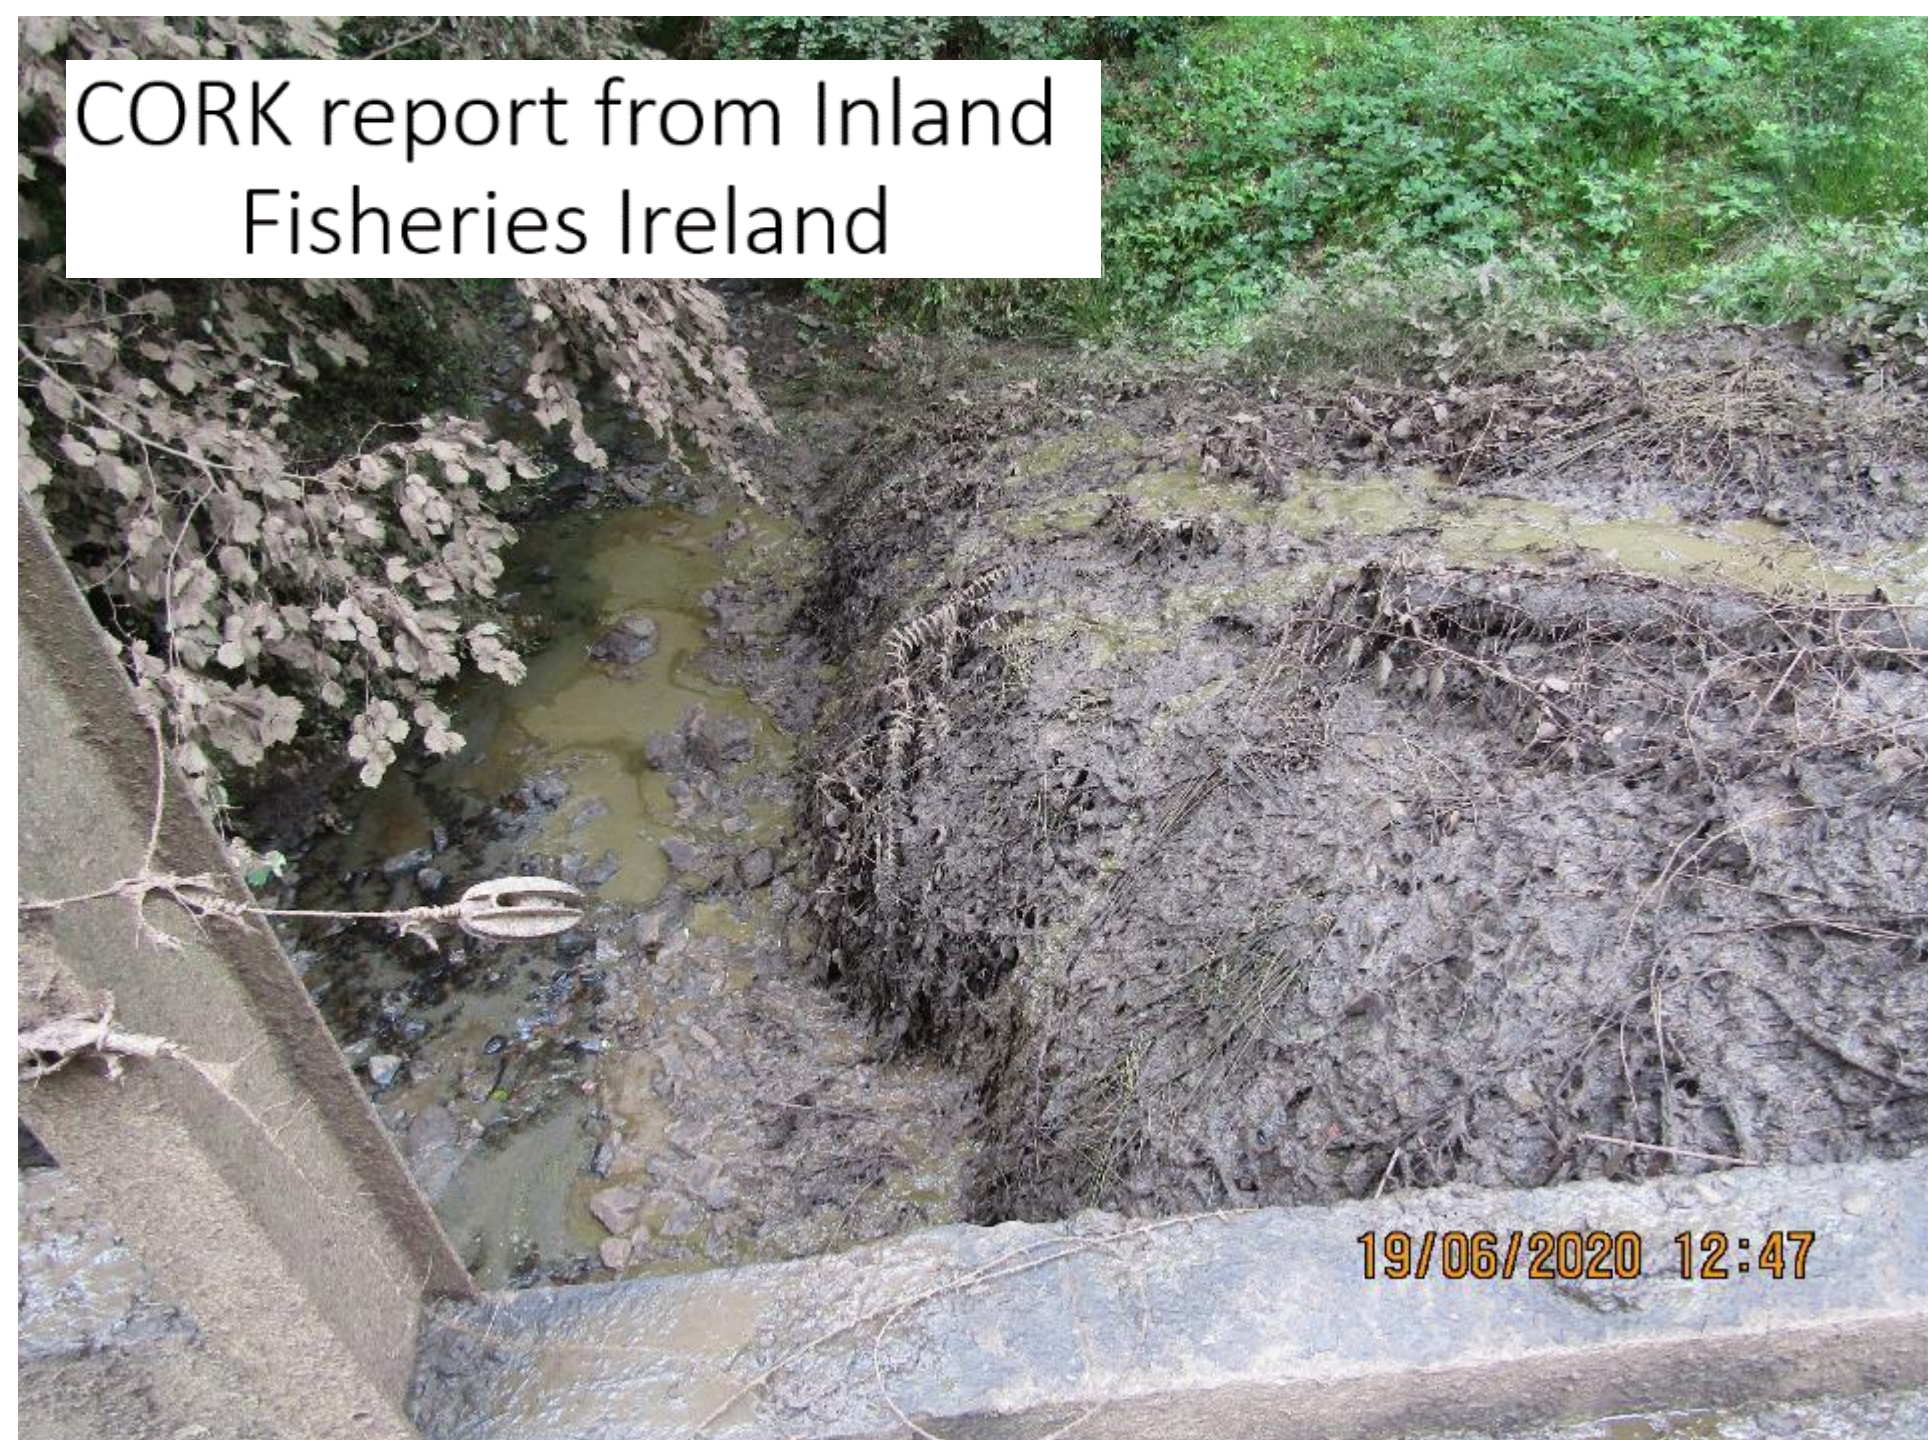
Burst umbilical during land-spreading operation.

These are popping up more often possibly due to their being more in use, incidents never good from a fisheries perspective, usually with short term and catastrophic deleterious discharge to waters.

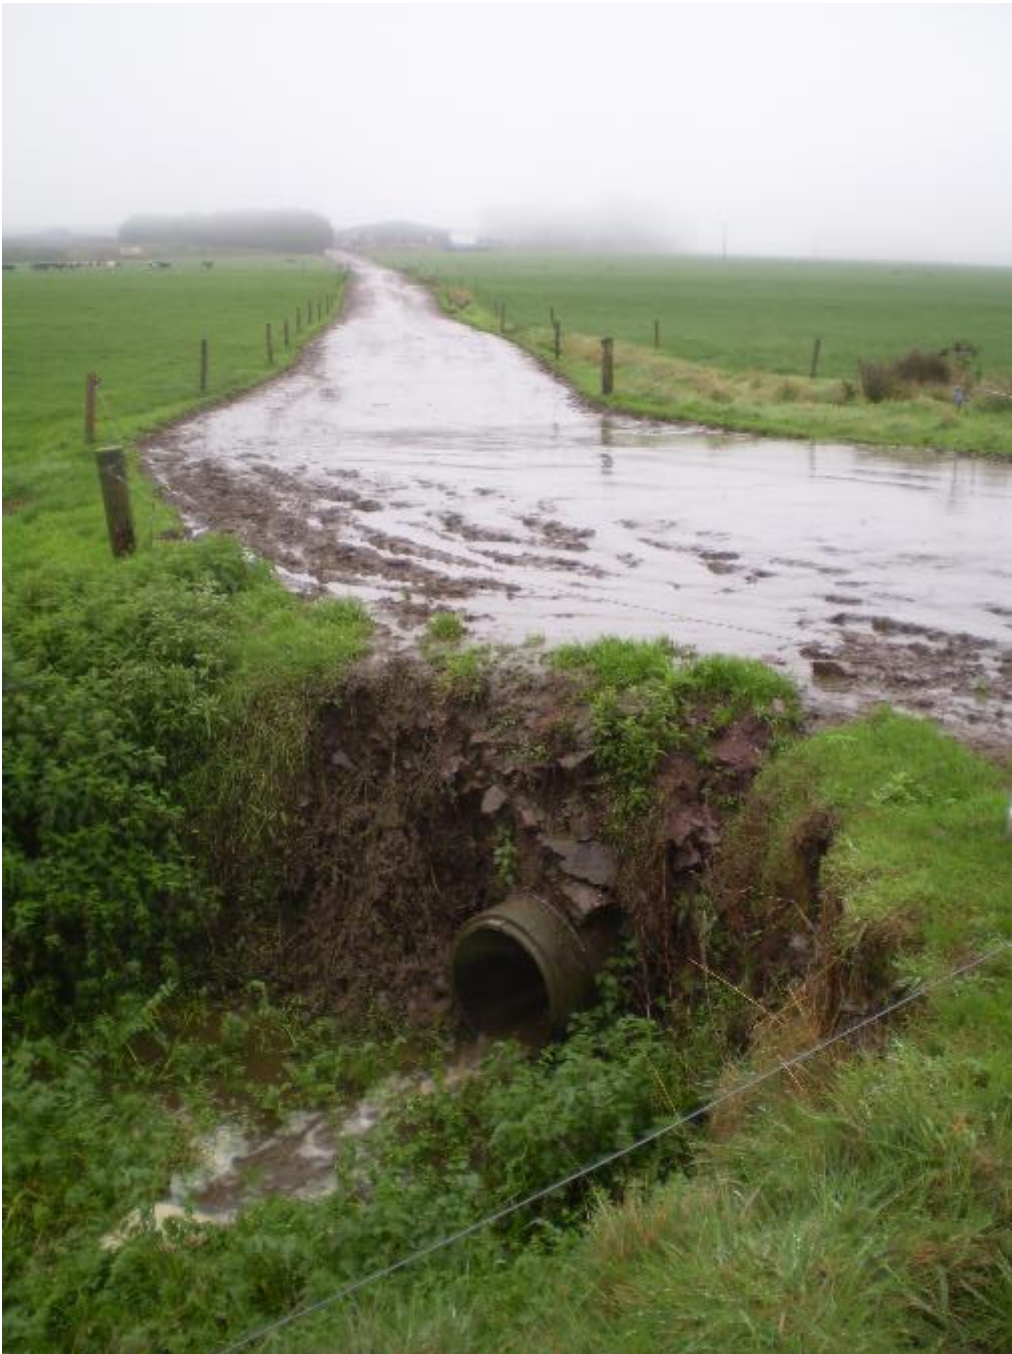
Large dairy unit track with fouling which is entirely typical of what's out there. Tracks are generally laid out primarily to get herds from A to B with little else in mind, this often has them linear down a hill and up the other side of a valley, ie direct conduit to receiving waters. The scale of herd numbers on individual units now means cumulative fouling with episodic wash-off may dwarf yard spillage incidents or land-spreading in poor conditions in its potential to pollute surface waters.

Of note it's good to see that many of the smaller streams that are affected by such track traffic in summer are all looking well just now. Then again the tracks are well cleaned, un-used in months and the herds are indoors!

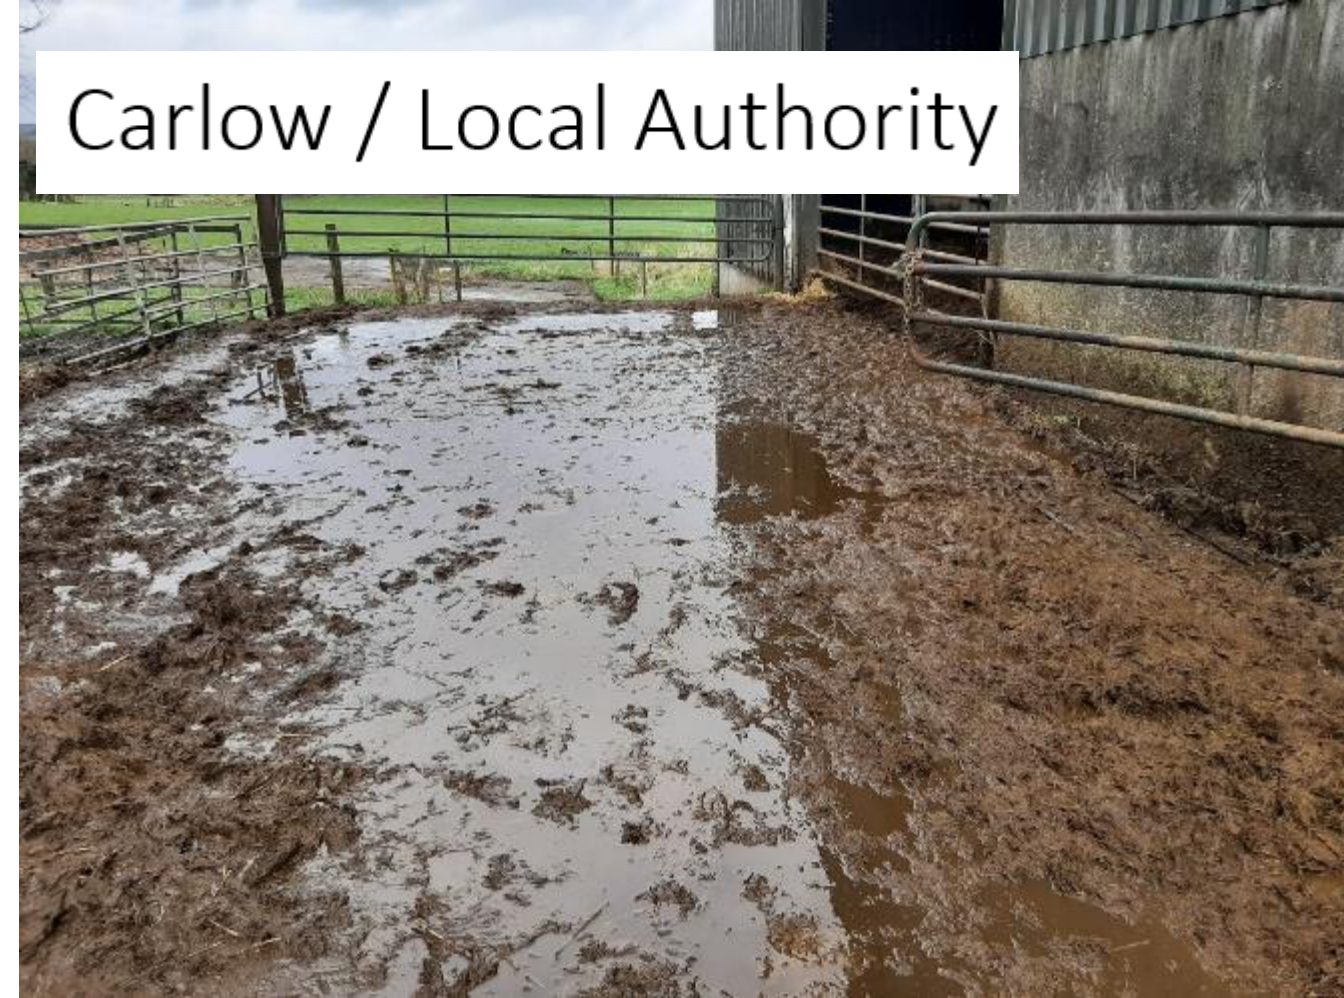
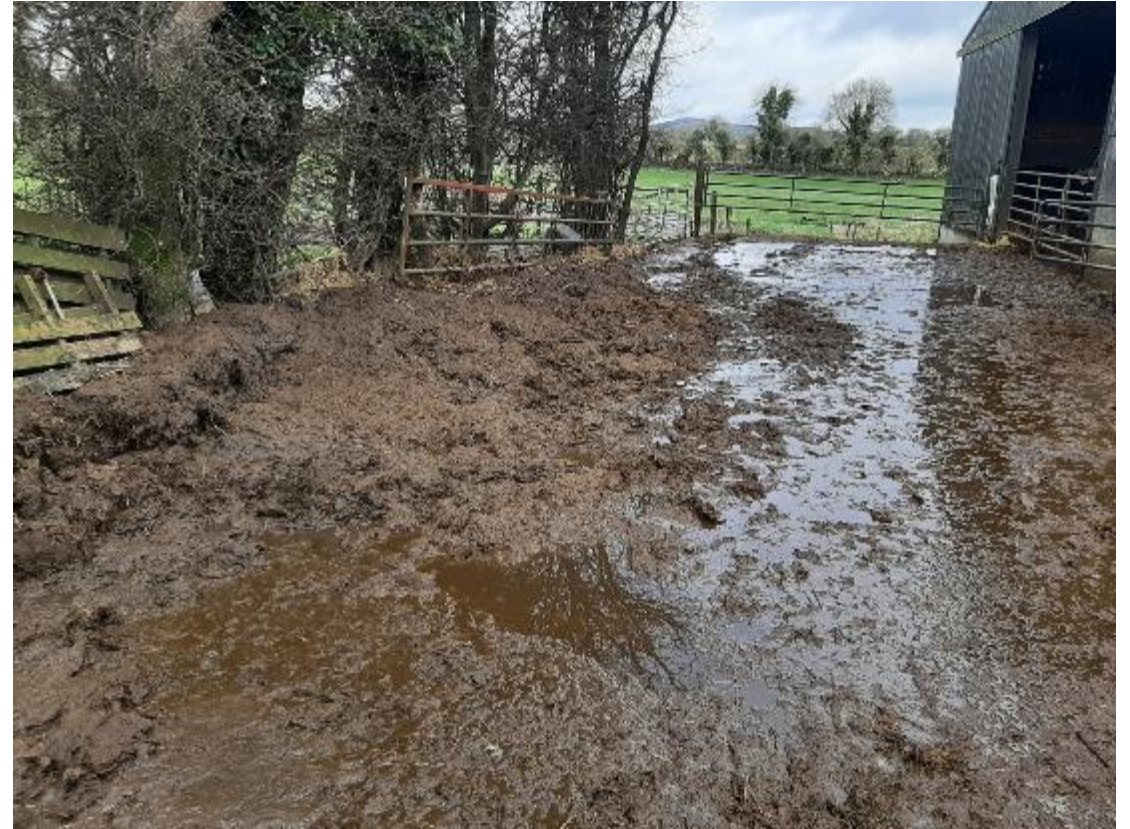
- Case 1 ; Found when conducting Planning inspection for new cubicle shed , Co Carlow.

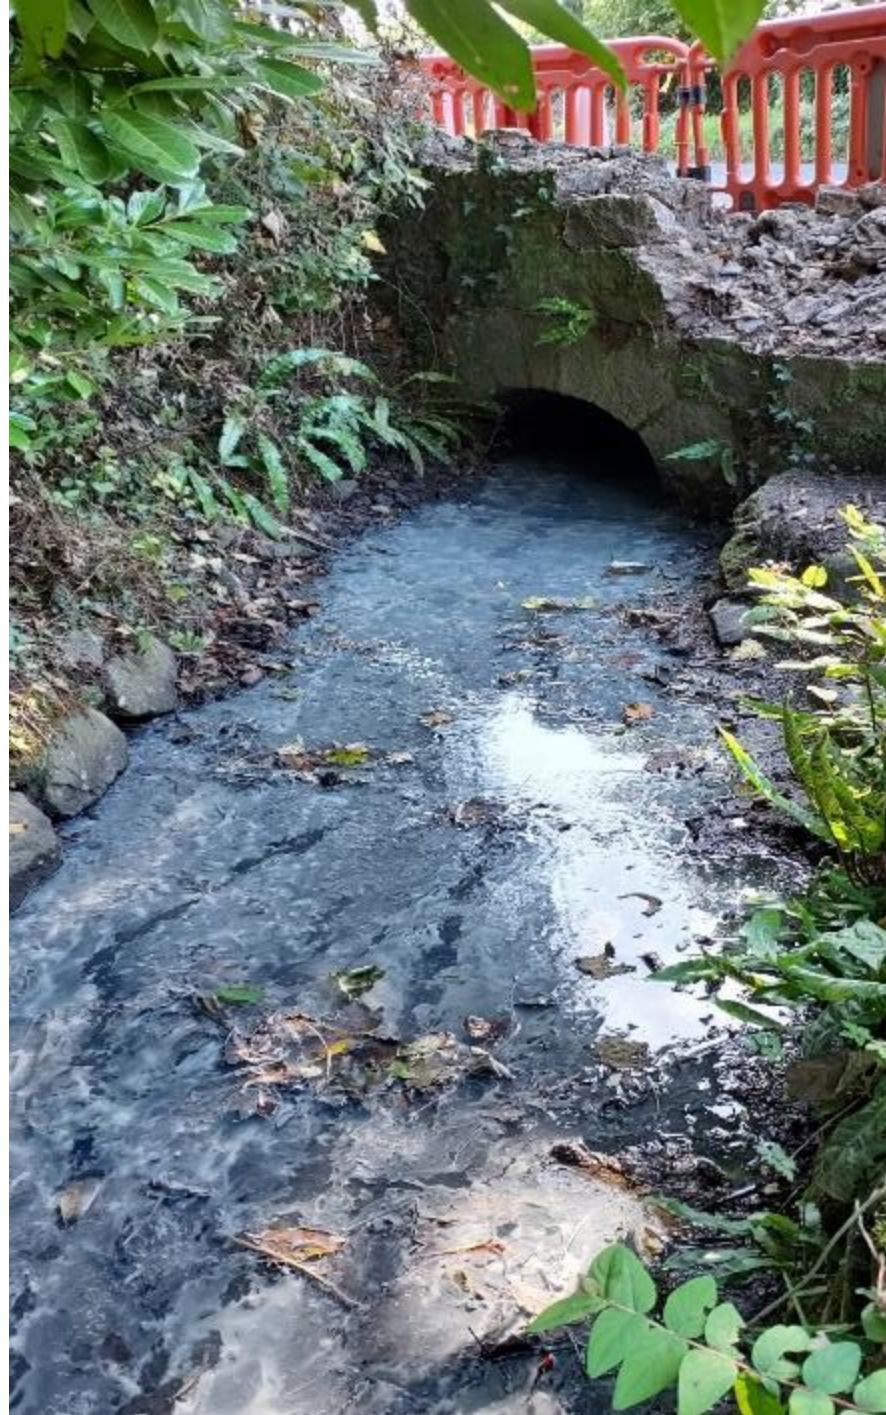
- Case2 ; 2021 Sewage Fungus in 3 km of a stream, caused by silage effluent escaping from large dairy farm-230 cows. It took 7 days to locate the source as it was passing through underground land drains.
- Impact on brown trout spawning areas

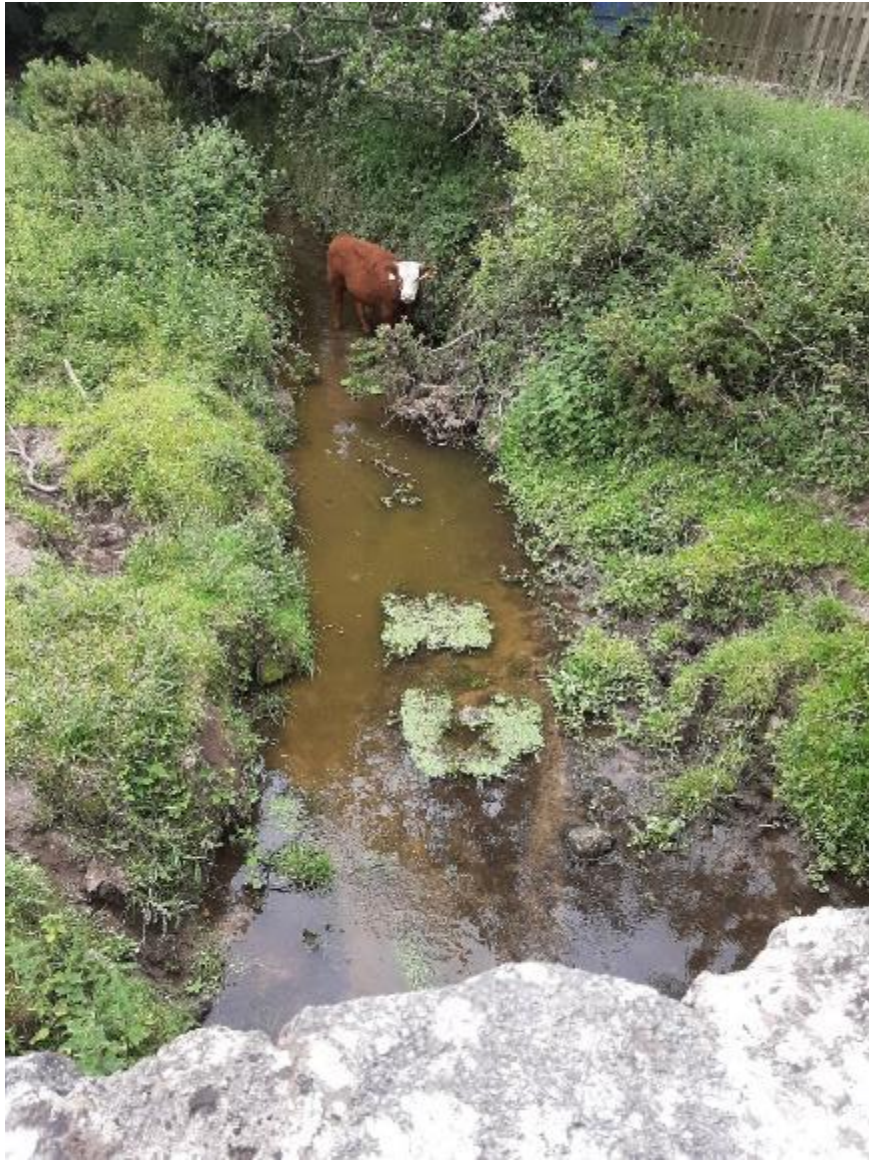
Impact on brown trout spawning and nursery areas

Seen at official WFD Co. Council sampling Point 2020 ;
no requirement to fence stream here as farmer is below the 170kg/N₂ / Ha

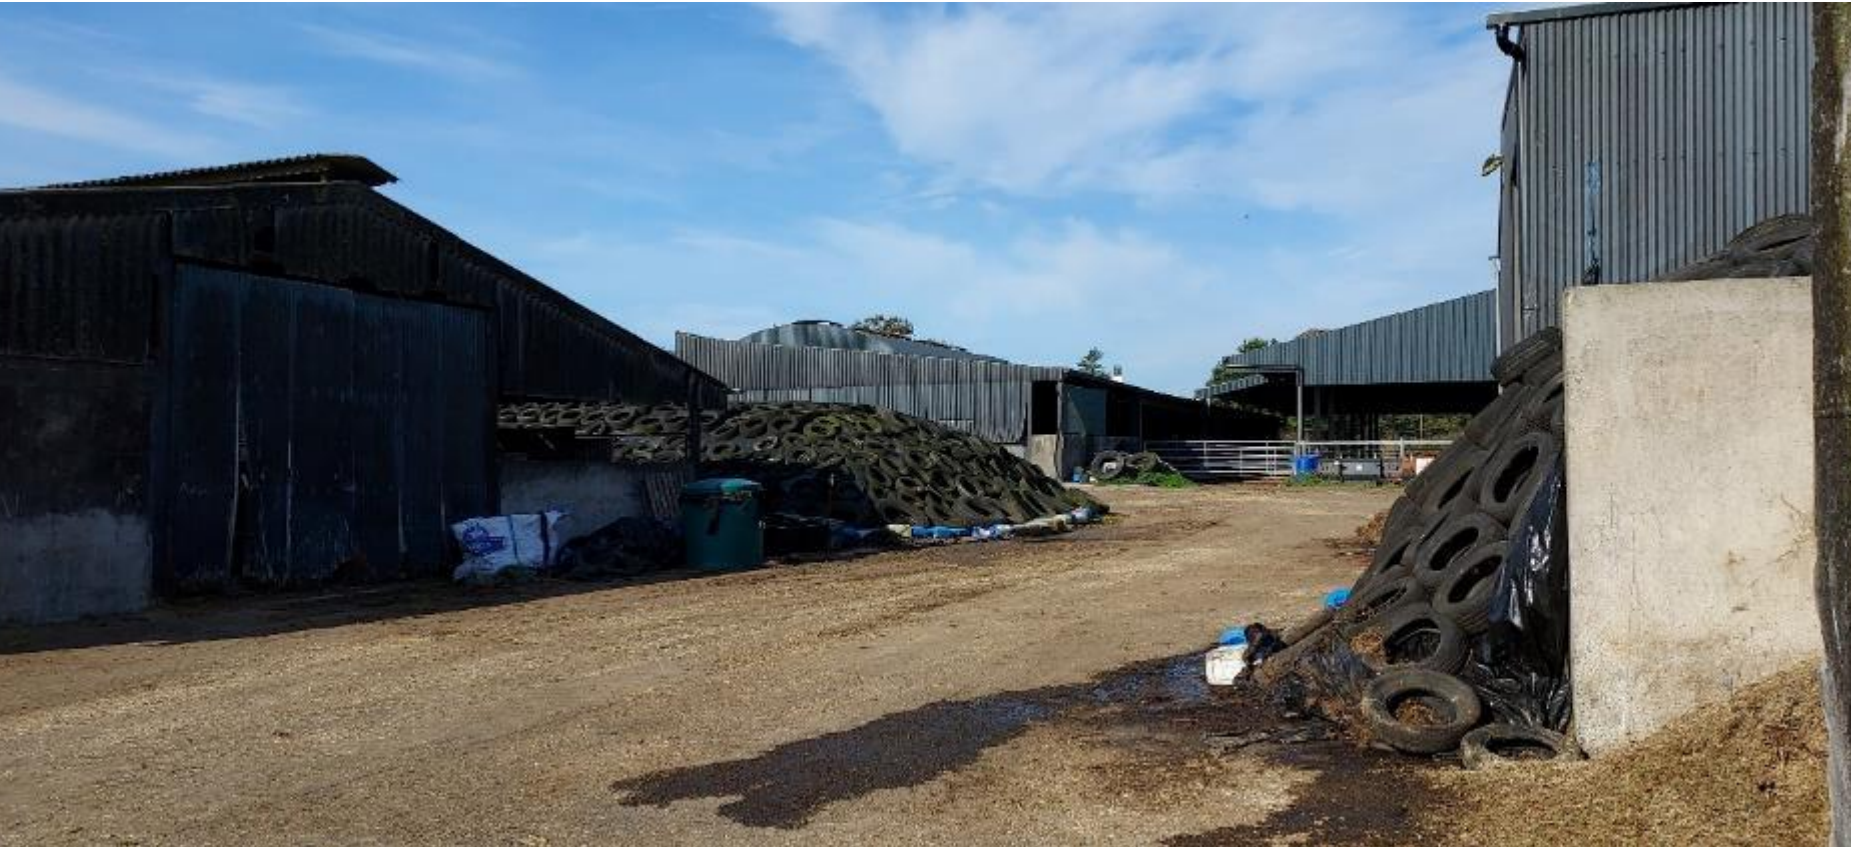
- Case 3; Source of pollution , overflowing silage pits – no concern shown for effluent collection. Farmer was busy converting cows to new Robotic Milk system and admitted to ignoring the problem of the effluent

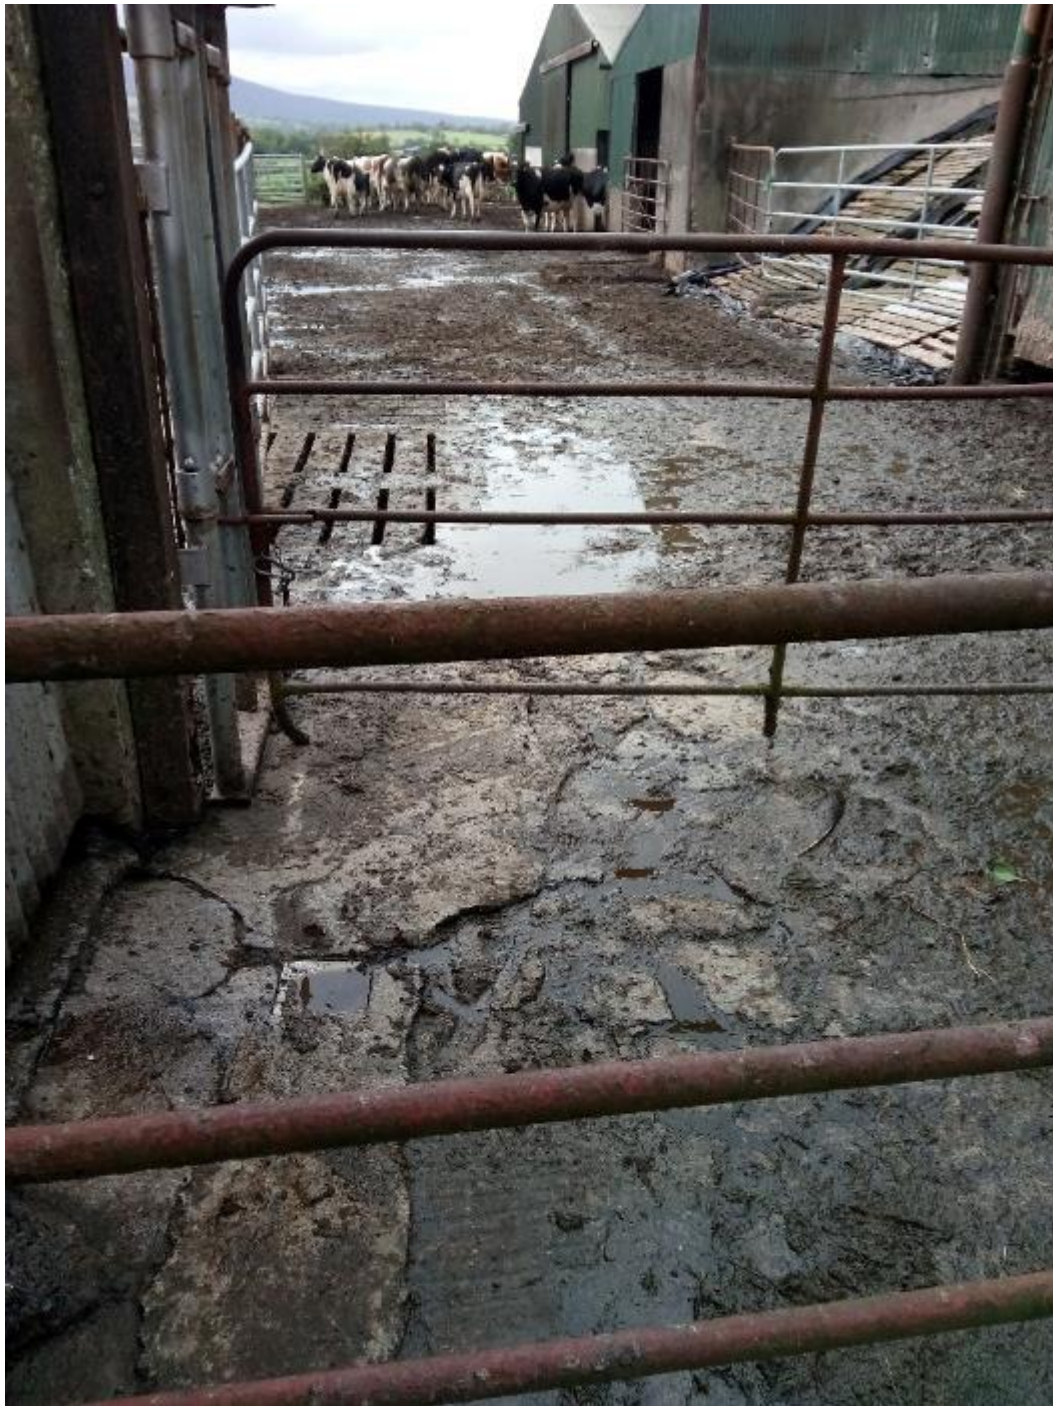
- Case 4; March 2021 Dairy collection yard for 55 cows, effluent directed into 2 surface water gullies, top and bottom of yard . Effluent found in neighbouring farmers field 1.5 km away.

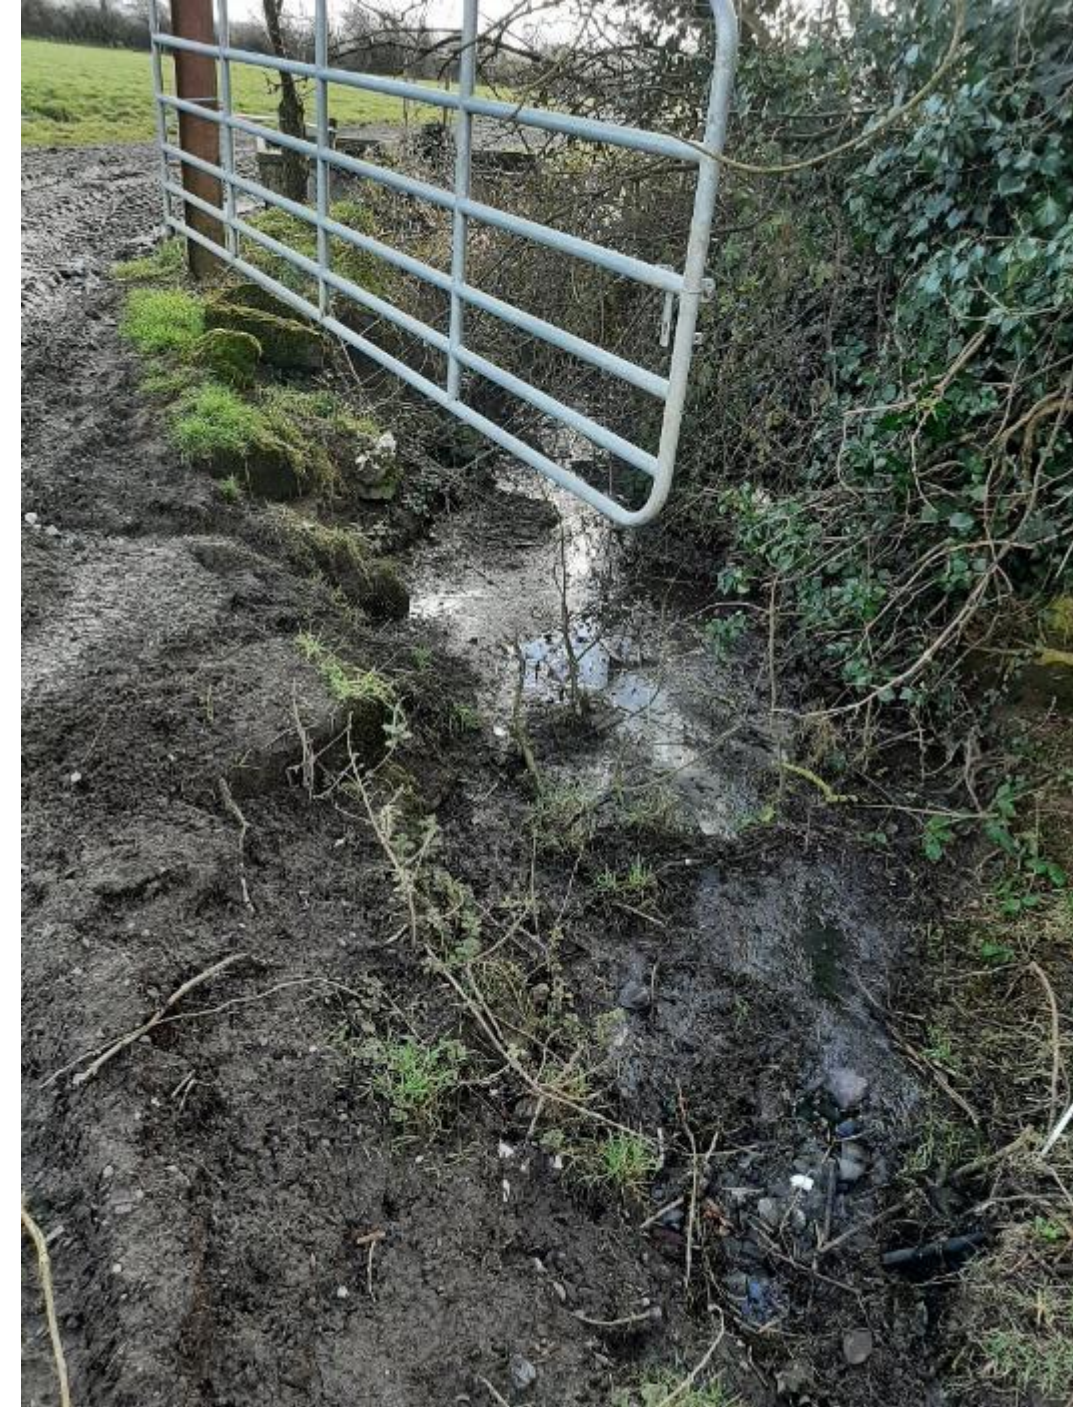
- Case 5; Slurry found in drain beside farmyard when conducting planning inspection for new milk parlour.
