Agricultural related water quality issue examples forwarded by Regional Operational Committee implementing bodies

**Observations on Agriculture GAP Regs compliance and good practice 2021
Presentation to ASSAP Farm Consultative Group Meeting 24 Jan 2022 &
discussion through WFD governance structure: SE and SW ROCs &
SERWEMC*

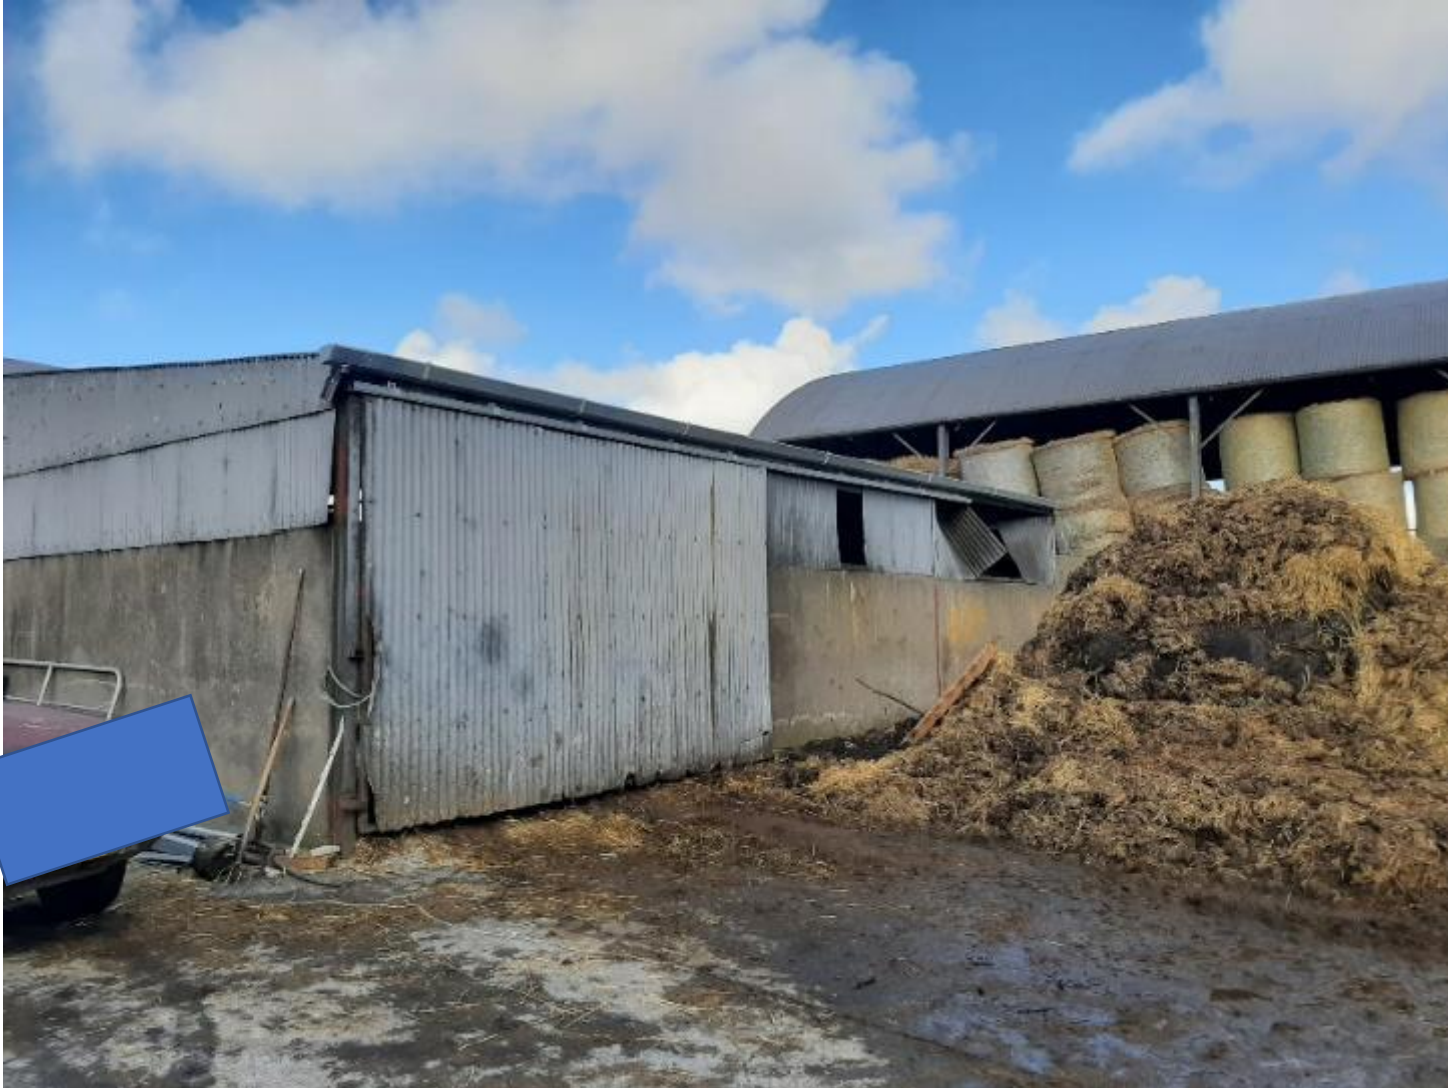
- Case 6 ; Found when inspecting farm for planning application for new slatted shed .

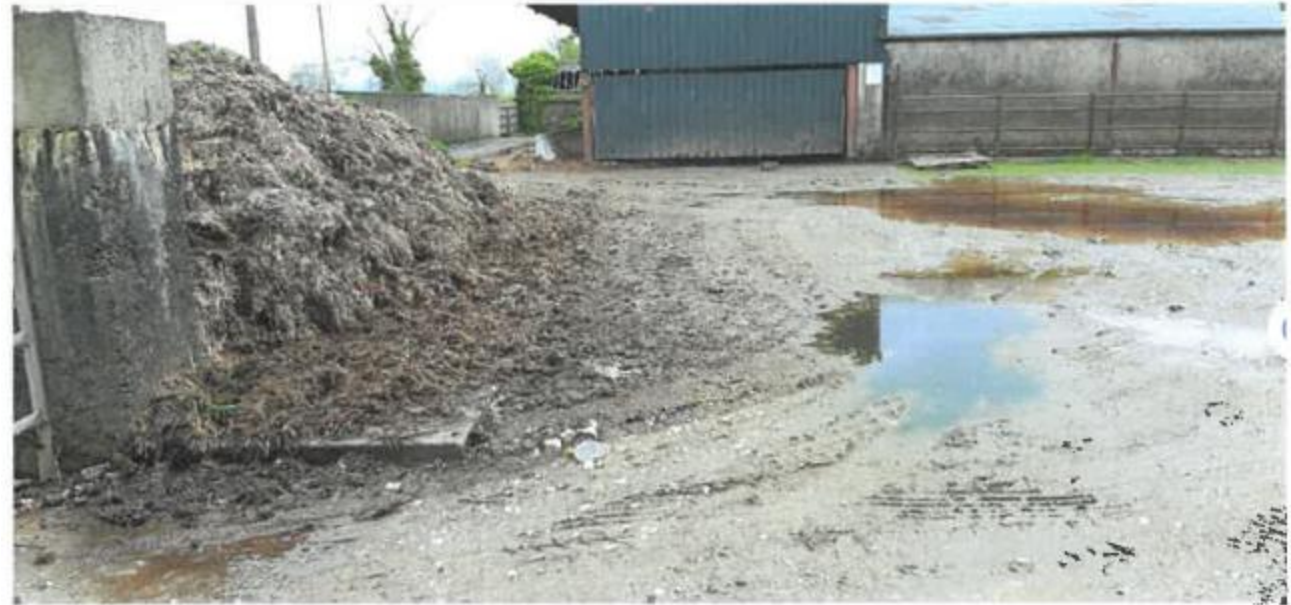
Inadequate effluent control.

Inadequate effluent control - Inappropriate Farm Yard Manure stored on a concrete yard on a drystock farm, without containment of effluent. No discharge to PAA Bunoke_010. Warning letter issued, FYM removed.

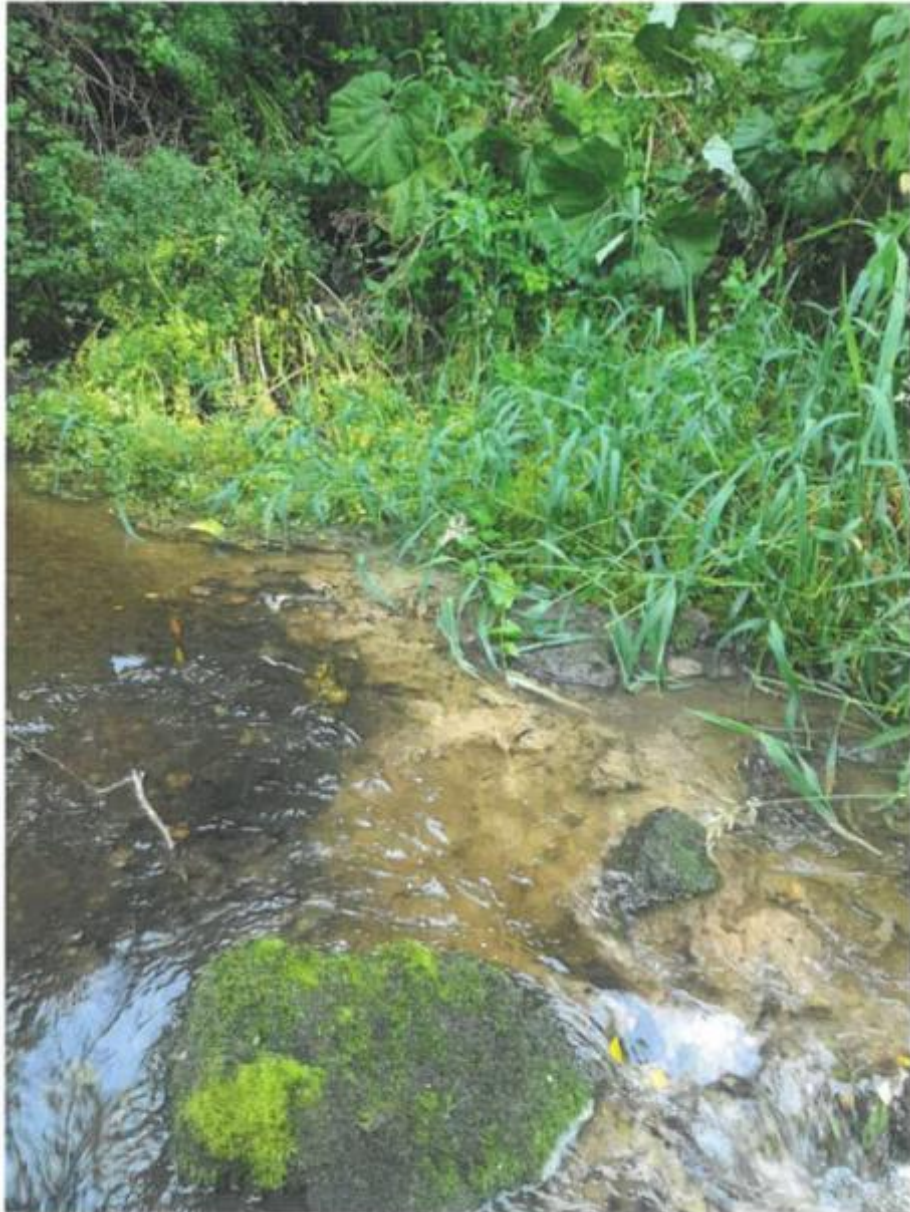
There were no reported fish kills in 2021. During 2021 we responded to 4 no. Complaints relating to silage effluent discharge to waters. Visible impact is typified by photo below (where Ammonia was 0.81mg/l - 3km d/s of the discharge point).

1. runoff from a silage pit
2. length of impact= >3km approx. “ammonia readings were off the scale”
3. Deel R – brown trout
4. in a priority Area for Action

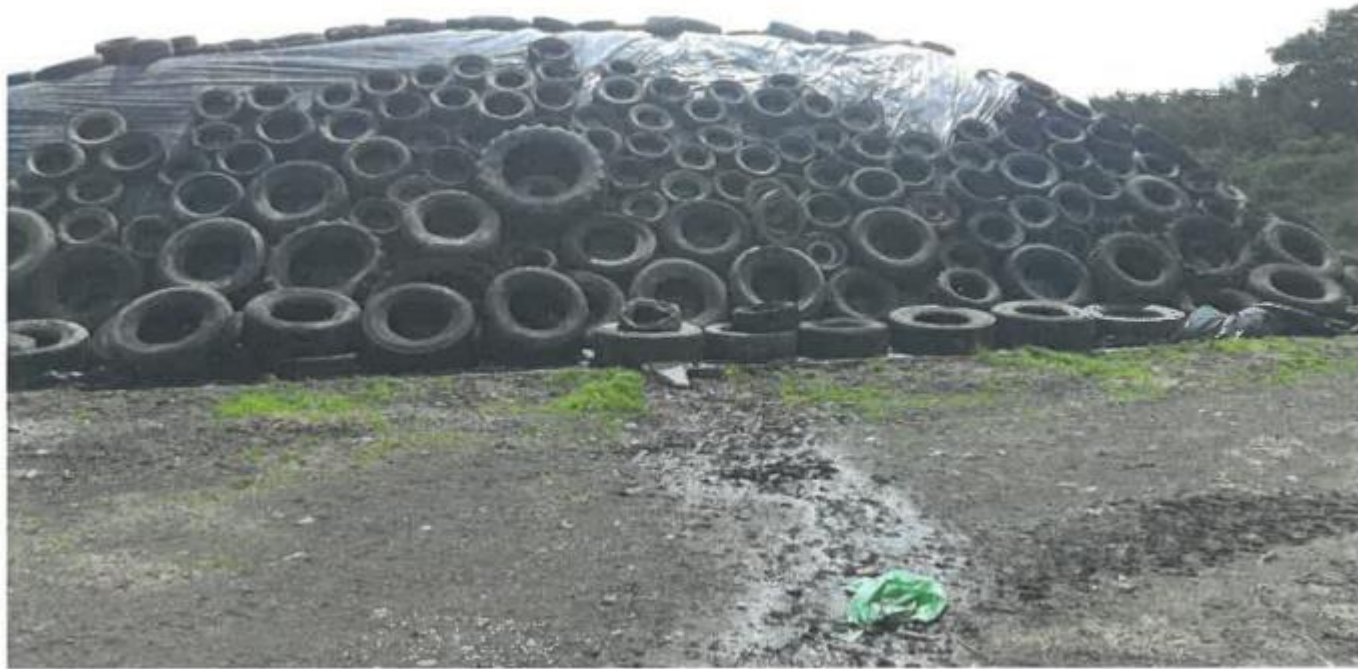
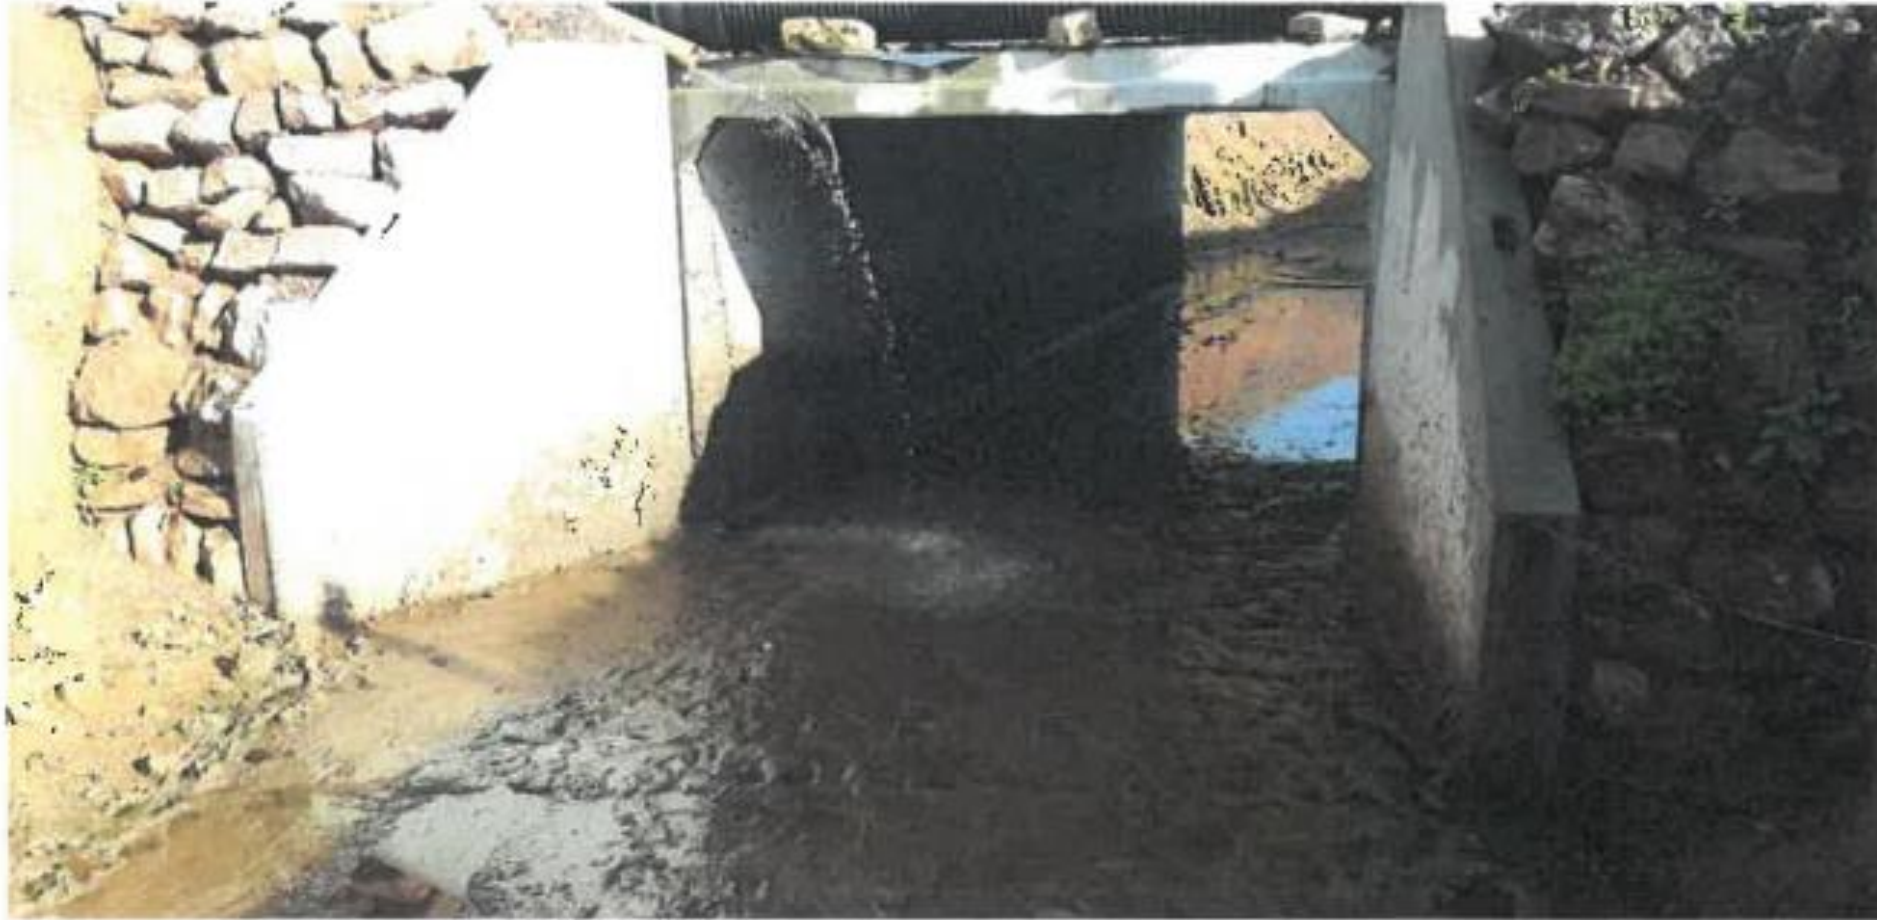
Dairy farm not in Derogation runoff from a silage pit

Silage pit on a dairy farm. Effluent flowed through cracks on the pit to a small stream (part of the Shannagolden_010), which flowed out to the Shannon Estuary.

There were no wild fish killed, except for a **pond of goldfish**, which is fed by the stream. Farmer cross-reported to DAFM and 20% fine imposed. Only baled silage will be made in future.

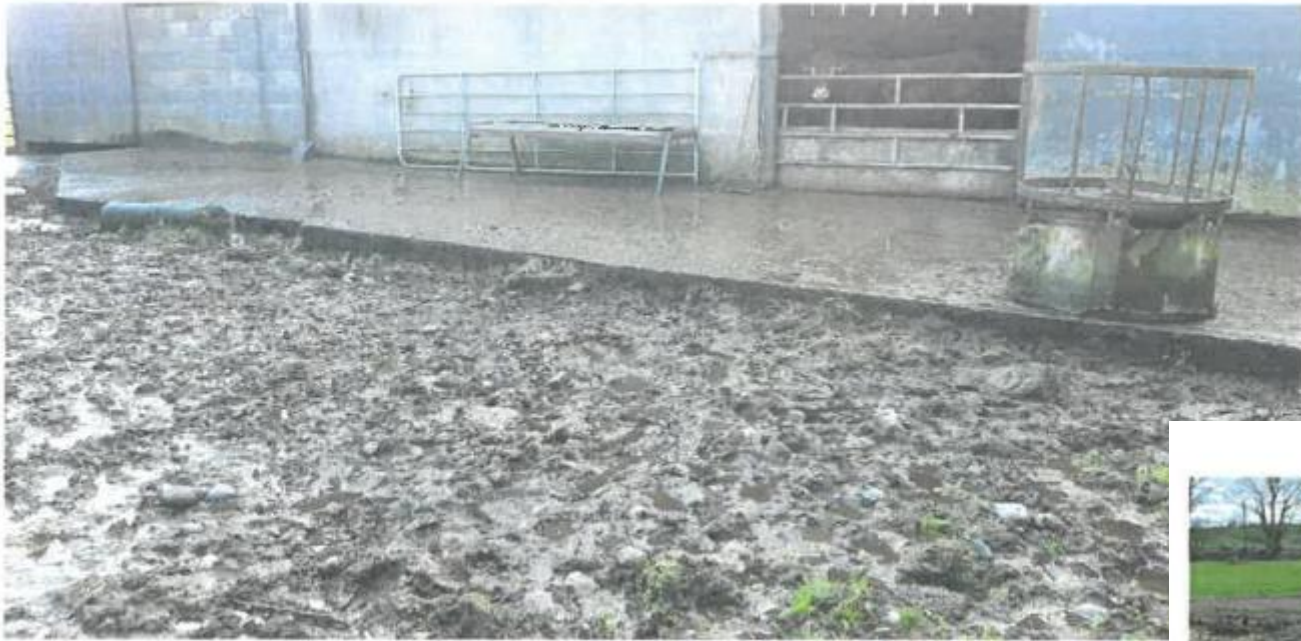
Small drystock farm not in Derogation

Pollution Complaint

Pollution complaint, as described, cattle given access to a small feeding yard, no effluent collection. No discharge to waters – the Killeenagarriff_010 (Lower Shannon SAC). Infrastructure – farmyard inspected under GAP. Tank was cracked and under-sized to contain all slurry produced from drystock. Warning letter issued.

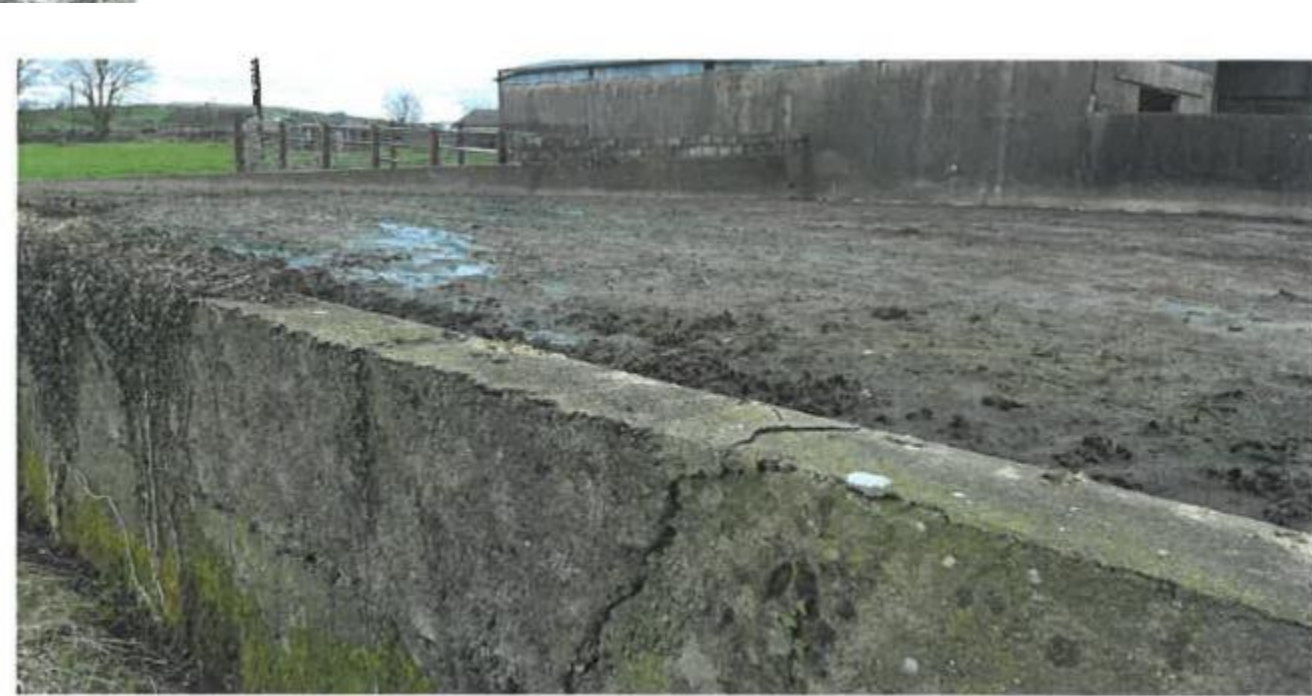
Pollution complaint – inadequate control of effluent from a feeding yard. No discharge to waters. Issue was resolved (cattle kept indoors).

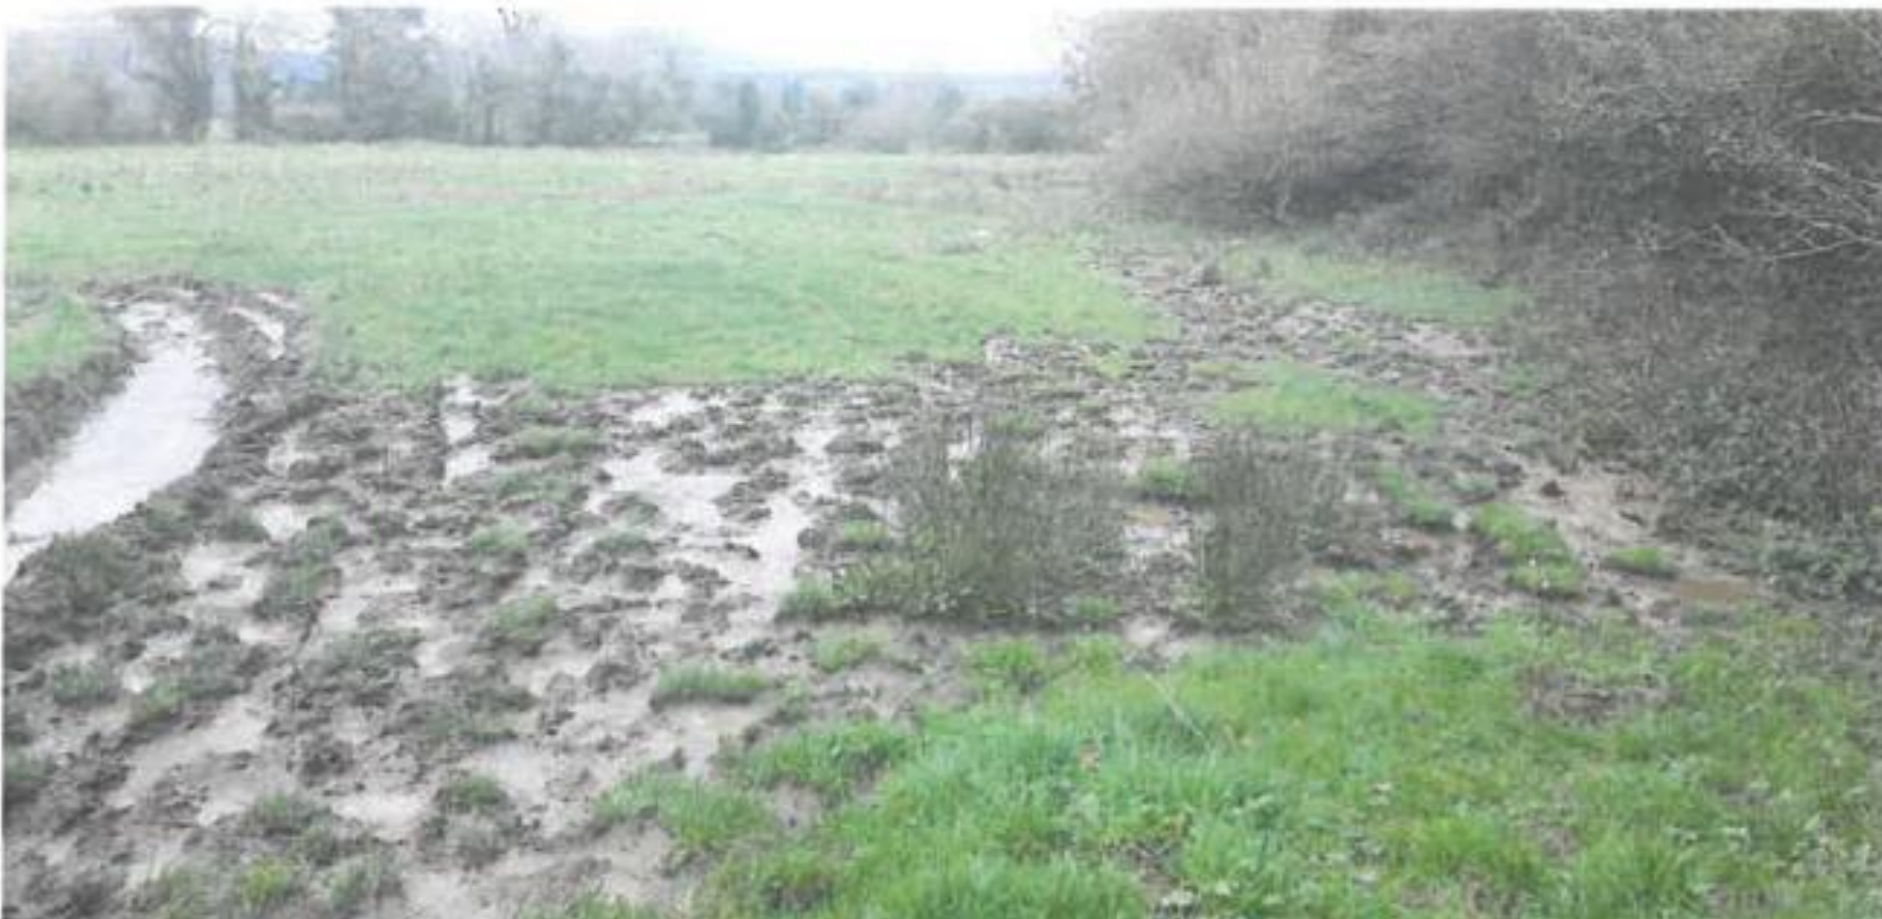
Accident – Burst tyre on vacuum tanker when spreading slurry. Slurry discharge to field at one point to allow replacement of tyre. Fortunately there was no discharge to waters.

Accident, as described, no discharge to the Aherlow_010, which is a Lawpro PAA.

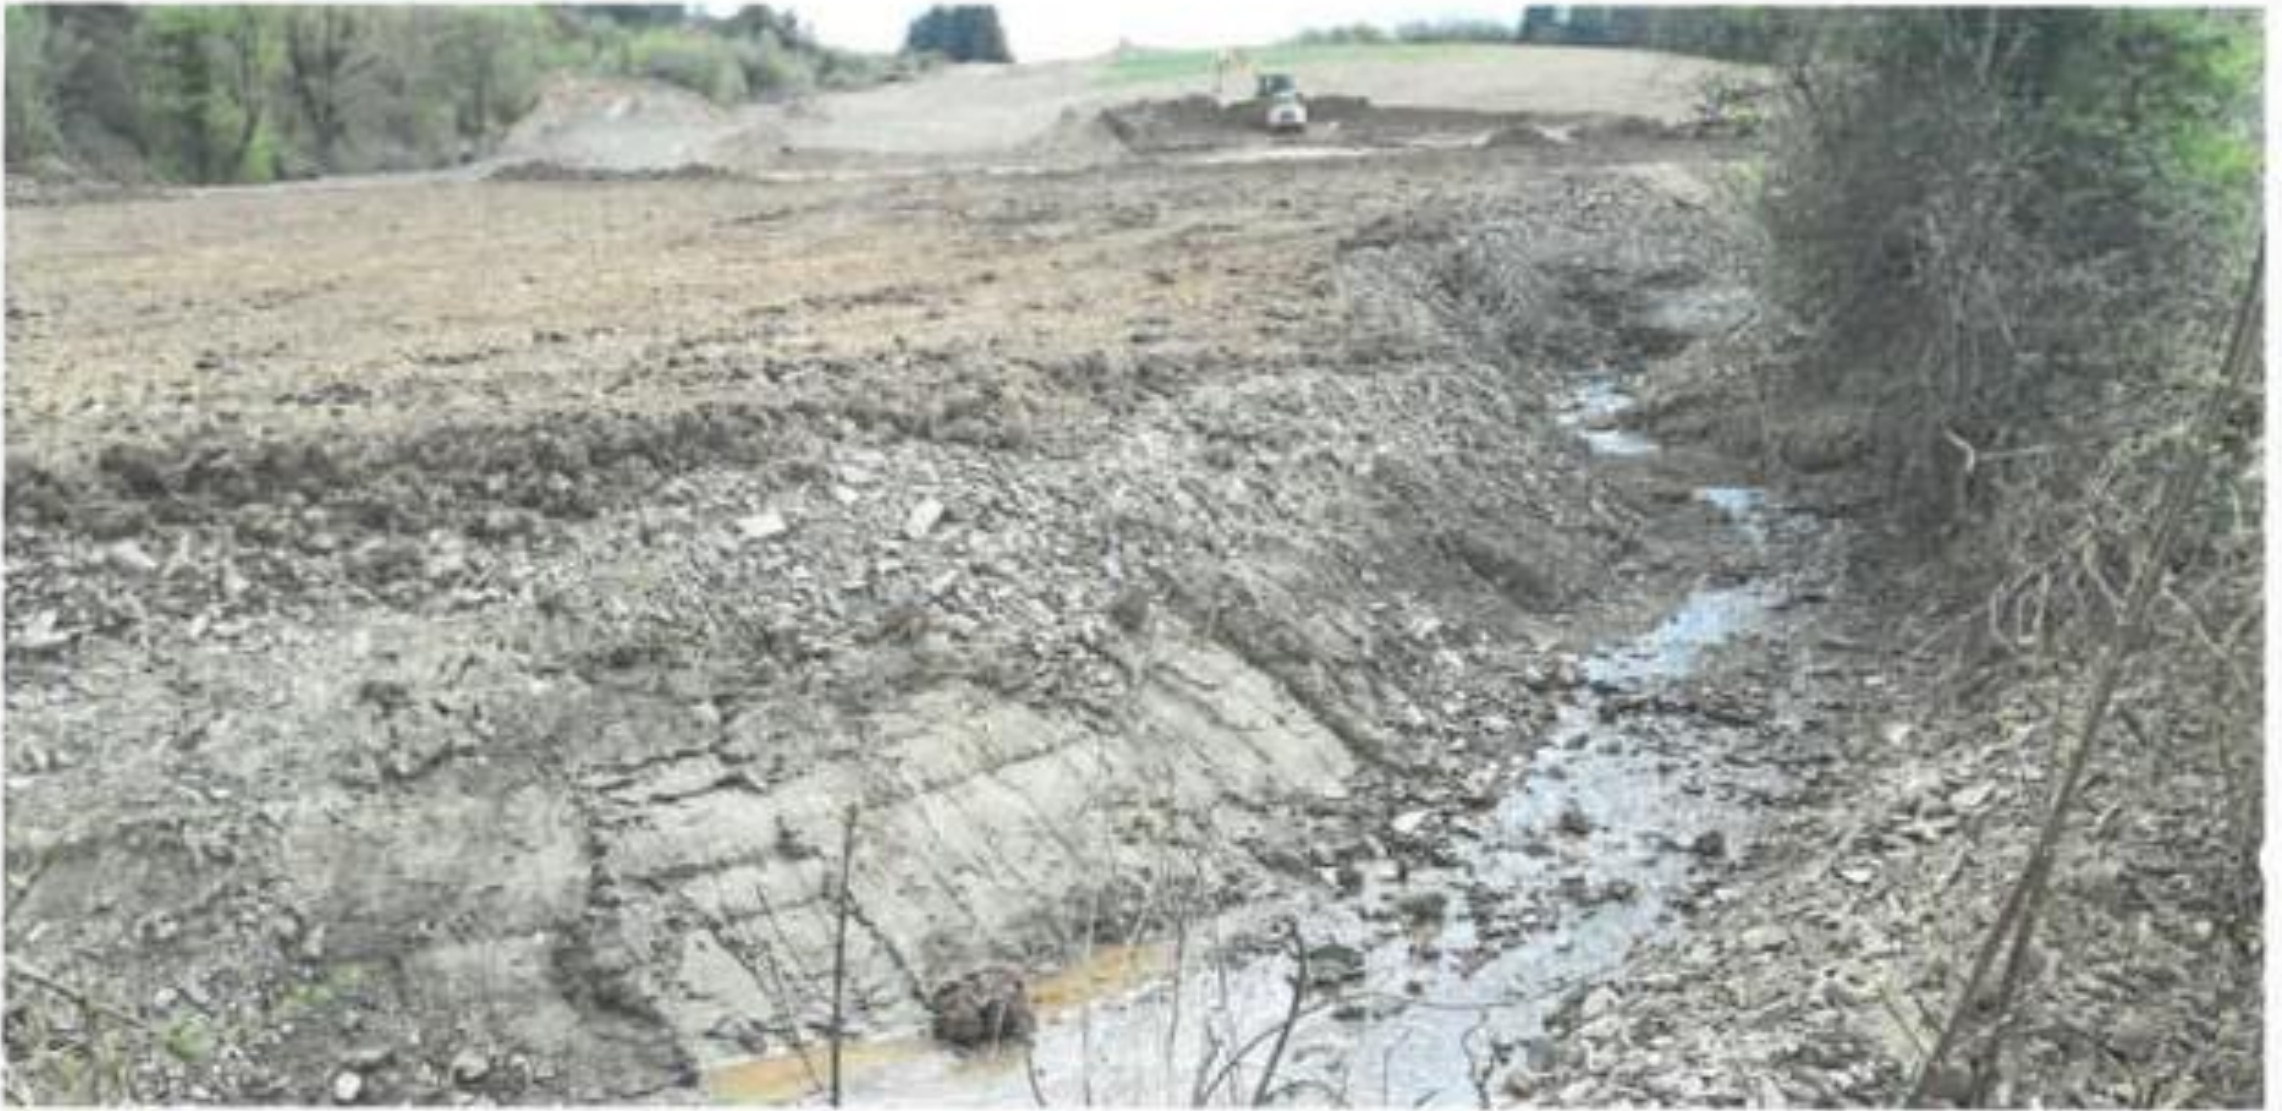
Land reclamation.

Land was not being farmed at the time. 2019 LPIS data indicate Not in derogation

Significant land reclamation took place on the Broadford Stream_010 and has been reported to IFI and DAFM.

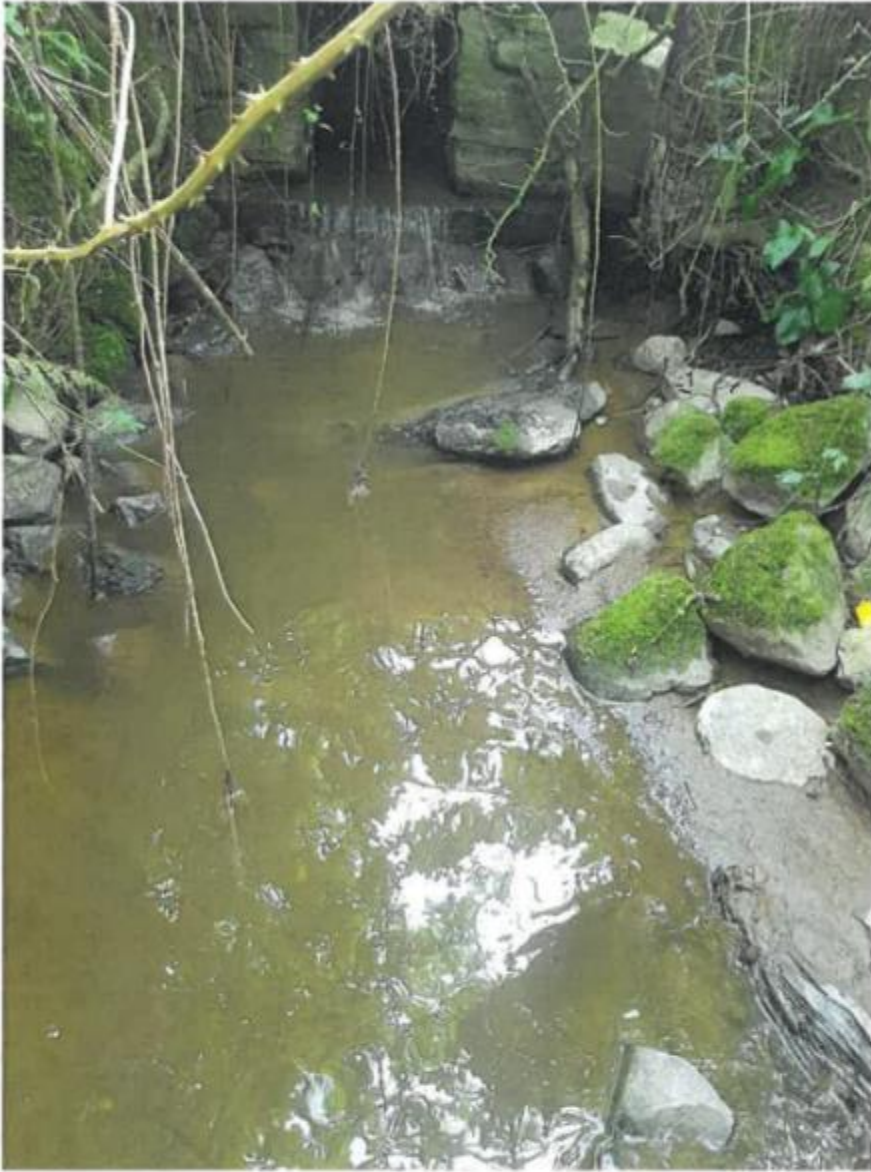
Stream polluted with slurry.

Stream polluted with slurry – Slurry spread on lands resulted in effluent flowing to underground drainage network and onwards to adjacent stream.

Tributary of the Bunoke_010 (LA PAA) from a dairy farm. Lands were drained. Farmer has been warned and will not be spreading slurry on this field in future.

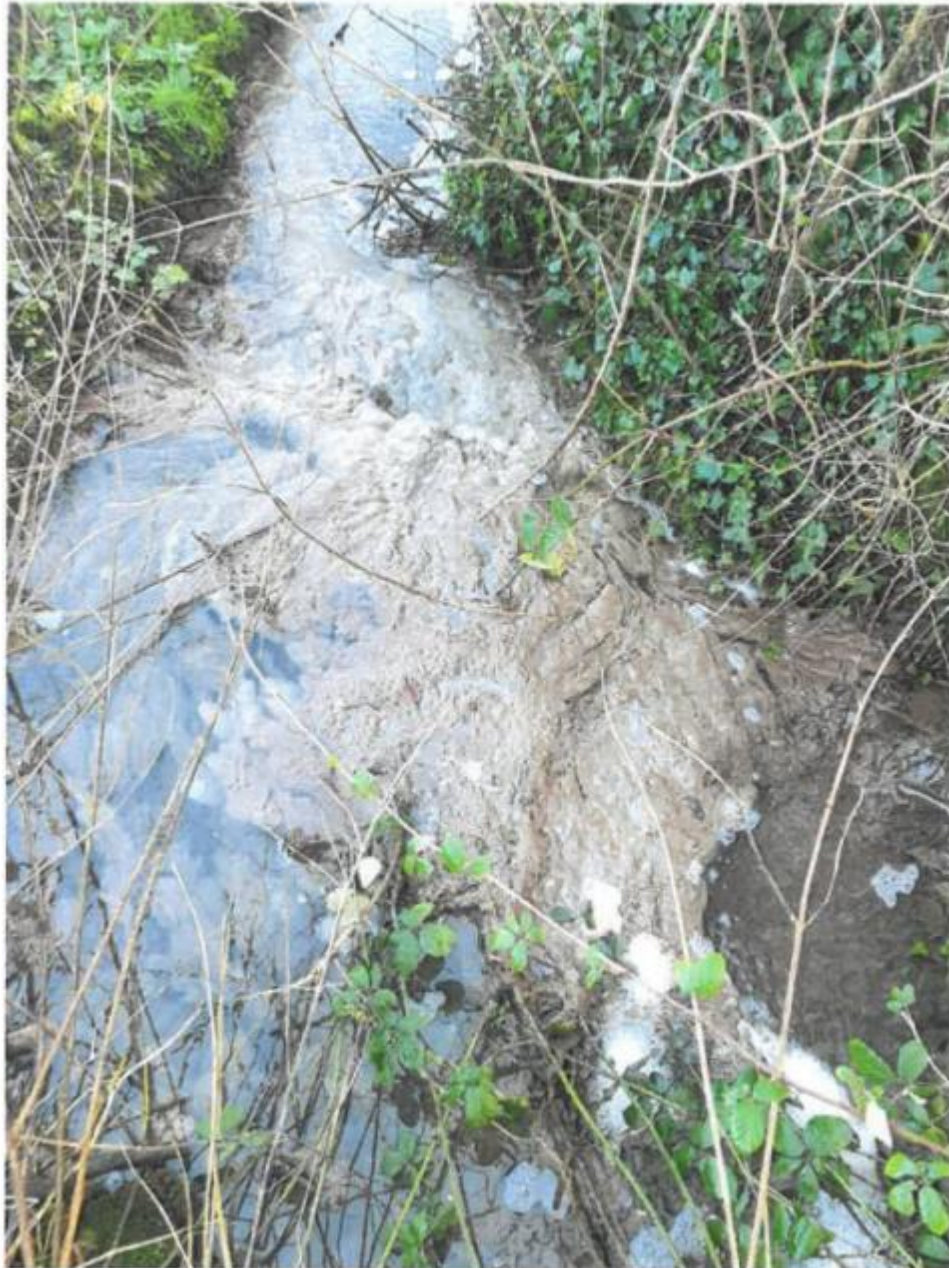
Silage pit diversion (sewage fungus and heavy siltation observed)

Silage pit diversion – as described. Sewage fungus observed for 300m of drain but no impact observed to the Ballynaclogh River.

Silage pit diversion –Typically when silage is made effluent is diverted to a tank. After a period of approx. 6 weeks (when flow no longer evident) the pipe is – in most instances - directed to a clean water outfall. We are finding (in significant no. of cases) that when the silage pit is opened (i.e. when foddering takes place on the yard) rainwater falling on the face of the pit results in an effluent flow to the clean water outfall (this effluent is rarely /never directed to effluent storage tanks). The photo shows the result (Sewage Fungus). We are planning to carry out investigation over the Winter to see if we can determine extent of this issue.

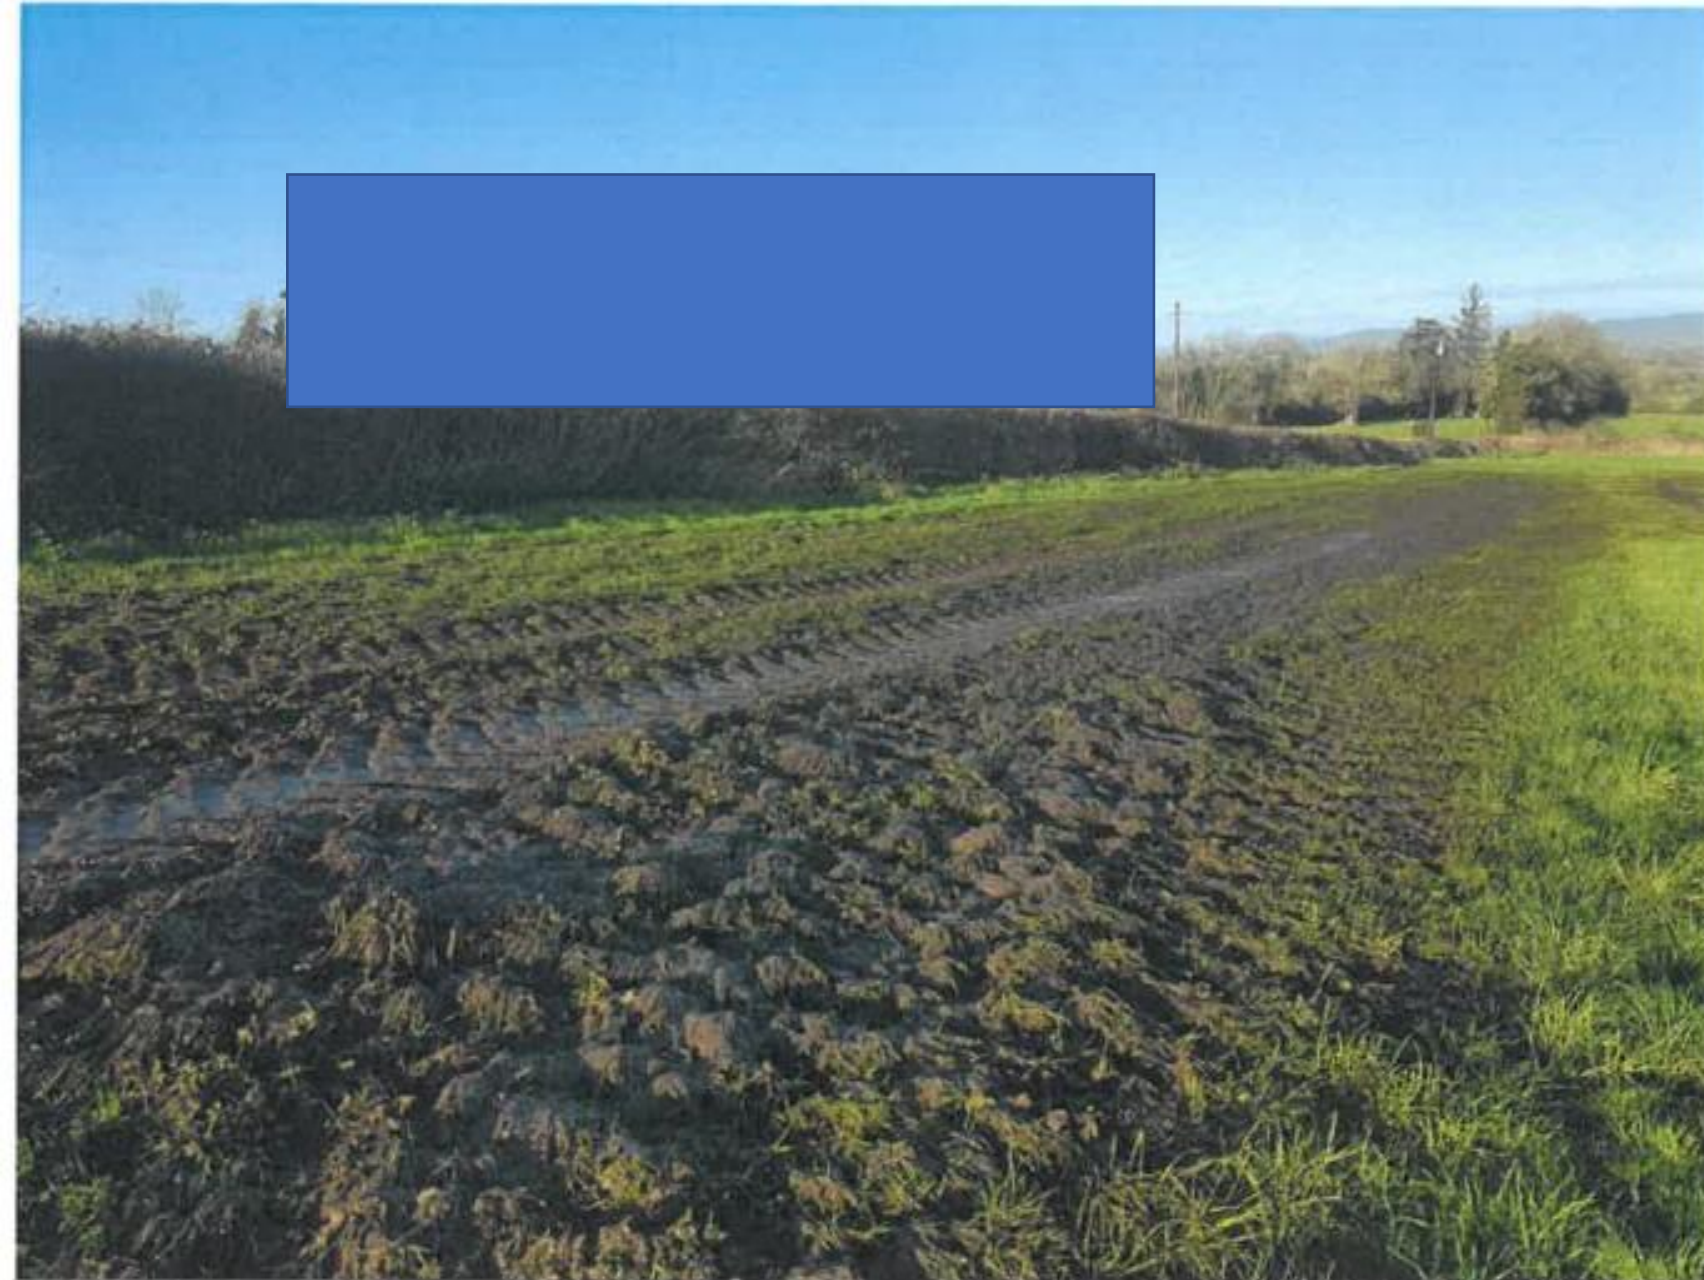
Management issues: Slurry spreading during the closed period.

Slurry spread during closed period on the Owvane_030 catchment. This just happened and will be cross-reported to DAFM and reported to LAWPRO.

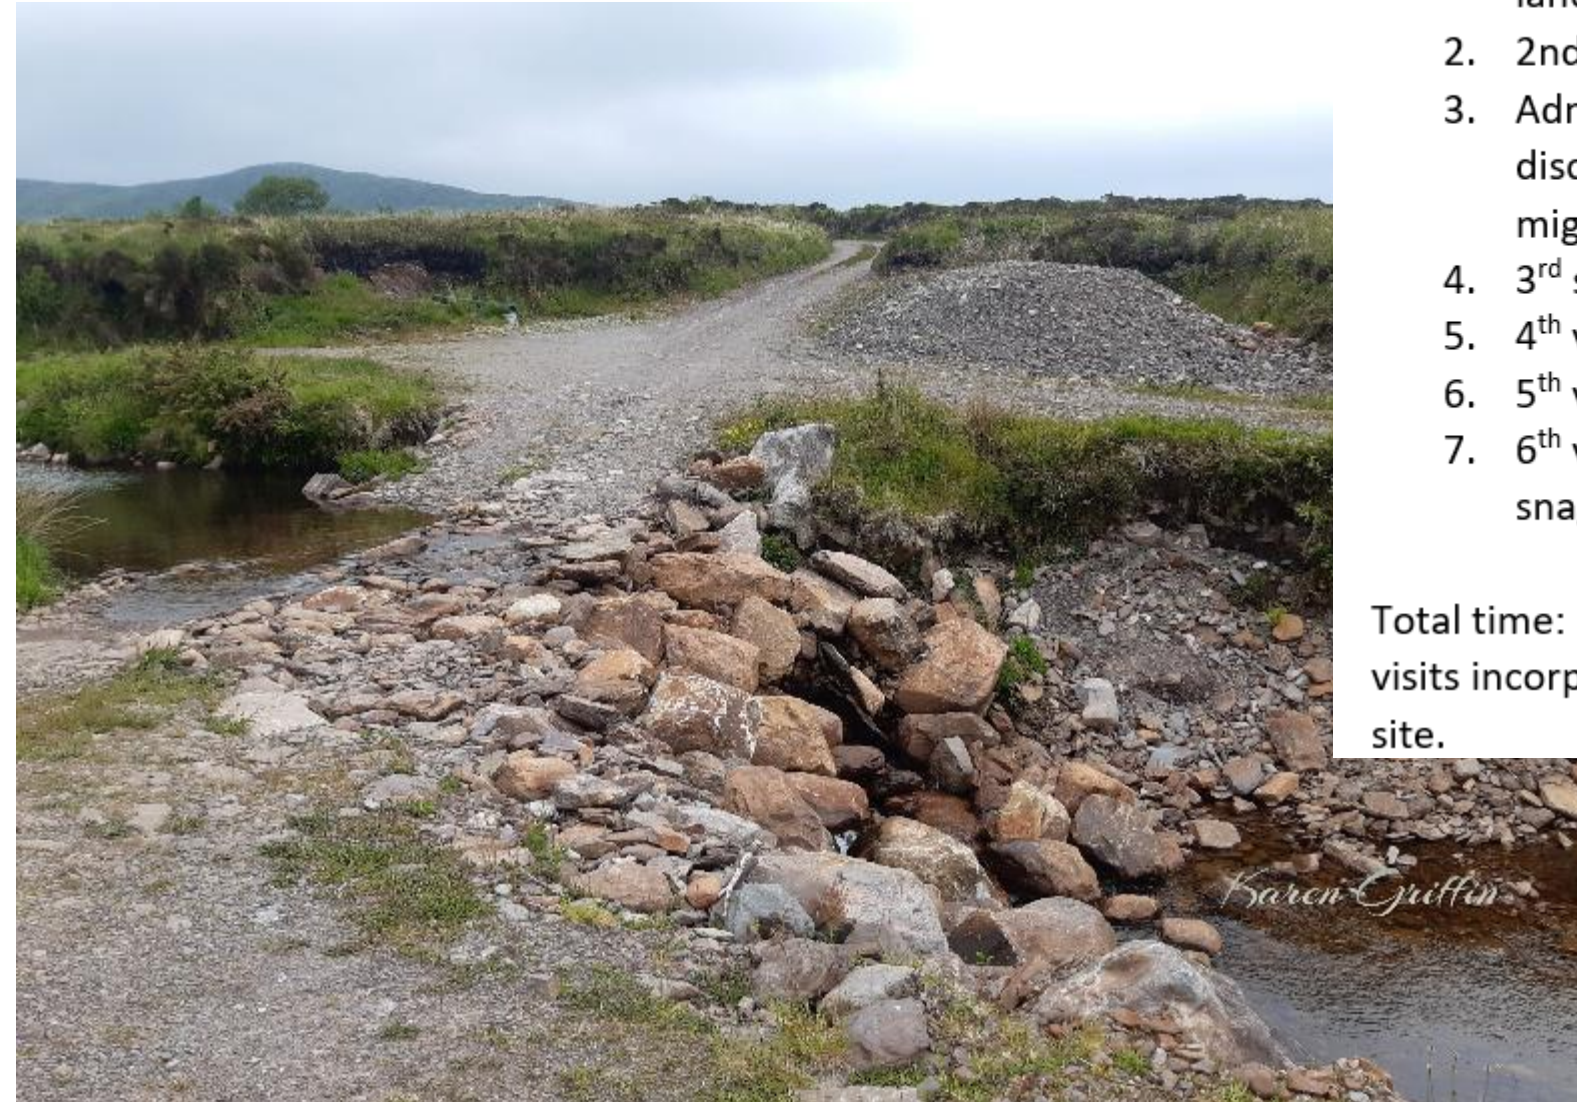
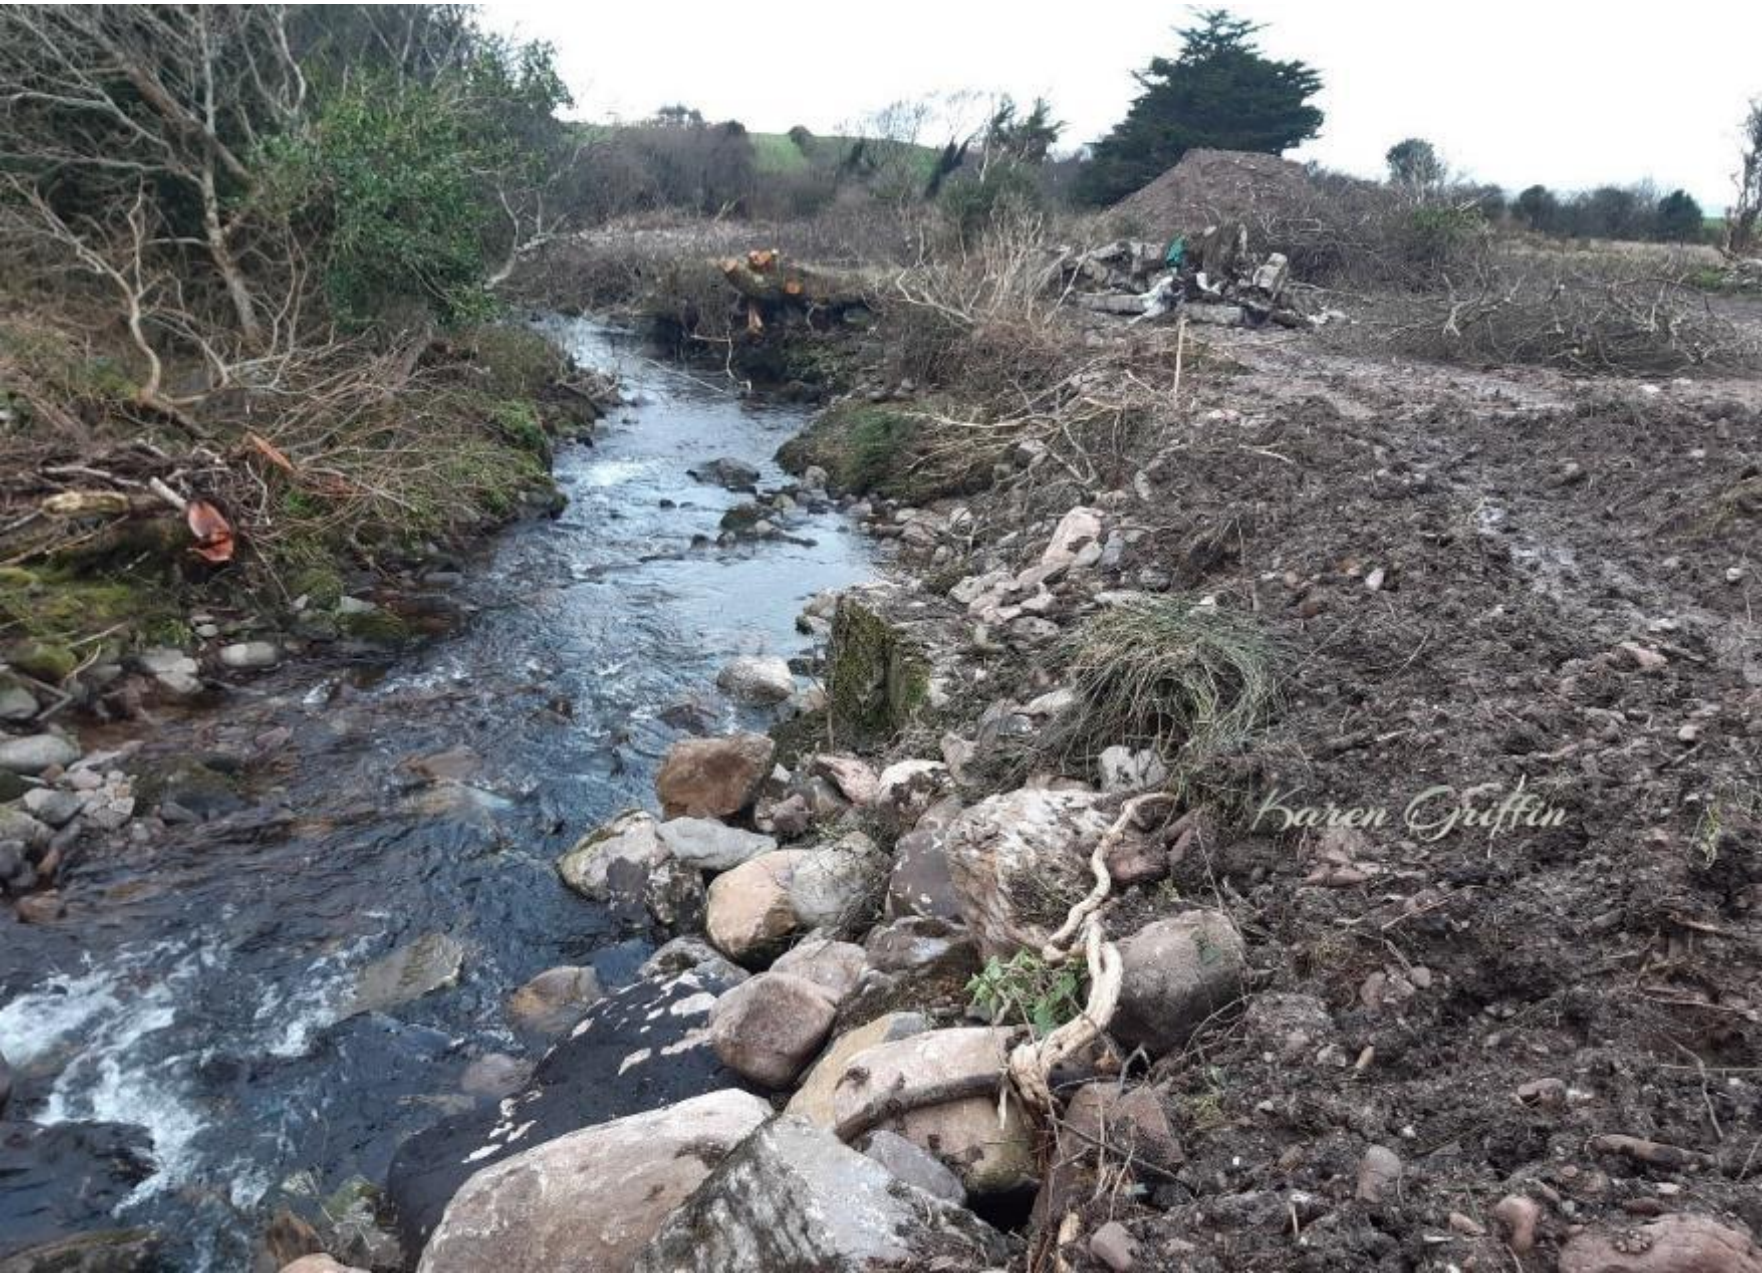
1. Bank clearance and bank works, without IFI consultation in closed season for fish spawning .

2. Finglas River, a tributary of the Laune. Here the owner is clearing land, cutting down hedges, mature trees and reclaiming lands.

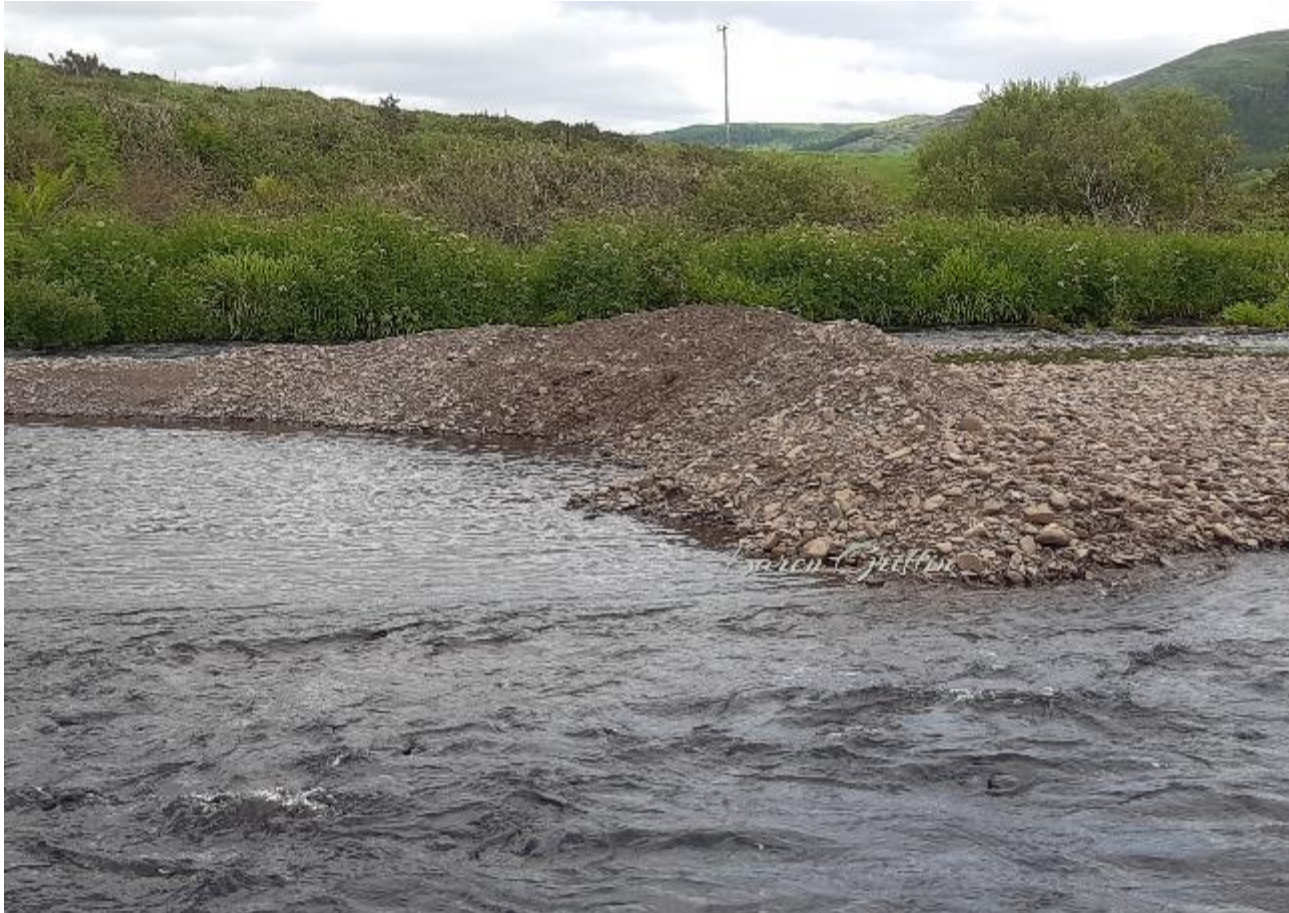
Unauthorised gravel removal River Inny.

1. This just one of many pictures along the system, it's a major problem on the Inny catchment going back over many many years.
2. Again, a sea Trout/Salmon River
3. Currently under Area of Action.
4. Work done by dairy and sheep farmers.
5. IFI have many more pictures of drainage, pollution, gravel extraction, erosion on many rivers within Kerry.

"IFI working on a plan for the Inny river to involve partnership with the landowners to stop the practice of gravel removal and work with nature rather than against, to allow sustainable farming while maintaining and improving fish stocks within the system. I think this is very achievable."
