Agricultural related water quality issue examples forwarded by Regional Operational Committee implementing bodies

**Observations on Agriculture GAP Regs compliance and good practice 2021
Presentation to ASSAP Farm Consultative Group Meeting 24 Jan 2022 &
discussion through WFD governance structure: SE and SW ROCs &
SERWEMC*

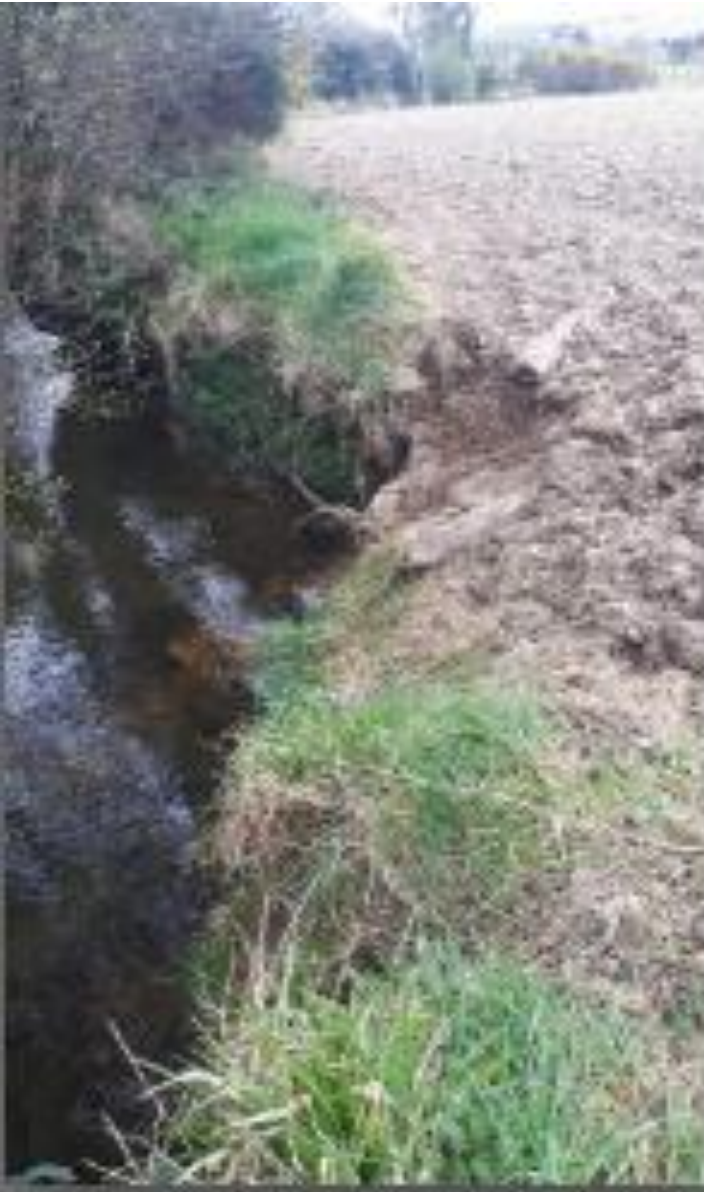
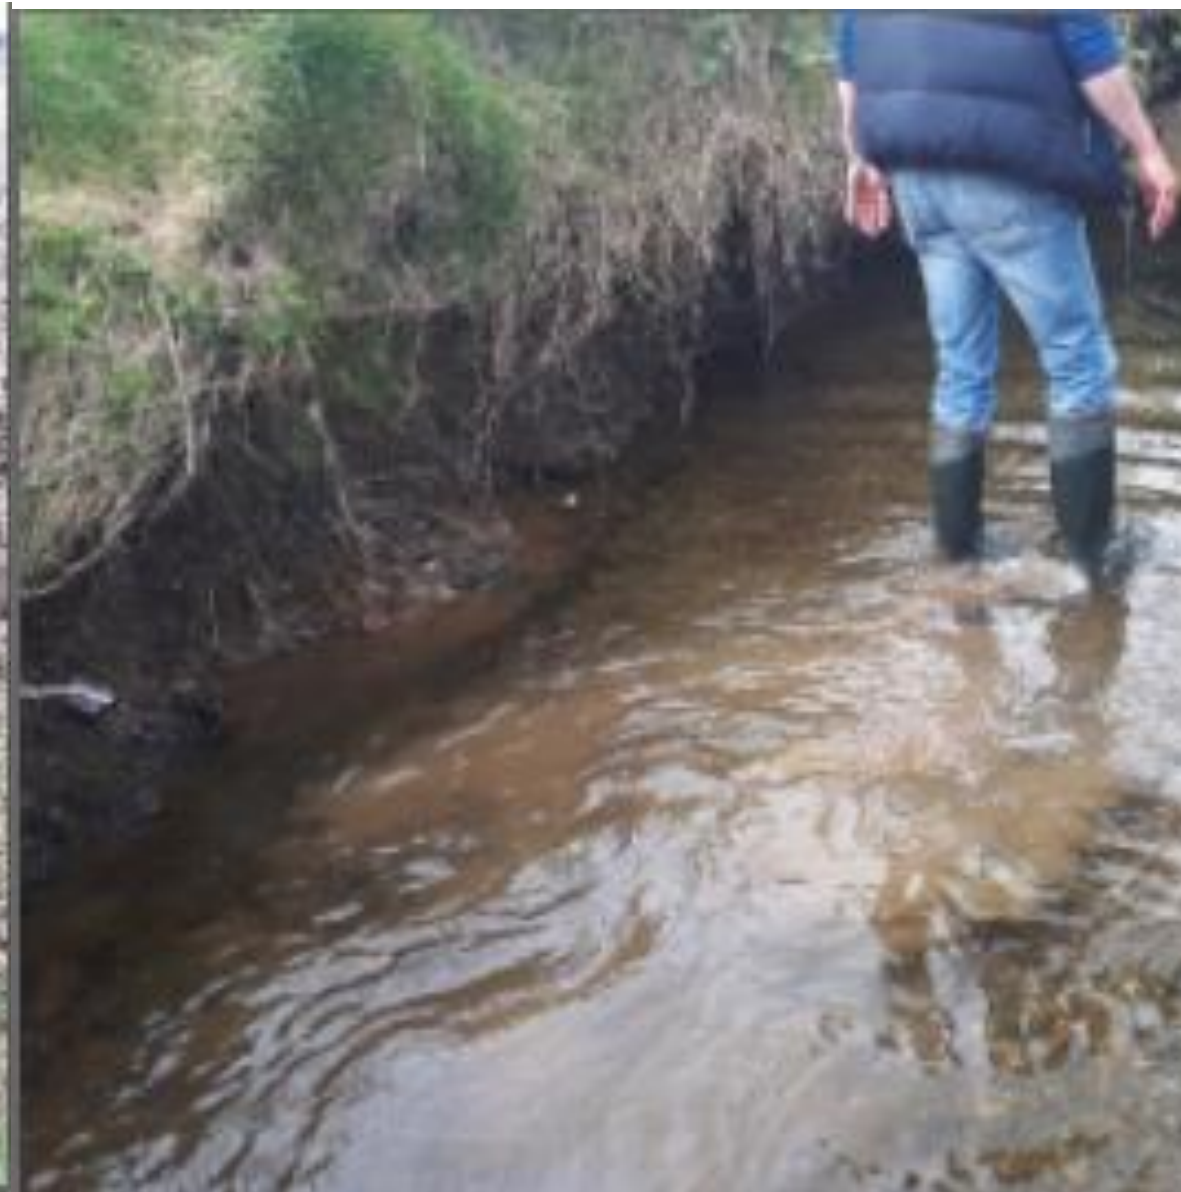
Tillage

1. Ploughing right onto River Bank
2. Siltation
3. Multiple locations over very large tillage fields
4. Ploughing the actual river bank and little or no buffer
5. Common enough occurrence In Co Wicklow
6. High status stream
7. Important for brown trout

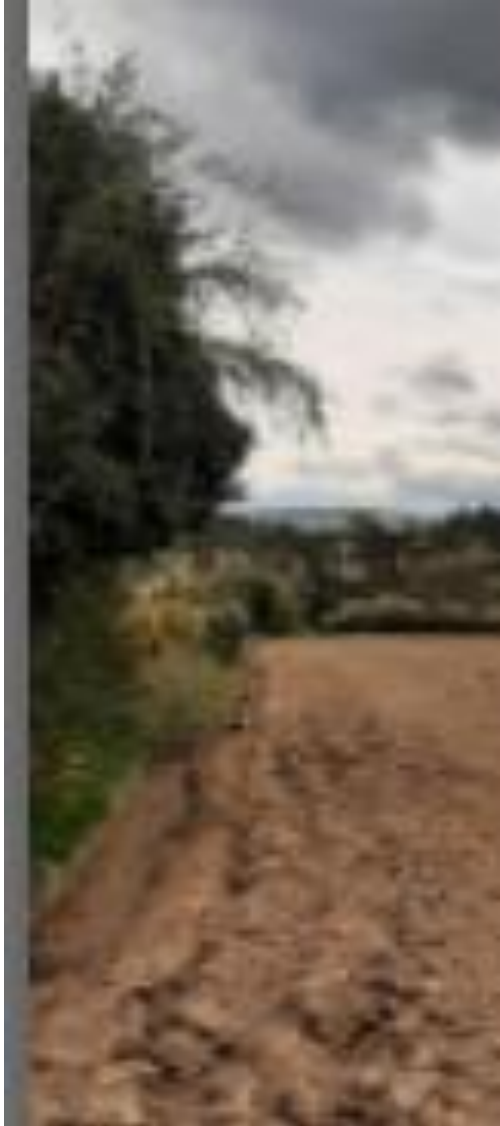
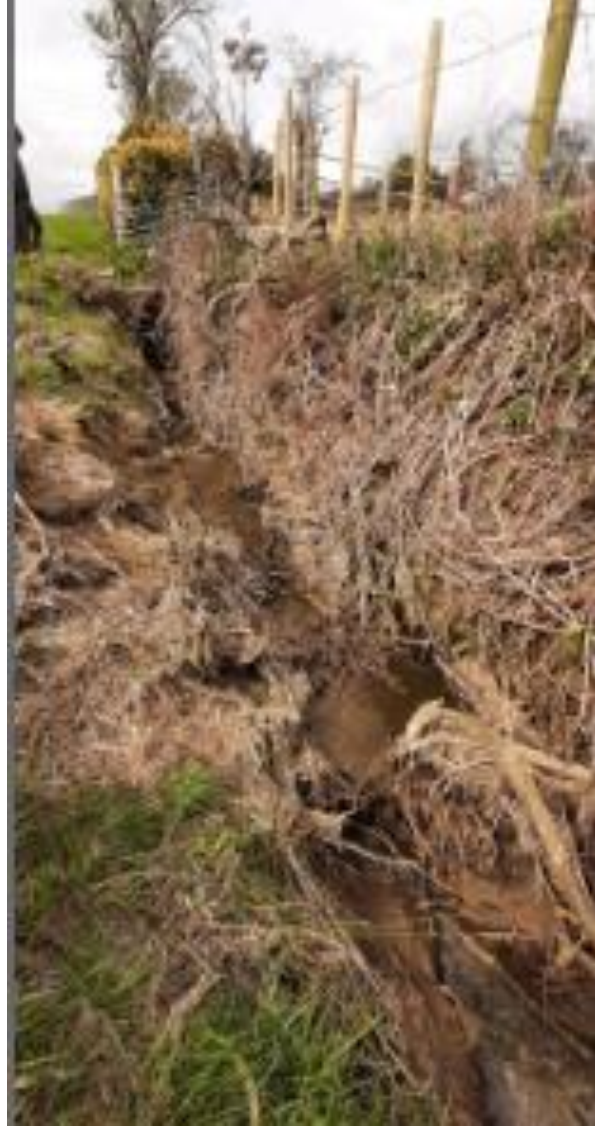
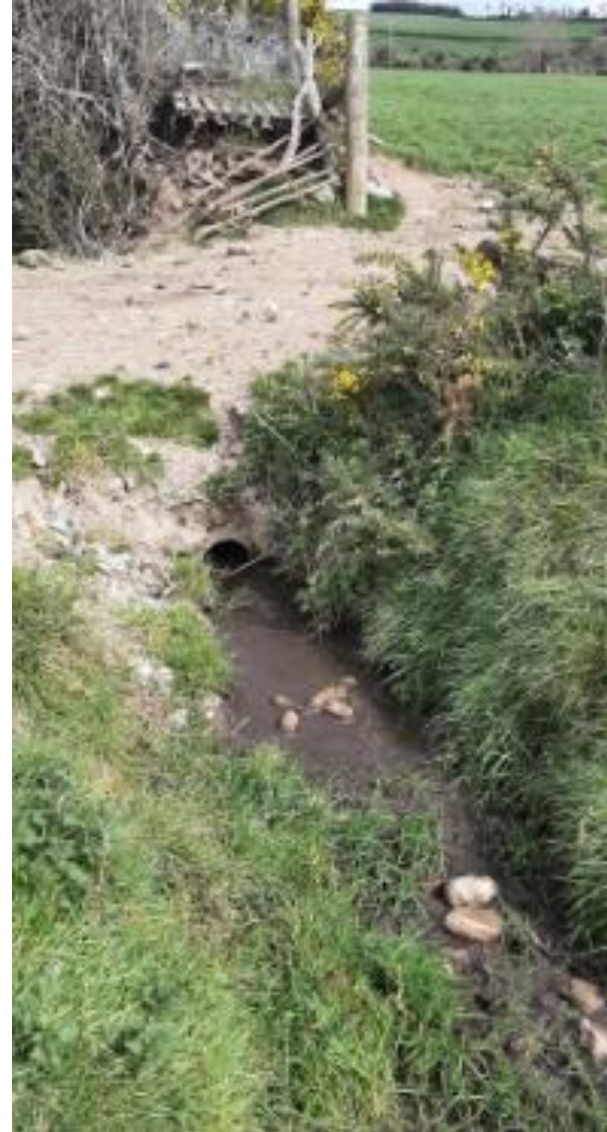
Poor Slurry Spreading Practices –

Mixed enterprise farm

1. Slurry in ditches connecting to river

1. Receptor is a PAA and
2. important for brown trout

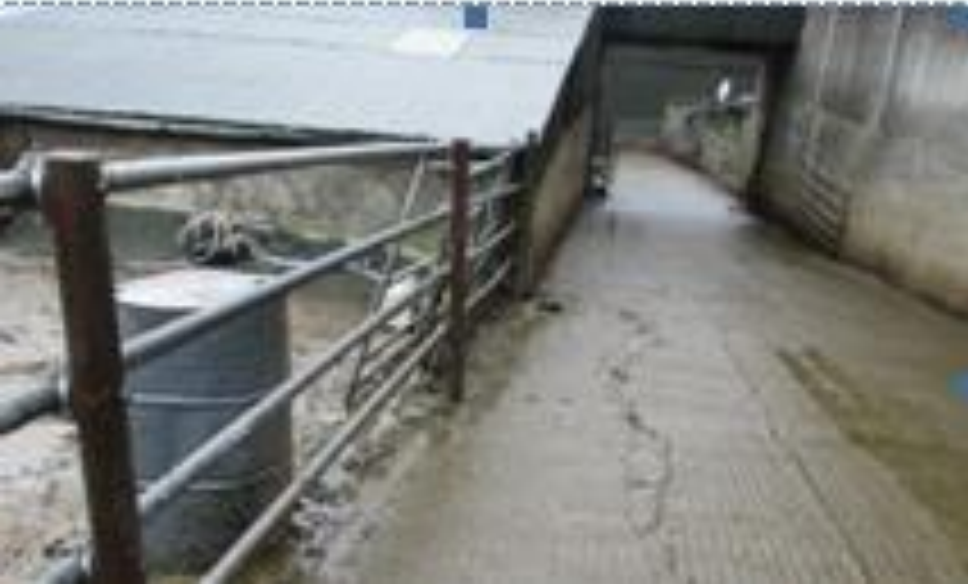
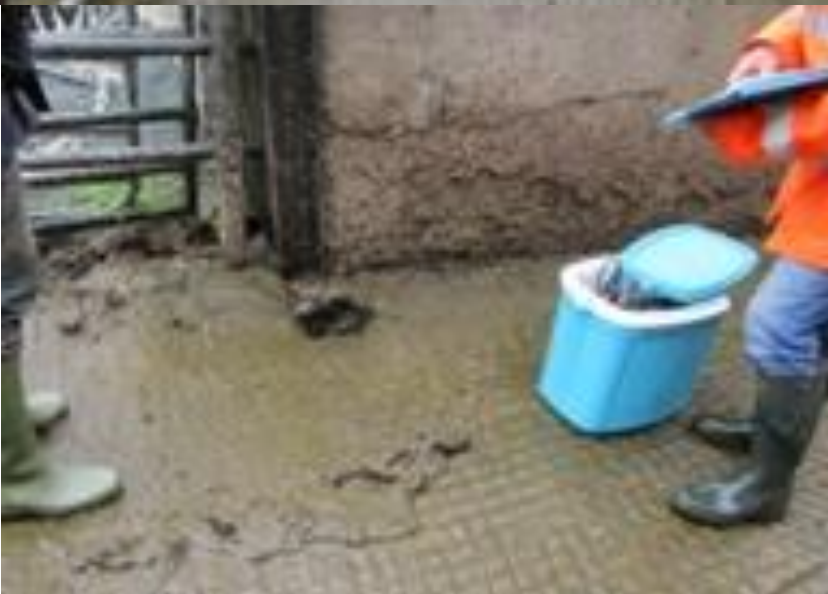
Soiled water to surface water drain and river –

Derogation Dairy Farm

1. High status
2. Brown trout stream
3. EPA monitoring station 2km downstream showing elevated nutrients and BOD in Aug and Oct 2021 (a trend reversal)

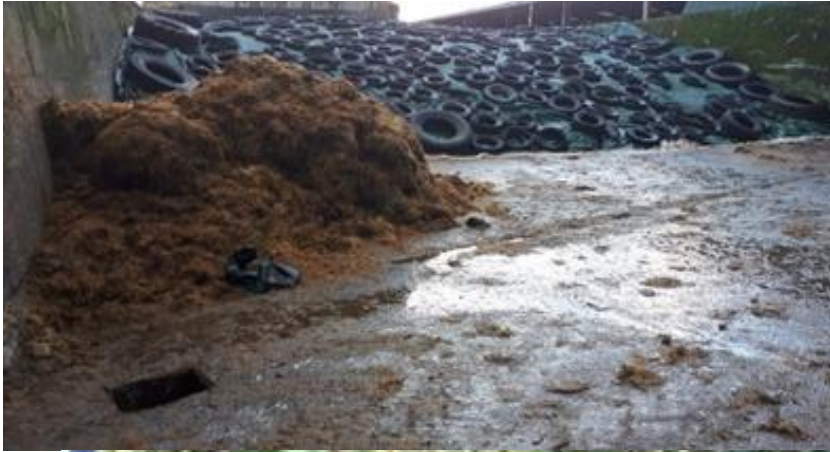
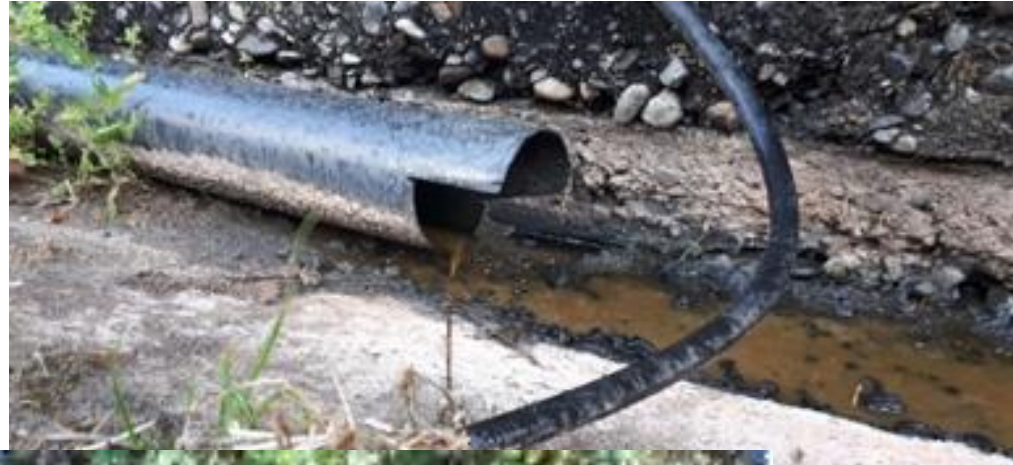
Silage Effluent to field drain & river 1 – Derogation Dairy Farm

1. Slaney tributary –
2. high status stream
3. Salmon and trout stream
4. Impact evident along 4kms of stream

Bottom picture – waist high in sewage fungus for 4kms

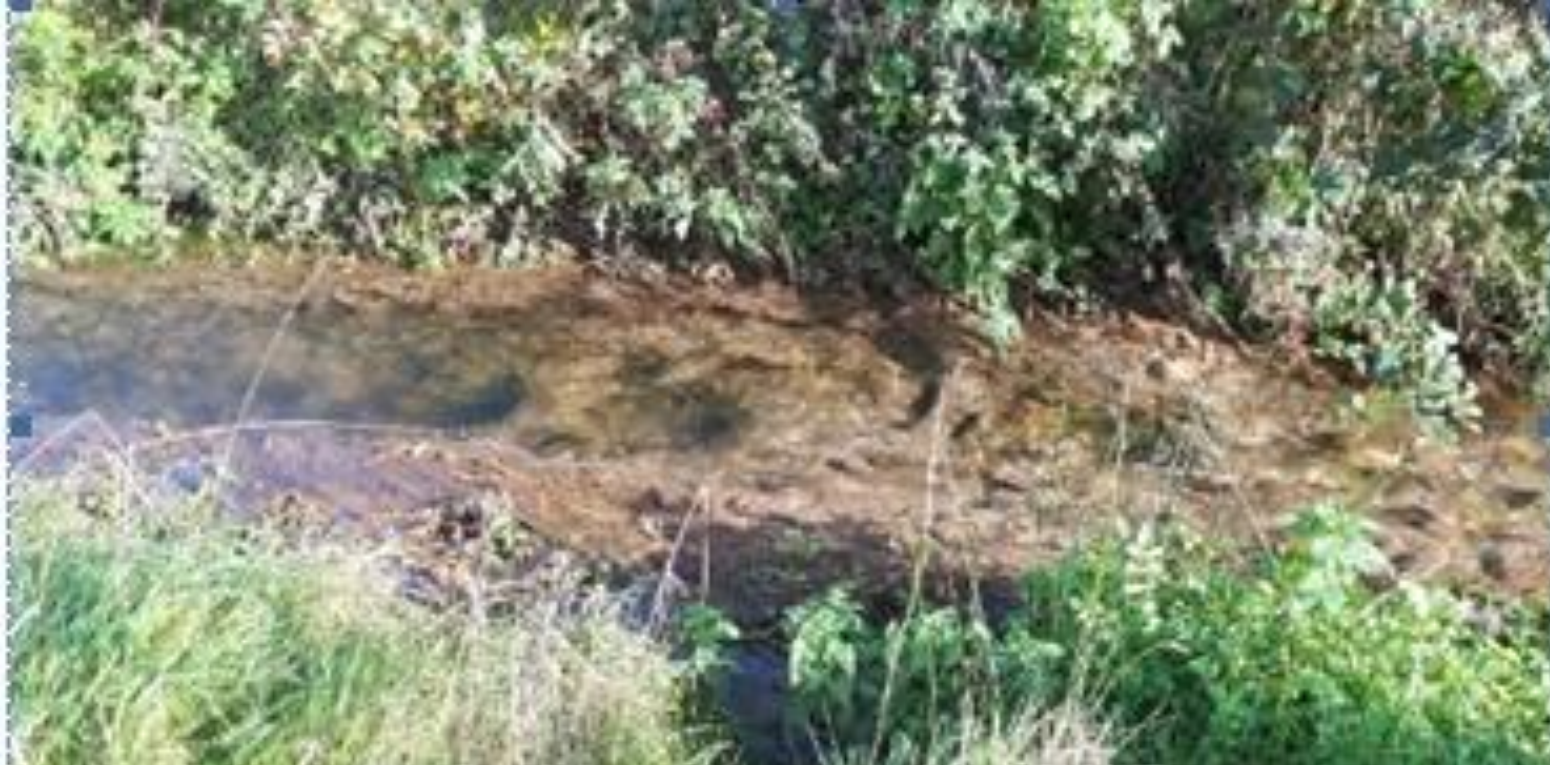
This was a well run farm but drain below (maize pit, silage pit and wheat pit) was blocked and seeping to surface water drain as drain to storage tank was blocked

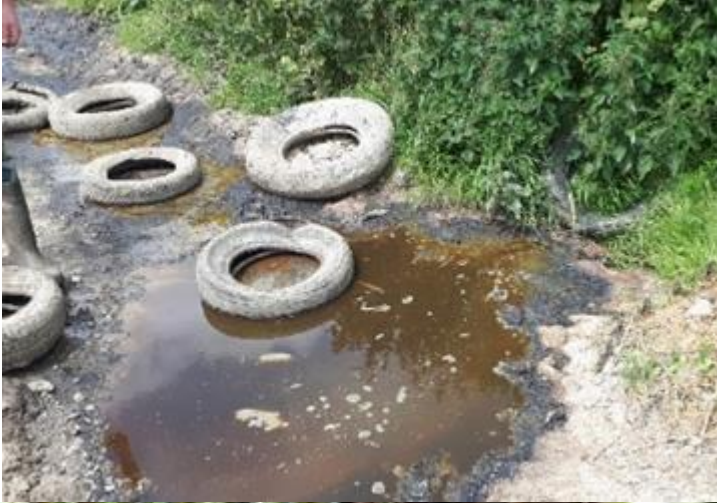
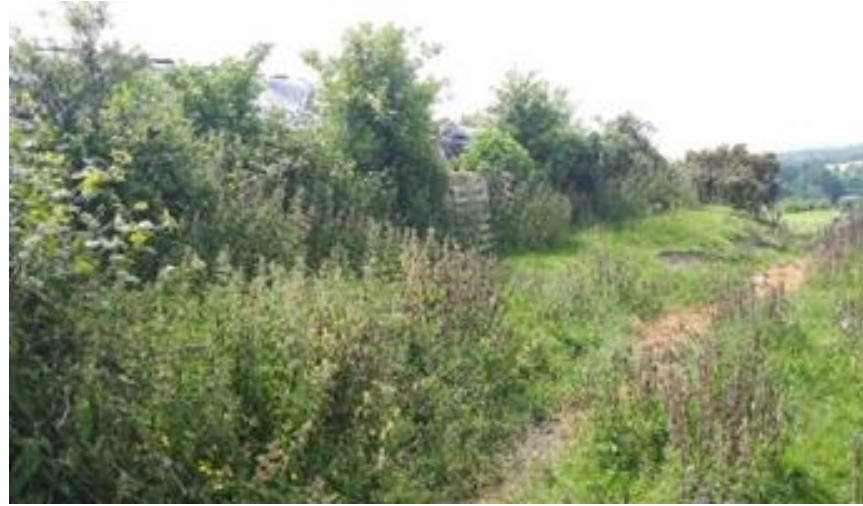
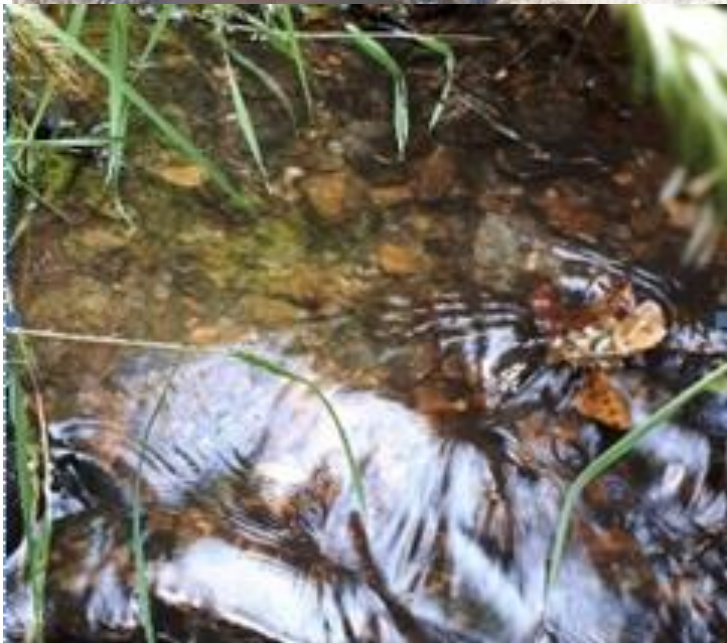
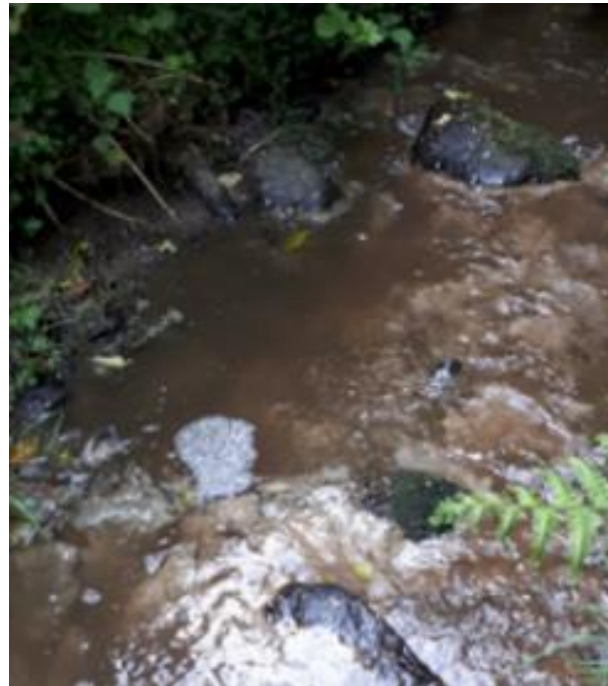
Derogation dairy farm.

1. Recent entrant to Derogation
- Silage pit not fit for purpose and
2. Seeping in river
3. Impact for 1km downstream
4. Brown trout river

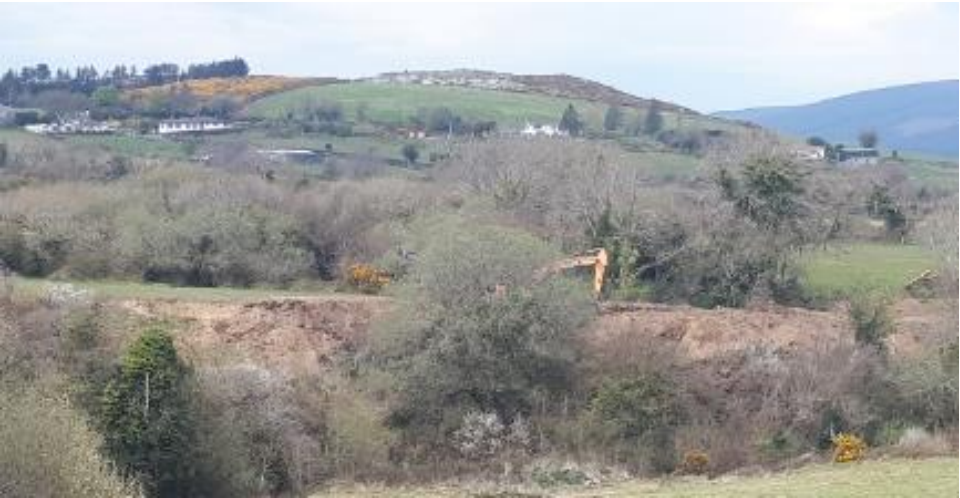
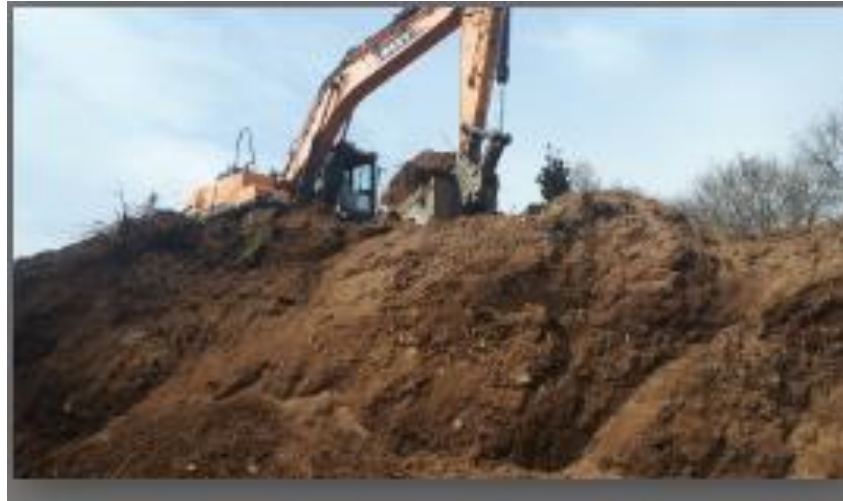
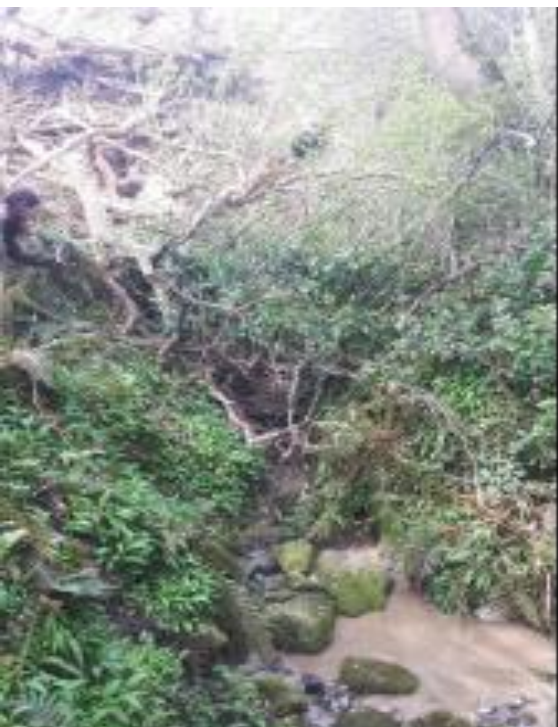
In-stream Works 1 – Culverting stream – non Dairy farm

1. Tributary of the Dargle River

2. Important river for sea trout and salmon – probably one of the most important sea trout rivers on the east coast.

Impact

1. Fish passage prevented
2. Ongoing siltation effects on the main channel

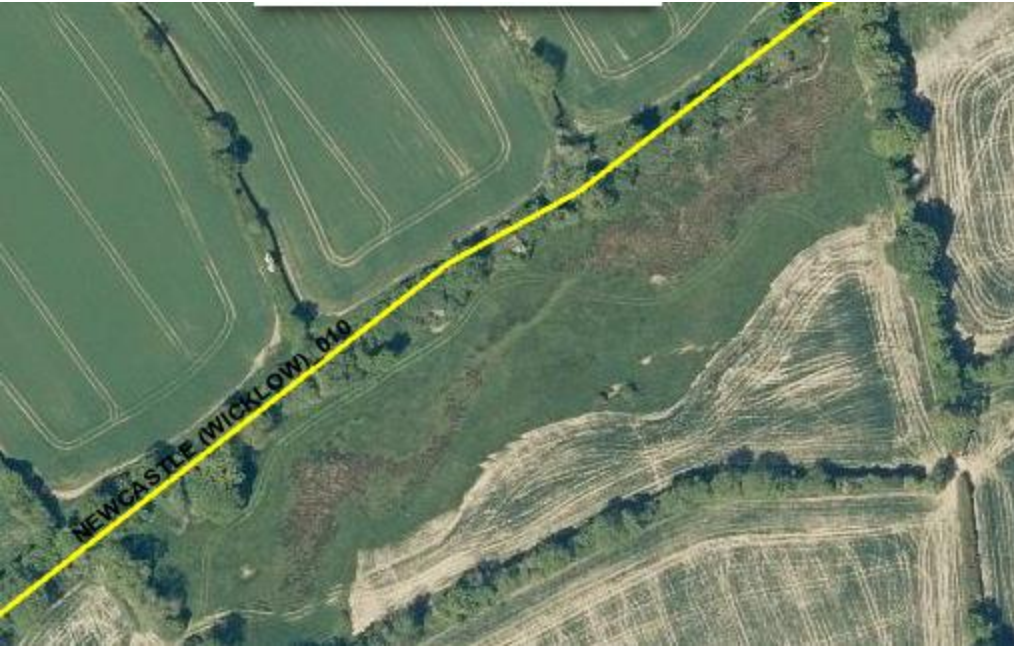
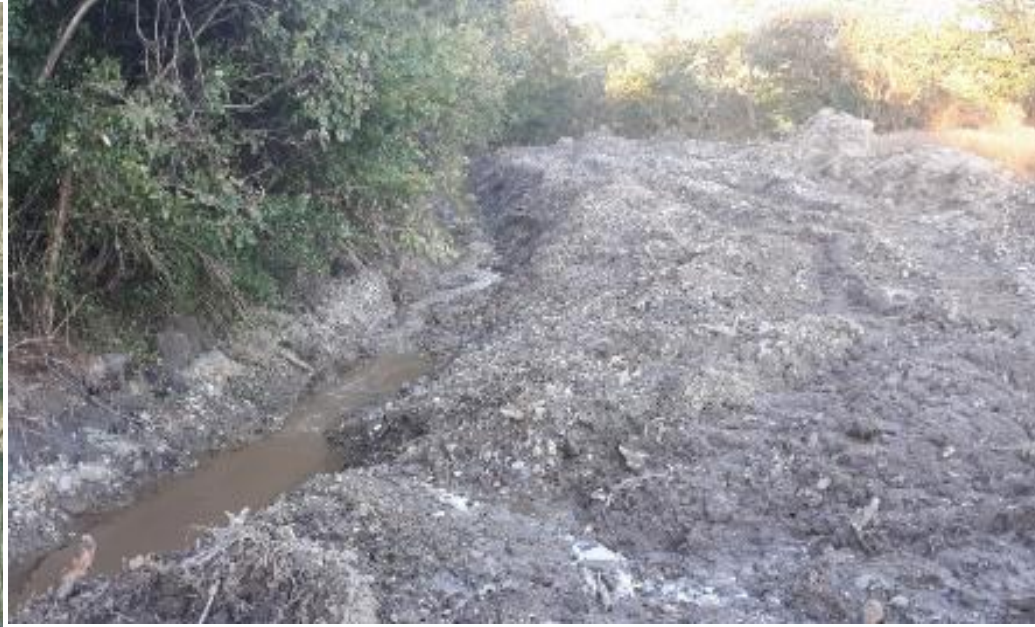
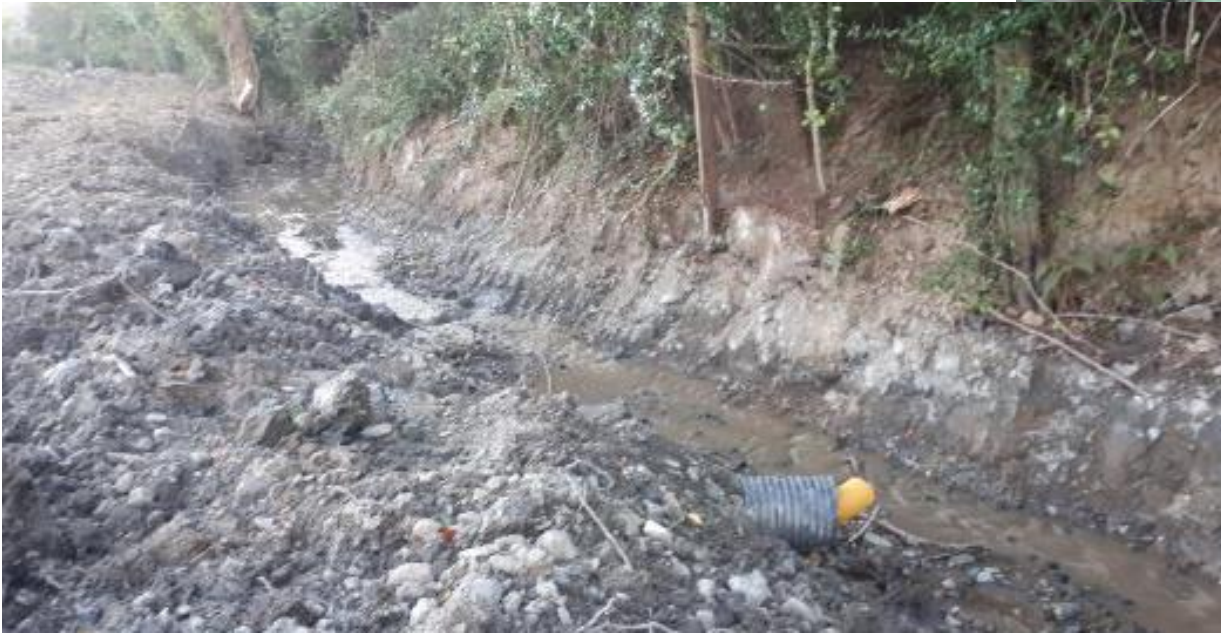
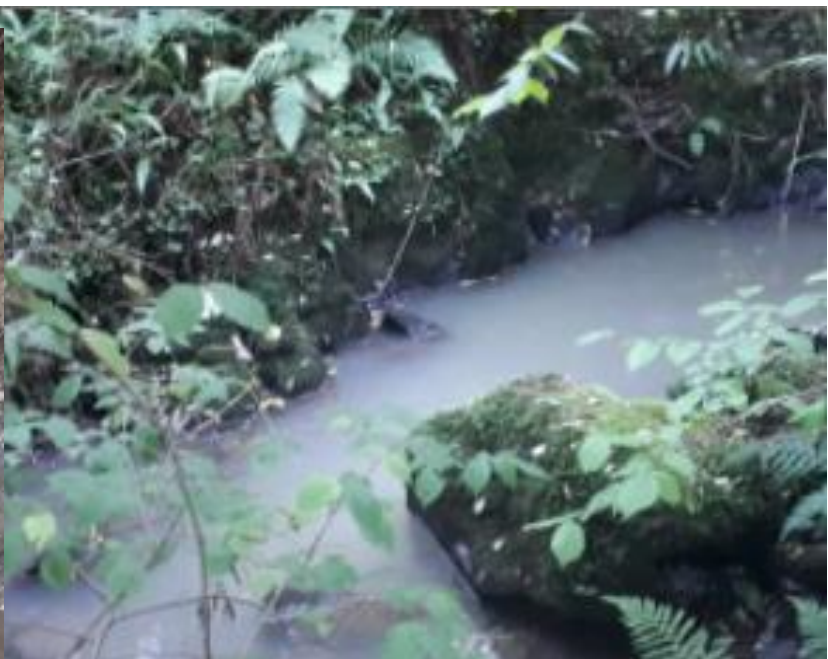
In-stream Works 2 – land reclamation - Tillage

1. Newcastle River main channel

2. Main channel excavated for 150m

3. Impact evident for **4km (bottom left picture)**

4. Brown trout and salmon stream

5. Works carried out during fish spawning season

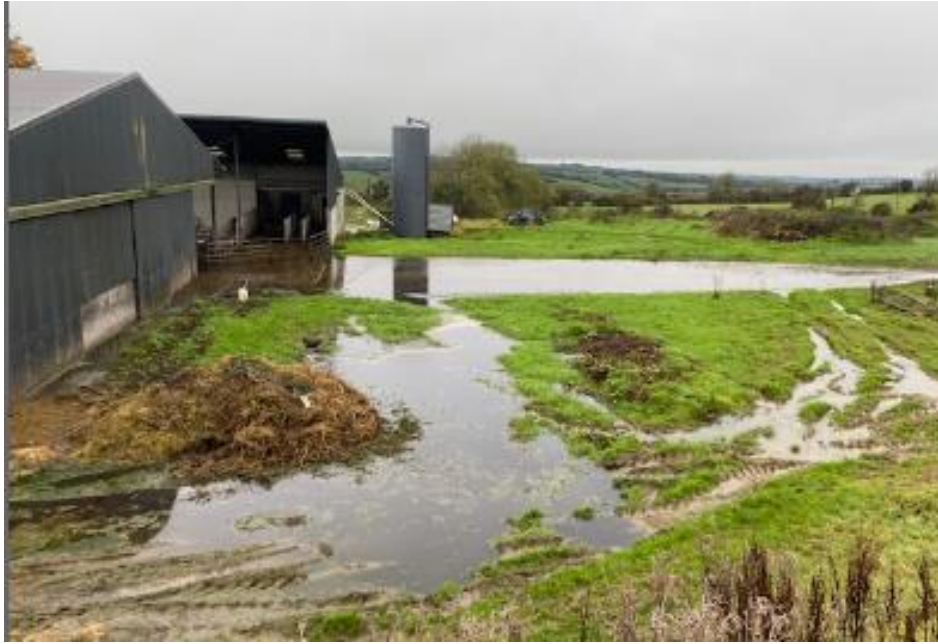
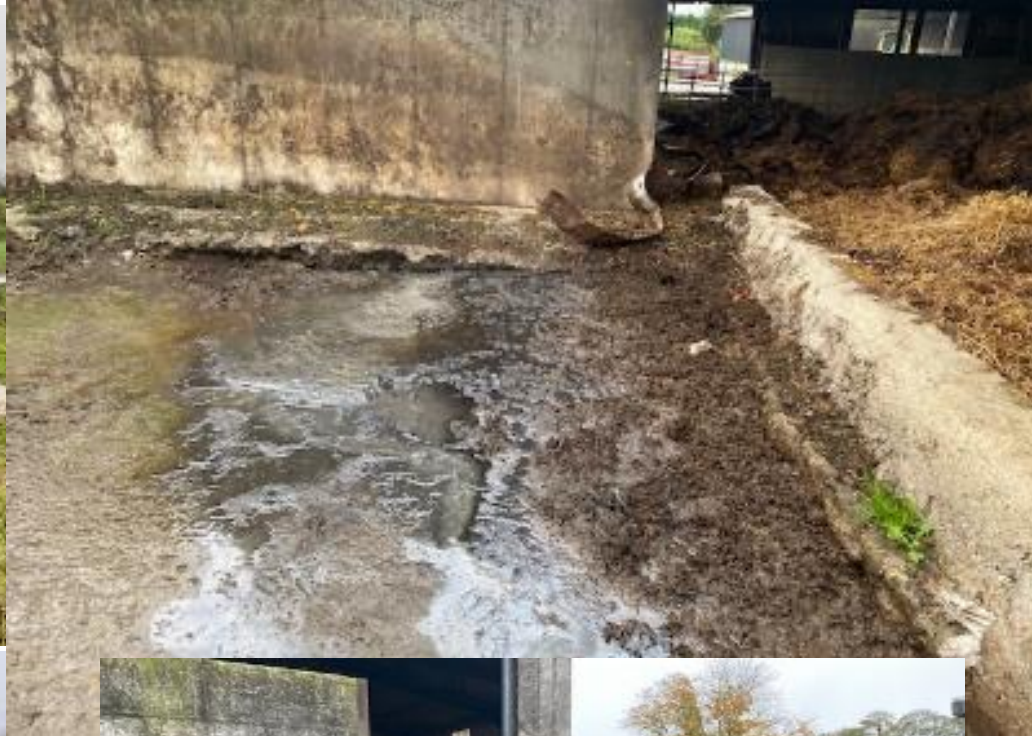
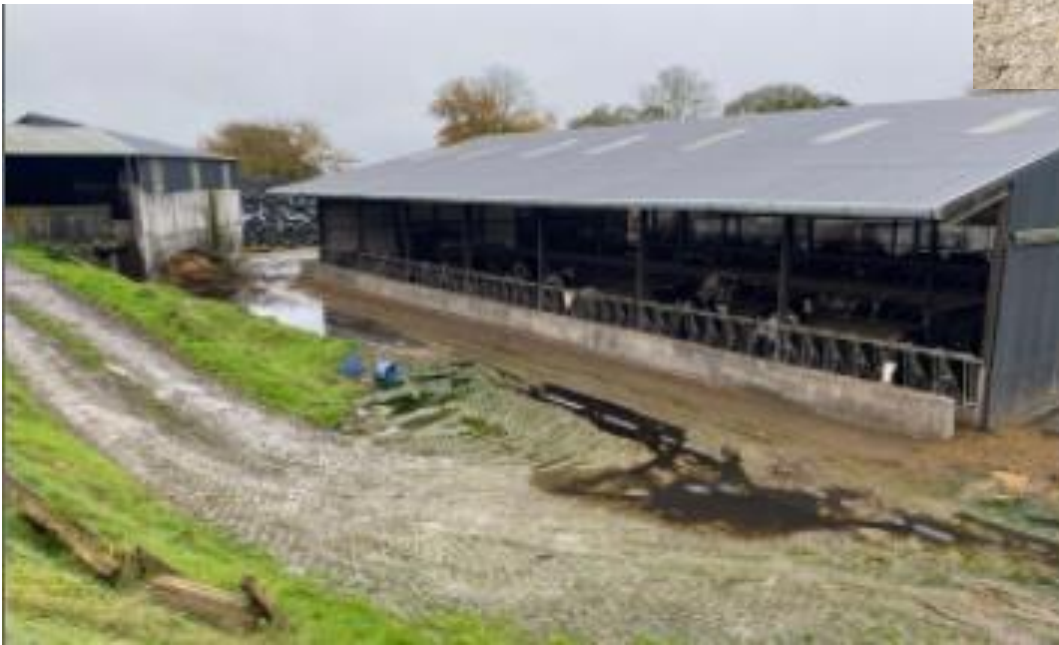
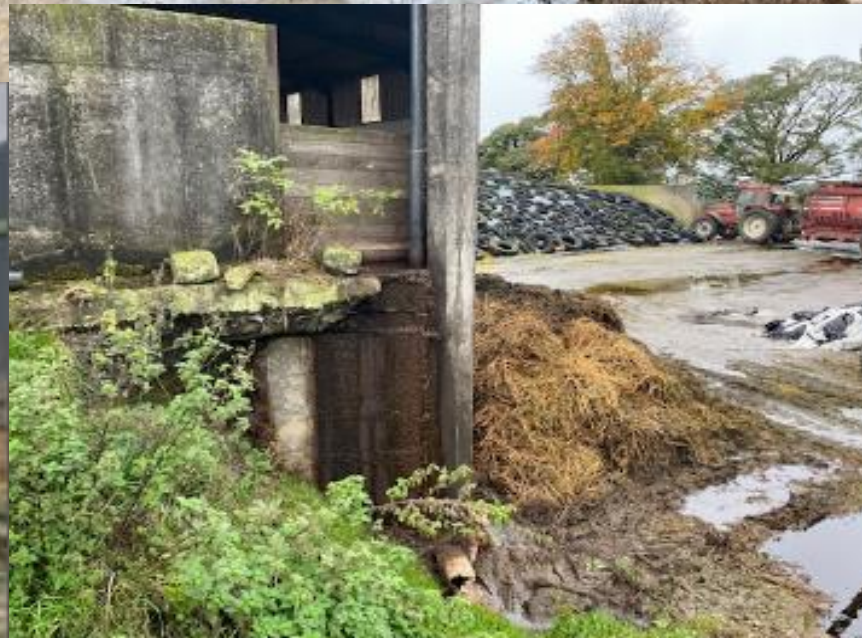
Dungstead effluent to groundwater

**Derogation Farm
Dairy**

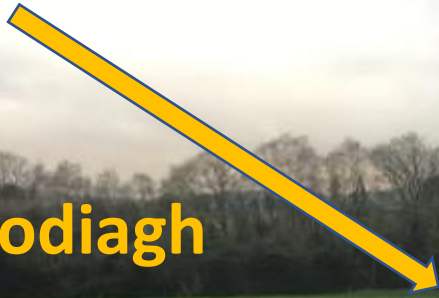
River Clodiagh

- Photo taken Jan 10th 2022. Spreading observed in the area on Jan 4th on icy conditions – very heavy rain between periods. River flows along field boundary.

CLOSED PERIOD SPREADING

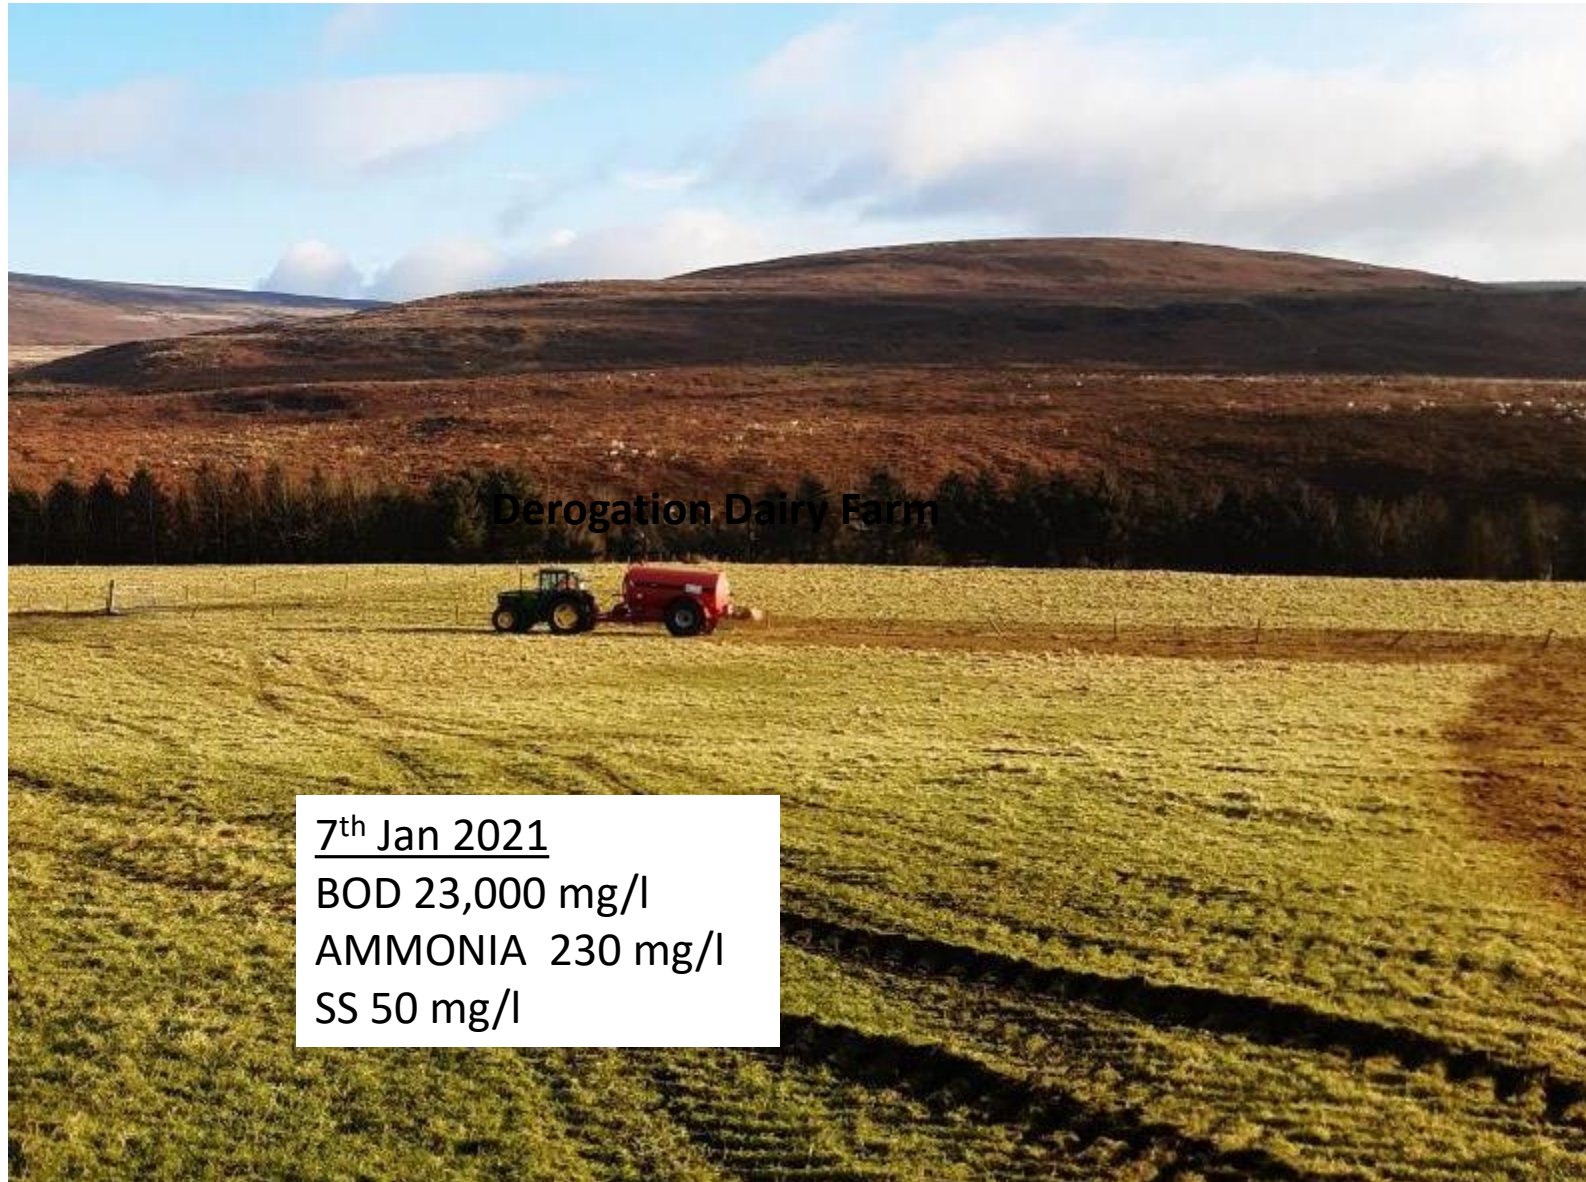
BOD 23,000 mg/l

AMMONIA 230 mg/l

SS 50 mg/l

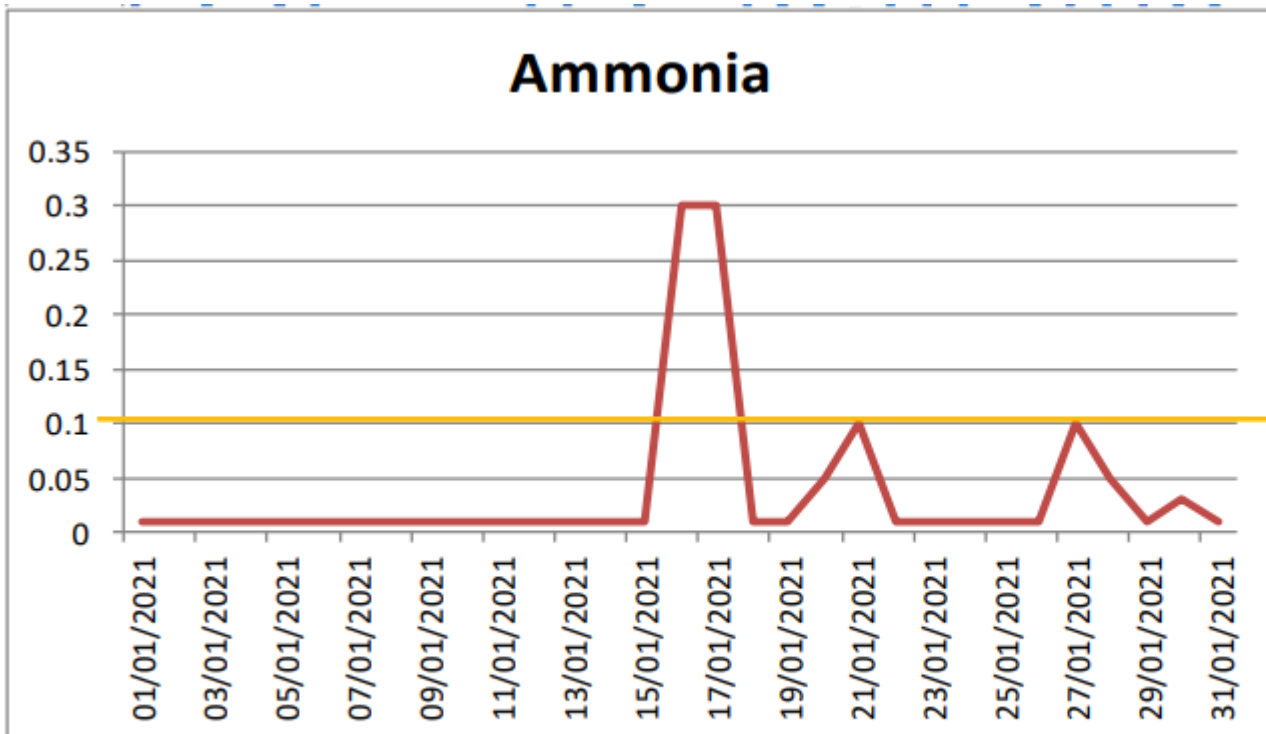
Ammonia level (0.1mg/l) at which drinking water source is switched off

The graph shows that the online ammonia monitor at a major drinking water plant (serving 65,000 people) detected high ammonia at the abstraction point in the river downstream of a cluster of farms where closed season slurry spreading was carried out. The abstraction had to be switched off due the ammonia levels detected. Waterford CoCo report. Data from Kilmeaden Water Treatment Plant – water supply for Waterford City

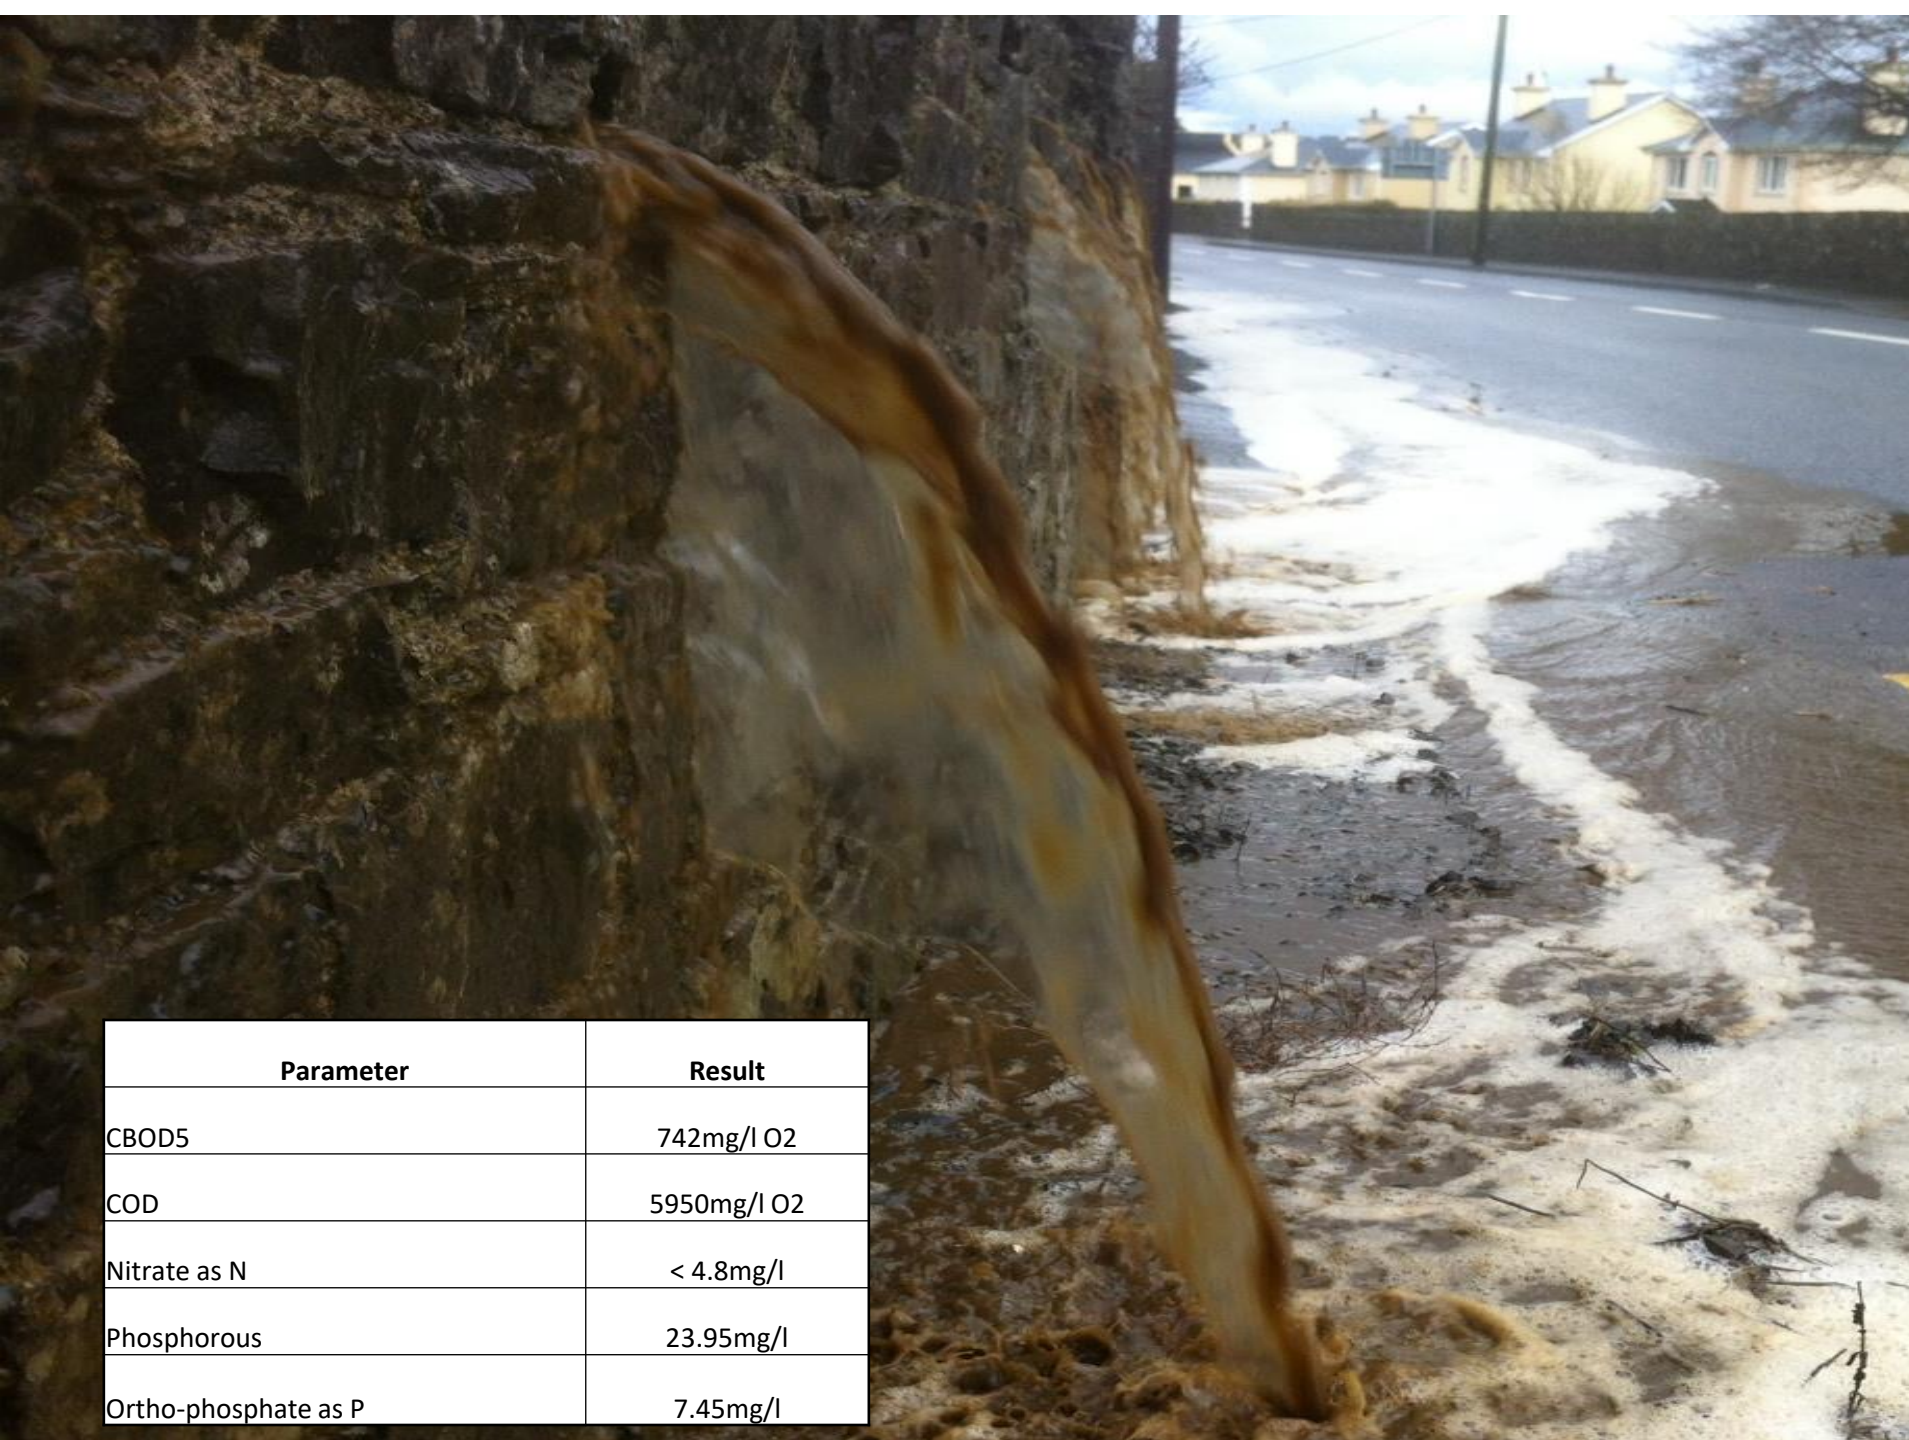
Example of slurry washout after spreading on frosty conditions – North Cork-DuhallowLIFE (*just for illustration*)

Parameter	Result
CBOD5	742mg/l O2
COD	5950mg/l O2
Nitrate as N	< 4.8mg/l
Phosphorous	23.95mg/l
Ortho-phosphate as P	7.45mg/l

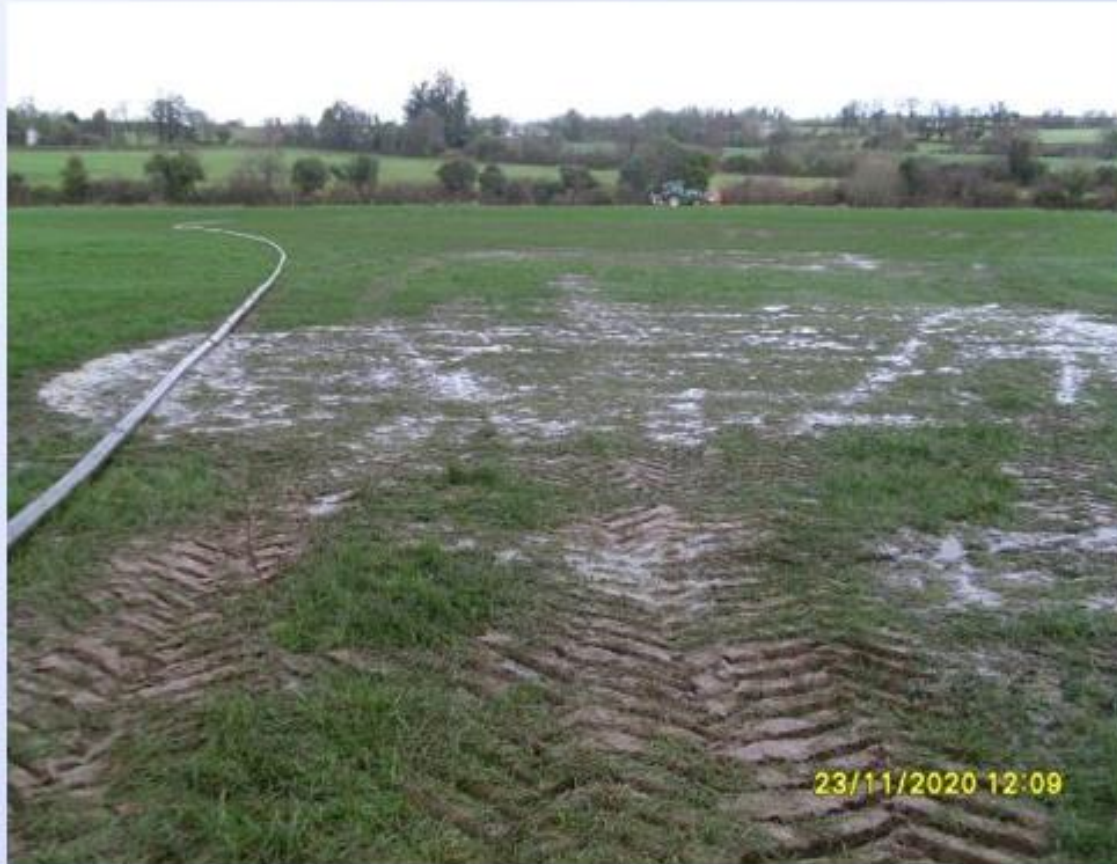
Tipperary Spreading during the closed period 2020/2021.

Derogation Dairy Farm

1. SAC catchment
2. Atlantic salmon and brown trout
