Agricultural related water quality issue examples forwarded by Regional Operational Committee implementing bodies

**Observations on Agriculture GAP Regs compliance and good practice 2021
Presentation to ASSAP Farm Consultative Group Meeting 24 Jan 2022 &
discussion through WFD governance structure: SE and SW ROCs &
SERWEMC*

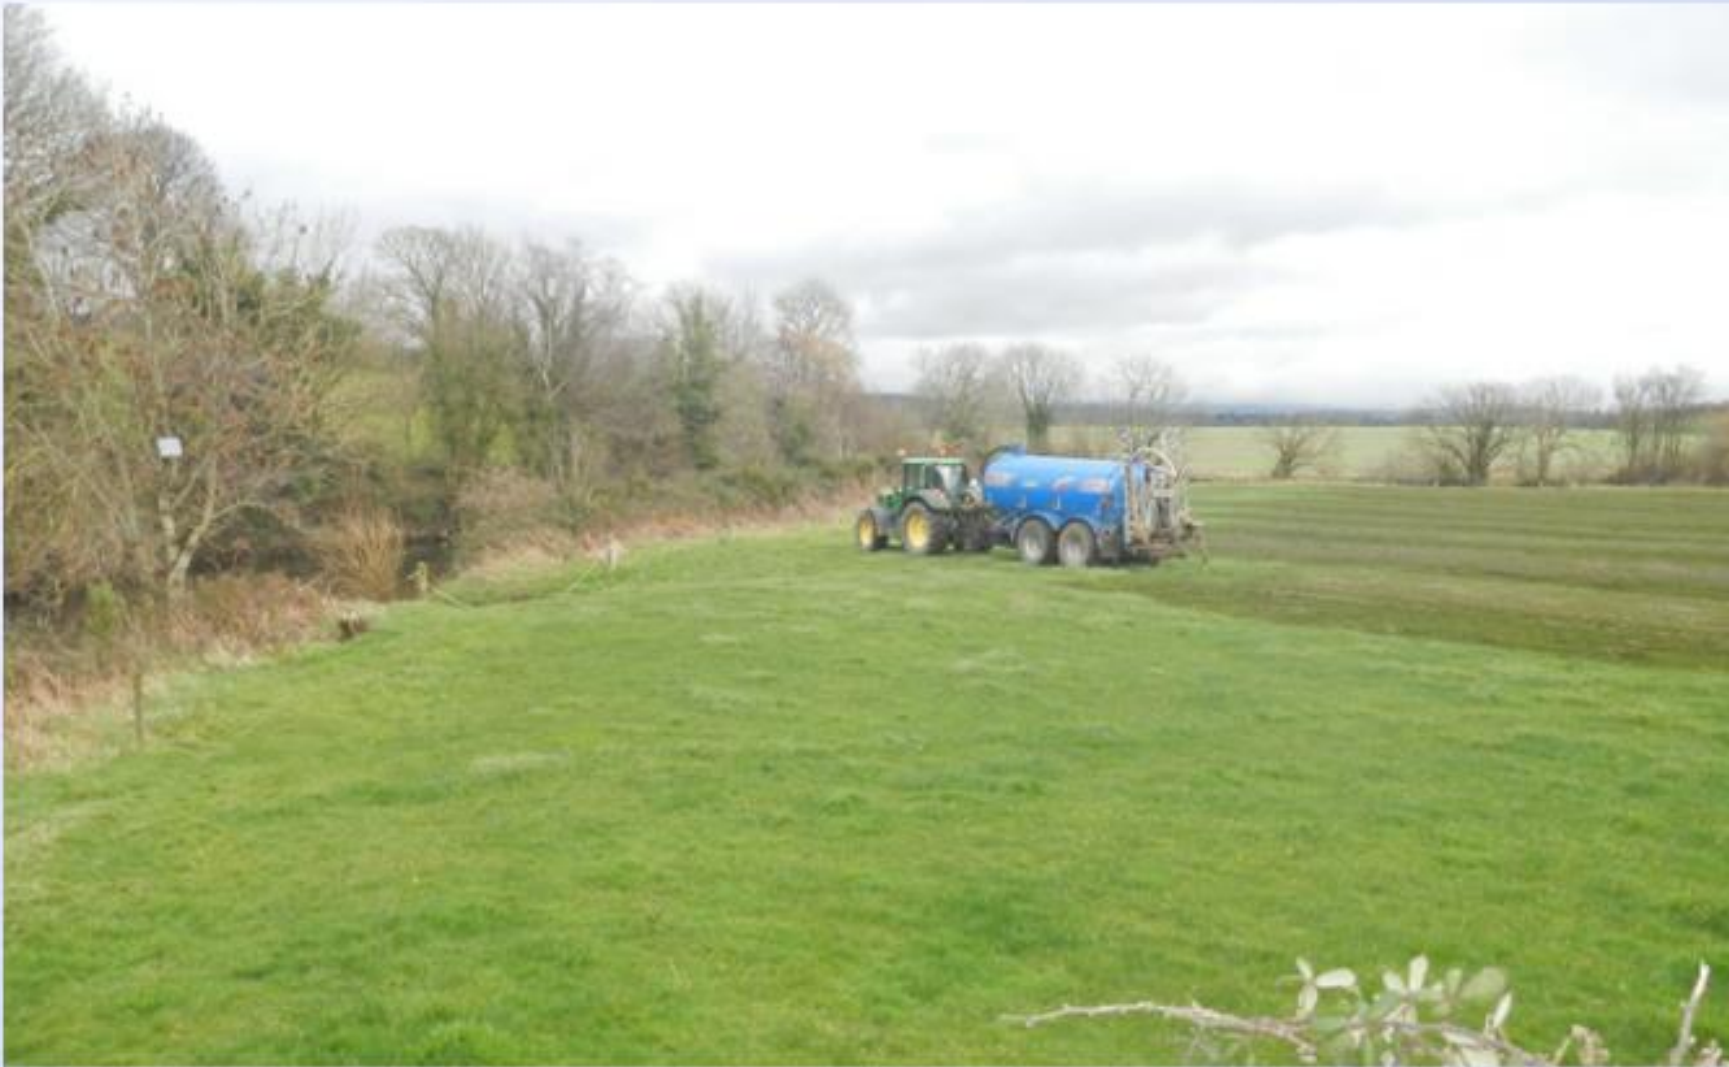
Tipperary Spreading during the closed period 2020/2021.

Derogation Dairy Farm

1. SAC catchment
2. Atlantic salmon
and brown trout

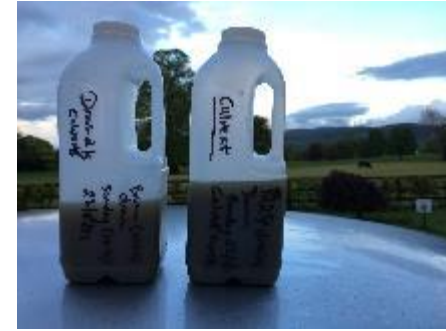
Derogation Dairy Farm

1. Heavy rain. Runoff from yards from 2 farms and drain.
2. 2. Continuous over a number of days.

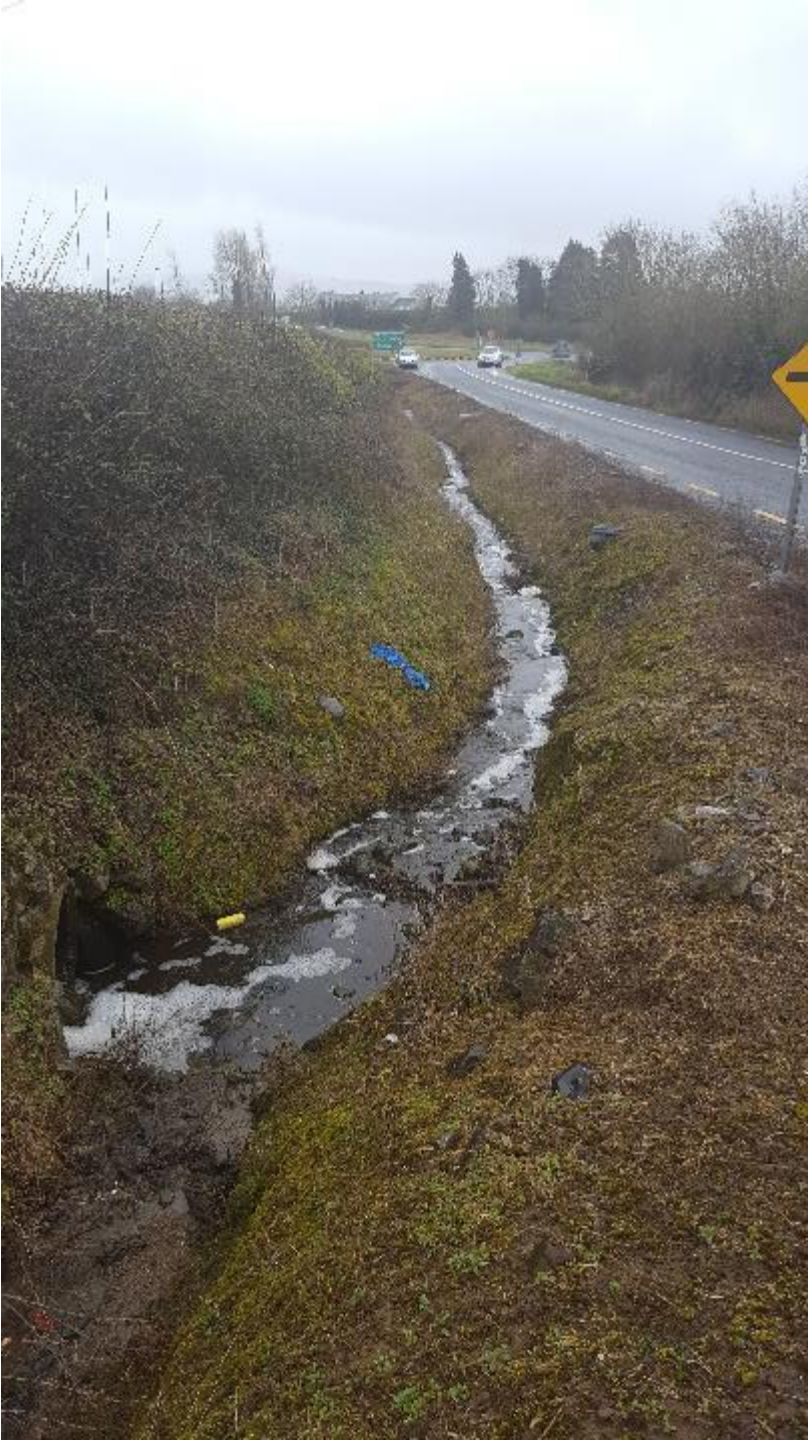
Same drain – reoccurring incidents the previous year

Pic taken on 13/03/20

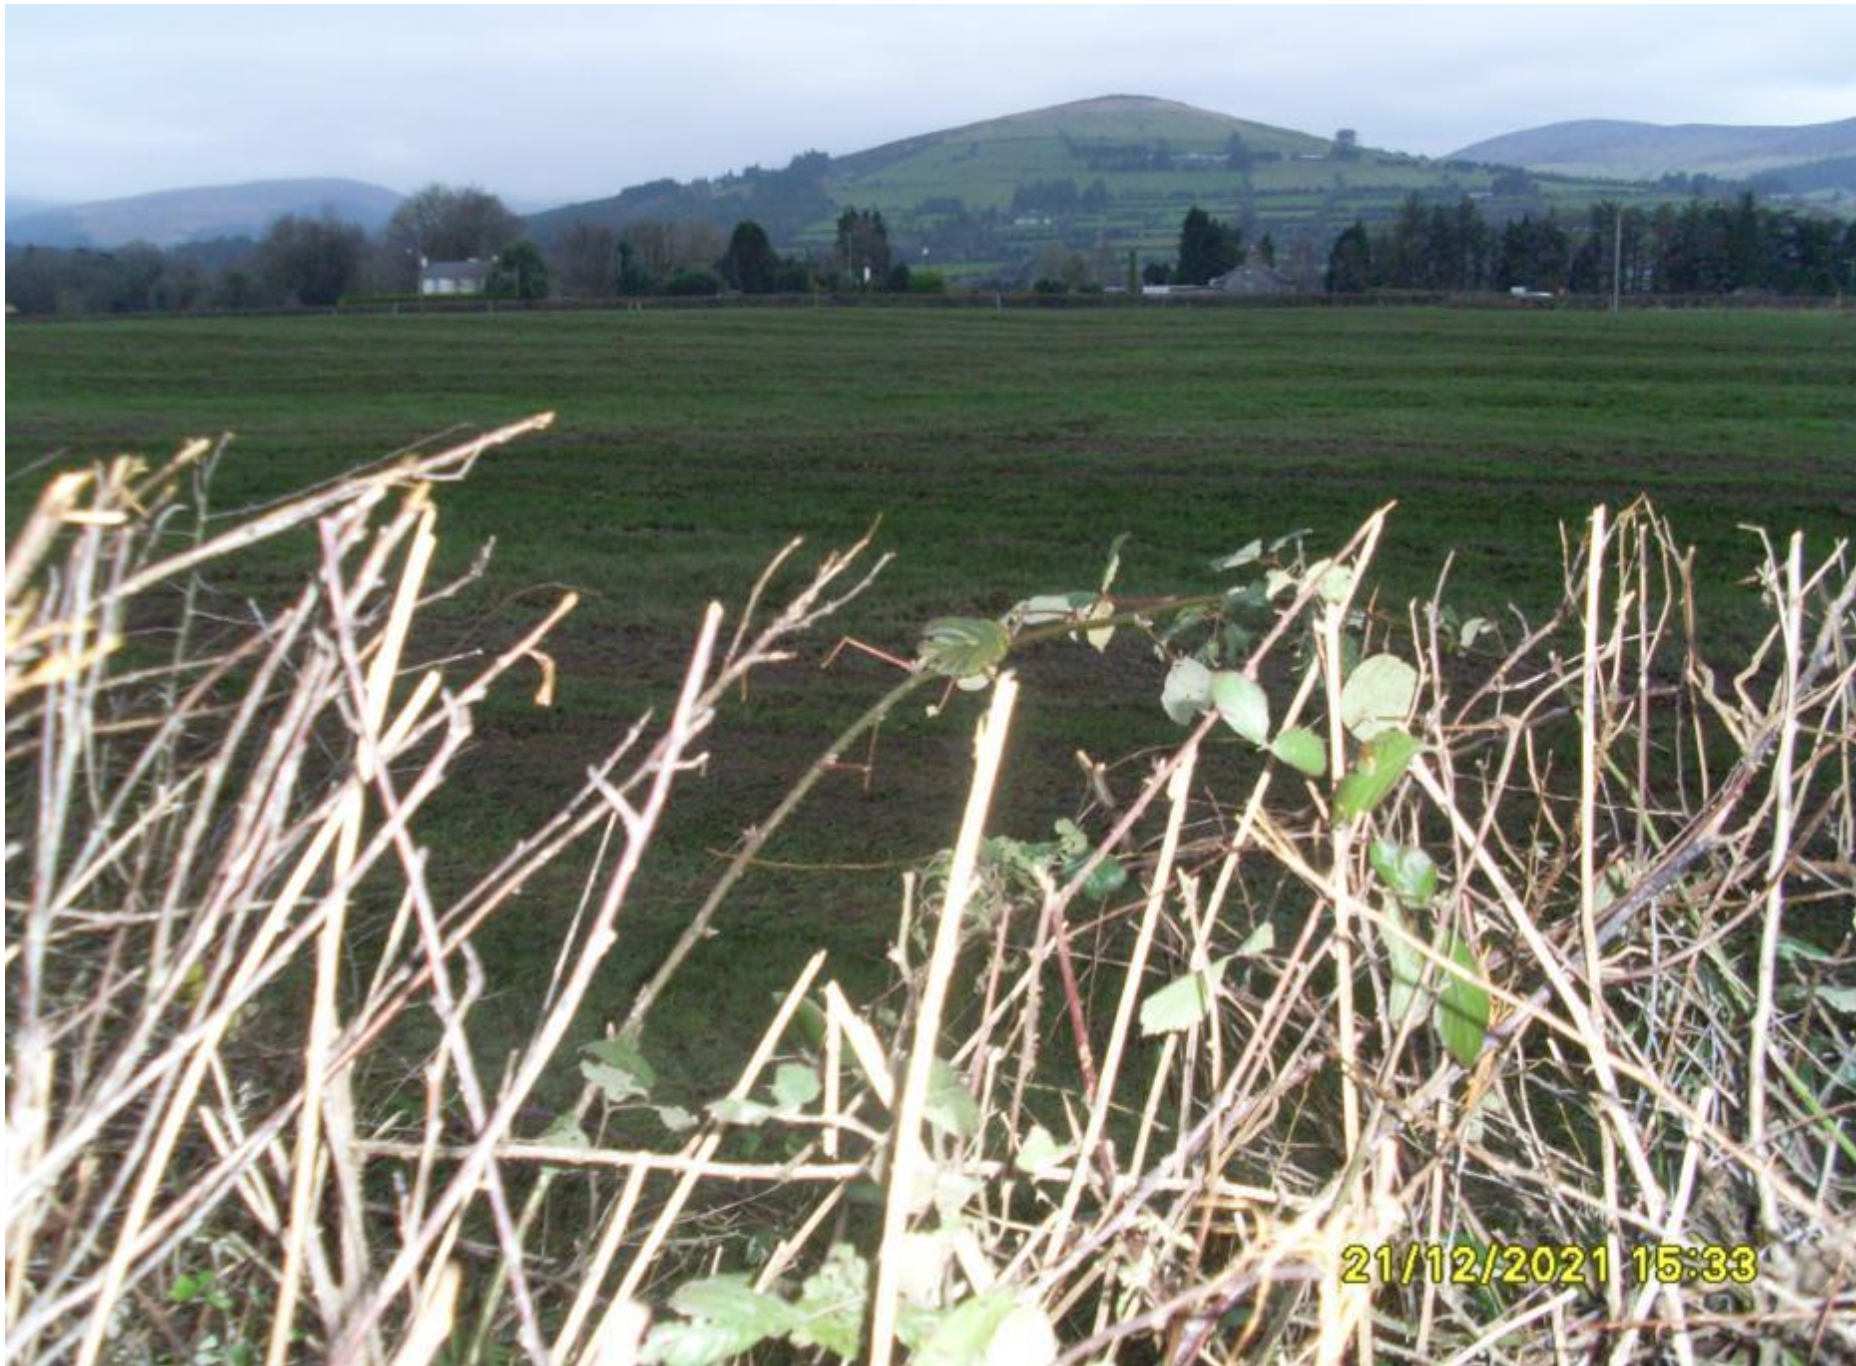
Derogation Dairy Farm

1. SAC catchment
Atlantic salmon
and brown trout

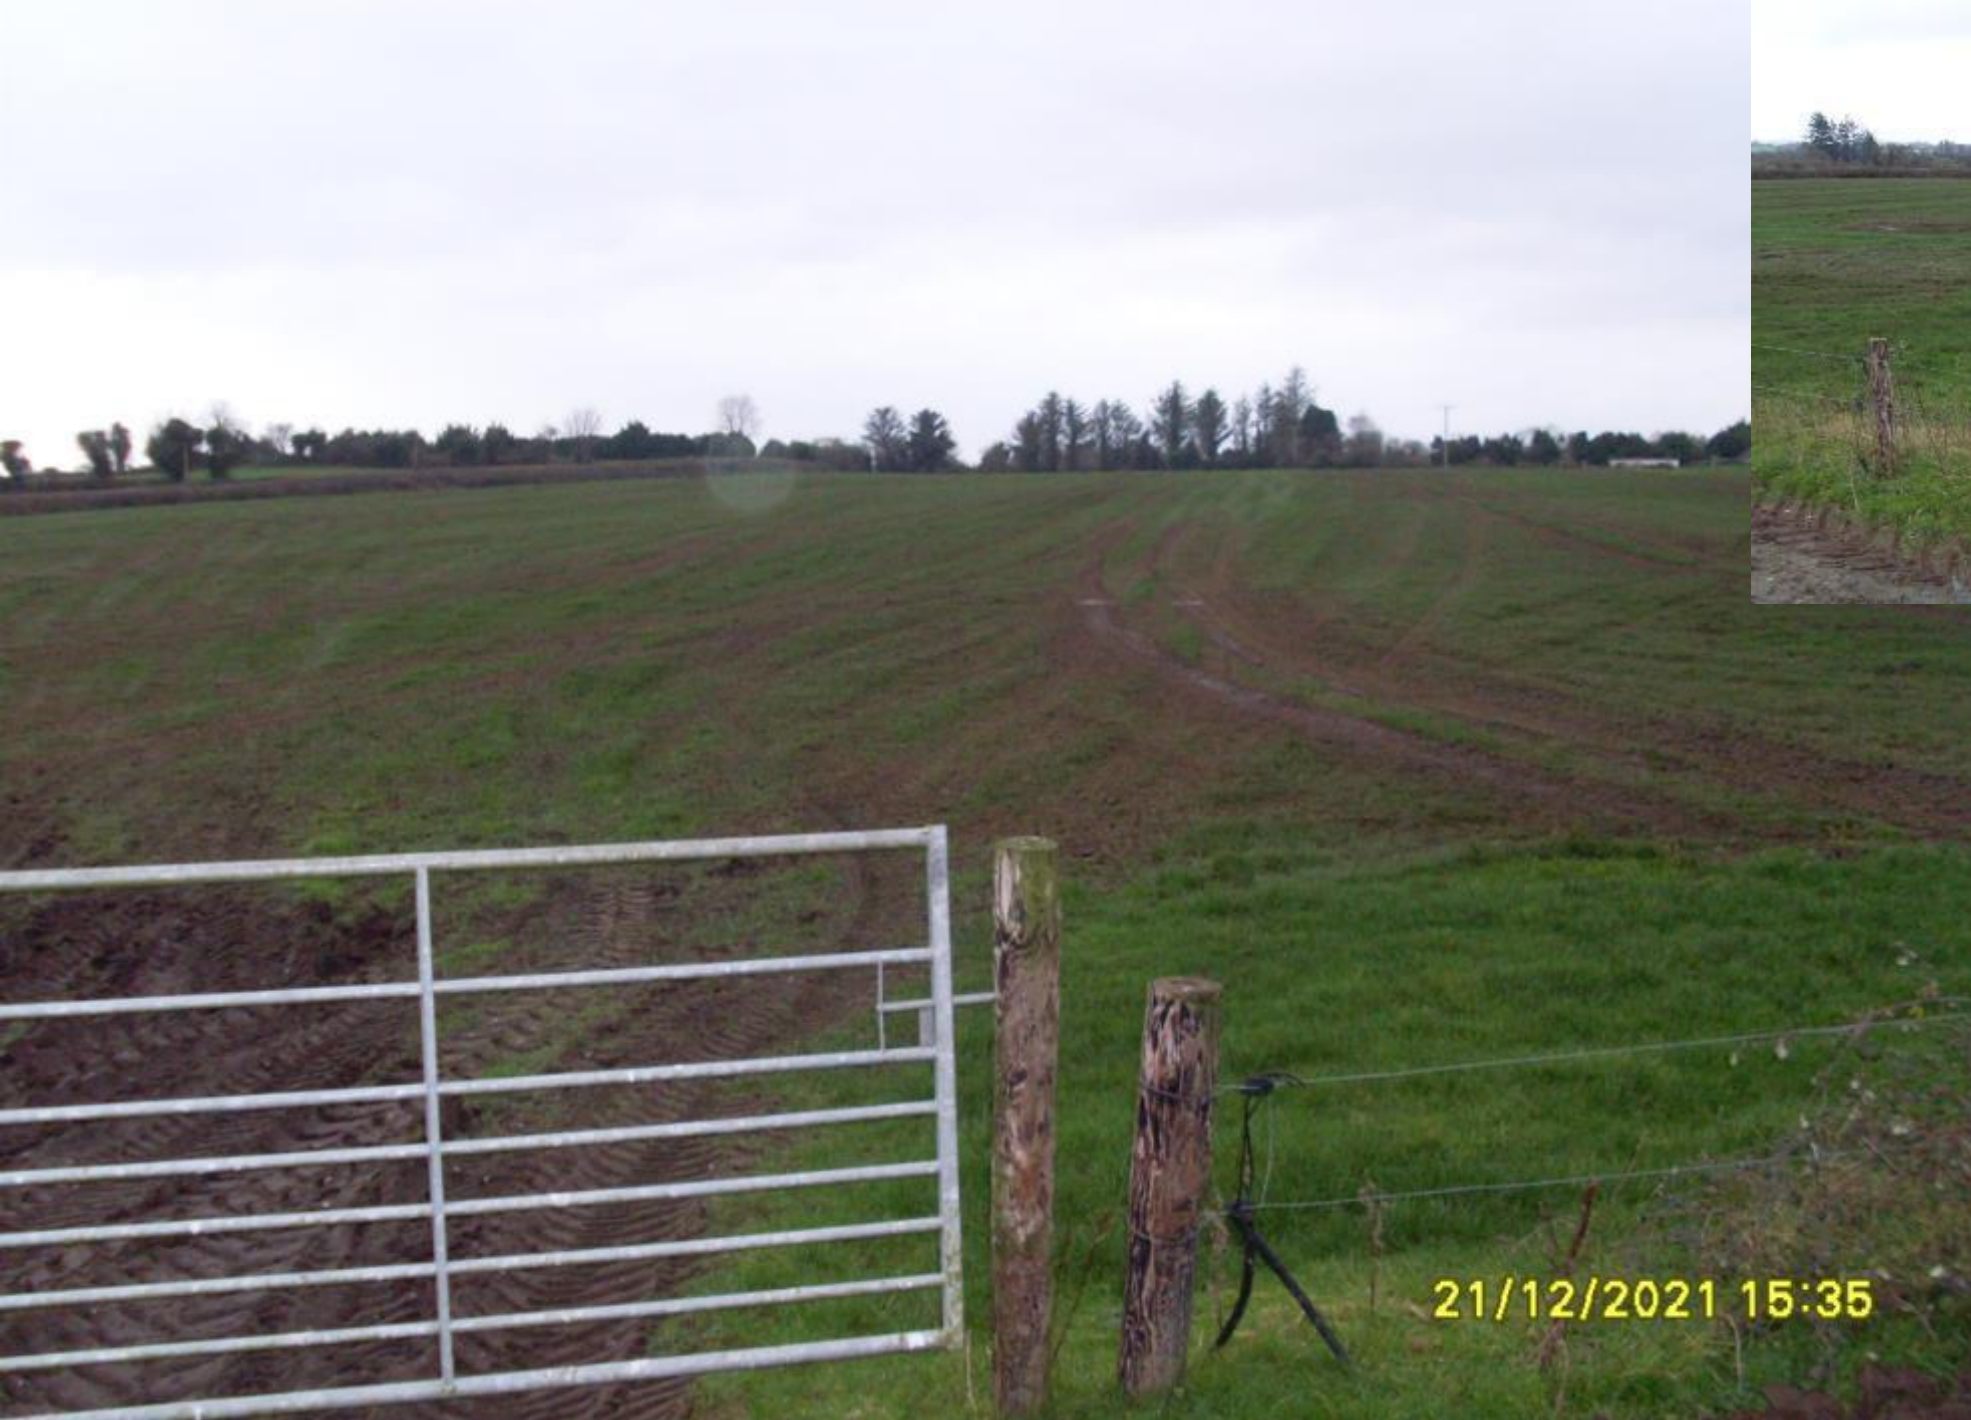
2. Slurry
spreading in the
closed period

20 tanker loads
over 9.5 acres

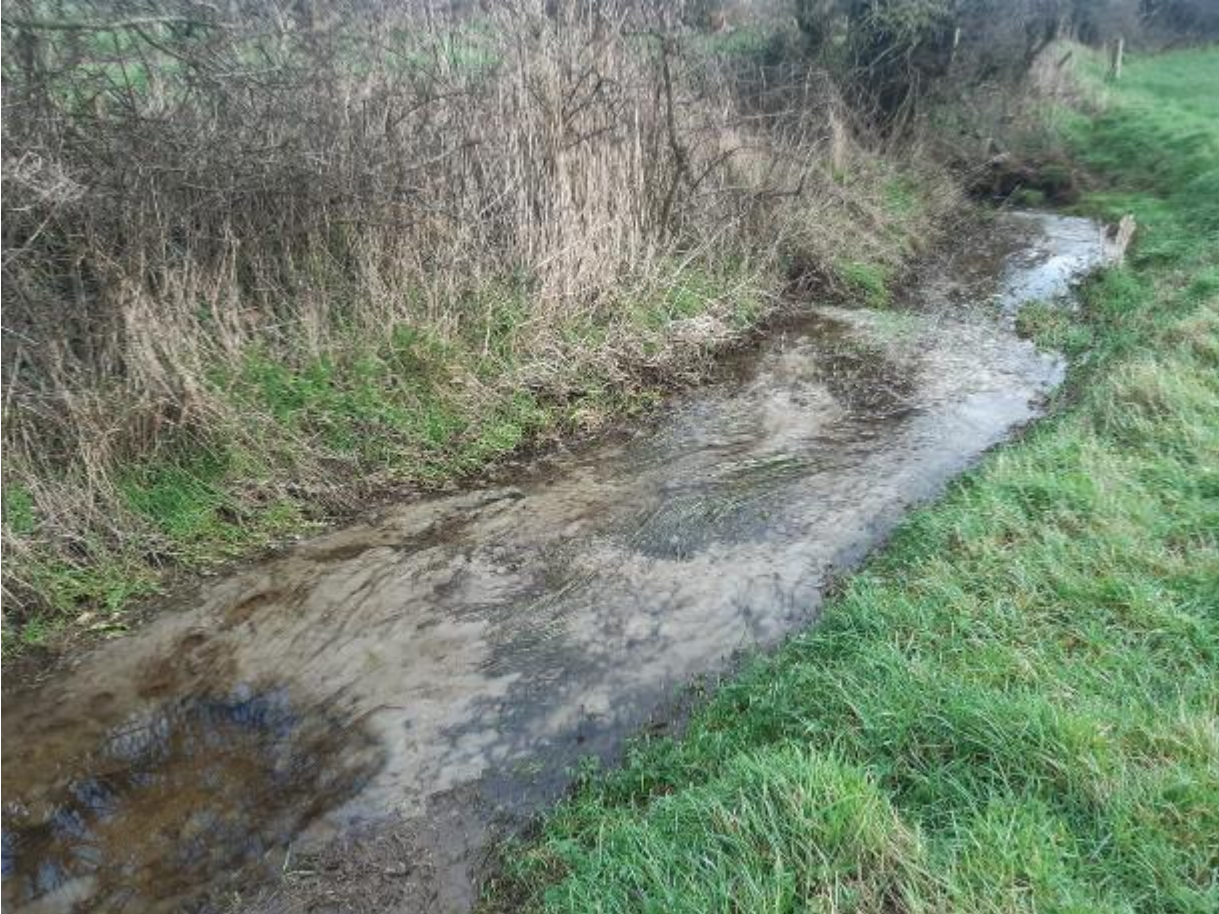
Silage effluent entering a stream – R. Suir

1. Pil River Co. Kilkenny
2. Atlantic salmon and brown trout river
3. Upstream of SAC

“silage effluent discharge to stream and effects(sewage fungus).
This stream was in slide show from last year but being polluted by farm 1 mile away.
Now it is being polluted by farm 20 meters away!! Frustrating.....”

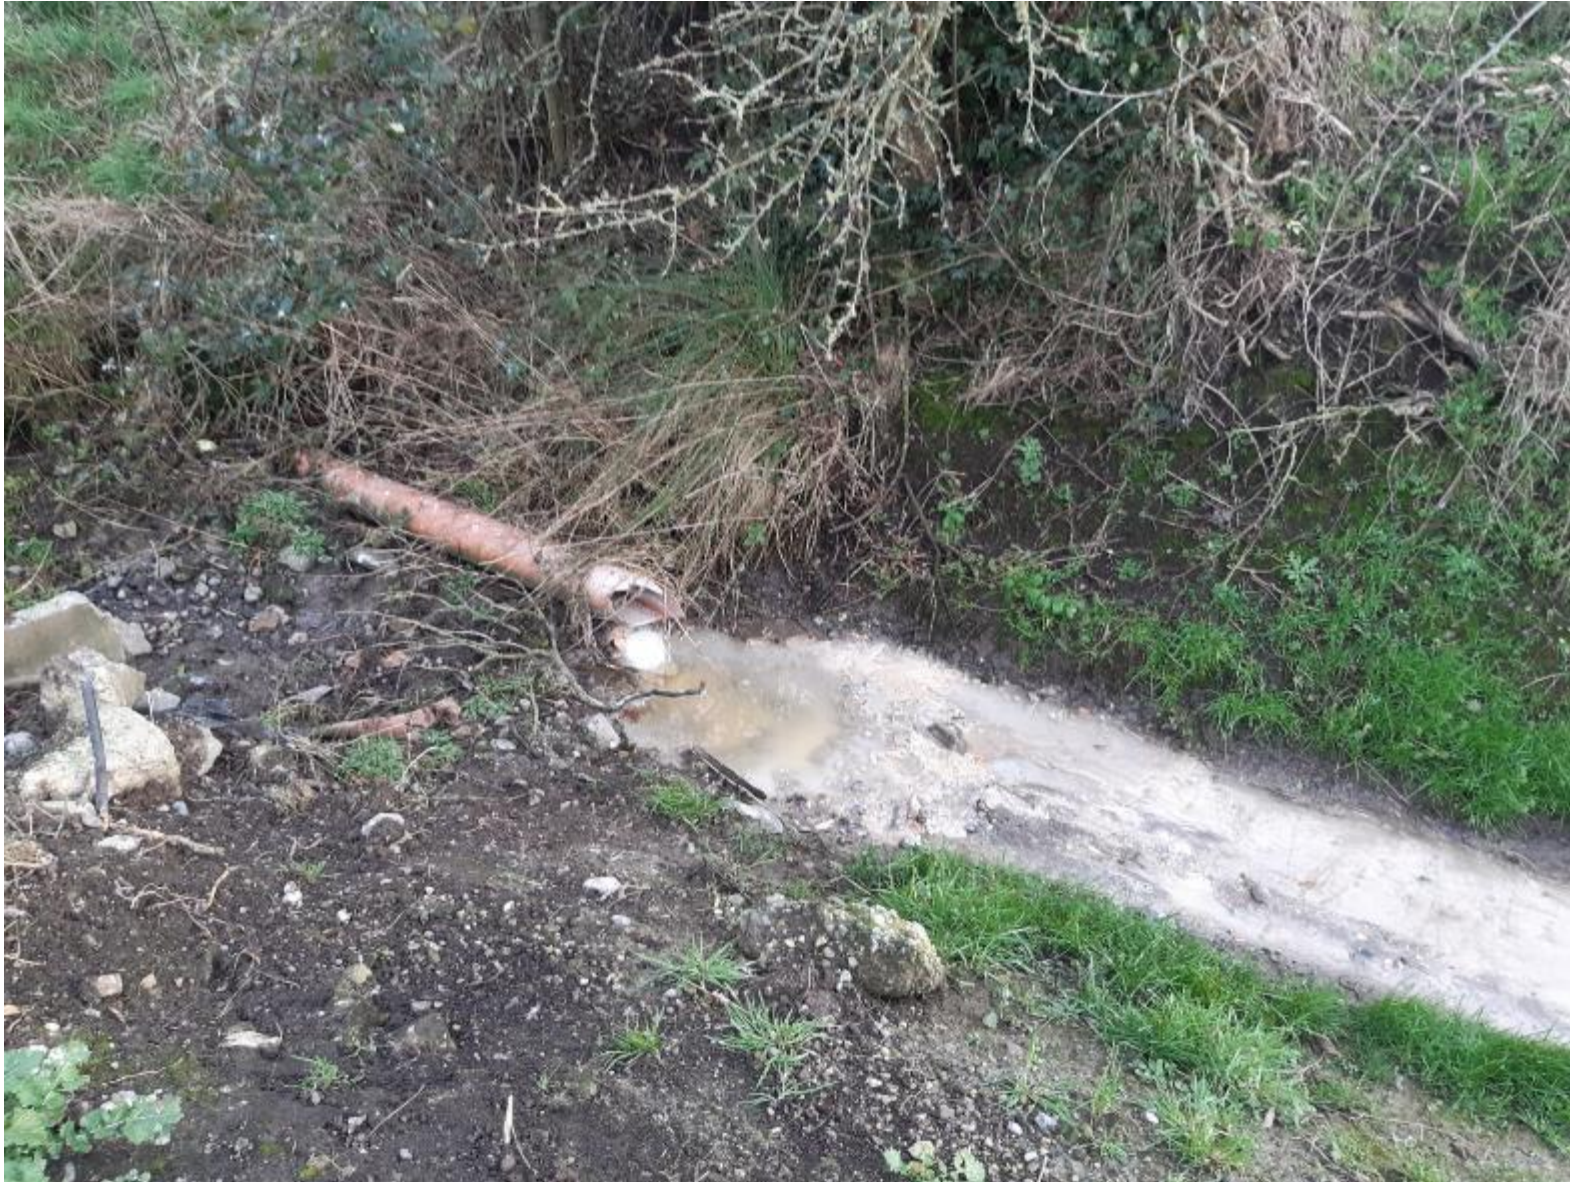
“dairy washings being discharged to drain that flows to stream.”

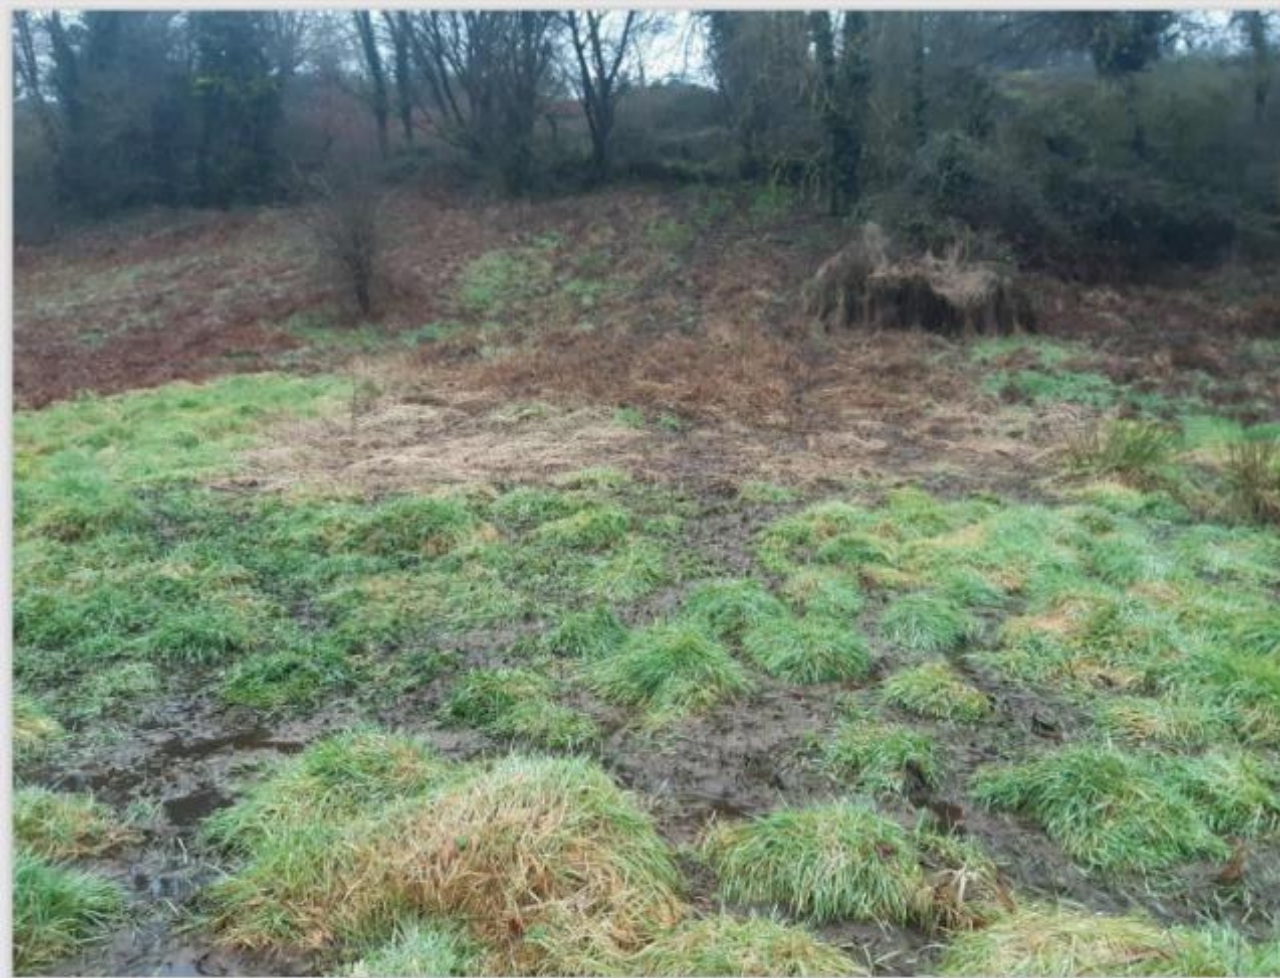
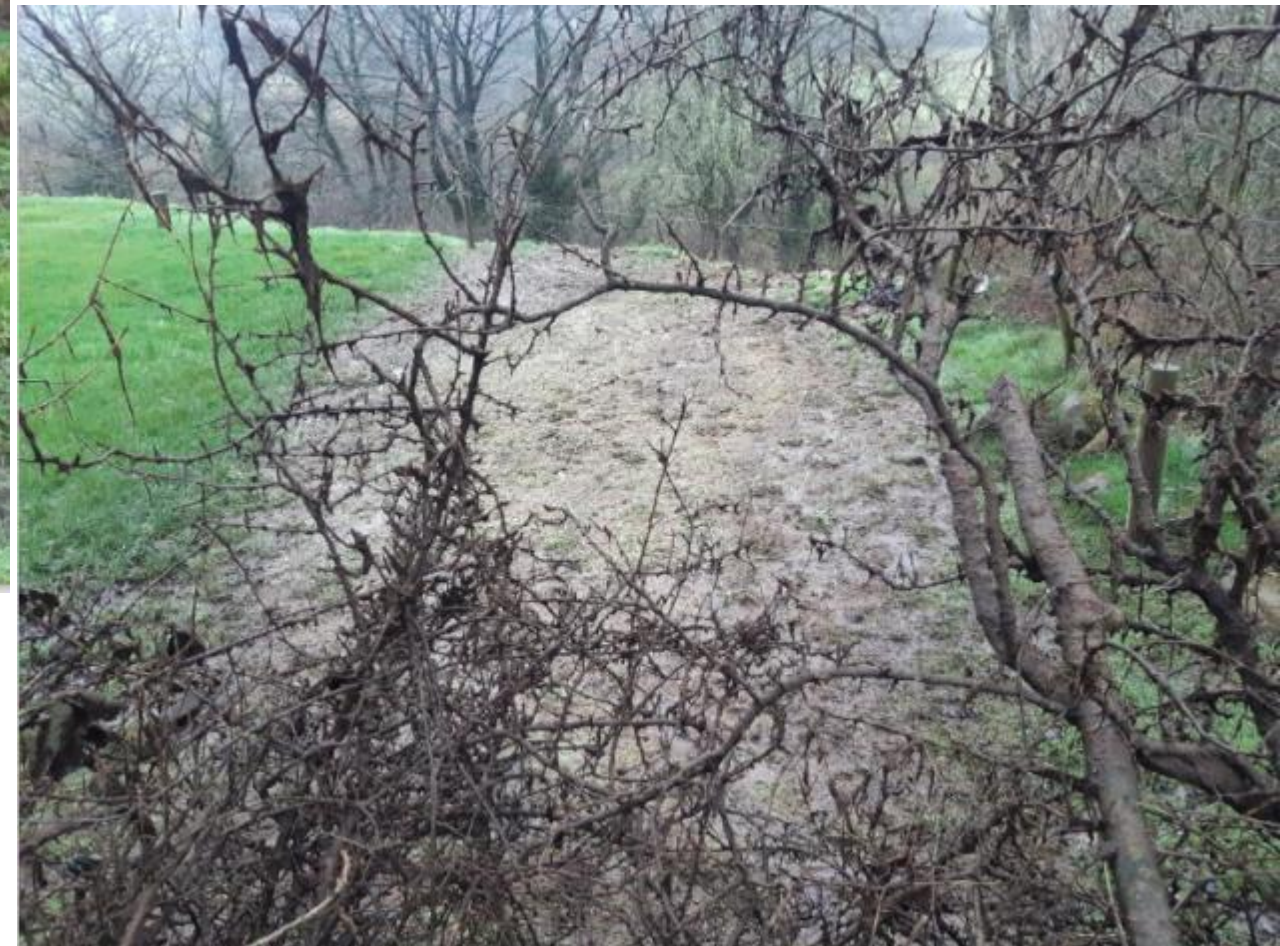
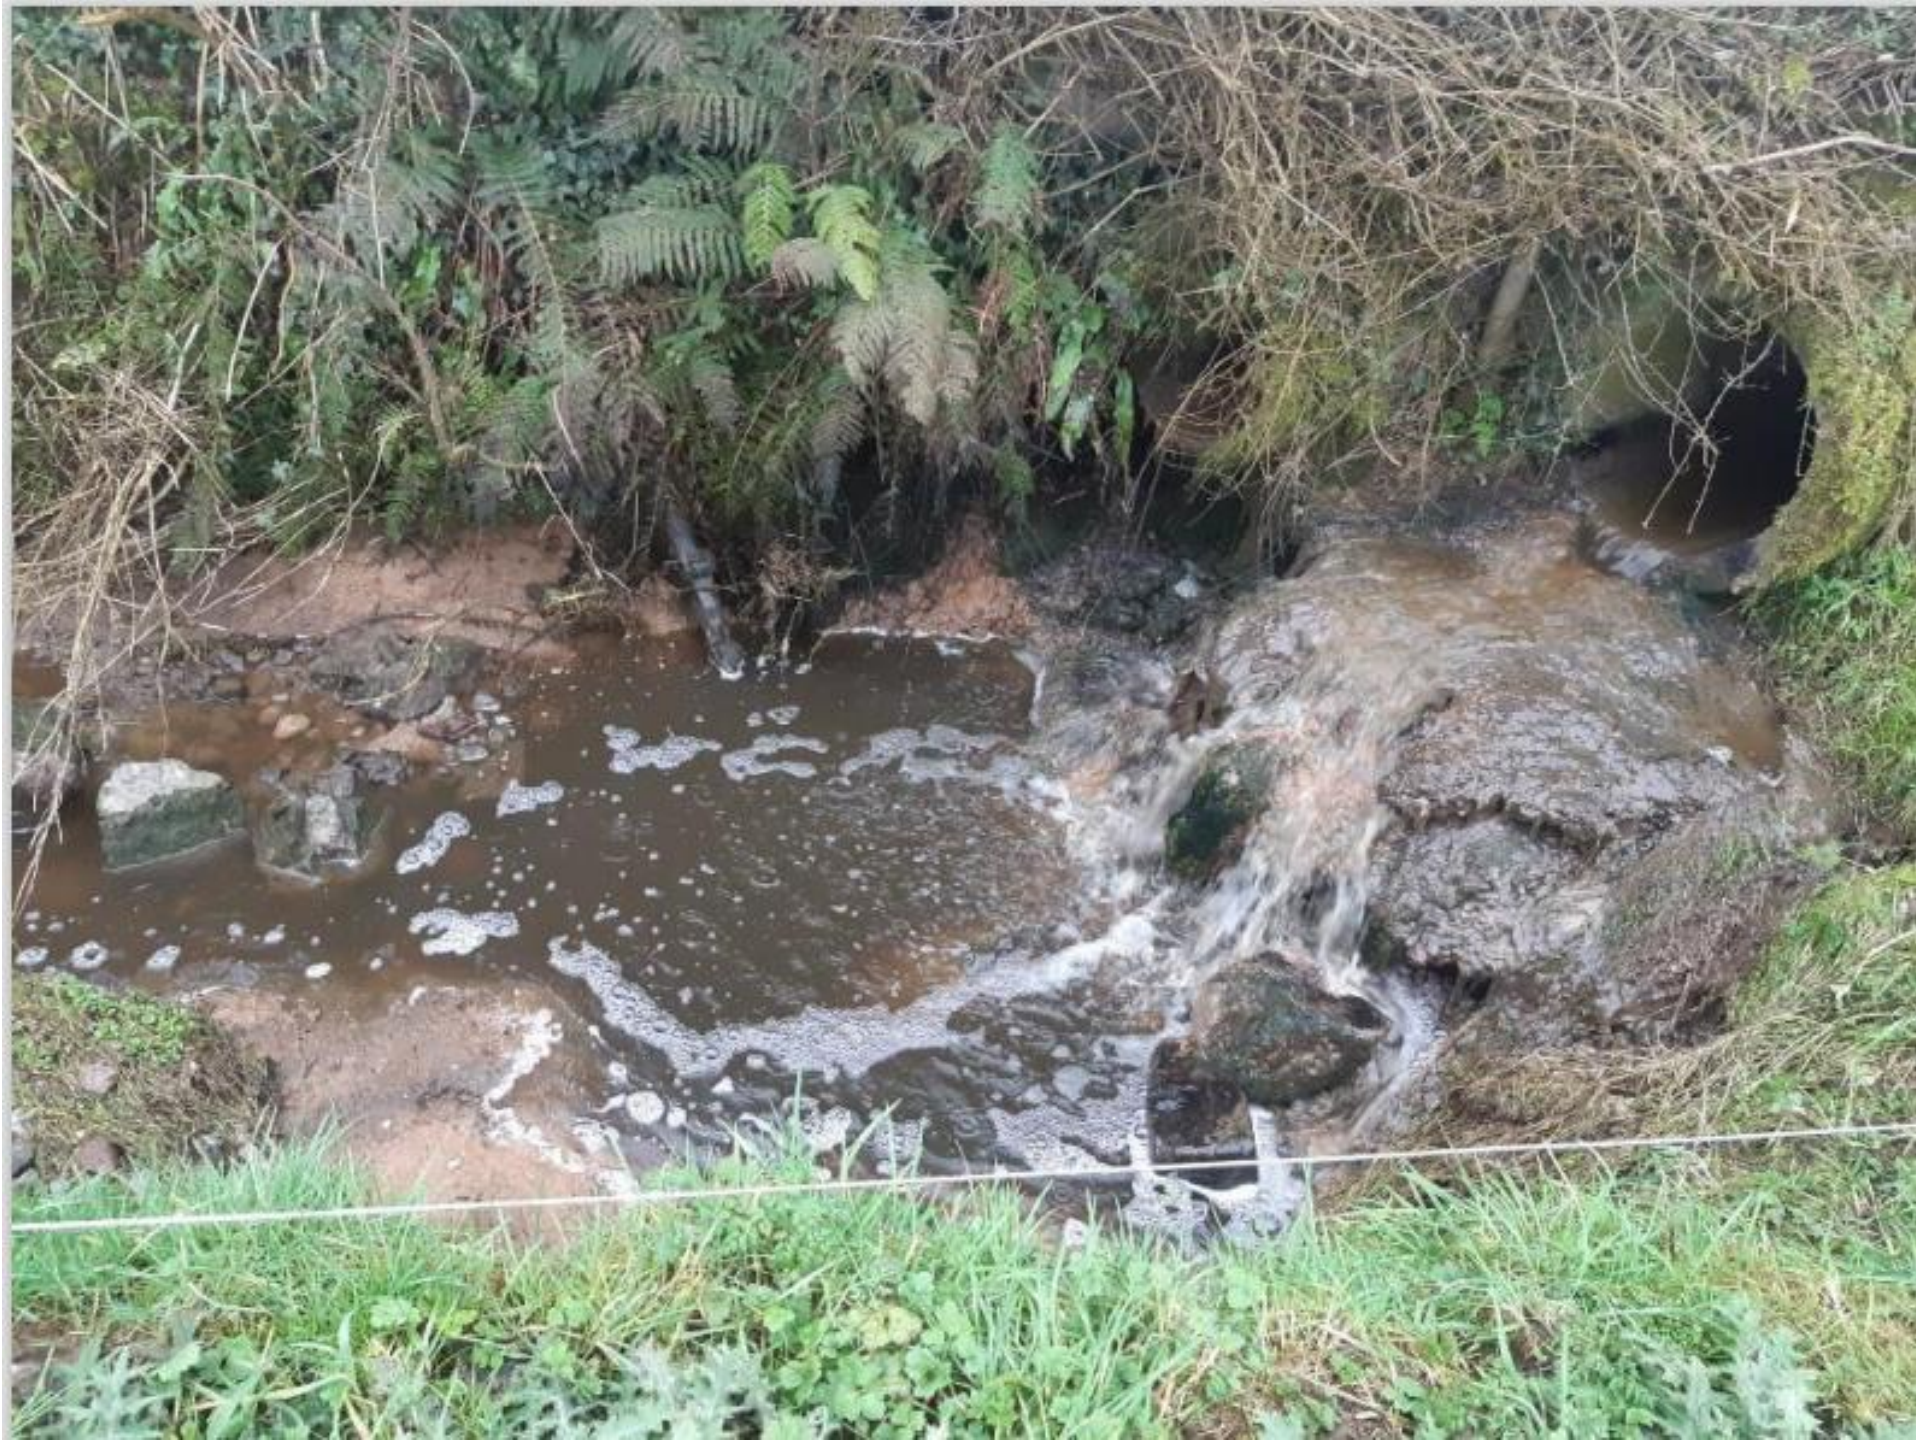
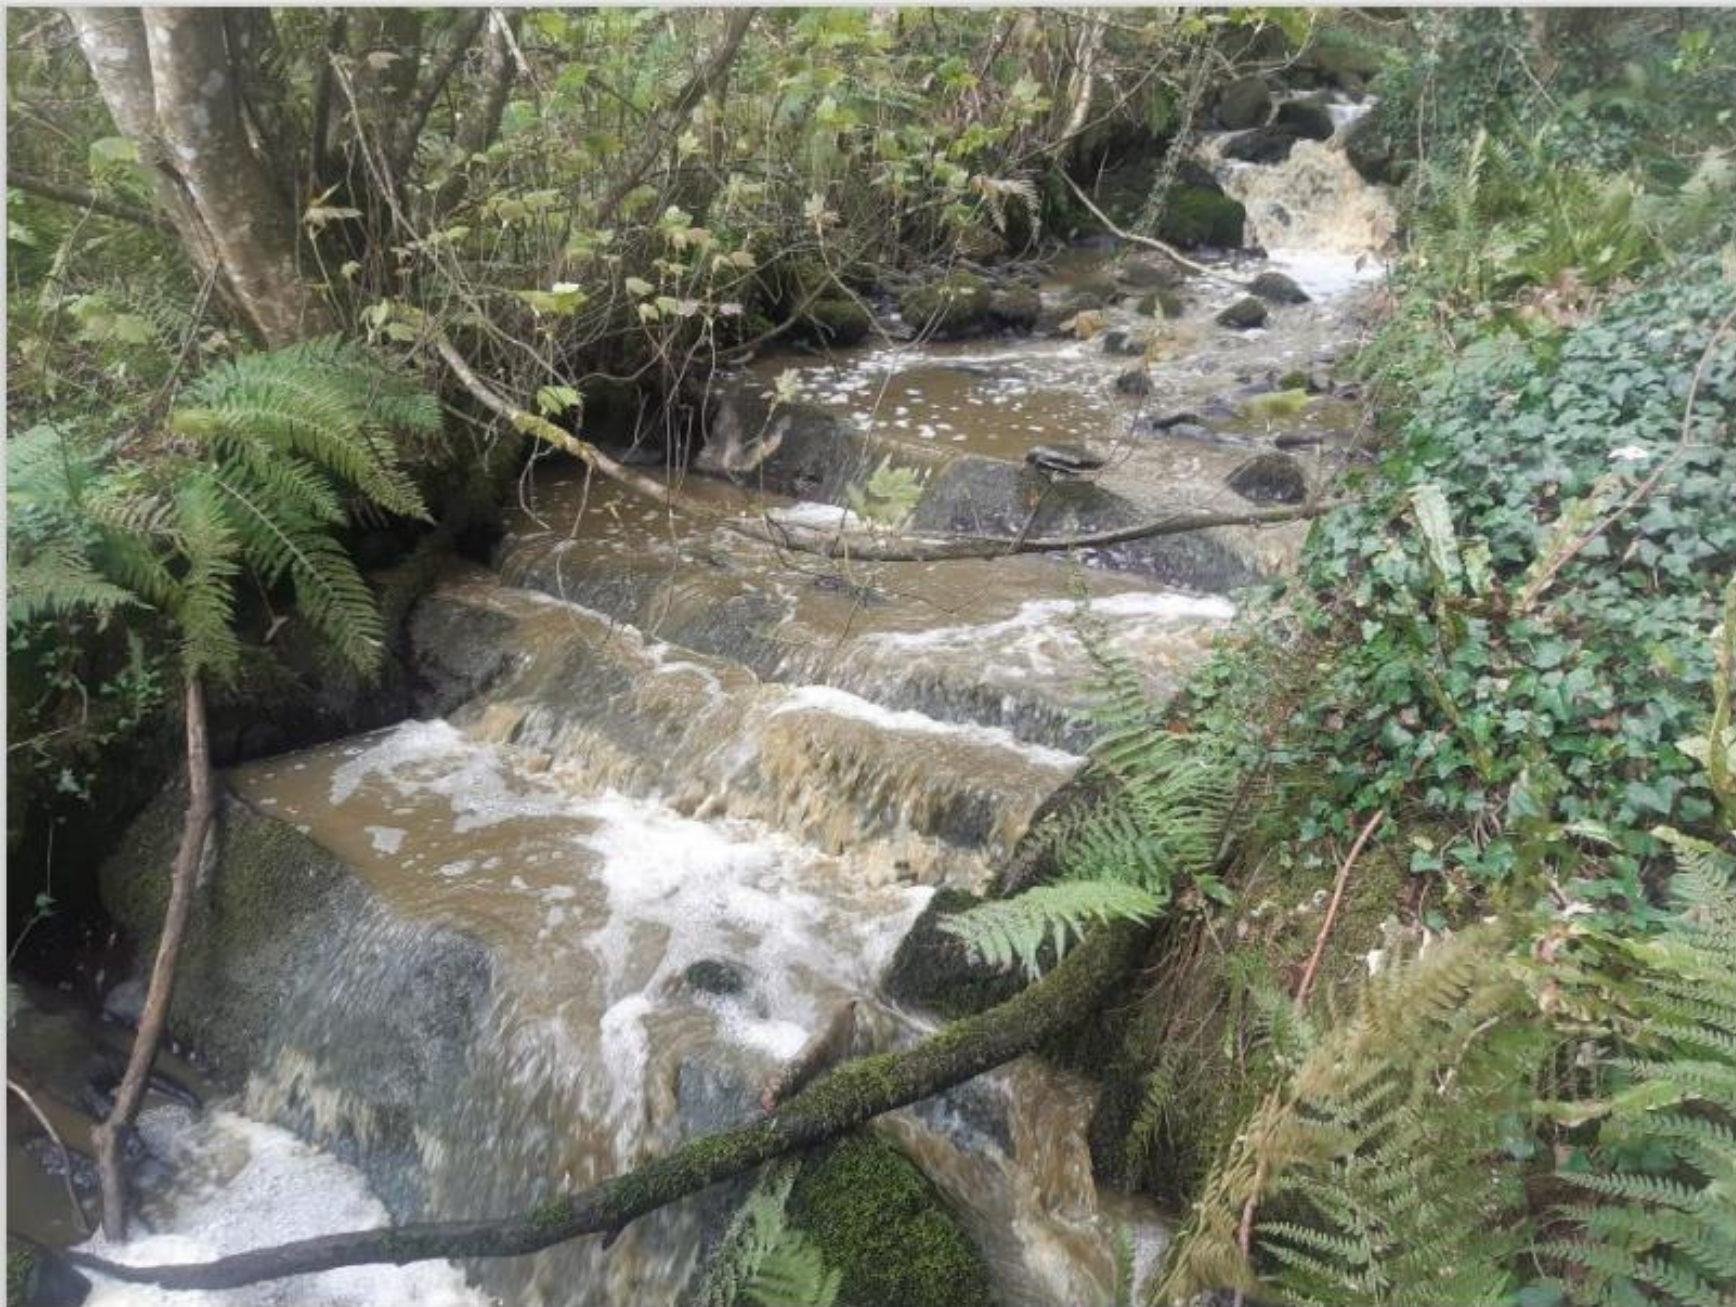
R. Suir Catchment (SAC)

Dumping of slurry

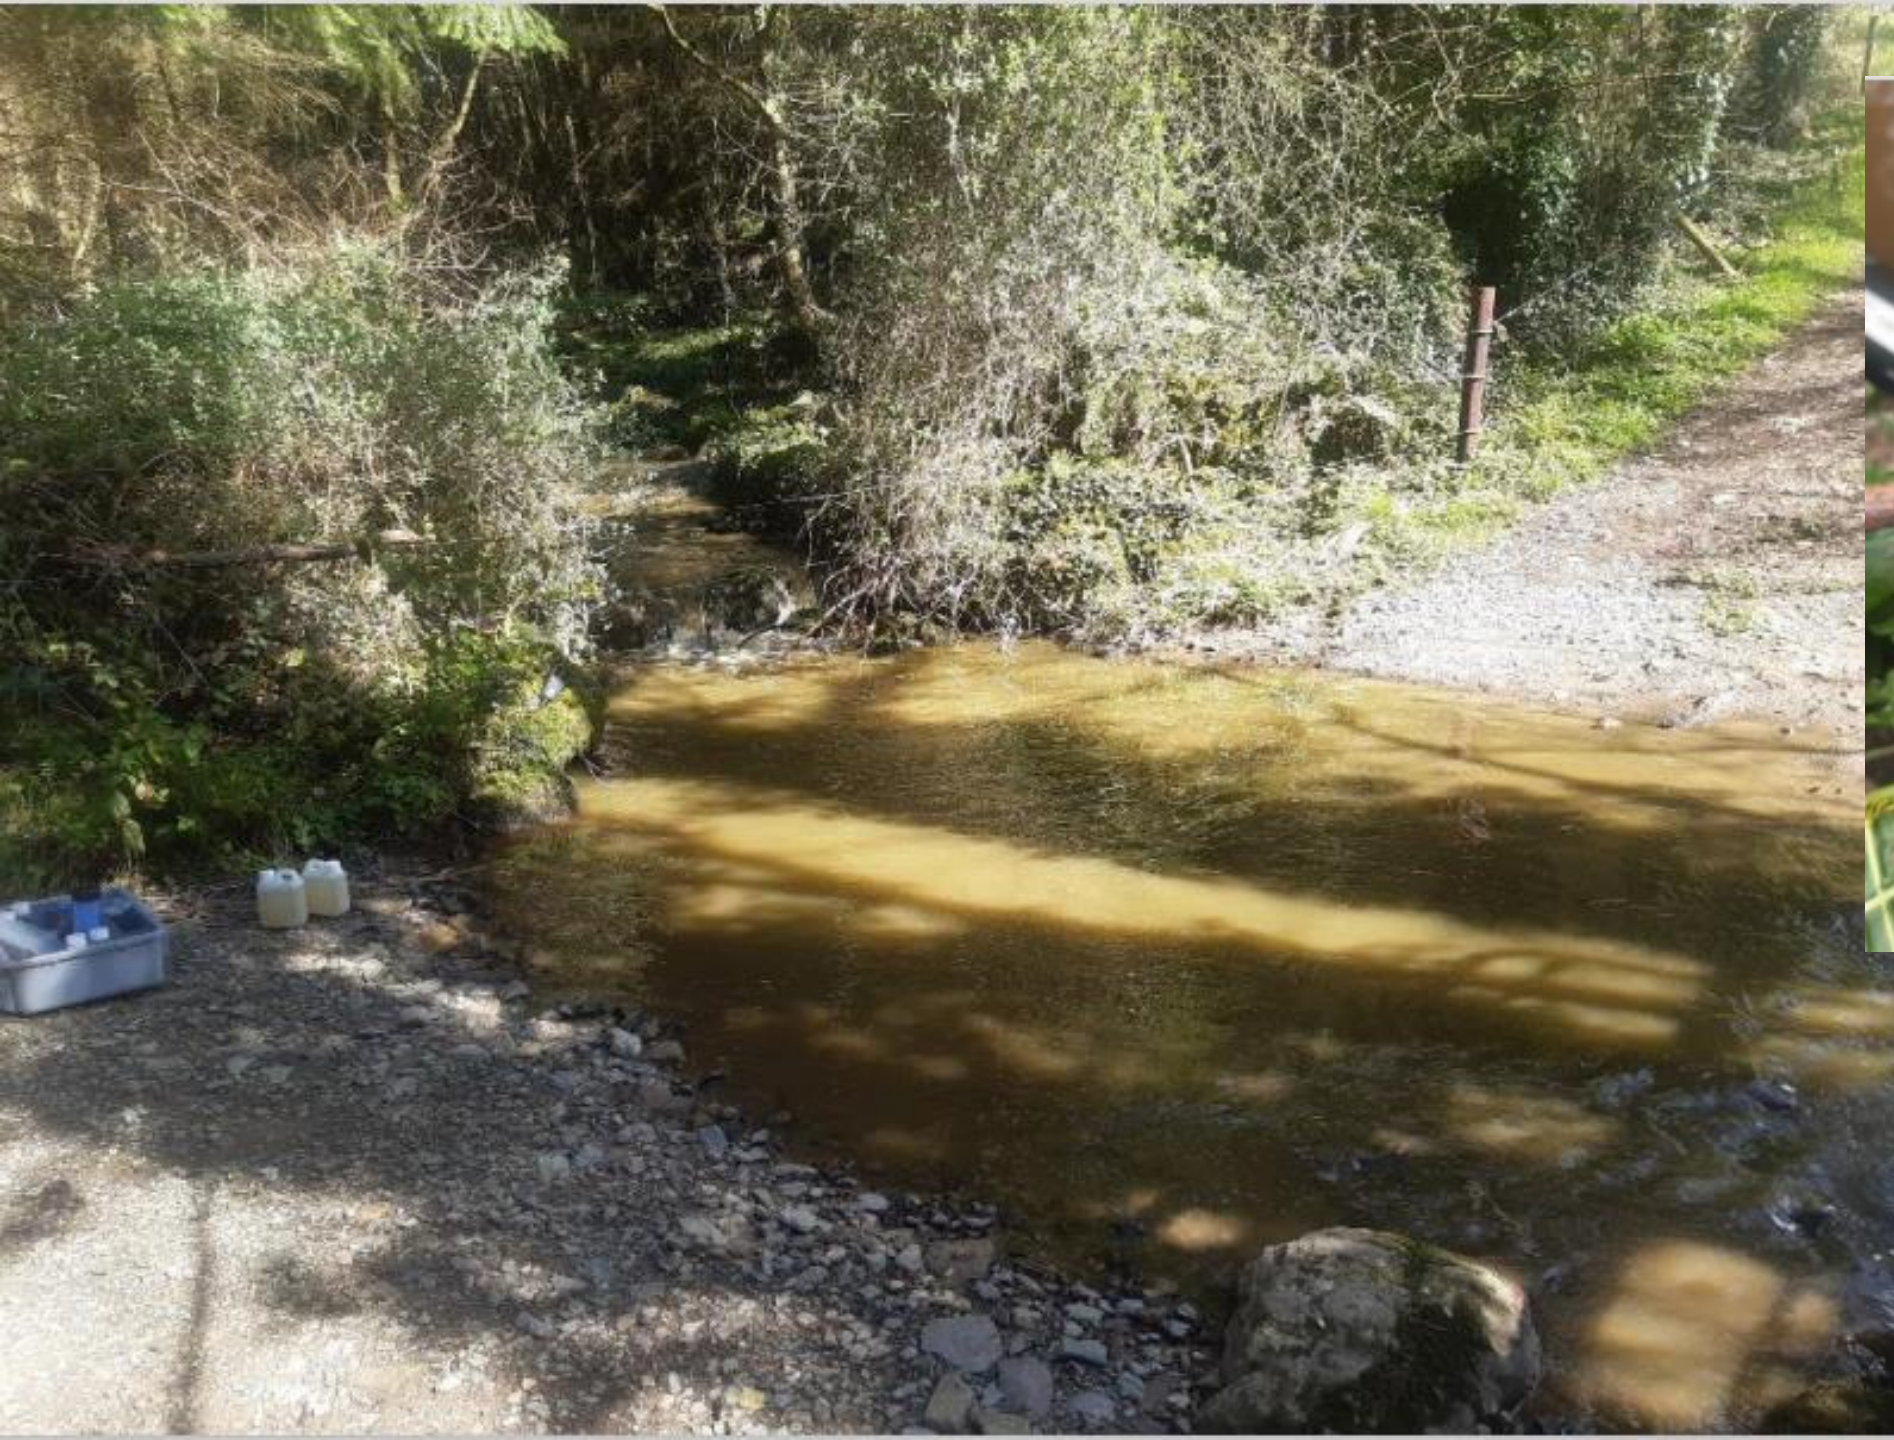
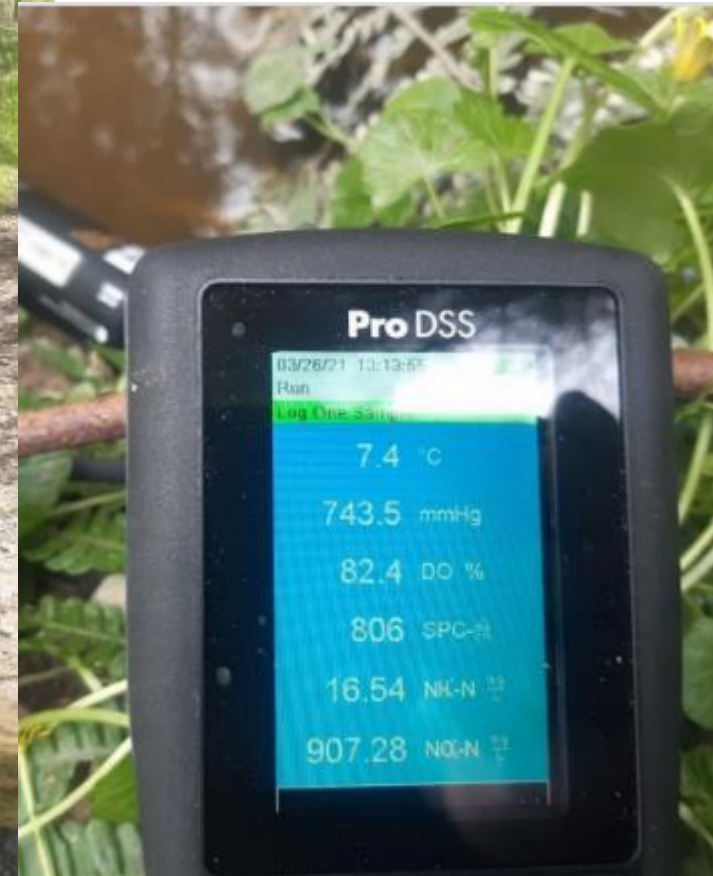
Dairy farm in Derogation (250 cows)

1. Trib. Of Duag river
Ballyporeen

2. Atlantic salmon
and brown trout
river
