Agricultural related water quality issue examples forwarded by Regional Operational Committee implementing bodies

**Observations on Agriculture GAP Regs compliance and good practice 2021
Presentation to ASSAP Farm Consultative Group Meeting 24 Jan 2022 &
discussion through WFD governance structure: SE and SW ROCs &
SERWEMC*

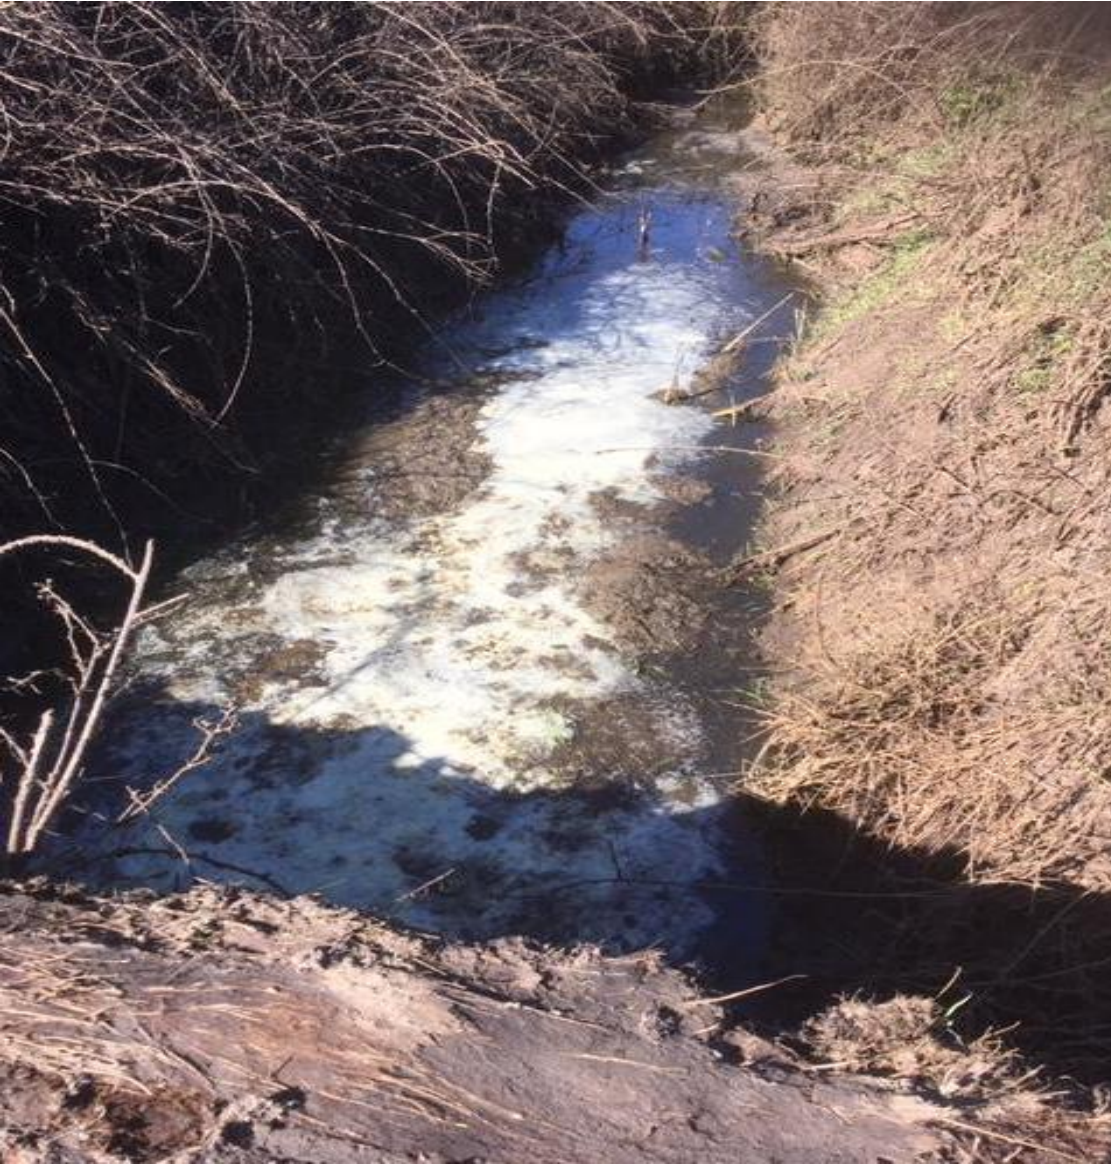
Photo of slurry in drain on edge of road as rain gun used to spray slurry into field.

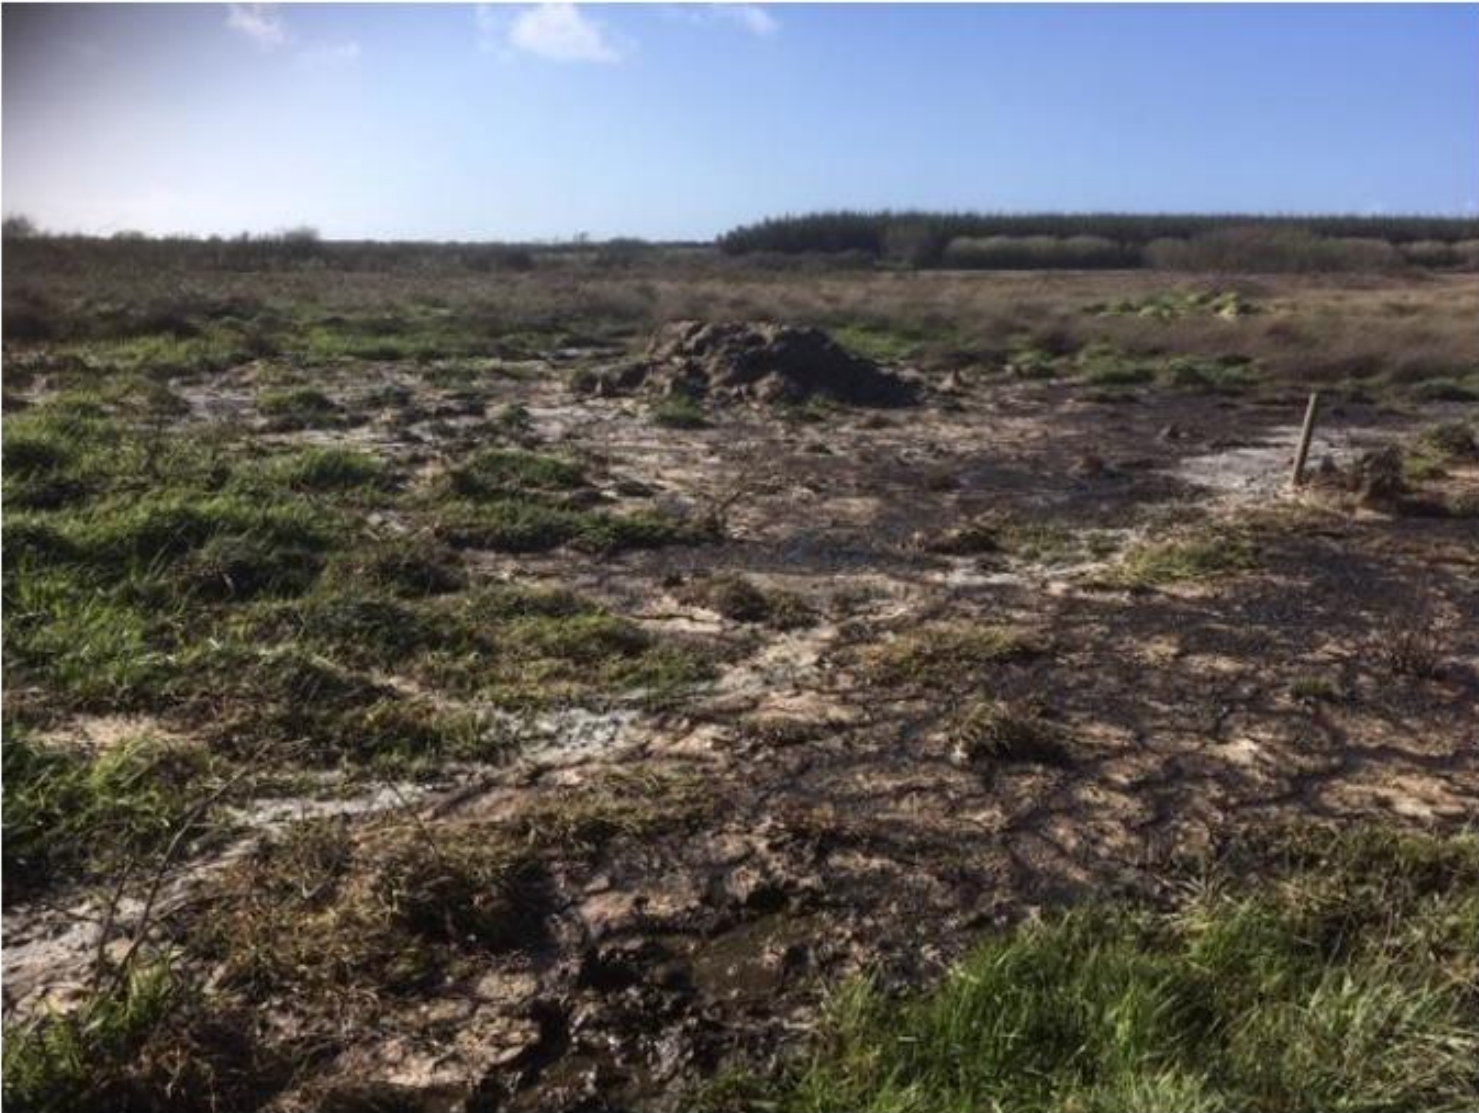
Photo of slurry dumped
in field

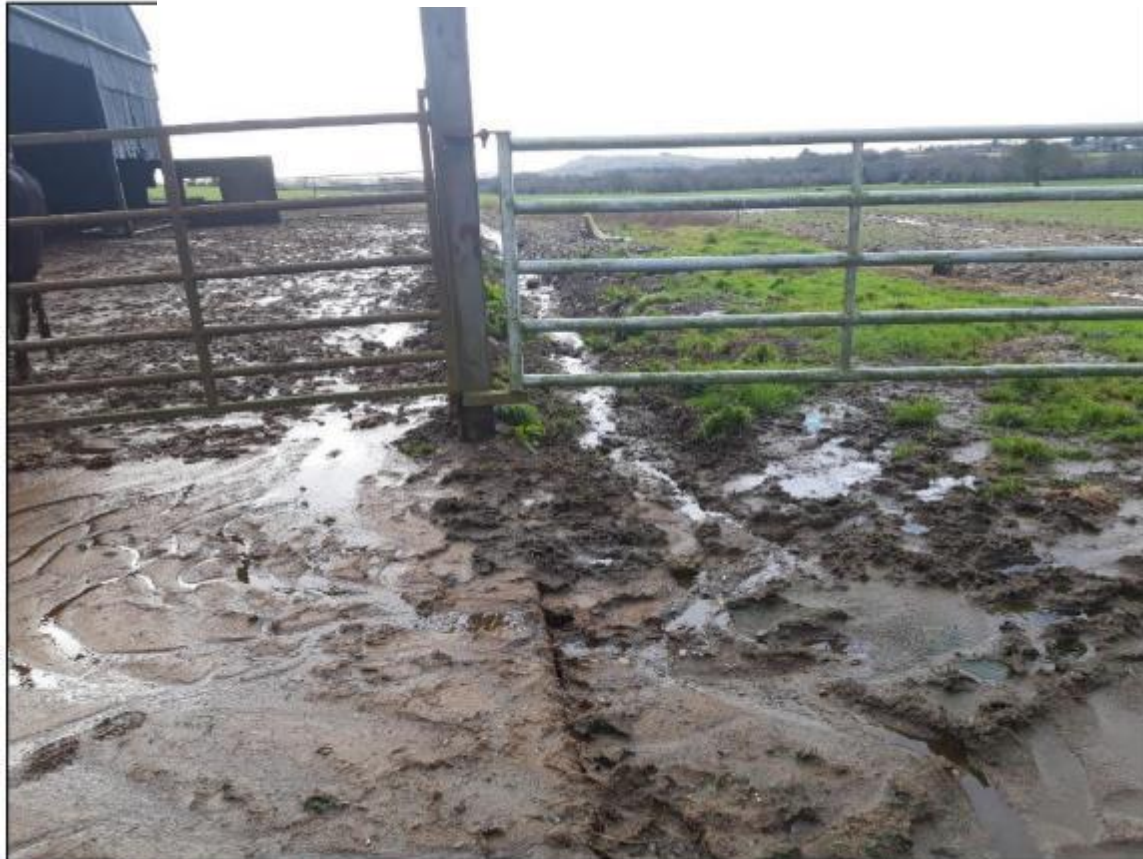
Photograph 1: Slurry & soiled Water not contained with farmyard

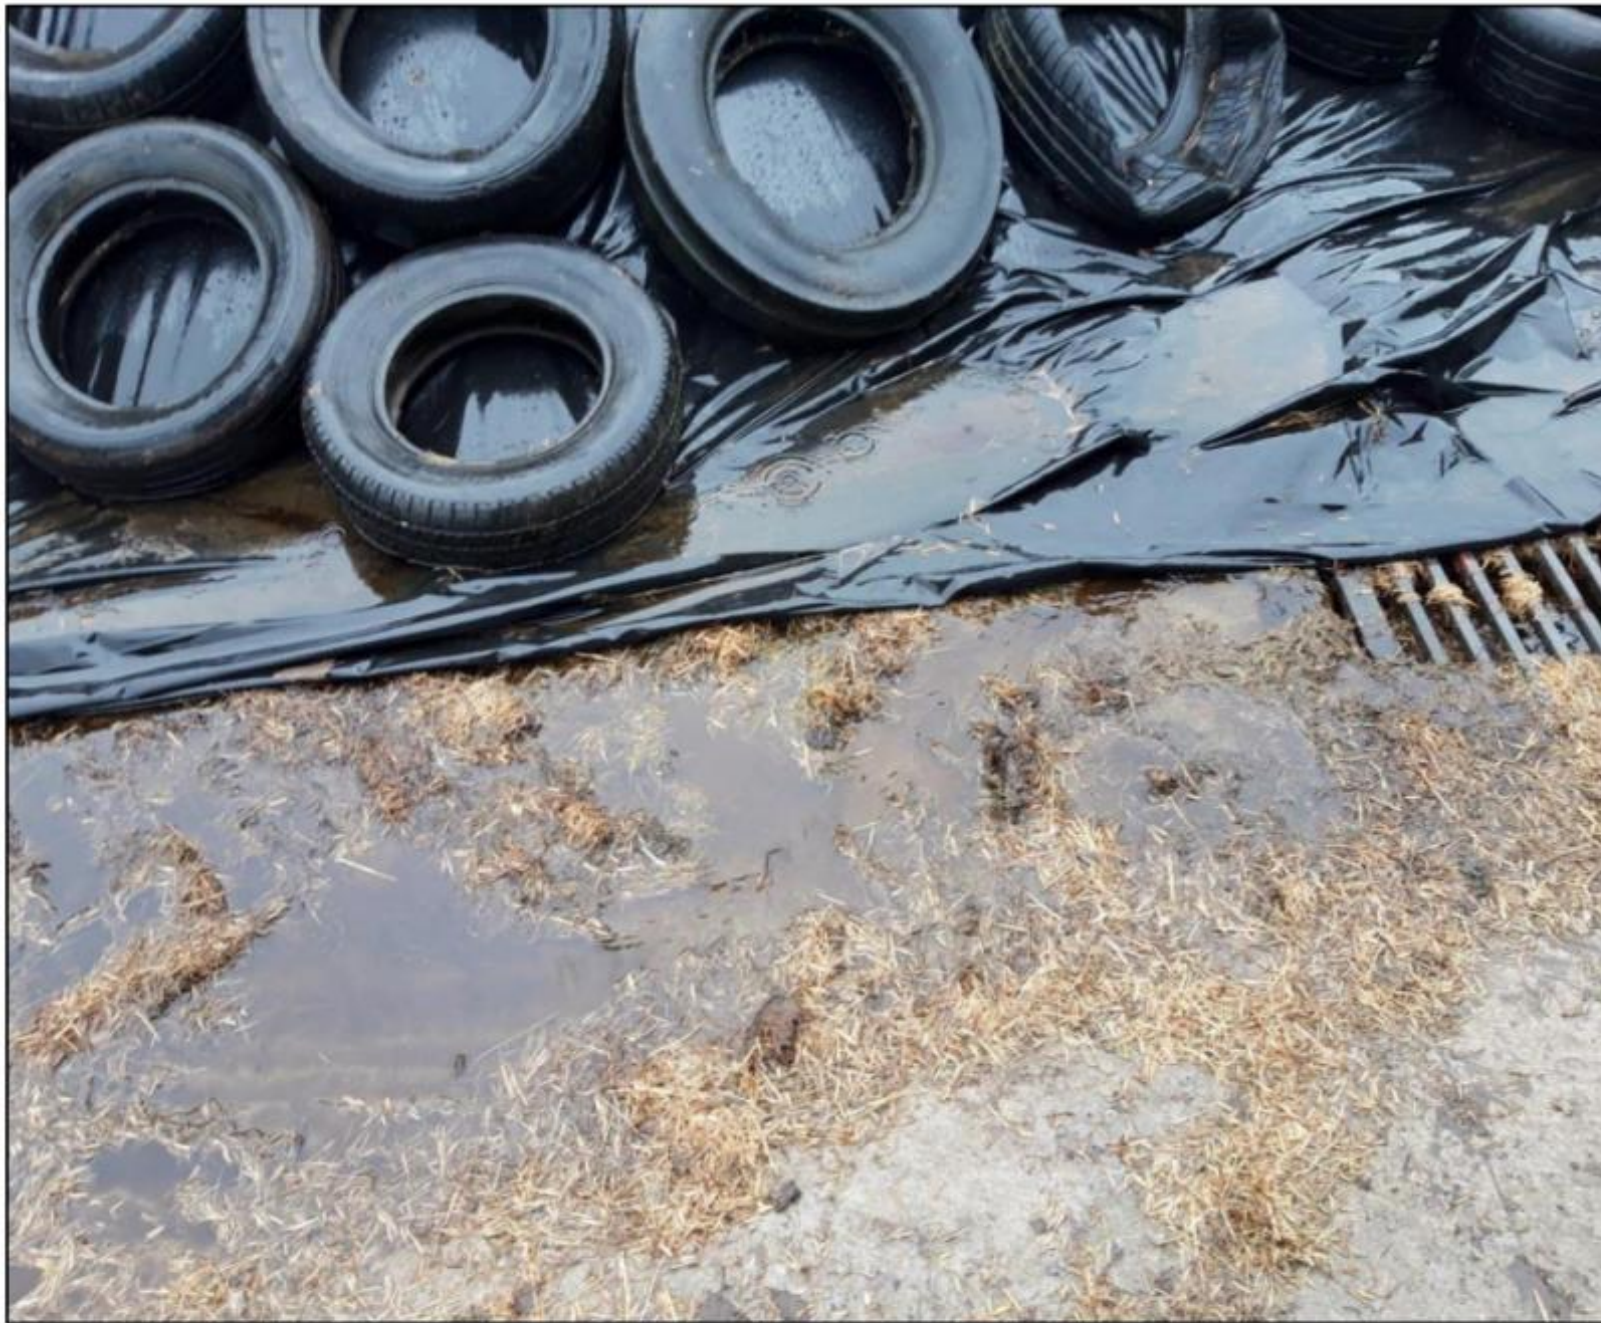
Photograph 3: Silage effluent contamination of clean water systems

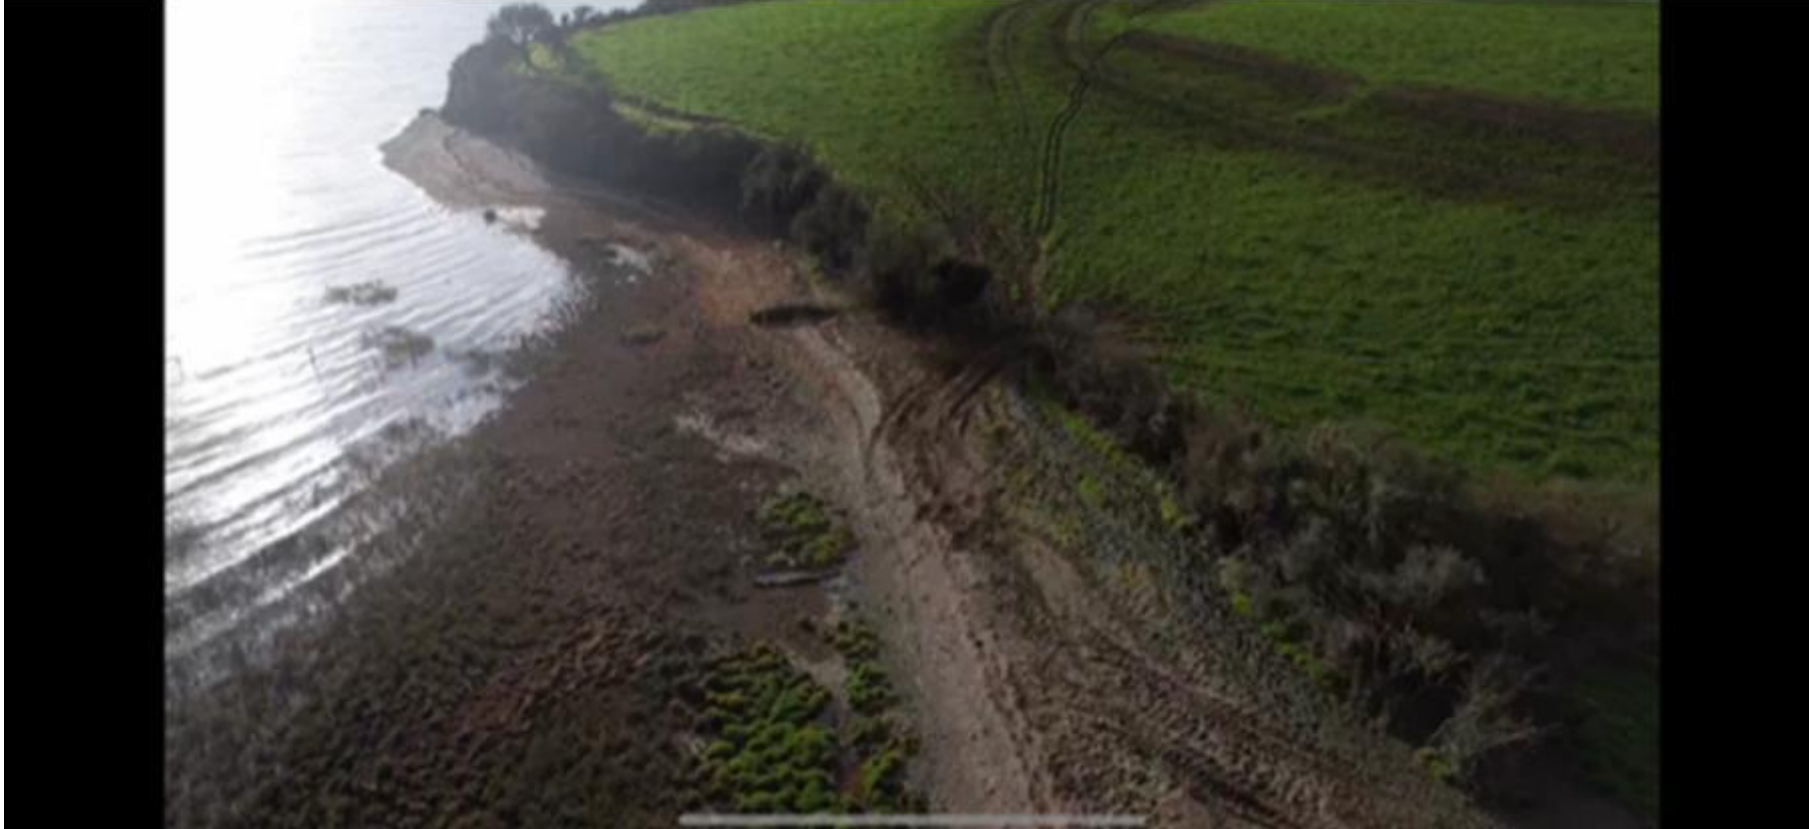
Bannow Bay

Field where we saw (at our shore meeting the 29th Nov) that Slurry had previously been spread on it. Note tracks into water below high water mark

Image forwarded by BIM- slurry spreading (and tracks to hightide shoreline) in closed period adjacent to shellfish production area (oysters) illustrating challenges facing the shellfish and WQ objectives in the SE.

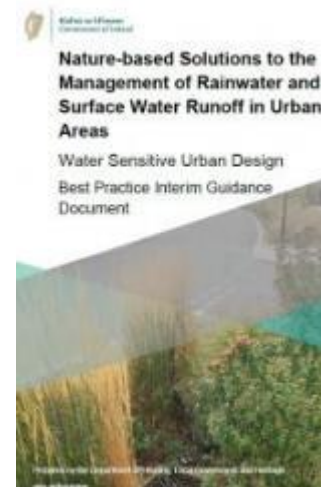
Rainwater management plan (surface water management plan)

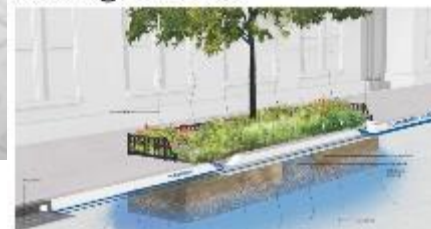
Rain gardens
