## **Response to Further Information Request**

Derryclare Wild Western  
Peatlands Project

Document Title: **Response to Further Information Request**

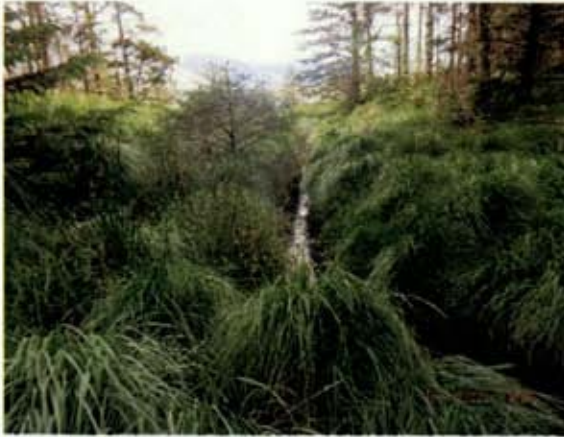
Plate 3-15: Straightened channel at site DB-5

The river here appears to have been modified into a drainage channel with straightening and deepening. Near the outlet to the lake the river becomes shallower and almost half the channel was covered in slimy filamentous green algae (40%). Dissolved oxygen readings were high (141% 13mg/l) likely due to the excessive algae creating super saturated conditions during the day. pH was low at 5.4 indicating slightly acidic conditions.
