DERRYCLARE PEATLAND REHABILITATION

Addendum to Geotechnical & Peat Stability Assessment Report

Prepared for:
MKO Ltd

Date: January 2024

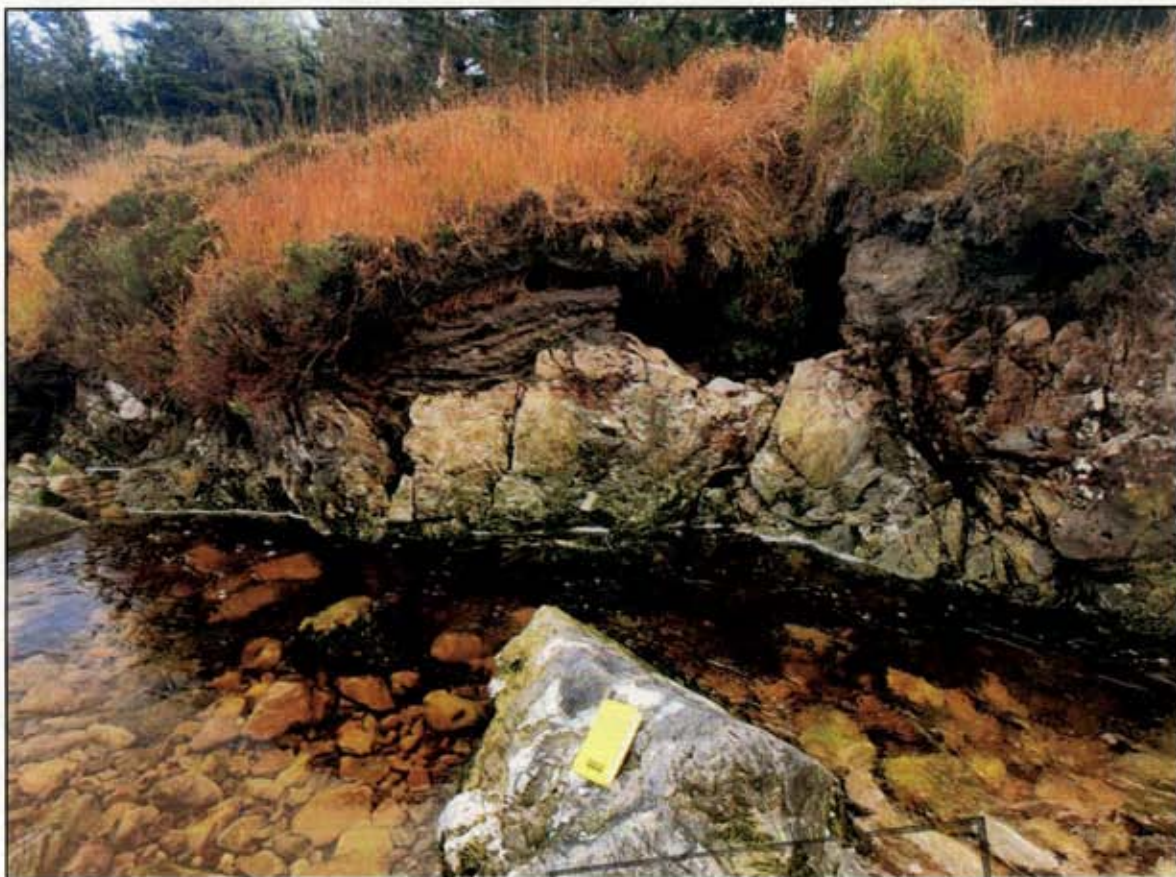
Plate 1 Peat overlain by bedrock along a stream section (Phase 1 - POI002)

Where open exposures of peat were encountered, they were exclusively underlain by either bedrock, granular till deposits or scree deposits (Plate 1 and Plate 2). This interface should be considered with respect to potential slip surfaces at the base of peat. Where large-scale peat failures have occurred in Ireland, the interface between the peat deposits and underlying geology is often planar in morphology, and typically underlain by fine grained mineral soils. In the instance of Derryclare, this interface is defined by a hummocky, irregular and high friction surface, thereby significantly limiting the risk of large-scale peat failures. If however, a smaller scale failure were to occur, it would likely take the form of a narrow channelised failure or debris flow. Due to the site's geology such failure mechanisms would not have the capacity to propagate downslope for any significant distance. This is evidence by the small failure observed at POI008 (Section 3.9 of the Assessment Report), where the total distance between the backscarp and leading edge of the failure lobe was measured at 40 in length. Peat probe depths taken immediately downslope of this historic failure showed peat depths of 0.3m (PP105).

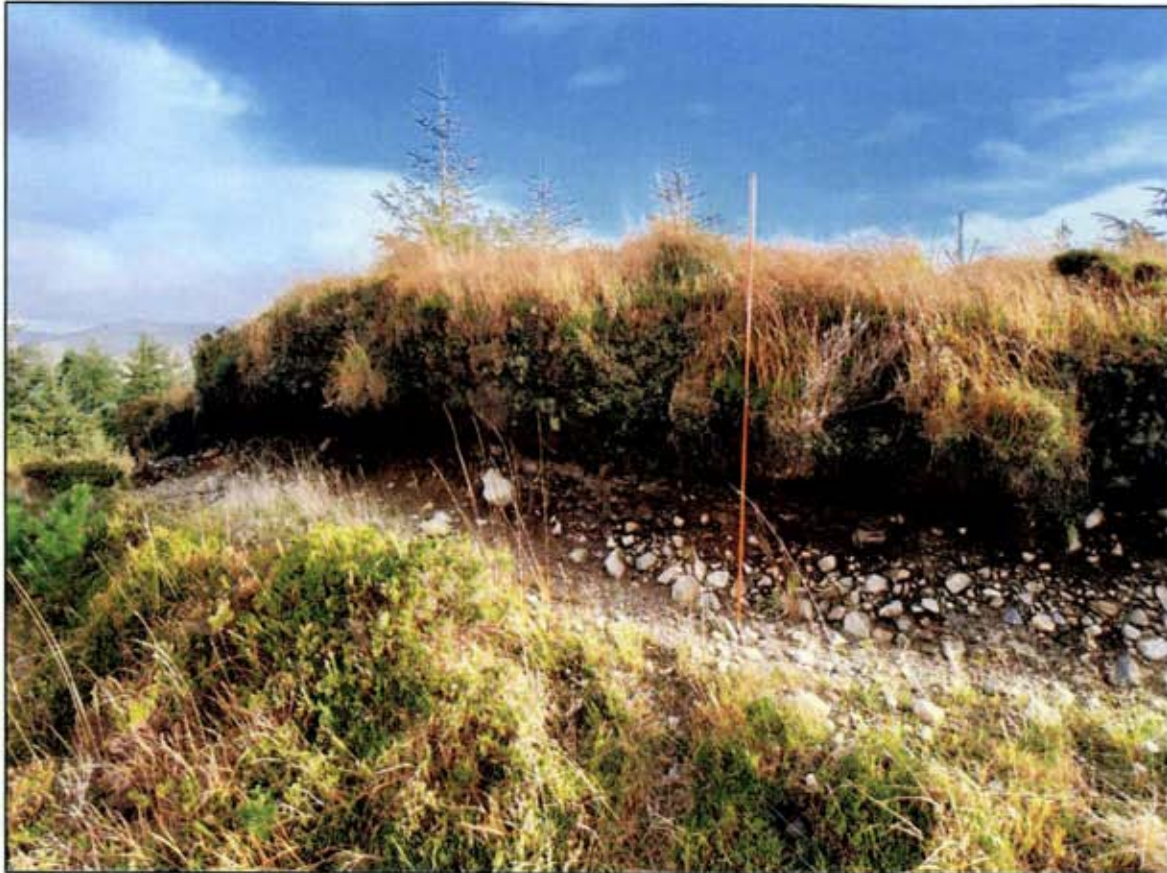
Plate 2 Exposure of peat underlain by granular till deposits (Phase 1 – PO1005)

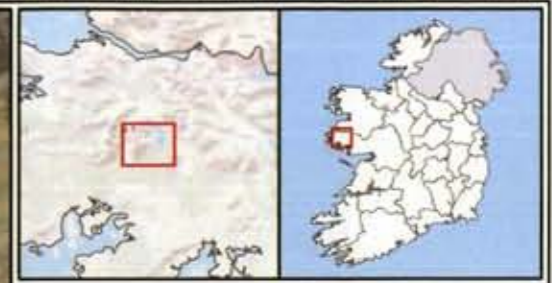
TITLE:	
Peat Probe Location Map (Phase 1, Phase 2 & RPS probe locations)	
PROJECT:	
Derryclare Peatland Rehabilitation	
DRAWING NO:	001
CLIENT:	MKO
SCALE:	1:20,000
REVISION:	0
DATE:	03/01/2024
PAGE SIZE:	A3

- Legend**
- Site Boundary
 - Phase 1 Peat Probe Locations
 - Phase 2 Peat Probe Locations
 - RPS Peat Probe Locations

1. In total, 77 no. additional peat probe locations were visited. The distribution of the combined Phase 1, Phase 2 and RPS probe locations are presented in Drawing No. 001.
2. Peat depths range from 0.0 to 6.3m bgl (PP087) with mean and median depths of 1.0 and 0.60m bgl respectively. The peat depths from both the Phase 1, Phase 2 and RPS surveys are presented in Drawing No. 002. The deepest peat deposits were almost exclusively found in areas of flatter terrain within the north, northeastern and southmost portions of the site.
3. Base of peat was typically recorded as bedrock. However, granular till and scree deposits were also noted. Profiles showing these geological sequences could often be observed in road cuttings and stream

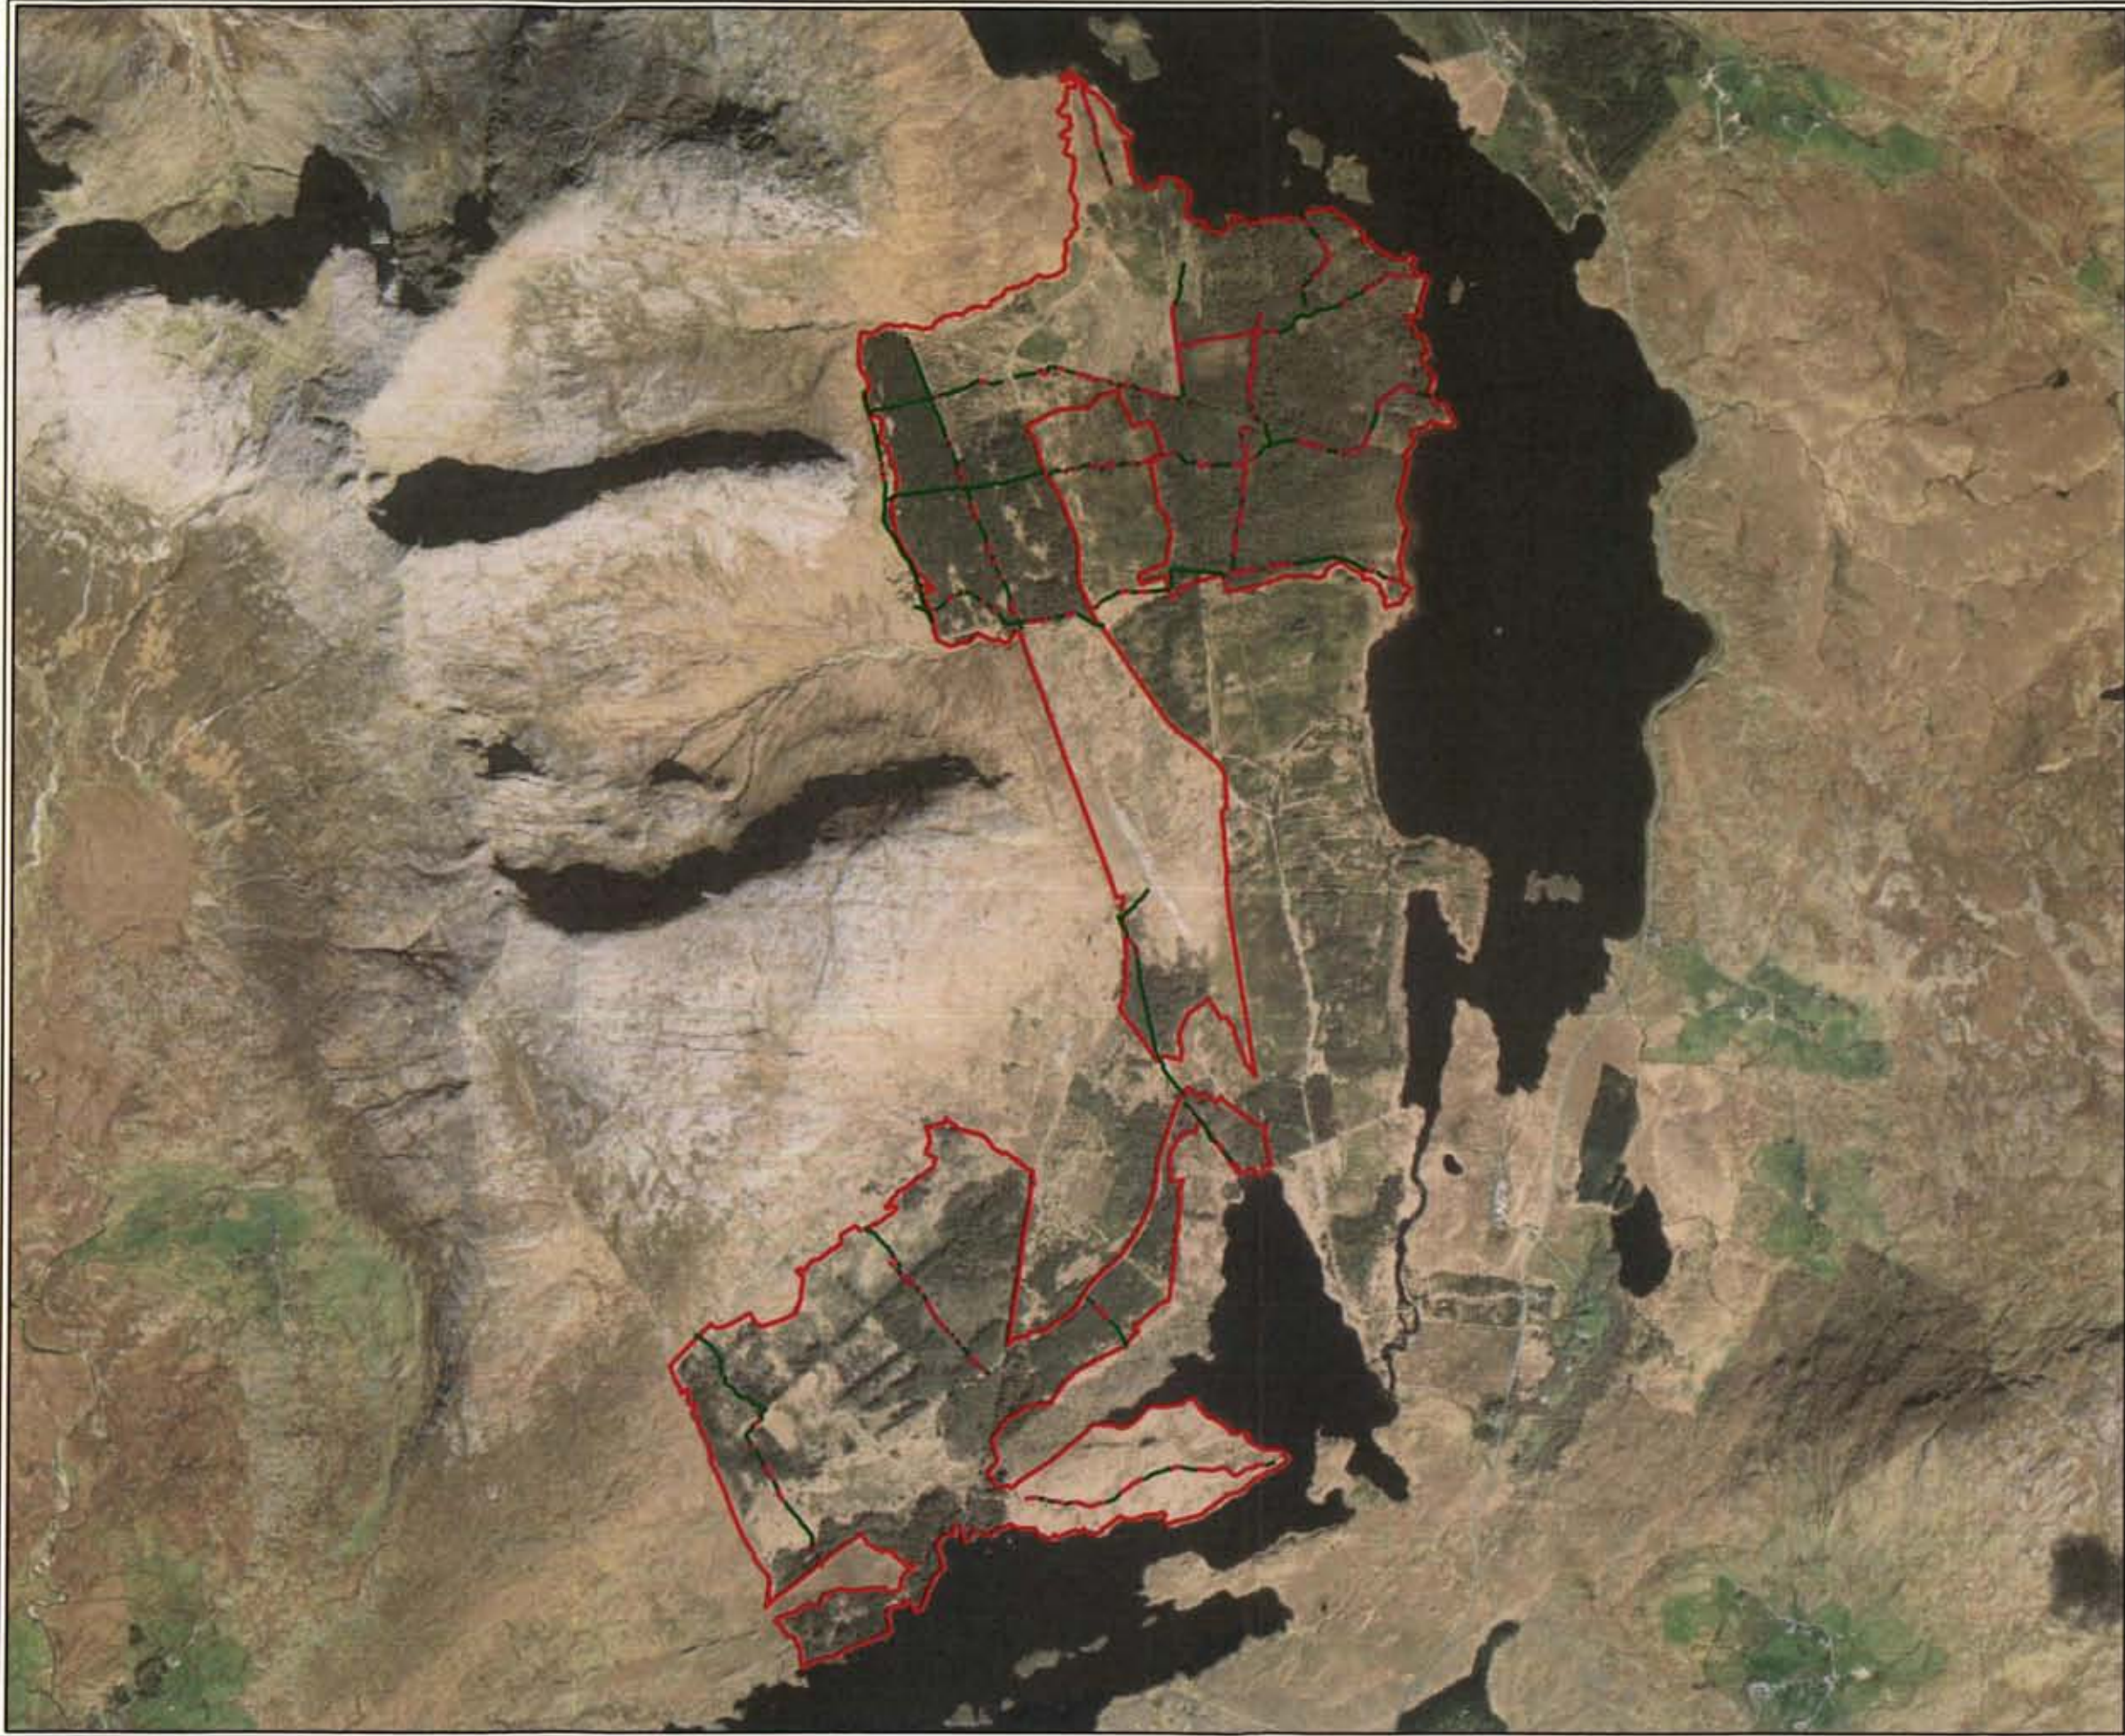
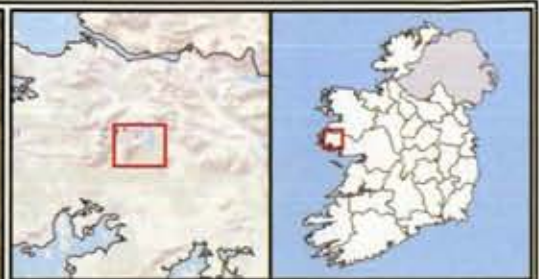
TITLE:	
GPR Profile Locations	
PROJECT:	
Derryclare Peatland Rehabilitation	
DRAWING NO:	003
CLIENT:	MKO
SCALE:	1:20,000
REVISION:	0
DATE:	20/12/2023
PAGE SIZE:	A3

- Legend**
- Site Boundary
 - No Peat Encountered
 - Peat Encountered

GPR profile G1 (Figure 1B employing a horizontal to vertical exaggeration of 1:5) which is located to the south of the site (Drawing No. 003), confirms the initial CGM interpretation whereby the peat forms in discrete, laterally discontinuous pockets. Importantly, this morphology is also clearly visible in nearly all of the GPR profiles. Site observations coupled with the GPR survey results show little to no interaction or interconnectivity between these pockets of isolated peat. These peat deposits are punctuated by ridges of outcropping to shallow sub-cropping bedrock. The flanks of these ridges are often steep and form bowl shaped depressions, which presumably have allowed in part for the development of blanket peat deposits at Derryclare. The relationship between the peat deposits and underlying bedrock is also illustrated in Figure 1C, which is a view of the lands to the immediate south of the site where there is significantly less vegetation coverage to obscure the terrain in its natural state.

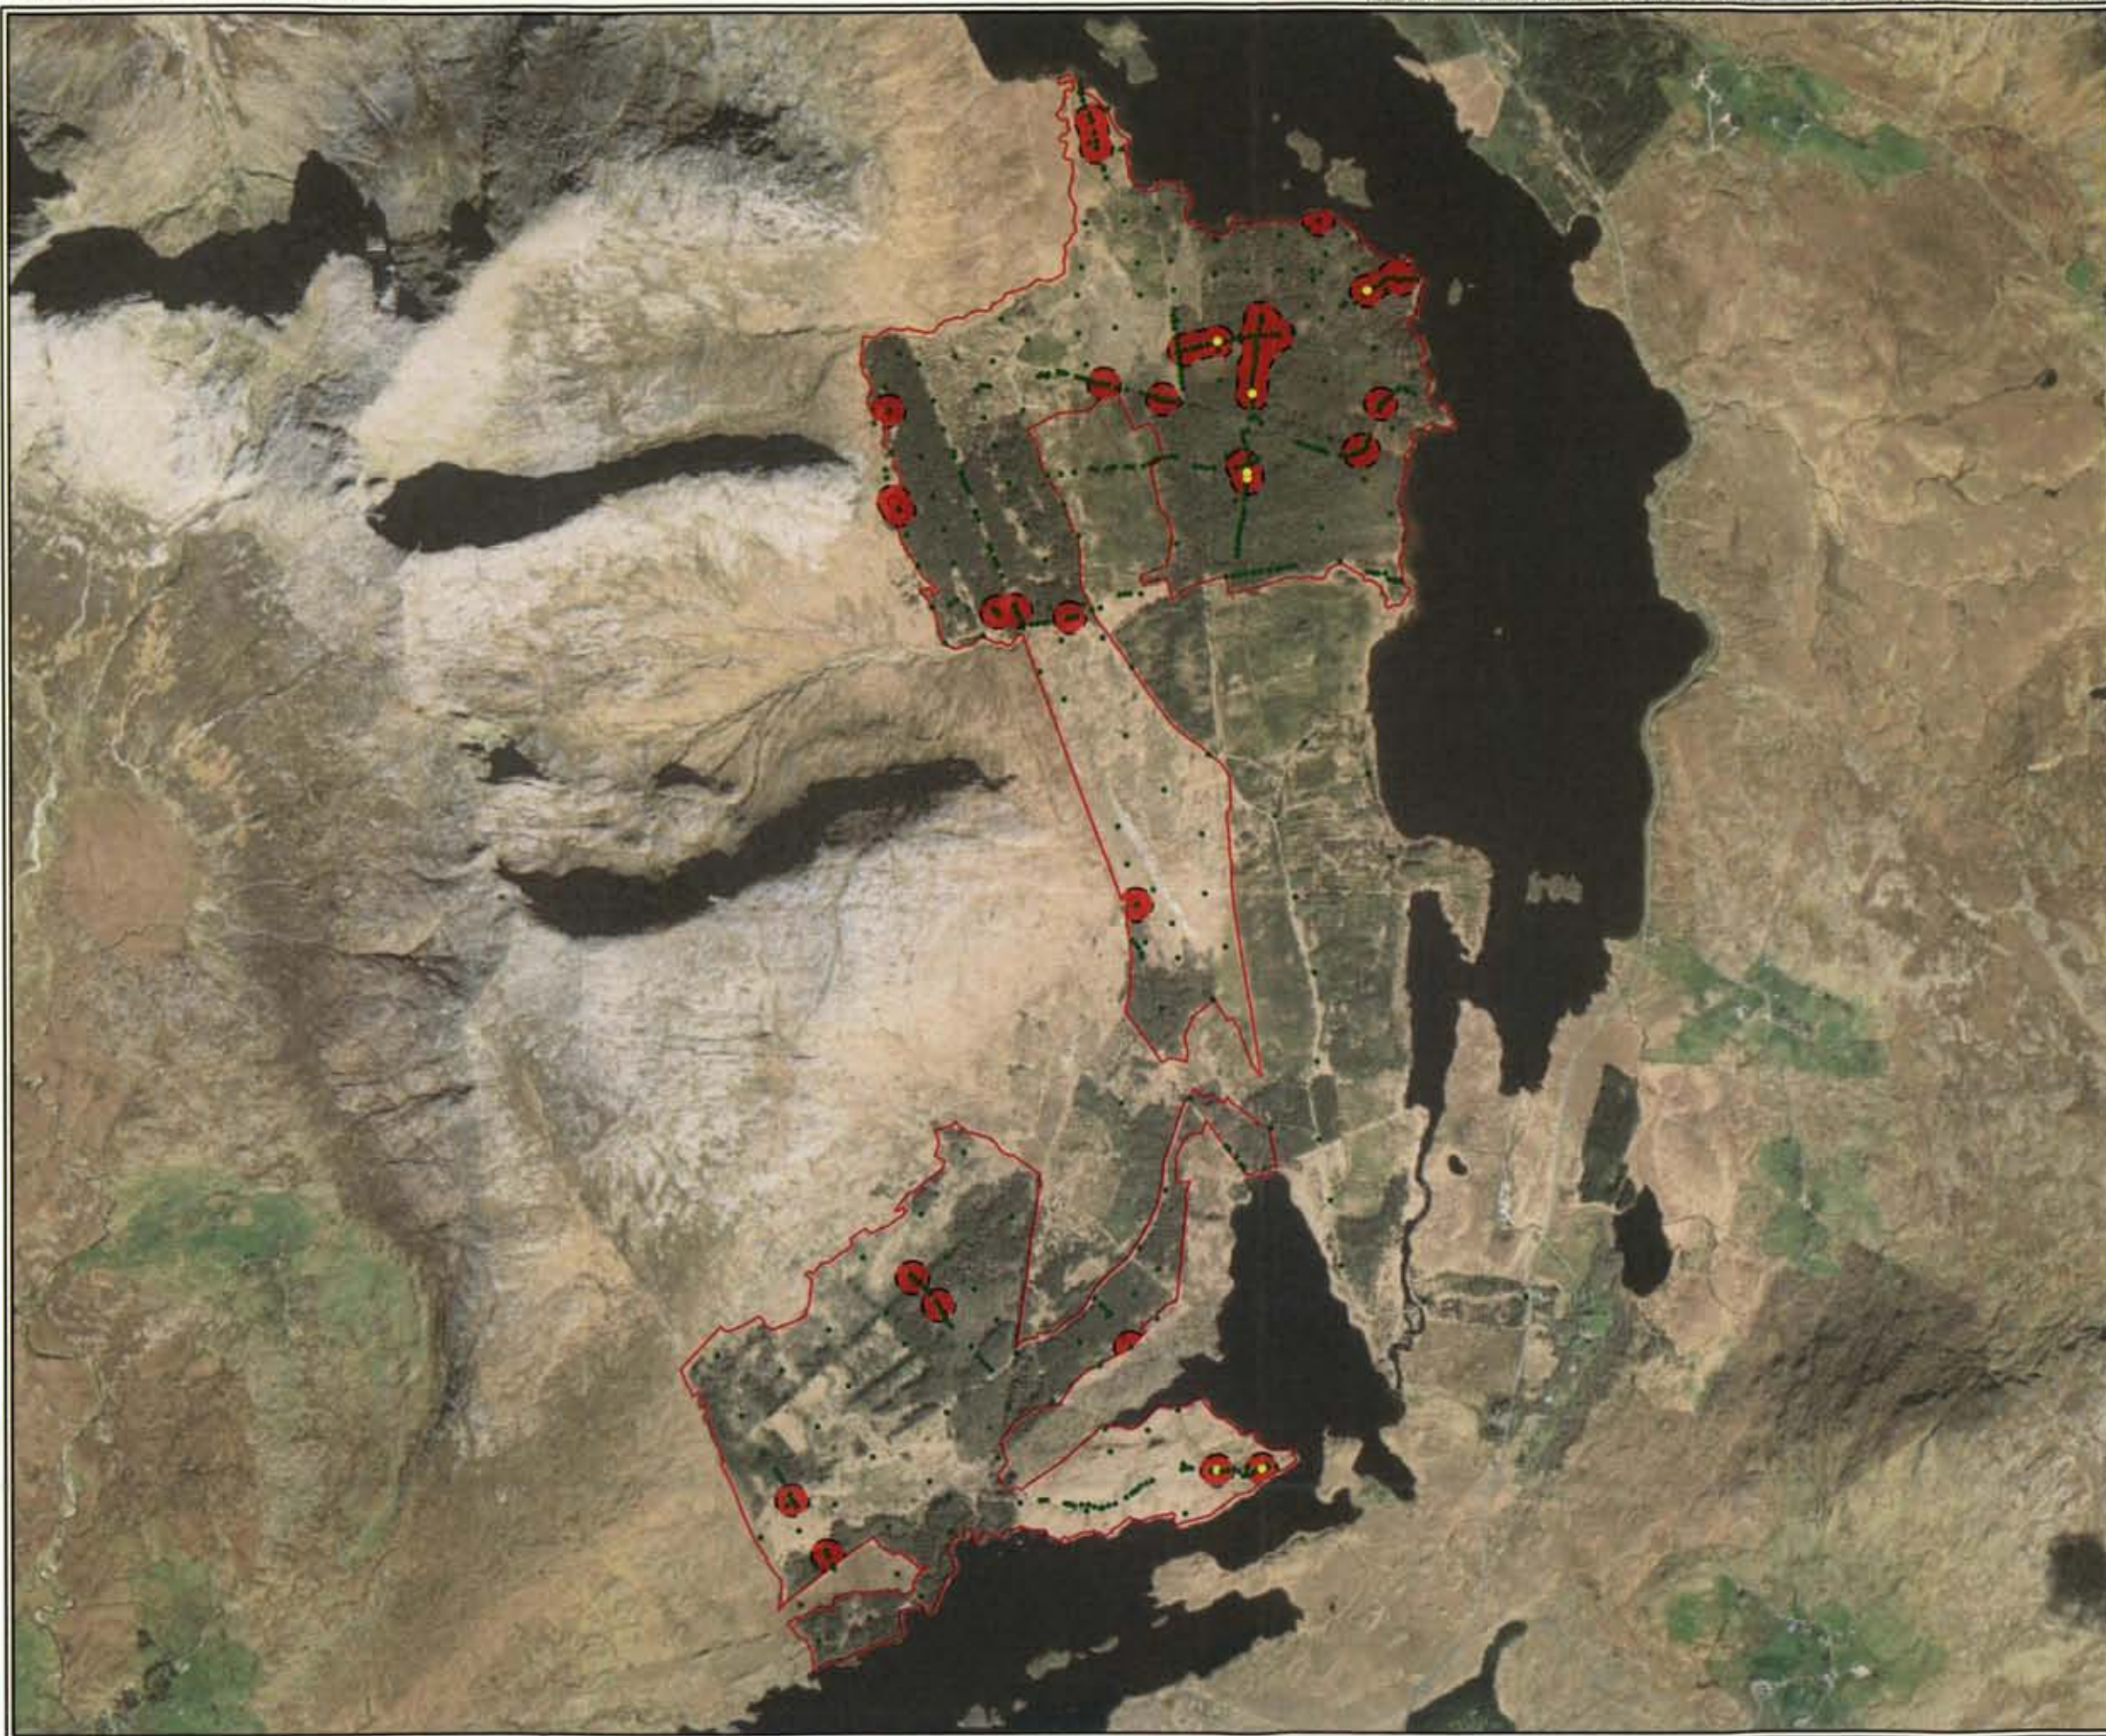
TITLE:	Factor of Safety Plan - Minimum Undrained	
PROJECT:	Derryclare Peatland Rehabilitation	
DRAWING NO:	004	
CLIENT:	MKO	
SCALE:	1:20,000	REVISION: 0
DATE:	03/01/2024	PAGE SIZE: A3

The Phase 1 results, along with the Phase 2 and RPS results (comprising 520 no. individual peat depth points) are presented in Drawing Number 004 (undrained condition) and Drawing No. 005 (drained condition). These drawings also include a number of exclusion zones based on areas having FoS values of <1.3 and will be discussed further in Section 3.2.4.

For load condition 1, 431 no. out of the 432 no. peat depth locations analysed gave a calculated FoS of >1.3 (FoS range 1.46 to 239). One peat depth location gave a FoS <1.3 (FoS of 1.25 at GPR profile location G25-278).

For load condition 2, a calculated FoS in excess of 1.3 (FoS range 1.31 to 60.32) was determined for 425 no. peat depth locations. Seven peat depth locations gave a FoS <1.3 but >1.0.

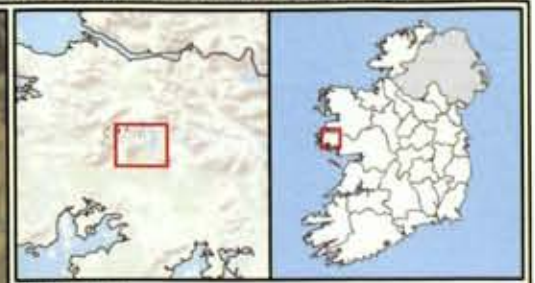
- Legend**
- Site Boundary
 - 50m Exclusion Zone
- Minimum Undrained FoS**
(Including Phase 1, Phase 2 and RPS Survey Results):
- <1
 - 1 - 1.3
 - > 1.3

In total 38 no. (7.3% of the total number of peat depth locations assessed across the site) peat depth locations from the Phase 1, Phase 2 and RPS surveys gave FoS values of <1.3. At these locations, a minimum 50m exclusion zone has been used as presented in Drawing Numbers 004 and 005. Within these exclusion zones the use of machinery for restoration purposes shall be restricted.

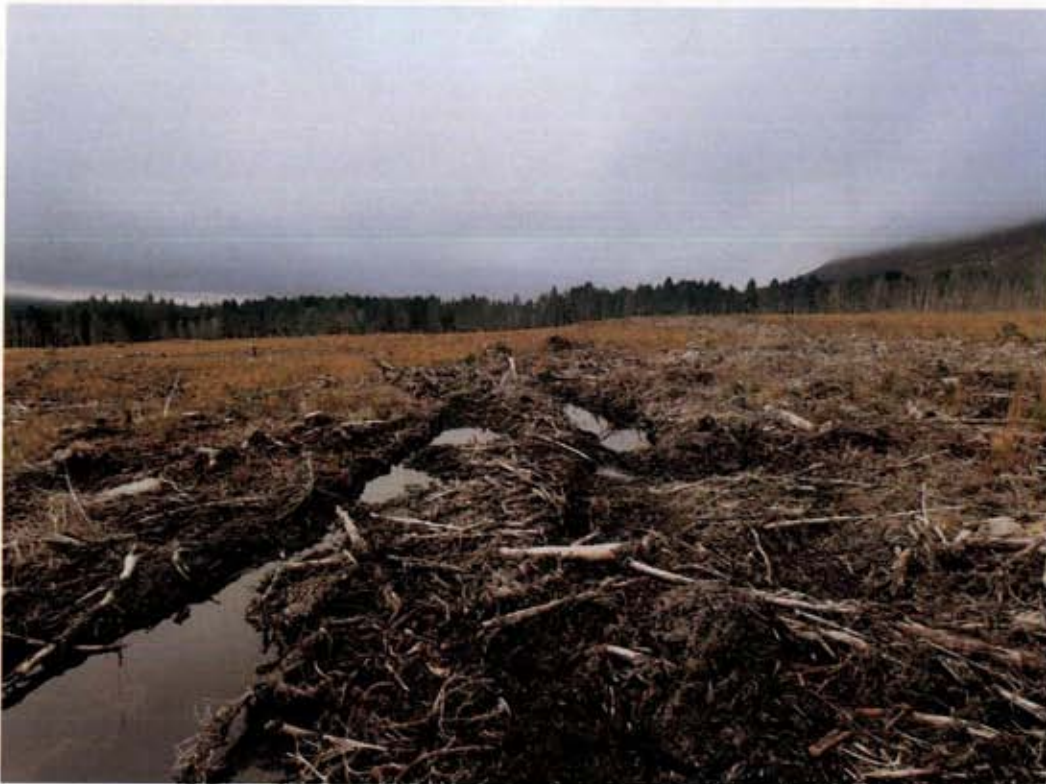
Photo 50 PP153 view south (water localised to ruts in brush tracks)

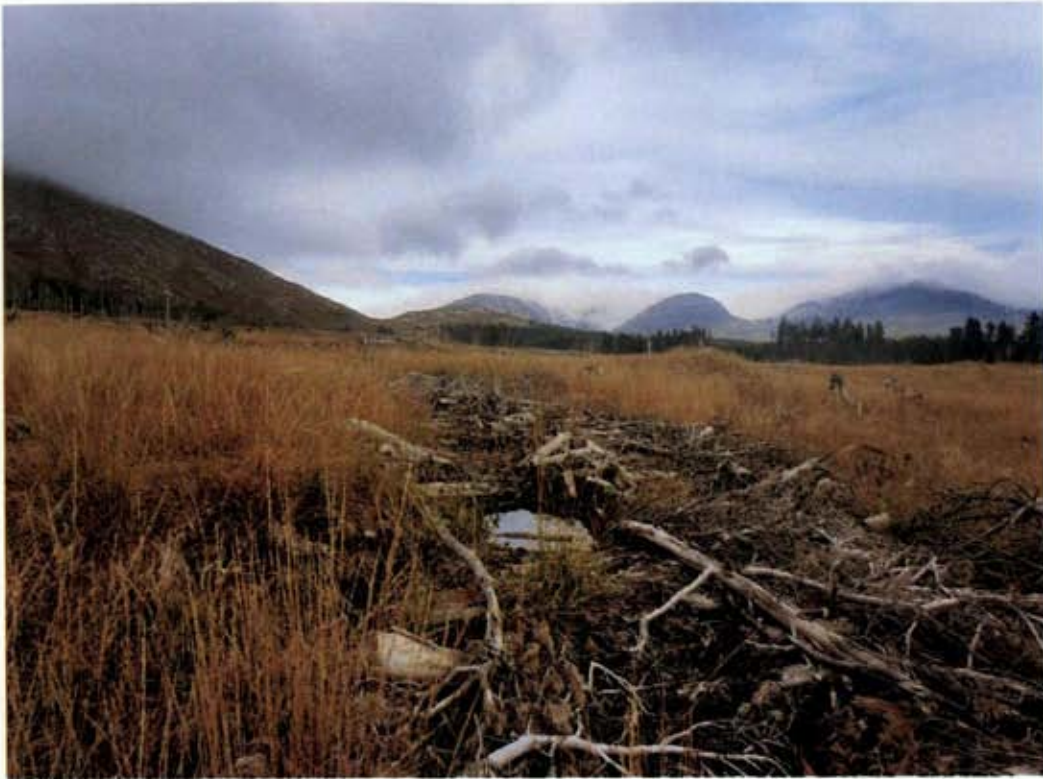
Photo 51 PP153 view north (water localised to ruts in brush tracks)

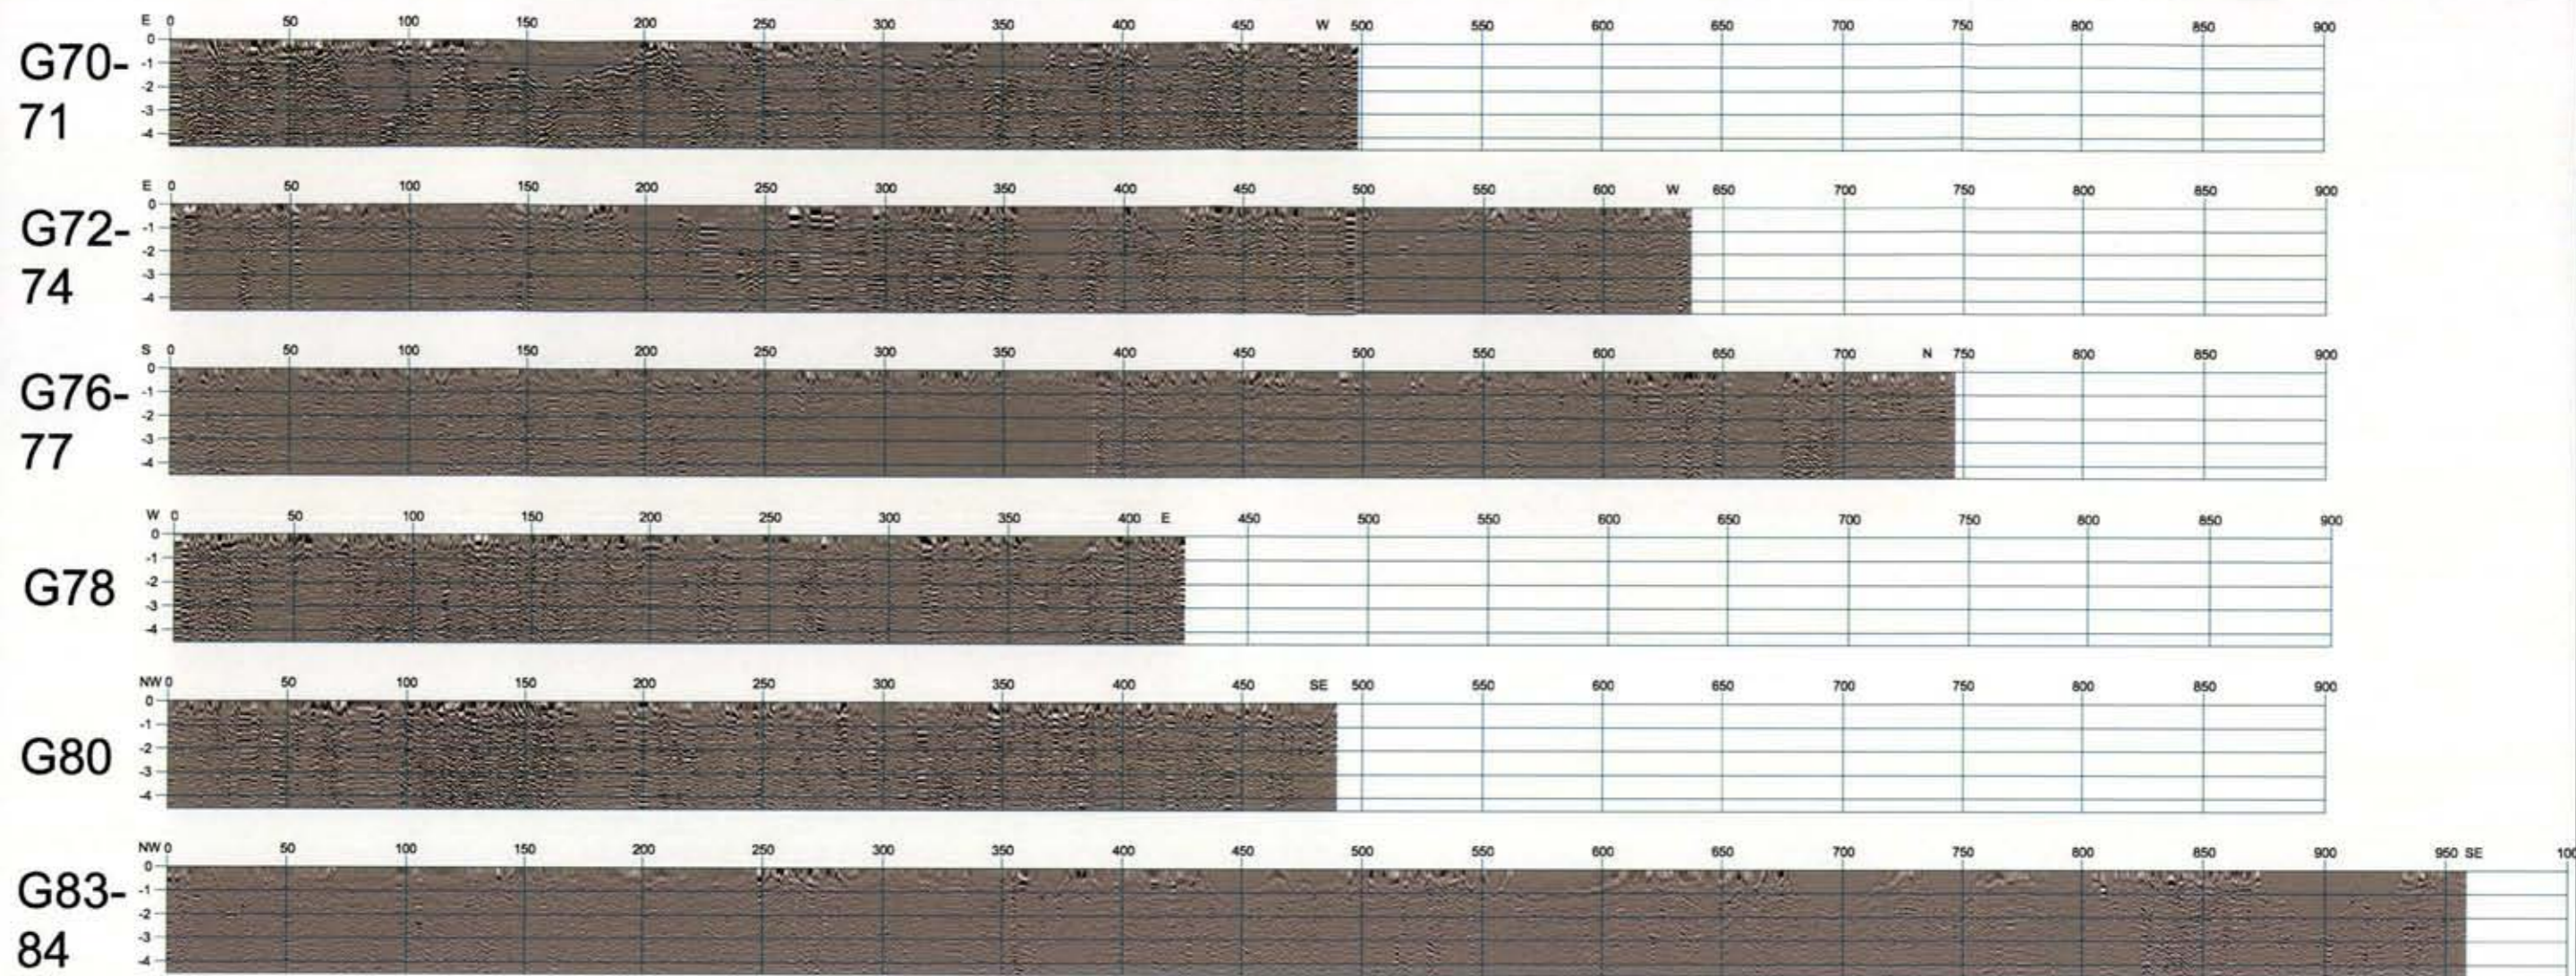
Grey scale images are depth stretch sections from 100MHz GPR survey. The vertical depth is approximate and computed with GPR wave velocity of 0.035 m/ns.
