SITE VISIT REPORT

Purpose of Site Visit:	Westmeath Peat Extraction
Site Address:	Milltownpass Townland, County Westmeath
Date of Visit:	12/04/23
Times of Visit:	1150 to 1235
Visit Criteria:	Peat extraction investigation
EPA Attendees:	Mick Henry and John Gibbons
Organisation	To be confirmed

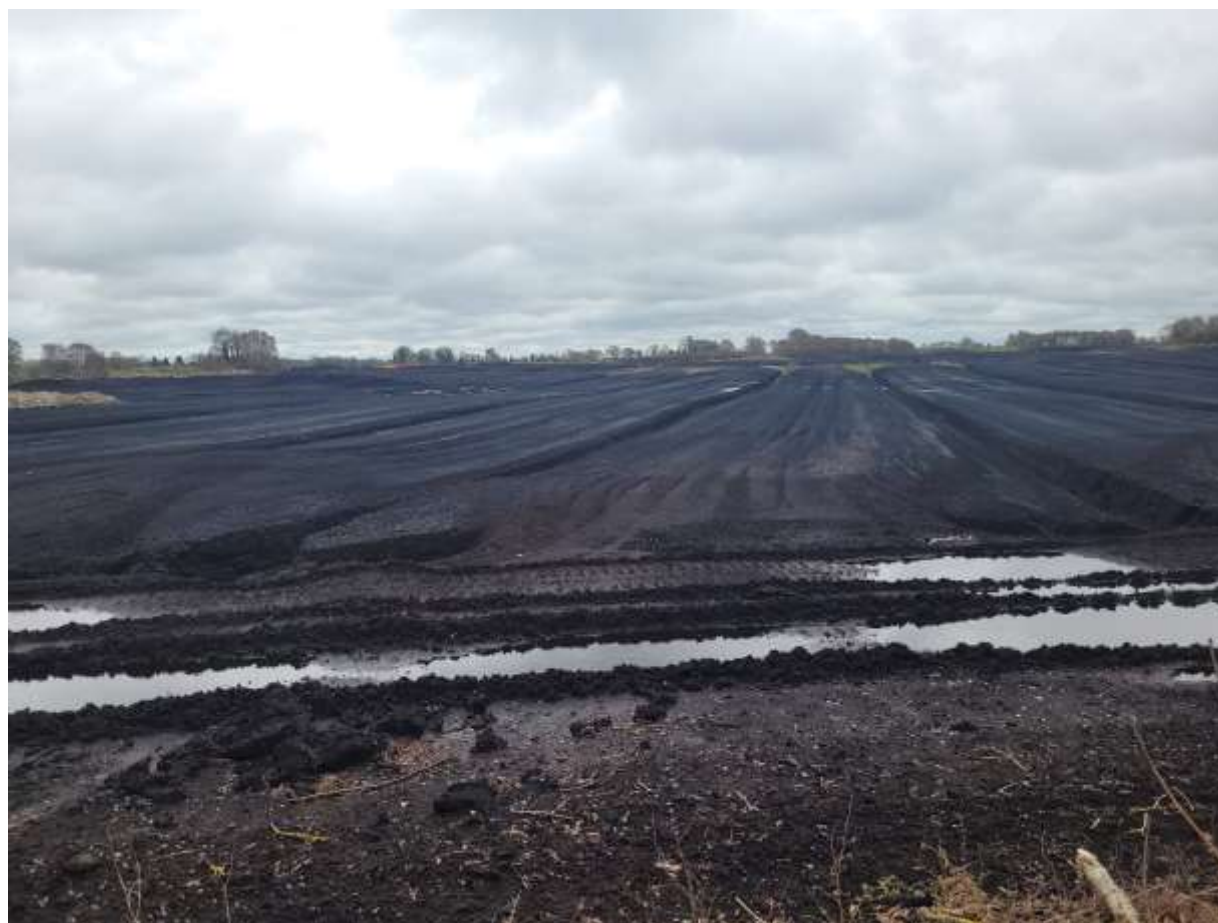
- A significant area of peatland (>30 Hectares) had been worked by the milling of peat.
 - Excavations to greater than 3 Meter's were noted below the adjacent public roadway and the excavations were estimated to have taken place across the worked area.

Photo 1: Large scale commercial peat extraction noted at Milltownpass Bog

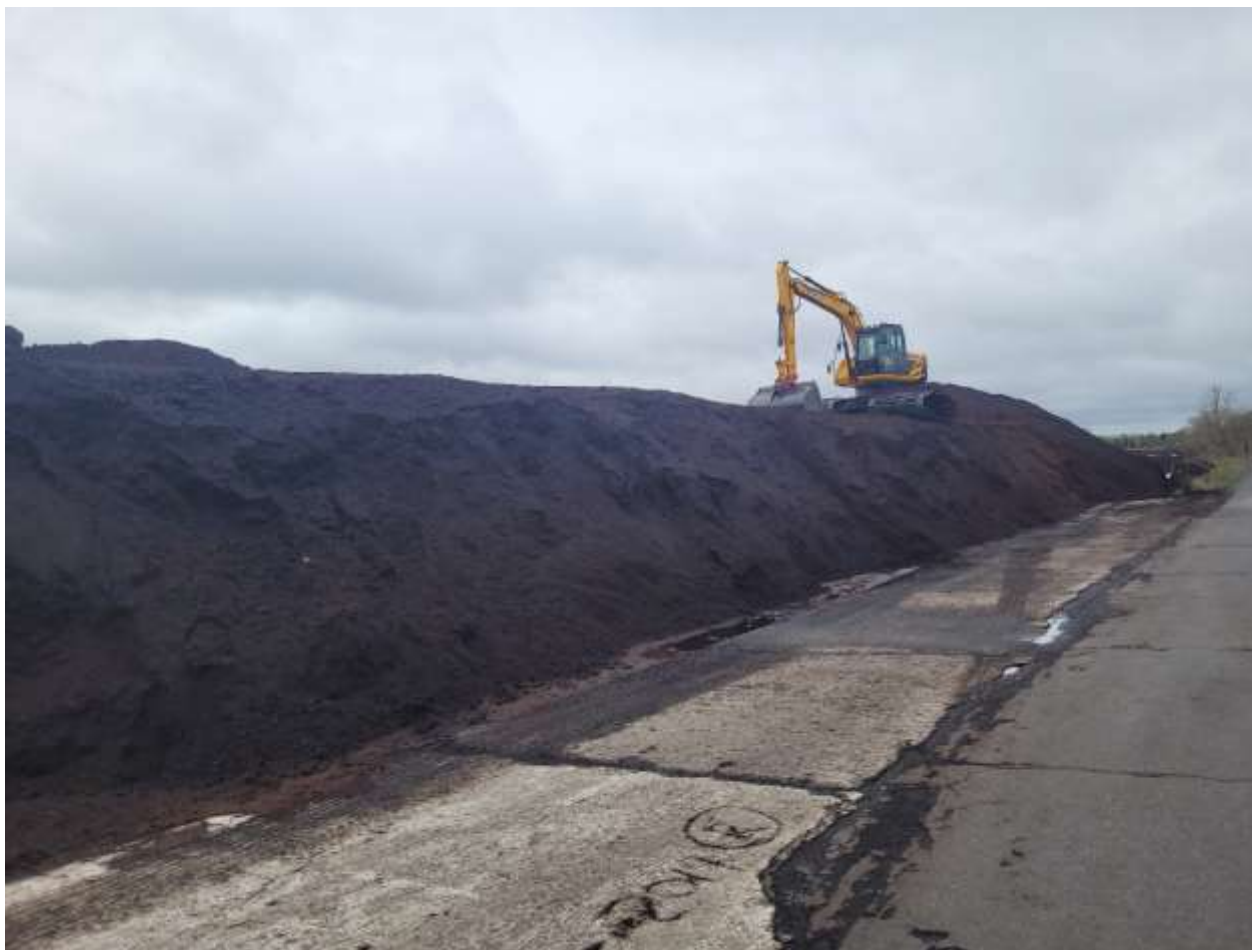
- A JCB loader/excavator was noted on top of the stockpile.
 - No peat extraction activity was noted at the time of the vist.
 - Machinery associated with peat extraction was noted (excavator, grader) for peat extraction.

Photo 2: Excavator noted on the large stockpile of milled peat at the loading area adjacent to the public road

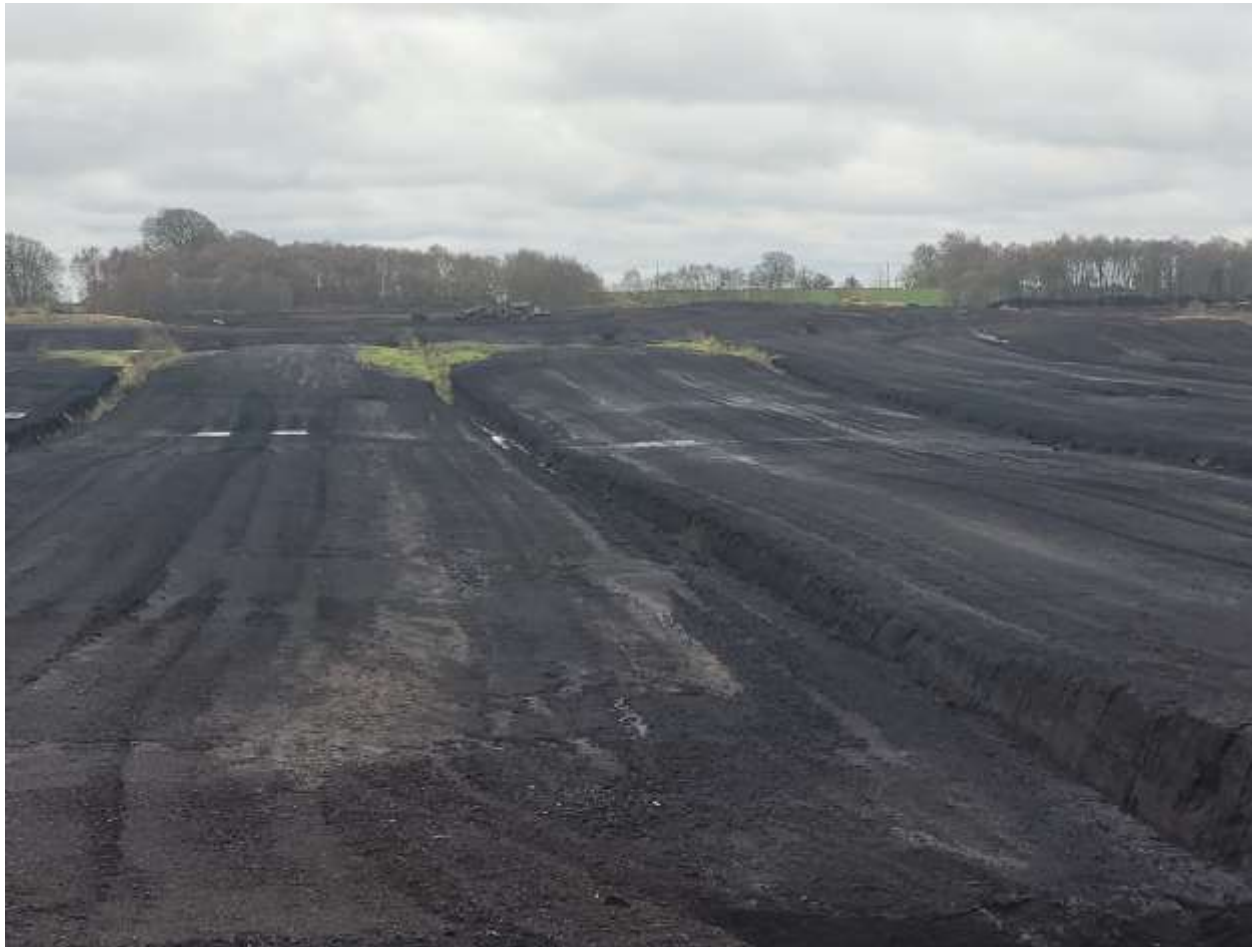
Photo 3: Machinery associated with peat extraction noted on the peatland.
