# SITE VISIT REPORT

<b>Purpose of Site Visit:</b>	<b>Peat Extraction in Co. Offaly</b>
<b>Site Address:</b>	Oldcroghan Bog, Green lane, County Offaly
<b>Date of Visit:</b>	24/05/2023
<b>Times of Visit:</b>	1210 to 1300
<b>Visit Criteria:</b>	Peat extraction investigation
<b>EPA Attendees:</b>	Mick Henry and Kealan Reynolds
<b>Organisation:</b>	Wright Peat Ltd, Bulrush Peat Ltd, Nippy Peat Ltd, Stom Barra Ltd

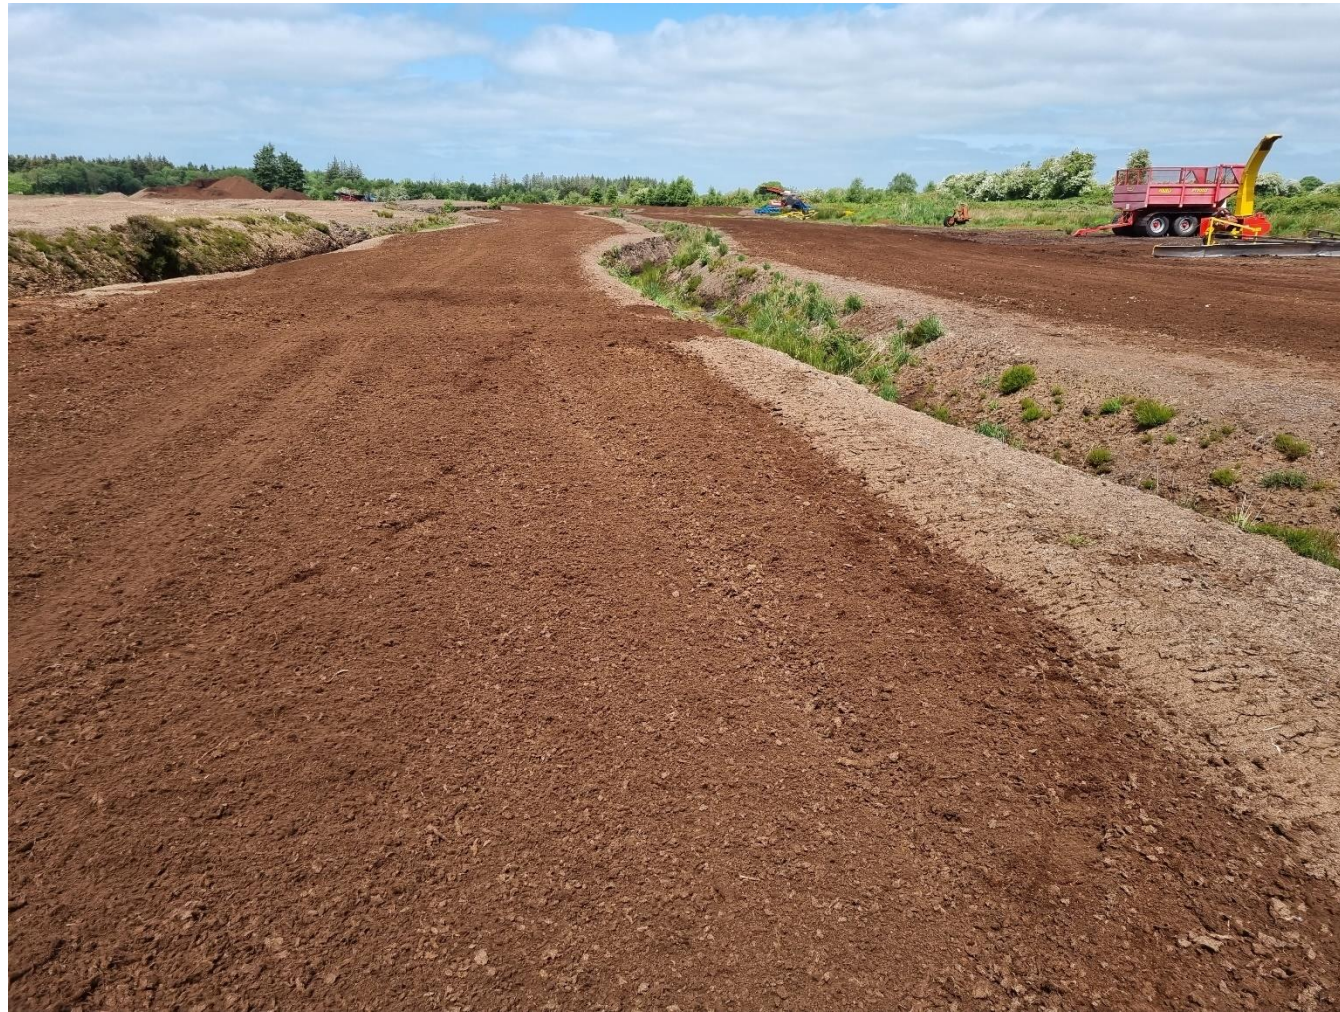
- It was noted that milled peat extraction/harvesting activity had recently taken place on some of the banks/rows on the northern part of the peatland.

**Photo 1: Recent milled peat extraction and harvesting noted on the Northern section of the peatland.**

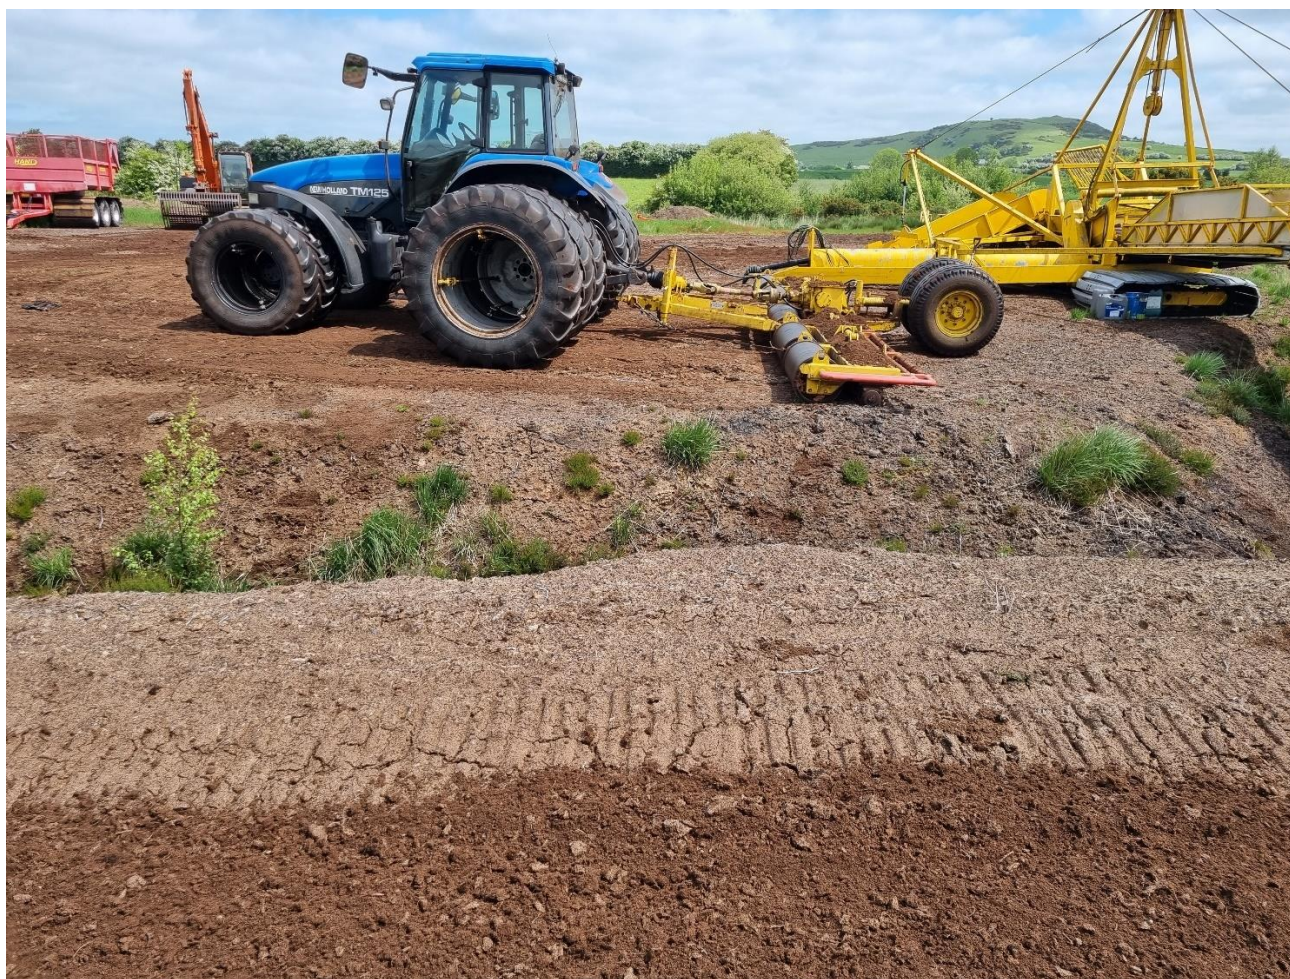
- A significant stockpile of milled peat was noted at the northern part of the peatland.
  - Machinery and equipment for milled peat harvesting/extraction was noted at the northern part of the peatland.

**Photo 2: Milled peat extraction machinery and equipment was noted at the northern end of the peatland.**

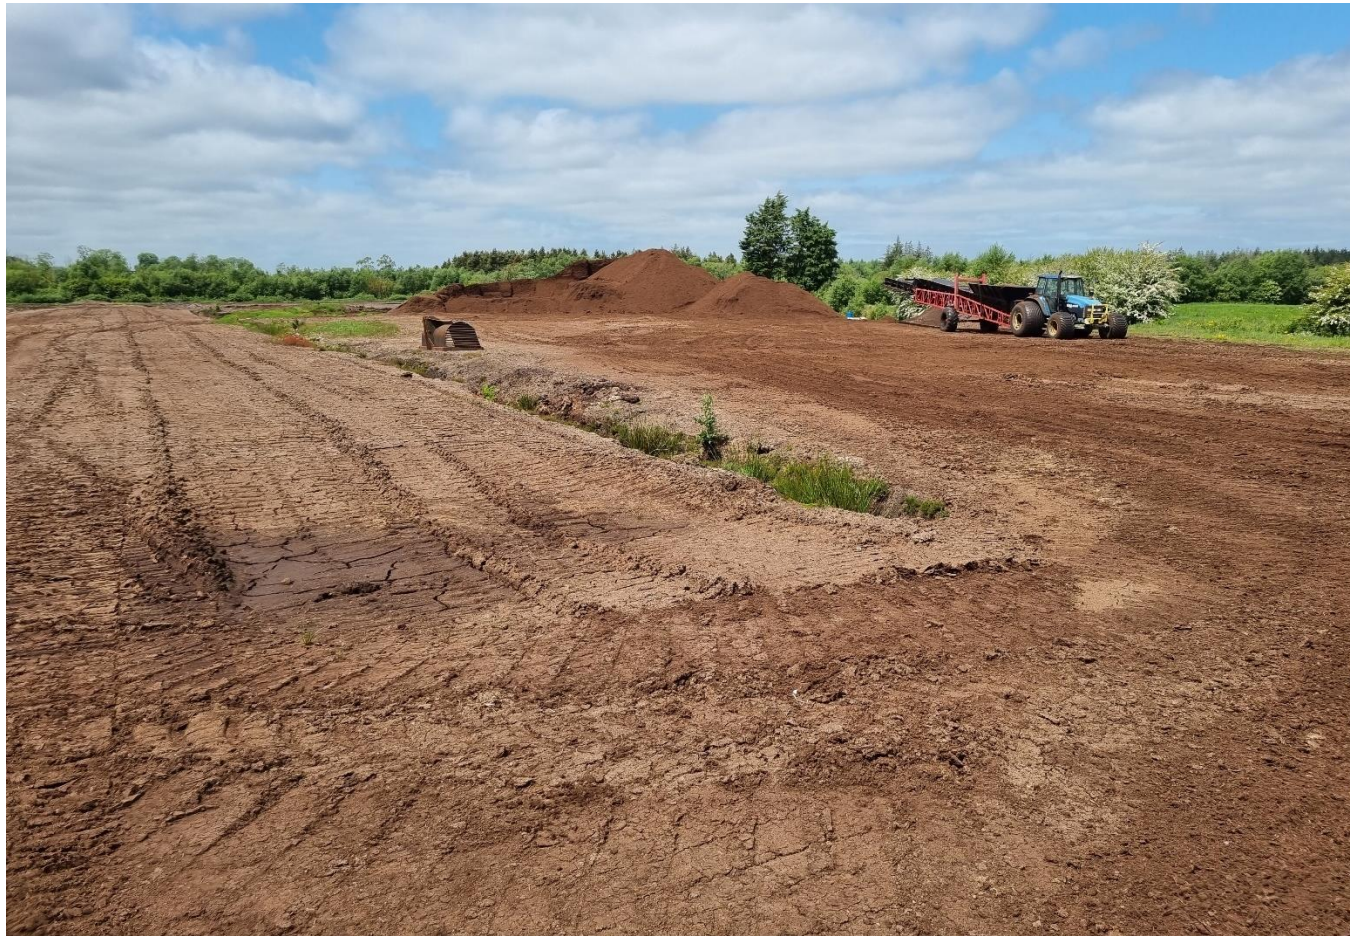
- At the northern end of the bog a large stockpile of milled peat was noted at the loading area. Milled peat machinery and equipment was noted adjacent to this area also.

**Photo 3: Large stockpile of milled peat noted at the northern end of the peatland.**
