CAMLIN_060

(Camlin Priority Area for Action)

Local Catchment Assessment Supporting
information.

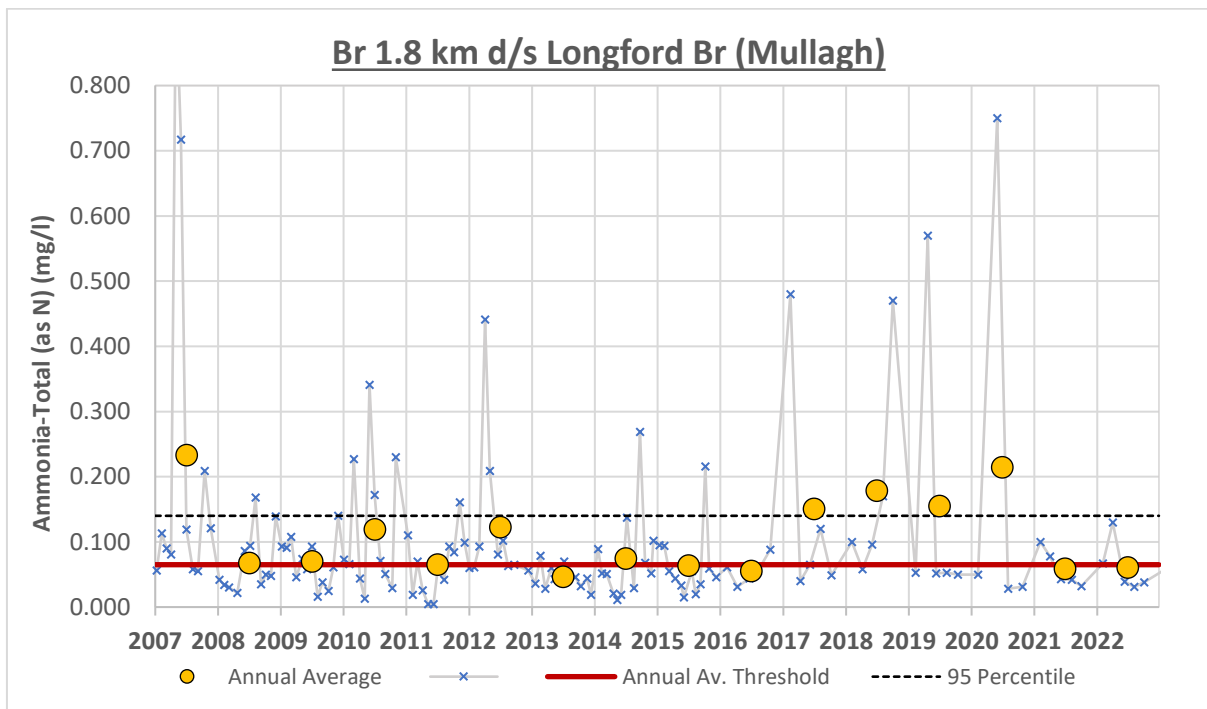
GRAPH 1 The total ammonia-total (as N) (Annual Average) trend for the operational monitoring station Br 1.8 km d/s Longford Br (Mullagh) Station code RS26C010900. Concentration of 0.95mgN/L in April 2007 not shown on graph.

Annual average Total ammonia ranged from below the EQS (0.065mgN/L) to over 11 times the EQS (0.75 mg/l on the 02/06/2020). An upward trend was evident from 2016 – 2020, with a marked decrease thereafter.

Data from Met Éireann at the Termonbarry weather station (10 km away) recorded some heavy rainfall in the mg/l at the operational monitoring point preceding days to these spikes. On the 4th of October, there was a value of 0.47mg/l total ammonia at the operational monitoring point but no heavy precipitation was recorded at the Termonbarry station however, there could have been more localised rain fall events. On the 25th of April 2019, there was a value of 0.57 mg/l total ammonia at the operational monitoring point and precipitation value of 9.1 mm the preceding day. On the 2nd of June 2020, there were no precipitation data available, but a value of 0.75 mg/l total ammonia recorded at the downstream monitoring station.

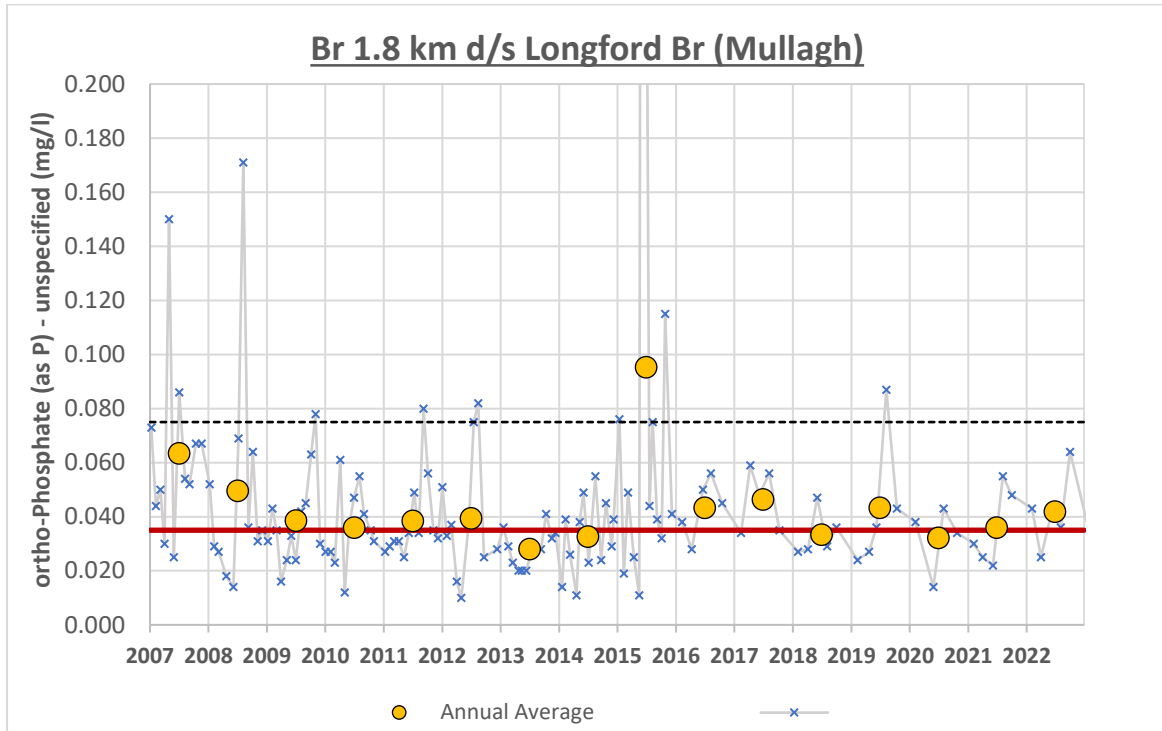
GRAPH 2 The orthophosphate (as P) (Annual Average) trend for the operational monitoring station Br 1.8 km d/s Longford Br (Mullagh) Station code RS26C010900.

Graph 2 shows the orthophosphate annual average value trends at the downstream WFD monitoring station. Temporal monitoring data at the downstream monitoring station shows improvement however there regular breaches of the mean orthophosphate EQS. This data

should be examined further regarding telemetry/ flow monitoring for spill patterns at SWO002 if available. The spikes in orthophosphate do not correlate with the spikes in total ammonia.

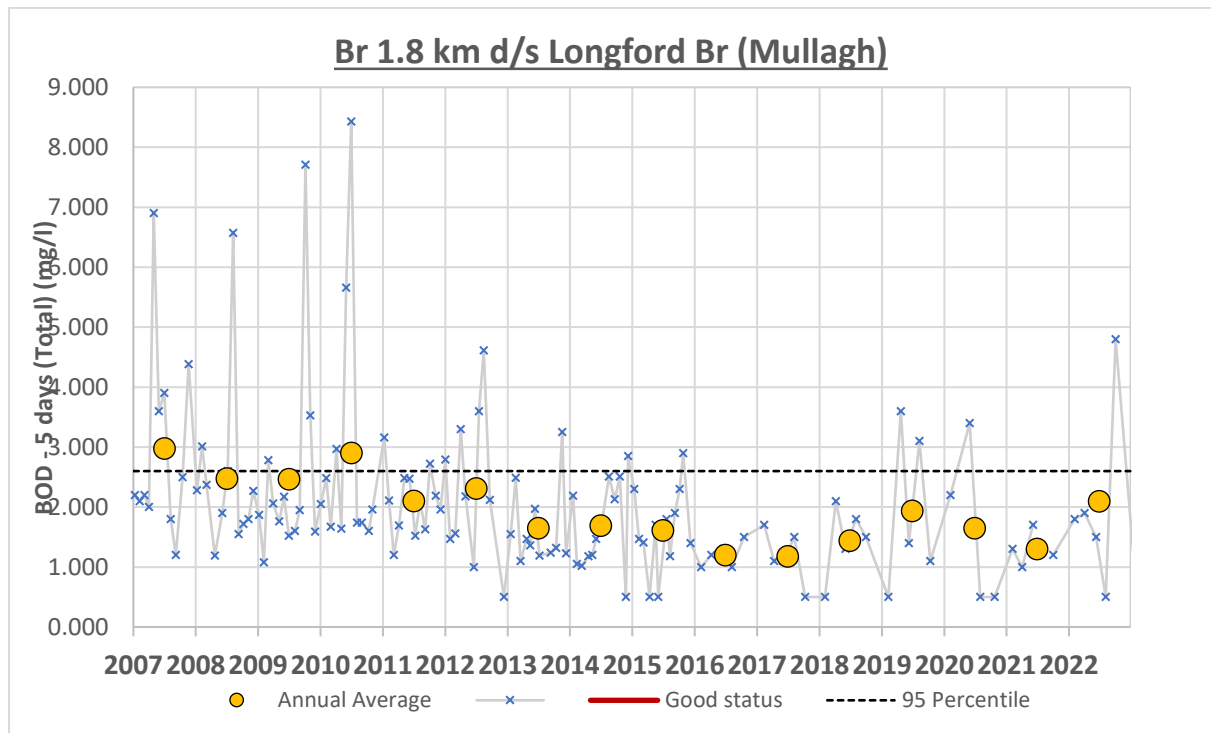
GRAPH 4 The BOD (mg/l) (Annual Average) trend for the operational monitoring station Br 1.8 km d/s Longford Br (Mullagh) Station code RS26C010900.

Graph 4 below shows BOD annual average value trends at the downstream WFD monitoring station. Temporal monitoring data that there was a recent breach of the EQS on the 05/10/2022 of 4.8mg/l BOD at the operational monitoring point. Spikes for BOD, Orthophosphate and Total Ammonia don't always correlate e.g., Spikes for BOD and orthophosphate for the 5th of October 2022 but no spikes were present on this date for for total ammonia.

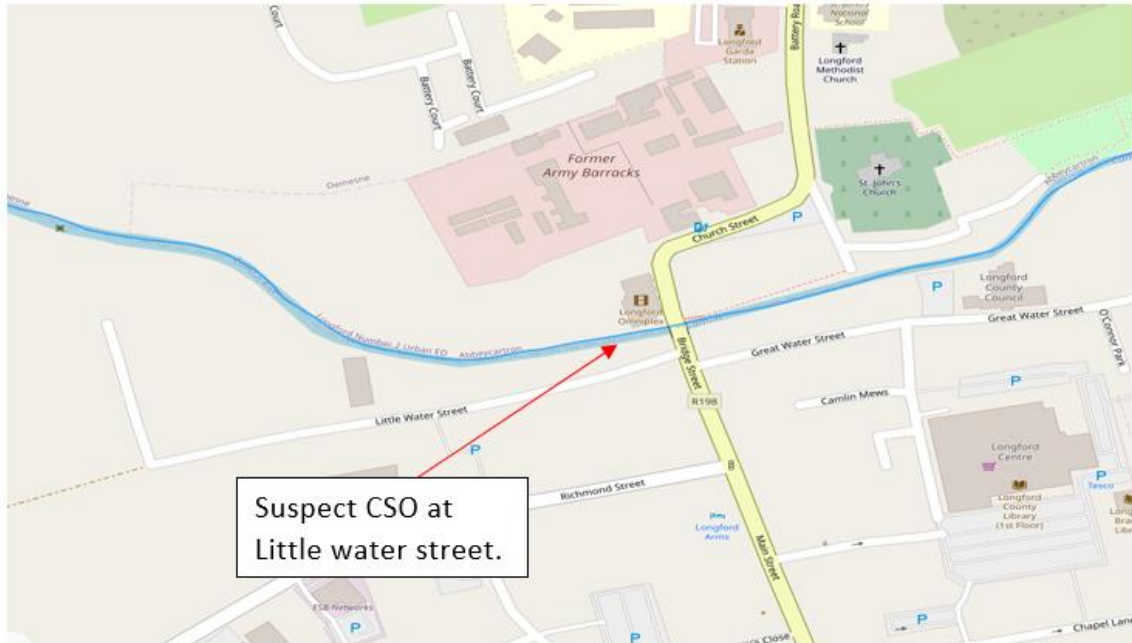
FIGURE 4 Suspect Combined Sewer Overflow at Little Water Street.

The suspect combined sewer overflow at Little Water Street was sampled on the 7/07/2020 and had the following parameter values - BOD was 126.4 mg/l, total ammonia was 2.3 mg/l and Ortho-P was 0.16 mg/l suggesting that it is from a combined network.

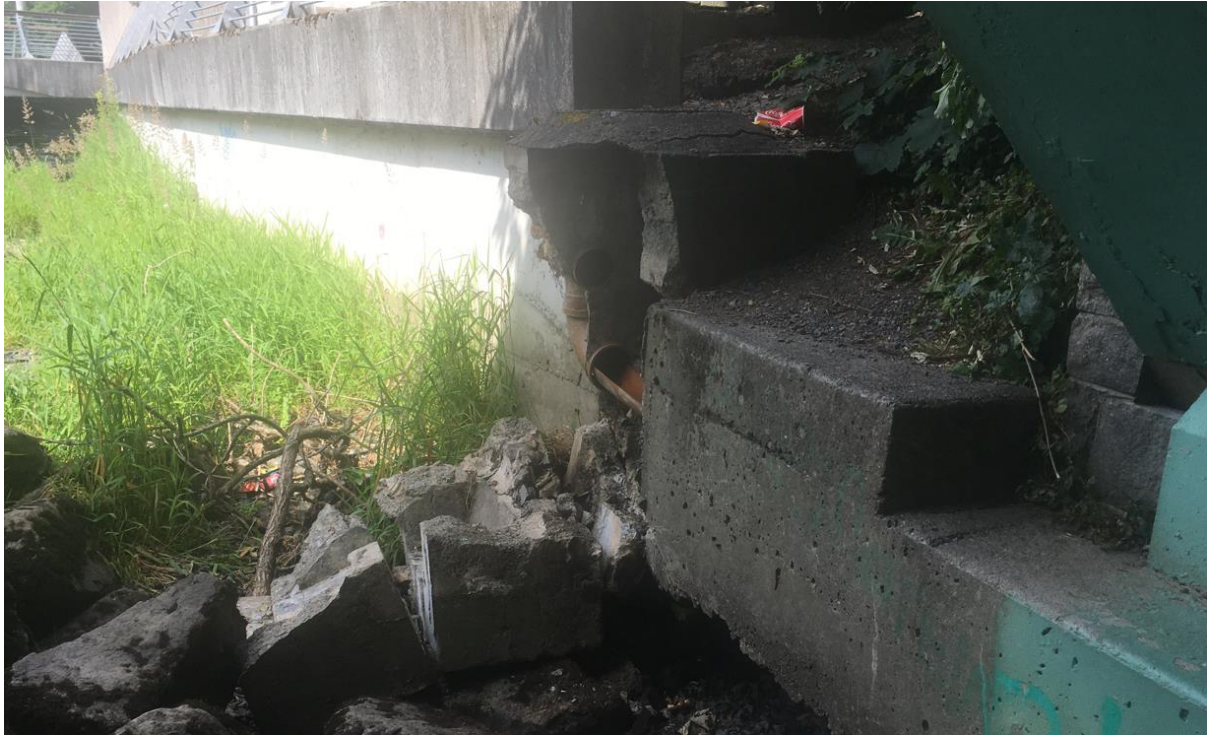
FIGURE 8 Collapsed sewer near the cinema which was rectified.

A collapsed manhole required remediation works by Longford County Council in Sept 2020. This removed the discharge of raw sewage beside Longford Bridge. The impact of this is unknown

(Figure 8). There may also be other overflows discharging under the waterline that are not visible during LCA. Surcharging of the line may need assessment in some locations (Figure 9) and there is evidence of misconnections in some locations (Figure 10)

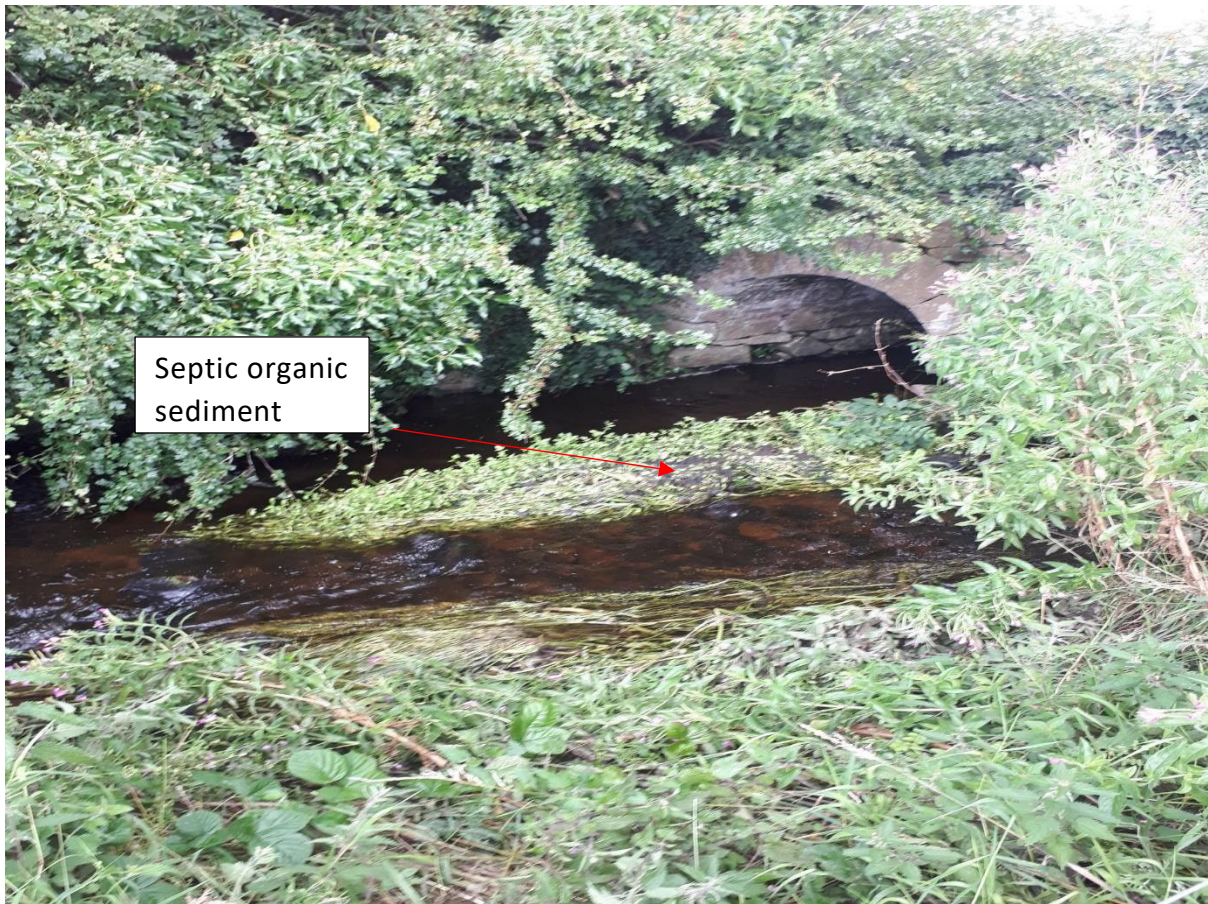
Figure 13 Downstream of Ardagh village, very poor water quality was found at (Bridge on the R393). SSIS Score of 0 "probably impacted".

- Local catchment assessment was undertaken at the headwaters of the CAMLIN_060 and Ardagh wastewater treatment plant was ruled out as a significant pressure. This agglomeration is located at the headwater of the incoming tributary the Ardagh river and serves Ardagh village. After consultation with UÉ, it transpired that the sewerage is tankered away to the Longford Agglomeration for treatment and that there was no direct discharge to the CAMLIN_060 waterbody. Very poor biological water quality was found downstream 13/08/2019, which resulted in an SSIS score of 0 – “probably impacted” with only very tolerant invertebrate taxa found downstream (only *Chironomus*, *Gammarus* and *Tubificidae* species present in sample). An agricultural

referral was issued to the ASSAP programme instead due to impacted water quality found at this location.

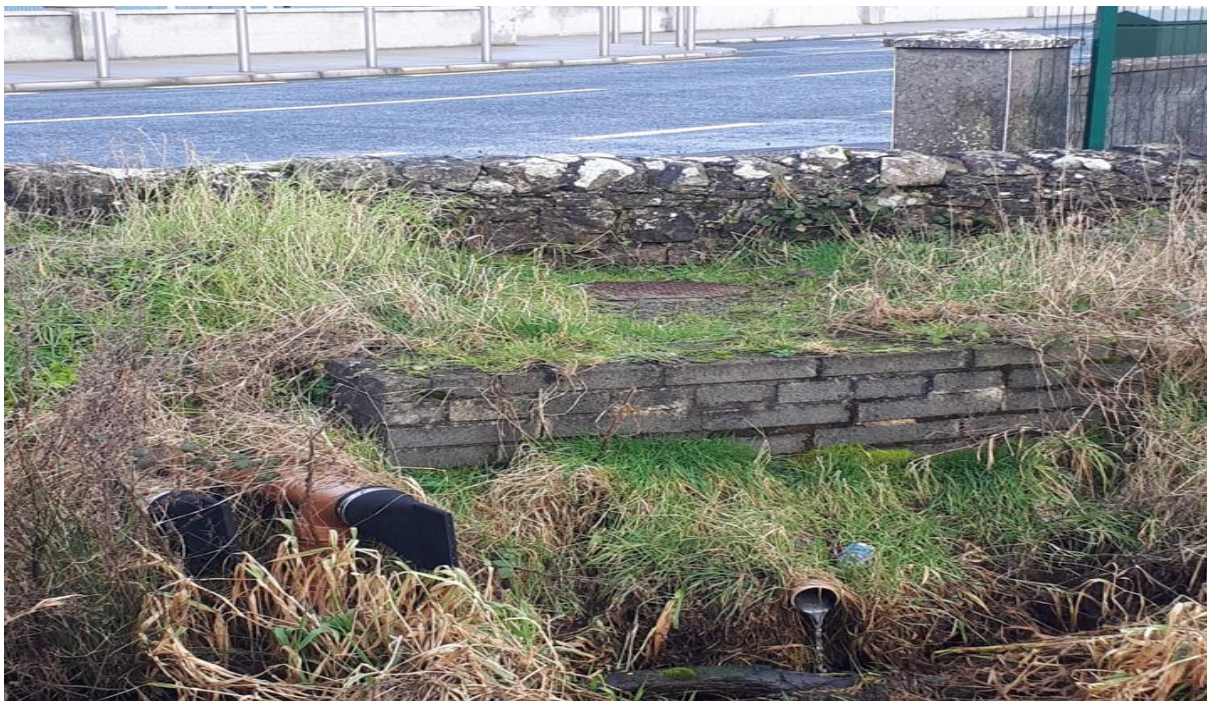
Figure 14 Discharge from a development led wastewater treatment at Stonepark that was referred to Longford County Council for further assessment.

- An unlicensed discharge was referred to Longford County Council at Stonepark from developer provided infrastructure. This will need to be assessed further by Longford County Council to determine its significance.

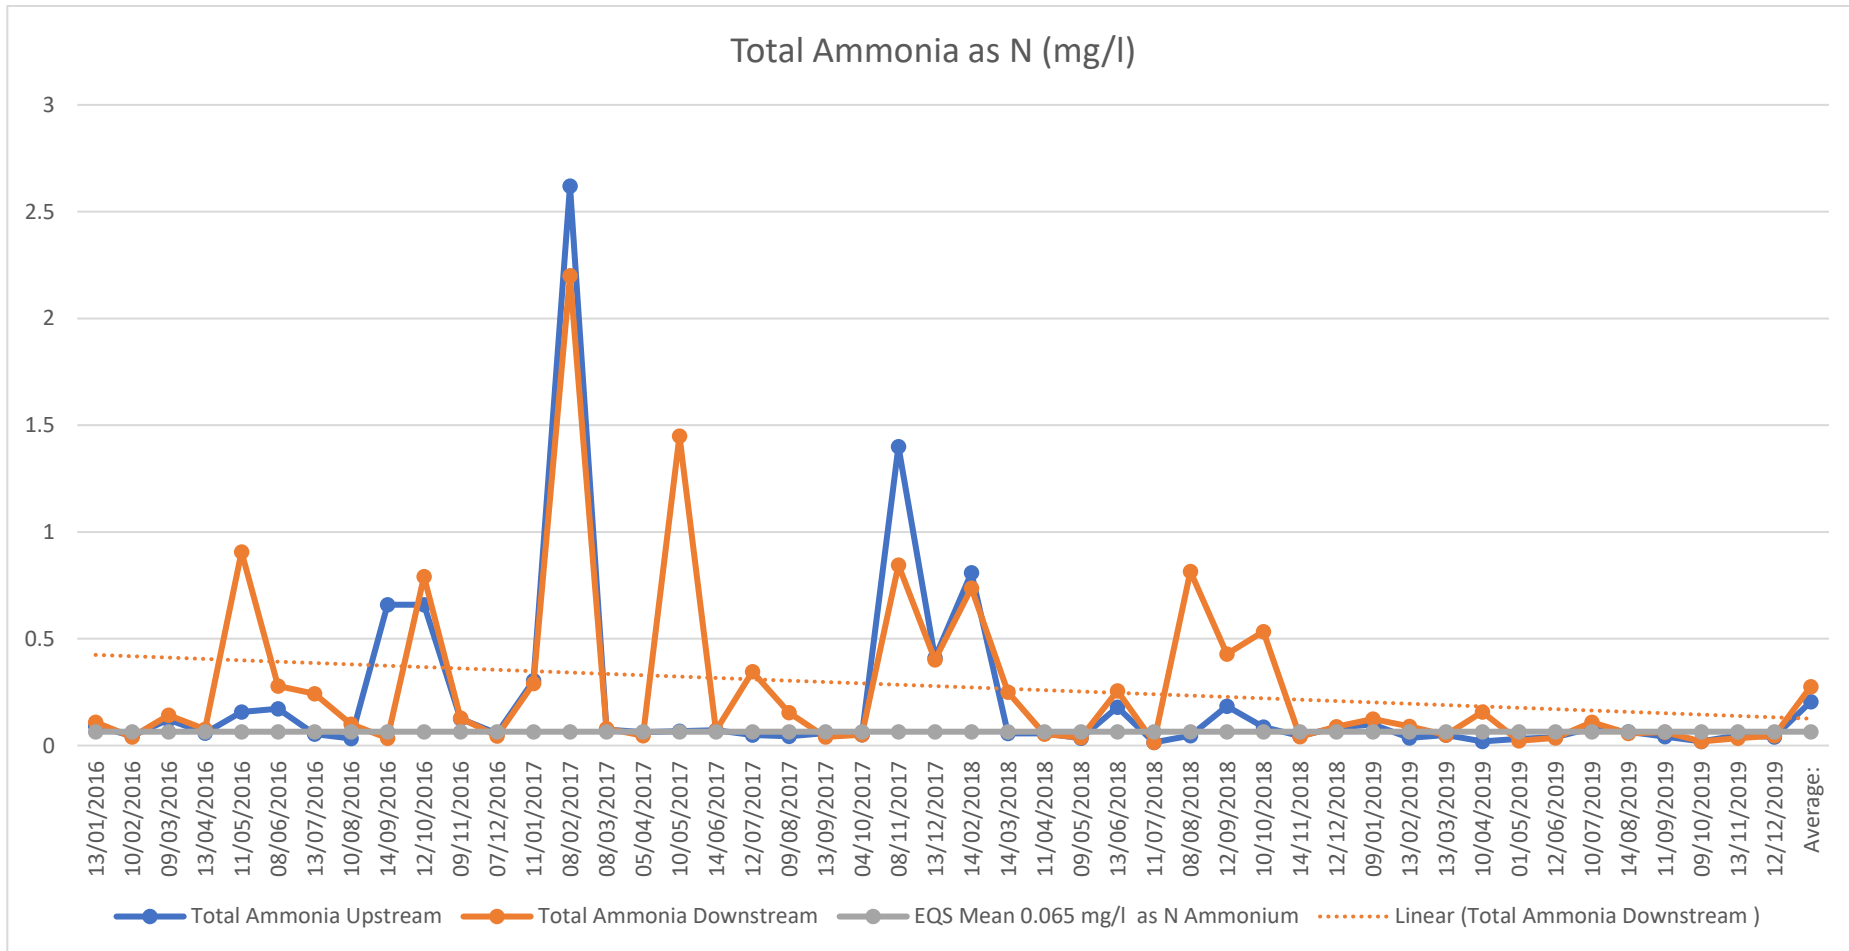
APPENDIX 6 UPSTREAM AND DOWNSTREAM CONCENTRATIONS FOR TOTAL AMMONIA 2016 TO 2019

- In conclusion, comparing the upstream and downstream data (Appendix 6), there are significant pressures upstream of the primary discharge (SW001) which can be classified as urban diffuse pressures. These may include discharges from SW002, which is located upstream of the primary discharge point (SW001), and this requires further assessment.

It is likely that the urban wastewater treatment plant was a significant pressure for total ammonia up to 2020 but when carrying out mass balancing calculations (See Section 3.1.2) using the new maximum Emission Limit Values for the agglomeration in effect since Jan 2020, it is thought that the primary discharge (SW001) is no longer significant and that upstream urban diffuse pressures should be prioritised for mitigation measures. Mass balance calculations are detailed in Appendix 1. These calculations used a flow estimate from the EPA hydrotool at the downstream monitoring station RS26C010900. The average hydraulic loading and final effluent concentrations annual averages from the 2019 AER were used in these calculations (which were much improved on 2018 values). Upstream and downstream data for 2016 to 2019 are displayed in Appendix 6 with downward trend evident.
