# **Lough Mask & Lough Carra (Mayo)**

**Claureen (Mayo)\_010**

**Significant Pressure Referral to  
Mayo County Council – Section 4 licence**

**Emissions from Ringarraun Quarry**

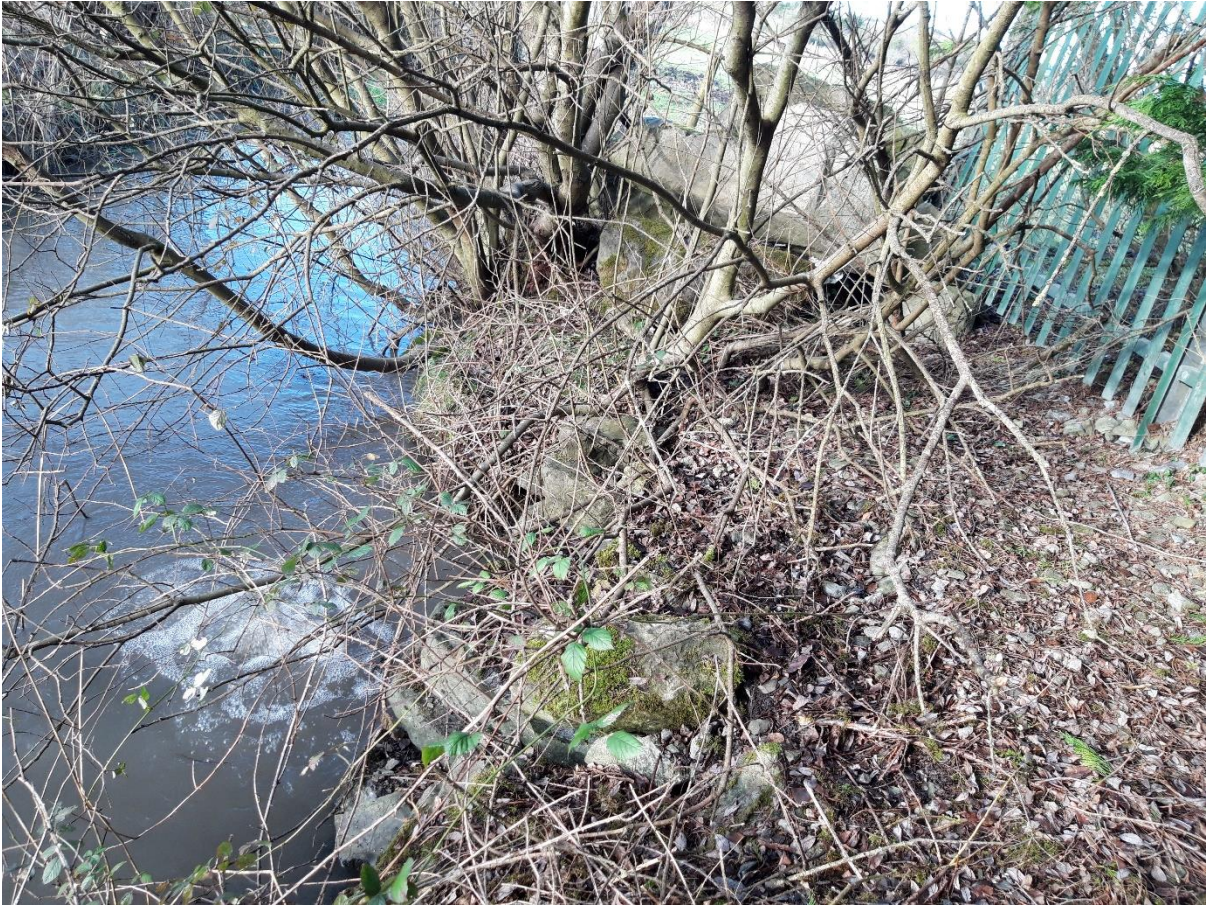
During January sampling a suspended solids level of 45 mg/l was determined from the discharge, which exceeds the ELV of 35mg/l. On any given sampling date, it was not possible to determine the depth of sediment deposition upstream and downstream of the quarry. Surface sedimentation was excessive, and the benthic substrate was too soft to measure with a graduated stick or pole. While the level of suspended solids contravened the discharge licence during January, extensive sediment deposition can be characteristic of a heavily modified waterbody impacted by arterial drainage such as the Claureen\_010. To that end it can be difficult to perceive likely improvements with the associated pressure of channelisation continuing.

*Figure 3: Quarry outfall actively discharging to tributary of Claureen\_010 (January 2023)*

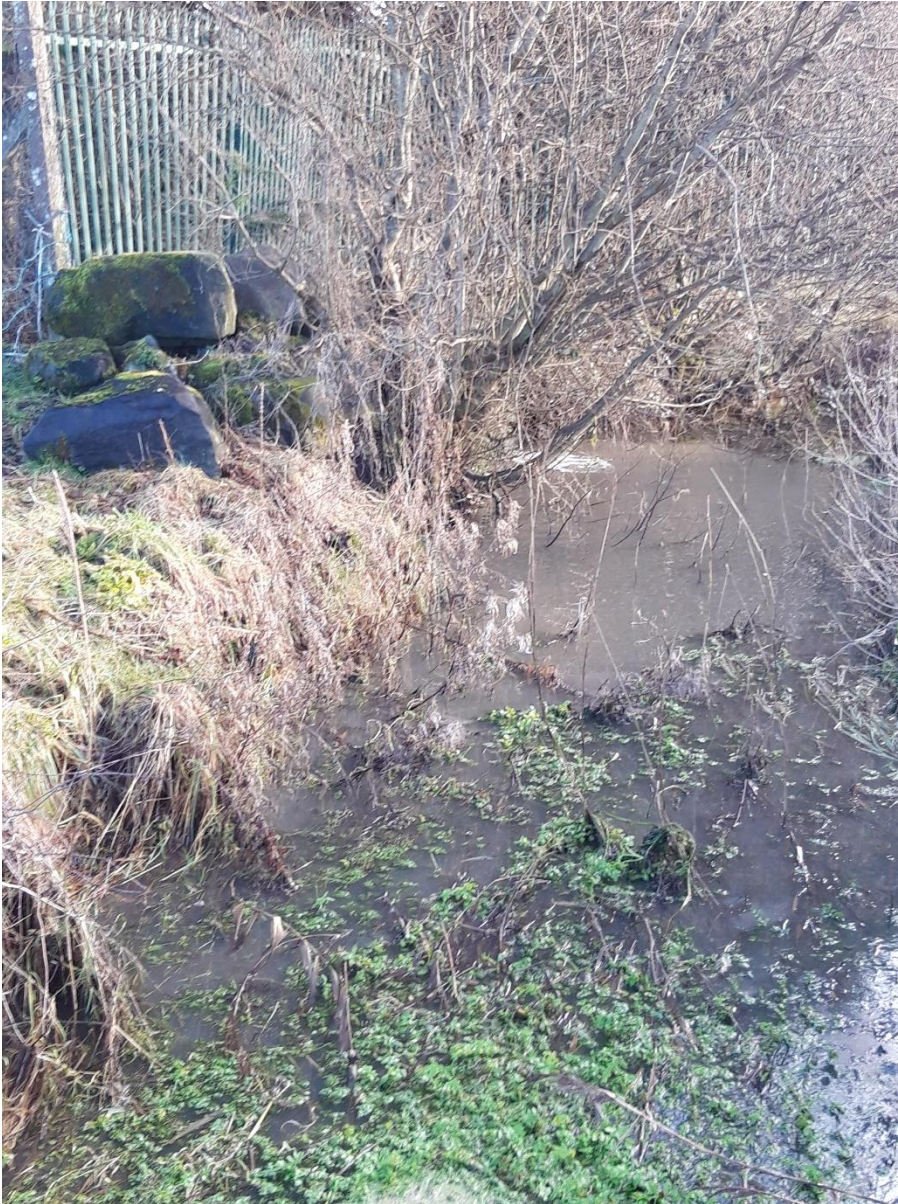
*Figure 4: Murky waters around quarry outfall (January 2019)*

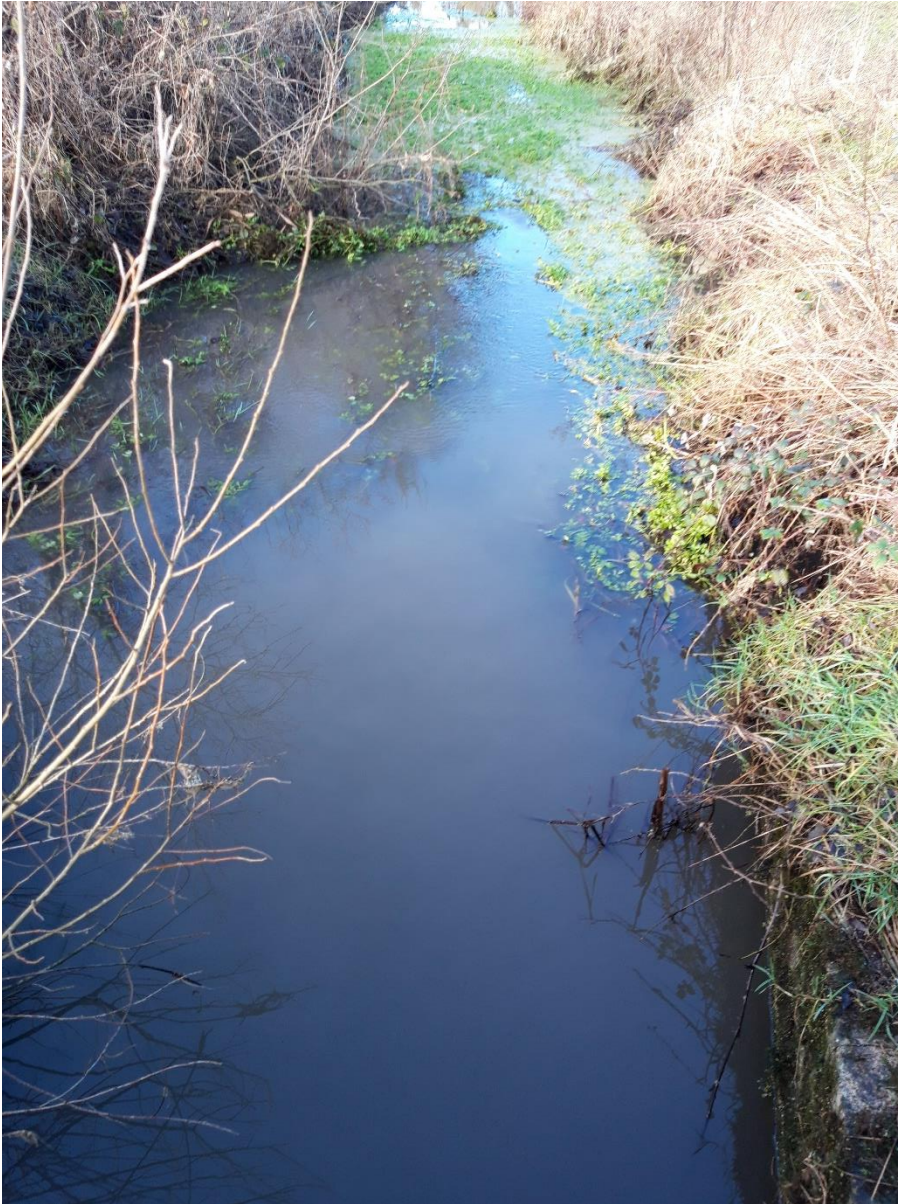
Dissolved oxygen saturation throughout the waterbody was almost uniformly below the concentration that could sustain healthy invertebrate communities (80% saturation). Ammonium breached the Good EQS threshold (0.065 mg/l) at site C110.5 D/S Ringarraun quarry during both sampling dates. January's exceedance (2.19 mg/L) was ten times that of July's exceedance (0.212 mg/l). The concentrations of ammonium on both dates were commensurate of that of the level discharging from the quarry outfall on both dates. While ammonium level upstream of the quarry were elevated (0.048 mg/l) in January, there were no ammonium exceedances upstream.

*Figure 5: Site Cl10.5 Downstream of quarry outfall (July 2023)*
