Carricknabraher

Owennaforesha\_010

Domestic Waste Water  
Discharge/Misconnection Referral

<b>LAWPRO Region</b>	Western Region
<b>Document Title</b>	Owennaforeesha_010 Domestic Waste Water Discharge Referral
<b>Document No.</b>	Owennaforeesha_010_Misconnection_RFL_F01

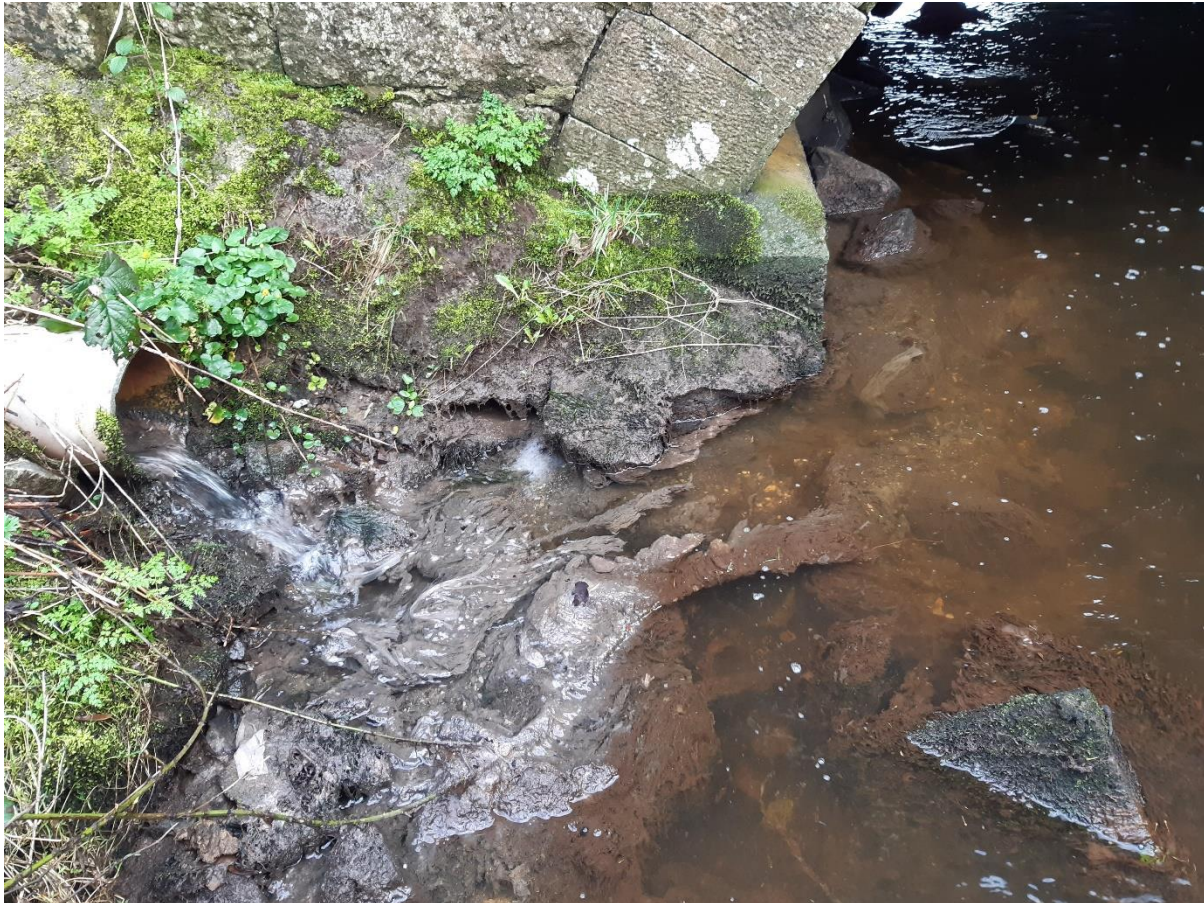
*Figure 3: Raggings and sewage fungus below discharge from pipe at LCA site 3.1.2 on 15/2/2023*

On 15/2/2023, it had been planned to kick-sample at LCA site 3.1 for SSIS, but the presence of raggings (i.e. toilet paper) and sewage fungus in the channel, accompanied by a foul smell when the substrate of the river was disturbed meant kick-sampling was not carried out due to health and safety concerns (see photo D, Appendix B). The density of the raggings and sewage fungus instream increased further upstream and continued under the N5 road bridge. Walking upstream and under the bridge, the presence of raggings and sewage fungus instream began below the pipe on the left bank (i.e. the misconnection discharge), immediately upstream of the bridge (see **Figure 3** and photo E, Appendix B). Raggings and sewage fungus were not present upstream of this point. It was also noted that coverage of filamentous diatoms was high downstream of the discharge and at LCA site 3.1 but were almost absent upstream of the discharge. While at the site for around 30 minutes, slightly cloudy water was observed discharging from the pipe at a constant rate of approximately 1 litre per second. Physico-chemical results from samples taken on the day show that the discharge from the pipe had a BOD of 3.1 mg/l, ortho-phosphate of 0.12 mg/l and ammonia of 0.459 mg/l (see **Table 1**). The concentrations of total coliforms and *E. coli* (689300 and 131700 MPN/100 mls, respectively) were significantly greater than those previously recorded from this discharge in January 2022, and provides further evidence that domestic wastewater is being discharged to the Owennaforeesha River in Bellanagare via this pipe. Suspended solids of 3 mg/l was low, but it is clear that greater levels of solid material are discharged via this pipe at times, as evidenced by the raggings instream.

On the day, the BOD concentration at LCA site 3.1 was greater than the concentrations coming from both the misconnection discharge and further upstream at LCA site 3.2.3, and is likely due to the high levels of raggings, sewage fungus and filamentous diatoms present at the site and immediately upstream which can be largely attributed to the misconnection discharge of untreated waste water.

It is unclear what activates the discharge from this pipe or what domestic dwellings in Bellanagare it comes from, but a solution is required to address the impact it is having on the Owennaforeesha River and the failing ecological status of the Owennaforeesha\_010 RWB.

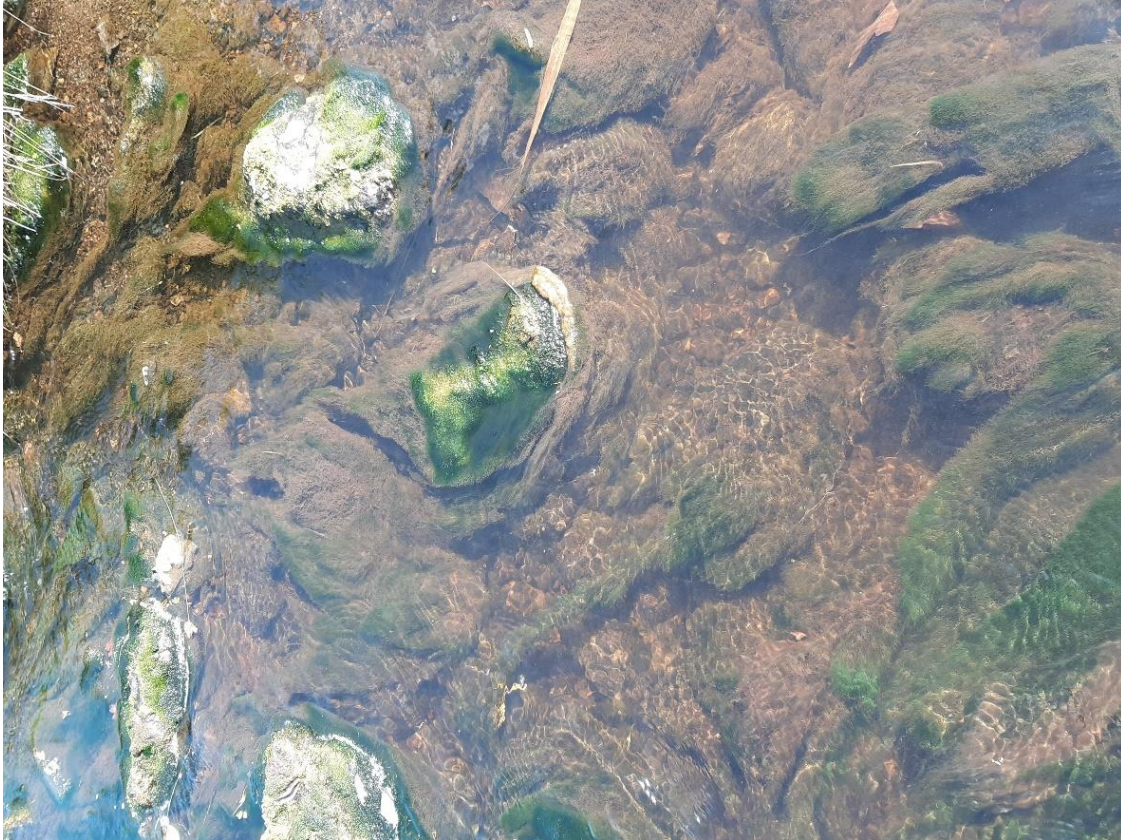
Photo A: High to excessive coverage of the macroalgae *Vaucheria* at the EPA operational monitoring station for the Owennaforesha\_010 (LCA site 3.1) on 7/9/2021.

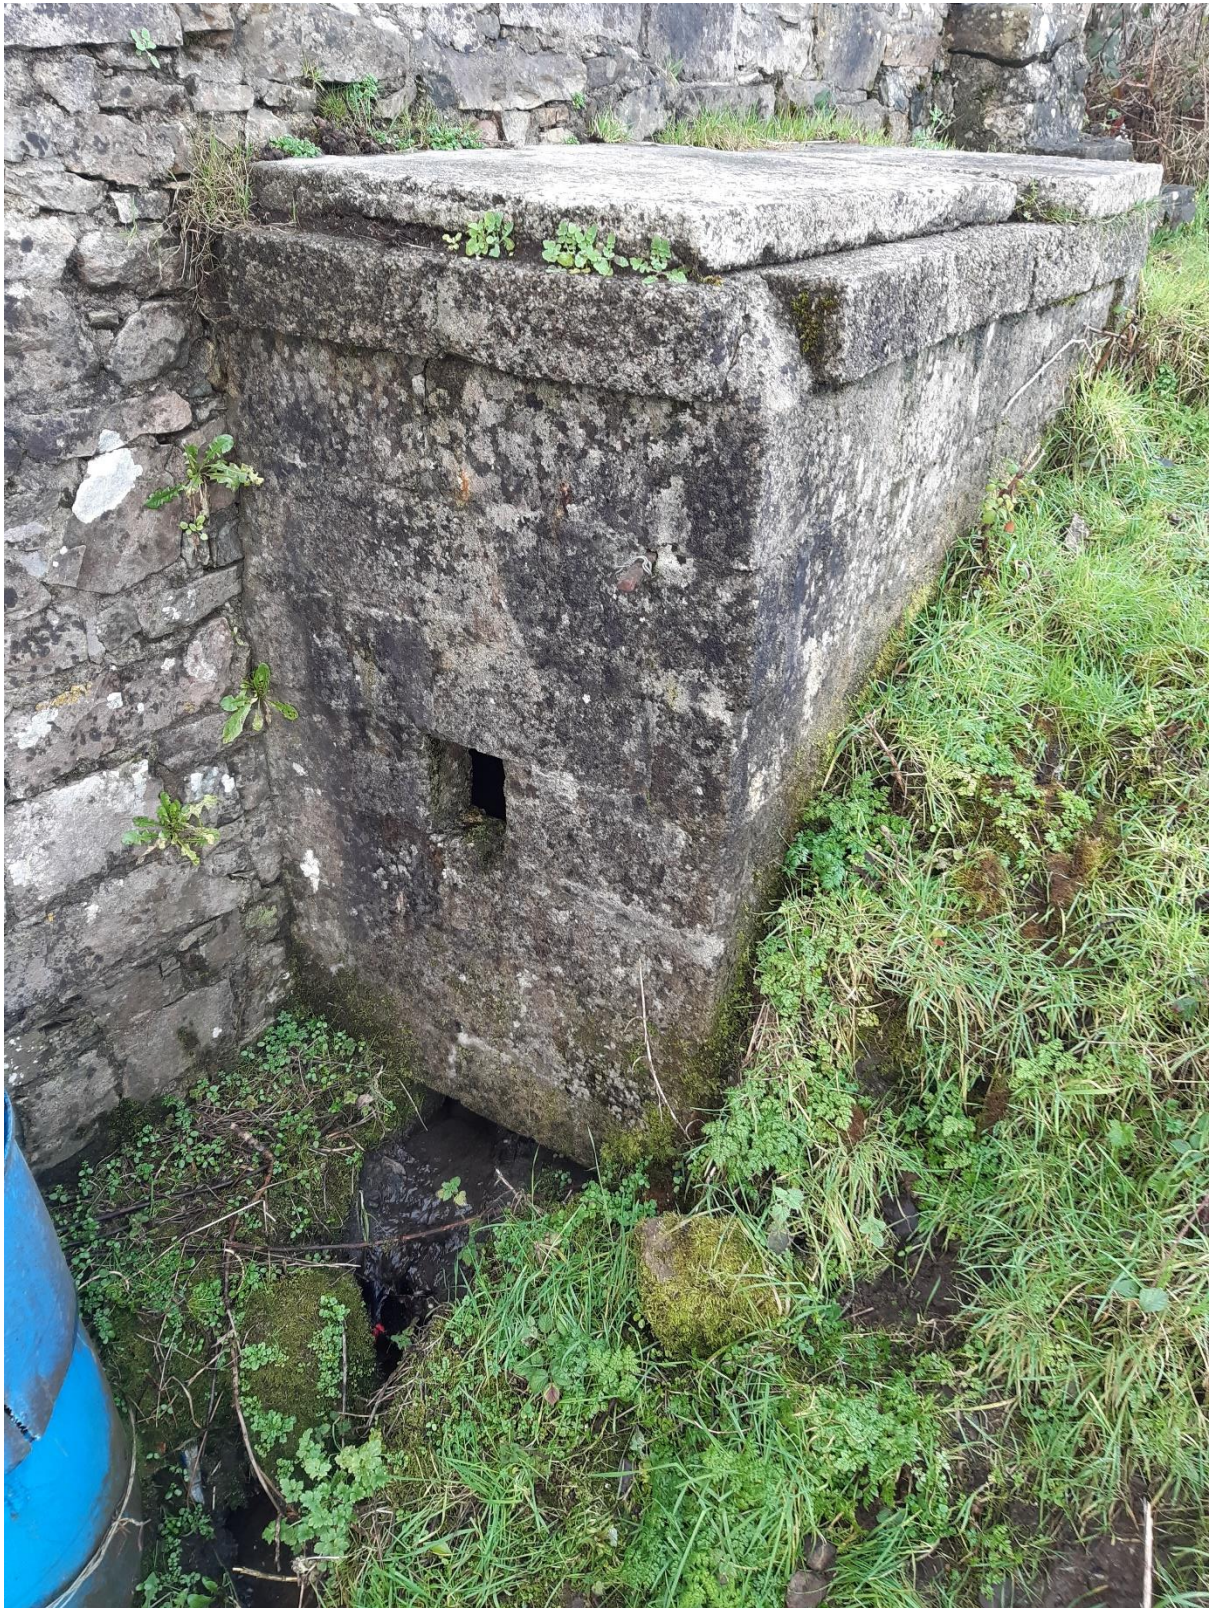
Photo B: Old stone/concrete tank at the base of the N5 road bridge from which water discharges to the Owennaforeesha River (LCA site 3.1.1).

On the downstream side of the N5 road bridge, on the left bank of the Owennaforesha River there is an old stone/concrete rectangular tank that is attached to the base of the bridge and from which a trickle of water was observed discharging from the bottom of the tank and entering the river (see Photo B, Appendix B). This discharge would later be sampled for physico-chemical analysis in March 2022 when the volume of discharge was greater following recent rainfall (LCA site 3.1.1), with results indicating it is unlikely to be a significant source of BOD or nutrients (see **Table 1**). It is suspected that run-off from the N5 road above enters this tank via a surface water drain. LCA to date has found no evidence that domestic waste water or any other significant pollutants enter the Owennaforesha River via this discharge.

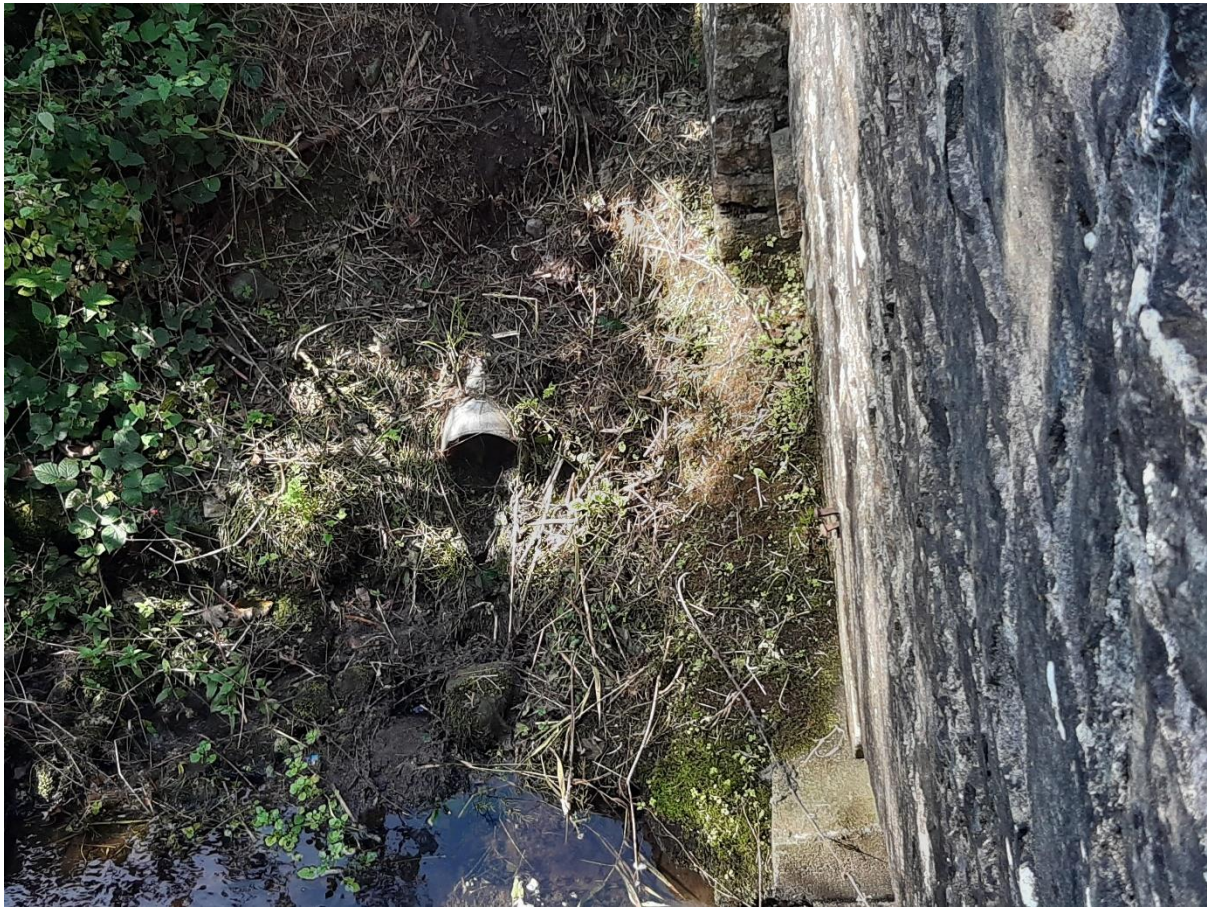
Photo C: Six-inch pipe protruding from the left bank, immediately upstream of the N5 road bridge as viewed from the bridge in September 2021 (LCA site 3.1.2, referred to as the misconnection discharge above).

Immediately upstream of the N5 road bridge, a six-inch pipe protrudes from the left bank (see Photo C, Appendix B). On two occasions in September 2021 (7<sup>th</sup> and 23<sup>rd</sup>), only a small trickle of water was observed dripping from this pipe directly onto the bank below, preventing a sample for physico-chemical analysis from being taken. In January 2022, when the volume of discharge from this pipe was greater, a sample was collected directly from the pipe for analysis (LCA site 3.1.2, hereafter referred to as the misconnection discharge). It should be noted that this pipe and the section of river

immediately upstream of the bridge can only be accessed by walking under the bridge when the depth and flow rate of the river is generally low and allows for safe access. BOD and nutrient concentrations were elevated compared to the main channel of the Owennaforeesha River at LCA site 3.1, but not excessively so, and would have been easily diluted by the river. This is supported by comparison of the similar physico-chemical results recorded on the day at LCA site 3.1 which is downstream of Bellanagare and LCA site 3.2.3 which is upstream of Bellanagare and presumably not impacted by urban pressures associated with the village (see **Table 1**). High concentrations of *E. coli* in the sample taken from the pipe, however, indicate the discharge was contaminated with bacteria that are found in the intestines and faeces of humans and other warm-blooded animals. In water, high levels of faecal coliform bacteria such as *E. coli* indicate the presence of pathogens that cause waterborne diseases and that may pose risks to humans and animals that come into contact with that water, particularly if it is used for drinking. The high concentration of total coliforms on the day also indicates there may be other harmful pathogens entering the Owennaforeesha River via this discharge, which likely originates from a nearby domestic source as a result of a waste water misconnection.

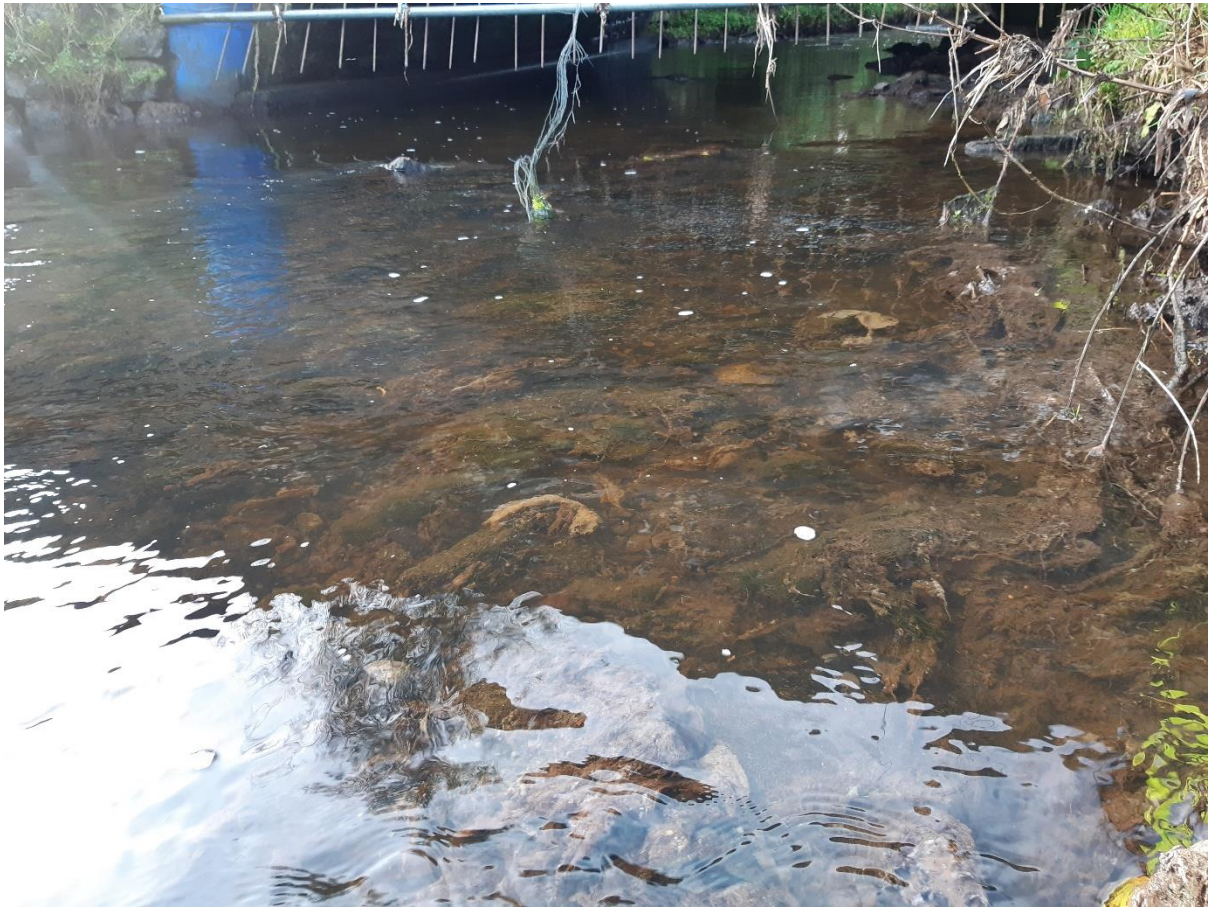
Photo D: Raggings and sewage fungus instream at the EPA operational monitoring station for the Owennaforesha\_010 (LCA site 3.1) on 15/2/2023.

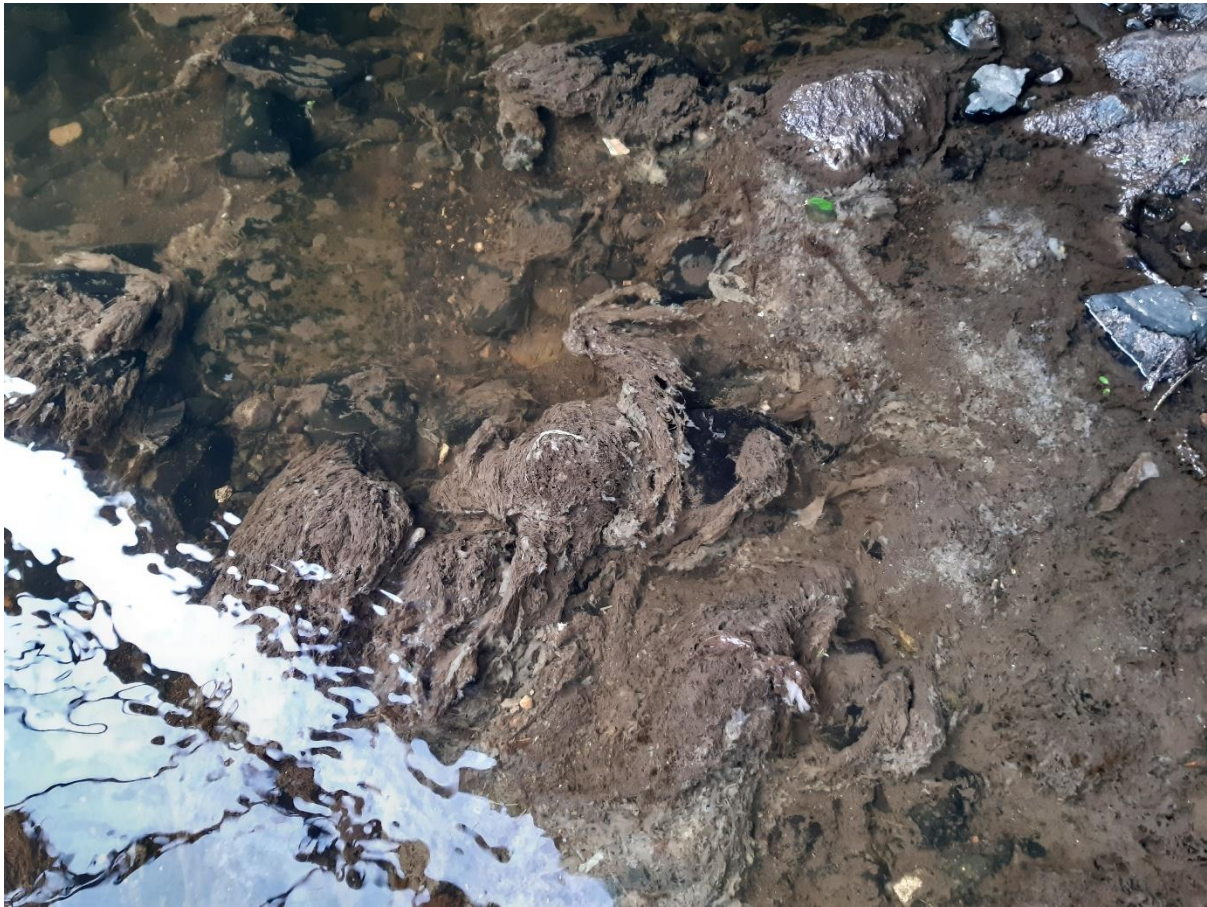
Photo E: Sewage fungus instream under the N5 road bridge, immediately downstream of the misconnection discharge and pipe at LCA site 3.1.2 on 15/2/2023.

The high levels of sewage fungus observed downstream of the misconnection discharge in February 2023 indicates that the discharge had been a persistent issue for some time prior to this. The relatively dry weather experienced for the time of year in the days leading up to this assessment also meant that the waste water network for the Bellanagare WWTP agglomeration should not have been overloaded. Therefore, waste water would not have been getting discharged via old storm water overflows that may exist on the network. Therefore, it seems likely that there are domestic misconnections to this pipe that discharges directly to the Owennaforeesha River instead of the agglomeration network. During previous LCA carried out in 2021 and 2022, however, raggings and sewage fungus had not been observed underneath or downstream of this pipe, and at times there was no discharge to the river at all via this pipe. While the impacts observed in February 2023 were because of a recently persistent deleterious discharge, it does seem to be somewhat episodic, and not always as impactful on the receiving surface waterbody. Similarly, this pipe was opportunistically observed discharging on the 6/7/2023 during wet weather with some raggings and sewage fungus visible instream, but on 4/9/2023 during dry weather conditions, no raggings or sewage fungus were visible instream.
