Drumcomoge Priority Area for Action

Referral to Tipperary County Council – Pipe Discharging
to Surface Waters in Emly

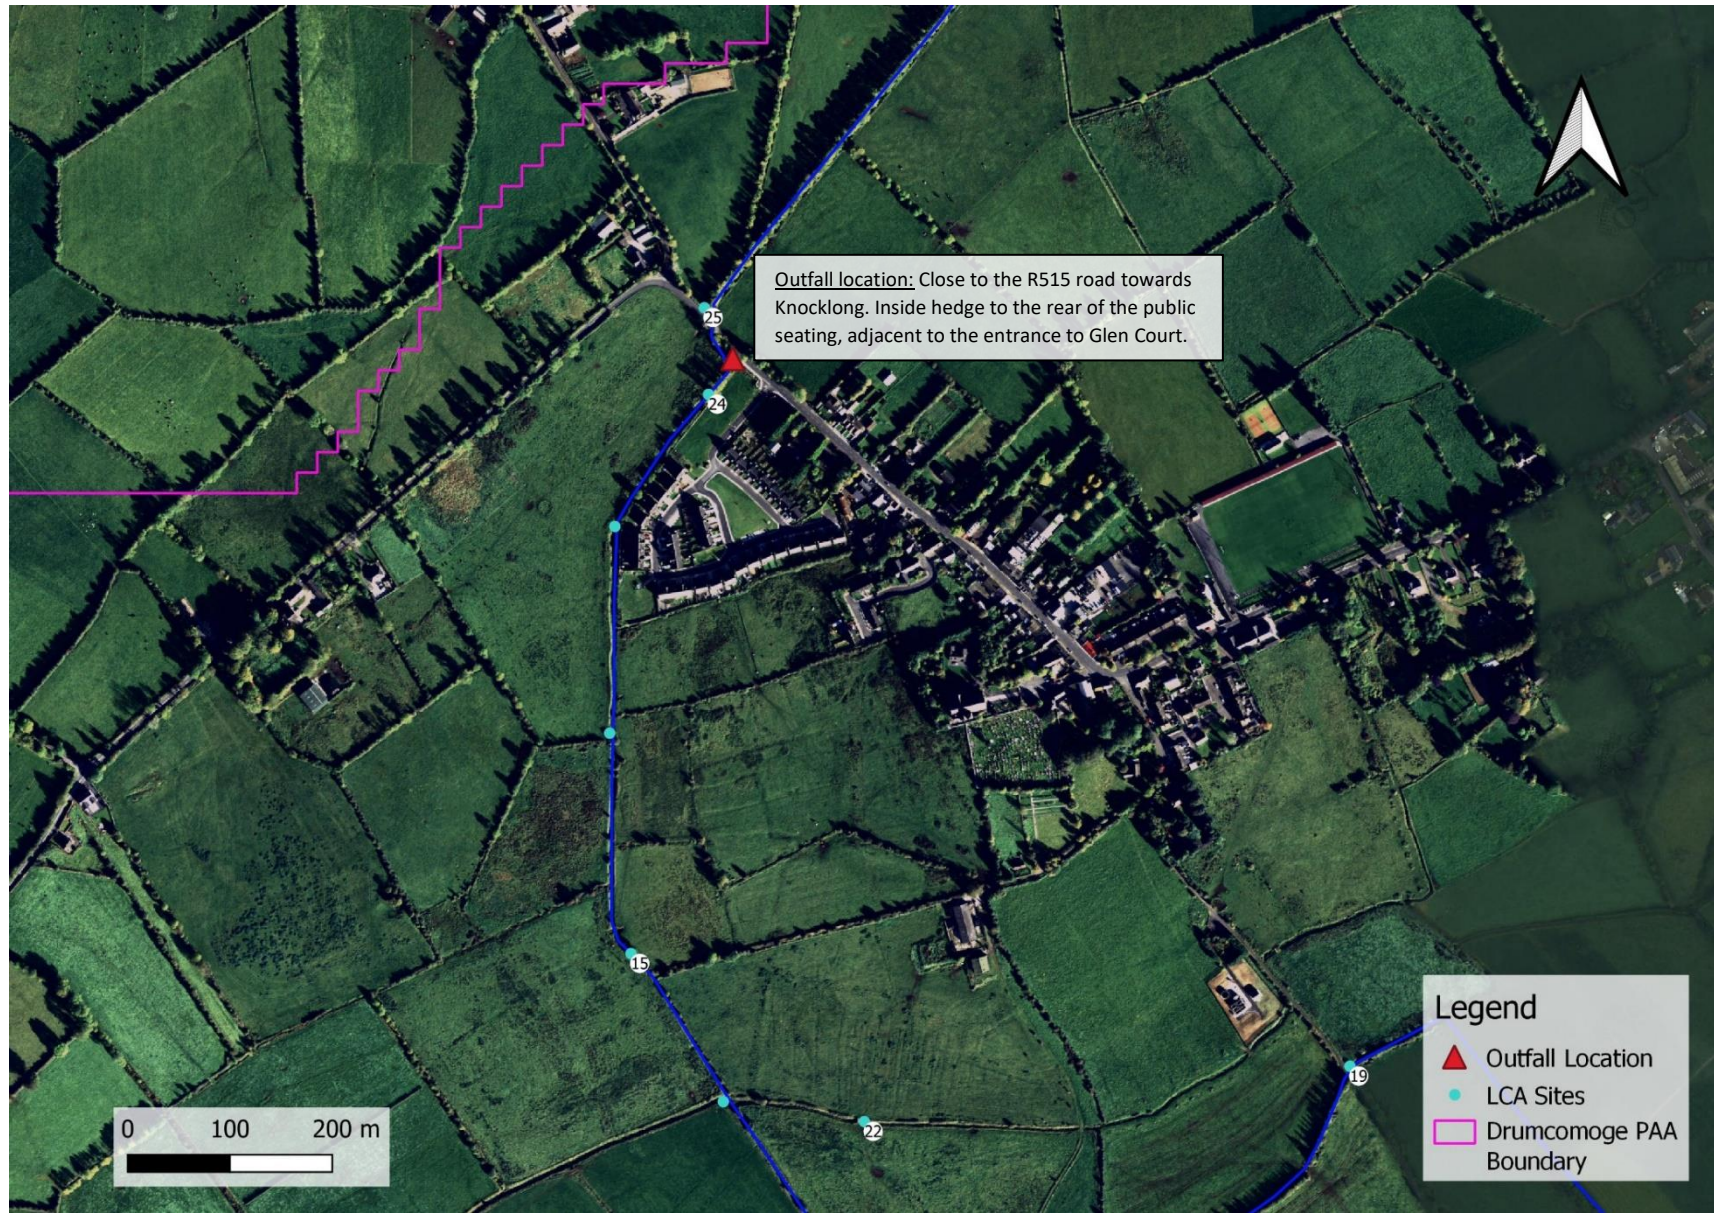
Figure 2: Map shows the outfall location and the local catchment assessment sites in the vicinity of Emly.

The location of the field sites visited are shown on the map in Figure 1 for the broader Drumcomoge PAA and the red box indicates the vicinity of the referral area. Figure 2 shows the outfall location (red triangle on map) where the assessment was focussed on in the vicinity of Emly. Field parameters (temperature, pH, dissolved oxygen, electrical conductivity and total dissolved solids) and nutrient analysis results are presented in Table 1.

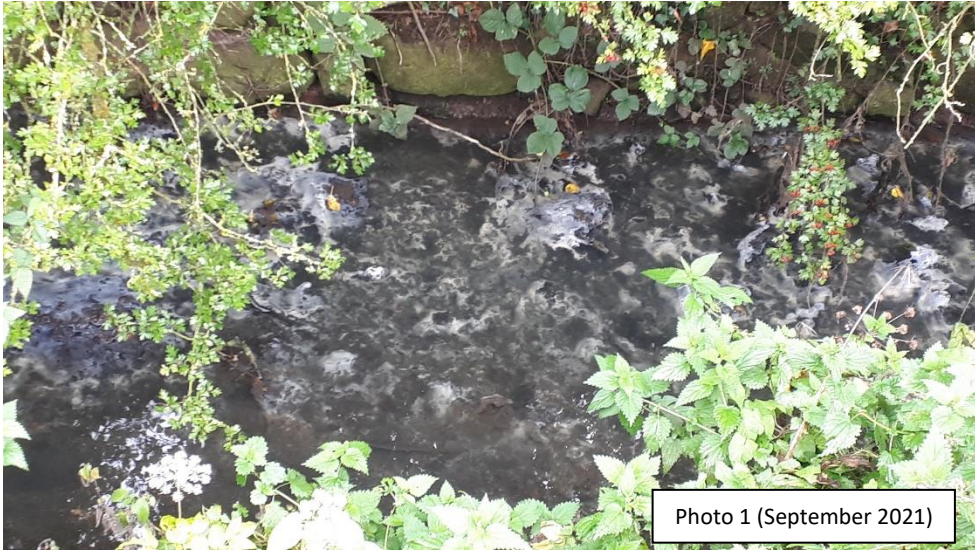
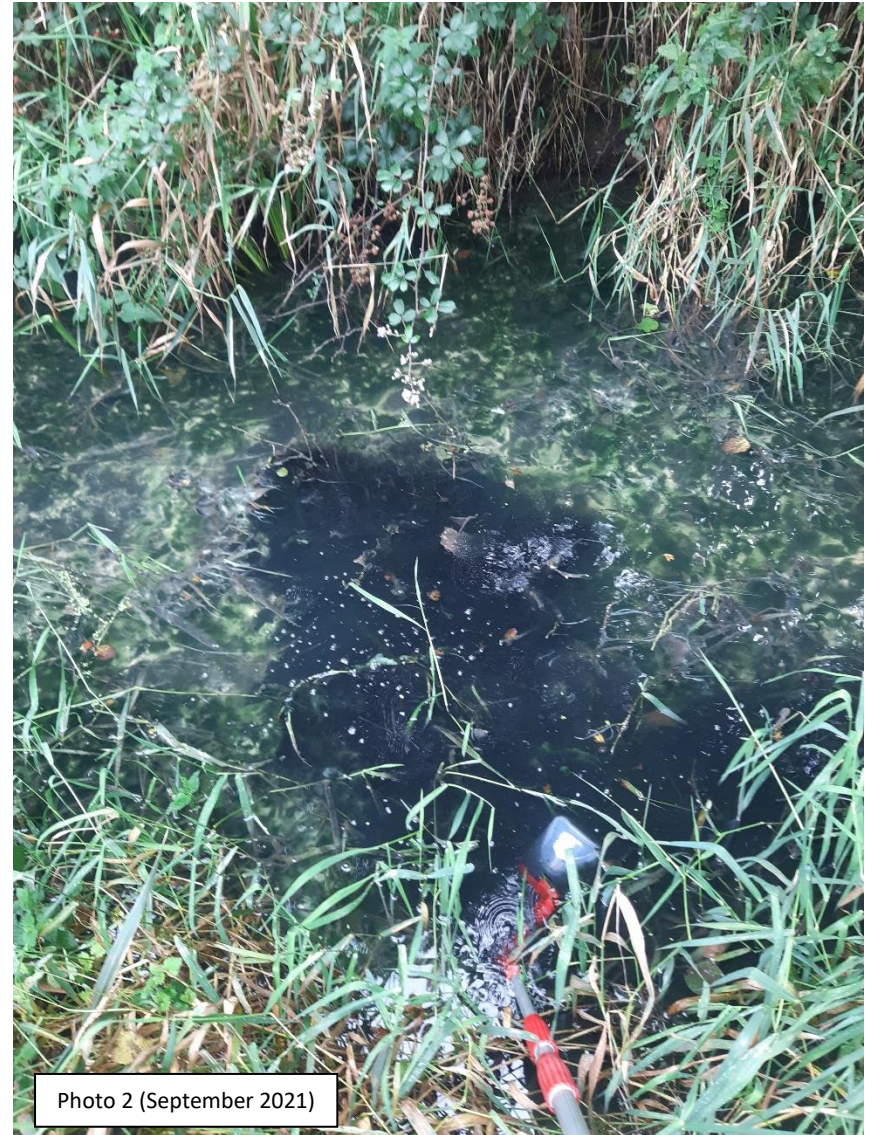
Three further field visits were undertaken between September 20th, 2021 and January 26th, 2022 as outlined in Table 1. A pipe was observed discharging to the stream upstream of Site 24 on the first visit. The same pipe was submerged during the November visit due to high flow conditions in the stream so no discharge could be confirmed. In the January visit the pipe was not discharging and the water level in the stream was low. Anoxic conditions and sewage fungus were present and continuous on the stream substrate from the discharge point to 400m downstream on all three visits (Photos 1 – 4). The receiving stream is first order and approximately 2m wide.
