CLIENT: Kilsaran Concrete	PROJECT: Sampling Programme	DRAWN: P.G.	CHECKED: T.H.	APPROVED: T.H.	DATE: 03/06/2016
DRAWING TITLE: Stepside Golf Centre (Sanrose Ltd.)	Project Ref: TH/16/9020SR01	Figure 1		1	A3
		REVISION DESCRIPTION		SHEET	REV
				1:1,500

CLIENT: Kilsaran Concrete	PROJECT: Validation Sampling Programme	DRAWN: G.W.	CHECKED: T.H.	APPROVED: T.H.	DATE: 23/06/2016
DRAWING TITLE: Stepside Golf Centre (Sanrose Ltd.)	Project Ref: TH/16/9020SR01	Figure 1A		1	A3
		REVISION DESCRIPTION		SHEET	REV
					1:1,500

RE: Stepaside Golf Centre, Co. Dublin

1.2 Site Specific Removal and Recovery Works

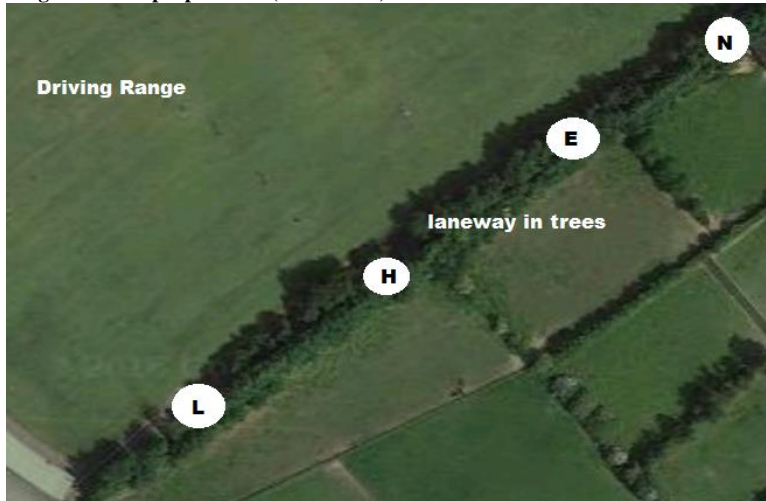
Diagram of sample positions (not to scale)

Anal- yst	Location	Sample Ref:	Samp. Head	Pump	Time on	Time off	Duration	Start/ Stop Flow (l/min)	Average Flow (l/min)	Volume (litres)	Fibres	Fields	Result f/ml
JK	Lane by driving range	Jkf 160616 01	L	14	09.50	10.40	50	10 l/m 10 l/m	10 l/m	500	0	200	<0.01
JK	Lane by driving range	Jkf 160616 02	H	11	09.50	10.40	50	10 l/m 10 l/m	10 l/m	500	1	200	<0.01
JK	Lane by driving range	Jkf 160616 03	E	13	09.50	10.40	50	10 l/m 10 l/m	10 l/m	500	0	200	<0.01
JK	Lane by driving range	Jkf 160616 04	N	12	09.50	10.40	50	10 l/m 10 l/m	10 l/m	500	0	200	<0.01

Comments: Air test satisfactory. The measured respirable airborne fibre concentration was less than the clearance indicator of 0.01 f/ml of air. Following a visual sweep of the area with the contractor, all asbestos containing materials have been removed as far as was reasonably practicable, with no visible contamination evident.

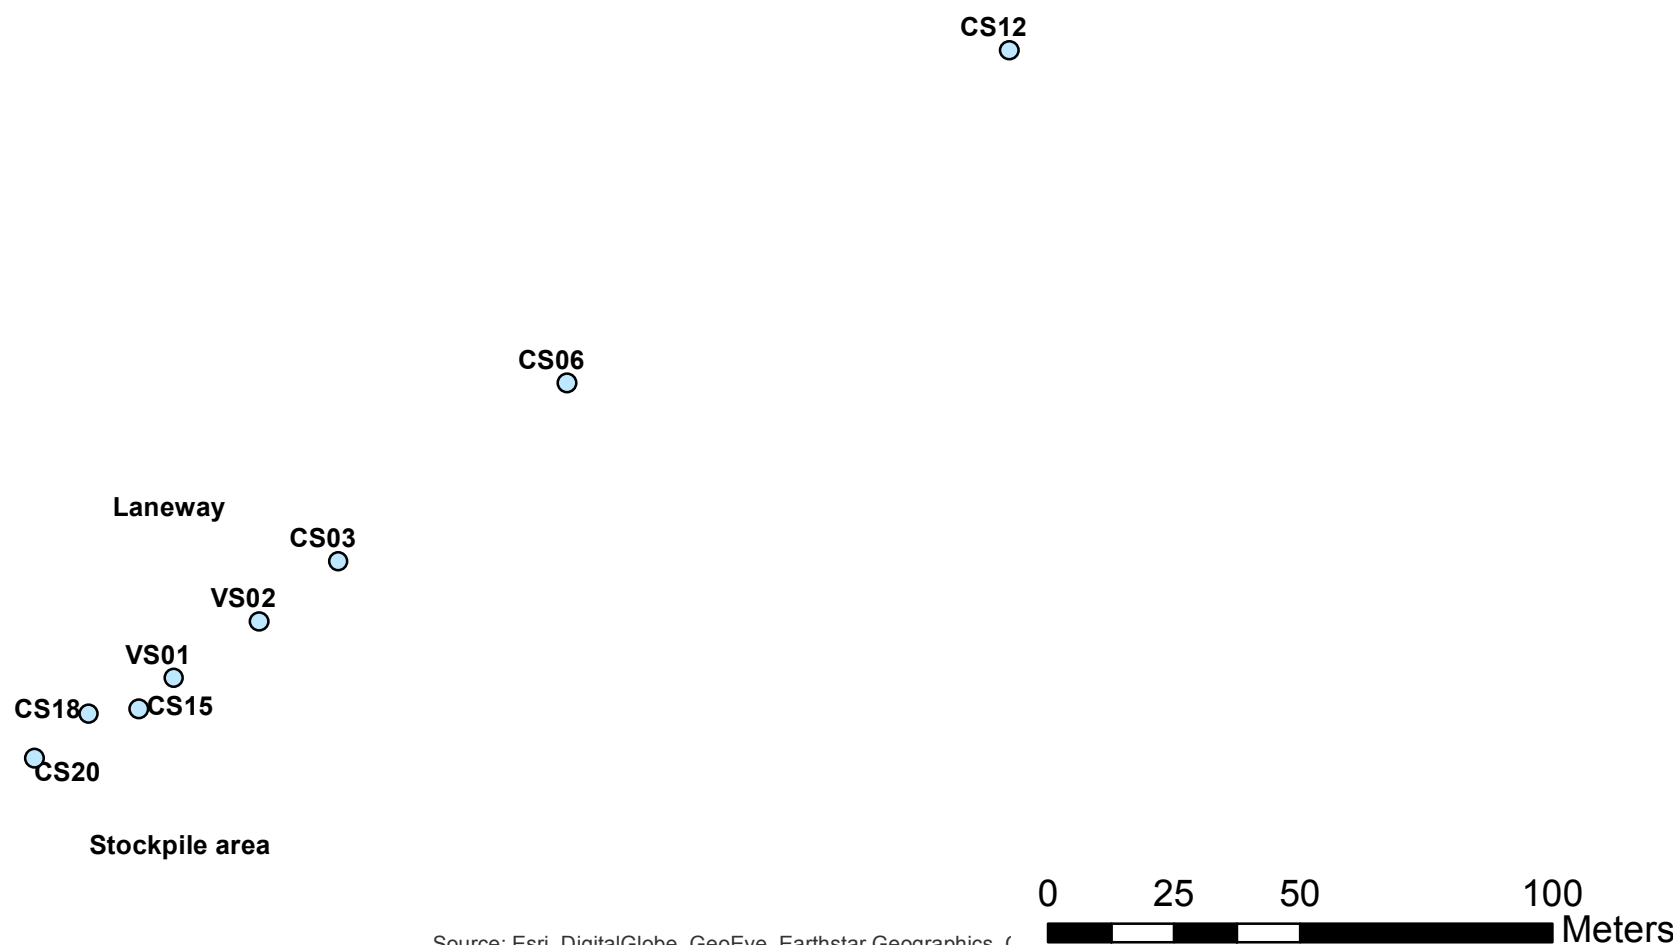
○ Validation soil sampling (13/06/2016)

○ Validation soil sampling (15/06/2016)

VS01, VS02, CS03, CS06, CS12
Laneway

CS15, CS18
Adjacent to stockpile

CS20
Main stockpile

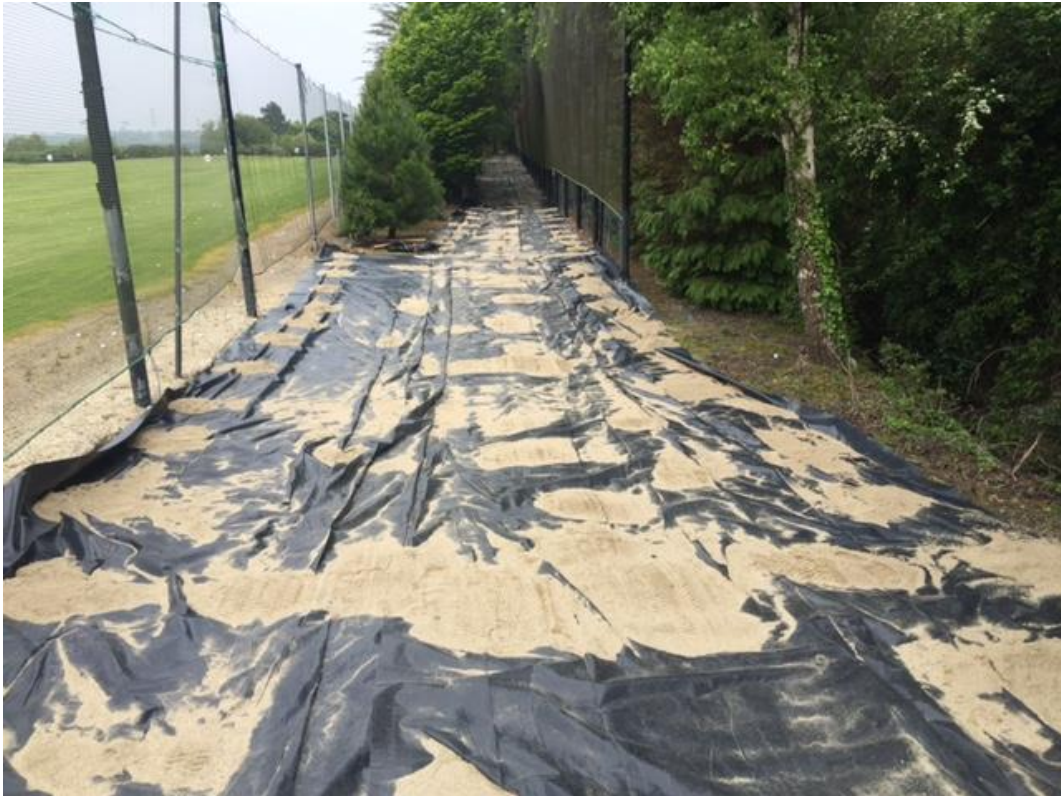
As an initial precautionary step, Kilsaran instituted a programme of covering the material on customer sites to avoid any possible wind-blown dust being generated. This initial covering took place at this site on 27th May 2016. The photo below shows a portion of the covering in place.

Works at Stepside Golf Centre were undertaken by approved asbestos removal contractors Insulation and Environmental Services Ltd (IES) from 10 to 15 June 2016 following a methodology approved by the HSA. This involved removing the contaminated aggregate from the surface of the laneway and the stockpile to a depth of approximately 50-100mm including some of the clean underlying soil material below.
