Re: Pollution incident for Knockacummer Wind Farm Ltd., TFL00376919

I am a Forest Service inspector, with the Forest Service, with my headquarters at Hibernian house, South Mall, Cork city, county Cork. I inspected the site in Glennakeel South townland, Clonfert East, Kanturk, Co. Cork on the 31-03-2020 (see map 1 and 2).

There is a clearfell harvesting operation in progress. The felling licence number is TFL00376919. The plot being clearfelled and which are relevant to this pollution incident is plot 1.

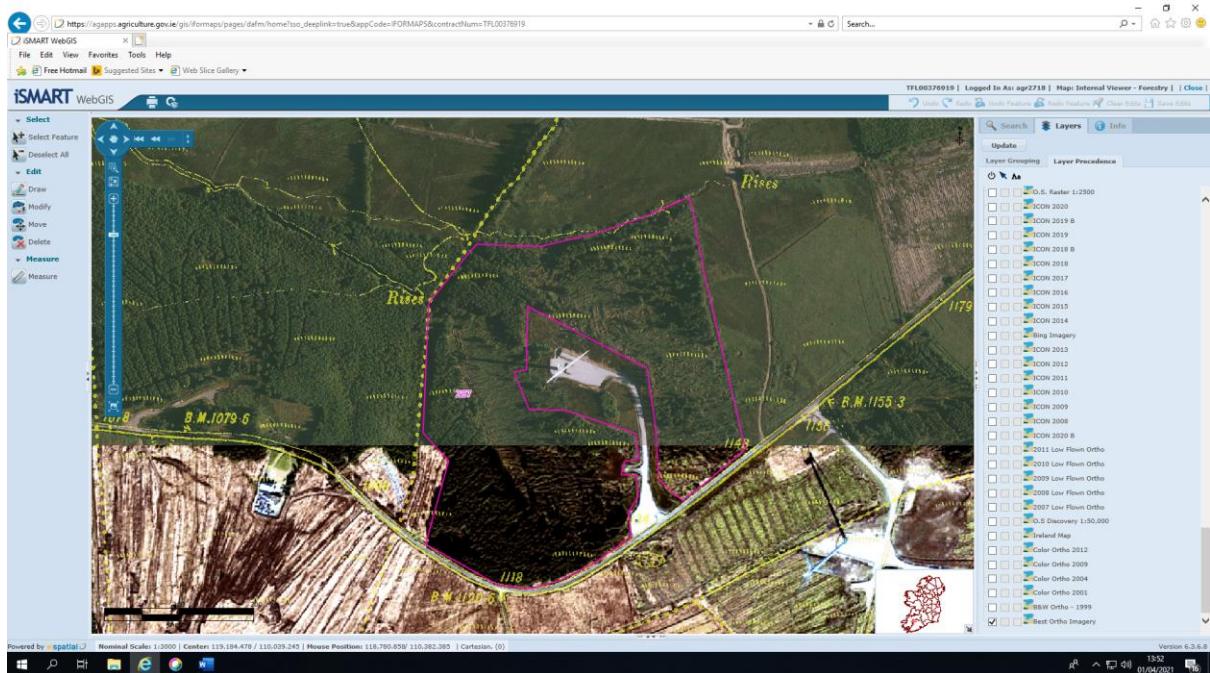
Map 2. Site map. 6 inch OS layer overlayed on the aerial photo. The hydrological network of 1<sup>st</sup> order streams are clearly shown with the > symbol and yellow line. The stream actually continues into the north-western area of plot 1, where its source is located.
