Cork County Council

Midleton Flood Relief Scheme

Storm Babet Flood Event Report

Draft 2 | 22 December 2023

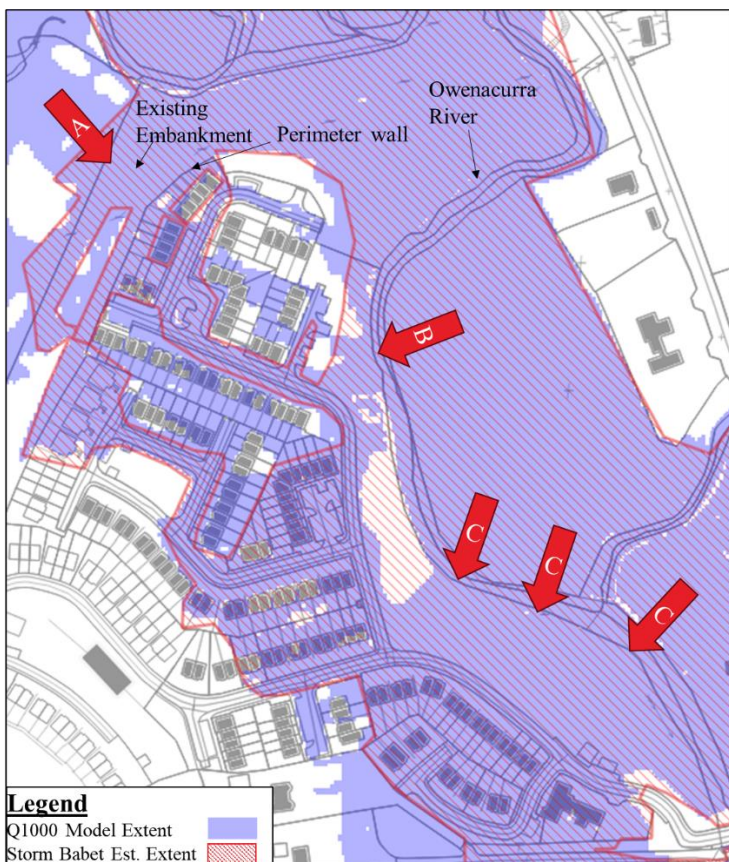
Figure 7: Existing Flood Mechanisms in Tir Cluain

The perimeter brick wall surrounding sections of the estate was removed from the Q100/Q200 and Q1000 hydraulic model. It is noted that this wall did not collapse during Storm Babet. This mechanism of flooding/ flow path is shown in Figure 7 using the “A” arrow.

- B. Further downstream there is an additional mechanism of flooding whereby the Owenacurra gets out of channel on the right bank. The threshold at which this mechanism leads to flooding of the estate in the hydraulic model is the circa Q1000 event. This potential mechanism is shown in Figure 7 using the “B” arrow.

- C. The southern area of Tir Cluain is at risk of flooding from overland flow resulting from the two mechanisms which are noted above. There is however an additional risk to this area from the Owenacurra overtopping the right bank which is shown in Figure 7 using the “C” arrow. The threshold of flooding of this mechanism in the hydraulic model is the circa Q100 event

Figure 7 presents the estimated maximum extent of Storm Babet within Tir Cluain along with the modelled existing scenario Q1000 maximum flood extent as per the Hydraulics report. As noted in the opening chapter of this report, the maximum extent from the event has been estimated by undertaking an in-depth review and assessment of a number of different data: observations during the post-event site visit, anecdotal information provided by the residents who were impacted by the flood, wrack mark surveys, aerial imagery, existing ground elevations from the Lidar data.

Each of the key mechanisms of flooding identified in the hydraulics report (and referred to above) occurred during the Storm Babet flood event. Data/ information gathered during/ after the flood event in relation to the Tir Cluain area is summarised in the next section.

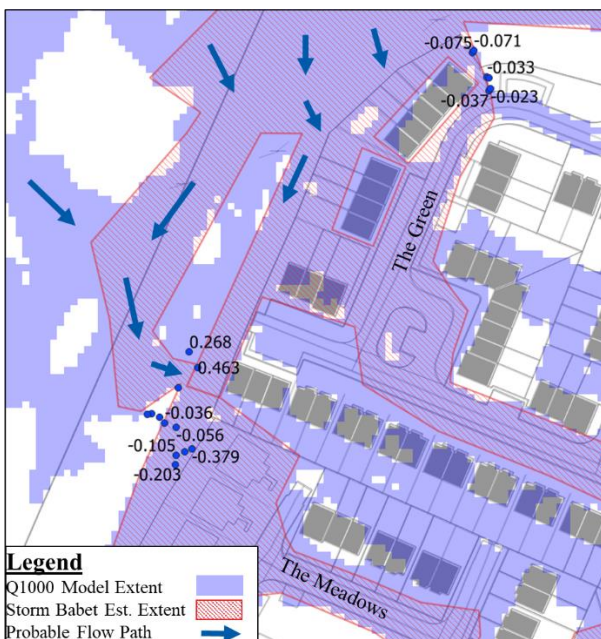
Figure 8: Tir Cluain North-West: Wrack Marks vs Q1000 Modelled Levels (m) and Flow Path

An estimation of the likely flow path for this area is presented in Figure 8. It can be seen from the figure that the Q1000 maximum extent is greater than the estimated extent from the event and includes a greater number of houses. The numbers in the figure represent the difference between the surveyed wrack mark levels and the Q1000 maximum water levels with positive value denoting that the wrack mark is at a higher elevation than the maximum modelled Q1000 elevation and negative values indicating that the wrack mark is lower than the model.

- In “The Green” the surveyed wrack marks are between 0.023m to 0.075m lower than the modelled Q1000 modelled water levels;
- In “The Meadows” the delta is between 0.379m lower and 0.463m higher

Given that the maximum water level gradient across the estate during the event would be consistent to the modelled water level profile, the validity of the recorded wrack marks in this area is therefore questionable and they may not be representative of the peak levels recorded during the event.

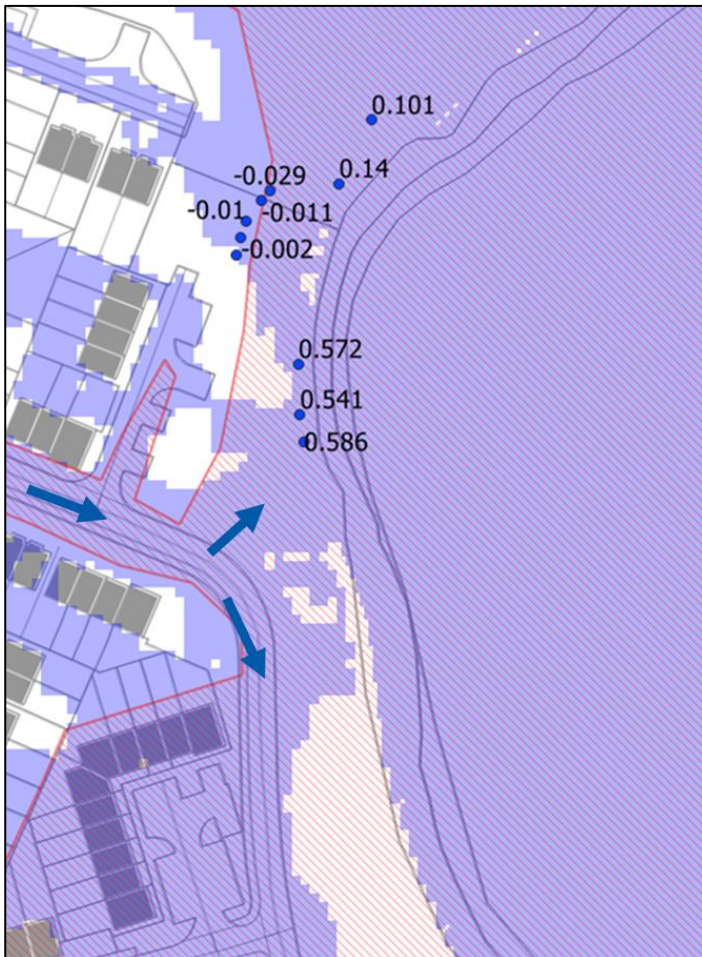
Figure 9: Tir Cluain North-East: Wrack Marks vs Q1000 Modelled Levels (m) and Flow Path

Figure 9 presents the estimated flood extents, modelled Q1000 extent and differences between the wrack marks and model for the area to the East of “The Green”. There is consistency between the modelled and wrack mark levels for the six Northern survey points. The points further down the reach are however inconsistent which may be due to uncertainty in the wrack mark data and/or uncertainty in the roughness parameters of the channel/floodplain in the model.

The primary mechanism of flooding in the model is indicated by the blue arrows in Figure 9 and represents overland flow moving across the estate from West to East. Should the three more southern wrack marks on the figure be representative of actual flood levels during Storm Babet then it is possible that the Estate is also at risk of flooding from overland flow from the Owenacurra moving from East to West at this location.

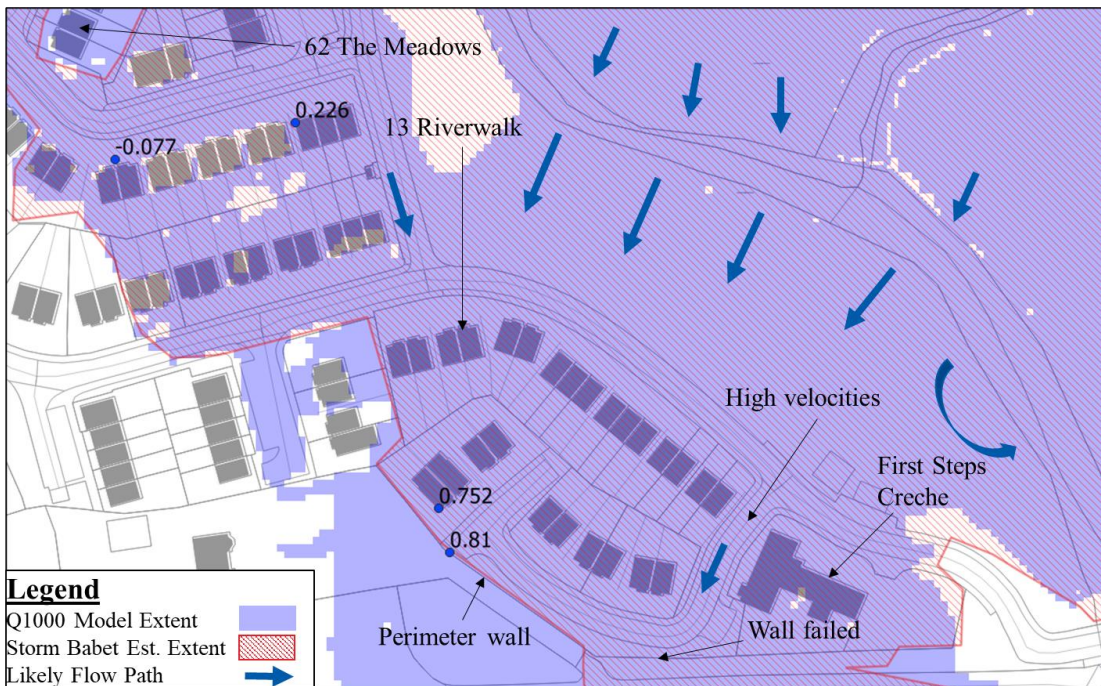
Figure 13: Tir Cluain South: Wrack Marks vs Q1000 Modelled Levels (m) and Flow Path

The southern area of Tir Cluain is at risk of flooding from (a) overland flow that originates from further up in the estate as described above, and (b) overtopping of the right bank of the Owenacurra upstream of the access bridge into the estate which is indicated using the “C” arrow in Figure 7 and with the blue arrows in Figure 13.

A wrack mark was recorded by Arup at No. 62 The Meadows and No. 13 Riverwalk (locations outlined in Figure 13). The maximum depth of flooding at No. 62 The Meadows was circa 0.55m as shown in Figure 14 and 0.95m at No. 13 Riverwalk as shown in Figure 15.

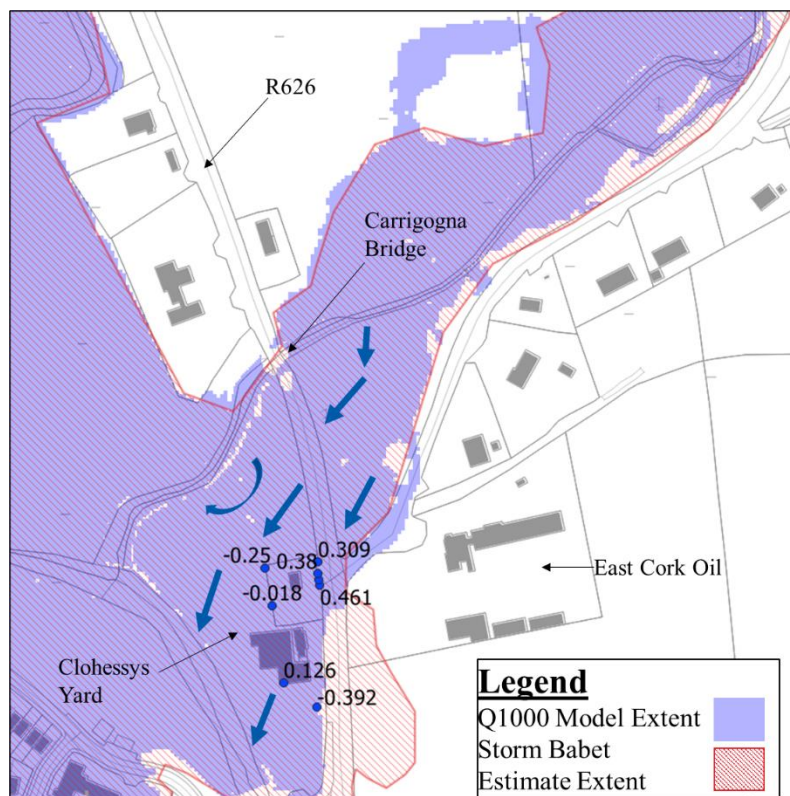
Figure 16: Carrigogna Bridge and Clohessy's Yard: Wrack Marks vs Q1000 Modelled Levels (m) and Flow Path

Figure 16 presents the modelled existing scenario Q1000 max flood extent in blue and the Storm Babet estimated extent in red hatch. The delta between the surveyed wrack marks and the modeled Q1000 max water levels, as well as the likely flow paths which occurred during the event are also detailed in Figure 16.

It can be seen from the figure that the modelled Q1000 extent is generally consistent with the estimated extent from Storm Babet with the exception of the area at the Southern end of the East Cork Oil property.

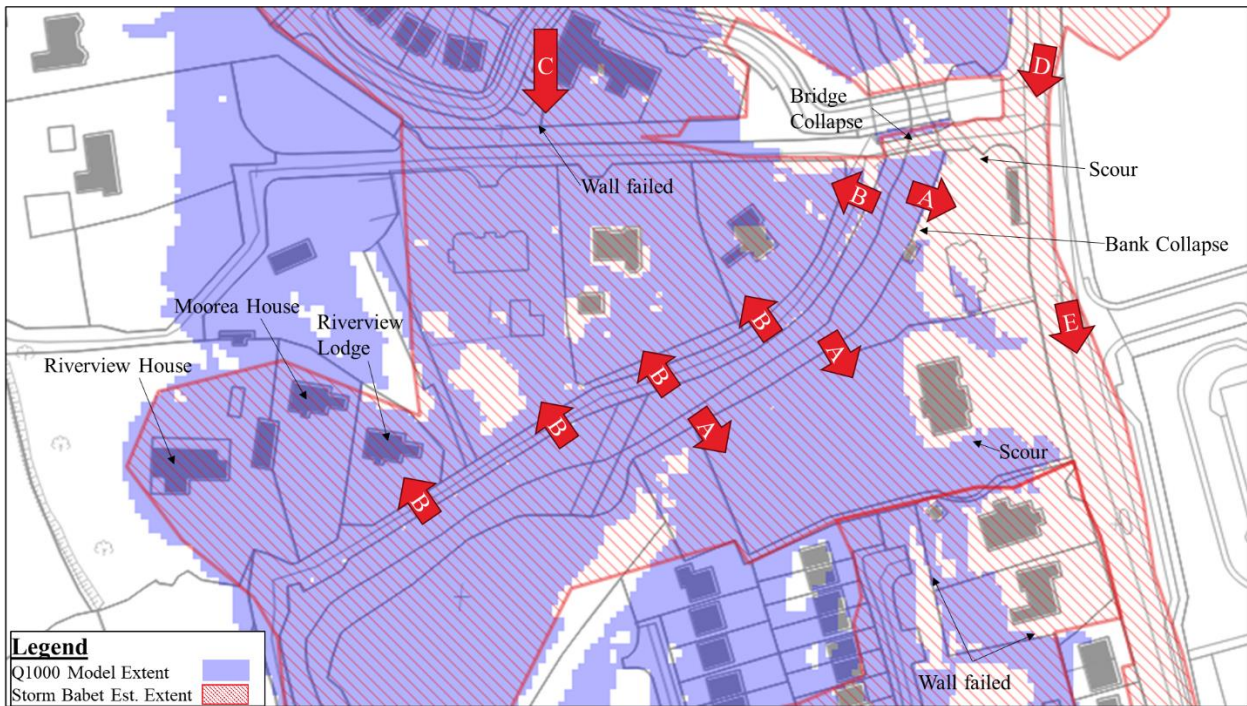
Figure 17: Existing Flood Mechanisms Moore's Bridge/ Mill Road Upper

- A. Water gets out of bank downstream of the bridge on the left bank. This mechanism is represented using the "A" arrows in Figure 17.
- B. Water also gets out of bank downstream of the bridge on the right bank. This mechanism is represented using the "B" arrows in Figure 17.
- C. A number of properties along the right bank downstream of Moore's Bridge are also at risk of overland flow coming from Tir Cluain to the North during extreme events (assuming the perimeter wall has been removed). This mechanism is represented using the "C" arrows in Figure 17.

Arup have confirmed that each of the key mechanisms of flooding identified in the hydraulic report (and as noted above) occurred during Storm Babet. Mechanism C occurred due to the collapse of the wall behind the First Steps creche, and mechanisms A and B occurred due to the capacity of the channel being greatly exceeded during the event.

- Water entered the property immediately downstream of Moore's Bridge on the left bank via the vehicle entrance from the R626. This mechanism is represented using the "D" arrow in Figure 17.
- Water also traveled South along the R626 (Mill Road) resulting in flooding of 2 residential properties in this area. This mechanism is represented using the "E" arrows in Figure 17.

The finished floor levels of the three houses on Moore’s Lane (plotted in Figure 17) range from 11.8mOD to 12.16mOD. Based on a maximum water level wrack mark of 12.58mOD recorded in this area, it is estimated that the depth of flooding of these properties during the event ranged from circa 0.42- 0.76m.

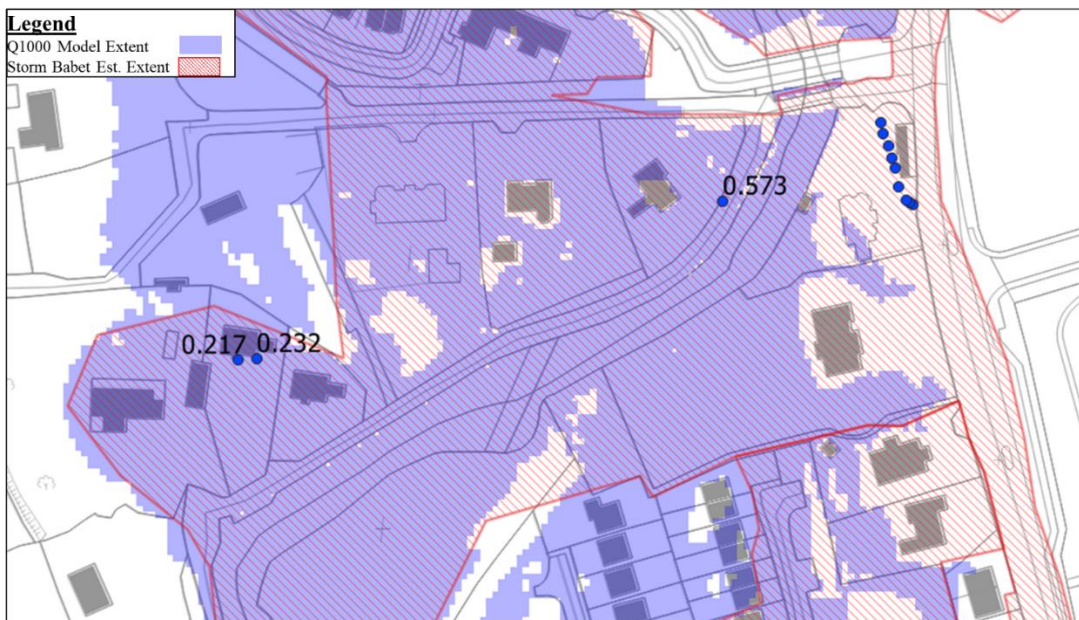
Figure 19: Downstream of Moore’s Bridge: Wrack Marks vs Q1000 Modelled Levels (m)

Figure 19 presents the modelled existing scenario Q1000 max flood extent in blue and the estimated extent from Storm Babet estimate in the red hatch. The delta between the surveyed wrack marks and the modelled Q1000 max water levels are also detailed in the figure. It can be seen that the estimated extent is greater than the modelled Q1000 extent along Mill Road and also within the properties which face out onto the road.

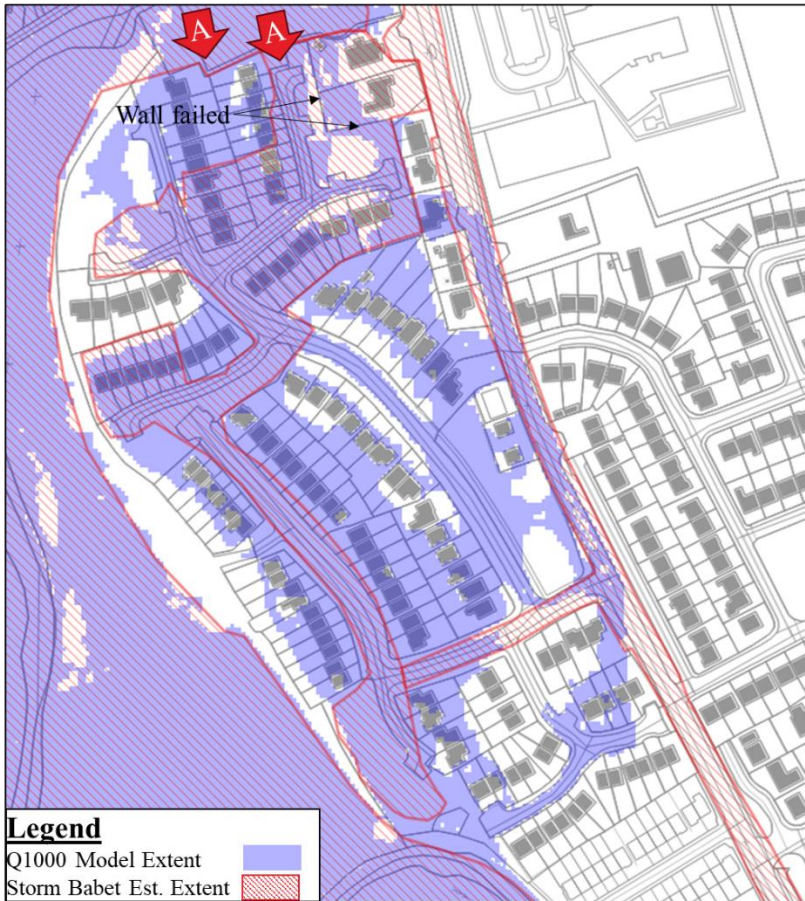
Figure 27: Existing Flood Mechanisms Willowbank

The primary mechanism of flooding to Willowbank in the hydraulic model is due to overland flooding from the North. This flood mechanism is represented by the “A” arrows in Figure 27.

The boundary walls around the estate were removed from the Q100 and Q1000 events in the hydraulic modelling such that all the overland flow enters the estate unimpeded. All the walls within the estate itself have also been removed such that there is no impediment to the movement of the water from any structures within in the estate in the model.

As noted above two boundary walls to the North of the estate failed during the event which justifies our approach in removing the walls for extreme events. The walls in the estate however remained standing and did exert an influence on the flow paths during the event. This needs to be considered when comparing the estimated extent from the event with the modelled Q1000 extent.

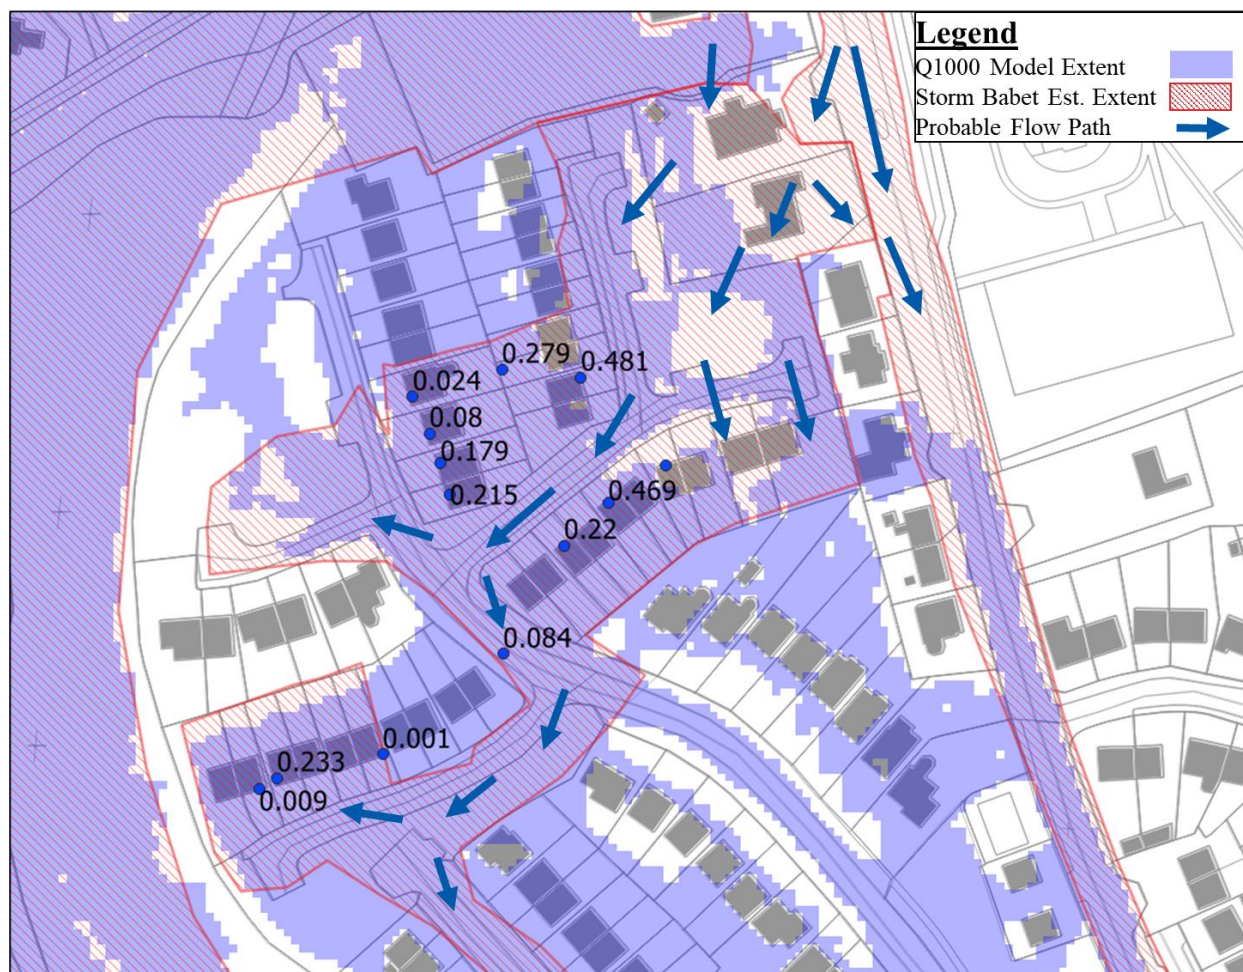
Figure 29: Willowbank: Wrack Marks vs Q1000 Modelled Levels (m) and Flow Paths

A number of wrack marks were recorded across the Willowbank Estate and in all cases, the Storm Babet maximum water levels exceeded the Q1000 modelled water levels. The delta between the surveyed wrack marks and the modelled Q1000 max water levels and the probable flow path are detailed in Figure 29. It is evident however that there are some inconsistencies between the modelled and observed levels indicated in the figure.

OPW staff discussed the observed flow paths with local residents and noted that that flood waters escaped back on to the R626 (Mill Road) south of properties on which the boundary walls failed. This flow path is also included in Figure 29.

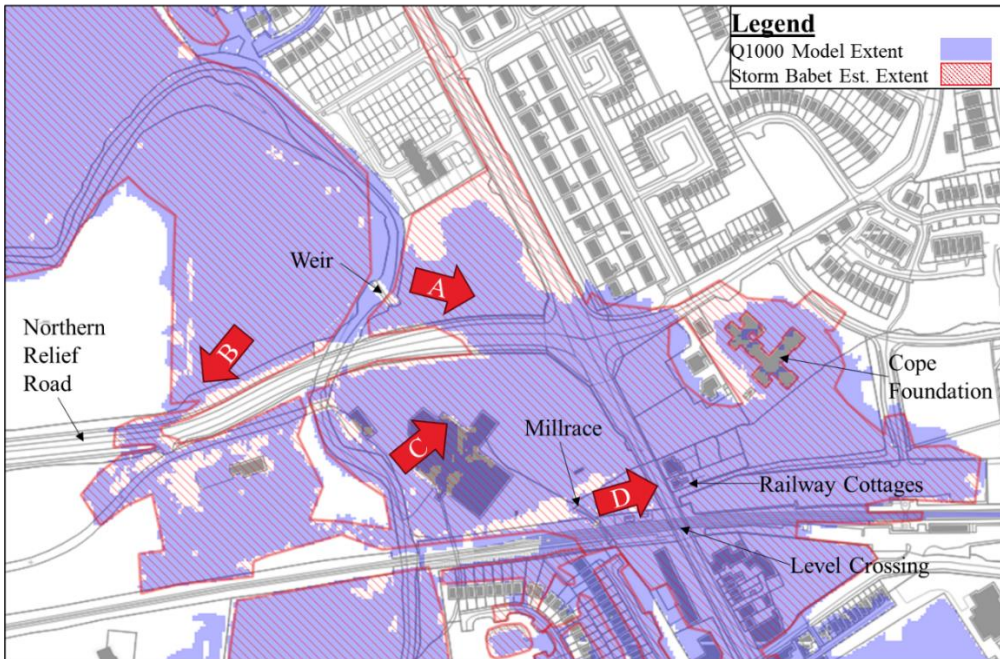
Figure 31: Existing Flood Mechanisms Northern Relief Road/ Rail Line Level Crossing

- A. The Northern Relief Road (NRR) Bridge and Weir cause an afflux along the Owenacurra River upstream of the structures which in turn leads to overtopping of the left hand bank of the river. Once water escapes, it flows in a South Easterly direction and proceeds to flood the R626 (Mill Road) and the Railway cottages
- B. For extreme events water over tops the NRR to the West of the NRR Bridge;
- C. Flood water escapes the Owenacurra River immediately downstream of the NRR and floods the site adjacent to the river. For the Q100 event and above the volume of water on the site is sufficient to drive water across the site and inundate the area of the railway cottages;
- D. Flood water escapes the millrace immediately upstream of the railway culvert for the Q100 event and flows overland towards the Railway cottages.

The railway crossing that intersects with the R626 road in the vicinity of the Railway cottages is elevated above existing ground levels and therefore acts as a control on flood levels. For the Q100 event, the volume of water collecting on the northern side of the railway line is sufficient to overtop the crest level and cause water to flow down Mill Road towards the Super Valu and roundabout at the top of Main Street.

Water got out of bank upstream of the NRR/Weir resulting in a very large volume of water travelling in a South Easterly direction towards Mill Road. This corresponds to Mechanism A in Figure 31.

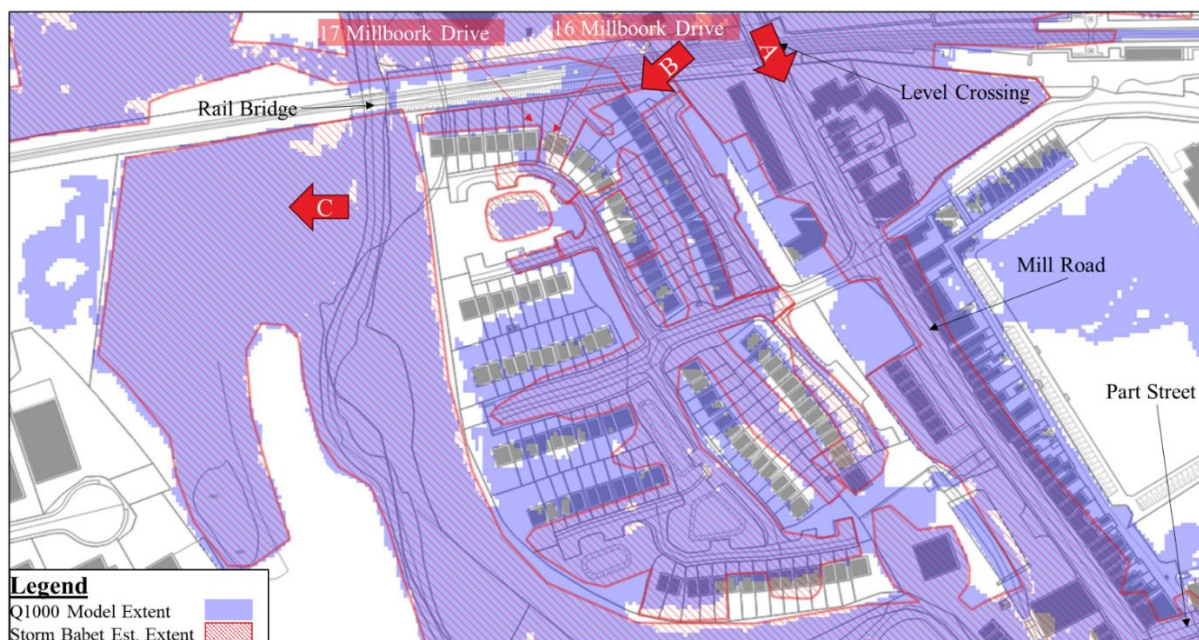
Figure 37: Millbrook/ Mill Road Lower: Existing Flood Mechanisms

- A. A large number of residential/commercial properties were inundated along Mill Road due to water overtopping the level crossing to the north and travelling south. It is noted that the head of water over the railway crossing on Mill Road during the event was observed to be circa 400mm-500mm above the rail track.
- B. The Millbrook housing estate to the East of the Mill Road is also at risk of overland flow from water overtopping the railway line via the back gardens of a number of the properties in the North of the estate.
- C. Water gets out of channel on the right bank downstream of the Rail Bridge at low return period events. This mechanism is not however significant and does not impact on any properties.

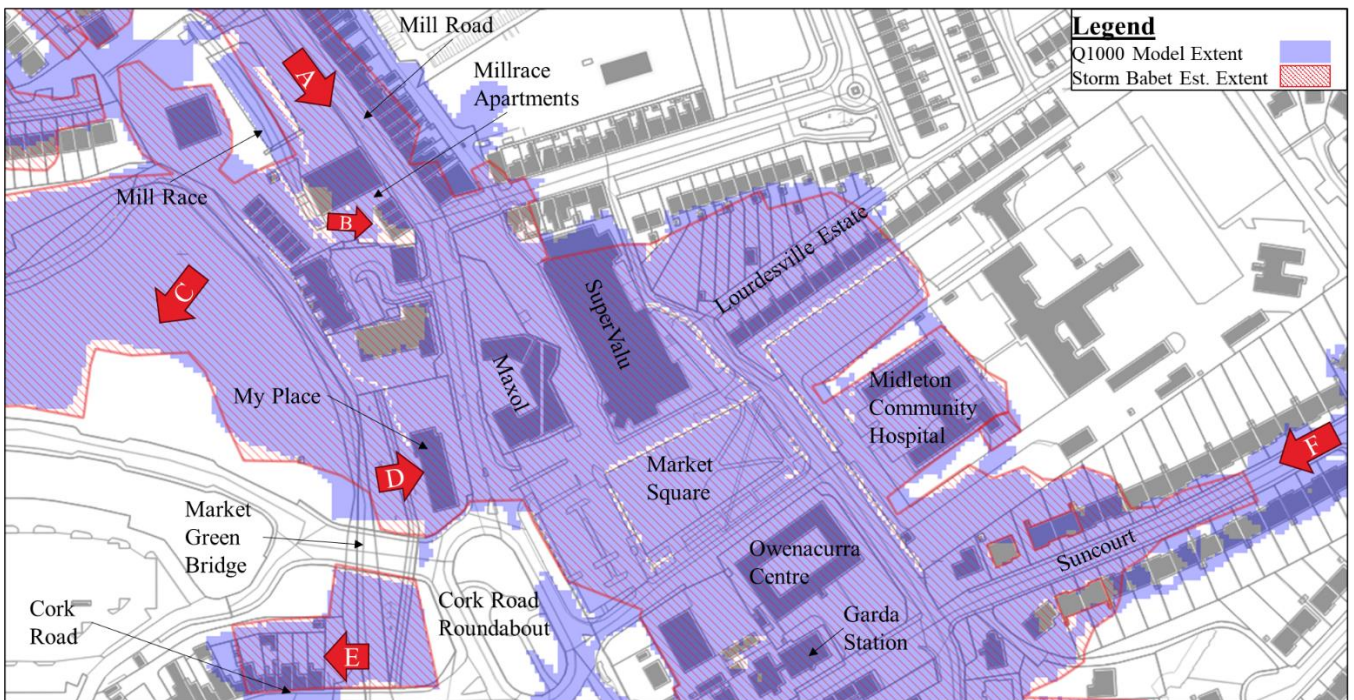
Figure 40: Millrace Apartments/ Market Square Area: Existing Flood Mechanisms

There are a number of mechanisms of flooding in the area from the Millrace apartments to the top of Main Street/Market Square area. This area includes a number of large commercial properties (Maxol Garage, Hurleys SuperValu, Riversdale Shopping Centre), public amenities (MyPlace, Midleton Garda Station), healthcare facilities (Midleton Community Hospital, Owenacurra Centre) as well as residential properties (Suncourt, Lourdesville Estate and properties on Cork Road). The mechanisms of flooding detailed below correspond to the arrows in Figure 40;

- A. As discussed in the previous sections, flood water overtops the railway line and flows south along the R626 road. This is the primary mechanism of flooding for this area for large events;
- B. Water overtops the downstream end of the Owenacurra Millrace in the Q100 event and enters the site of the Millrace Apartments block complex. From here it flows out onto the Mill Road and proceeds to flow south towards the Supervalu supermarket.
- C. Water overtops the right bank of the Owenacurra upstream of the Market Green Bridge at low return period events but is contained by existing ground levels;
- D. Water overtops the left bank of the Owenacurra upstream of the Market Green Bridge in the Q100 event. The volume of water escaping the channel at this location however is relatively minor and flood risk is primarily driven by overland flow coming from the R626 as discussed above.

- E. Water overtops the right bank of the Owenacurra downstream of the Market Green Bridge in the Q100 event.
- F. Overland flow from Area 4 (Lauriston Mews/Midleton Rugby Club)
