# Bray to Greystones Cliff Walk Assessment

North Beach Greystone – Recent storm damage and risk to path

February 2026

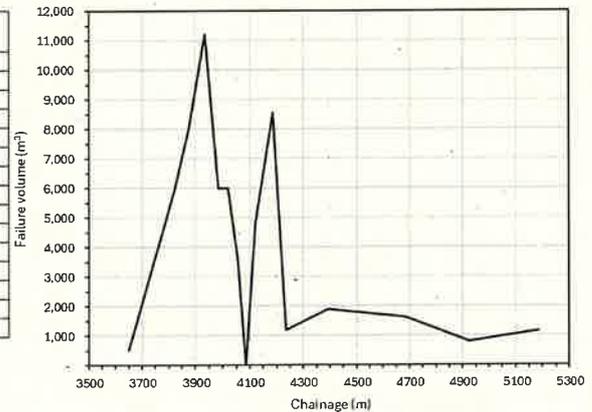
Path running beside Marina Park has numerous slope failures (PATH CLOSED)

Northern section of path has numerous slope failures (PATH CLOSED)

Path is actively being undermined in the northern section, particularly at ch 3880 where:

- THE PATH IS UNDERMINED WITH A 4 TO 5m VERTICAL FACE BELOW
- THERE IS PROGRESSIVE CRACKS OPENING UP IN PATH
- THIS REPRESENTS AN IMMINENT RISK TO PERSONS ON THE PATH

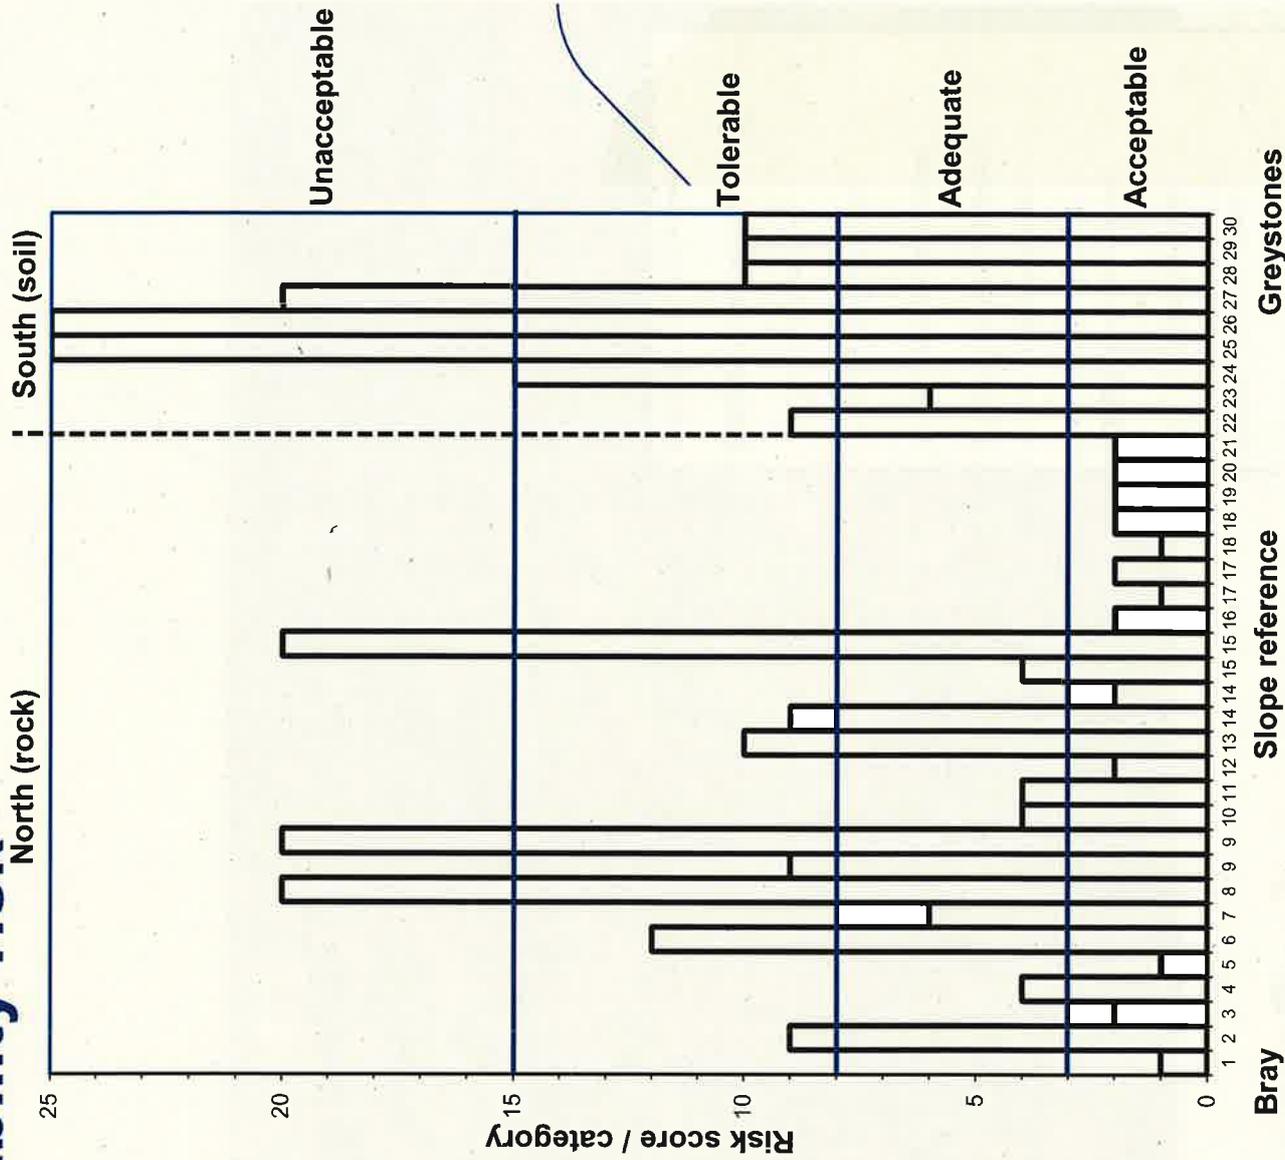
Slope Reference	Upslope		Downslope		End Chainage (m)	Likelihood (L)	Impact (I)	Risk Category (R)
	Start Chainage (m)	End Chainage (m)	Start Chainage (m)	End Chainage (m)				
1	0	275	0	275	275	1	1	1
2	275	800	275	800	800	3	3	9
3	800	900	800	900	900	1	2	2
4	900	1000	900	1000	1000	2	2	4
5	1000	1100	1000	1100	1100	1	1	1
6	1100	1200	1100	1200	1200	4	3	12
7	1200	1250	1200	1250	1250	2	3	6
8	1250	1350	1250	1350	1350	5	4	20
9	1350	1575	1350	1575	1575	3	3	9
9	1350	1650	1350	1650	1650	5	4	20
10	1575	1700	1575	1700	1700	2	2	4
11	1700	1830	1700	1830	1830	2	2	4
12	1830	2020	1830	2020	2020	1	2	2
13	2020	2150	2020	2150	2150	5	2	10
14	2150	2300	2150	2300	2300	3	3	9
14	2150	2300	2150	2300	2300	1	2	2
15	2300	2800	2300	2800	2800	2	2	4
15	2300	2400	2300	2400	2400	5	4	20
16	2800	2900	2800	2900	2900	2	1	2
17	2900	3000	2900	3000	3000	1	1	1
17	2900	3000	2900	3000	3000	1	2	2
18	3000	3085	3000	3085	3085	1	1	1
18	3000	3085	3000	3085	3085	1	2	2

19	3085	3200	3085	3200	3200	1	2	2
20	3200	3300	3200	3300	3300	2	1	2
21	3300	3400	3300	3400	3400	2	1	2
22	3400	3500	3400	3500	3500	3	3	9
23	3500	3600	3500	3600	3600	3	2	6
24	3600	3700	3600	3700	3700	3	5	15
25	3700	3800	3700	3800	3800	5	5	25
26	3800	3900	3800	3900	3900	5	5	25
27	3900	4000	3900	4000	4000	5	4	20
28	4000	4100	4000	4100	4100	2	5	10
29	4100	4235	4100	4235	4235	2	5	10
30	4235	5032	4235	5032	5032	2	5	10
