BORD NA MÓNA – LODGE BOG

Drainage Management Plan

IBE1803 | BnM Drainage Management Plans - Template | Rp10 | November 2021

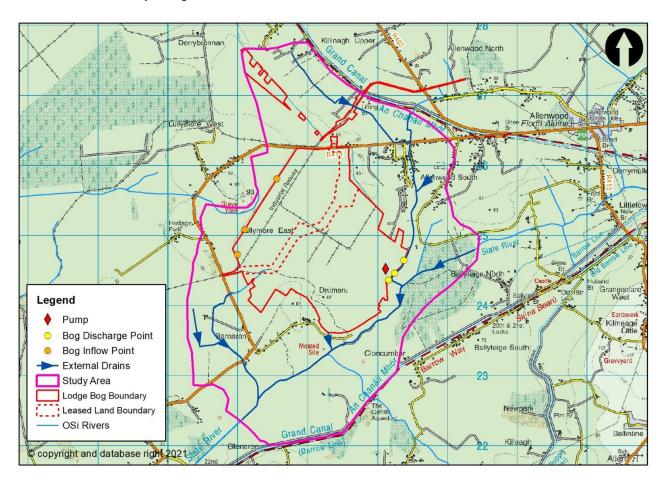
Figure 2-1 Lodge Bog

To characterise the catchments a study area was determined encompassing the total catchment area draining the bog. Lodge Bog discharges to the south east to a tributary which meets the Slate River south east of the bog. A review was carried out to delineate the external drains around the bog as presented in Figure 2.1 along with their associated hydrological catchment area.

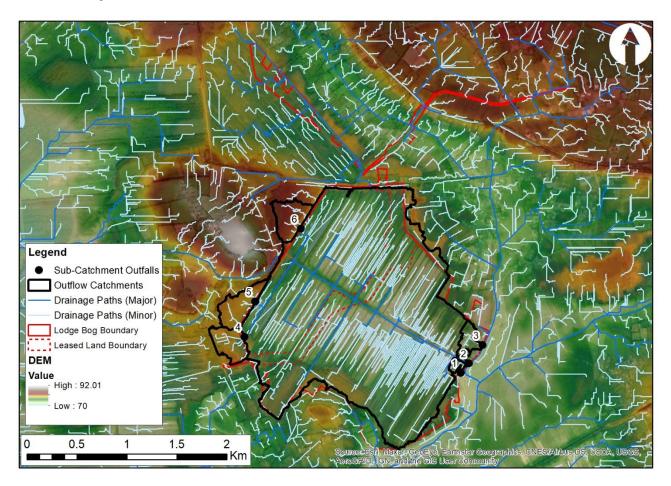
Figure 2-2 Drainage Networks and Sub-Catchments Draining Lodge Bog

A hydrological analysis was carried out within the study area to delineate the sub catchments of the bog drains and the external drains. A recent survey of drainage was carried out by Bord na Móna and this was reviewed, and the bog sub-catchments confirmed. Sub-catchments of the external drains were identified using ARC GIS Hydrology tools. The sub catchments are presented in Figure 2.2.

There are three sub-catchments draining Lodge Bog (1-3) and three minor sub-catchments (4-6) draining adjacent lands into the bog, catchments area ranging in area from 0.02km^2 to 4.14km^2 . The catchments are subject to rainfall of 805-819 mm/year. The Baseflow Index for the catchments is 0.361-0.399 representing a low catchment permeability. The catchments range from very flat to moderately flat. This information is based on wider catchment characteristics and it is acknowledged that these will vary within the bog.

The Flood Studies Update (FSU) catchment characteristics provide an overview of how much rain a catchment receives, how impermeable the catchment is and how quickly the water will runoff the catchment due to topography and drainage. Table 2.1 summarises the FSU catchment descriptors for the sub-catchments identified in Figure 2-2.

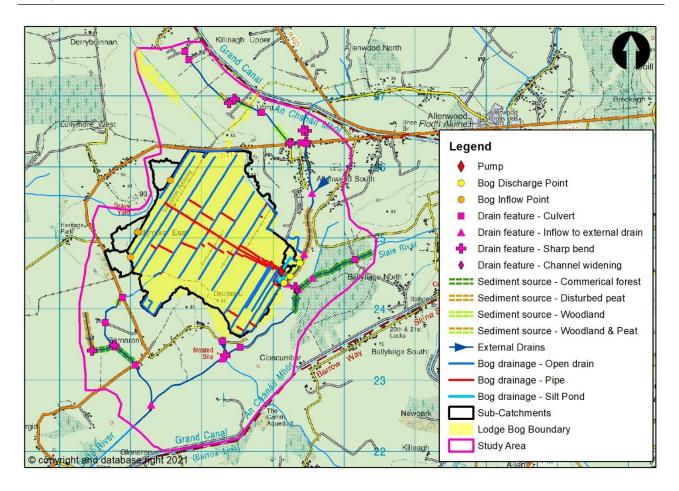
Figure 2-3 Morphological and Hydraulic Characteristics of Lodge Bog and environs

The external drains are generally small with gentle bed slopes. Aerial photography shows no signs of erosion or deposition however, given that the drains are considered small with gentle bed slopes there would be a risk of deposition, and therefore reduced land drainage efficiency. Risk of deposition would occur where there is potential for an erosion or debris source from the surrounding land and where there is potential head loss in the channel due to instream features. Figure 2.3 details the reaches of the external drains where there are potential erosion or debris sources and where instream features may facilitate deposition. The figure shows that due to the location of woodlands, peat and commercial forest in the surrounding lands outside of BnM ownership and control there are existing potential sediment sources that could enter the external drains. Given the presence of culverts, sharp bends, channel widening and inflows along the external drains there would be a potential of sediment settling and deposition occurring. The potential for Lodge bog being a sediment source to the external drains is considered low as all of the discharge points from the production fields have a silt pond present.

A review of the bog drains was carried out. The Bord na Móna drainage survey details the open drains, pipes, settlement silt ponds and discharge points. All of the discharge points from the production fields have a silt pond located upstream which will will ensure suspended solids have settled in pond, thus complying with emission limit values set by the EPA. The drains in the bog have very gentle bed slopes and pass through numerous pipes before discharging from the bog. It is anticipated that the bog drainage network would be sensitive to drain and pipe alterations.

The morphological and hydraulic characteristics of the external drains were assessed. No signs of erosion of deposition could be observed. Areas of deposition risk were identified along each drain. Culverts, bends and inflows were identified as potential factors for sediment deposition. Woodlands, commercial forest, and peat adjacent to the drains were identified as potential sources of sediment. The potential for Lodge bog being a sediment source to the external drains during proposed PCAS activities is considered low due to the presence of silt ponds at all discharge points. In addition to the cessation of peat harvesting.

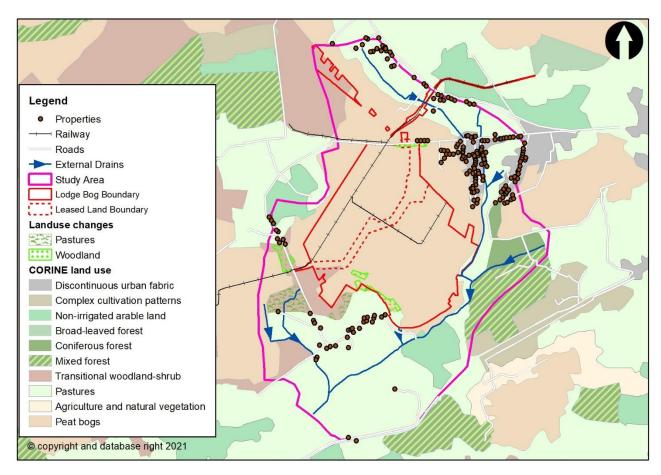
Figure 2-4 Land Use Characteristics of Lodge Bog and environs

The majority of the land within the study area is peat bog and pasture. The remaining areas of the study area consist of non-irrigated arable land, coniferous forest, mixed forest, discontinuous urban fabric and transitional woodland. The CORINE land use dataset was used to identify landuse types. This dataset was then reviewed using aerial photography to establish land use amendments or land use alterations. The review found that additional areas of pasture and woodland are present in the study area. There are some locally important roads servicing Allenwood at the northern extents of the study area, the outer extents of Allenwood village at the north eastern extents of the study area, minor roads, railway and properties are located in the study area also.

The pasture land is mainly used for livestock which provides food production. The commercial forests provide for timber production. The peat bog outside of the Lodge bog boundary is Ballydermot Bog also in the possession of BnM and proposed for rehabilitation. Other areas of peat bog are undisturbed which contribute to carbon storage and biodiversity. The woodland areas are likewise providing carbon storage and biodiversity albeit as a different habitat to the peat bogs. The roads within the study areas service properties, Allenwood and provides access to the pastures, forests and peat bogs. The railway provides access between bogs.

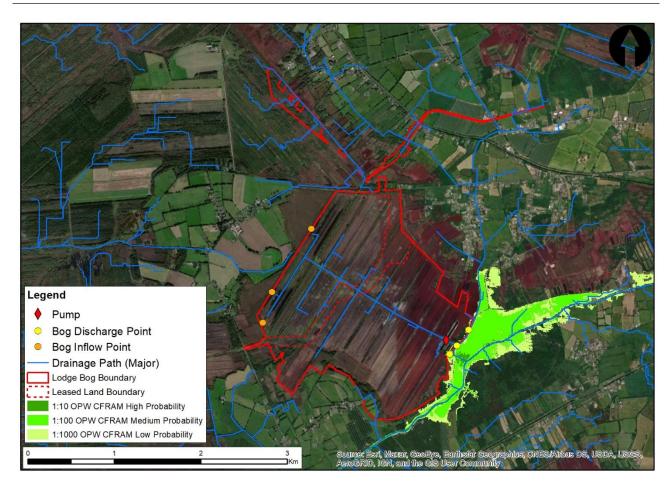
Figure 2-5 Flood Risk at Lodge Bog

- CFRAM Study maps setting out the predicted fluvial 10%, 1% and 0.1% Annual Exceedance Probability (AEP) fluvial flood scenarios
- GSI predicted water table flood maps for high, medium and low probability events
- Mapped fluvial flood extents for the 2009 flood event
- Mapped flood extents for the 2015 flood event (from Sentinel-1 satellite imagery) and a GSI surface water flooding dataset for the same event
- Anecdotal evidence from Bord na Móna

The CFRAM maps show that the area where the bog discharges may be at risk of experiencing flooding or reduced drainage from the Slate River. It should be noted this analysis did not consider the fluvial flood risk from the smaller watercourses which drain the land adjacent to Lodge bog. The 2015/2016 surface water flooding indicate that areas of the bog are at risk of flooding. This is consistent with the local knowledge from Bord na Móna operatives familiar with Lodge Bog.

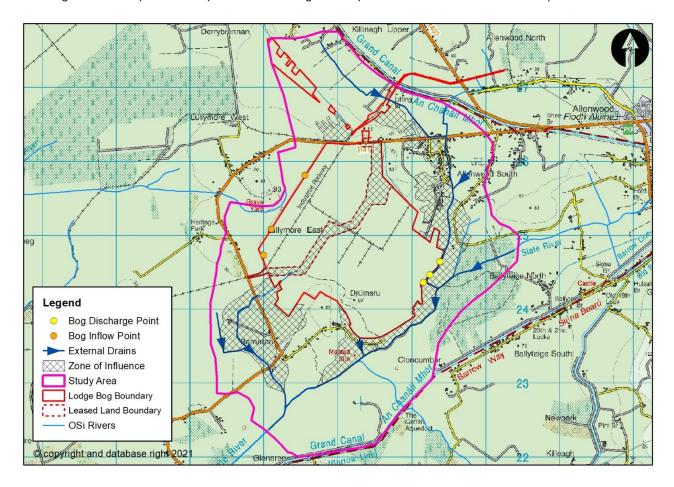
Figure 3-1 Lodge Bog Rehabilitation Plan - Zone of Influence

Three potential impact sources were identified; water table rise, increased runoff from the bog and low flow risk. These impact sources have the potential to make the adjacent land wetter and drain less efficiently or reduce water supply in adjacent drains. An assessment was carried out to delineate the zone of influence resulting from these potential impact sources. Figure 3.1 presents the areas which are at potential risk.

For Lodge Bog the adjacent land lies lower than the bog in some locations, identified in Figure 3.1 as the Zone of Influence, and higher in other locations. Water table rise in lands adjacent to the Lodge Bog was assessed firstly by estimating the potential rise in water table within the bog. The drainage system in the bog is, on average, 0.8m deep. It can be expected that the water table would rise by 0.8m to bring it to the surface. A cross section was surveyed, as shown in Figure 3.3, to assess the potential impact of a water table rise.

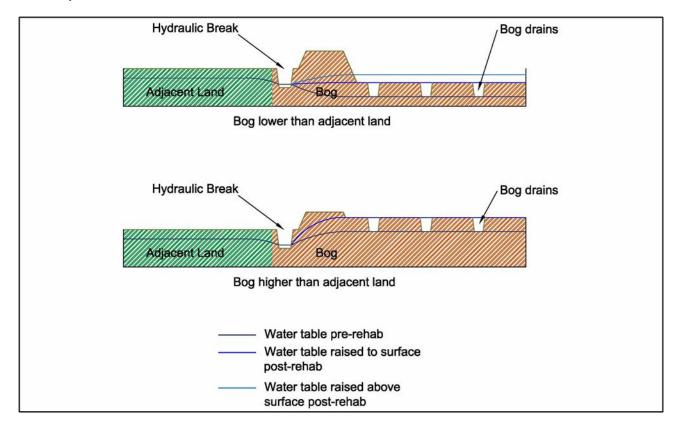
Figure 3-2 The effect of water table rise due to bog rehabilitation

The surface of the bog may lie higher or lower that the adjacent land. This relationship between the bog and adjacent land needs to be considered when assessing potential water table rise. Figure 3.2 show these two relationship scenarios. Where the bog is lower than the adjacent land it would be expected that the water table would remain lower on the bog side even when the water table is raised to the bog surface. If wetland areas are created and the water level is raised above the surface it may result in higher levels than the water table in adjacent lands. In this case the presence of a boundary drain can act as a hydraulic break bringing the water table down to its original level and preventing a rise in the water table in the adjacent land. Where the surface level of the bog is higher that the adjacent land the risk of raising the water table in the adjacent land is greater. However, in this scenario the presence of an effective boundary drain will collect runoff from the bog and act as a hydraulic break bringing the water table back down and preventing a rise in the water table in the adjacent land.

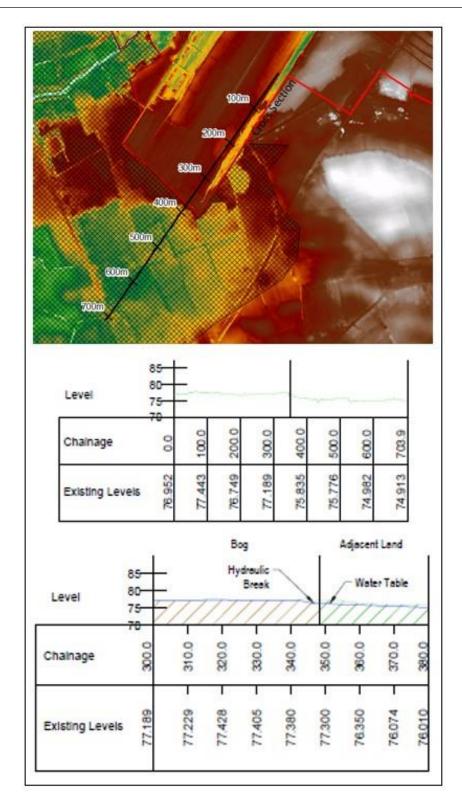
Figure 3-3 Conditions affecting water table

The cross section shows that a rising head in the bog would create a hydraulic gradient across into the adjacent land with the potential for a raised water table in the adjacent land also. This action determines the zone of influence and the areas of potentially wetter ground. The presence of boundary drains however will act as a hydraulic break controlling the hydraulic gradient and reducing the zone of influence. As these boundary drains

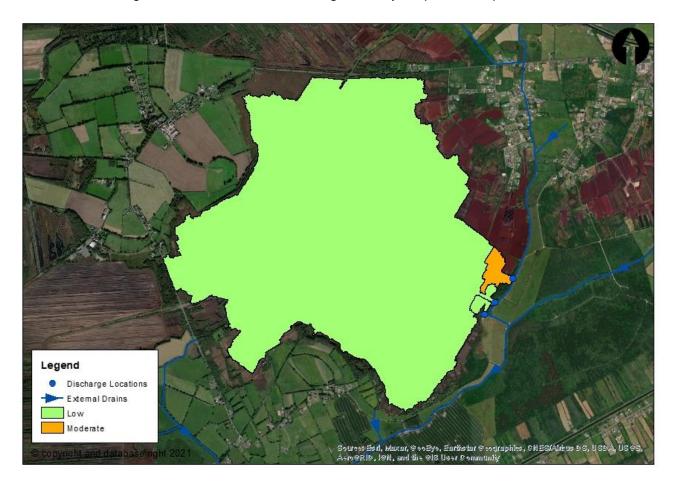
Figure 3.3- Overall Catchment Risk

Through assessing the catchment areas and rehabilitation intensity, one catchment was classified as moderate risk and two were classified as low risk. No high risk catchments were identified that would require further survey and assessment.

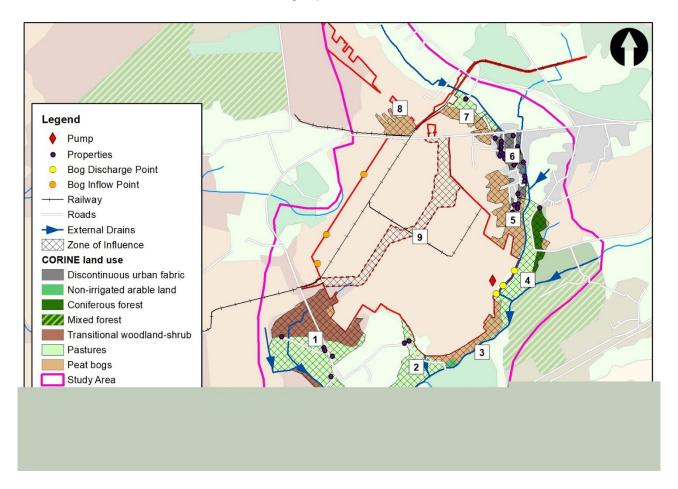
Figure 3-4 Lodge Bog Rehabilitation Plan – Assets at Risk

The following assets have been identified as being at potential risk from flooding or wetter conditions as a result of measures described in Table 3.1 being implemented.

The assets at risk are set out in Table 3.3 along with the vulnerability, based on the current landuse, of the asset. It should be noted that the appraisal of the assets at risk considers the consequences of flooding or wetter conditions, not the likelihood of flooding or wetter conditions occurring.

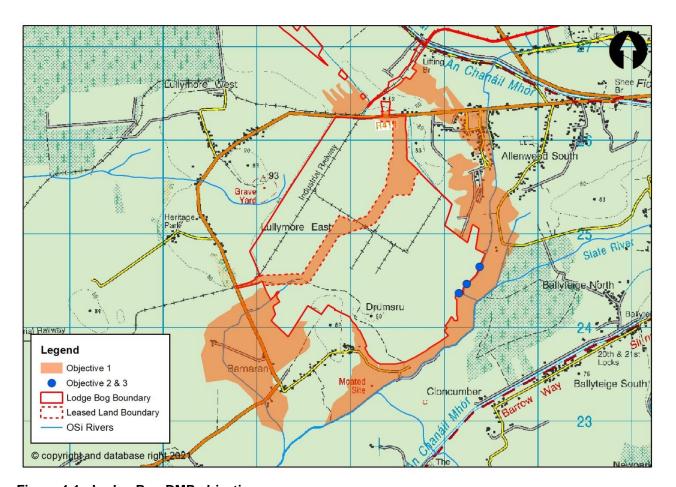
Figure 4-1 Lodge Bog DMP objectives

- 1. To manage potential water table impacts between adjacent land and Lodge bog during and after rehabilitation measures.
- 2. To maintain or reduce flows released from the bog at the discharge locations.
- 3. To manage sediment entering the Slate River during and after rehabilitation, these measures are to ensure compliance with current discharge limits in IPC Licence.

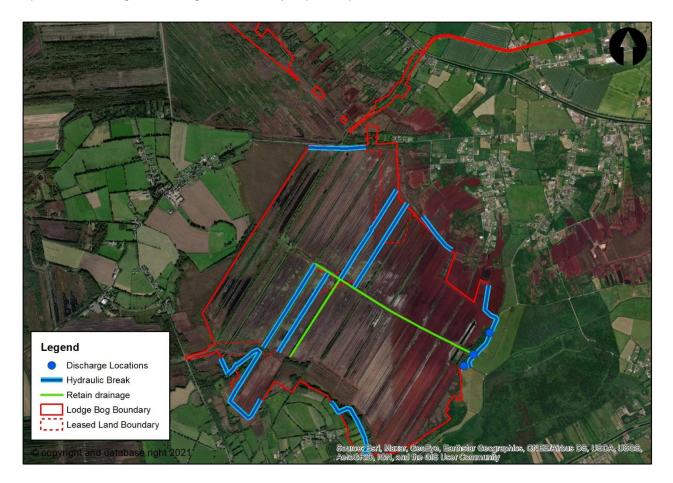
Figure 5-1 Key drainage features for Lodge Bog

An assessment was carried out to identify the existing key drainage features available to meet the objectives set. Figure 5.1 presents the key drainage features identified. It can be seen in the figure that for water table level rise to be managed between the bog and adjacent land that a hydraulic break will be required where available. To ensure that the flow and sediment discharging from the bog is managed the discharge control points will need to be maintained.

Outside the Bord na Móna bog boundary key external drains were identified. These drains are hydrologically connected to the bog drainage network. While no drainage issues were identified along these external drains, see section 2.4, a risk of sediment deposition was highlighted from sources outside the bog. The maintenance of the existing silt ponds will mitigate the risk of sediment deposition arising from rehabilitation. Post implementation of the measures there will be in general a reduction in risk of sediment/silt escape once the bog reaches environmental stabilisation. It is noted that sediment deposition in the external drains could impede the drainage of the bog and adversely impact adjacent lands.

Boundary drains can provide hydraulic breaks between the bog and adjacent land, see Figure 5.1. In most areas of the Lodge Bog where hydraulic break would be required there are existing boundary drains. Available information indicate that these drains are suitable to provide hydraulic breaks and can be designated as such and retained in the future. Observing and recording the suitability of the boundary drains is recommended and where they are found to be not functioning as predicted upgrade works will be required. This would involve modification of the drain to make them larger/deeper/wider/steeper. This may be only in specific locations along the drain or an entire reach may require upgrading. Where there is no boundary drain present a new drain can be excavated in order to create the hydraulic break required. In these cases a channel of specified dimensions and slope will be required and where possible will not extend into the mineral soils (See section 3.2.1).

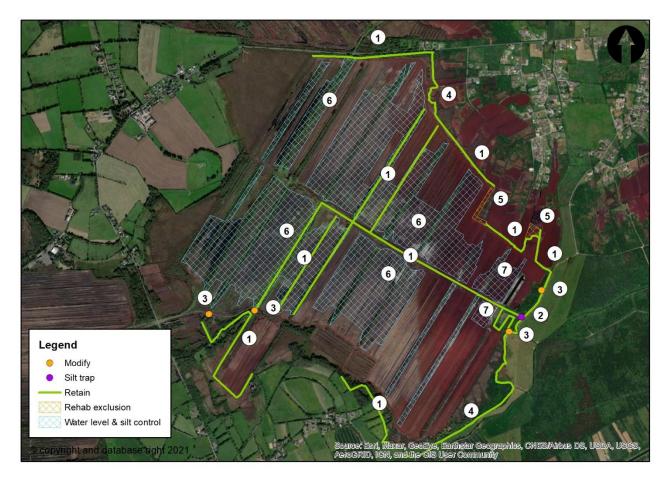
Figure 5-2 DMP Measures for Lodge Bog

Table 5.1 list the DMP measures identified for Lodge Bog and where they sit within the suite of possible measures that could be taken.
