Re: **Garden Village STP: Your letter dated 20<sup>th</sup> November 2023 refers**

**Sub: Letter from Wicklow Co. Co. to Christopher Weinman, re compliance conditions.**

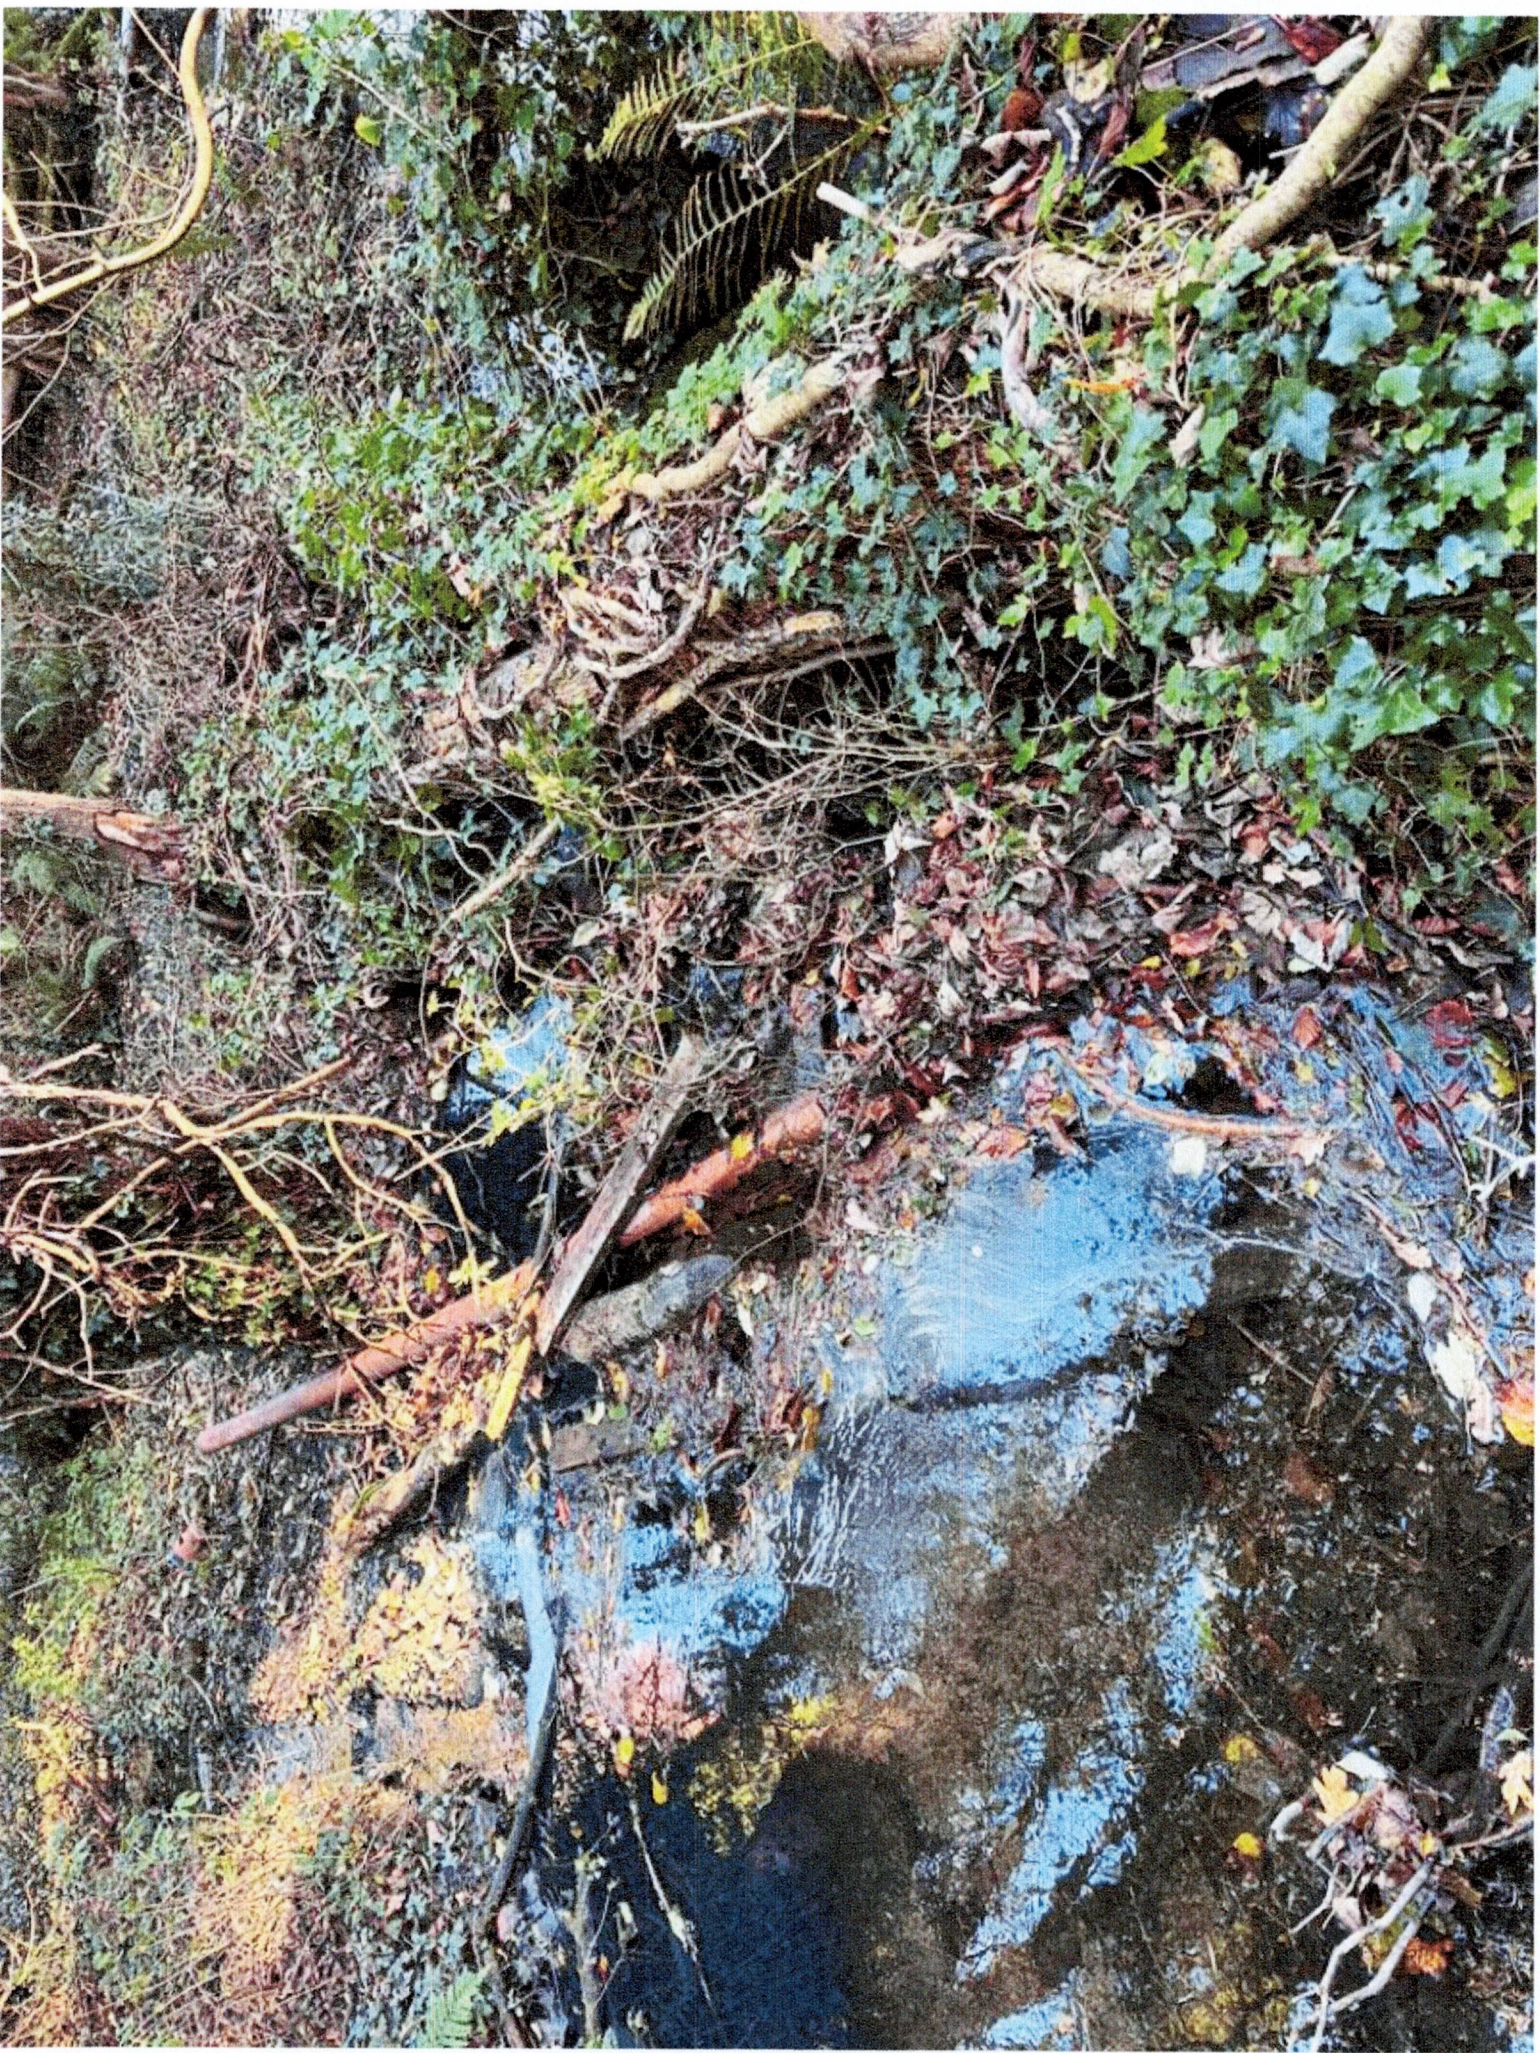
WA0009.

He also found the level of the stream was higher than normal causing flooding of the area.

A tree has fallen across the river creating a barrier and allowing a build up of loose branches see photos WA0009, WA0014.

Our operator cleared the blockage at the fallen tree to the best of his ability allowing the water level to drop he reinstalled the sewer pipe see photo WA0011.

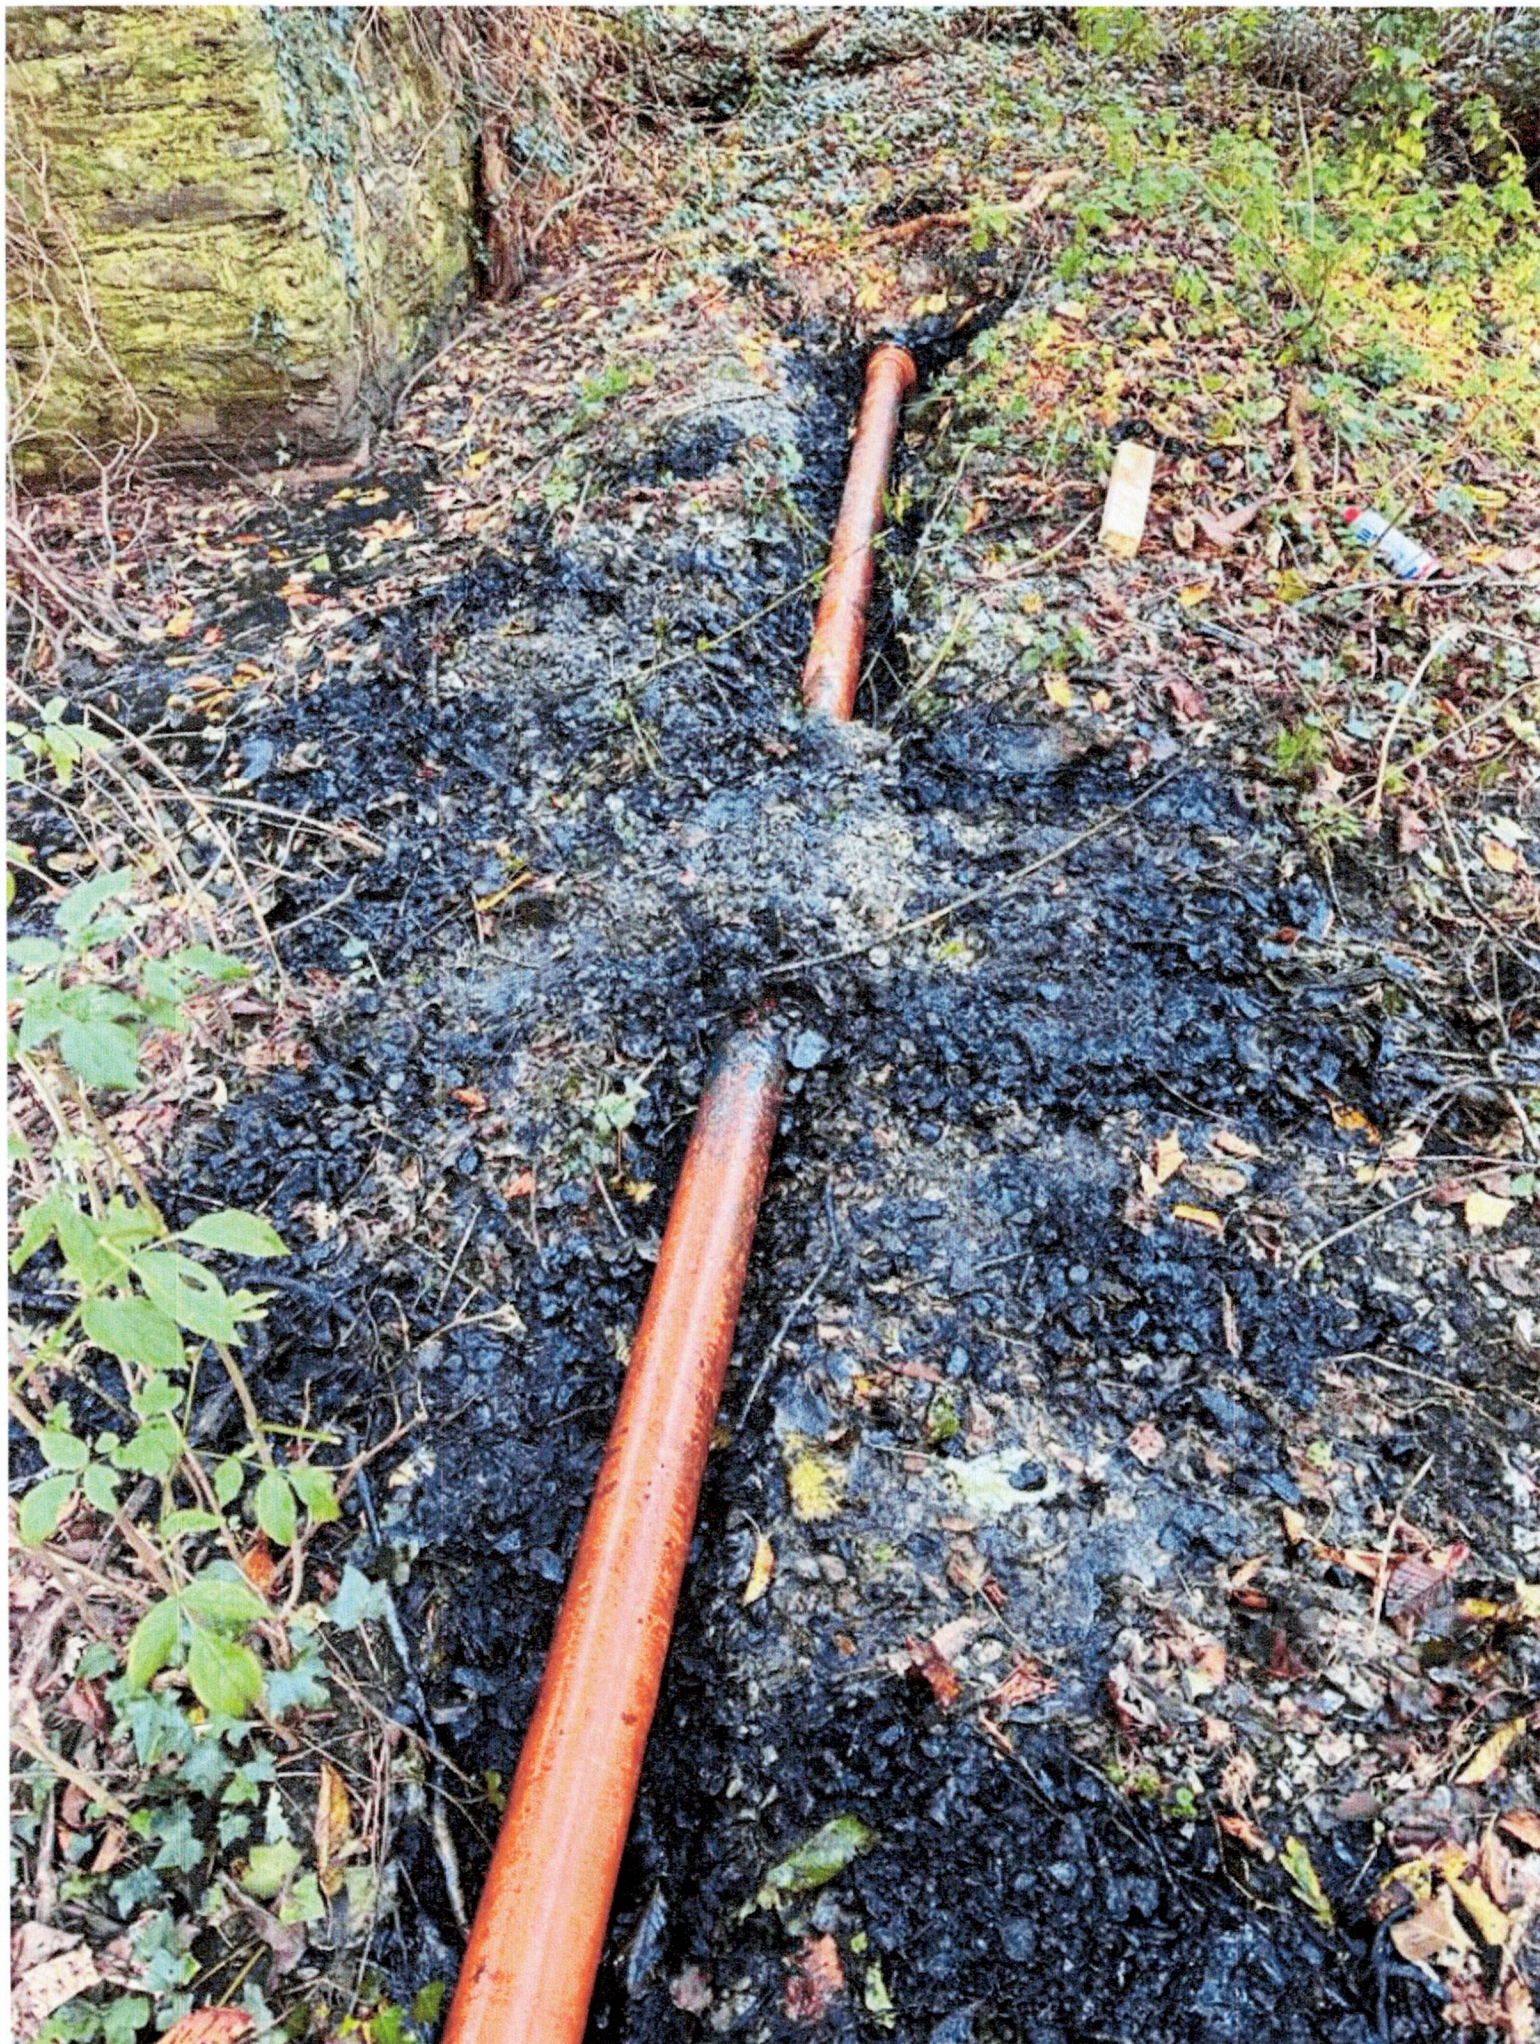
WA 00011

He found the Dn100 sewer discharge pipe blocked with leaves and debris.

The sewer pipe was pulled out from its normal position.
